Flood and Water Management Act 2010

Section 19 Flood Investigation Report

**Storm Callum - Brook Street
Aberaman**

October 2019

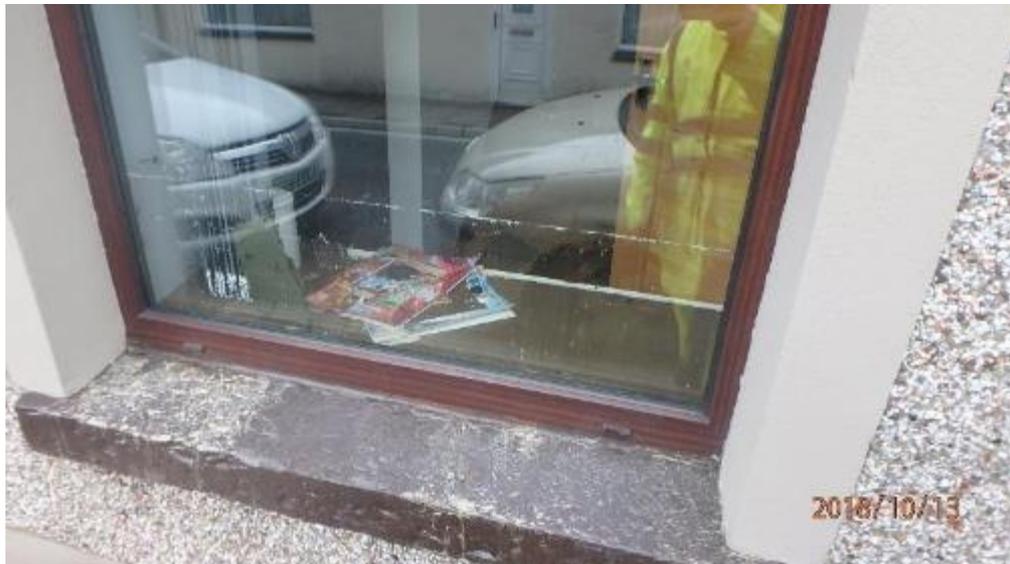
The volume of floodwater within the property was identified during the post event surveys through the debris marks left within the properties that depicts the maximum water level during the event, image 1 and 2 identify flood marks identified within 2 of the properties and indicate a flood depth between 1m – 1.4m. It was noted that the severity of flood depth varied between the four houses as a result of the compartmentalised arrangement of the rear gardens.

Image 1: Post event flood Investigation Photos; this photo depicts the flood depth within the property during the event.

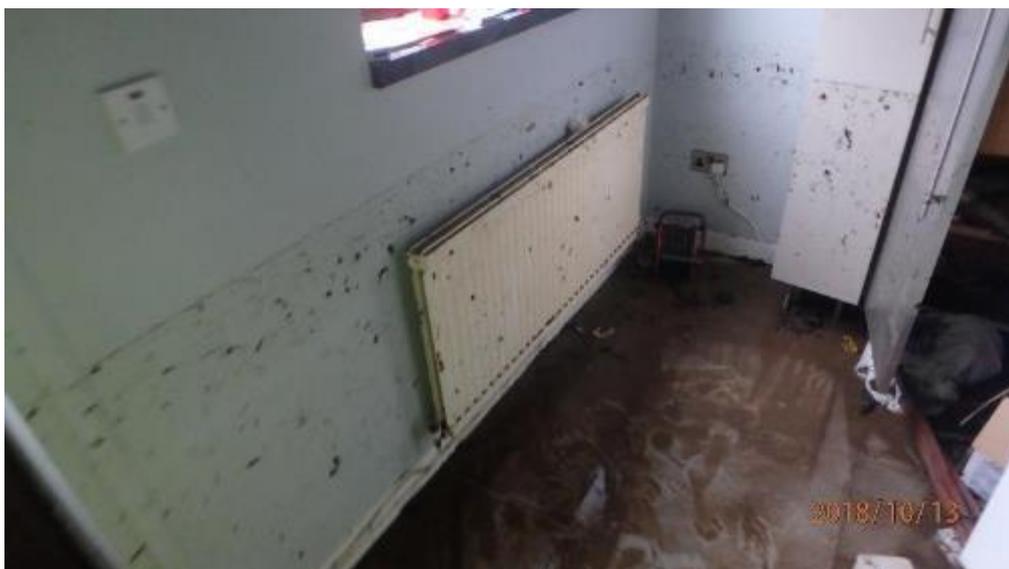
Image 2: Post event flood investigation Photo: This photo depicts the flood depth within a property on Brook Street.

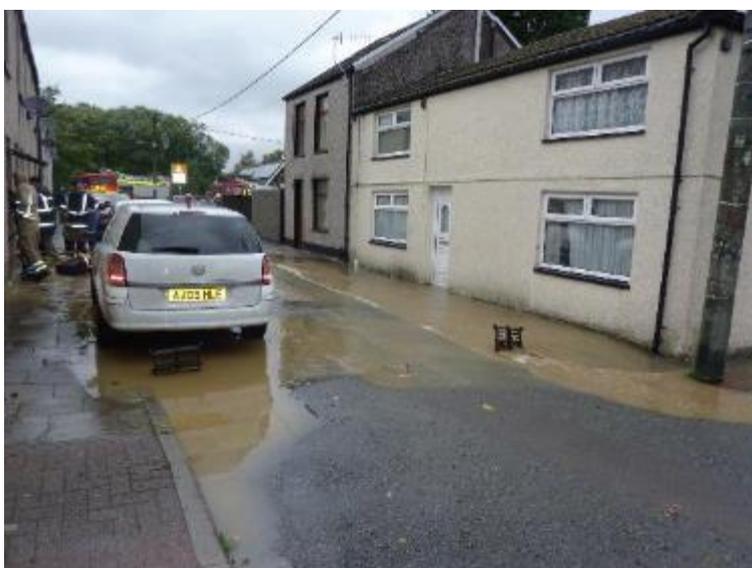
During the initial event the flood water entered through the rear of the properties and released onto the Brook Street highway where the flood water conveyed into the adjacent highway drainage network. As a result of the volume of water the Brook Street highway experienced flooding for several hours during the incident and following the event when the rainfall had dissipated (Image 3).

Image 3: Event Photograph: This photo depicts the conveyance of flood water across Brook Street highway.

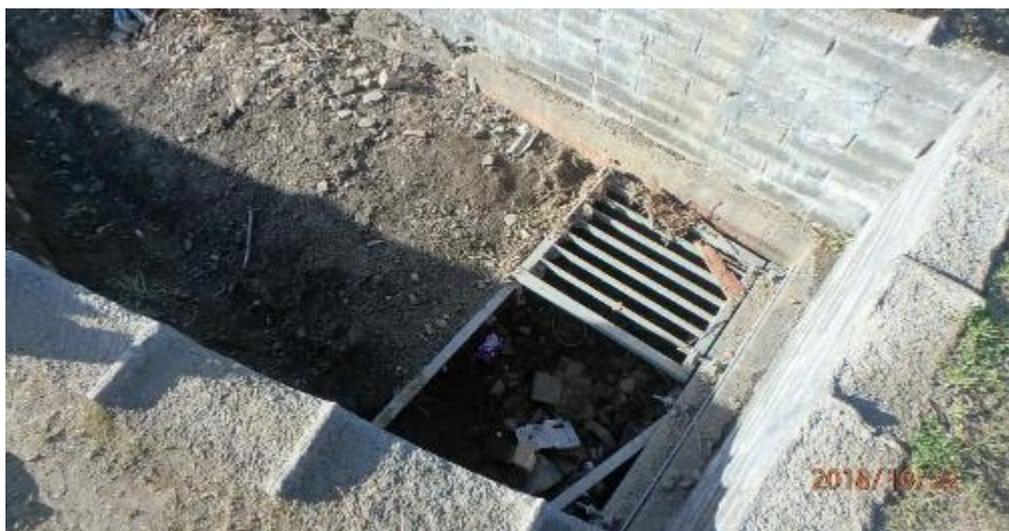
During the post event inspection, the Culvert 2 inlet was found to be holding several tons of silt and debris that was retained by the debris screen, which was identified as damaged (Image 4). The watercourse evidenced signs of surcharging at the inlet due to the debris accumulation however, there was no evidence of conveyance from the inlet area and based on information gained from the South Wales Fire and Rescue Service was not considered to be flooding outside of its channel during the 13th October 2019.

Image 4: Post Event Flood Inspection: This photo depicts the accumulated debris and defective trash screen of Culvert 2 following Storm Callum.

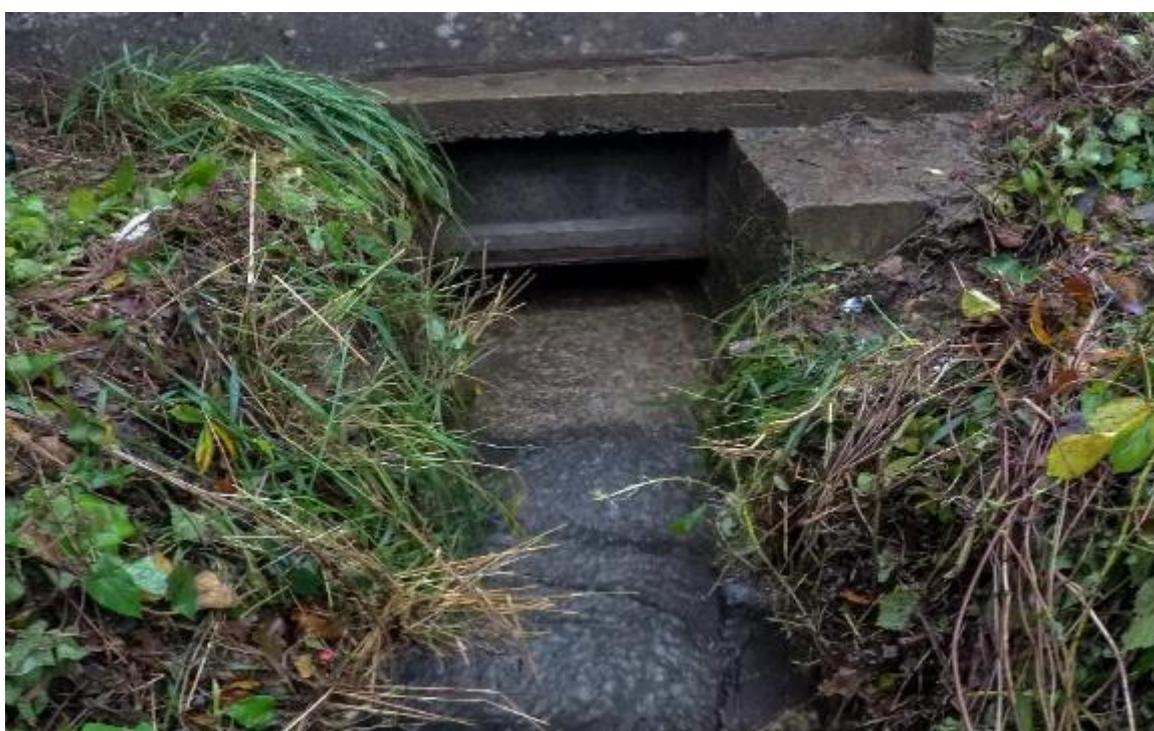
The inlet structure depicted by Image 5 identifies an 'Obstruction'⁴ within the culvert inlet which appears to restrict the inlet structures efficiency to convey the flow of the watercourse.

Image 5: Post Event Photo – Depicts Culvert 3's inlet structure provided by a local resident..

The results from the hydraulic model identified that flooding would occur during a Q30 +30 climate change event with the obstructed inlet of the culvert 3 (assuming no sediment accumulation within the network) (Image 5). ‘Technical note 2’ further reviewed the interaction between the culvert network and the relative level of the Nant Gwawr i.e. outlet control. The results identified that the culvert network was unaffected by the bed level within the Nant Gwawr in its current condition (current bed level).

In review of the flooding event the hydraulic performance of Culvert 3's network was undertaken. The results identified that Culvert 3 with the obstruction present (Image 5) would flood during a Q30 + 30% Climate Change event. When compared to Culvert 3 as with the obstruction removed (Image 8) the inlet was found to flood above Q100 + 30% which represents current design standards for new culverts.

The evidence gathered within this report demonstrates that the cause of the internal flooding at Brook Street on the 13th October 2019 was a result of an un-consented structure being erected by the riparian owner of Culvert 3.

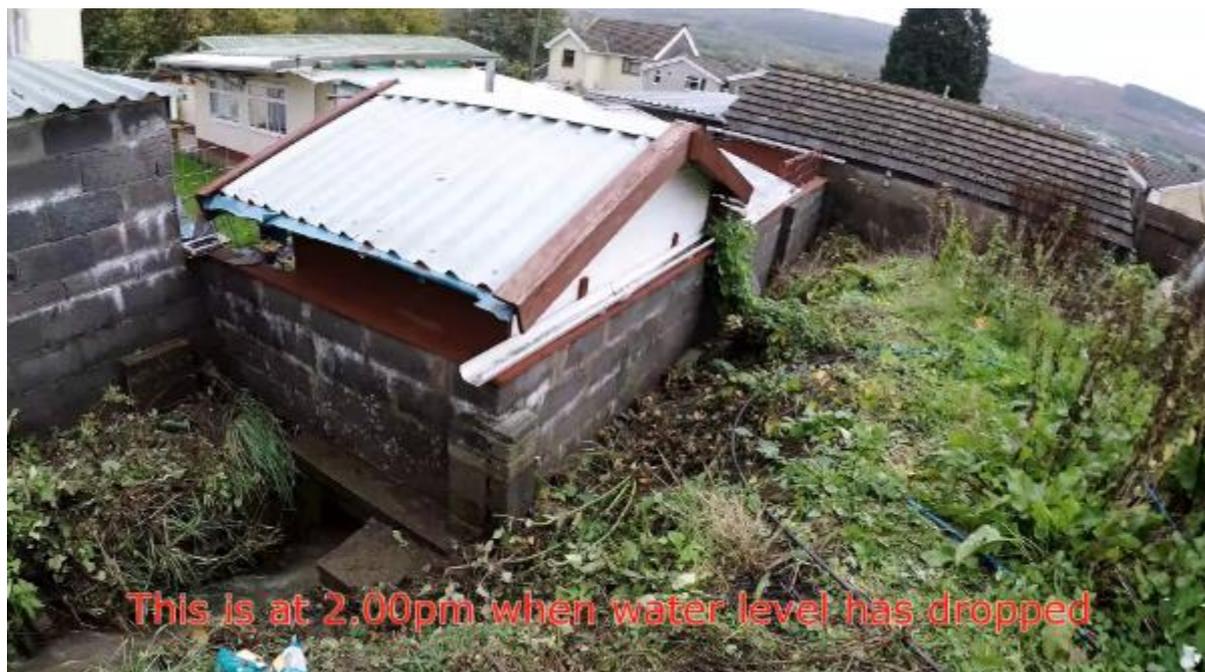
Images passed over to the LLFA by residents (Image 6 and 7) identified a pre and post view of the inlet area where the channel is surcharged and in flood and the post event condition which confirms the source of flooding recorded by the first responders residents and FRM officers.

Image 6: Post event Photo - Depicts Culvert 3's Inlet area following the flooding event on the 13th October 2019 provided by a local resident.

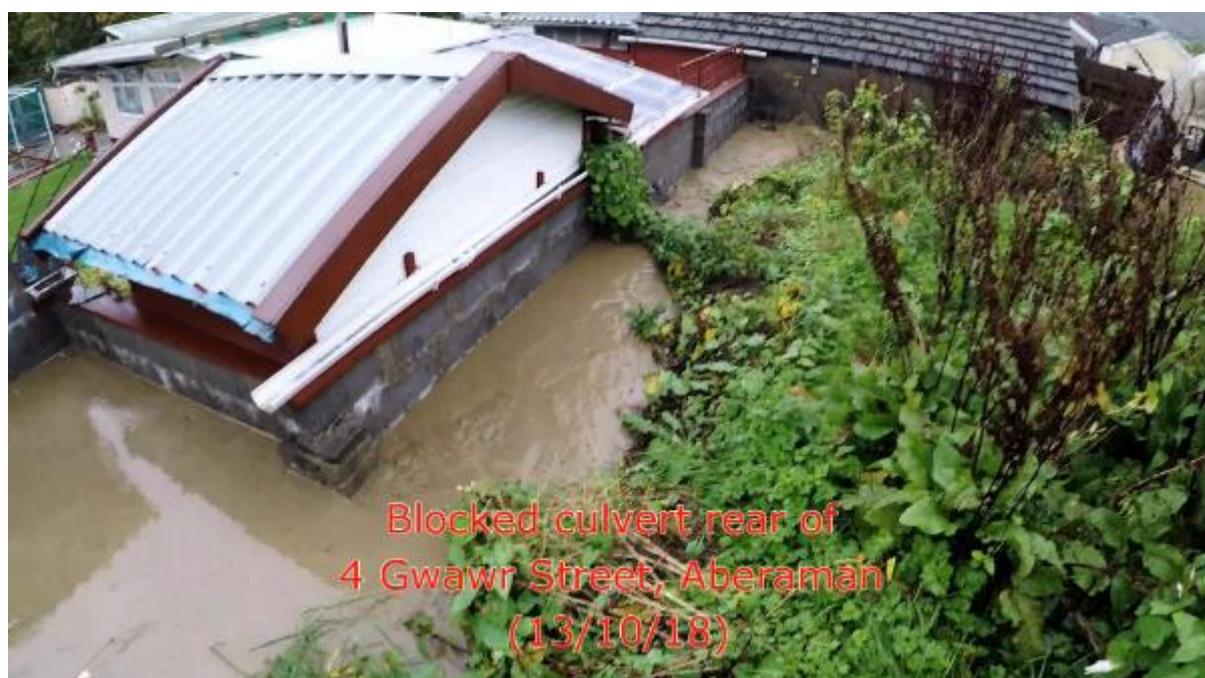
Image 7: Event Photo – Depicts the Culvert 3's Inlet area during the Flood event on the 13th October 2019 provided by a local resident.

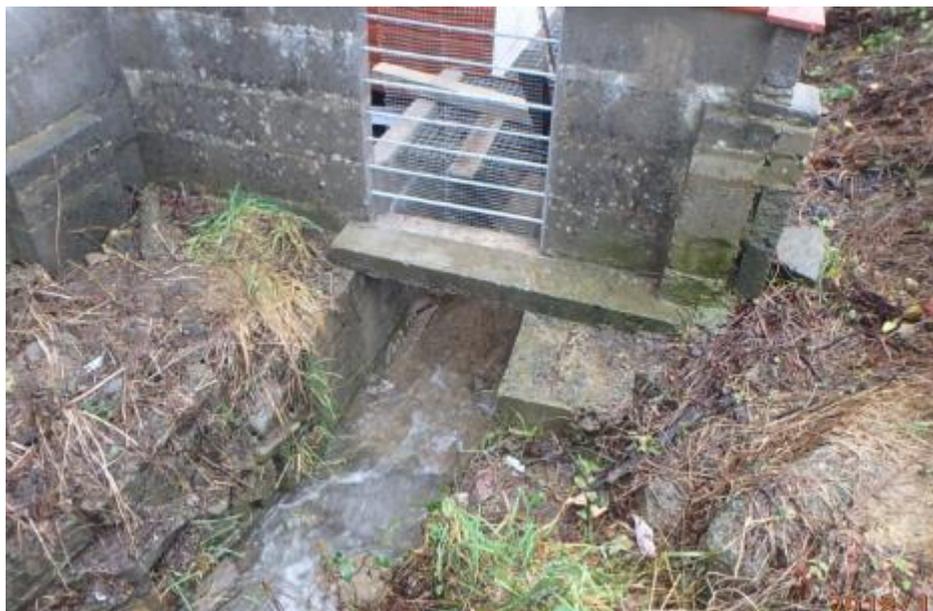
Image 8: Post event photo: Depicts Culvert 3 Inlet area following remedial work undertaken by the riparian owner to reinstate an unobstructed flow.

Following identification of the obstruction within the watercourse the Land Drainage Authority reviewed its records associated to consent's under section 23 of the Land Drainage Act 1991 and identified that the modified structure did not have a consent. Following which, an enforcement warning was issued under section 24 Land Drainage Act that resulted in the owner removing the obstruction within the culvert inlet and reinstating a 670mm opening (Image 8).

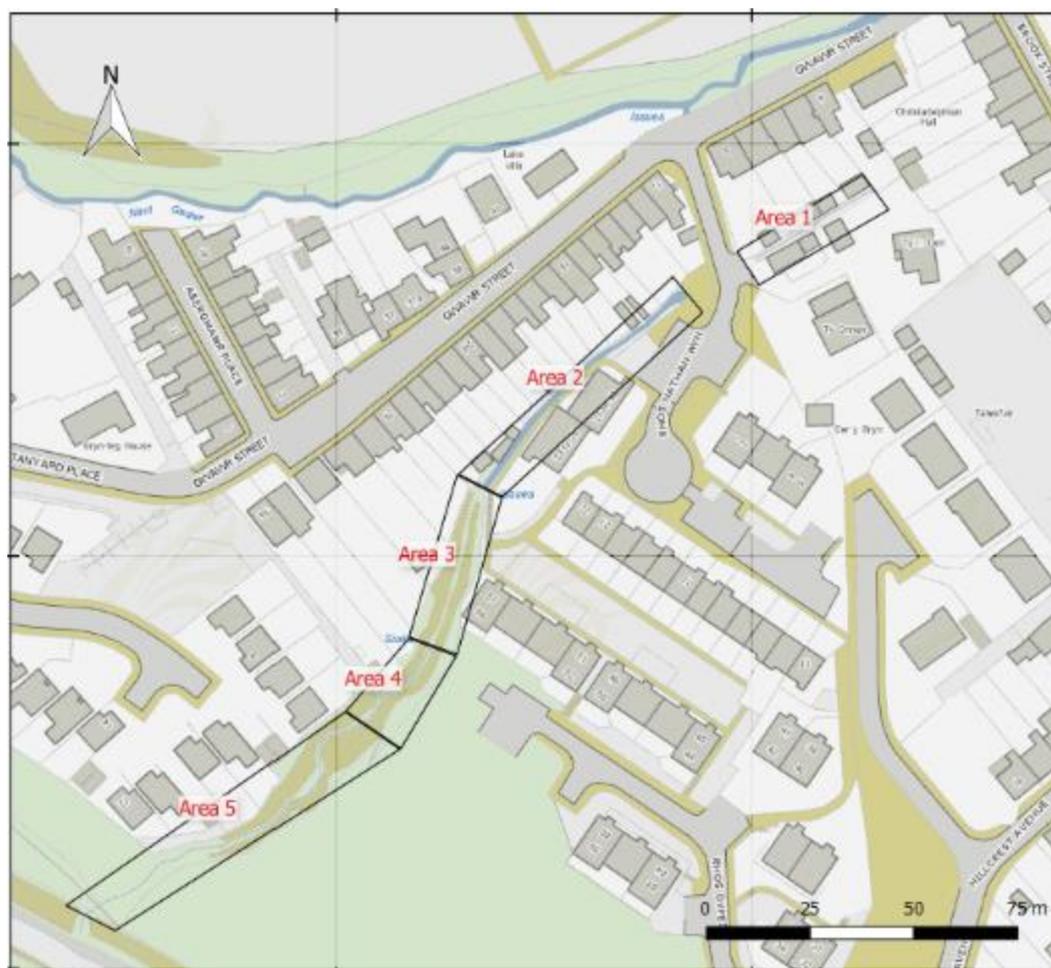
Figure 4: Channel Inspection Location Plan (Technical Note 1)

The summary within 'technical note 1' identified several sections between Area 2 – 4 where the channel and embankments have evidence of scour which is the likely cause of the material deposited against the inlet of Culvert 2. It is of note that Area 1 and 3 show signs of fly tipped material, which is more pronounced within Area 3, which is likely to become mobilised during future high flow events.

Based on the level of debris in Area 2 compared to Area 1 it is considered that Culvert 2 acted as barrier to the conveyance of sediment to the downstream network, debris blockage as a result of upper channel scour is considered to be an unlikely factor related to the flooding on the 13th October.

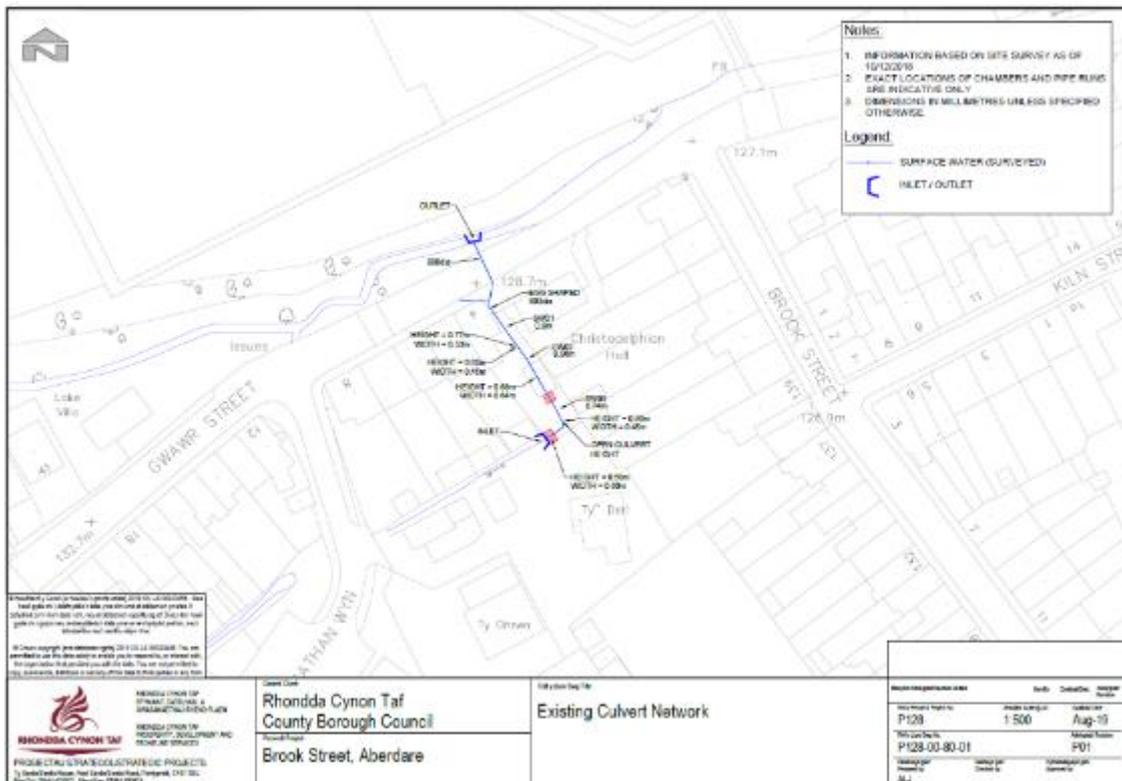
The evidence gathered post event has identified the source of flooding located at Culvert 3. Following identification of the culvert inlet the network was surveyed to ascertain the internal condition of the network (Figure 5), the result of which fed into a review of the hydraulic performance of the network to ascertain the likely cause of flooding.

Figure 5: Depicts the summary results of the Culvert Survey undertaken by the LLFA
