Section 19 Flood Investigation Report

Storm Dennis – Flood Investigation Area RCT12

January 2022

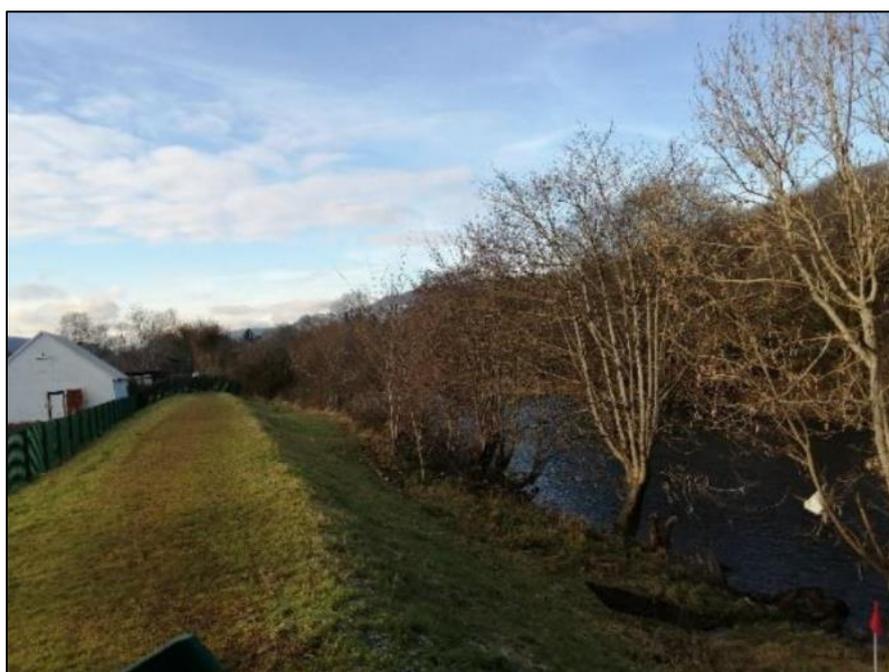
During the early hours of Sunday 16th February, RCT received several calls from residents at Treforest reporting the overtopping of the River Taf which was causing water ingress into properties. The primary flow paths observed during the event saw fluvial flood water convey beyond the western riverbank of the River Taf (Figure 3) and onto Nile Street, following local topography. Flood water subsequently flowed onto Egypt Street and Niagara Street before subsiding at the rear of Broadway (B4595) (illustrated in Figure 7).

Figure 3: A view of the River Taf and southern riverbank, looking north-east (Redstart's Flood Investigation Report)

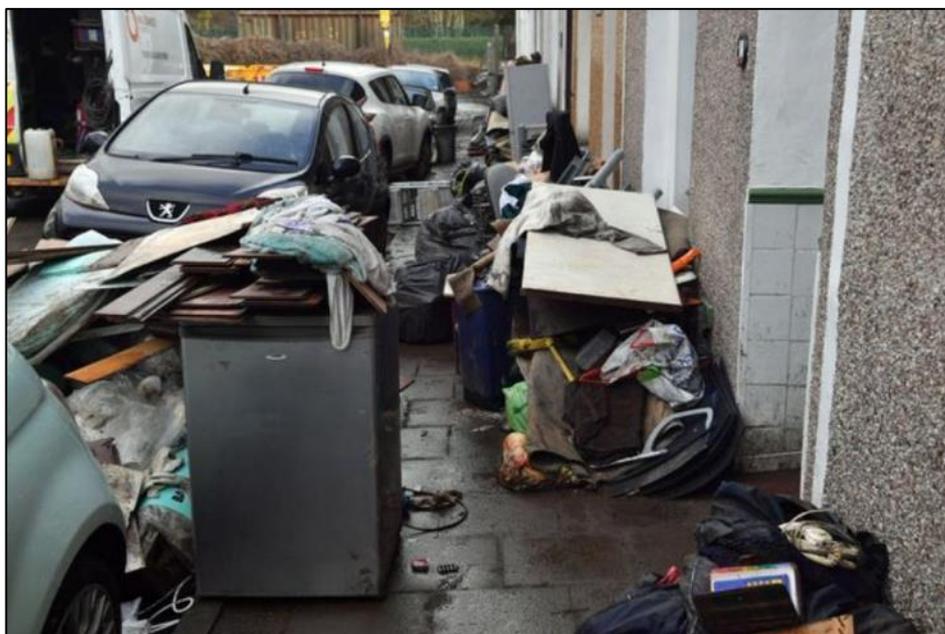
Significant flood depths of over 1.5 metres were reported by residents at Egypt, Niagara and Nile Streets, where at least 42 residential and 6 non-residential properties were internally impacted by the River Taf. Figure 4 depicts the damages caused to property at Treforest following the flood event.

Figure 4: Image capturing the damage to property and belongings at RCT12 following Storm Dennis
(Image: WalesOnline/Rob Browne)

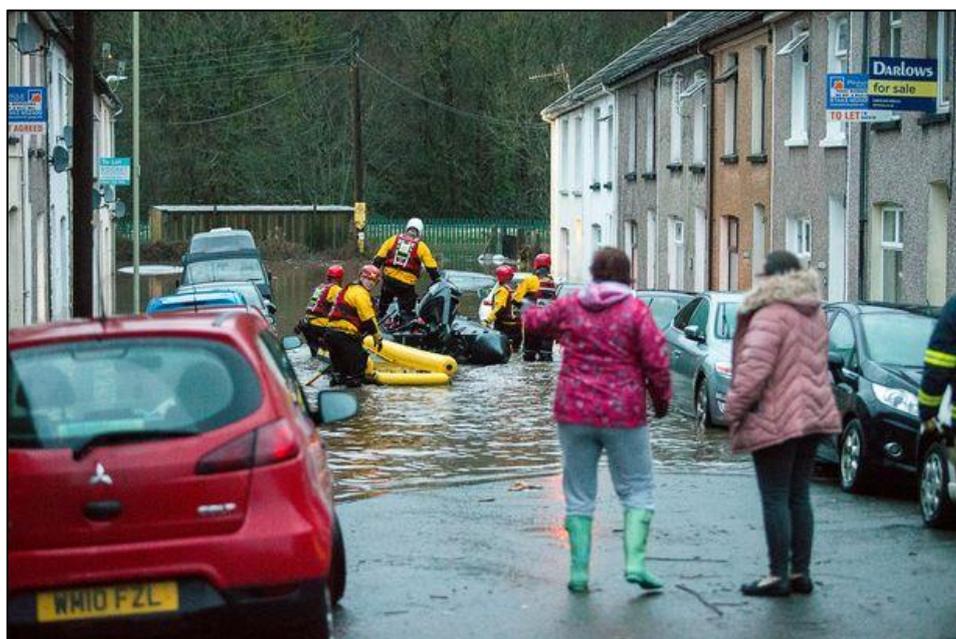
Emergency rescue efforts by the Fire Service were in operation following the overtopping of the River Taf on the 16th February 2020 to evacuate residents from their homes (Figure 5).

Figure 5: Image capturing South Wales Fire and Rescue Service undertaking evacuations within Egypt Street on 16th February 2020, (Image: Huw Evans Picture Agency Ltd)

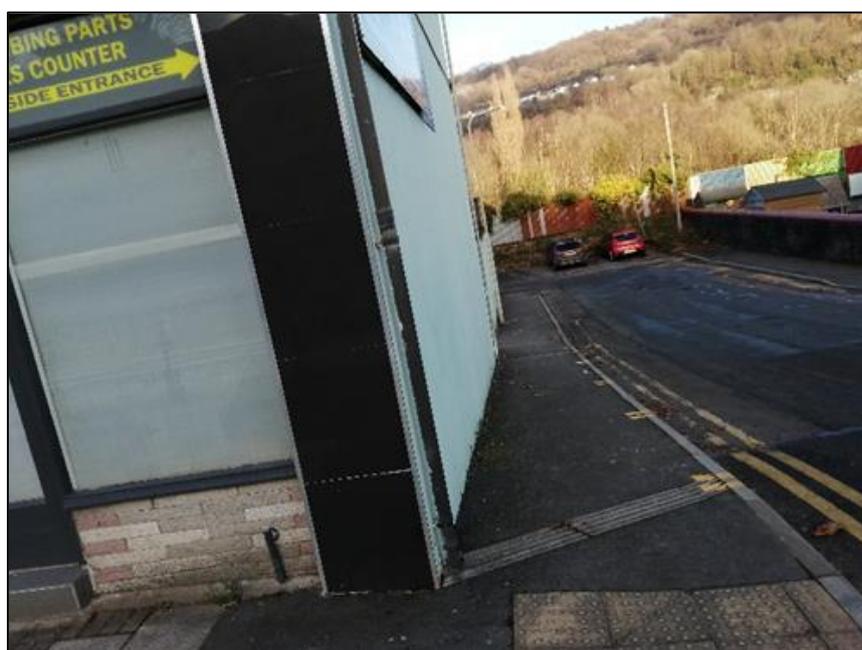
Surface water was also identified as a primary source of flooding at an end of terrace property on Broadway (B4595), whereby pluvial flows from the highway network accumulated on the access road west of Parc Lewis Primary School (Nile Road), depicted in Figure 6, due to local topography.

Figure 6: A view of Nile Road from Broadway. (Redstart's Flood Investigation Report)

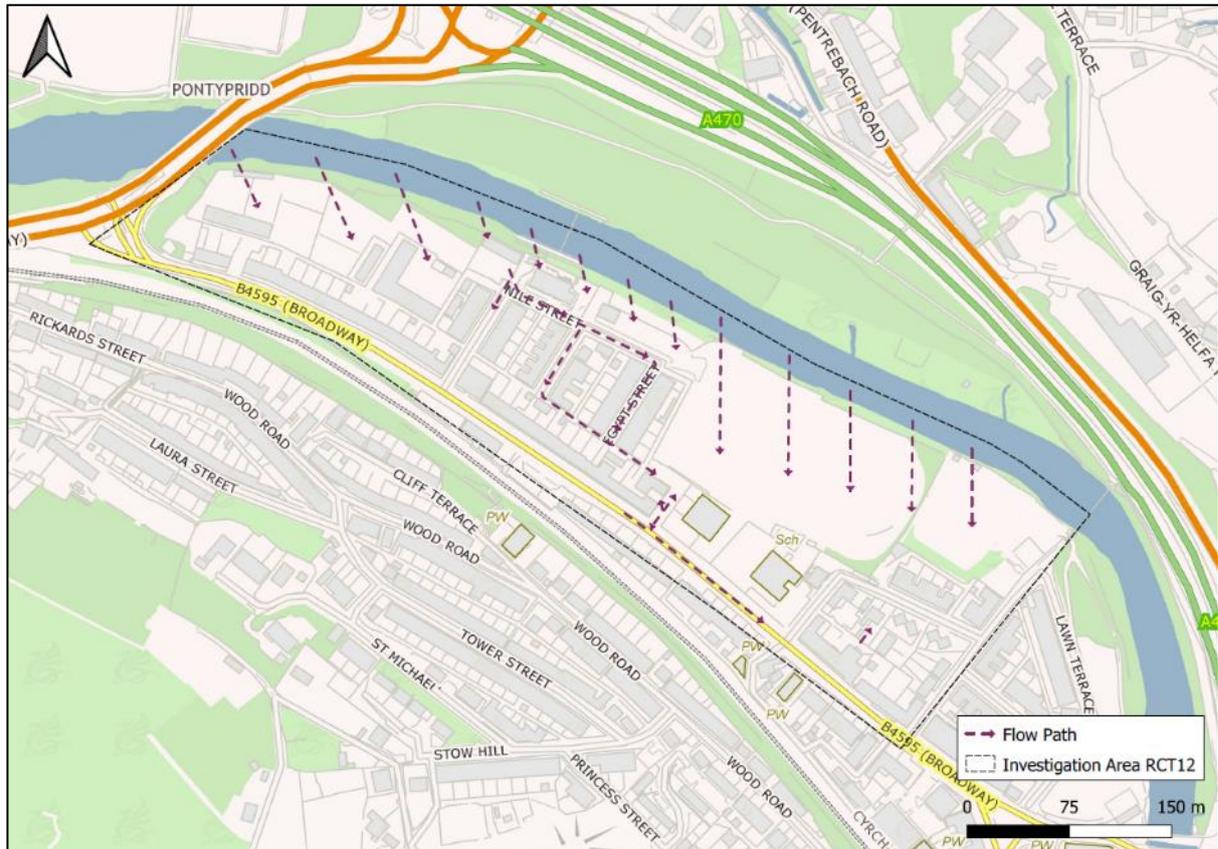
The observed flow pathways that resulted in the internal flooding of properties within the investigation area are illustrated in Figure 7.

Figure 7: Observed flow paths that caused internal flooding within RCT12 during Storm Dennis

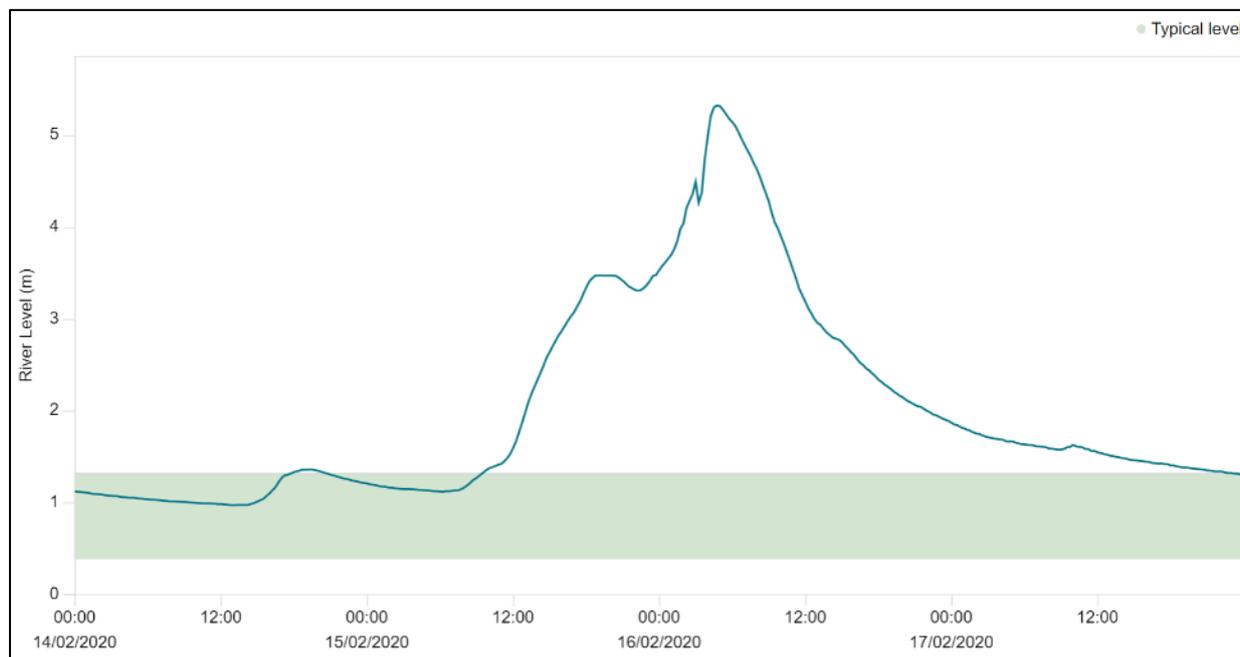
The green bar displayed on the hydrograph shows the typical level of the River Taf at the Pontypridd station, ranging between 0.4 and 1.3 metres. The river level was above this green line for over 48 hours, highlighting the severity of the storm event and its unprecedented nature. At its peak, the River Taf at Pontypridd was almost four meters higher than its average level.

Figure 8: The River Taf levels at Pontypridd station between the 14th and 17th February 2020 (Natural Resources Wales)

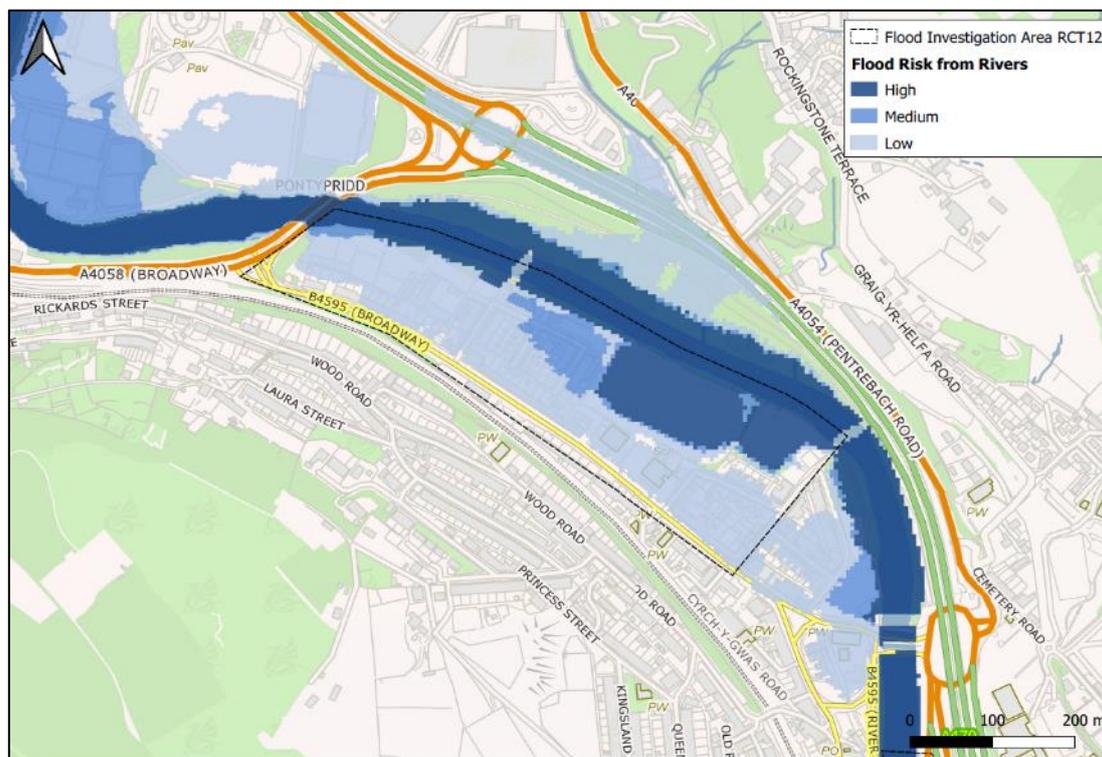
Considering Storm Dennis has been estimated as a 1 in 200 annual probability (Q200) flood event, the area of flooding aligns with those depicted by the low main river flood risk extent (Figure 9).

Figure 9: NRW's Flood Risk Assessment Wales (FRAW) map for River sources in RCT12. Contains Natural Resources Wales information © Natural Resources Wales and database right. All rights reserved.

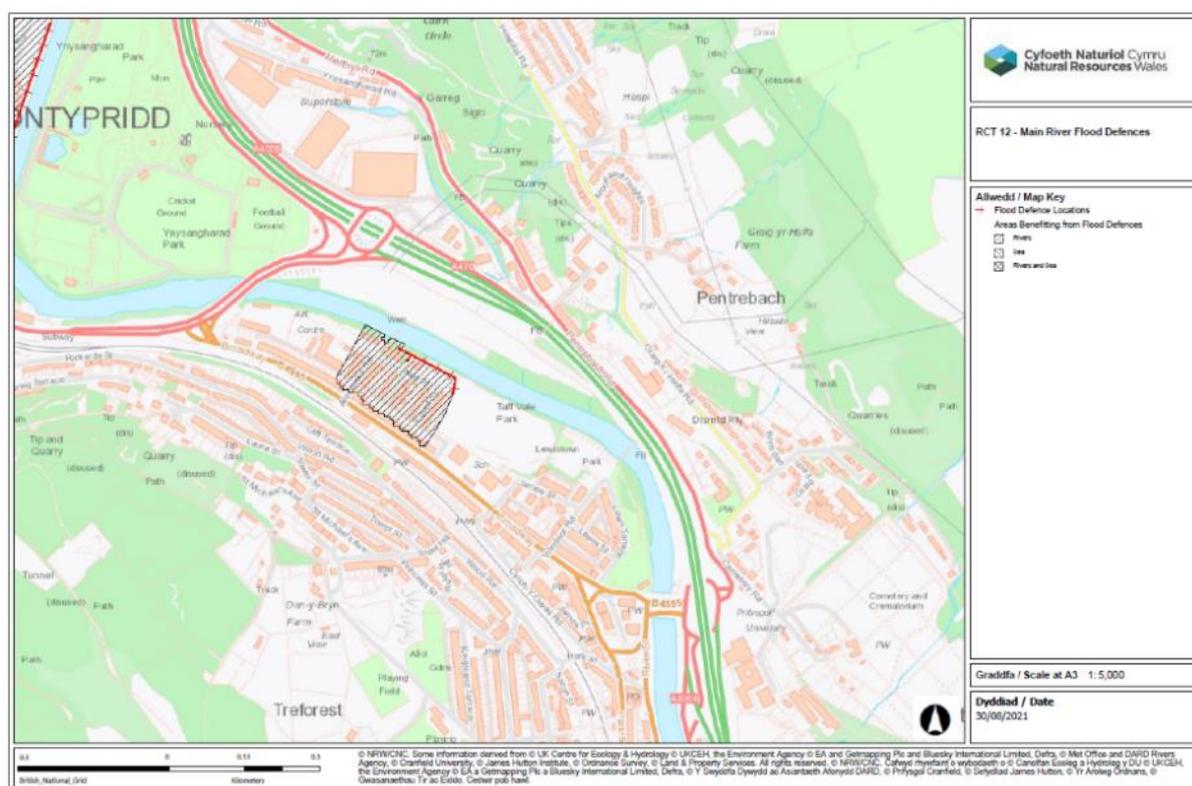
Figure 11: Natural Resources Wales’ map for Main River Flood Defences and areas benefiting at RCT12. Contains Natural Resources Wales information © Natural Resources Wales and database right. All rights reserved

The current indicative design standard of protection for flood defences on a main river is 1 in 100 annual probability (Q100) flood event plus, for new defences, an allowance for climate change. This is stated within the Welsh Government’s National Strategy for Flood and Coastal Erosion Risk Management which encourages main river flood alleviation schemes to provide a Standard of Protection (SOP) up to Q100⁵. It is thereby inferred that the current SOP of flood defence infrastructure at RCT12 is below current indicative standards.

Whilst the flood defences identified at RCT12 are below the current indicative standard, the unprecedented rise of river levels in the Taf during Storm Dennis resulted in the overtopping of assets up to Q100 SOP. NRW’s ‘Flood Incidence Response Review’⁴ does in fact outline that no flood defences failed in the lower Taf region and that the flooding was the result of river flows exceeding the construction design standard.

R1B	<p>NRW to investigate the standard of protection provided by flood defences at RCT12 and “consider improvements to NRW flood alleviation schemes and structures on a prioritised basis”. Aligns with recommendation ‘Action FD3’ within NRW’s Flood Incident Management Review.</p>
					R1C	<p>NRW to review its flood warning service provision, especially for extreme events. This will form part of NRW’s Flood Warning Service Review Implementation Programme and aligns with the recommendations set out in their ‘Flood Incidence Management Review’.</p>
2	Surface water drainage network across RCT12	Rhondda Cynon Taf CBC Highway Authority	Surface Water	Highway Authority and Lead Local Flood Authority	R2A	<p>The Highways Authority to jet and cleanse the highway drainage network and action repairs accordingly.</p>

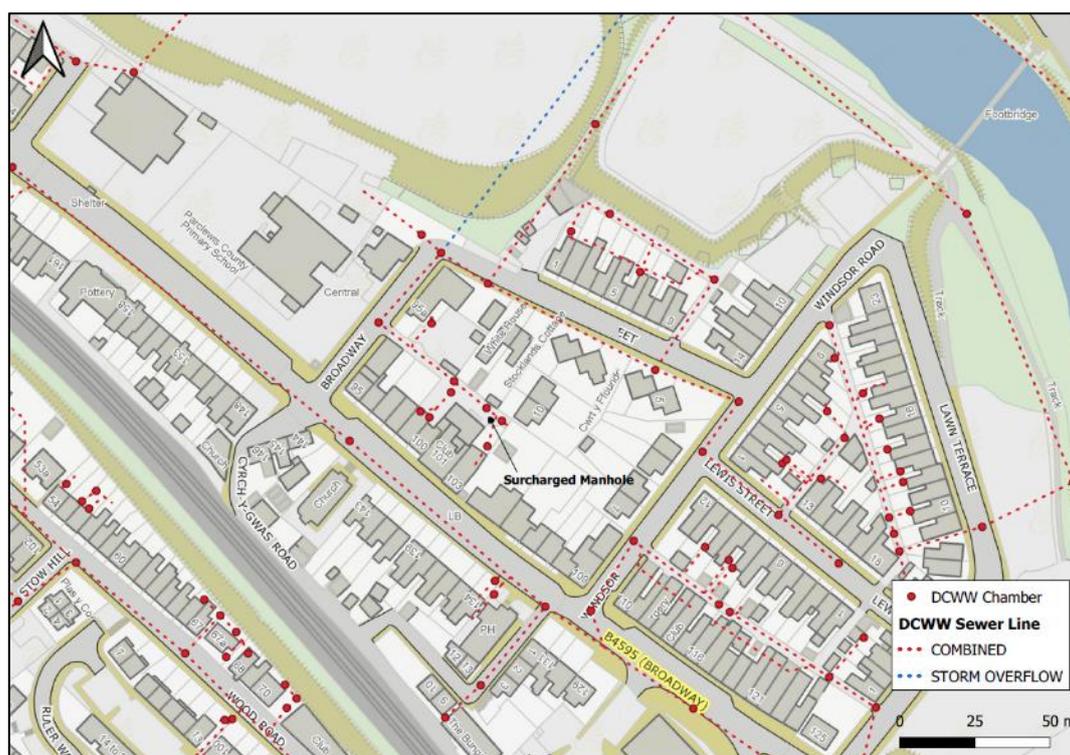
In addition to the highway drainage infrastructure within RCT12, the overtopping of the River Taf and the intensity of rainfall during Storm Dennis is considered to have overwhelmed parts of DCWW's combined drainage infrastructure during the storm event. This is evidenced by the surcharging of a DCWW combined sewer manhole on James Street (illustrated in Figure 12), resulting in the internal flooding of a nearby residential property which is also situated at a localised low point.

Figure 12: Location of surcharging manhole on DCWW's Combined Sewer network

Furthermore, reports from properties on Niagara Street during the flood event also refer to being impacted by sewage. Surcharging from the combined sewer network in this area may have occurred during the storm event, however, this cannot be confirmed due to the dominant impact of fluvial flooding sourced by the River Taf during the event. The unprecedented height of main river levels within the River Taf may have also impacted the ability of DCWW's infrastructure to manage the discharge of water during the storm event.

R2B	The LLFA and Highway Authority to evaluate surface water management options to alleviate pluvial flooding at locations across the investigation area.
3	DCWW combined sewer and associated manhole	DCWW	Sewer	DCWW	R3A	DCWW to evaluate the standard of service and the condition of the combined sewer network servicing RCT12.

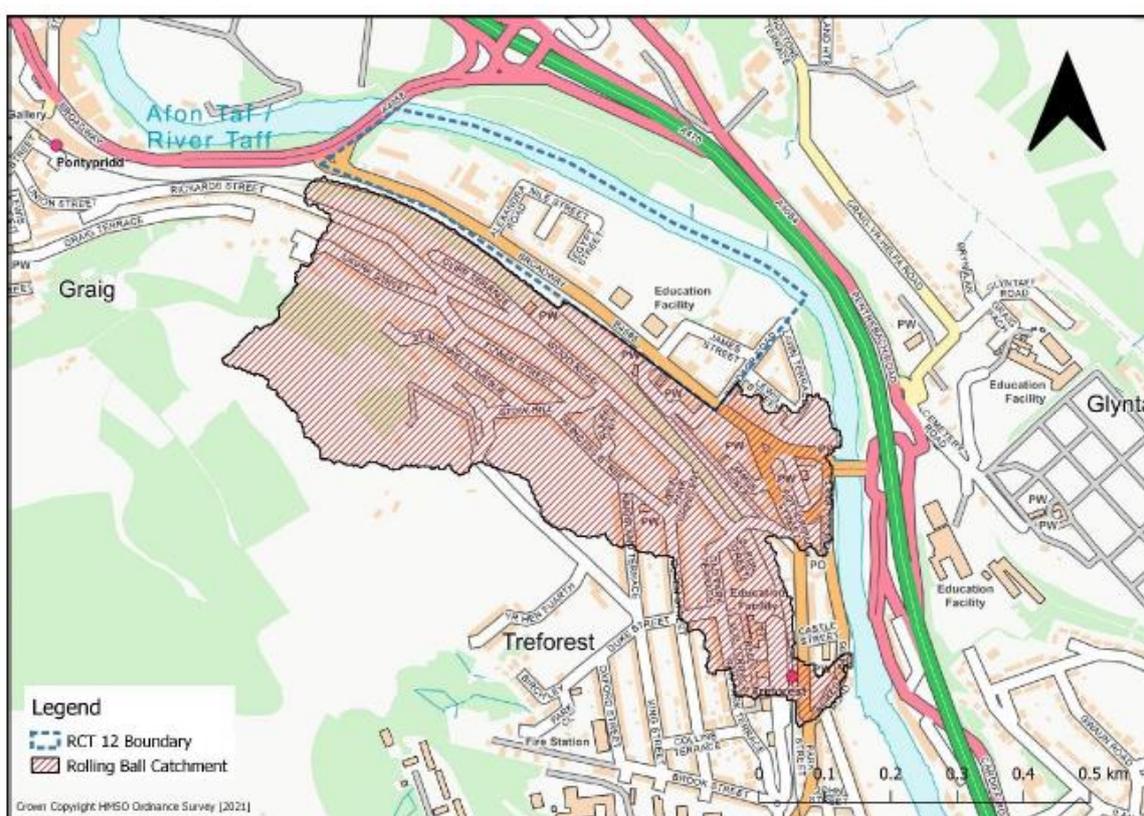
Figure 13: Topographic Watershed above RCT12

Figure 13 shows that surface water runoff originating from the hillsides to the south and southwest of Treforest are separated from the investigation area by the railway embankment running alongside Broadway. This suggests that whilst overland flows may have contributed to the pluvial flooding that occurred at Broadway, it is considered that surface water flooding within RCT12 was predominantly localised and not a consequence of the dominant valley gradient.
