Flood and Water Management Act 2010

Section 19 Report

Storm Bert – Flood Investigation Area 02

October 2025

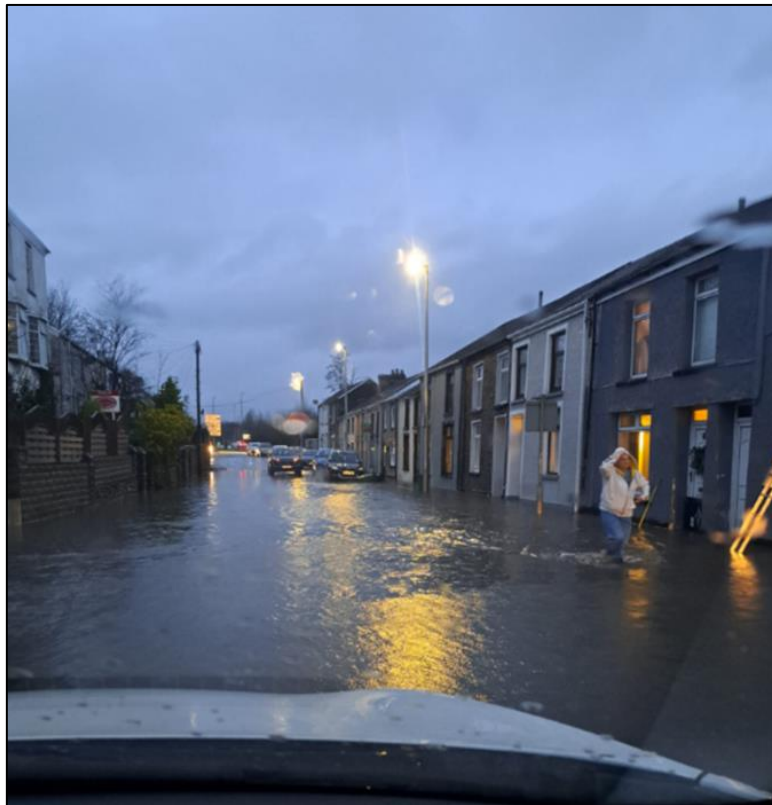
Exceedance flows travelling along the highway were also observed by residents to have overwhelmed the highway drainage infrastructure along Cardiff Road, contributing to the accumulation of standing flood water outside the fronts of several properties. Figure 4 depicts the rising flood water along Cardiff Road during the storm event. Flood depths in this area were reported to have reached 2 feet within the street.

Figure 4: Image of surface water and ordinary watercourse flooding at Cardiff Road during Storm Bert (image provided by resident).

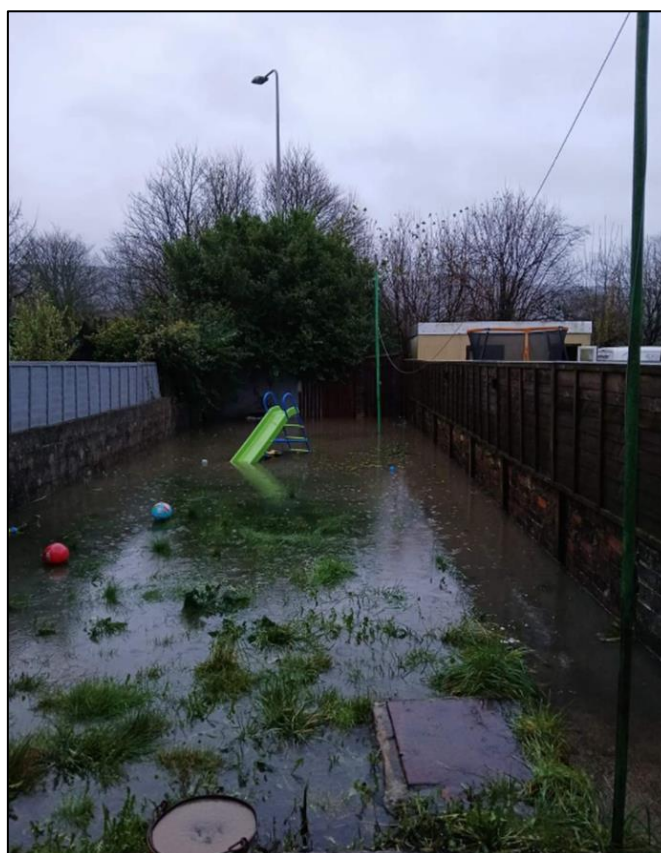
Residents at Cardiff Road also reported external flooding to their rear gardens during the storm event (depicted in Figure 5). Based on the available evidence, the external flooding to the rear gardens of 3 residential properties at Cardiff Road was a result of

the section of open ordinary watercourse to the east of impacted properties overtopping during the storm event (labelled 'Area 2' in Figure 3) and conveying towards the lower elevations of the rear gardens. These ordinary watercourse flows also contributed to the internal flooding of at least 1 residential and 1 non-residential property at Cardiff Road, situated in close proximity to the watercourse.

Figure 5: Image of flooding to the rear garden of a property at Cardiff Road due to the overtopping of an open watercourse during Storm Bert (image provided by resident).

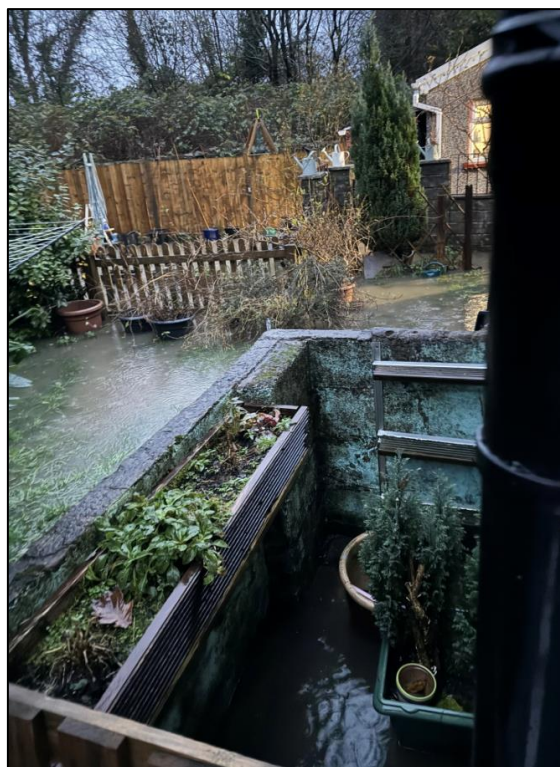
Figure 6: Evidence of flooding to the rear garden of a property at Sunnybank Street during Storm Bert (image provided by resident).

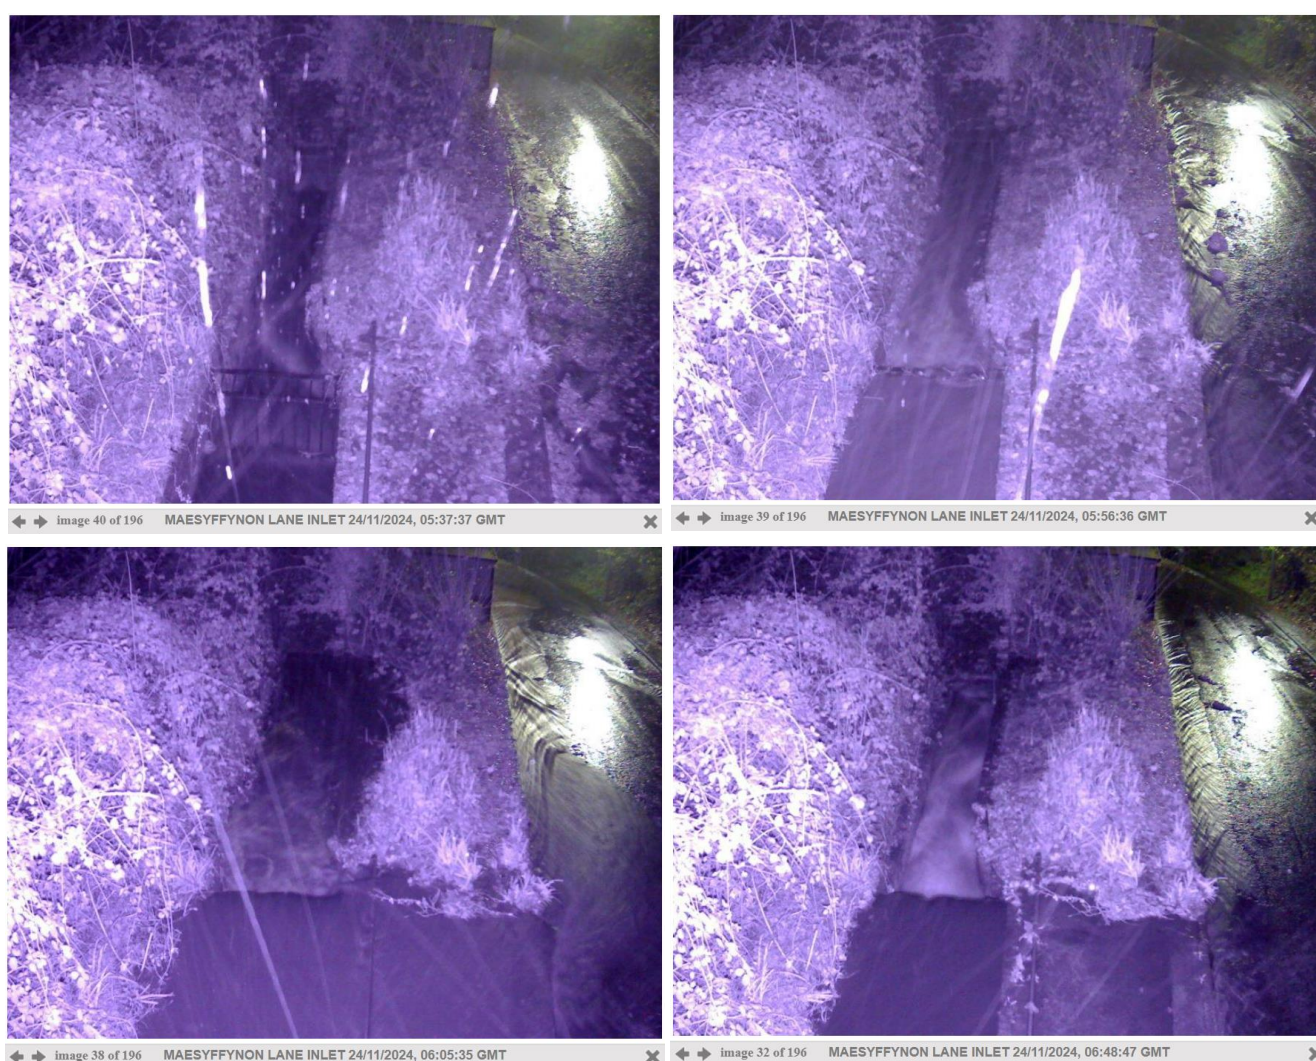
The rapid rise in levels within 30 minutes is indicative of the steep and fast-flowing catchments in the area. The watercourse continued to overtop for an estimated 45 minutes, before water levels receded. Following the overtopping of the ordinary watercourse, Council operatives cleansed the upper trash screen of debris. The debris largely consisted of leafy, natural debris which is considered to have been transported by the fast flows during the storm.

Figure 8: CCTV footage of the unnamed ordinary watercourse and 'Culvert Inlet 1' captured at RCT's monitoring station on Sunday 24 November 2024 at 05:37 (top left), 05:56 (top right), 06:05 (bottom left) and 06:48 (bottom right).

The trash screen upstream of 'Culvert Inlet 1' is considered to have become overwhelmed with debris and high flows during the peak of the storm event, causing the watercourse to overtop its channel walls and flow onwards down Maesyffynon Lane towards Cardiff Road.

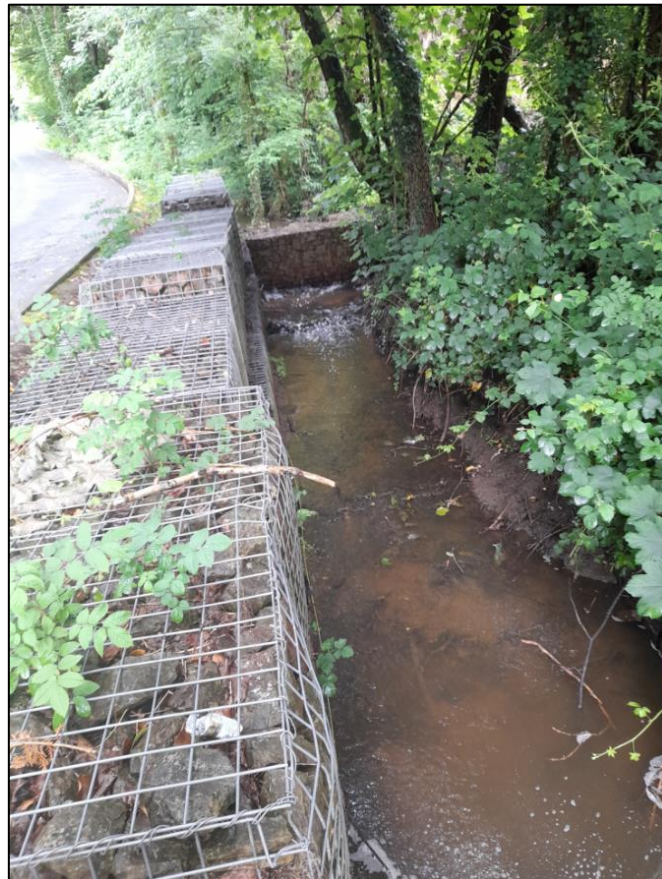
‘Area 1’ in Figure 9 was observed via CCTV footage to have overtopped during the storm event. The open channel upstream of ‘Area 1’ is largely natural while the downstream channel comprises of gabion structures and twin debris screens to minimise the risk of scour and debris mobilisation entering the culvert system. The watercourse was identified to be in acceptable condition albeit with evidence of minor scouring to the eastern embankment and some natural debris deposition in the channel, as shown in Figure 10.

Figure 10: Photo of the unnamed watercourse channel upstream of ‘Culvert Inlet 1’ and ‘Area 1’
(captured by RCTCBC officers post event)

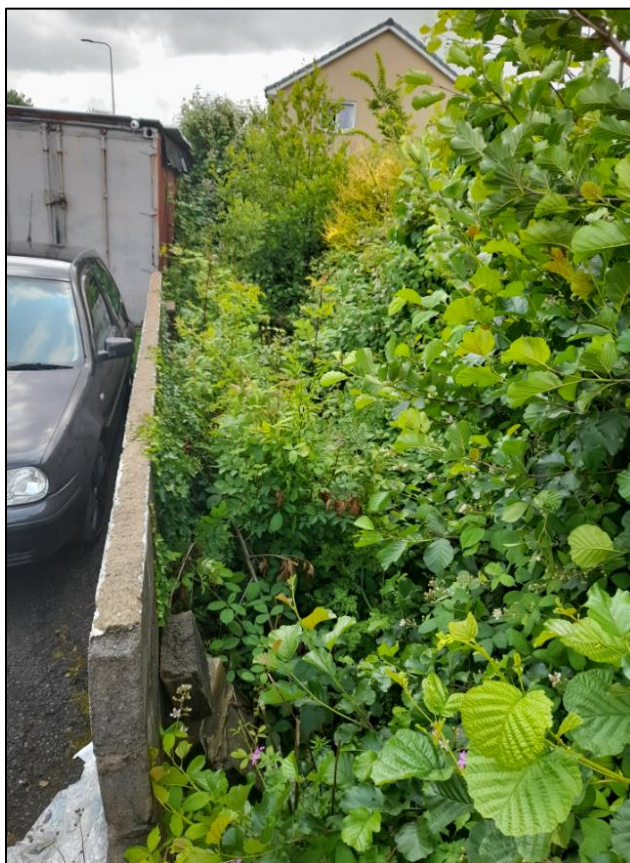
'Area 2' (shown in Figure 9) was also identified as a contributing source of flooding to approximately 5 properties along Cardiff Road during Storm Bert. Upon an inspection of 'Area 2' following Storm Bert, the watercourse was identified to be in poor condition, with dense vegetation obstructing the flow of water through the channel. On-site inspections were also restricted due to the dense vegetation, as shown in Figure 11. This section of open watercourse and its associated drainage infrastructure is identified to be in private ownership.

Figure 11: Photo of the unnamed watercourse channel upstream of 'Culvert Inlet 2' and 'Area 2' (captured by RCTCBC officers post event).

The poor condition of the open watercourse channel in 'Area 2' is considered to have contributed to its overtopping however, the primary cause of overtopping at 'Area 2' has been attributed to the significant flows entering the system and the poor capacity of the ordinary watercourse and the downstream culvert network resulting in the system becoming hydraulically overloaded and overtopping during the storm event.

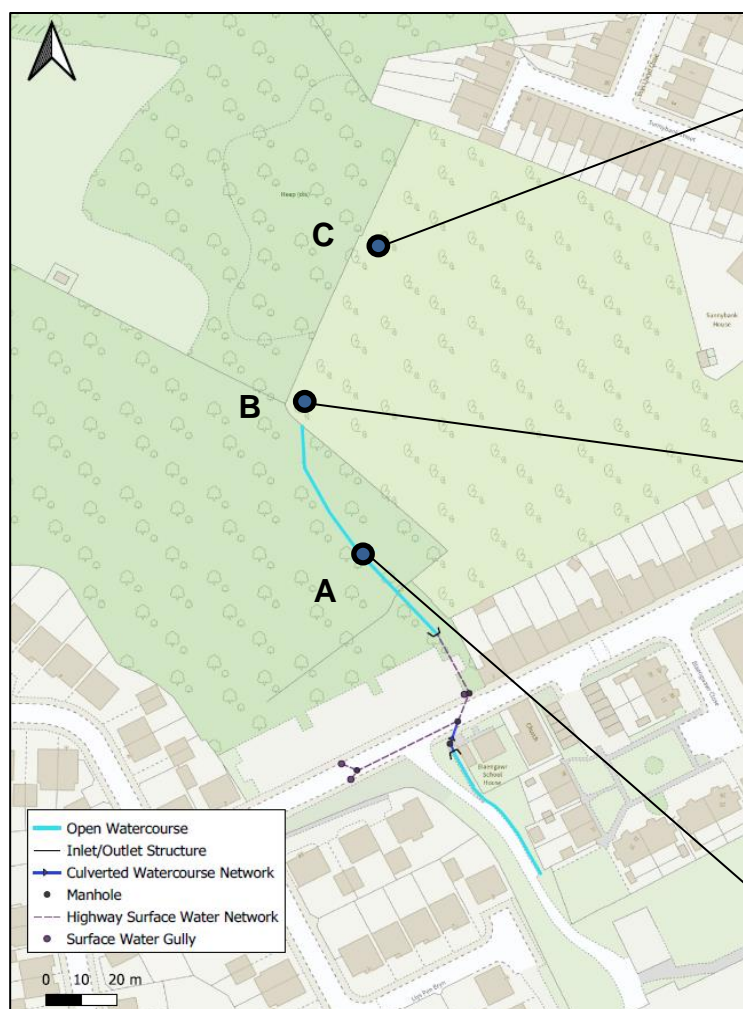
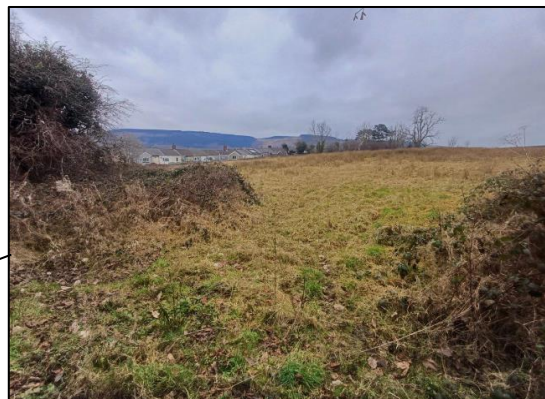
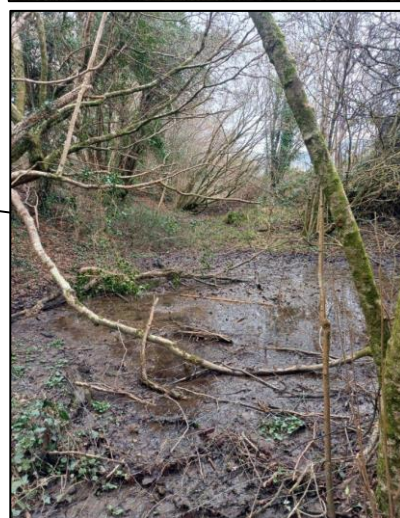
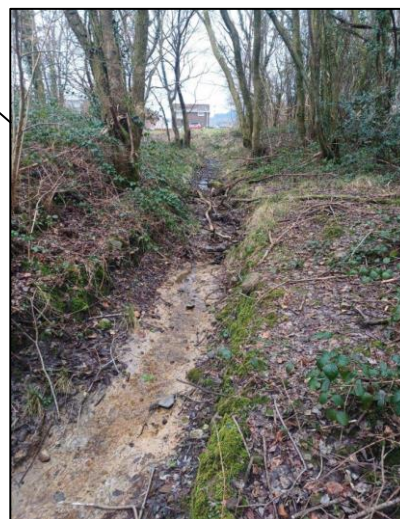
Figure 15: Site map showing photo locations and associated images captured by RCT's Flood Risk Management team post event of the hillside to the rear of Sunnybank Street.

The open field immediately to the rear of the impacted properties at Sunnybank Street ('Area C' in Figure 15) is comprised of dense vegetation and shrubs, with no defined drainage channel present nor drainage infrastructure. The grassy terrain showed evidence of flattened grass, indicative of the overland flow paths during the storm event.

Historical mapping from 1944-74⁸ (shown in Figure 16), indicates the presence of a natural sink located at the base of the open channel ('Area B' in Figure 15). This feature appears to have historically served as a point of infiltration for surface water flows. Observations made during the site visit did not identify any formal drainage infrastructure at the base of the channel, and the land surrounding the sink was saturated and boggy, indicating limited infiltration capacity.
