**Flood and Water Management Act 2010**

# **Section 19 Report**

**Storm Bert – Flood Investigation Area 25**

**October 2025**

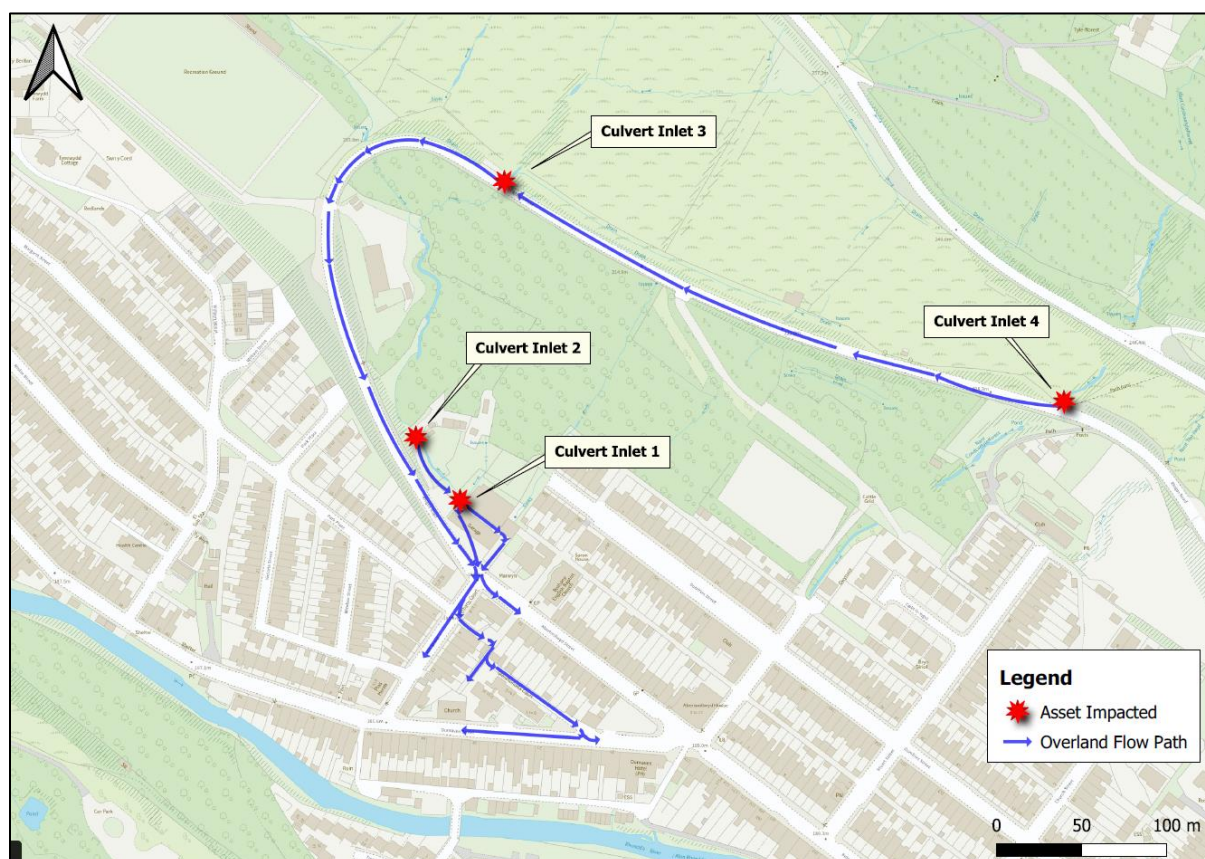
The infrastructure known to have surcharged and contributed to the flooding of properties, and the observed pathways of overland flooding during Storm Bert in FIA 25, have been illustrated in Figure 3.

**Figure 3:** Observed overland flow paths and surcharging assets at FIA 25 during Storm Bert (23-24 November 2024).

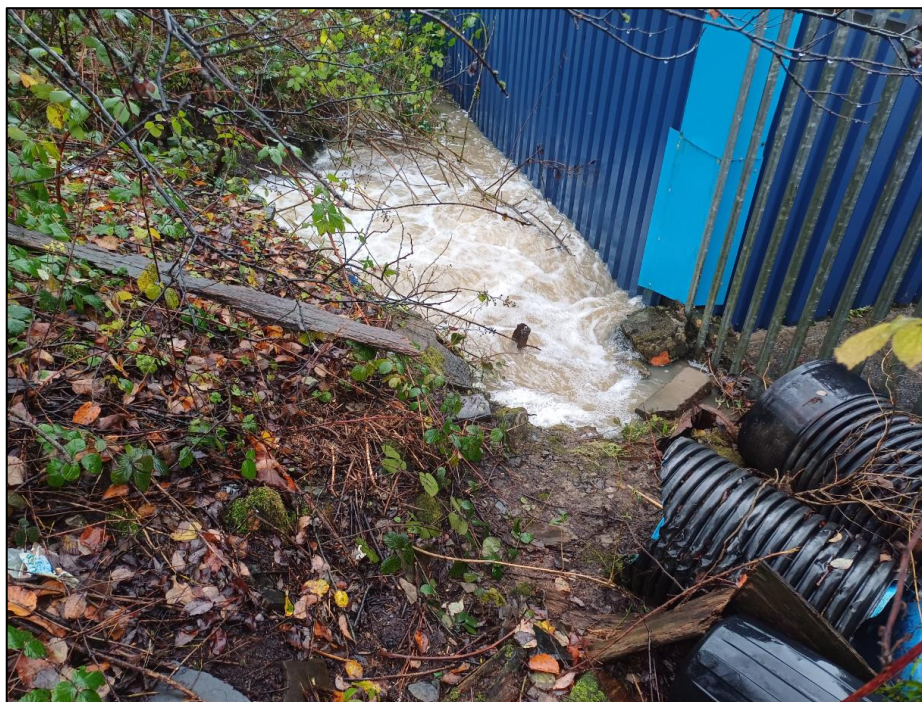
Management team at midday on 24 November, 'Culvert Inlet 1' was completely submerged and continuing to surcharge. This is illustrated in Figure 4.

**Figure 4:** Evidence of submerged 'Culvert Inlet 1' which surcharged during Storm Bert (captured by RCT's FRM team on 24 November 2024).

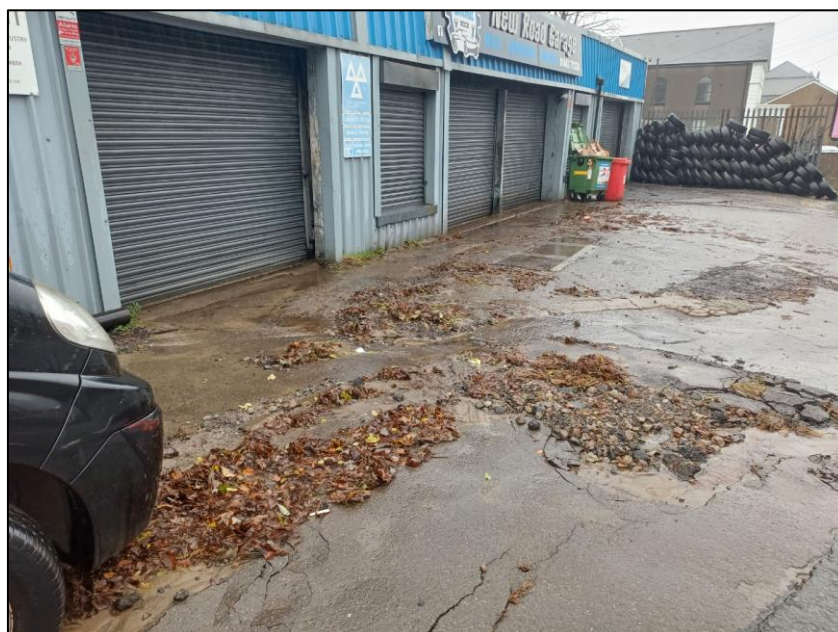
Exceedance flows from 'Culvert Inlet 1' resulted in water conveying through the adjacent commercial unit and around the rear of the unit, onto Abertonllwyd Street. Evidence of deposited silt and debris outside the commercial property and along the highway is shown in Figure 5, indicative of the pathways of flooding during the event.

**Figure 5:** Evidence of deposited silt and debris outside the impacted commercial unit at Abertonllwyd Street (captured by RCT's FRM team on 24 November 2024).

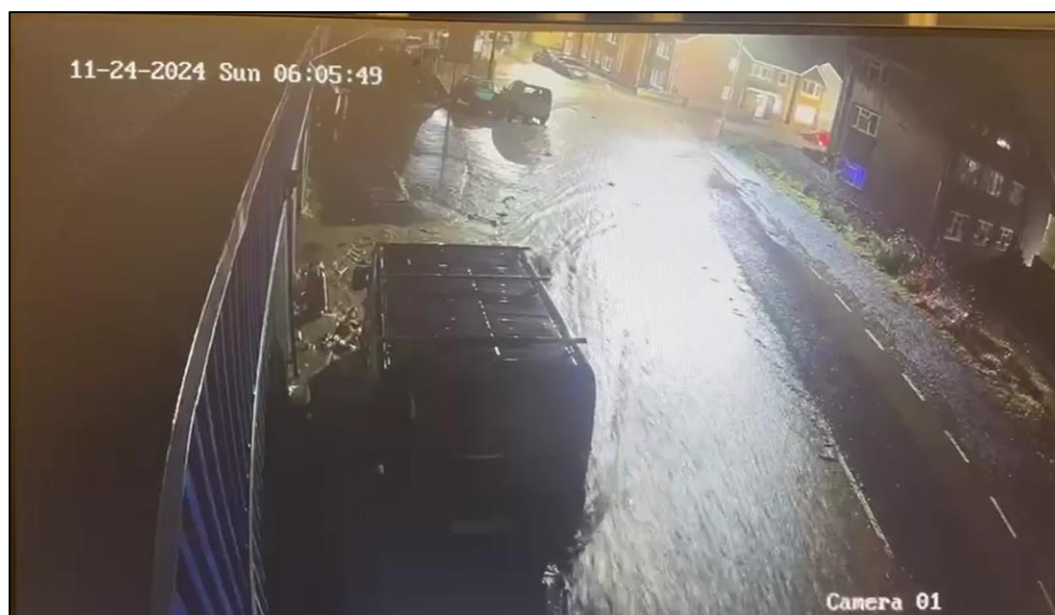
Surface water flows were also observed by on-site investigating officers as entering the investigation area from the west from Rhigos Road. CCTV footage from the commercial unit at Abertonllwyd Street (shown in Figure 6) depicts the exceedance flows from 'Culvert Inlet 1' conveying through the property, in addition to flows conveying from further up the catchment along Rhigos Road at approximately 06:00 on Sunday 24 November 2024.

**Figure 6:** CCTV footage showing evidence of flooding along Abertonllwyd Street at 06:05 on 24 November 2024 (image received from business owner).

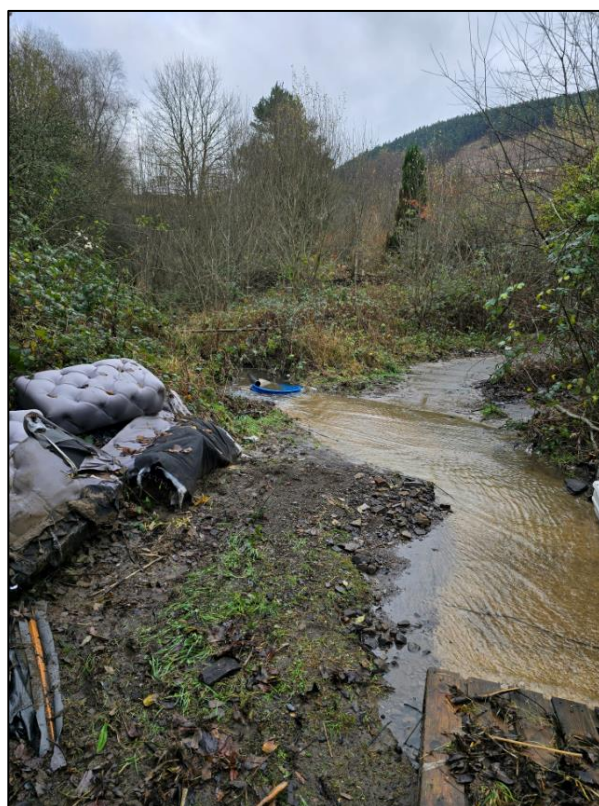
‘Culvert Inlet 2’ situated upstream of ‘Culvert Inlet 1’ was observed as surcharging during post event inspections (shown in Figure 7). The inlet showed evidence of blockage caused by fly-tipping material and was still surcharging during the site visit (on 27 November 2024). This inlet is considered to have surcharged during Storm Bert. Based on the topography of the channel and surrounding area, exceedance flows from ‘Culvert Inlet 2’ are considered to have overtopped the inlet structure and entered the downstream channel towards ‘Culvert Inlet 1’, exacerbating the surcharging at this location.

**Figure 7:** Image of 'Culvert Inlet 2' surcharging and evidence of fly-tipping material in the surrounding area (captured by RCT's Flood Risk Management team on 27 November 2024).

'Culvert Inlet 2', also identified as a privately owned asset, was identified during post event inspections to be in poor condition, with debris and fly tipping material identified within the surrounding area (as shown in Figure 7). It was reported by the Council's Highway and Streetcare Depot that the identified fly tipping material was removed from the downstream watercourse, as opposed to the inlet structure, during the storm event. Based on the available evidence, it is considered that the identified fly tipping material influenced 'Culvert Inlet 2's ability to manage flows, contributing to its surcharging, in addition to causing an obstruction to the watercourse upstream of 'Culvert Inlet 1'.

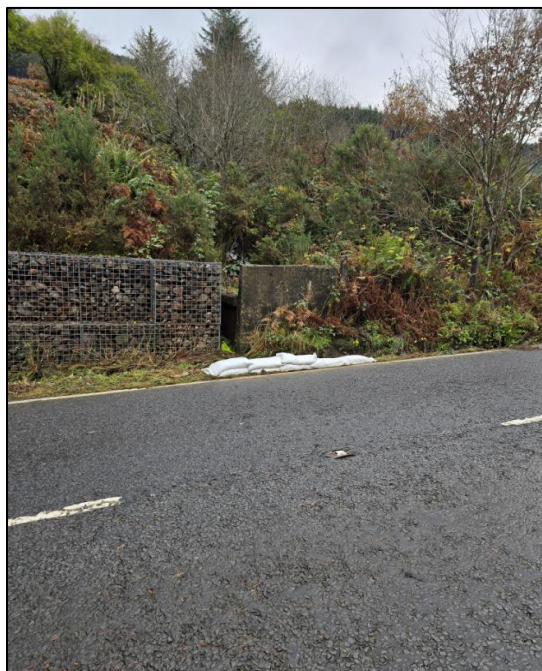
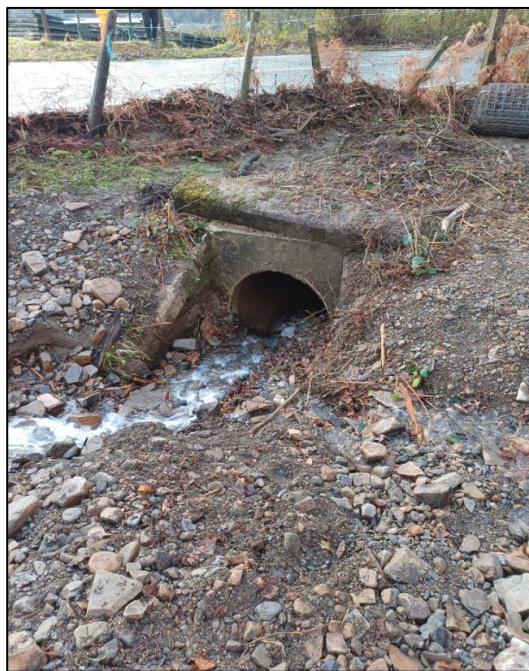
The pathway of flooding from 'Culvert Inlet 3' and '4' contributed to the flows from 'Culvert Inlet 1' and '2' which travelled onwards towards the lower reaches of FIA 25, impacting 39 properties.

**Figure 8:** Evidence of flattened grass and sandbags to redirect flow at 'Culvert Inlet 3' (left) and stonewash debris in the surrounding area of 'Culvert Inlet 4' (captured by RCT's Flood Risk Management team on 27 November 2024).

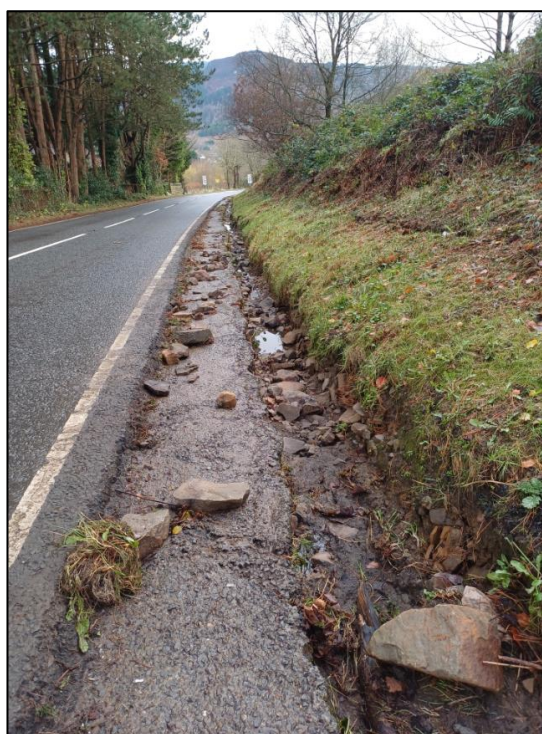
**Figure 9:** Evidence of scoring to the highway verge as a result of mobilised debris during the storm event (captured by RCT's Flood Risk Management team on 27 November 2024).

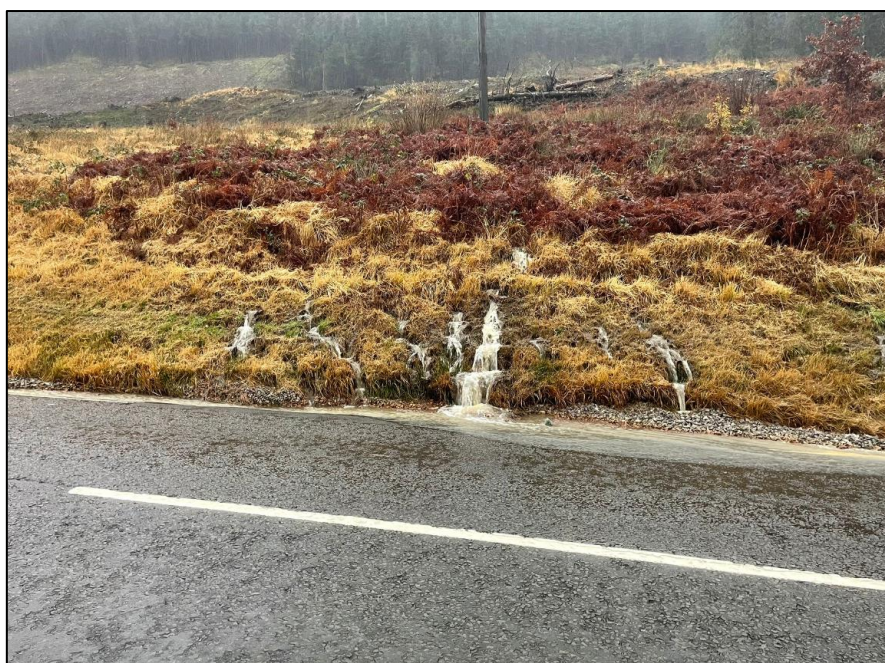
Post event inspections and resident accounts also identified significant overland flows to be conveying down the steep areas of hillside above Rhigos Road and onto the highway network. These areas of hillside comprise of both open farmland fields and areas of woodland. According to on-site officers, overland flows conveying down the hillsides were still present at approximately 15:00 on Sunday 24 November, following the peak of the storm (depicted in Figure 10). Overland flows from the steep hillsides are considered to have contributed to the ordinary watercourse flooding conveying along Rhigos Road towards Abertonllwyd Street.

**Figure 10:** Surface water flows conveying overland from the steep area of hillside above Rhigos Road (image captured by a Council officer at 15:00 24 November 2024).

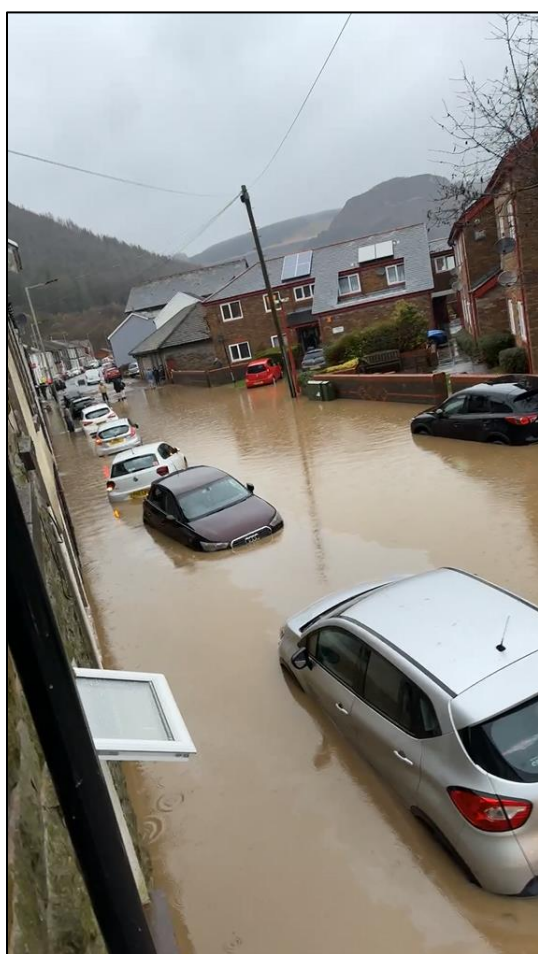
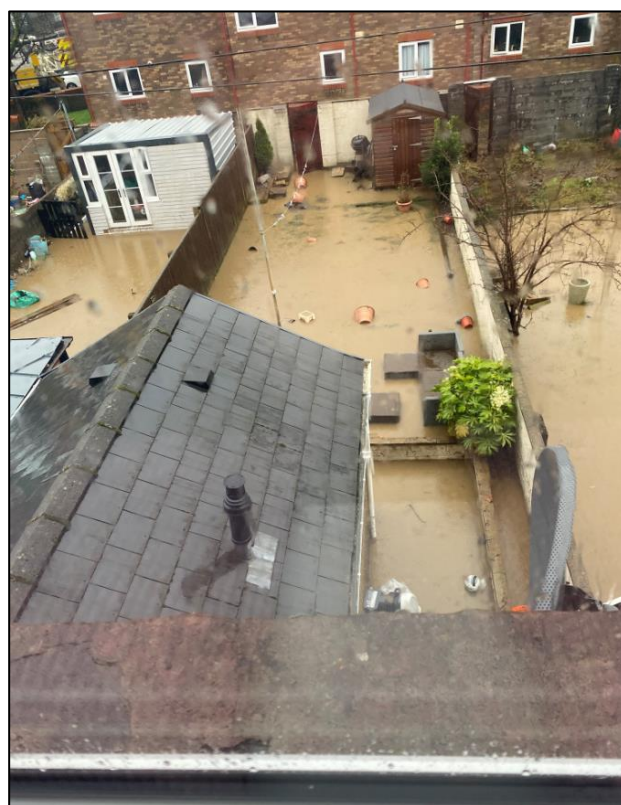
Eighteen residential and one non-residential property at Dunraven Street were impacted by the accumulation of surface water and ordinary watercourse flows during the storm event. Thirteen residential properties along Abertonllwyd were also impacted internally as a result of this flow path and accumulation of water. Residents at Abertonllwyd Street reported 4 feet of water within the basements and rear gardens of their properties as a result of the pooling of water at Dunraven Street and the rear lane behind their properties (depicted in Figure 11 (right)).

**Figure 11:** Image of flooding at Dunraven Street (left) and to the rear gardens and basements of properties at Abertonllwyd Street (right) during Storm Bert (images provided by residents).

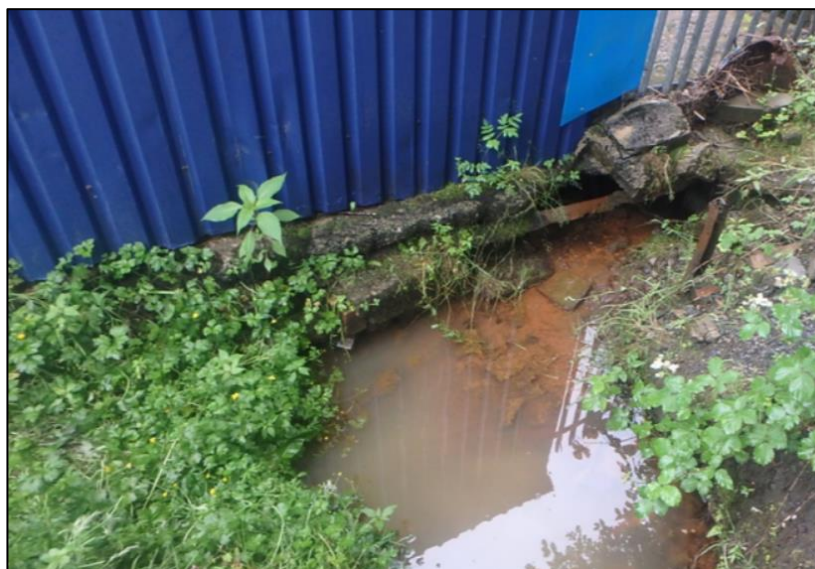
As noted in Section 2.2, 'Culvert Inlet 1' was identified as the primary source of flooding to 39 properties within the investigation area. 'Culvert Inlet 1', depicted in Figure 13, is a privately owned asset and comprises of a shallow informal box structure which conveys beneath a commercial unit before entering a culvert network. 'Culvert Inlet 1' is not a traditional inlet structure and is considered inadequate to manage the flows entering the network.

**Figure 13:** Image of 'Culvert Inlet 1' prior to the storm event.

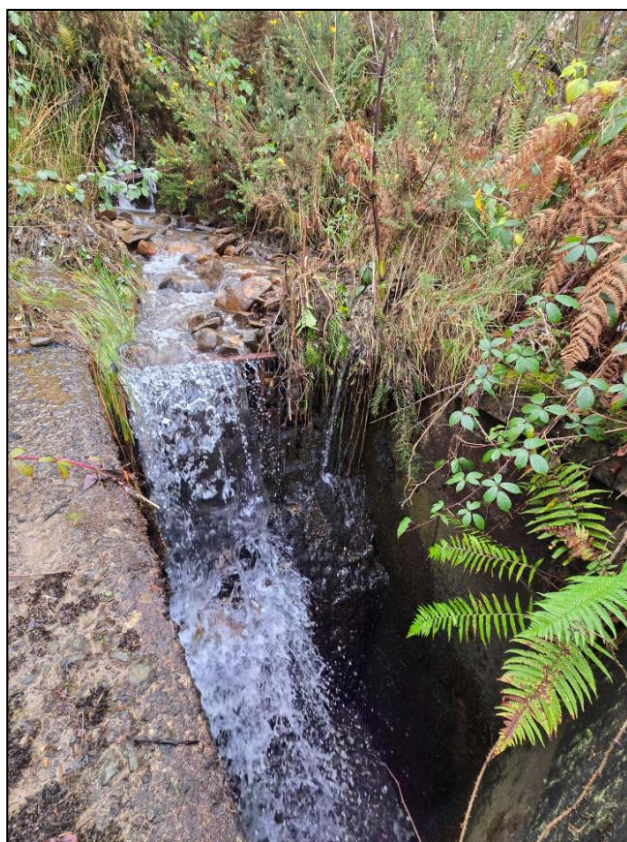
**Figure 14:** Evidence of blockage caused by stonewash to the upper debris screen associated to 'Culvert Inlet 3' (captured by RCT's Flood Risk Management team on 27 November 2024).

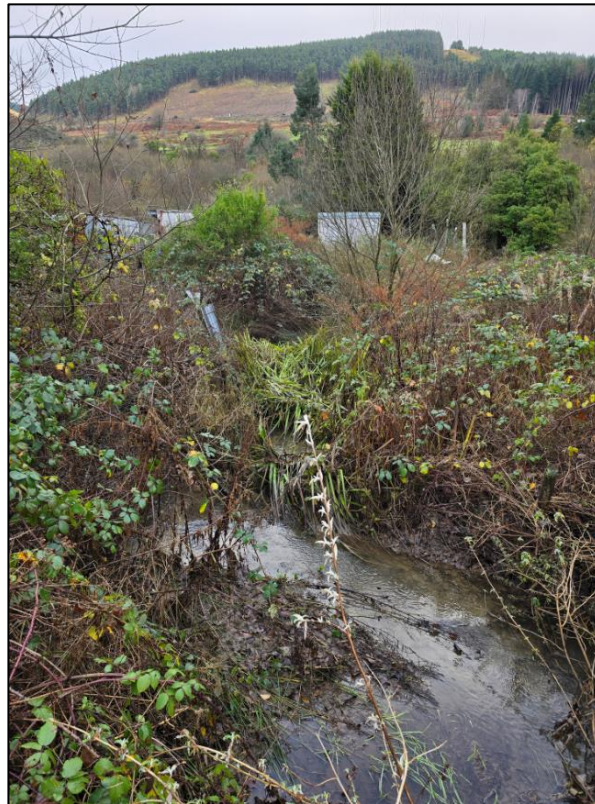
On review of the unnamed open watercourse conditions between 'Culvert Inlet 1' and '2', the watercourse appeared to be largely undefined, with dense vegetation restricting on-site inspections. Evidence of flattened grass and saturated ground (shown in Figure 16) indicated that significant flows had occurred during the event. As discussed in Section 3.1, fly tipping material within the channel had been removed during the storm event by the Council. This material is considered to have caused an obstruction to the watercourse during the storm event, contributing to the surcharging of both inlets.

**Figure 16:** Ordinary watercourse channel upstream of 'Culvert Inlet 1' (captured by RCT's Flood Risk Management team on 27 November 2024).

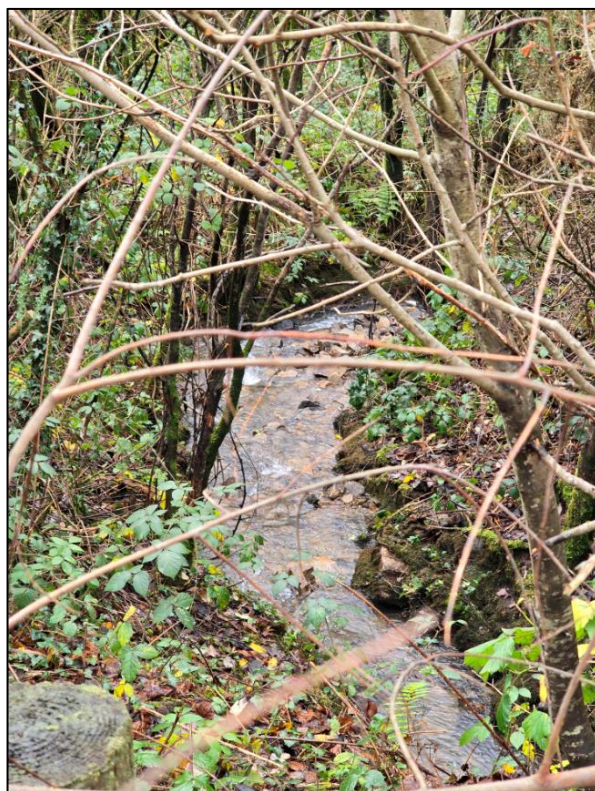
contributing to the blockage to the upper debris screen (shown in Figure 17) of 'Culvert Inlet 3'.

**Figure 17:** Image of the unnamed watercourse conditions upstream of 'Culvert Inlet 3' (captured by RCT's Flood Risk Management team on 27 November 2024).

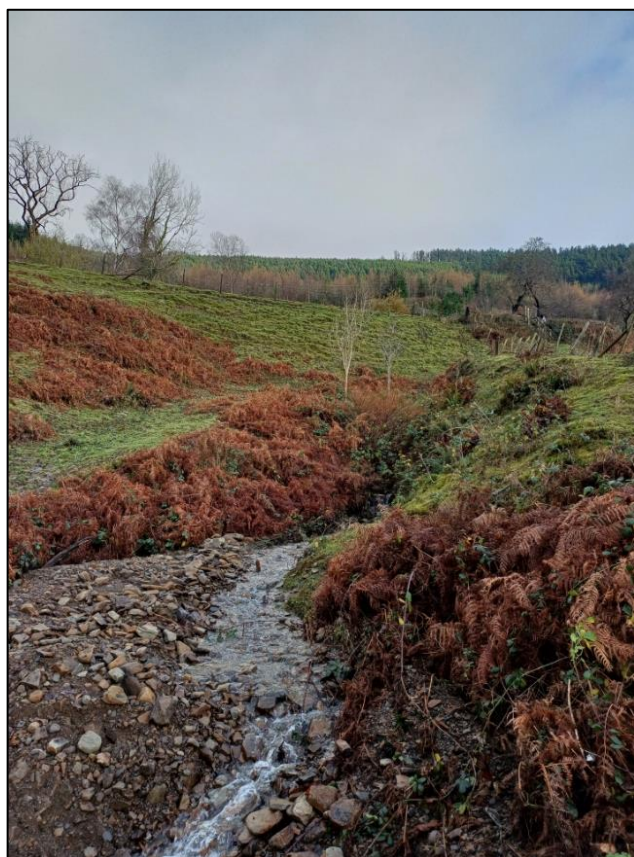
'Culvert Inlet 4', associated to the Nant Coedcaetyllefforest, was identified as blocked with debris, consisting of stonewash, silt and woody debris, during the event. The obstruction has been identified as the primary cause of flooding to the inlet.

The Nant Coedcaetyllefforest rises steeply from the town of Treherbert and the area immediately above 'Culvert Inlet 4' is comprised of land used predominately for grazing of livestock. Within this reach, bed incision has created a small V-shaped valley within the hillside. The channel is extremely steep, and the substrate is coarse, comprising of angular cobbles and gravels which has the potential to be transported during high flow energy. Figure 18 depicts the steepness of the channel above 'Culvert Inlet 4' and shows evidence of coarse stone and silt material that is considered to have been

mobilised and carried downstream towards the inlet by high flows during the storm event.

**Figure 18:** Image of the Nant Coedcaetylefforest watercourse looking upstream from 'Culvert Inlet 4' (image captured by RCT's Flood Risk Management team on 27 November 2024).

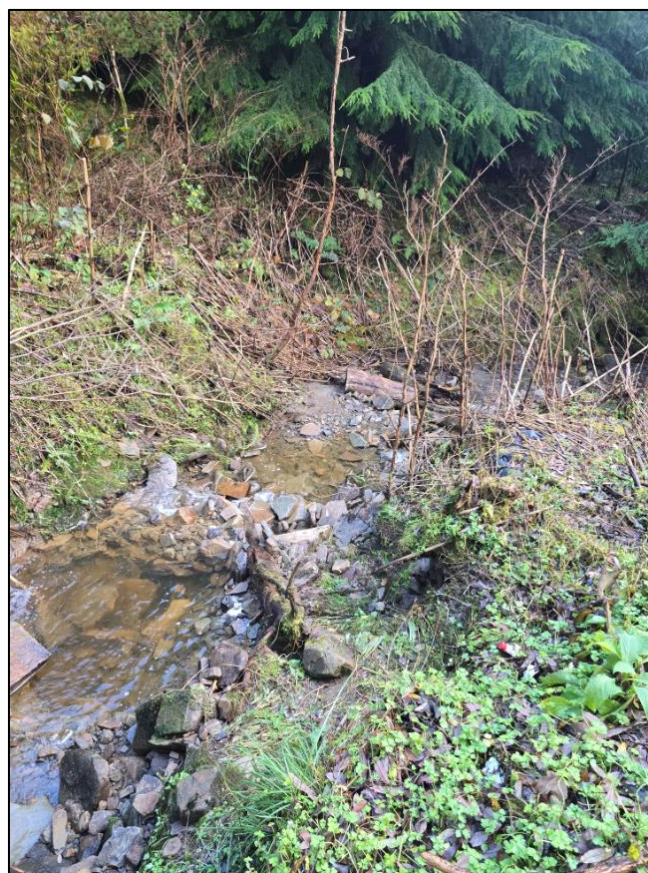
The upper valley reaches of the Nant Coedcaetylefforest are within a steep forested area, with dense vegetation surrounding the channels. The morphology of the valley is characteristic of a cobble cascade, meaning that active bank erosion and bed incision is present, resulting in both coarse and fine sediments feeding into the channel. Areas of embankment scouring and debris deposition throughout the channel was observed during site investigations (shown in Figure 19), further indicative of the high flows conveying down the steep catchment and mobilising scour material towards the investigation area during Storm Bert.

**Figure 19:** Evidence of minor embankment scouring and deposition of cobbles and stones within the upper reaches of the Nant Coedcaetylleforest (image captured by RCT's Flood Risk Management team on 27 November 2024).

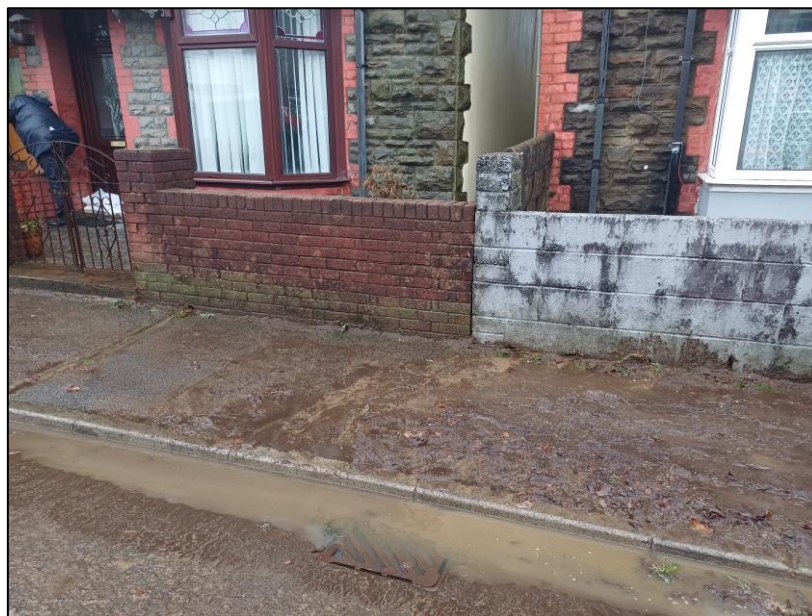
Evidence of flood water and deposited silt and debris as a result of the surface water and ordinary watercourse flows are depicted in Figure 21 and 22. These sediments and debris are considered to have entered the highway drainage system, leading to blockages and a reduction in the hydraulic capacity of the surface water network.

**Figure 21:** Evidence of silt deposited and blocked highway gullies along Hill Street (captured by RCT's Flood Risk Management officers on 24/11/2024).

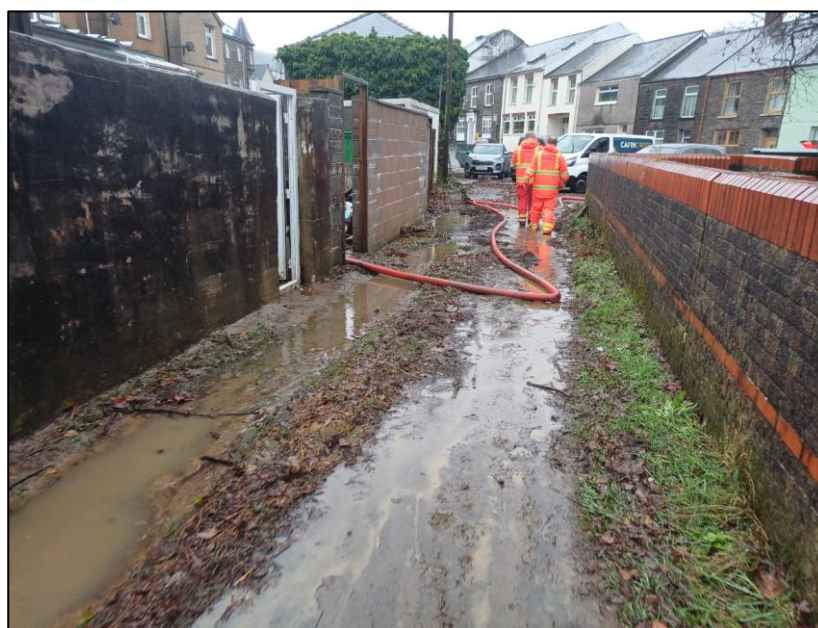
**Figure 22:** Evidence of silt and debris deposited across the lane behind properties at Abertonllwyd Street (captured by RCT's Flood Risk Management officers on 25/11/2024).
