Section 19 Flood Investigation Report

Storm Dennis – Flood Investigation Area RCT10

September 2021

| Document Ref | FRM – S19 - 010 |

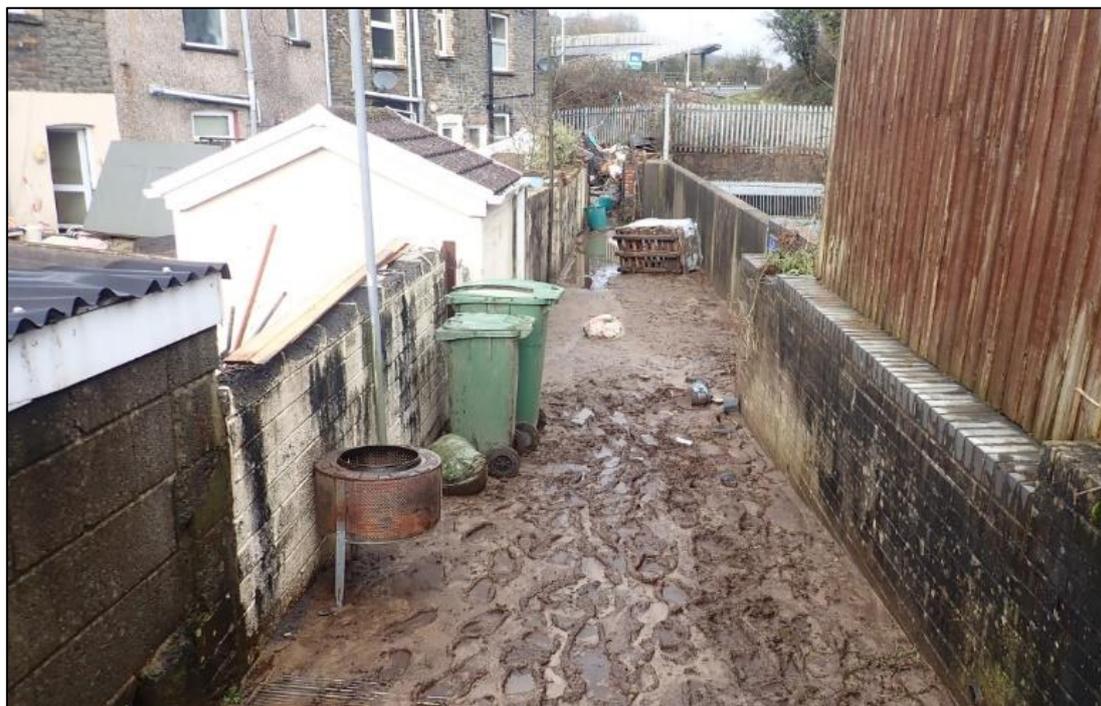
During the early hours of Sunday 16th February, the Nant Cae Dudwg ordinary watercourse overtopped the flood wall at the inlet, causing water to accumulate within the lane behind properties at Cilfynydd Road. The result of which saw riverine debris including silt and mud being deposited in the lane area. This resulted in blockages to the surface water drainage gullies in the lane, reducing the capacity of the drainage network to manage the excess water (Figure 5).

Figure 5: View of the lane between the Nant Cae Dudwg inlet and the rear gardens of properties on Cilfynydd Road captured by FRM officers on 17th February 2020.

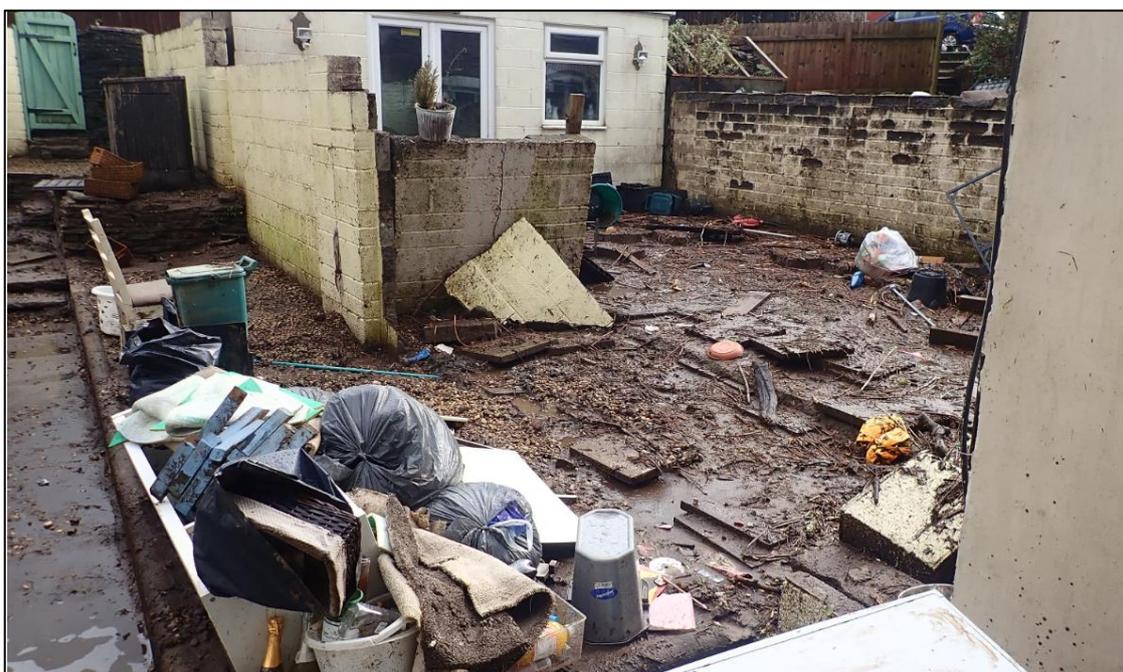
Post event inspections found evidence of collapsed concrete boundary walls, exemplifying the force of the water emanating from the watercourse and flowing through the gardens during the event. The images below reveal the severe and long-lasting damages caused by the flood event to properties at Cilfynydd Road (Figure 6).

Figure 6: Damages left after the event to the rear of a property at Cilfynydd Road captured by FRM officers on 17th February 2020

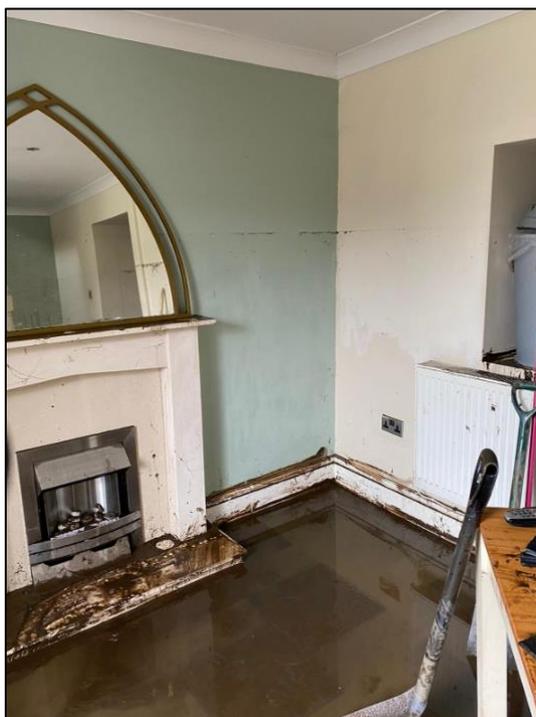
Figure 7: Water depth marks in a property at Cilfynydd Road following Storm Dennis (image provided by resident)

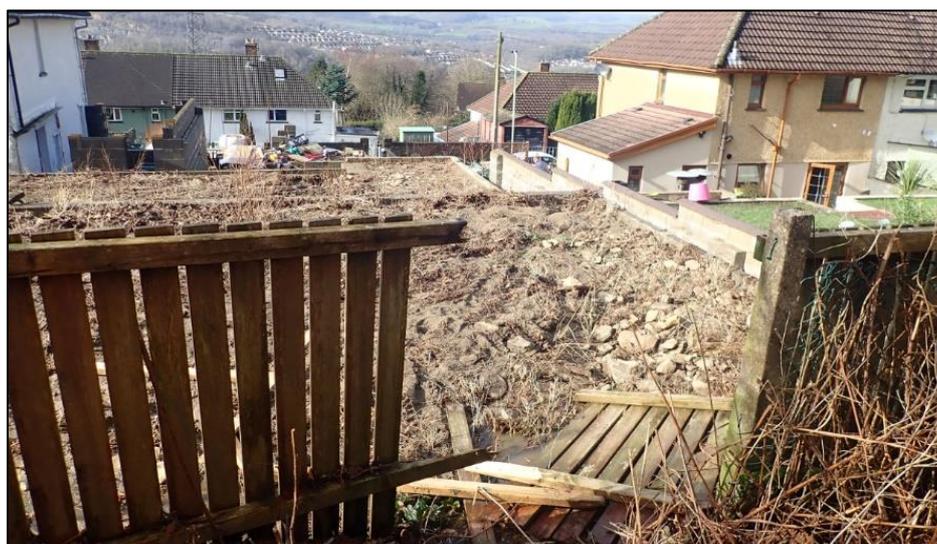
Figure 9: Damages to rear garden of a property at Heol Mynydd following the storm event (captured by FRM officers on 17th February 2020)

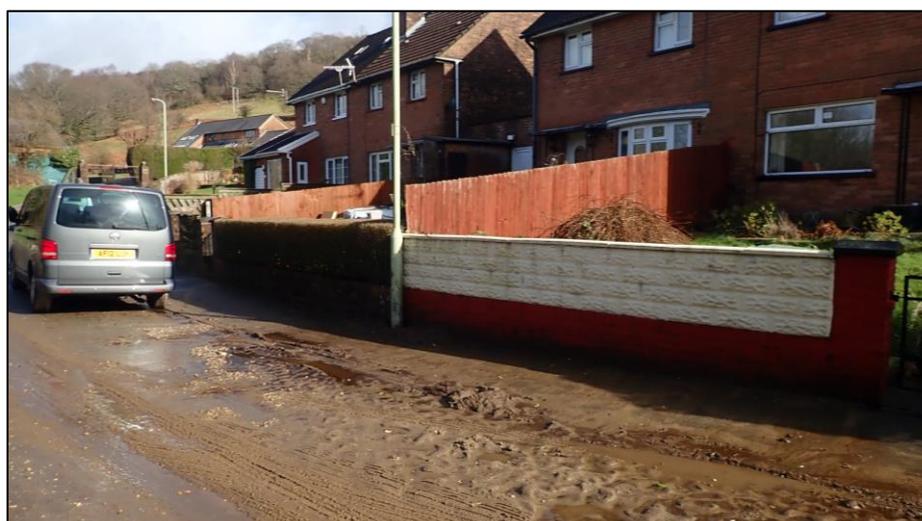
Figure 10: Road damages and debris deposited along Heol Cronfa following the storm event (captured by FRM officers on 17th February 2020)

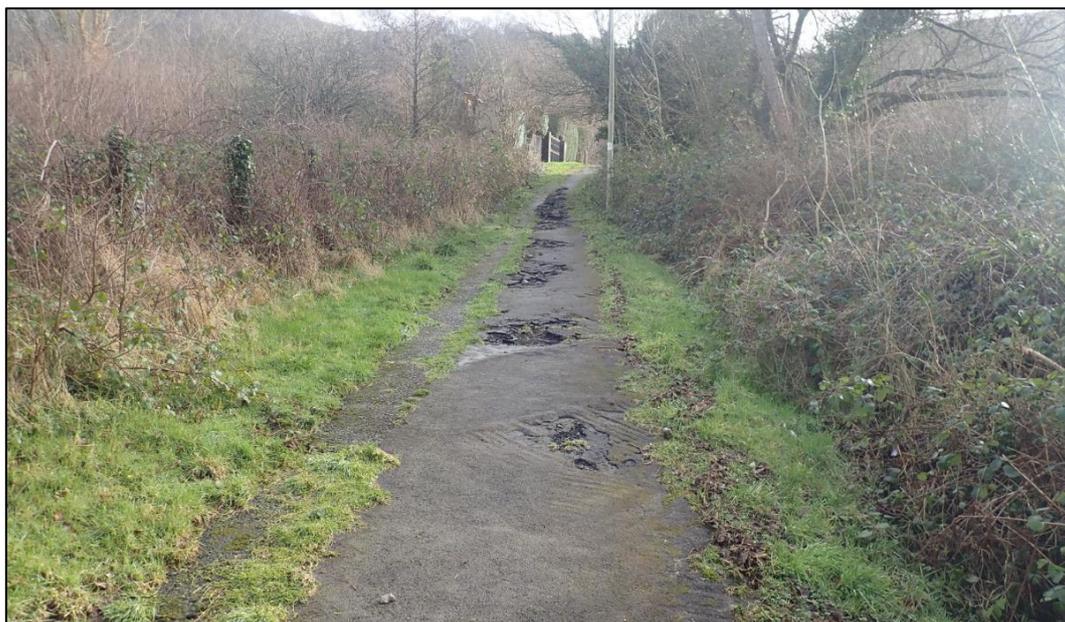
Water was observed coming out from the field before conveying onto the path towards Brynderwen. The path was badly damaged, assumed to be caused by the force of water flowing towards Brynderwen (Figure 11). Damages to the path were identified higher up than the gate, indicating that significant flows were also travelling from the overtopped watercourse at Heol Mynydd (Figure 12). The water entered the road, carrying debris in its flow which caused highway and private drainage infrastructure to block and surface water to pool. Properties on the western side of Brynderwen are situated slightly lower than the road, which resulted in internal flooding to three residential properties and external flooding to the front of several others.

Figure 11: Evidence of damages to the top of the path looking up towards Heol Nant (captured by FRM officers on 17th February 2020)

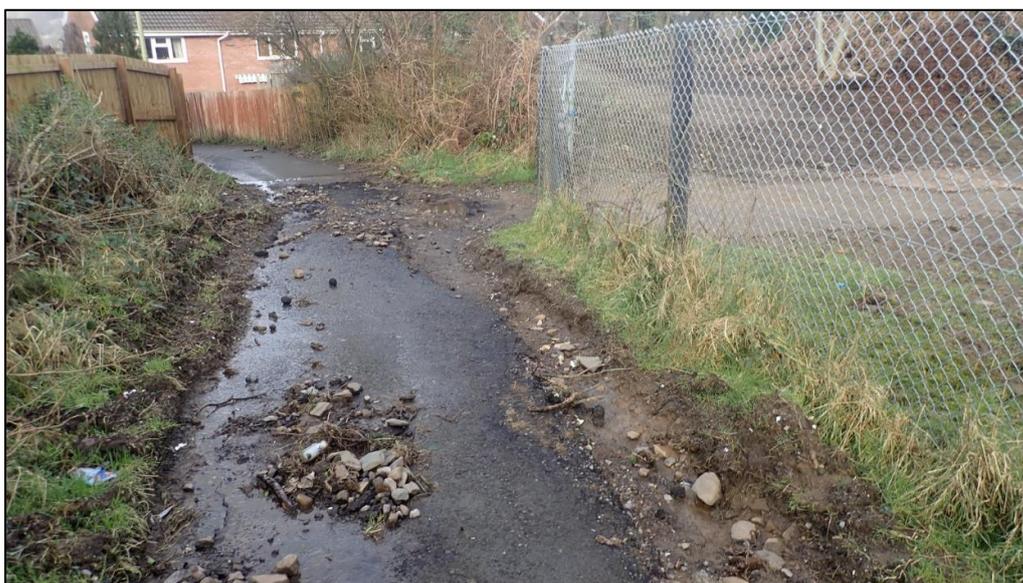
Figure 12: Evidence of deposited debris and damages to the bottom of the path looking down towards Brynderwen. Overland flows were observed flowing through land to the right behind the fencing (captured by FRM officers on 17th February 2020).

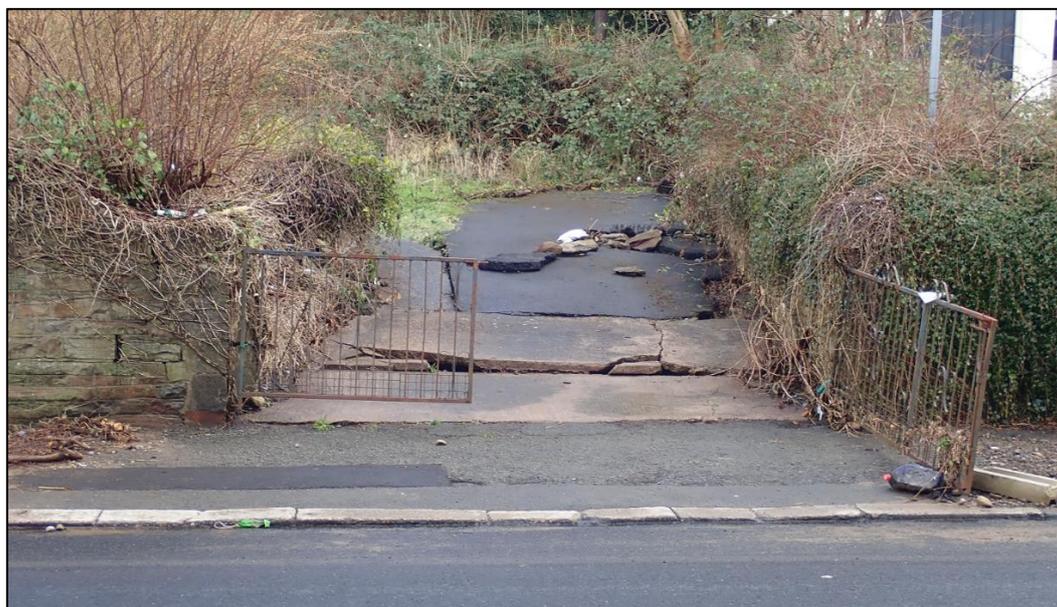
The evidence suggests the inlet became blocked with debris during the storm event which caused water to overflow from the culvert inlet and flow down the driveway of a residential property opposite the Royal Oak Inn, and onto Pontshonnorton Road. Post event inspections also identified a section of the tarmac driveway to have suffered from subterranean hydraulic pressure, i.e., the driveway appears to indicate that water from the culvert network erupted, through the tarmac and contributed to the flooding along Pontshonnorton Road (Figure 14).

Figure 14: Damages to the driveway situated below the Ely Brook culvert inlet showing evidence of subterranean hydraulic pressure (captured by FRM officers on 17th February 2020)

of 'Culvert Inlet 3' (noted in Figure 13), alongside evidence of culvert failure (Figure 14), it is likely that the networks' hydraulic capacity was further reduced.

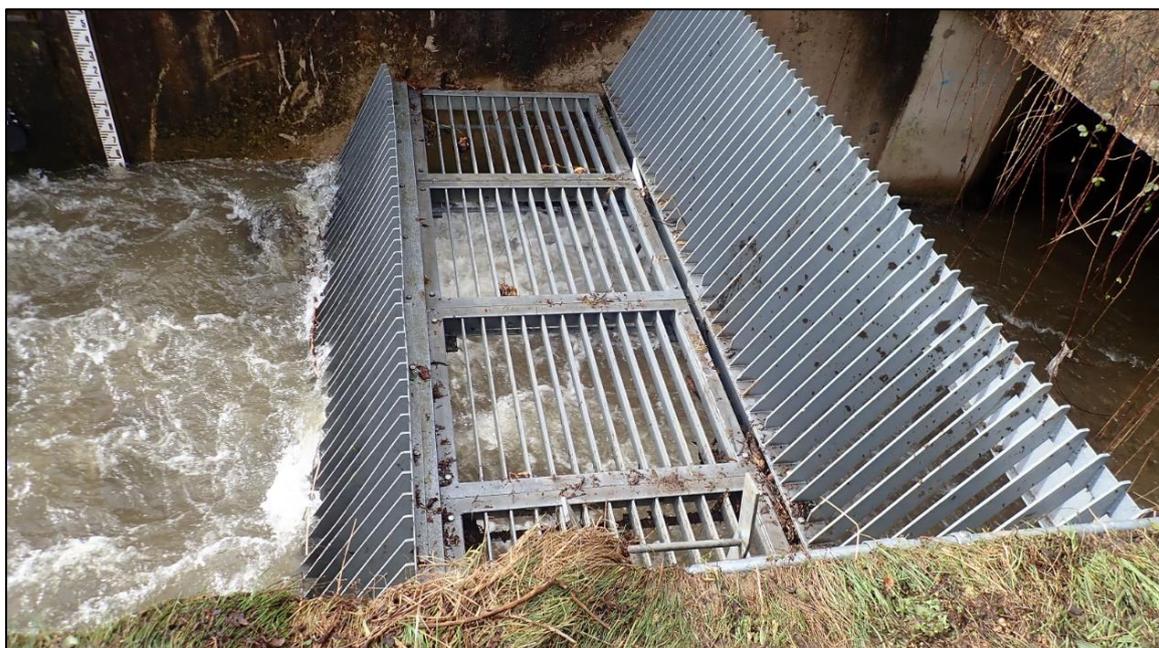
Following reports that 'Culvert Inlet 1' which conveys the Nant Cae Dudwg ordinary watercourse beneath Cilfynydd Road was the source of flooding to eight residential properties at Cilfynydd Road, post event inspections were carried out. According to emergency responders, the culvert inlet debris screen was partially blocked with woody debris, suggesting some debris was likely deposited during Storm Dennis however, there was little evidence to suggest that the inlet surcharged due to blockage during the event.

The culvert inlet was cleared of debris on 17th February 2020 by the Council's Depot once the watercourse level had subsided and safe working conditions were available. Notably, the debris screen shows no evidence of damage caused by the flood event (Figure 17). Trash screens further upstream of the inlet had significant stonewash and debris trapped behind which would suggest that the largest debris did not reach the

Figure 17: Nant Cae Dudwg culvert inlet (captured by FRM officers on 17th February 2020)

Although some settled coarse deposits was identified downstream of the inlet, the condition of both the inlet and culvert network is not considered to be the primary cause of flooding to properties at Cilfynydd Road. The water level within the Nant Cae Dudwg was high enough that debris likely travelled over the debris screen, avoiding any significant blockages, therefore the cause of flooding to Cilfynydd Road is considered to be related to the watercourse becoming overwhelmed during the storm event.

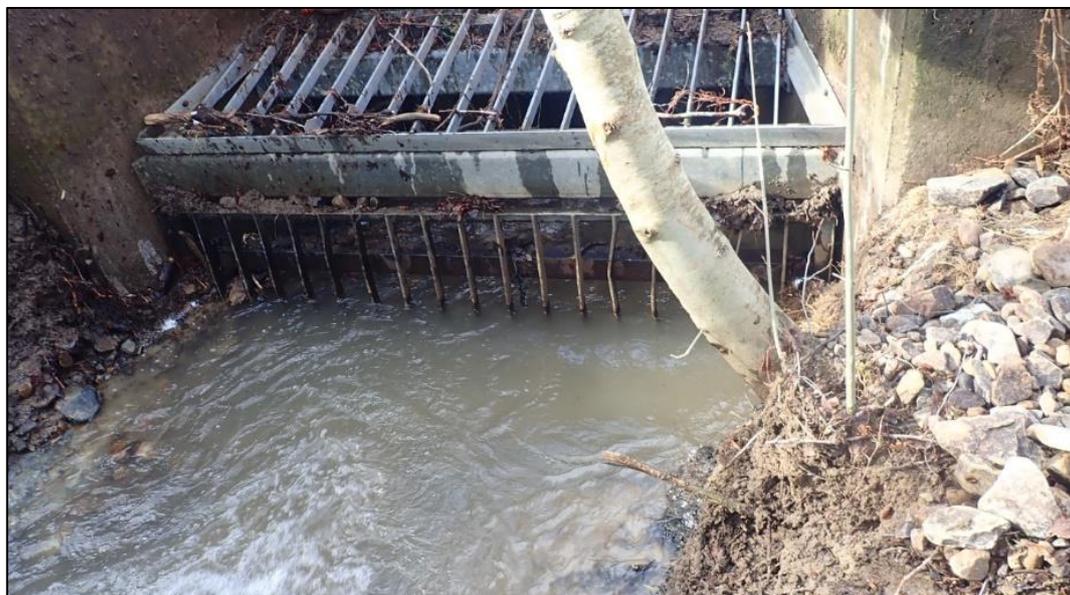
Figure 18: Culvert inlet to the rear of Heol Mynydd which surcharged during Storm Dennis due to blockages at the inlet (captured by FRM officers on 17th February 2020 following clearance works)

The culvert network was found to be in acceptable operational and structural condition following internal CCTV surveys. It is considered that blockages to the debris screen itself was the primary cause of flooding to Heol Mynydd and not the condition of the culvert network.

Figure 18 depicts the culvert inlet cleared from debris by the Council Highway and Streetcare Depot following the storm event.

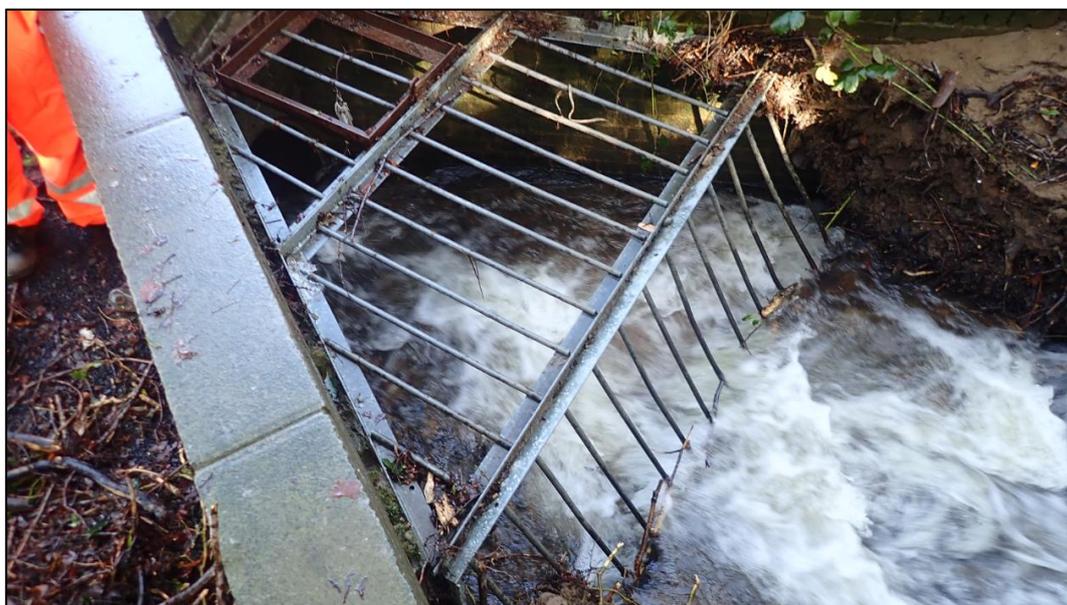
Figure 19: Ely Brook culvert inlet to the rear of Pontshonnorton Road which surcharged during Storm Dennis due to blockages at the inlet (captured by FRM officers on 17th February 2020 following clearance works)

The poor condition of the culvert network is considered to have contributed to the flooding, however, the blockage to the inlet structure has been determined as the most significant contributor to flood flow path C (Figure 3) during Storm Dennis.

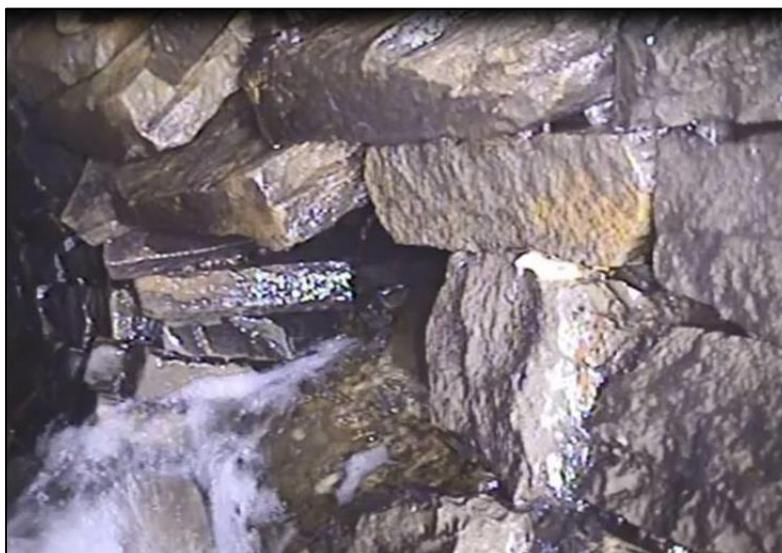
A Grade 5 structural defect was identified approximately 23 meters downstream of the inlet (Figure 20), located on the driveway below the Ely Brook culvert inlet, and has been determined as a secondary source of flooding to properties along Pontshonnorton Road, Norton Court and Evans Square, whereby water breached the culvert system below the tarmac driveway due to hydraulic pressure, contributing to the flooding at Pontshonnorton Road.

Figure 20: Hole in culvert 22.9 meters downstream of the Ely Brook inlet opposite Royal Oak Inn

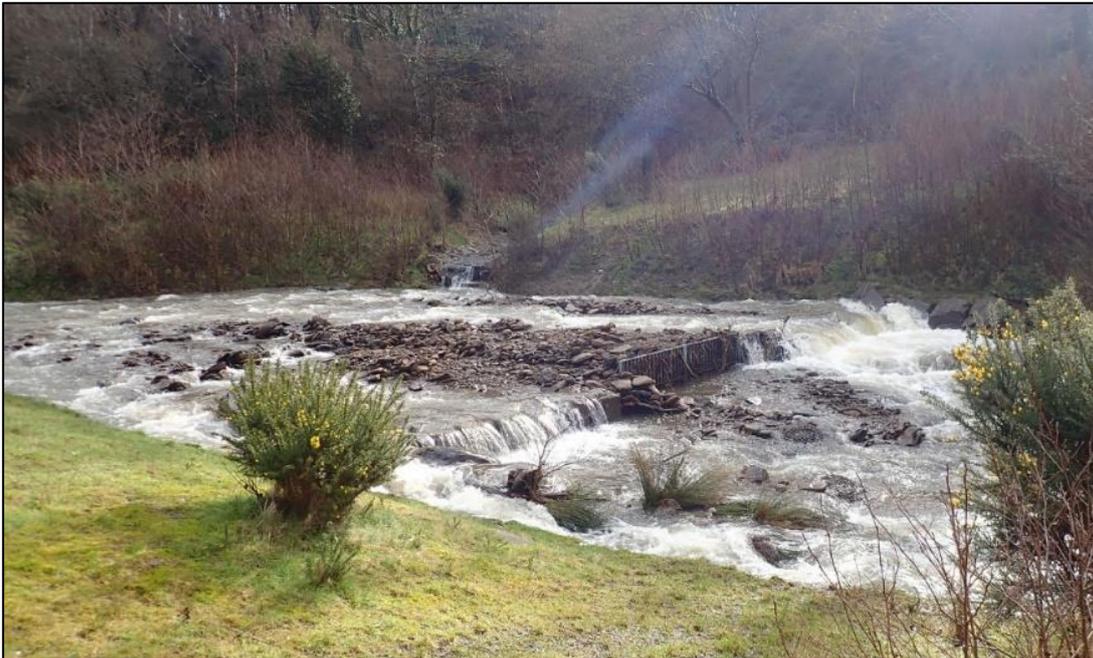
Figure 22: Initial upstream debris screen in the Nant Cae Dudwg watercourse (captured by RCT's Flood Risk Management team on 17th February 2020)

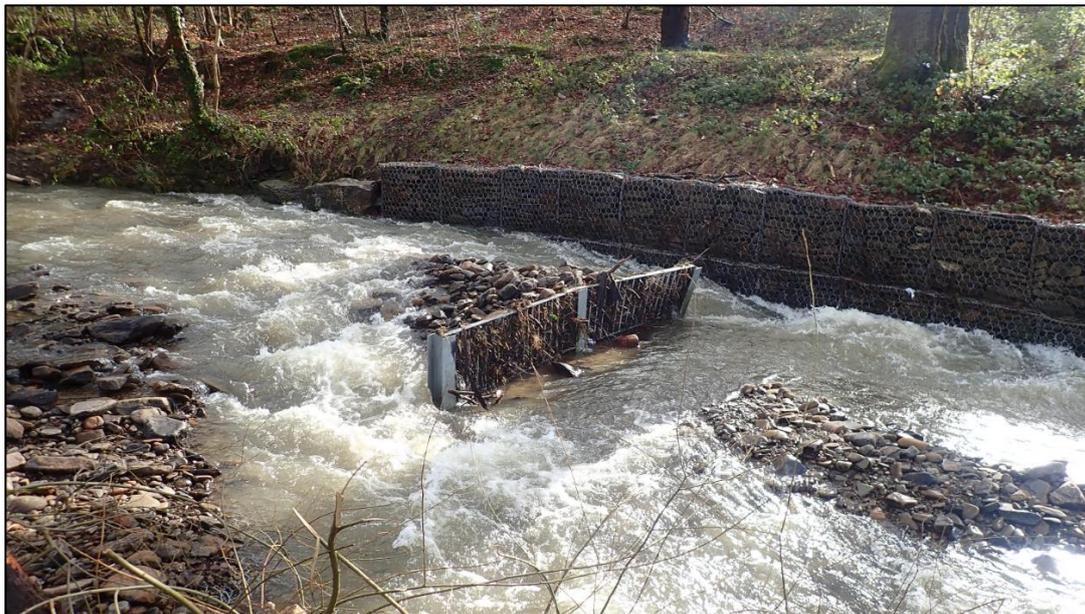
Figure 23: Second upstream debris screen in the Nant Cae Dudwg watercourse (captured by RCT's Flood Risk Management team on 17th February 2020)

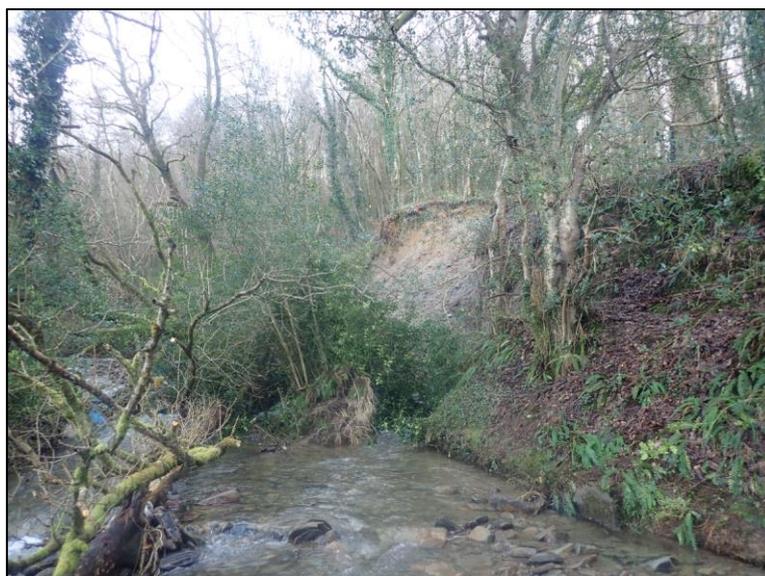
Evidence of embankment scour and localised landslips were identified along sections of the Nant Cae Dudwg watercourse (Figures 26 and 27). It is considered that this scoured material contributed to the volume of debris deposited along the watercourses' upper debris screens.

Figure 26: Photo of localised landslip on the embankment of the Nant Cae Dudwg watercourse (image captured by RCT's Flood Risk Management team on 02/03/2020)

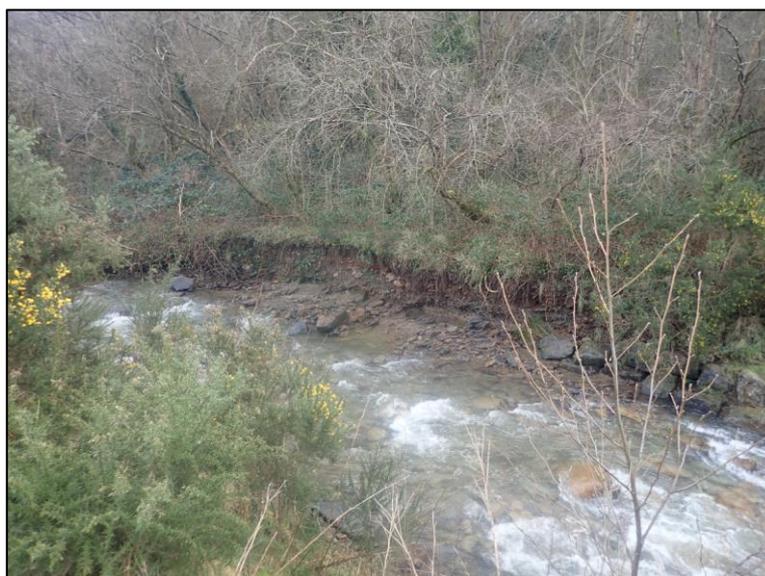
Figure 27: Photo of embankment scour to the Nant Cae Dudwg watercourse (image captured by RCT's Flood Risk Management team on 02/03/2020)

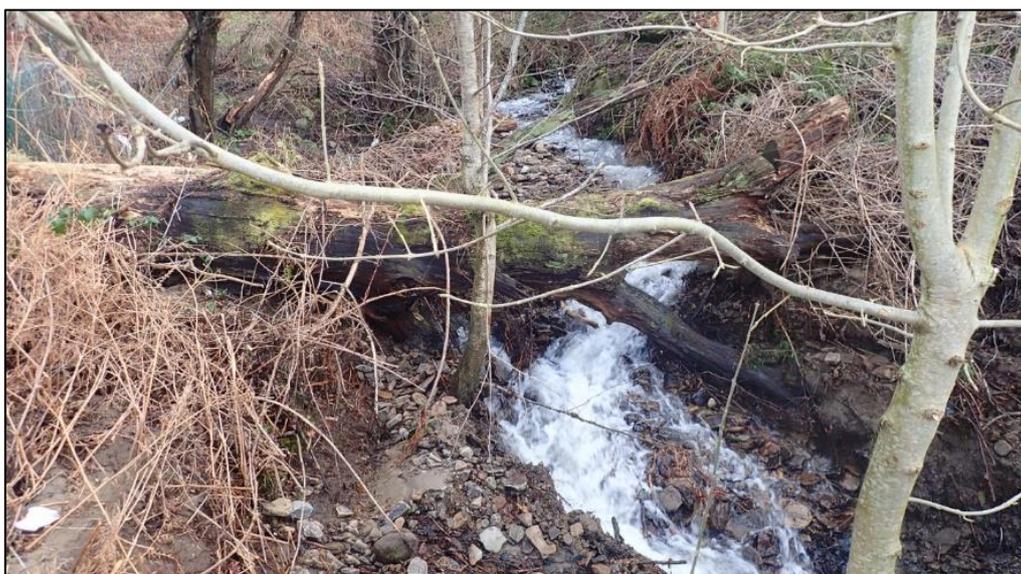
Post event inspections undertaken by RCT's FRM officers also identified a collapsed tree within the watercourse (Figure 29), just upstream of the culvert inlet. It is not believed that the collapsed tree contributed to the flooding at Cilfynydd, however it does provide evidence of the powerful flows within the watercourse during the storm event which caused embankment scouring as well as mobilisation of debris, contributing to the inlet blockage downstream. Emergency clearance works were undertaken by the Council's Depot to remove the tree from the watercourse.

Figure 29: Tree collapse in the unnamed ordinary watercourse to the rear of Heol Mynydd (captured by FRM officers on 17th February 2020)

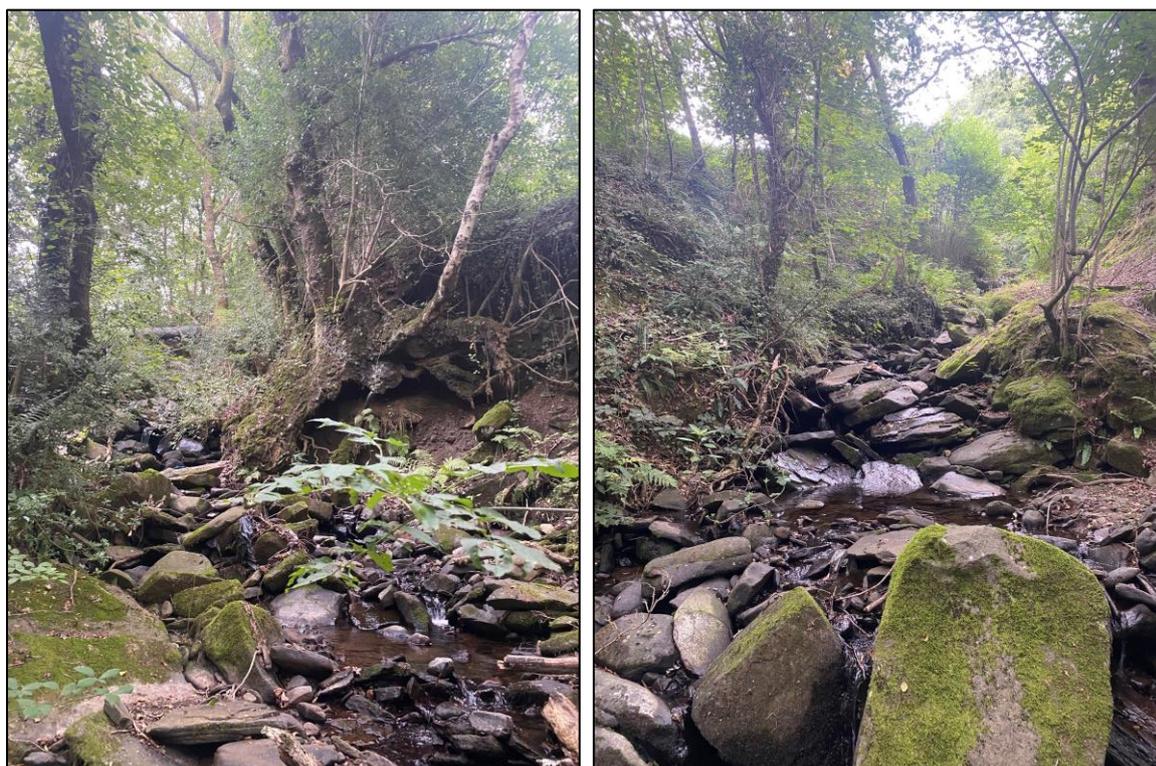
The Ely Brook watercourse was observed as having significant deposition of erosive debris along its length. The evidence suggests that the debris identified at the surcharged inlet originated from the upstream sections of watercourse where natural hillside material is likely to have been washed down onto the structure following intense rainfall.

Post event inspections of the Ely Brook watercourse identified large stonewash within the channel, as well as the undercutting of large trees caused by bank erosion in the upper catchment (depicted in Figures 30). The inspection also noted that the watercourse is very steep in its upper reaches, indicating that fast flowing water generating large debris mobilisation and sedimentation is likely in this part of the catchment during storm events.

Figure 30: Photo of stone deposition, bank erosion and undercutting of trees within the Ely Brook ordinary watercourse in the upper catchment (captured by RCT's Flood Risk Management team post Storm Dennis)

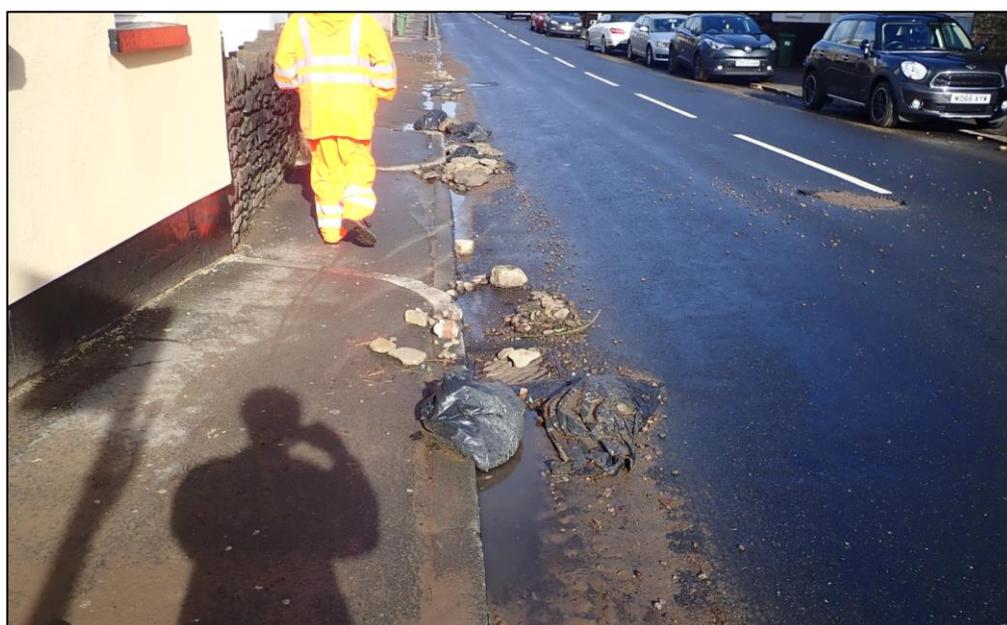
Overland flows from private land and runoff originating from the surcharged inlet to the rear of Heol Mynydd caused water to travel towards Heol Nant and Heol Cronfa, and onwards toward Brynderwen via a small pathway. Deposited mud, silt and debris was evident across these streets, along with several reports of blocked highway drainage gullies, illustrating the flow path of water during the event. Likewise, water sourced by the Ely Brook watercourse travelled north along Pontshonnorton Road, depositing debris on its course, causing blockages to the highway drainage infrastructure (Figure 31).

Figure 31: Debris left after the storm event at Pontshonnorton Road (captured by FRM officers on 17th February 2020)

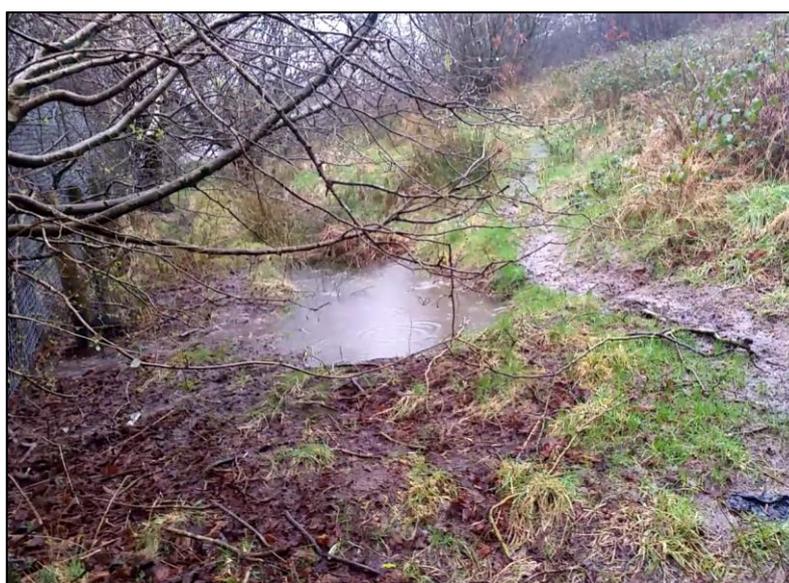
Surface water flooding from an area of land behind Brynderwen was observed by residents as a secondary source of flooding to properties at Brynderwen during Storm Dennis. Upon an inspection of the land by RCT's Flood Risk Management team a small land drainage channel was identified, within privately owned land.

Figure 32: Photo of the drainage ditch overtopping (image captured by resident on 16/02/2020)
