RHONDDA CYNON TAF COUNTY BOROUGH COUNCIL

UPDATE REPORT (OPTION IDENTIFICATION) – HAWTHORN SWIMMING POOL

REPORT OF THE GROUP DIRECTOR CORPORATE SERVICES

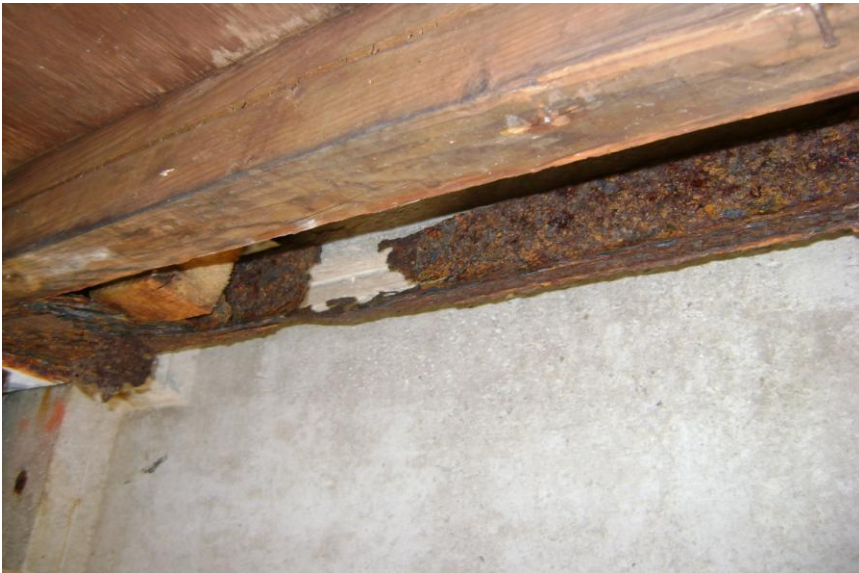
Photograph 1 - Corrosion to building ring beam that extends around the roof to support roof timbers

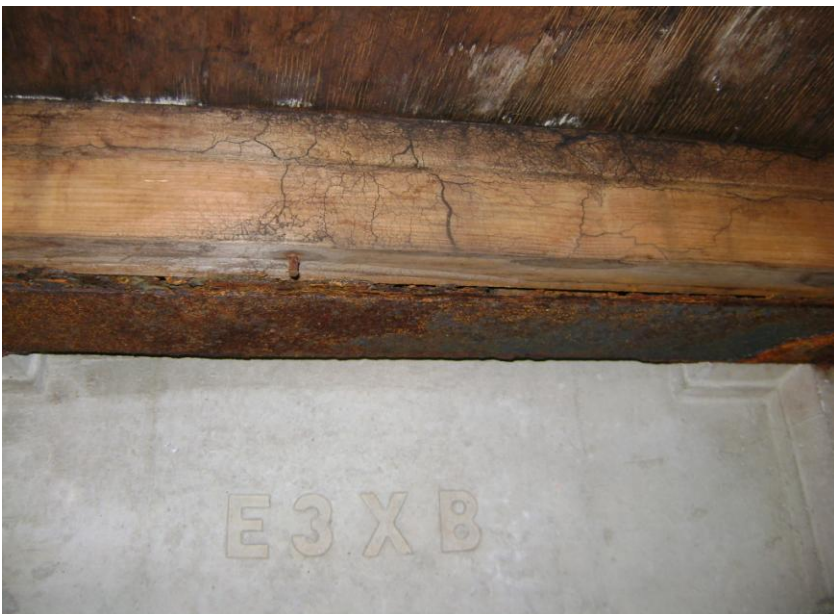
Photograph 2- Water ingress resulting in wet and dry rot that will spread though to all timber and concrete if left untreated

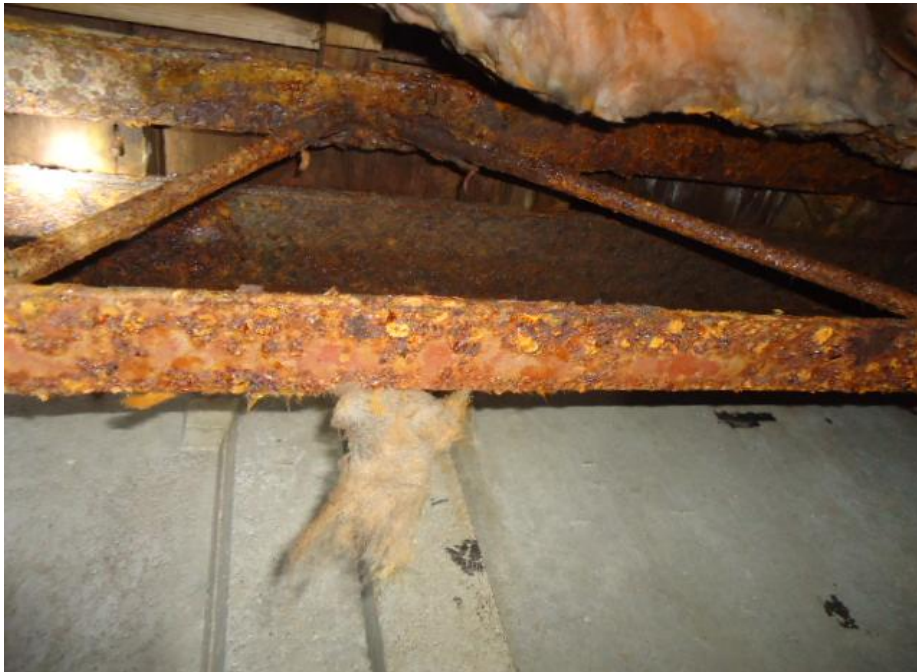
Photograph 3 - Corrosion to steel support roof trusses

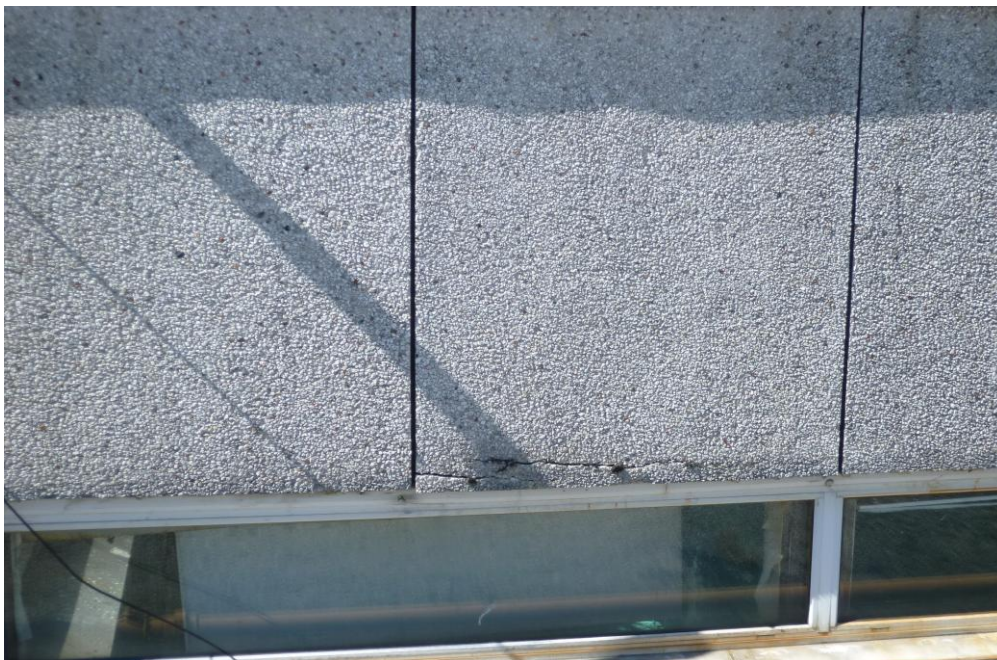
Photograph 4 – External concrete wall panel displaying spalling concrete resulting from corrosion to steel reinforcement bars.
