Flood and Water Management Act 2010

Section 19 Report

Storm Bert – Flood Investigation Area 08

October 2025

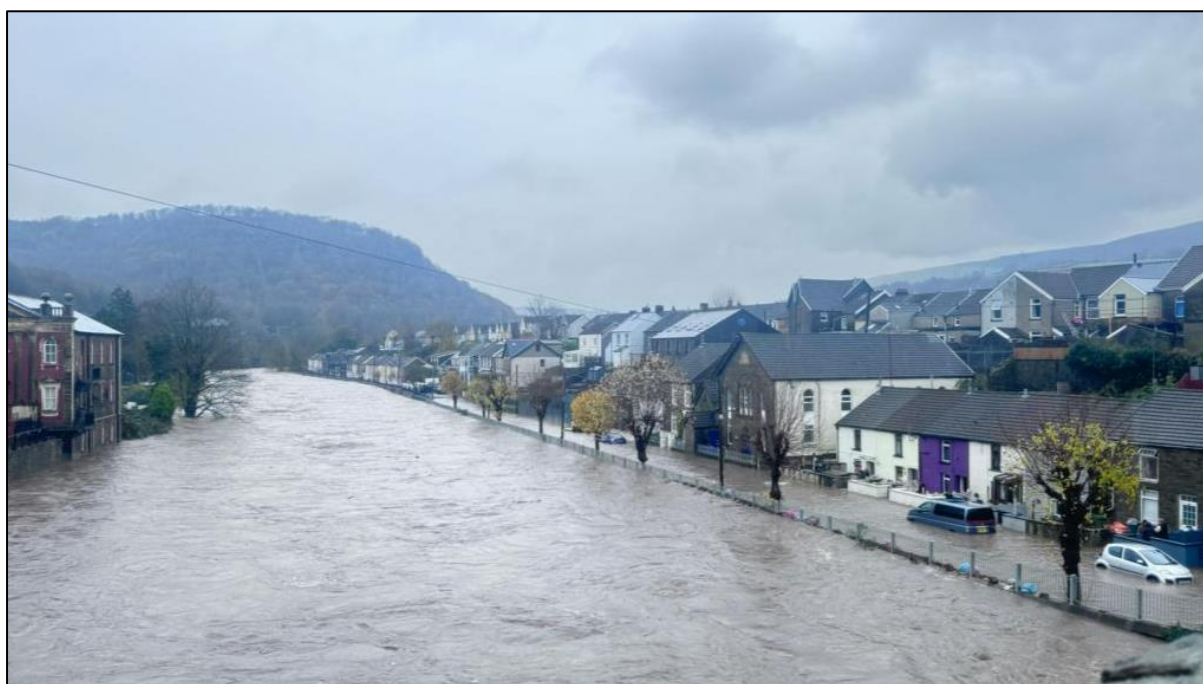
Figure 3: Image of the River Taf exceeding its channel capacity and overtopping the highway wall at Sion Street on the eastern river bank during Storm Bert (Image: BBC News).

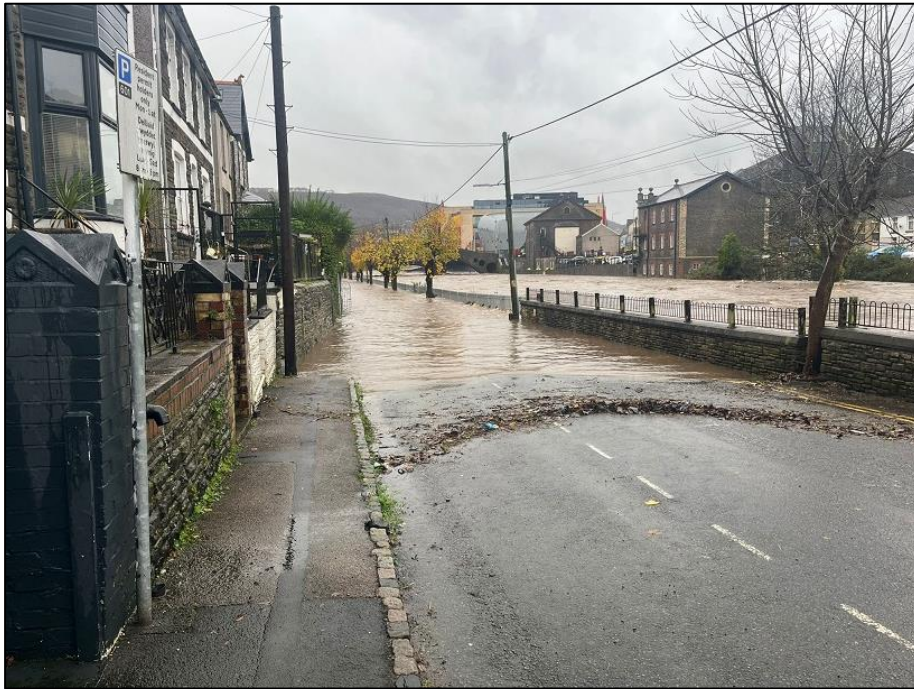
Figure 4: Image of the River Taf exceeding its channel capacity and overtopping the highway wall at Sion Street on the eastern river bank during the morning of Sunday 24 November 2024 (image captured by RCT FRM officer).

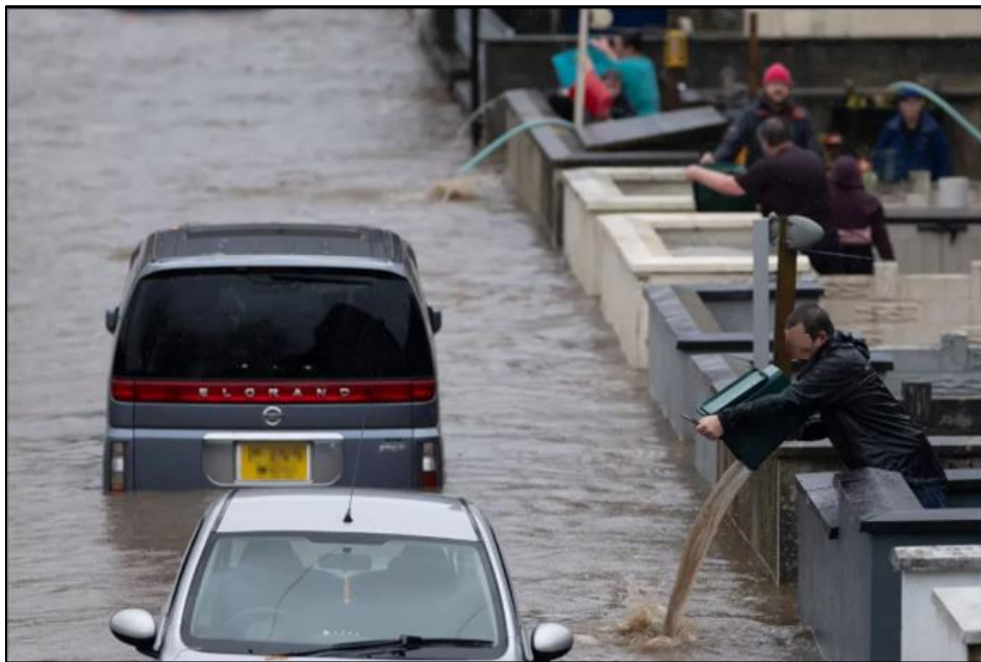
Figure 5 depicts residents at Sion Street bailing water out of their properties over their garden walls and flood doors. Reports from residents noted the water entering their properties from the ground was dirty brown water with sand and mud. Water ingress was also reported to have occurred at the same time as the overtopping of the River Taf onto the road.

Figure 5: Residents at Sion Street bailing water out of their homes during Storm Bert (Image: Getty Images).

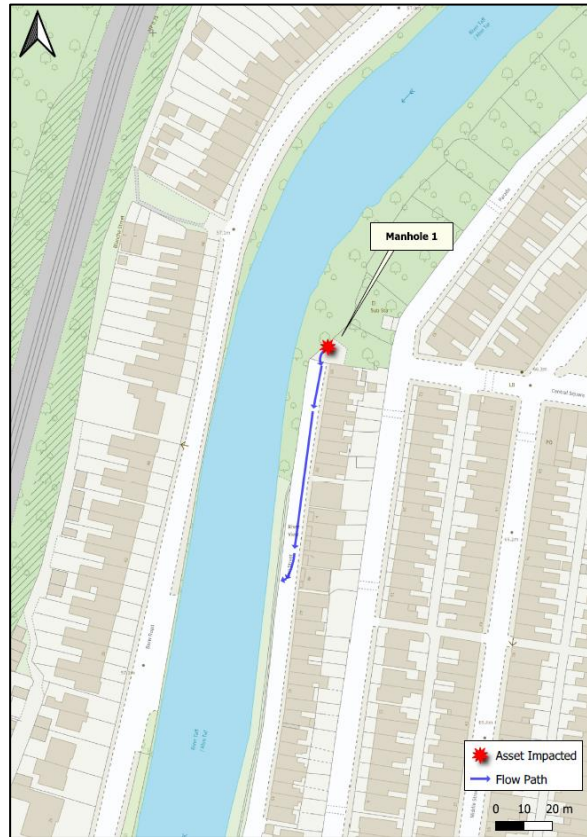
A combined sewer manhole at the northern end of Sion Street (referred to as 'Manhole 1' in Figure 6) was also noted as surcharging during the storm event. Flood water from the manhole flowed southwards down the street and was diverted by residents into the highway surface water drainage system. As a result, flooding to nearby properties was avoided.

Figure 6: Location plan showing 'Manhole 1' which surcharged and flooded at Sion Street during Storm Bert.

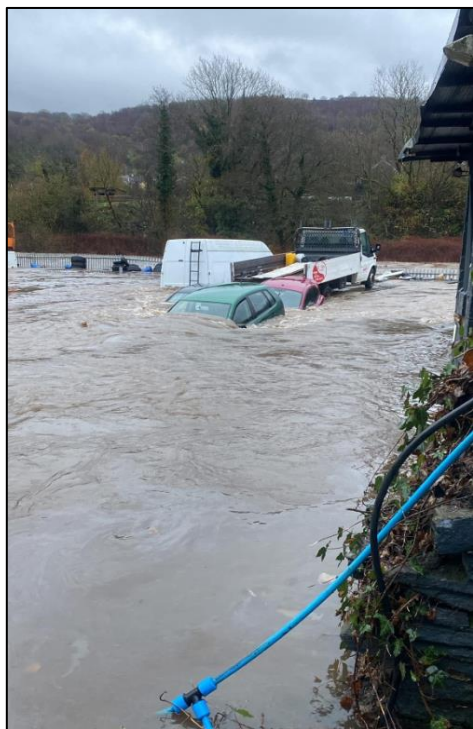
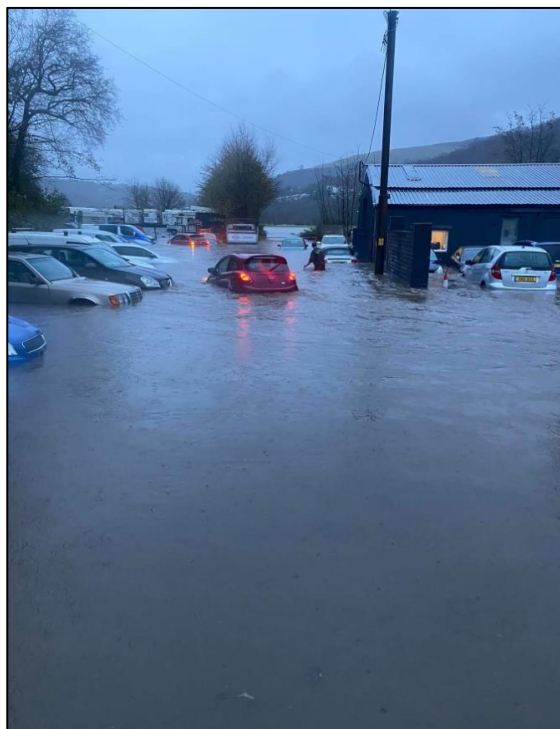
Figure 7: Image of main river flooding at the Old Coach Works, Berw Road on 24 November 2024 (image captured by RCT FRM officer).

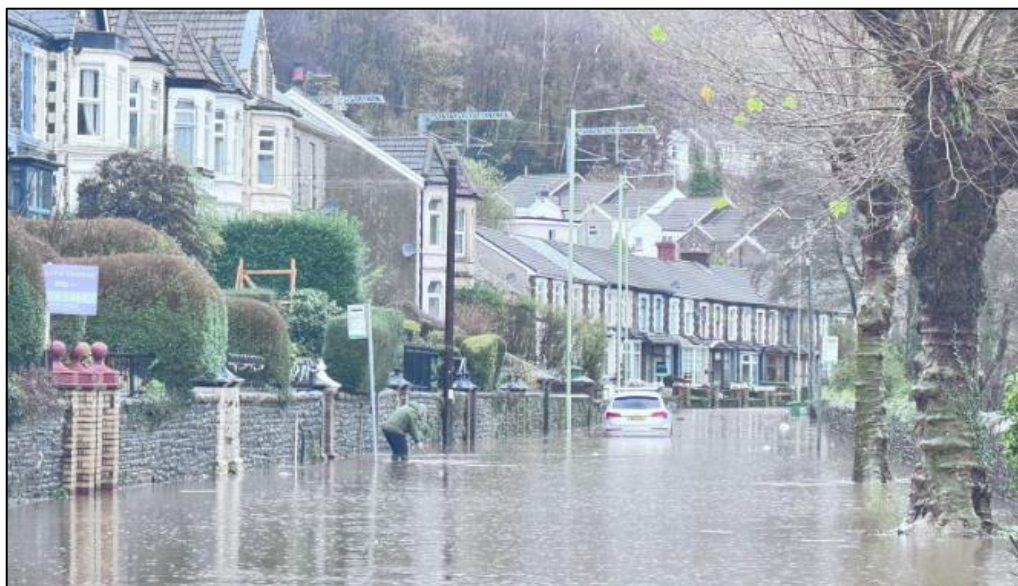
Figure 8: Image of main river flooding along Berw Road on Sunday 24 November 2024 (Image: Social Media).

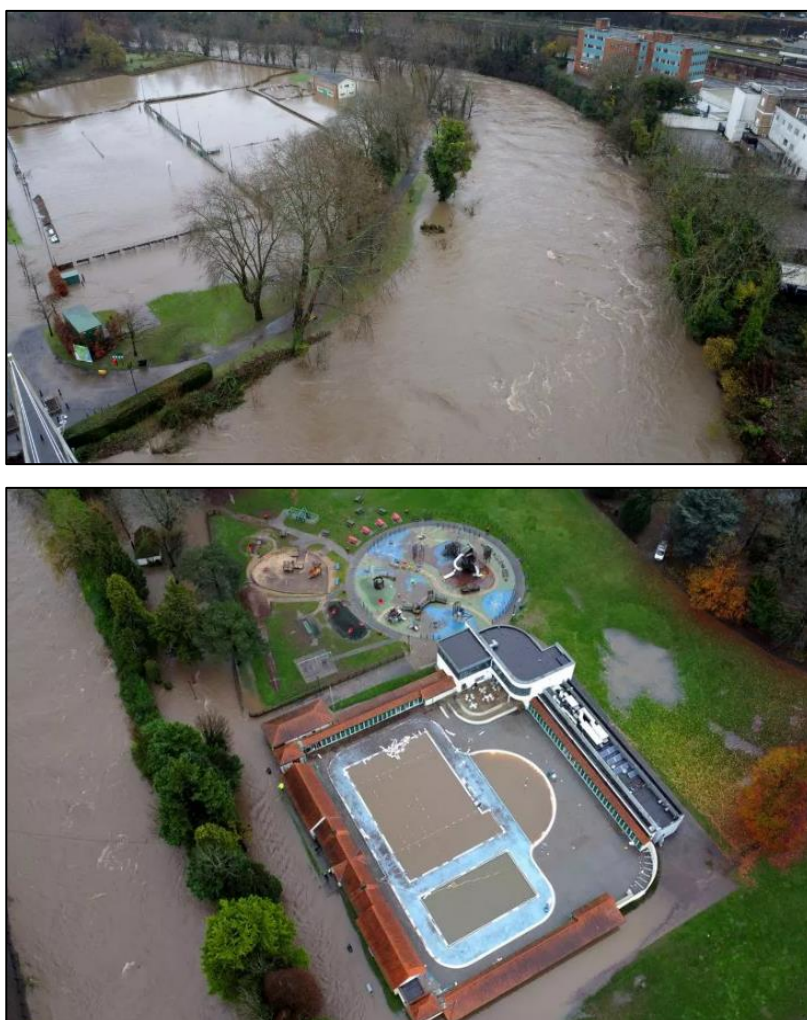
Figure 9: Image showing the flood damage to the National Lido of Wales and Ynysangharad Park as a result of main river flooding from the River Taf during Storm Bert (Image: Wales Online).

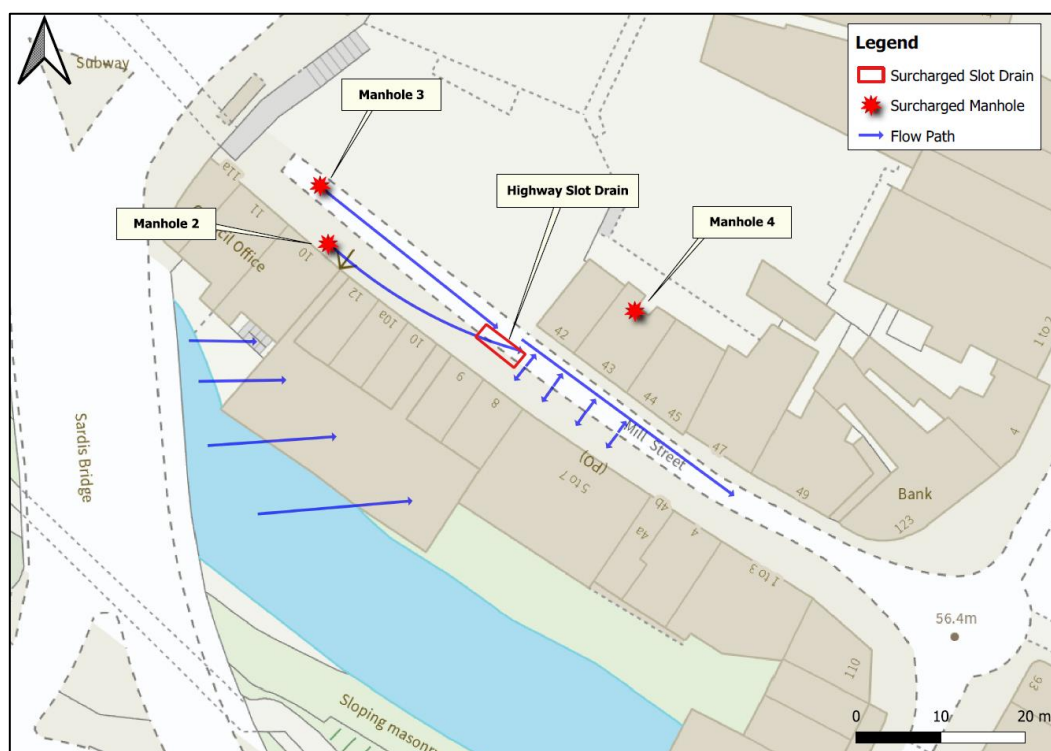
Figure 10 depicts the observed pathways of flooding at Mill Street and the infrastructure known to have surcharged and contributed to the flooding during Storm Bert.

Figure 10: Observed flow paths and surcharging drainage infrastructure at Mill Street during Storm Bert (23-24 November 2024).

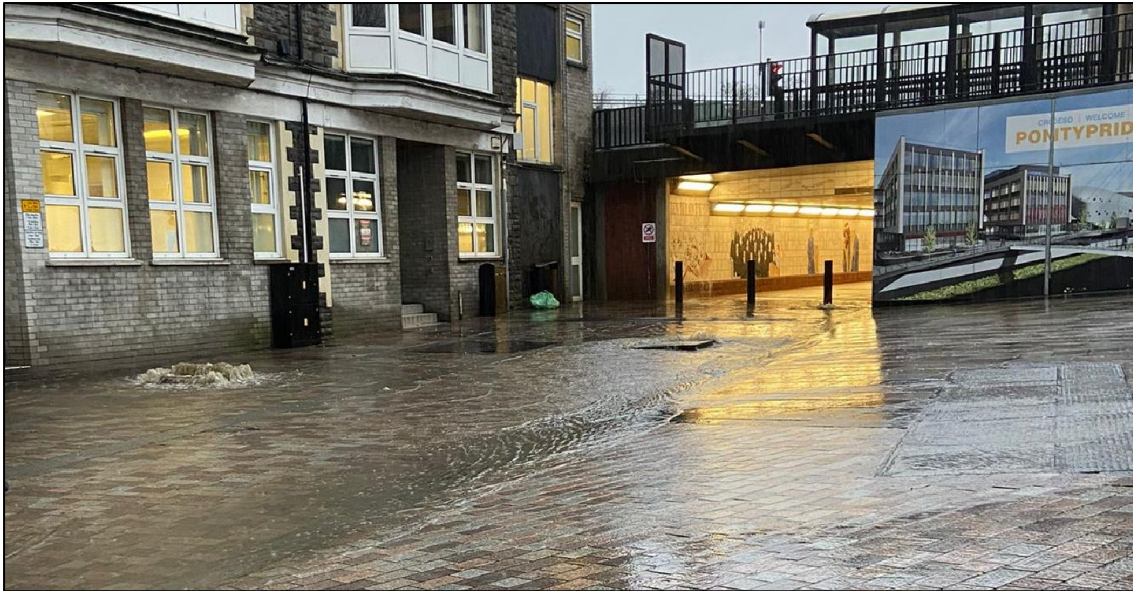
southwest of Mill Street. Figure 11 depicts both manholes surcharging during Storm Bert.

Figure 11: Image of ‘Manhole 2’ and ‘3’ associated to the combined sewer network at Mill Street surcharging during Storm Bert on Sunday 24 November 2024 (Image provided by business owner).

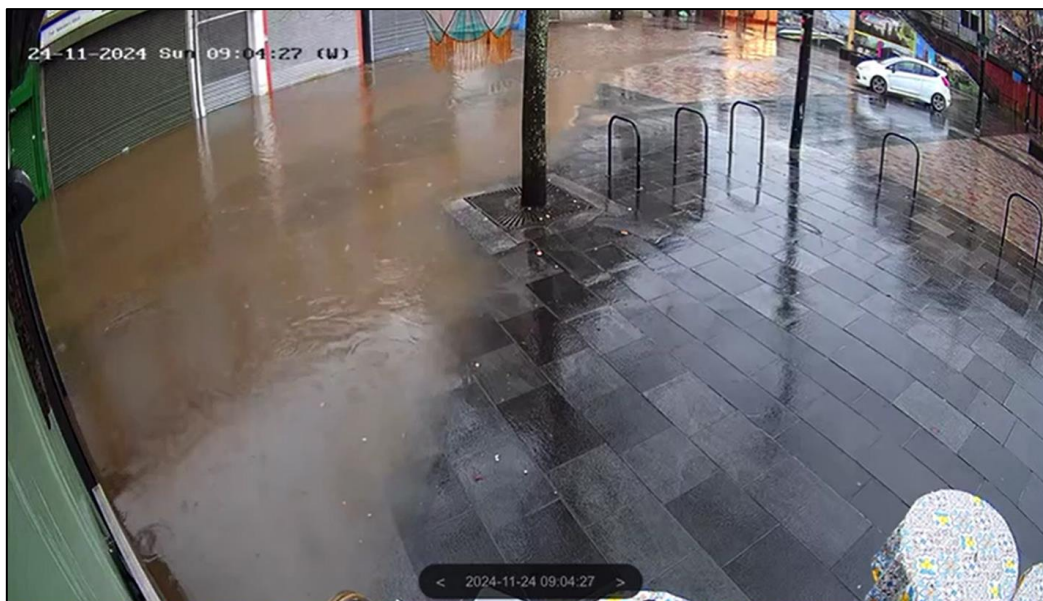
The pathway of water from the surcharging manholes travelled east along Mill Street and accumulated within the street’s topographical low point approximately 50 metres east of the surcharging infrastructure. A highway surface water slot drain (referred to as ‘Highway Slot Drain’ in Figure 10) was also identified as a contributing source of flooding in the area. The slot drain was observed as surcharging brown coloured water during the storm event, contributing to the accumulation of flood water within the low point.

Figure 12: Image of flood water accumulating at Mill Street and evidence of 'Manhole 2' and '3' surcharging during Storm Bert (image captured at 09:04 on 24 November 2024) (image provided by business owner)

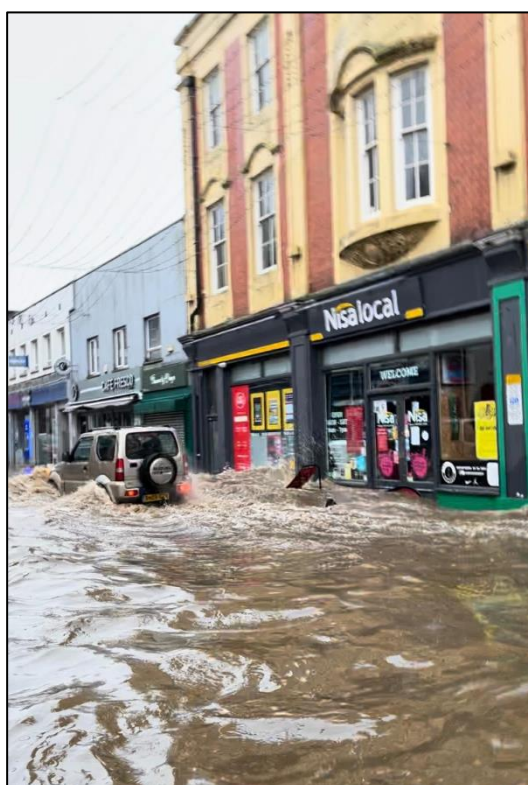
Figure 13: Image depicting the flood water depth within the low point at Mill Street during Storm Bert (image provided by business owner)

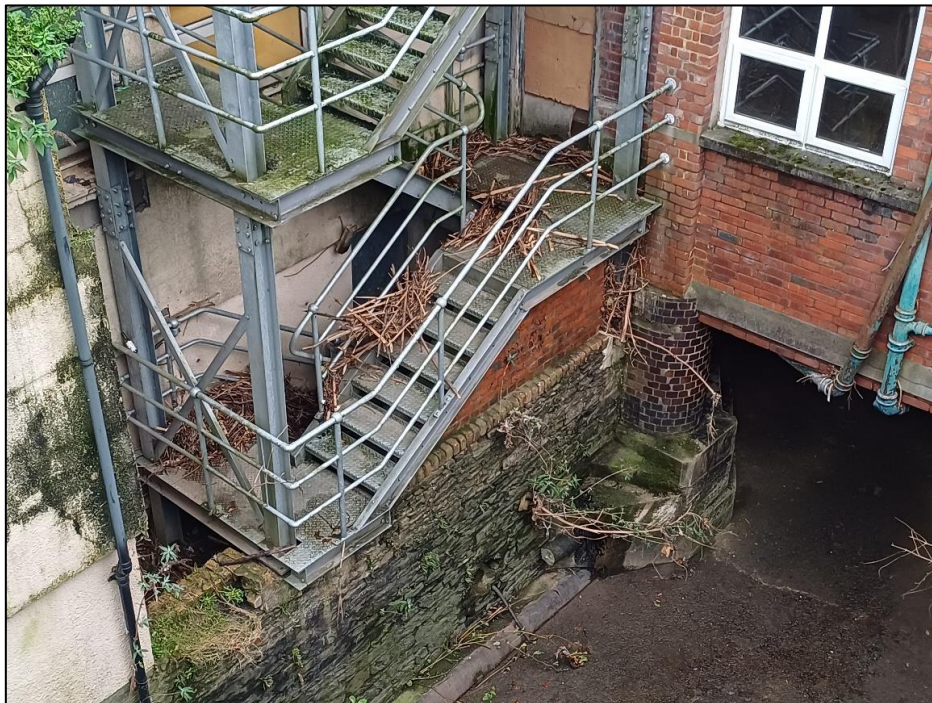
The River Rhondda was also identified to have entered the basement area of 3 commercial premises located adjacent to the main river at Mill Street. Main river water was observed by business owners as emerging from the basements and impacting the ground floor level of properties. Figure 14 shows evidence of debris carried by the high flows in the River Rhondda and deposited along the fire exit of a commercial premise at Mill Street following the storm event. The deposited debris is indicative of the height that the River Rhondda rose to during Storm Bert, submerging the basement level and reaching the ground level of the commercial property.

Figure 14: Image showing debris deposited by the River Rhondda on fire exit steps outside the basement and ground level of a commercial property at Mill Street (image captured by RCT FRM officer on 25 November 2024).

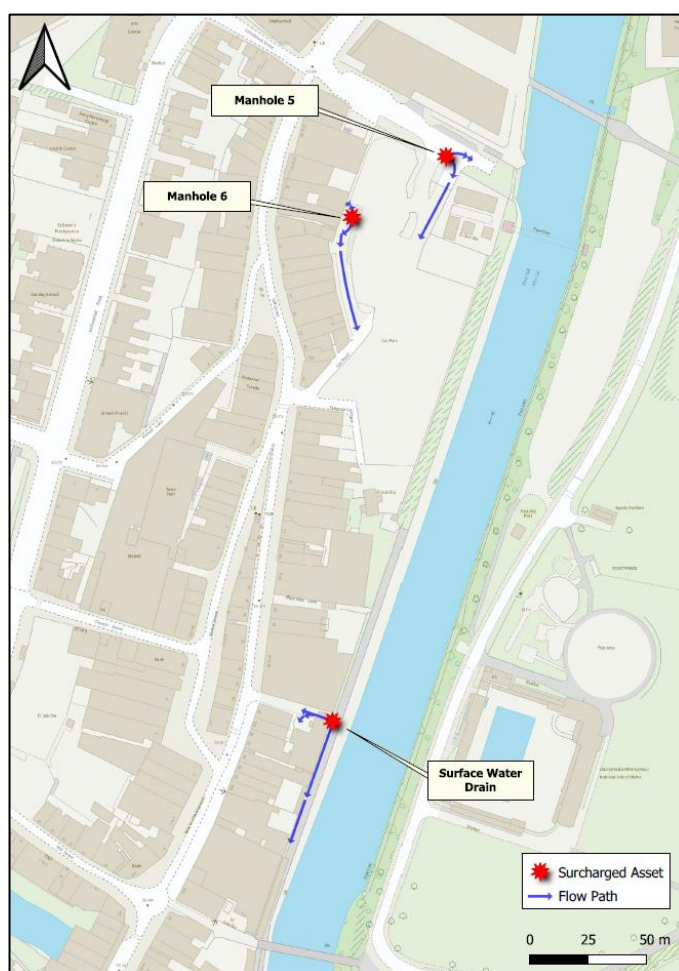
Several commercial properties along Taff Street also reported internal flooding during Storm Bert. Post event inspections and accounts provided by business owners identified sewer and surface water flooding to be the primary types of flooding along Taff Street. Figure 15 depicts the observed pathways of flooding and the infrastructure known to have surcharged and contributed to the flooding at Taff Street during Storm Bert.

Figure 15: Observed flow paths and surcharging drainage infrastructure at Taff Street during Storm Bert (23-24 November 2024).

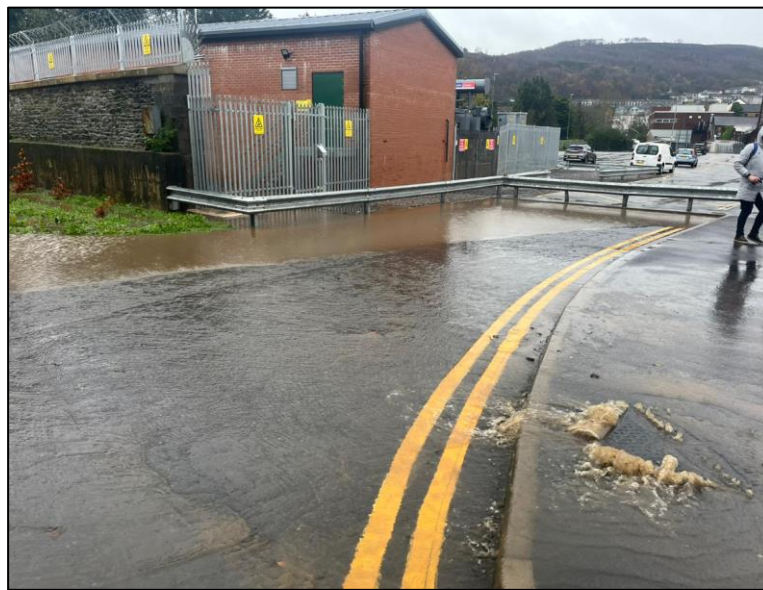
Figure 16: Image of 'Manhole 5' surcharging at Gas Road Car Park, Taff Street during Storm Bert (captured by an RCT FRM officer on 24 November 2024).

Based on GPS-based topographic surveying undertaken by Council appointed contractors, the peak level of the River Taf during Storm Bert was higher than the cover level of 'Manhole 5'. Without the presence of a non-return flap valve, the elevated pressure of the River Taf is considered to have caused river water to enter the drainage network and overwhelm the system, resulting in the surcharging of 'Manhole 5'.

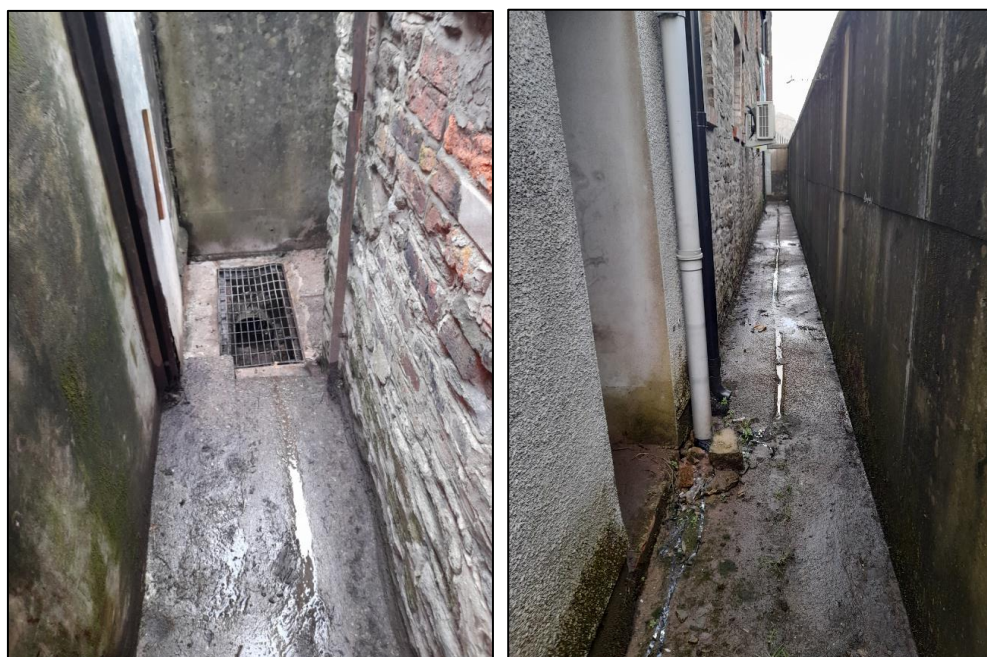
Figure 17: Image of the 'Surface Water Drain' (left) and the rear lane which discharges into the 'Surface Water Drain' behind commercial properties along Taff Street (right) (captured by an RCT FRM officer following Storm Bert).

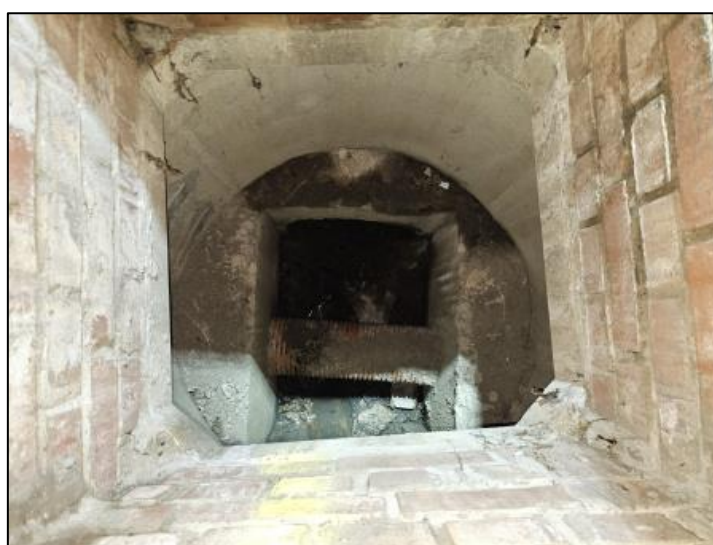
An image of 'Manhole 5' is shown in Figure 19 which shows a large diameter culvert with a DCWW combined sewer pipe crossing through. Based on the CCTV survey, the culvert appears to no longer be in use, showing physical signs of deterioration, corrosion and blockages at the downstream and upstream part of the culvert. The culvert was also dry during both CCTV operations, indicating the network no longer functions as part of the active drainage network.

Figure 19: Image of the internal condition of 'Manhole 5' showing a DCWW combined sewer pipe crossing through the large diameter culvert (captured during CCTV operations in August 2025).

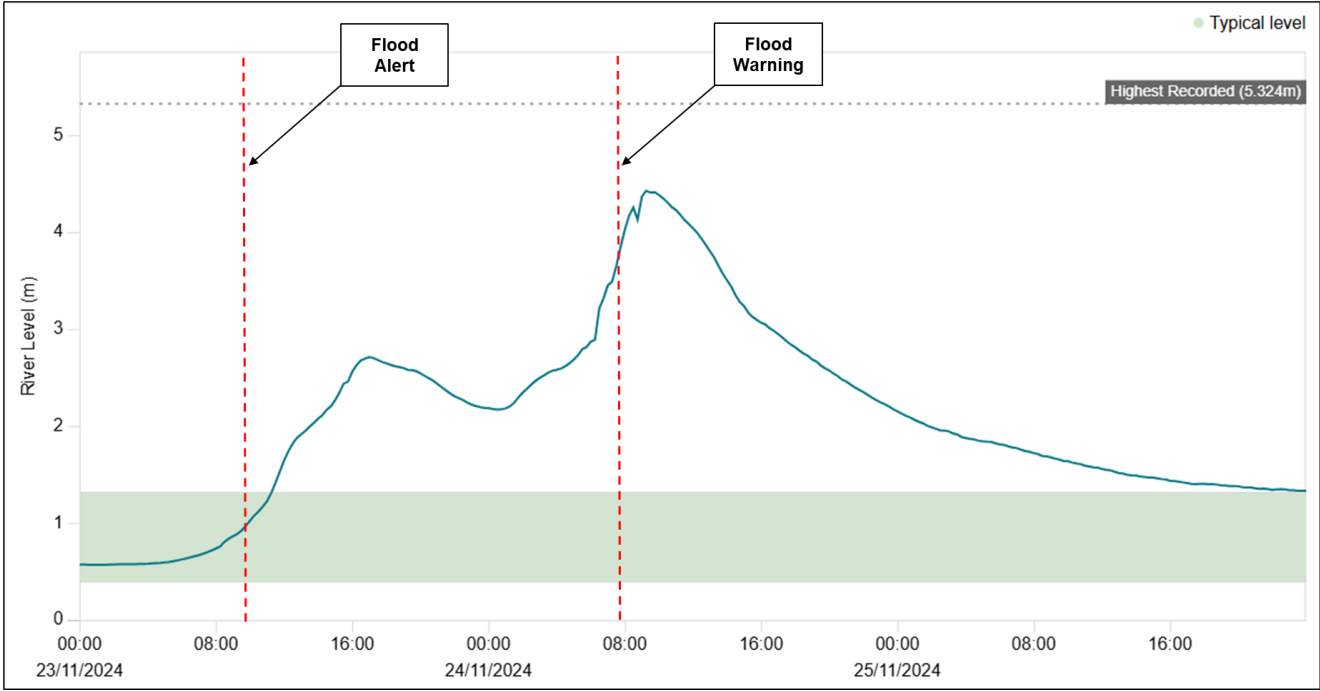
Figure 20: The River Taf levels at Pontypridd station between 23 and 25 November 2024 (Natural Resources Wales)

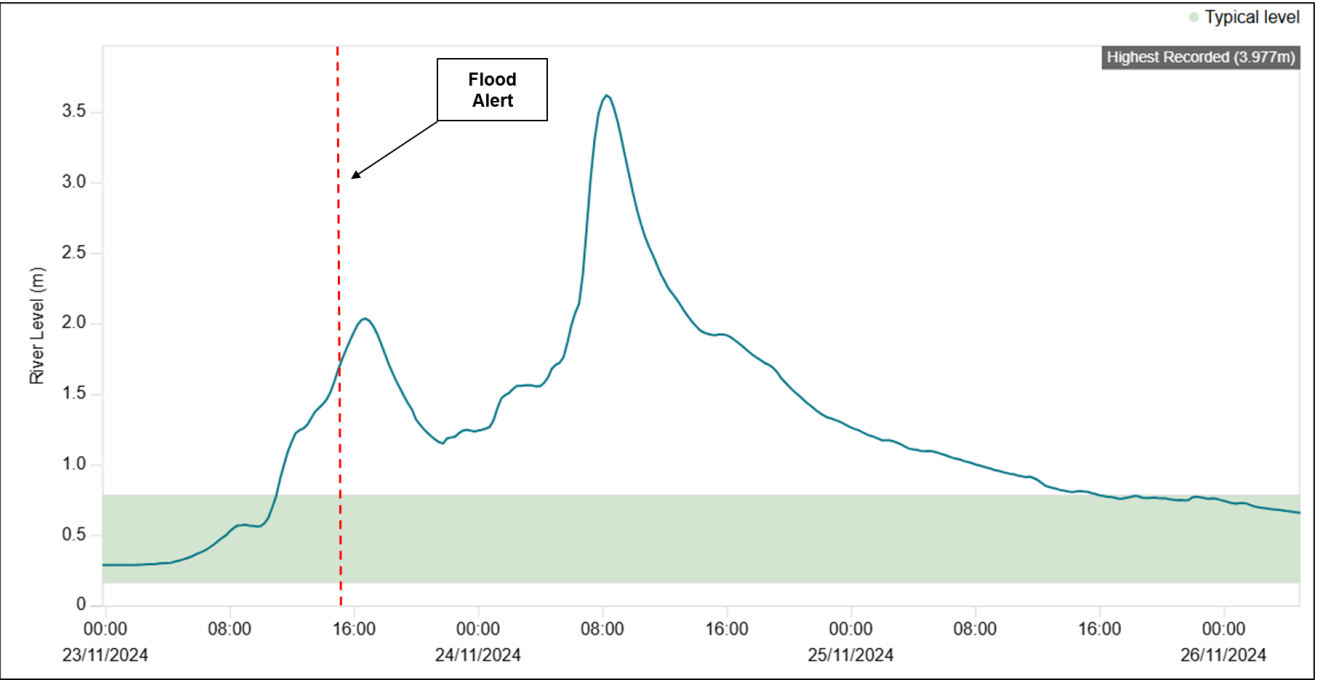
Figure 21: The River Rhondda at Trehafod station between 23 and 25 November 2024 (Natural Resources Wales)

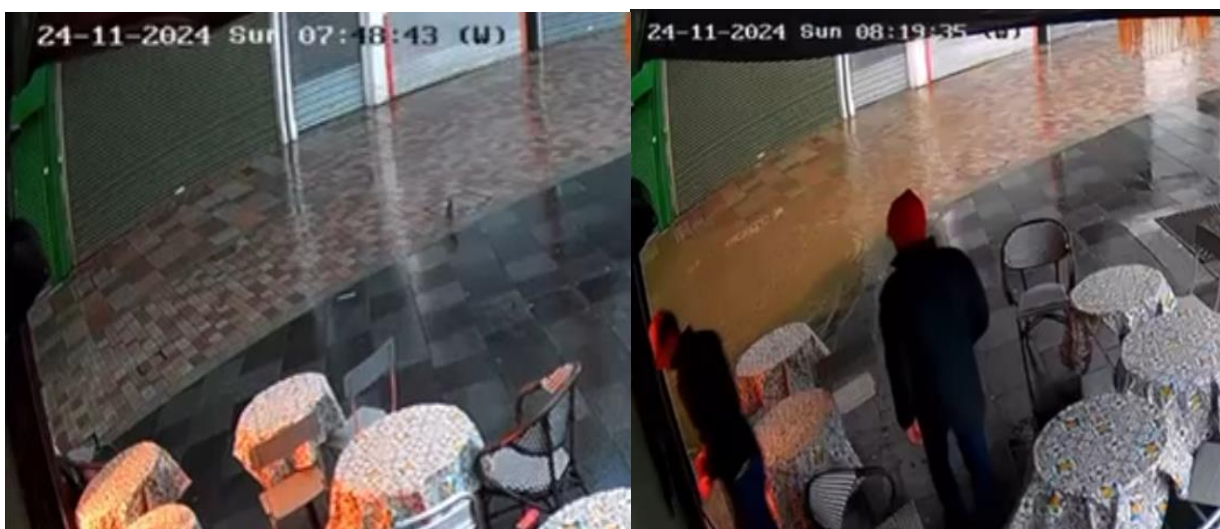
As discussed in Section 2.2, a highway surface water slot drain was observed as surcharging at Mill Street during Storm Bert, contributing to the sewer flooding which impacted 17 commercial properties. This was identified following a review of CCTV footage shared by a local business owner (Figure 25).

Figure 25: Image (left) showing Mill Street slot drain following the subsidence of heavy rainfall at 07:48 and image (right) at 08:19 showing surcharging over 30 minutes later.

In review of the footage shown in Figure 25, the slot drain was depicted as operating throughout the main rainfall event until approximately 07:48. At around 08:19 the slot drain began to surcharge with silty and brown coloured water which is not typical of urban surface water runoff.

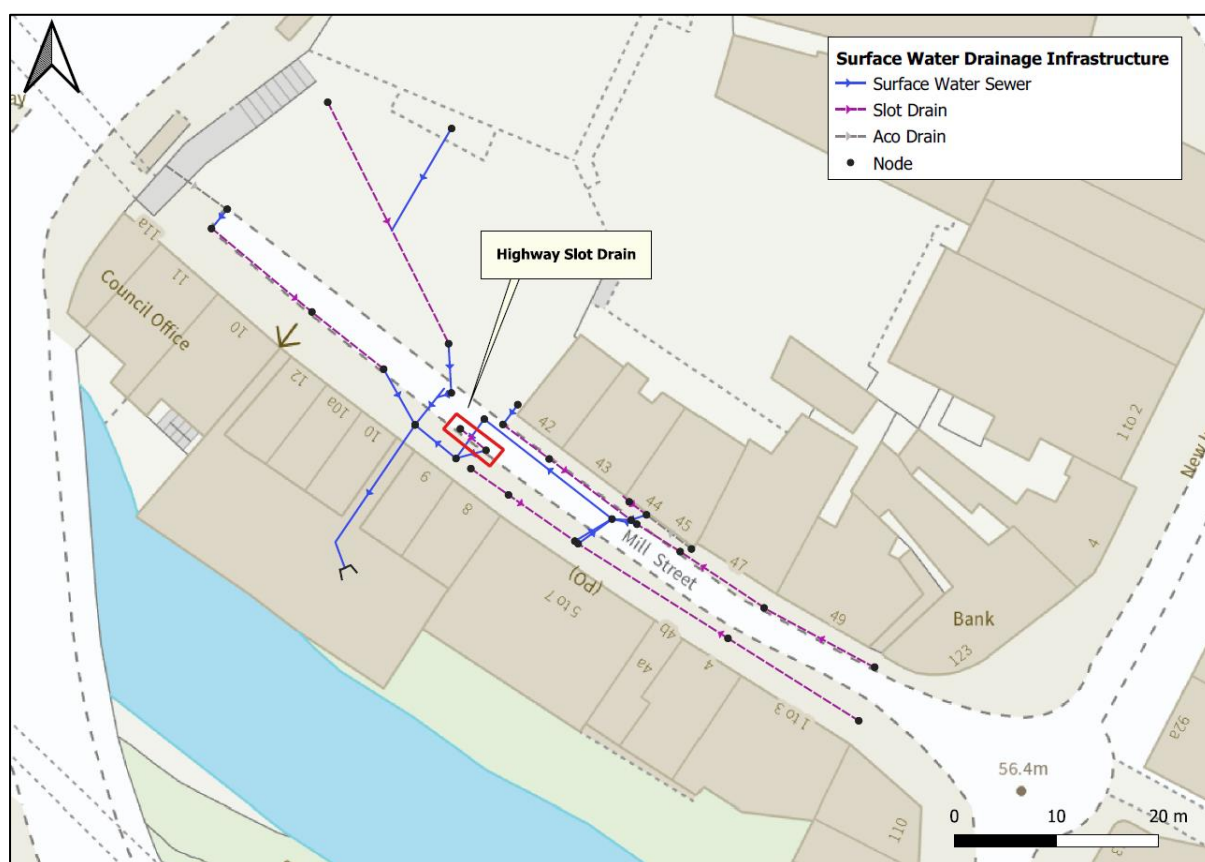
To determine the condition of the highway drainage network at Mill Street following Storm Bert, a CCTV survey was undertaken in December 2024. The survey found no obstructions or defects within the highway slot drain or carrier line. The network was assessed as free-flowing and in acceptable condition, inferring that the drainage network became hydraulically overwhelmed during the storm event. The maintenance condition of the highway surface water drainage system at Mill Street is not considered to have significantly impacted the flooding experienced.

Figure 26: Plan showing the surface water drainage infrastructure in and around Mill Street, along with the location of the slot drain which surcharged during Storm Bert.

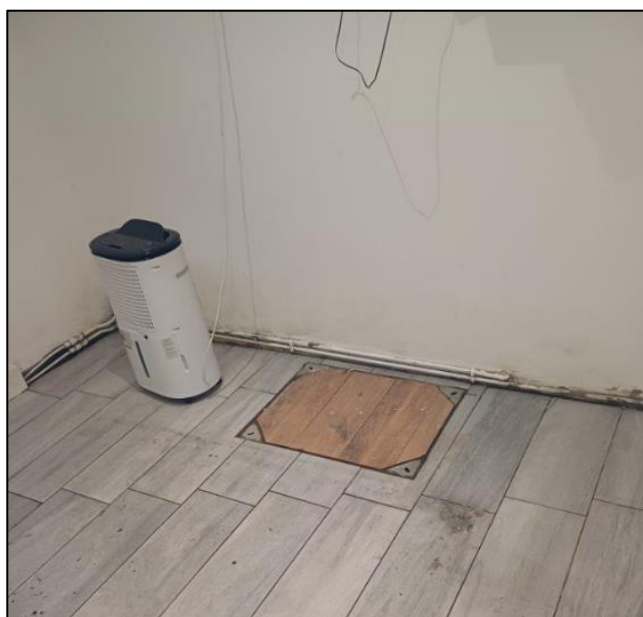
Figure 29: Image of 'Manhole 4' which surcharged during Storm Dennis and contributed to the flooding of 1 commercial property at Mill Street.

DCWW were contacted by the Council in respect of the operation and condition of the various combined sewer assets within Mill Street. Their investigations following Storm Bert did not identify any blockages or structural issues within the combined sewer network.

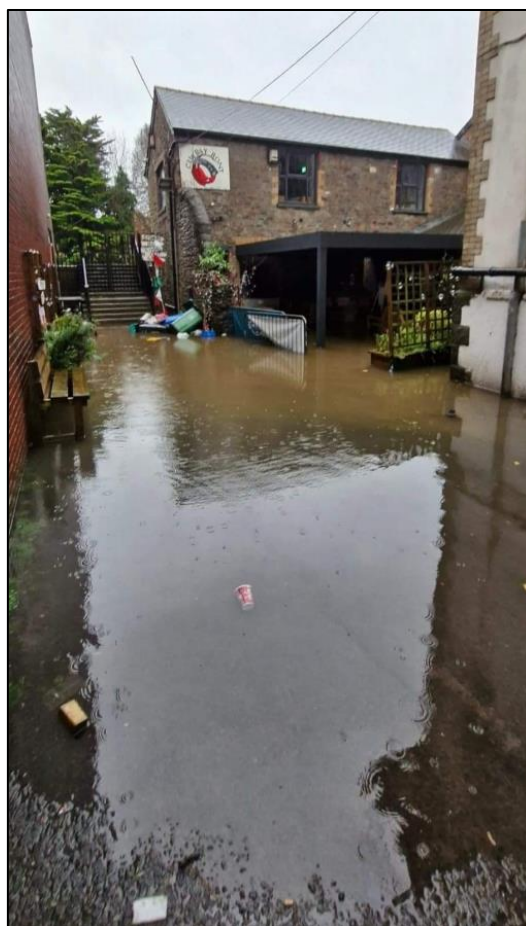
Figure 32: Image of flooding to a commercial property at Taff Street during Storm Bert (captured by an RCT FRM officer on 24 November 2024).
