# Flood and Water Management Act 2010

## Section 19 Flood Investigation Report

Storm Dennis –

Flood Investigation Area RCT02  
(Aberdare & Aberaman)

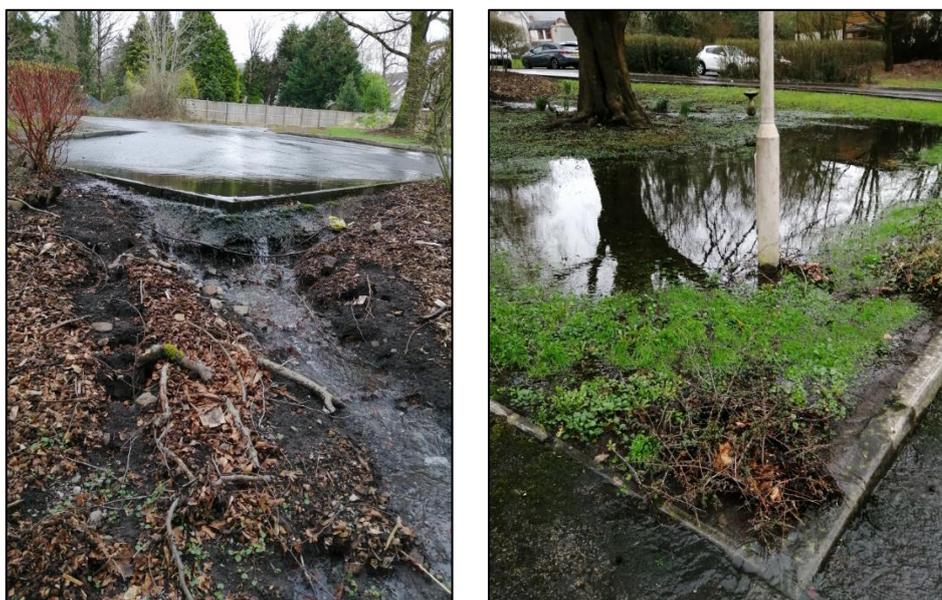
Upon an inspection of the area undertaken by RCT officers in the days following the storm event, significant surface water was observed as pooling within the car park grounds of a non-residential property at Abernant Road (Figure 4) and conveying towards localised low points in the area. Evidence of blocked highway drainage infrastructure and a surcharged surface water sewer manhole along the unadopted road were also identified in the area, considered to have contributed runoff towards localised low points during Storm Dennis.

**Figure 4:** Evidence of surface water ponding and runoff within localised low points at Abernant Road (captured by RCT officers post Storm Dennis)

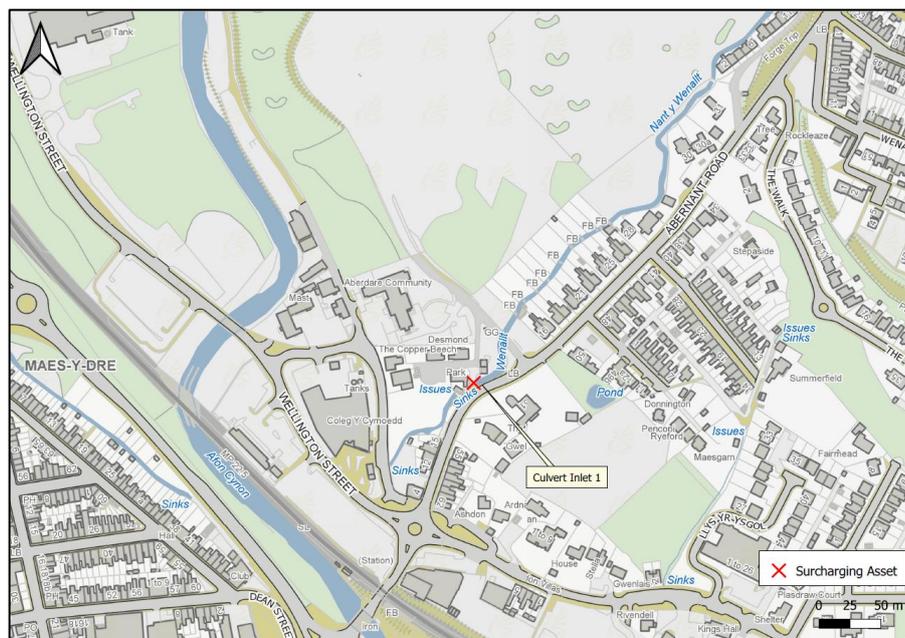
Furthermore, it was reported by residents within the lower reach of Abernant Road that flooding was originating from a “culvert” close to their properties. The Nant y Wenallt watercourse is culverted in three sections at the bottom of the valley however the available evidence suggests that ‘Culvert Inlet 1’ (shown in Figure 5) surcharged during the storm event.

**Figure 5:** ‘Culvert Inlet 1’ associated to the Nant y Wenallt watercourse identified as a source of flooding within the Abernant sub-catchment during Storm Dennis (15-16<sup>th</sup> February 2020)

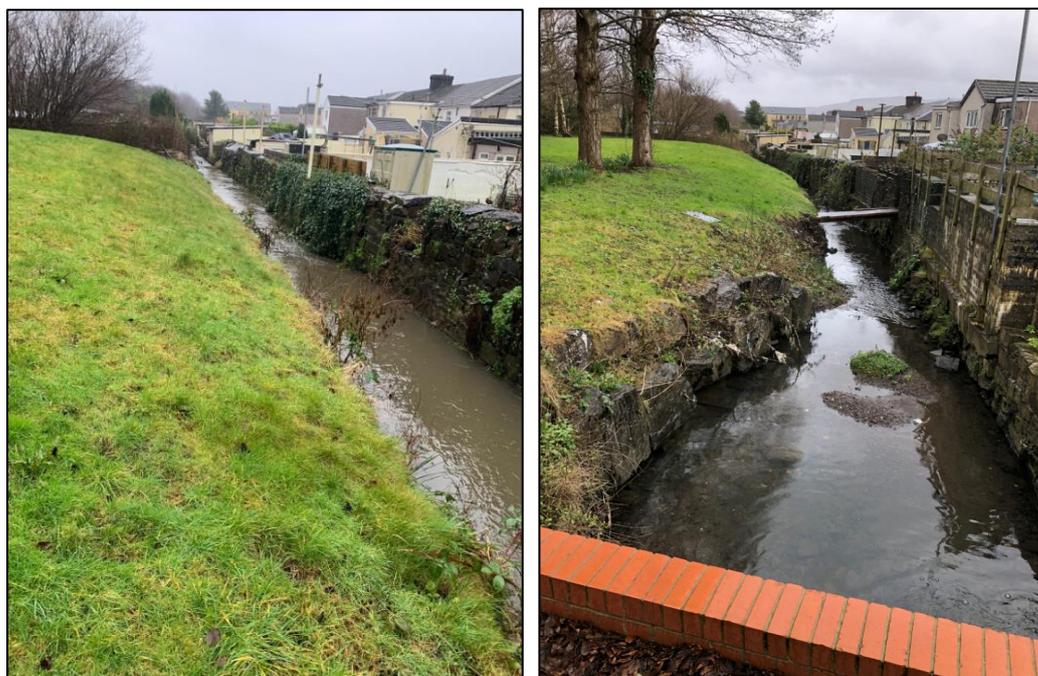
Several calls were received from residents at Gloucester Street on the 16<sup>th</sup> of February 2020 to report water ingress into multiple residential properties. Upon a site inspection undertaken by RCT's Flood Risk Management team in the days following the storm event, an unnamed ordinary watercourse to the rear of properties at Gloucester Street was identified. The unnamed watercourse is illustrated in Figure 6, captured post event.

**Figure 6:** Images of the unnamed ordinary watercourse to the rear of properties at Gloucester Street within the Aberdare East sub-catchment (captured by RCT officers post Storm Dennis)

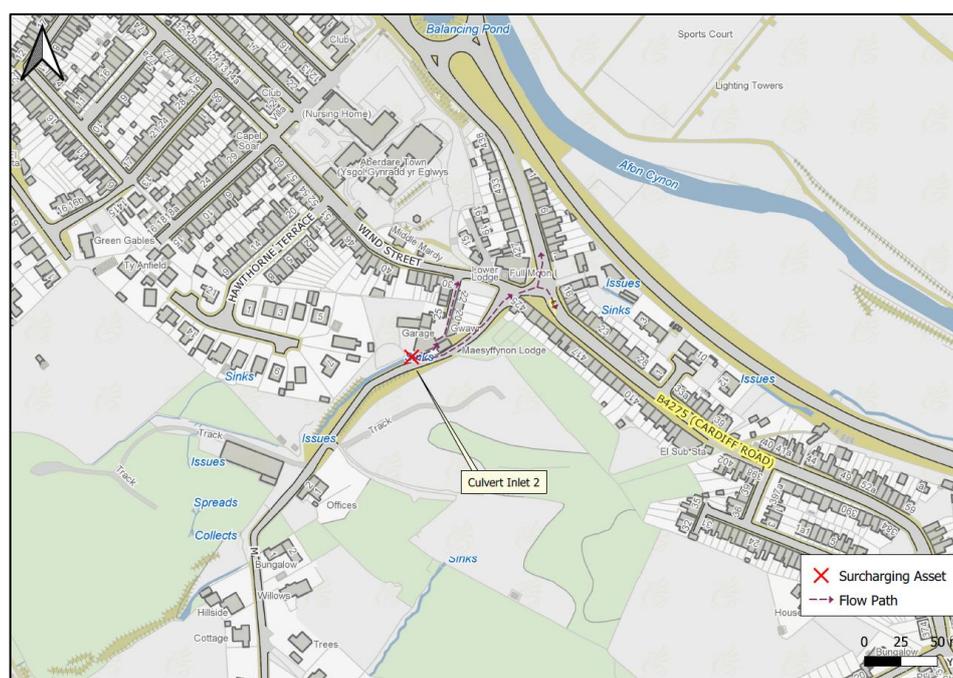
Further south within the Aberdare East sub-catchment, a culvert inlet adjacent to Maesyffynon Lane was identified as surcharging during the storm event. Exceedance flows from the surcharged inlet travelled towards Wind Street and Cardiff Road, resulting in internal flooding to one residential property at Wind Street and one residential property at the junction to Cardiff Road. The location of the culvert inlet (labelled 'Culvert Inlet 2') and the associated flow paths are illustrated in Figure 7).

**Figure 7:** Observed flow path as a result of 'Culvert Inlet 2' surcharging during Storm Dennis (15-16<sup>th</sup> February 2020)

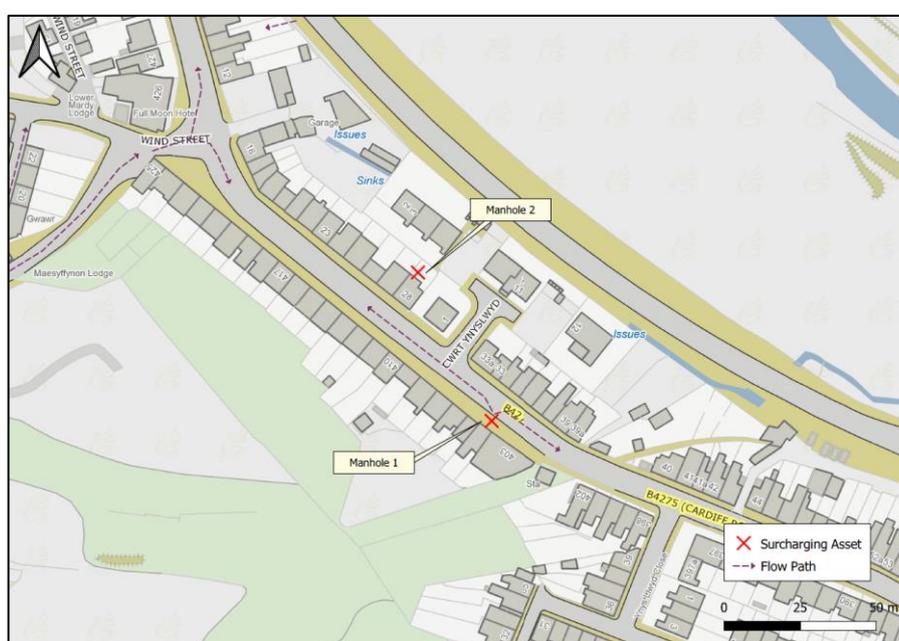
A surcharging ordinary watercourse manhole (labelled 'Manhole 1' in Figure 8) at Cardiff Road was also reported as surcharging during the storm event, contributing additional surface water to the highway which was unable to drain away via the surface water drainage infrastructure along the B4275 (Cardiff Road). In addition to contributing to the internal flooding of 13 residential properties along Cardiff Road, overwhelmed surface water drainage infrastructure was also identified as the primary source of flooding to one commercial property at Cardiff Street.

**Figure 8:** Observed flow path as a result of surcharged infrastructure along the B4275 (Cardiff Road) during Storm Dennis (15-16<sup>th</sup> February 2020)

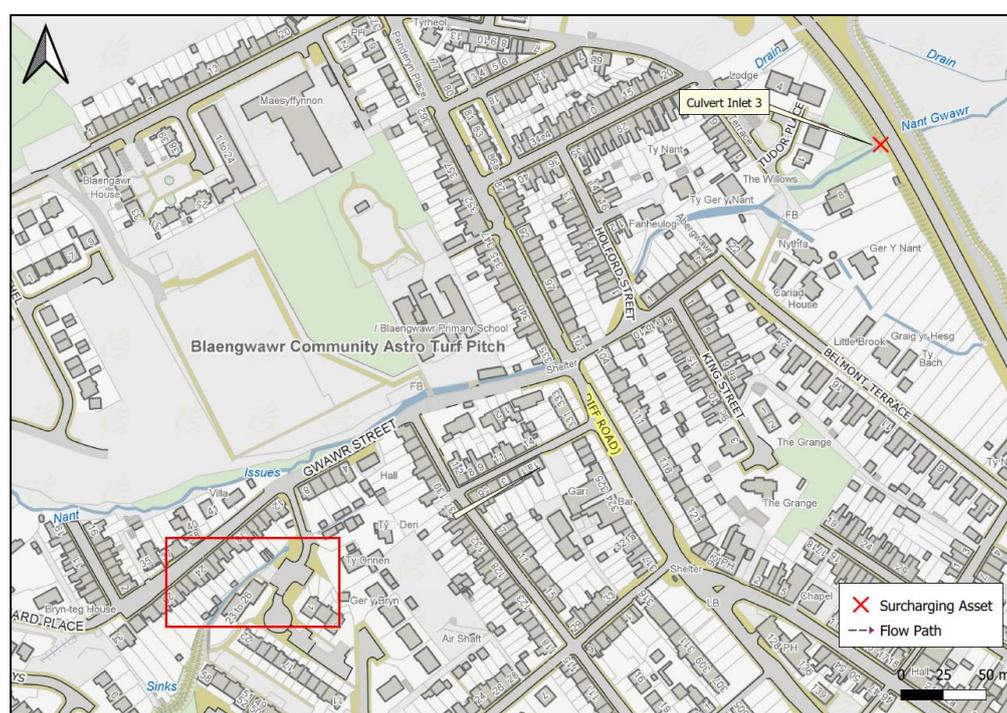
Anecdotal reports provided by residents during post event inspections carried out by RCT officers identified a tributary to the Nant Gwawr ordinary watercourse, which flows adjacent to Gwawr Street, to have overtopped during the storm event following intense rainfall. The unnamed tributary is highlighted within the red box in Figure 9. The watercourse exceeded its typical levels and entered the rear gardens of some properties, resulting in internal flooding to two residential properties at Gwawr Street.

**Figure 9:** Observed flow path as a result of surcharged infrastructure and the unnamed tributary associated to the Nant Gwawr watercourse during Storm Dennis (15-16<sup>th</sup> February 2020).

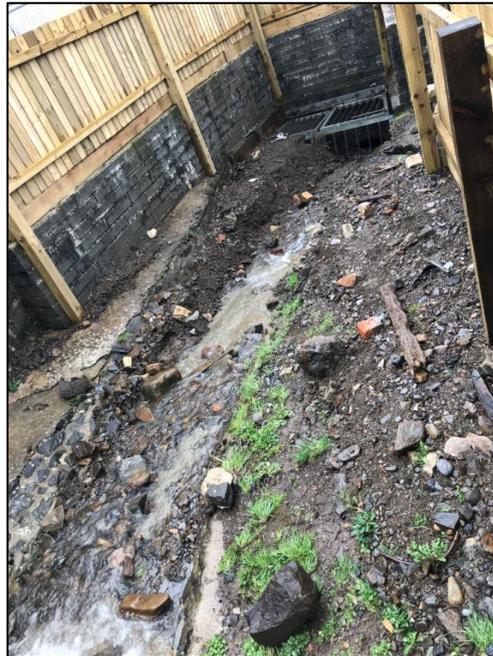
The unnamed channel and associated culvert inlet were identified as heavily silted with deposited debris during post event inspections (depicted in Figure 10), indicating that the culvert inlet was operating at a reduced capacity during Storm Dennis. Damage caused to the rear retaining wall of the impacted properties suggest that the watercourse became overwhelmed during the storm event and overtopped.

**Figure 10:** Evidence of deposited silt and debris within the unnamed ordinary watercourse channel and culvert inlet during post event inspection (captured by RCT's Flood Risk Management team on 21/02/2020)

source of flooding to two residential properties at Gwawr Street, was observed as heavily silted with deposited debris (Figure 10) which was observed as causing a 50% obstruction to the inlet's debris screen. This debris is considered to have impacted the culvert inlet's ability to manage the flow of water, resulting in a backing up effect of flow upstream which contributed to the overtopping of the watercourse over the rear retaining walls of properties at Gwawr Street. The high velocity flows within the Nant Gwawr watercourse during Storm Dennis are also considered to have influenced the overtopping of the unnamed tributary by impacting the discharge of water into the Nant Gwawr at the outfall.

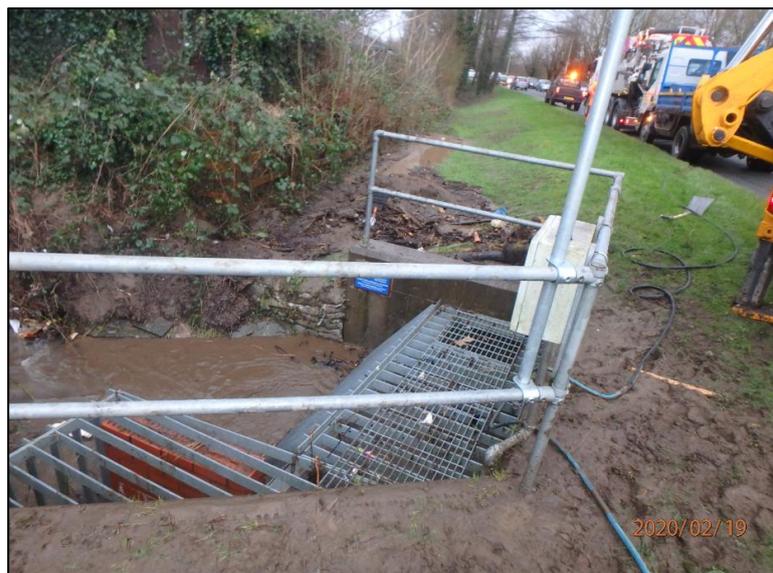
Further downstream of the Nant Gwawr ordinary watercourse, a culvert inlet (labelled 'Culvert Inlet 3' in Figure 9) which conveys beneath the A4059 was identified as surcharging during the storm event. Figure 11 depicts evidence of saturated ground and debris surrounding 'Culvert Inlet 3' following clearance works carried out by the Council's Highway and Streetcare Depot.

**Figure 11:** Image of 'Culvert Inlet 3' captured post event during cleansing operations (captured by RCT officers on 19<sup>th</sup> February 2020)

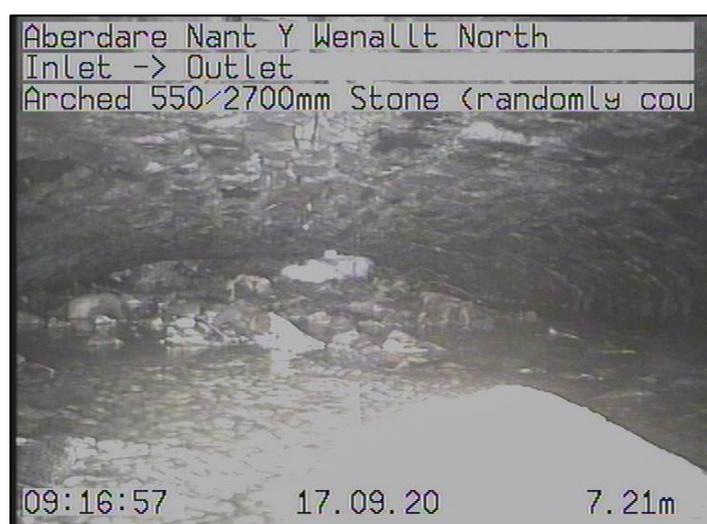
The CCTV survey also identified significant defects and blockages present in the culvert network downstream of 'Culvert Inlet 1', further indicative of the mobilisation of debris from the upper catchment.

**Figure 14:** Evidence of settled debris within the 'Nant y Wenallt' culvert network downstream of 'Culvert Inlet 1' (captured during post event CCTV surveying)

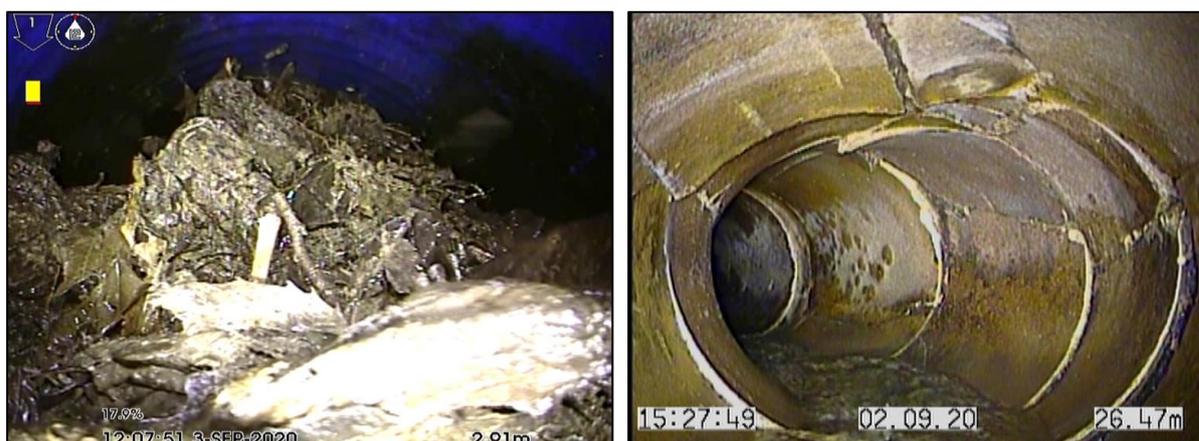
Following the observed surcharging of 'Manhole 1', the associated 'Cardiff Road' culverted watercourse network and overflow system (Figure 13) were surveyed on several occasions post Storm Dennis. The culvert network was assessed as being in poor structural and operational condition with debris identified within the network, both downstream and upstream of 'Manhole 1', restricting CCTV operations. Figure 15 illustrates the poor condition of the 'Cardiff Road' culvert network during CCTV survey operations.

**Figure 15:** Debris accumulation upstream of 'Manhole 1' (left) and deformed overflow culvert network downstream of 'Manhole 1' (right) (captured during post event CCTV surveying operations)

The main line culvert network downstream of 'Manhole 1' was assessed as being in poor condition. The culvert network was identified as deformed with several fractures present which is considered to have impacted the hydraulic efficiency of the network to manage the flows entering the system. The main line culvert network also has a 90-degree bend downstream of 'Manhole 1' which is considered to have hydraulically locked the culvert system, contributing to the surcharge at 'Manhole 1' during Storm Dennis.

The overflow network was also assessed as being in poor condition with several fractures, cracks and sections of broken pipe present (Figure 15, right). The outlet to the overflow network was also identified as buried with silt and debris which is considered to have impacted the outflow control, further contributing to the surcharge of 'Manhole 1'.

Based on the available evidence, the poor condition of the 'Cardiff Road' culvert network is considered to have contributed to the surcharging of 'Manhole 1' during Storm Dennis. The debris identified throughout the network and at the outfall is also indicative of the high flow rates which enabled the erosion and transportation of debris from the upper catchment and into the culvert network during the storm event.

In response to the defects identified within the culvert network, the Council appointed a contractor to cleanse the 'Cardiff Road' culvert network and undertake culvert lining and repair works to the overflow culvert network.

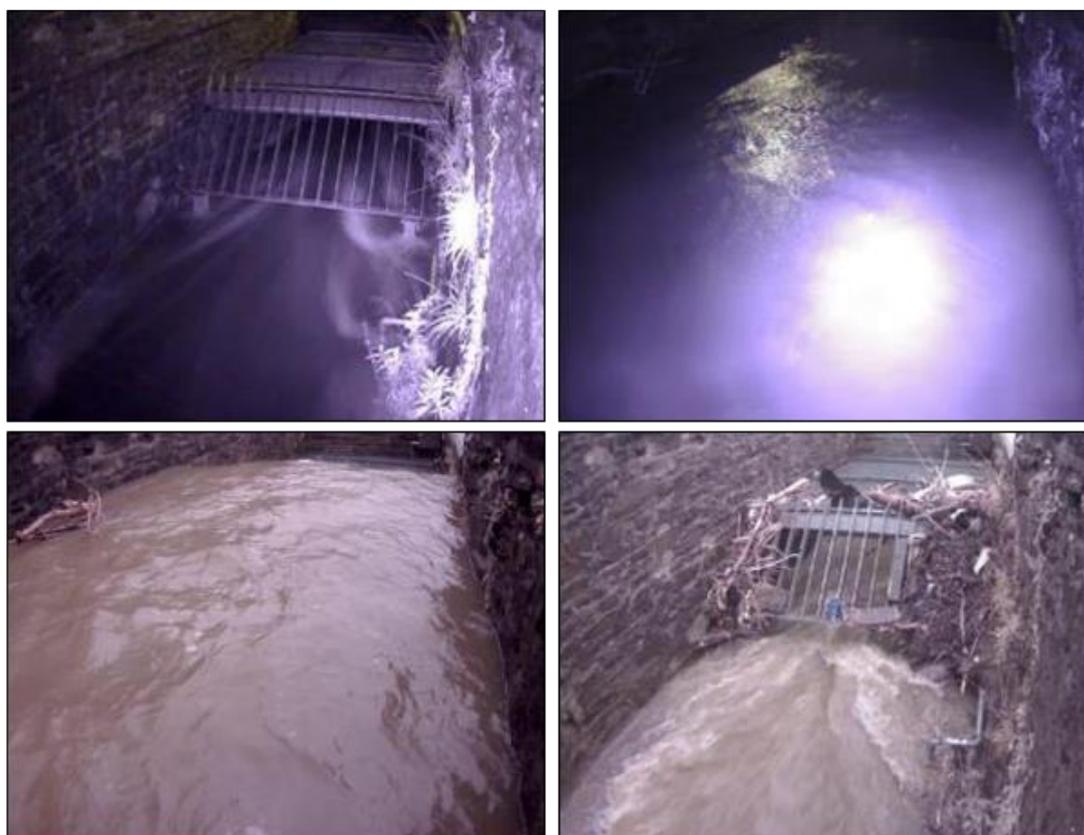
The Nant Gwawr is initially culverted beneath the B4275 (Cardiff Road) and outfalls adjacent to Holford Street. The culvert inlet was inspected following the storm event and found to be partially blocked with debris however no flooding was attributed to the inlet. CCTV footage captured by RCT's monitoring station depicts the rapid rise and fall in water levels on the Nant Gwawr watercourse during Storm Dennis (Figure 16). Within a 14-hour period, levels within the Nant Gwawr rose extremely suddenly during Saturday (15 Feb) night and remained high until suddenly falling by Sunday (16 Feb) morning, leaving behind deposited debris mobilised during the peak flows.

**Figure 16:** Images of the Nant Gwawr inlet at the B4275 (Cardiff Road) captured at RCT's monitoring station (15/02/20 20:34 (top left), 16/02/20 03:30 (top right), 16/02/20 08:27 (bottom left), 16/02/20 10:27 (bottom right))

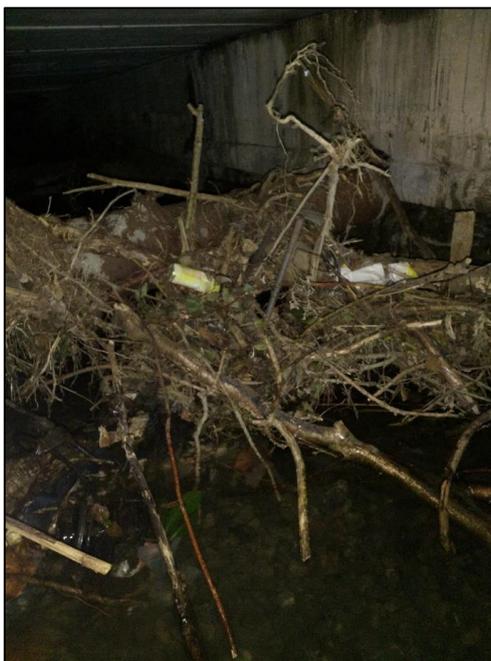
The 'Nant Gwawr' culvert network downstream of the culvert inlet depicted in Figure 16 was surveyed to be in poor operational condition. Debris, inclusive of woody debris, was identified downstream of the culvert inlet (shown in Figure 17), indicative of the mobilisation of debris carried downstream during the storm event.

**Figure 17:** Large woody debris identified within the culvert network downstream of the culvert inlet adjacent to the B4275 (Cardiff Road) (captured during CCTV surveying operations)

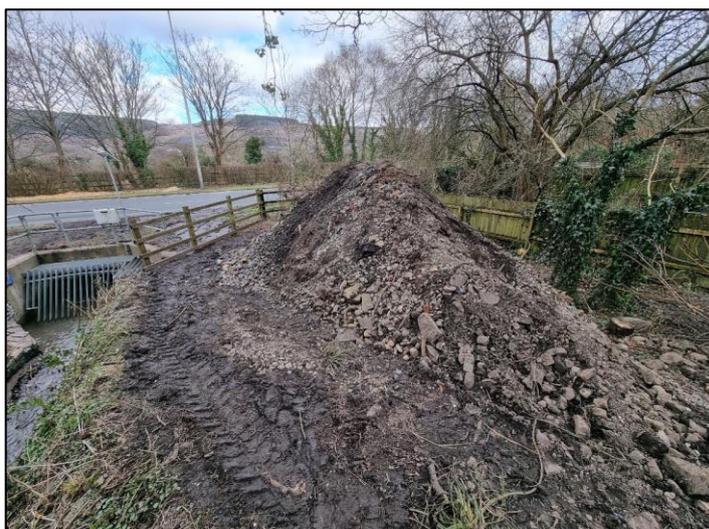
The culvert network downstream of 'Culvert Inlet 3' was assessed as being in acceptable condition with no structural defects and little settled debris observed, inferring that the obstruction to inlets' debris screen was the primary cause of surcharge at 'Culvert Inlet 3'.

**Figure 18:** Debris removed from 'Culvert Inlet 3' and the upstream watercourse (captured by RCT officer post Storm Dennis)

The observed blockages to the 'Nant Gwawr' culverted infrastructure are indicative of the mobilisation and conveyance of debris carried downstream during the storm event. Residents in the downstream section of the Nant Gwawr watercourse also reported that debris, inclusive of woody material, was creating a damming effect within the watercourse. This debris is considered to have been washed down through the culvert network, causing an obstruction at 'Culvert Inlet 3' which led to its surcharging.

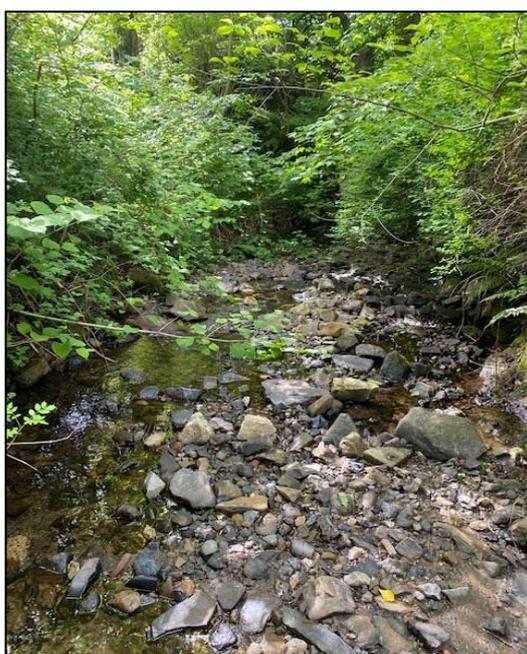
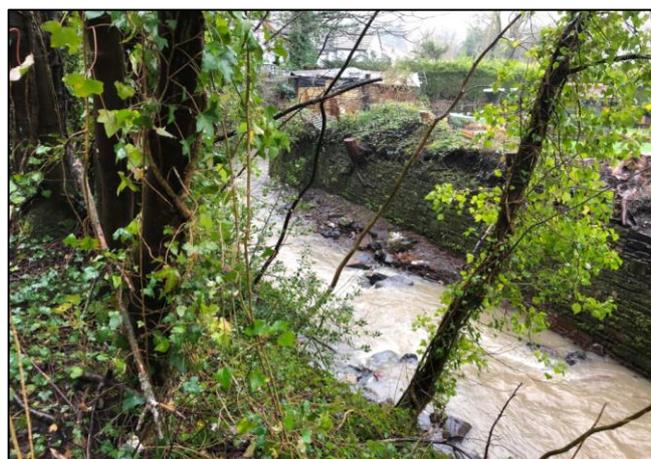
On review of the Nant y Wenallt ordinary watercourse post event there was evidence of deposited natural scour material and debris throughout the length of the channel (Figure 20). The watercourse was also observed as showing signs of embankment scouring and undercutting within the upper reaches, indicative of the fast-flowing water conveying downstream.

**Figure 20:** Debris deposition within the Nant y Wenallt ordinary watercourse during post event inspections carried out by RCT officers

The debris removed from the culvert network downstream of ‘Culvert Inlet 1’ was indicative of natural scour material, indicating that the condition of the upstream ordinary watercourse contributed erosive material towards ‘Culvert Inlet 1’ during the storm event. Although it is not possible to conclude that this material was wholly transported downstream during the storm event, the material cleansed from the downstream culvert network consisted of similar natural erosive material identified upstream of the Nant y Wenallt.

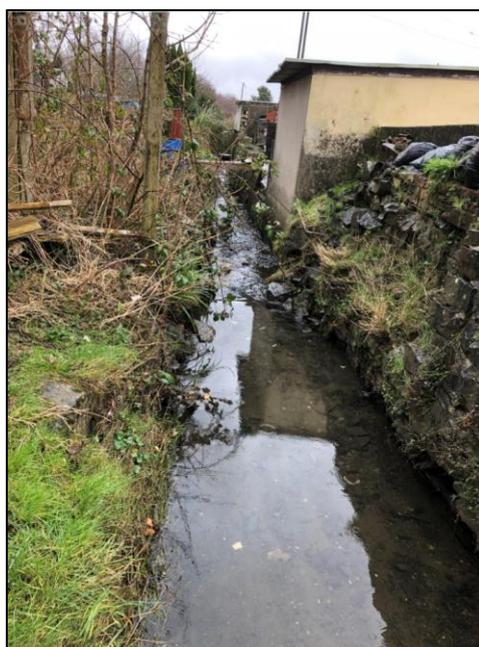
During post event inspections, the watercourse was observed to be in poor condition with heavy vegetation restricting on-site inspections, particularly towards the lower extent of the watercourse. Figure 22, captured post storm event, shows evidence of settled debris within the watercourse, in addition to areas of minor scouring of the embankments, indicative of the high and fast flows during the storm event. The condition of the unnamed ordinary watercourse is not considered the primary cause of overtopping during the storm event, however.

**Figure 22:** Evidence of stripped topsoil on the embankments of the unnamed ordinary watercourse to the rear of Gloucester Street (captured by RCT officers post storm event)

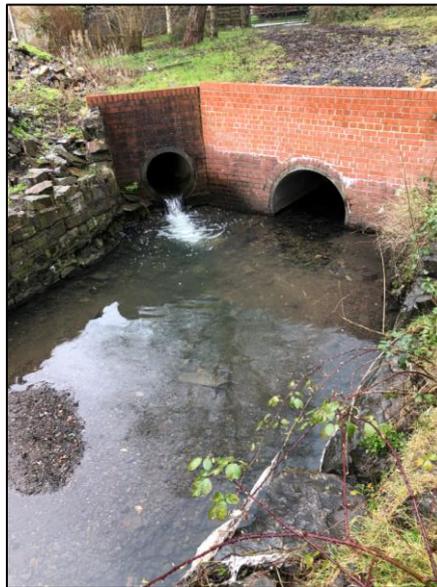
No flooding was observed at 'Outlet 2 and 3', further supporting the belief that high levels on the River Cynon contributed to the overtopping of the ordinary watercourse.

**Figure 23:** Image of 'Outlet 2 and 3' associated to the 'Gloucester Street' culvert network (captured by RCT officers post event)

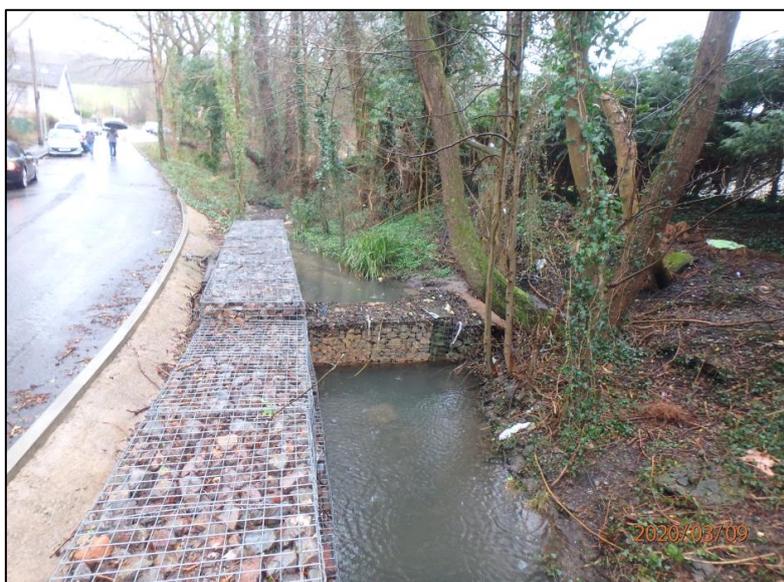
The unnamed ordinary watercourse showed some evidence of debris deposition within the channel however the upper watercourse channel was observed as largely undefined with dense vegetation restricting on-site inspections. The inspecting officer did however observe evidence of out-of-bank flows whereby debris and flattened grass was identified along the eastern embankment in Figure 25. It is considered that significant flows conveying downstream, as a result of intense rainfall during Storm Dennis, caused the watercourse to overtop and mobilise material from the surrounding embankment area towards 'Culvert Inlet 2', contributing to its blockage and associated surcharge.

**Figure 25:** Photo of the unnamed ordinary watercourse channel upstream of 'Culvert Inlet 2' (captured by RCT officers post event)

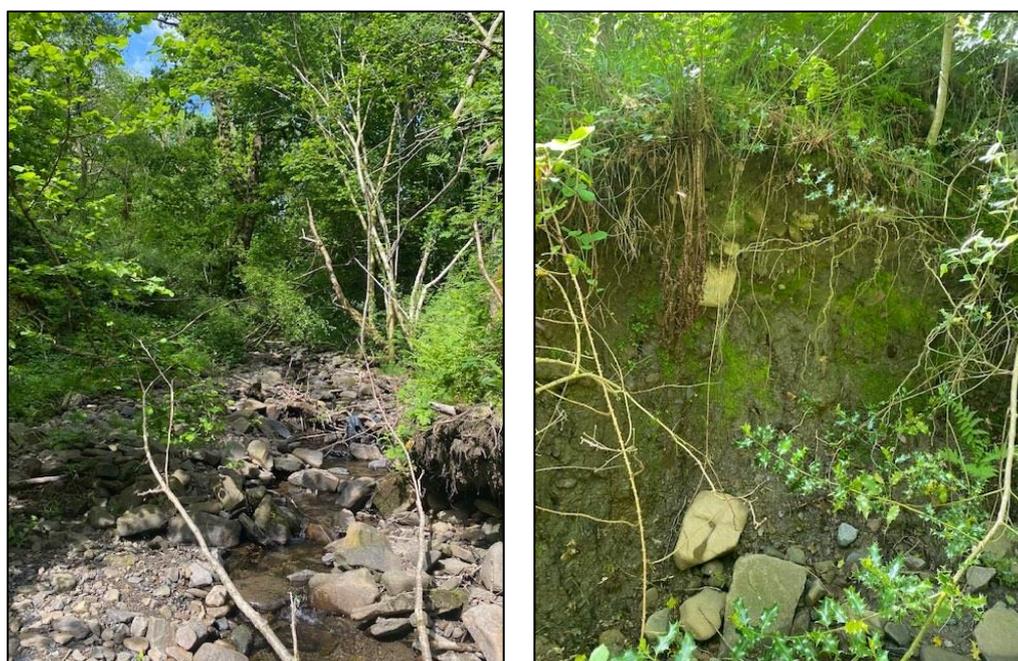
Following reports of debris mobilisation throughout the Nant Gwawr culvert network and sections of open channel during Storm Dennis, the Nant Gwawr ordinary watercourse was inspected post Storm Dennis. On review of the upstream watercourse, significant debris deposition was observed. This debris comprised primarily of large boulders, mixed stonewash, silt and woody debris, indicative of natural erosive material. Areas of embankment scour and undercutting were also observed within the upper reaches of the Nant Gwawr watercourse, as depicted in Figure 26.

**Figure 26:** Evidence of debris deposition and embankment scour within the upper section of the Nant Gwawr ordinary watercourse (captured by RCT officers post Storm Dennis)

The condition of the watercourse in the upper reaches of the Nant Gwawr are considered to have contributed to the deposited debris observed within the downstream channel. Figure 27 depicts the deposition of eroded material within the Nant Gwawr channel adjacent to Gwawr Street. This material is considered to have been washed down the catchment towards the culverted infrastructure during the storm event.

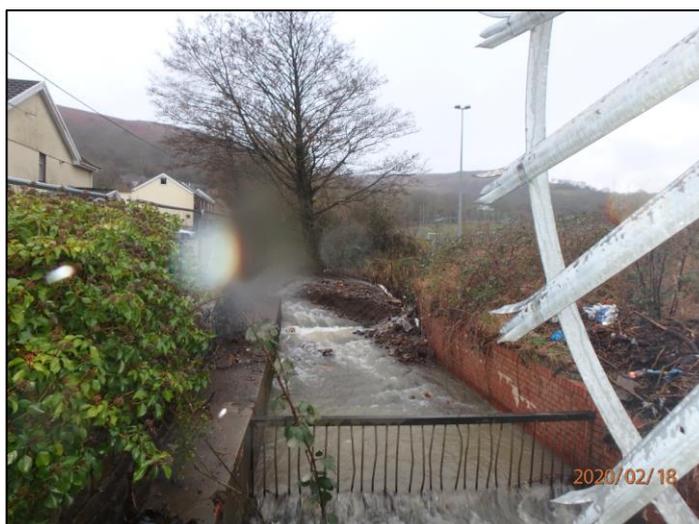
**Figure 27:** Deposition of material and scouring to the eastern embankment of the Nant Gwawr ordinary watercourse adjacent to Gwawr Street (captured by RCT officers on 18<sup>th</sup> February 2020)

The rapid flows conveying down the Nant Gwawr also caused significant channel and embankment scour adjacent to Gwawr Street (Figure 27), further indicative of the mobilisation of material within the watercourse during the storm event. The eroded sections of embankment at Gwawr Street have since been repaired by a Council appointed contractor.

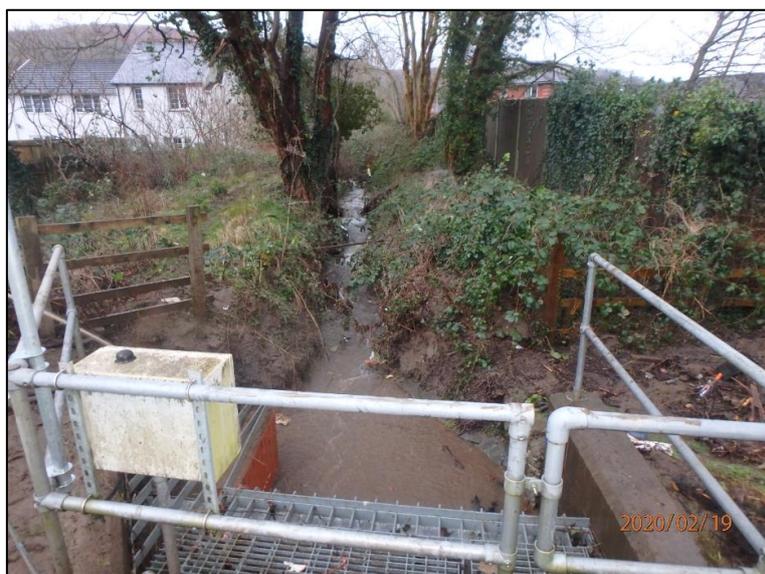
On review of the ordinary watercourse conditions upstream of 'Culvert Inlet 3', which surcharged during the storm event after becoming blocked with debris, the channel was observed to be largely undefined with evidence of embankment scour and out-of-bank flows identified (Figure 28). These out-of-bank flows are considered to have mobilised material from the surrounding embankment area towards 'Culvert Inlet 3', contributing to its blockage and associated surcharge.

**Figure 28:** Condition of the Nant Gwawr ordinary watercourse upstream of 'Culvert Inlet 3' (captured by RCT officers on 19<sup>th</sup> February 2020)

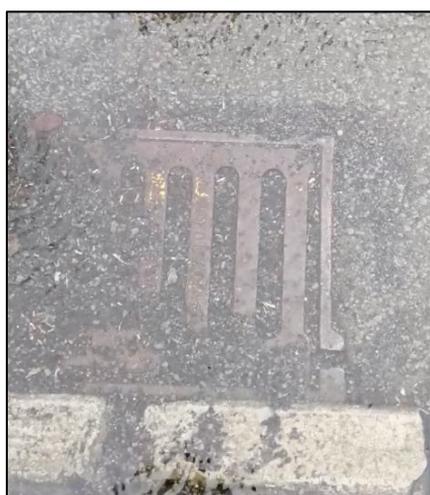
**Figure 31:** Blocked highway drainage gullies and ponding surface water along the unadopted road to the west of Abernant Road (captured by RCT officers post event)
