# Flood and Water Management Act 2010

## Section 19 Flood Investigation Report

### Storm Dennis – Flood Investigation Area RCT03 (Cwmbach)

April 2022

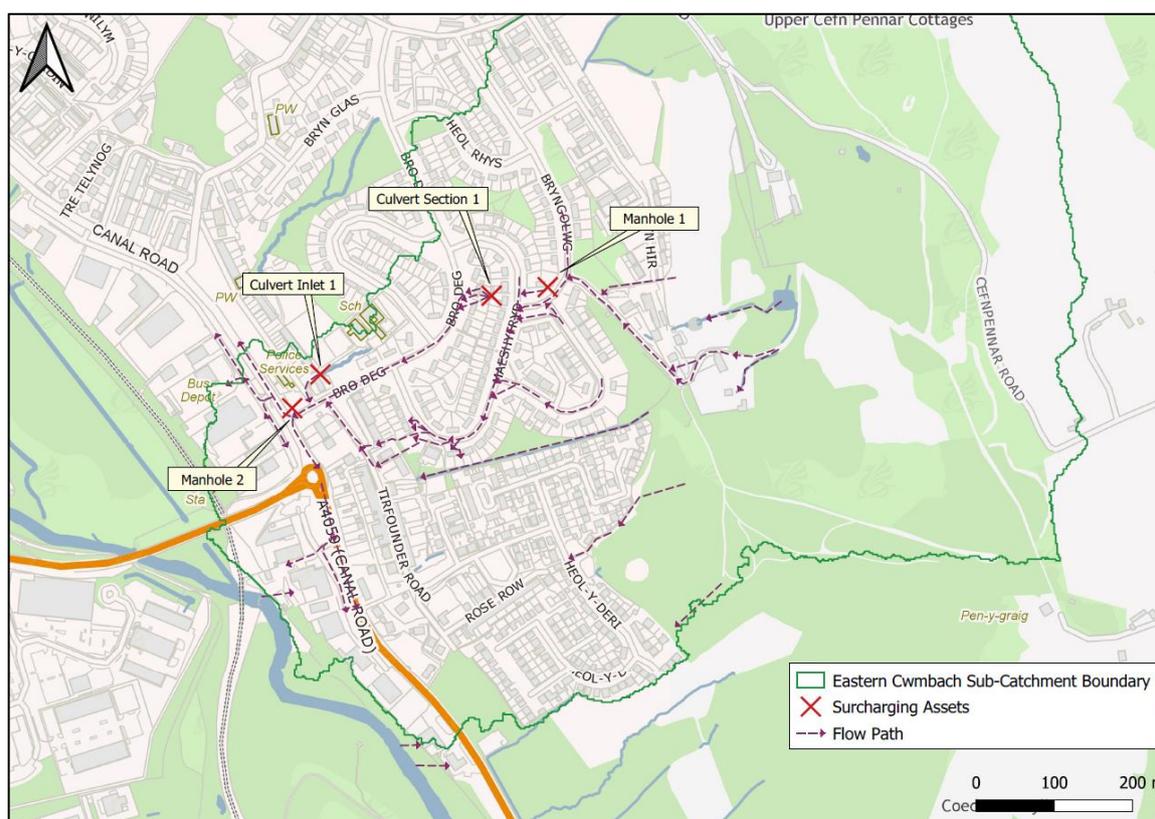
Figure 4 depicts the observed pathways of flooding within the 'Eastern Cwmbach' sub-catchment during Storm Dennis. The infrastructure known to have surcharged and contributed to the flooding are also illustrated in Figure 4.

**Figure 4:** Observed flow paths and surcharged assets within the 'Eastern Cwmbach' sub-catchment during Storm Dennis (15-16<sup>th</sup> February 2020)

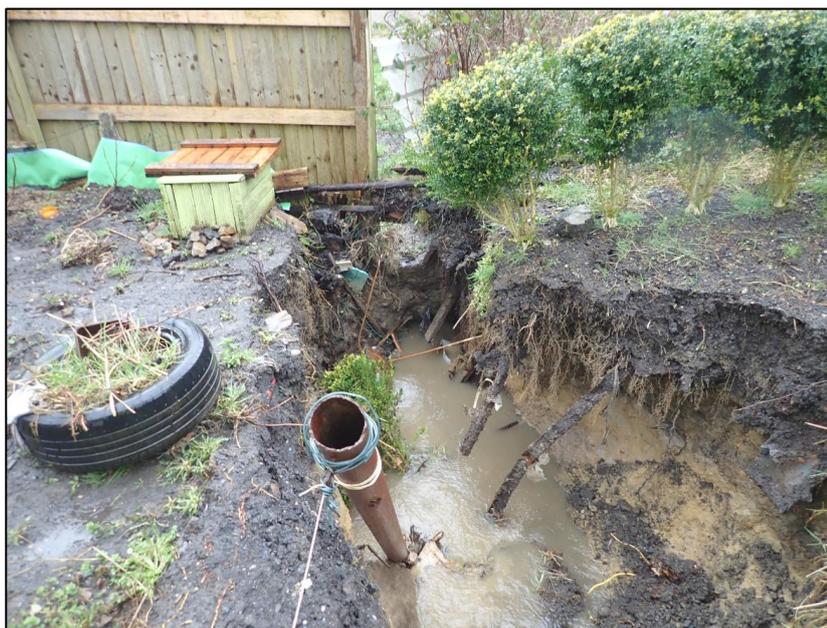
Upon an inspection undertaken by RCT's Flood Risk Management and Highway and Streetcare Depot on 10<sup>th</sup> February 2020, it was identified that the ground within the rear garden of the property at Maeshyfyrd had collapsed, exposing a section of damaged culvert network (Figure 5). The location of the collapsed culvert network is shown in Figure 4, labelled 'Culvert Section 1'.

**Figure 5:** Collapsed culvert in the rear garden of Maeshyfyrd identified by RCT's Flood Risk Management team on 10/02/2020

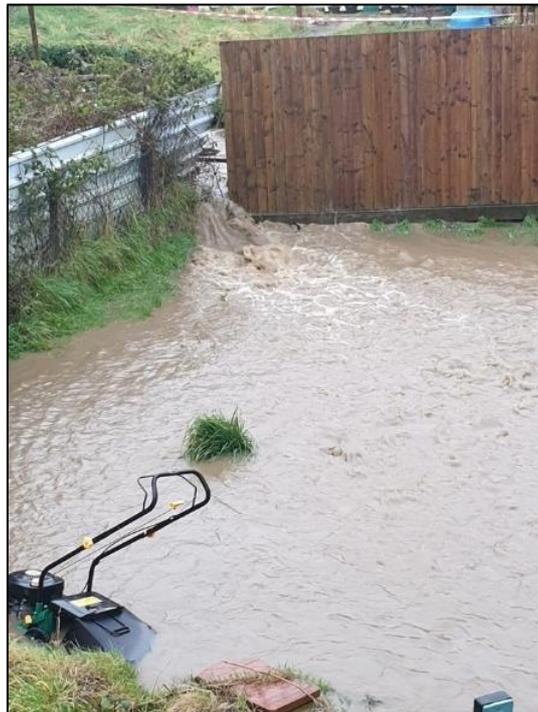
**Figure 6:** Rear garden of a residential property at Bro Deg during Storm Dennis (immediately downstream of the collapsed culvert) (image provided by resident)

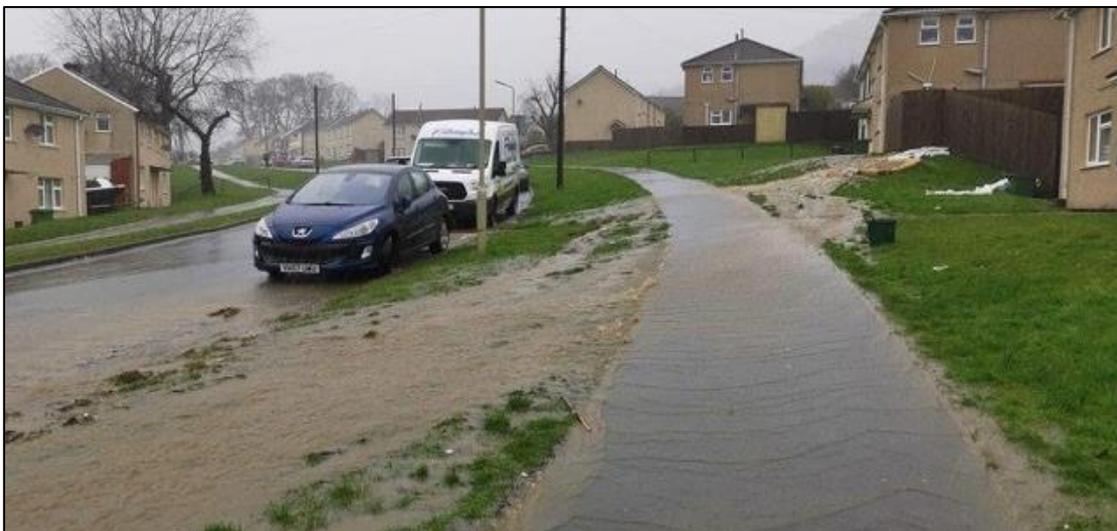
The flow of water was observed to travel downhill on Bro Deg towards the lower reaches of Cwmbach (Figure 7), contributing to the surface water flooding at this location.

**Figure 7:** Looking upwards at Bro Deg (shows water emanating from properties impacted by the collapsed culvert network at Maeshyryd during Storm Dennis) (image provided by resident)

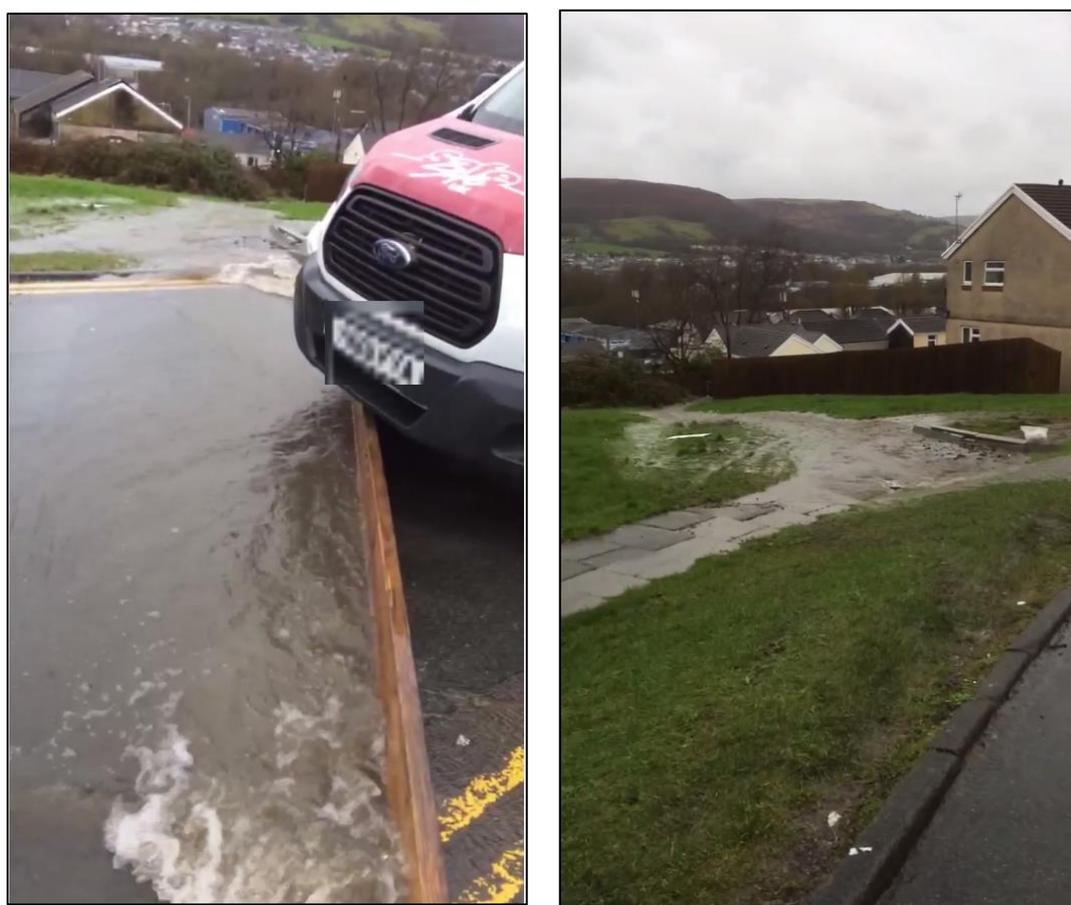
**Figure 8:** Surface water flows travelling down Maeshyfyd and channelled towards the rear of Tirfounder Road during Storm Dennis (images provided by resident)

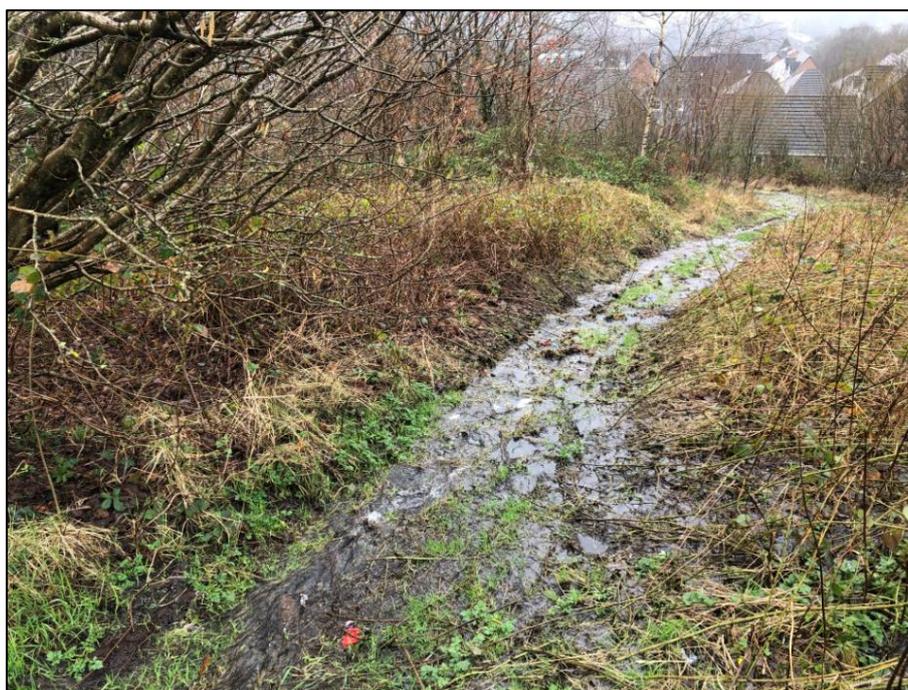
Evidence of saturated ground, overland flows and ponding surface water was observed during post-event inspections of the hillside immediately to the rear of Glas-y-Gors and Heol-y-Deri (Figure 9). These flows are considered to have been a primary source of surface water within the lower reaches of Cwmbach, where a further residential property at Canal Road was reportedly impacted internally.

**Figure 9:** Surface water runoff and saturated ground on land to the rear of Heol-y-Deri (image captured by RCT Flood Risk Management officers post storm event on 24/02/2020)

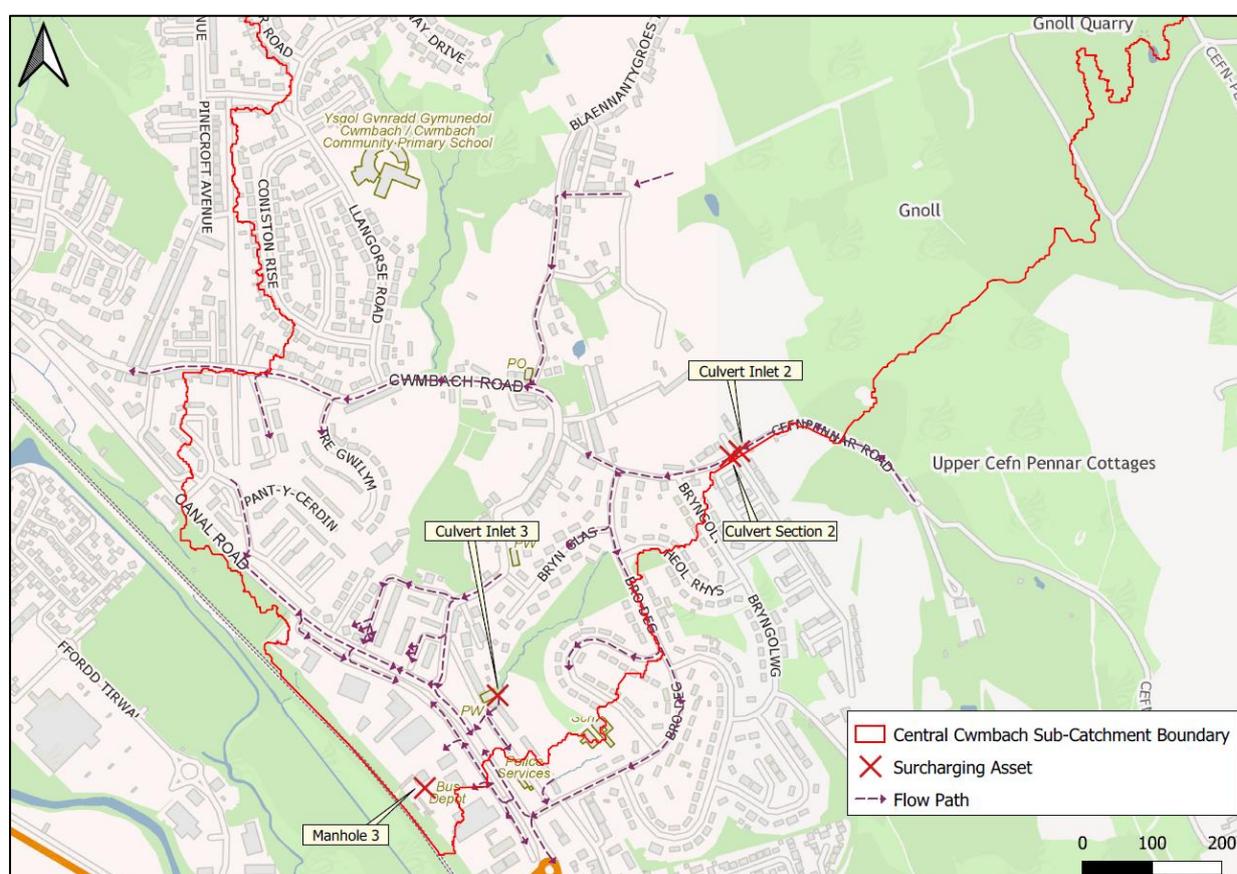
Figure 10 depicts the observed pathways of flooding within the 'Central Cwmbach' sub-catchment during Storm Dennis. The infrastructure known to have surcharged and contributed to the flooding are also illustrated in Figure 10.

**Figure 10:** Observed flow paths and surcharged assets within the 'Central Cwmbach' sub-catchment during Storm Dennis (15-16<sup>th</sup> February 2020)

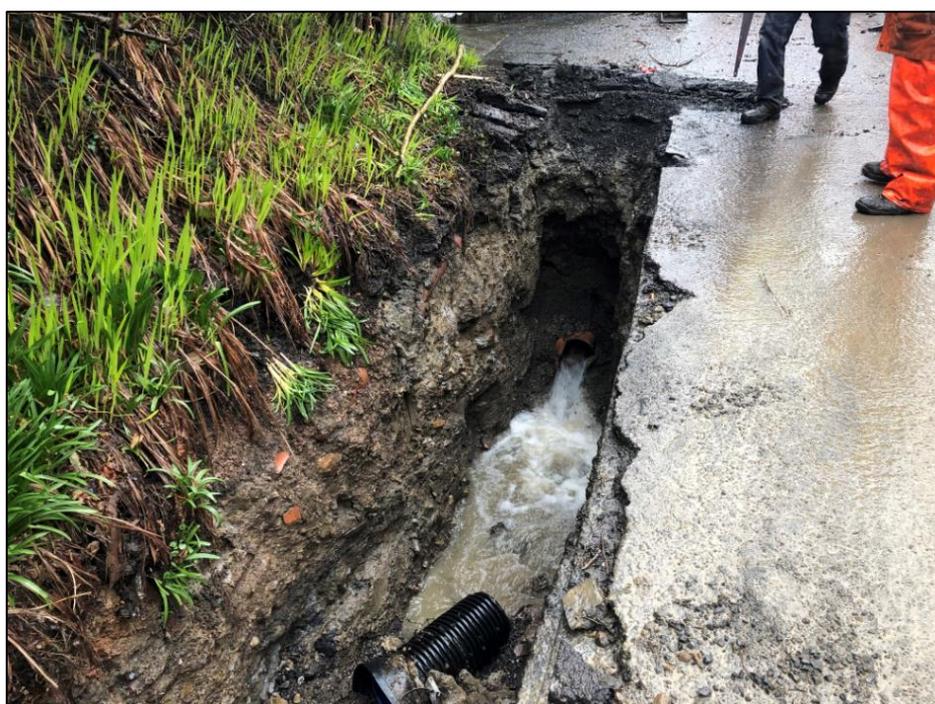
Upon an inspection of the issue, the hole in the highway was identified as a collapsed ordinary watercourse culvert along the highway approximately 25 metres downstream of a culvert inlet situated at the junction to Springfield Close from Cefnpennar Road (Figure 11). The location of the collapsed culvert network is shown in Figure 10, labelled 'Culvert Section 2'.

**Figure 11:** Collapsed culvert network ('Culvert Section 2') to the north of Cefnpennar Road identified during post event inspections (image captured by RCT's Flood Risk Management team on 18<sup>th</sup> February 2020)

In response to the identified culvert collapse at Cefnpennar Road, emergency repairs were carried out to repair the culvert section, followed by further culvert lining works undertaken by a Council appointed contractor in August 2021 to repair the structural damages within the network length.

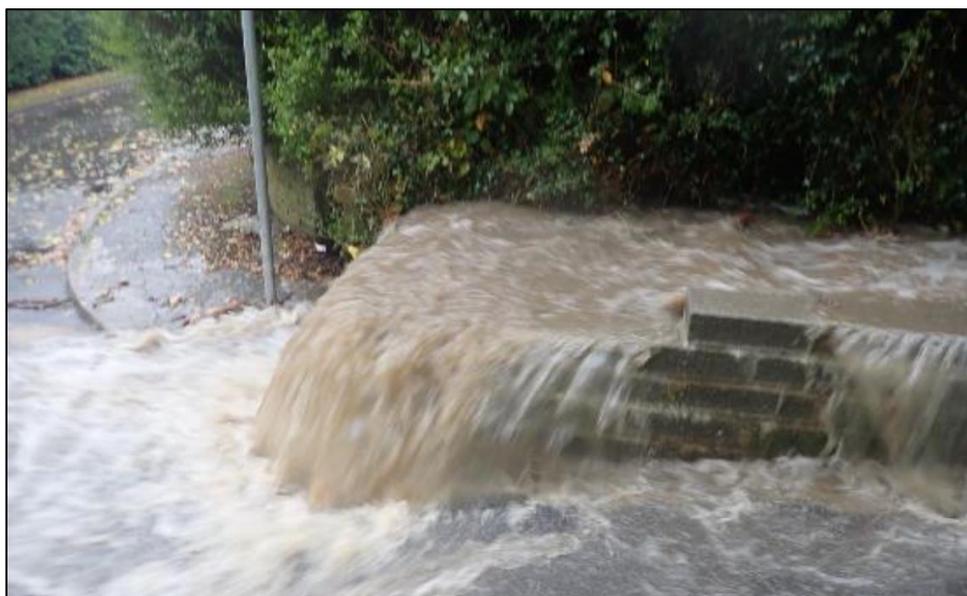
The upstream culvert inlet, labelled 'Culvert Inlet 2' in Figure 10, was also observed as surcharging during the storm event after becoming blocked with debris. Figure 12 depicts the surcharging flows from 'Culvert Inlet 2' on 16<sup>th</sup> February 2020 which conveyed towards the lower reaches of Cwmbach.

**Figure 12:** 'Culvert Inlet 2' at Cefnpennar Road surcharging and flooding onto the highway during Storm Dennis

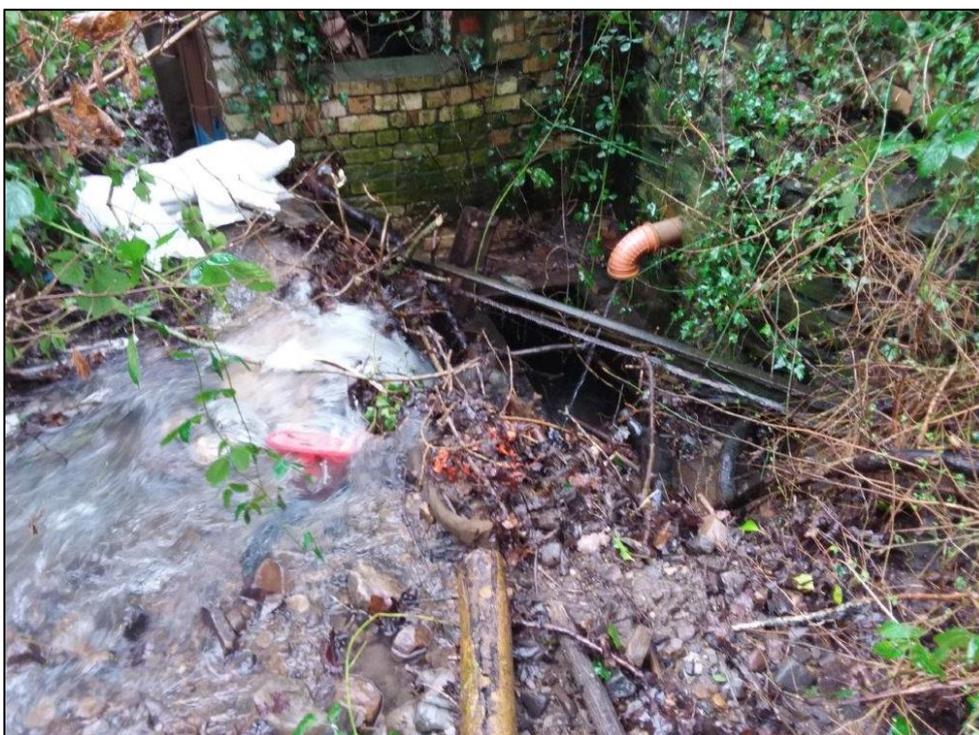
'Culvert Inlet 3' situated to the rear of Sion Terrace was also observed as surcharging during the storm event, contributing additional flows towards Canal Road. Figure 13 depicts the condition of the culvert inlet following Storm Ciara which occurred a week

before Storm Dennis. The image shows sandbags placed near the inlet, indicating that 'Culvert Inlet 3' had surcharged ahead of Storm Dennis. Flow path from 'Culvert Inlet 3' passes through a derelict property situated below the inlet and flows east towards Tirfounder Road and onwards towards Canal Road. No flooding to residential properties has been directly attributed to the surcharge of 'Culvert Inlet 3'.

**Figure 13:** Image of 'Culvert Inlet 3' captured by RCT's Highway and Streetcare Depot following Storm Ciara on 7 – 8<sup>th</sup> February 2020

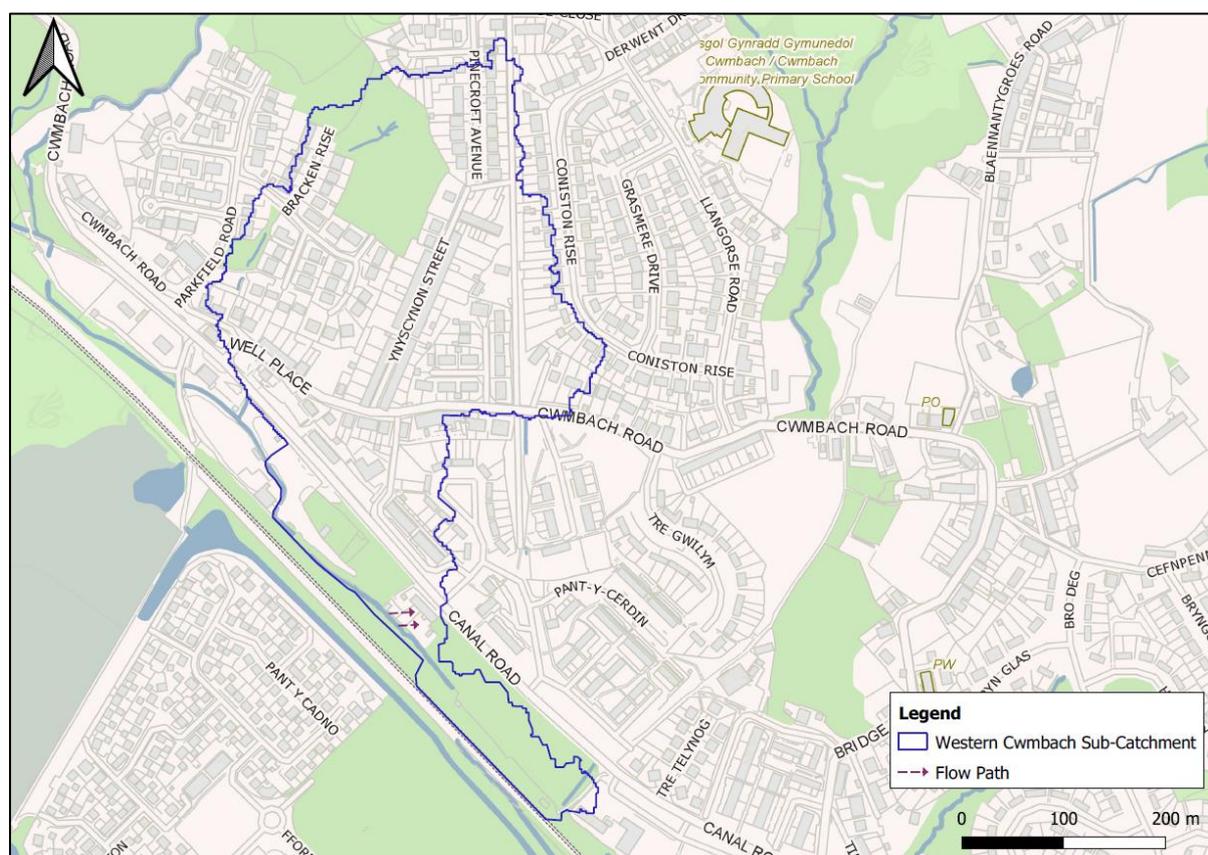
Figure 14 depicts the observed pathways of flooding within the 'Western Cwmbach' sub-catchment during Storm Dennis.

**Figure 14:** Observed flow paths within the 'Western Cwmbach' sub-catchment during Storm Dennis (15-16<sup>th</sup> February 2020)

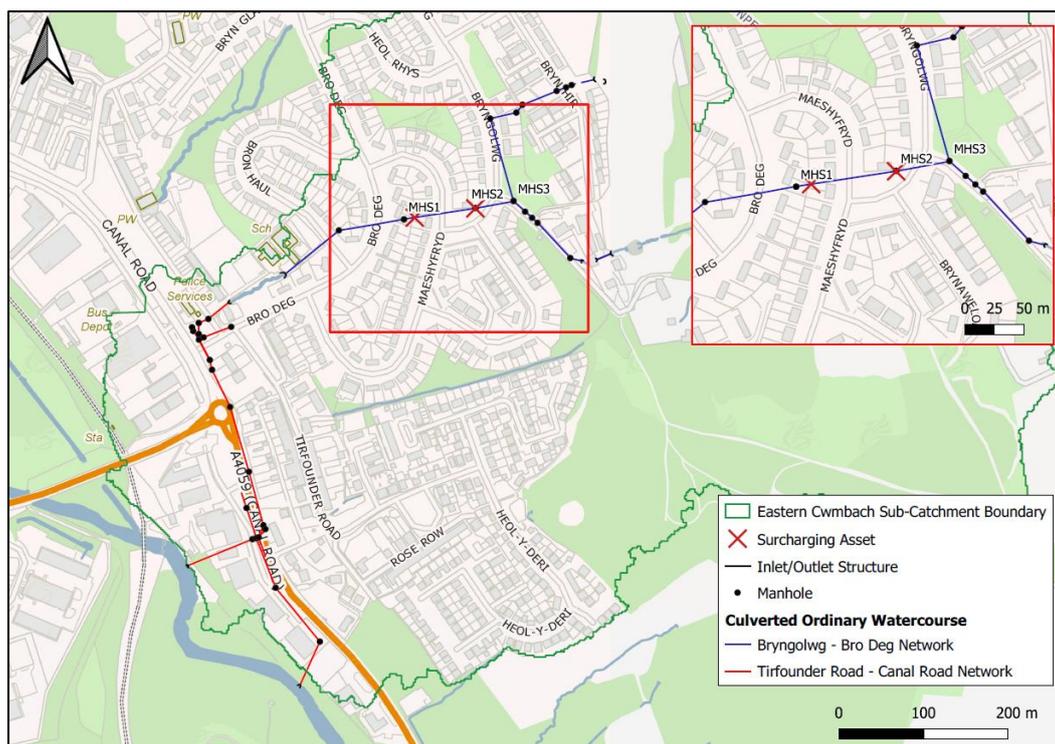
**Figure 15:** Surveyed culverted ordinary watercourse networks within the 'Eastern Cwmbach' sub-catchment. The infrastructure identified as surcharging during Storm Dennis along the 'Bryngolwg – Bro Deg' network is highlighted.

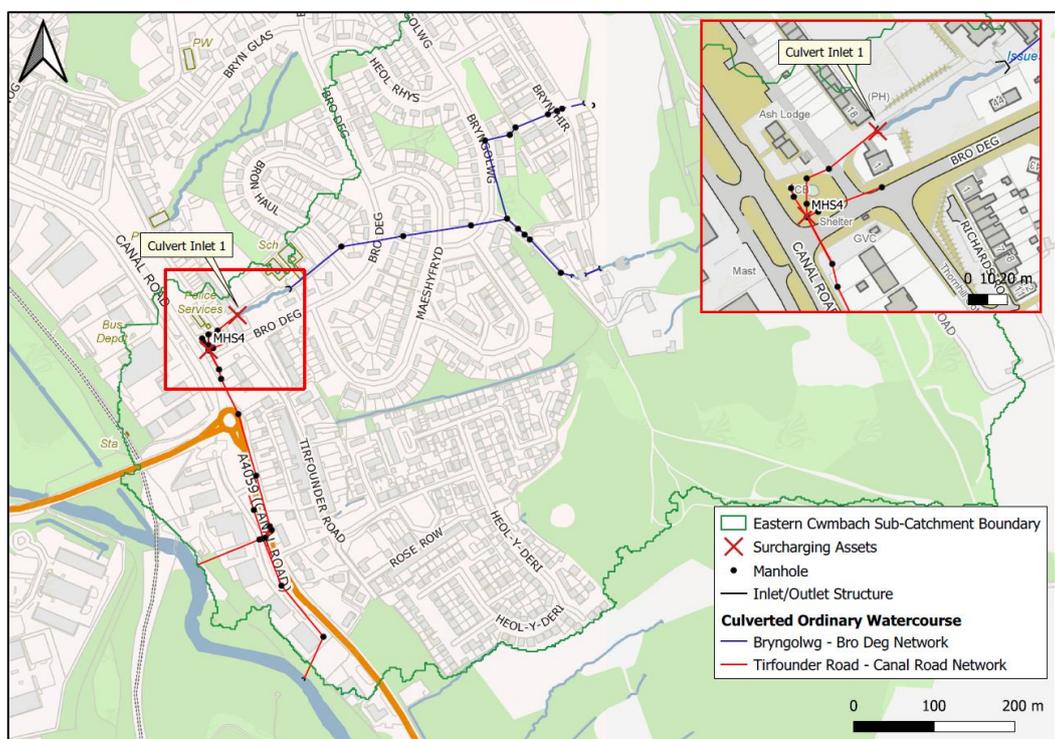
**Figure 16:** Surveyed culverted ordinary watercourse networks within the 'Eastern Cwmbach' sub-catchment. The infrastructure identified as surcharging during Storm Dennis along the 'Tirfounder Road – Canal Road' network is highlighted.

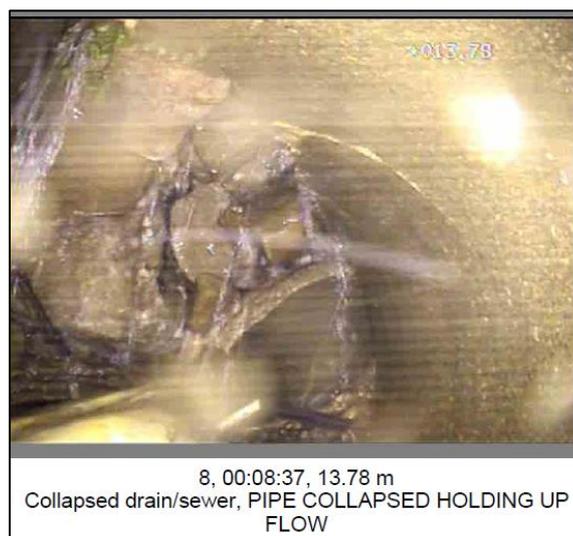
The culvert network between MHS1 and MHS3 was surveyed to be in poor structural and operational condition with large holes, root mass and collapsed pipework observed, particularly between MHS1 and MHS2. Figure 17 shows the condition of the internal culvert barrel at the point of collapse approximately 14 metres upstream of MHS1.

The poor condition of the culvert network between MHS1 and MHS3, and the subsequent collapse of the culvert structure has been determined as the primary cause of flooding at this location in addition to causing 'MHS2' ('Manhole 1', Figure 4) to surcharge.

**Figure 17:** CCTV image of the collapsed 'Bryngolwg - Bro Deg' culvert network 13.78 metres upstream of MHS1 (CCTV survey undertaken 02/03/2020)

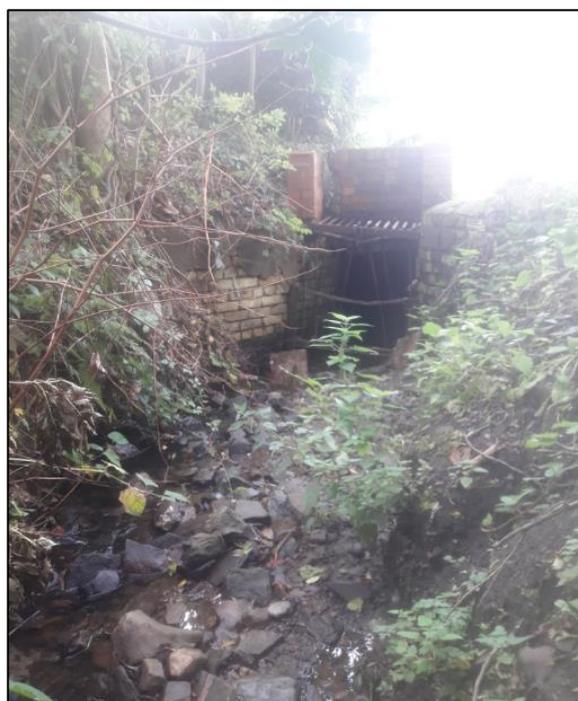
'Culvert Inlet 1' was also observed to be in poor structural condition following the storm event. Figure 18 shows evidence of damages to the culvert's debris screen assumed to have been caused by debris during the storm event.

**Figure 18:** Image of 'Culvert Inlet 1' at Tirfounder Road following the storm event

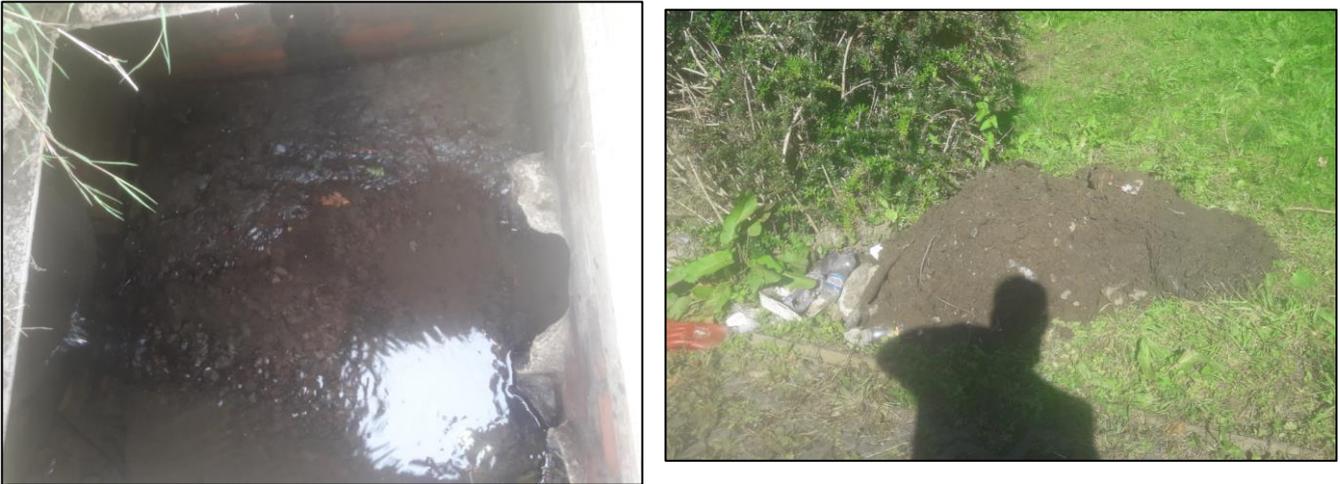
The 'Tirfounder Road – Canal Road' culvert network was surveyed in September 2020 and identified multiple Grade 5 operational defects within the majority of the network. The survey operation was abandoned at several locations due to settled deposits and debris in the network restricting camera access, particularly along the network length at Canal Road where it was reported that several manholes surcharged during the storm event and continued to surcharge in the days following.

Figure 19 identifies 'MHS 4' ('Manhole 2', Figure 4), associated to the 'Tirfounder Road – Canal Road' network, as heavily silted with silt and stone during surveying operations. Significant volumes of silt and stone was identified at several manholes and catchment pits along the culverted network. A significant cleansing operation was carried out to remove approximately 5 tonnes of debris from the culvert network.

**Figure 19:** Mud and silt identified at MHS4 (Manhole 2, Figure 4) during CCTV survey operations prior to cleansing (left) and the debris removed from the MHS4 (right)

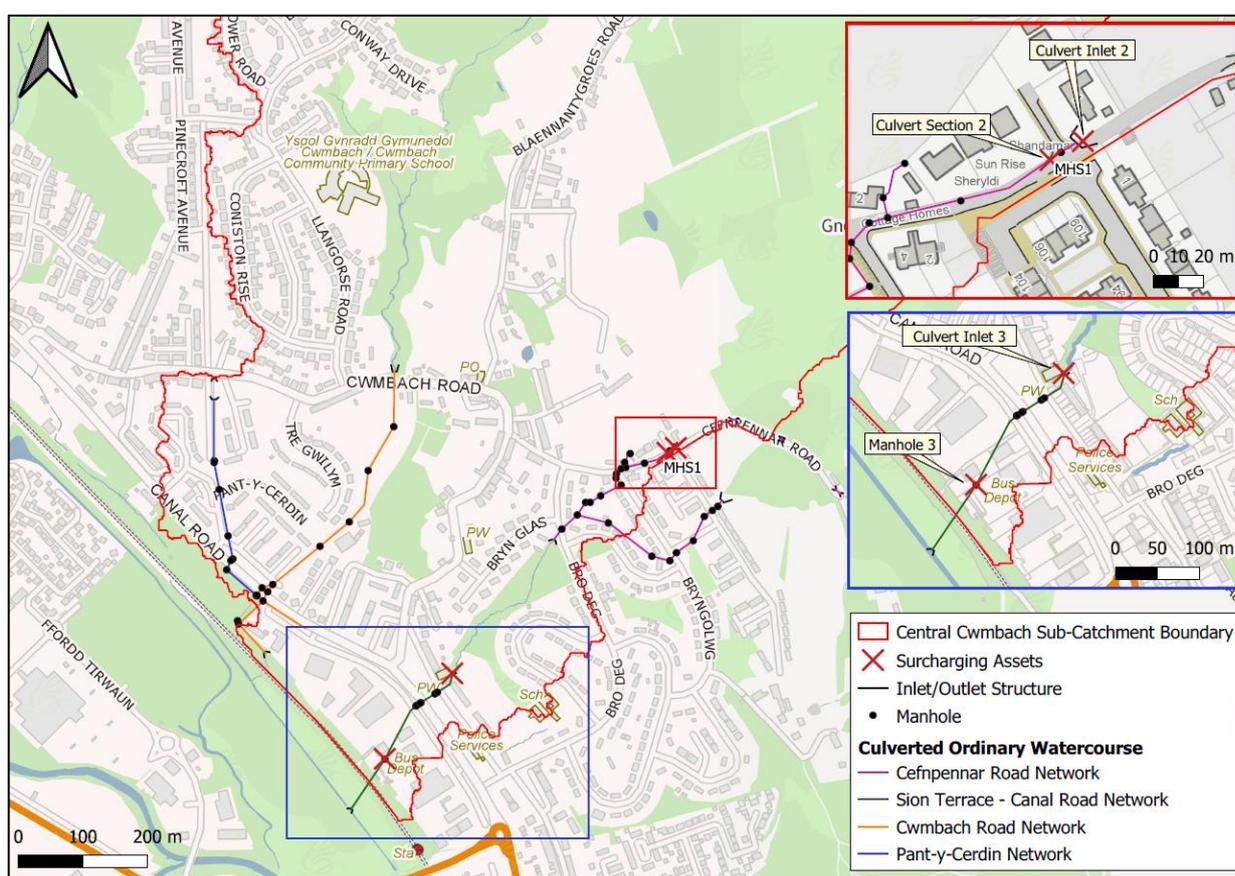
**Figure 20:** Surveyed culverted ordinary watercourse networks within the ‘Central Cwmbach’ sub-catchment. The infrastructure identified as surcharging during Storm Dennis along the ‘Cefnpennar Road’ and ‘Sion Terrace – Canal Road’ networks are highlighted.

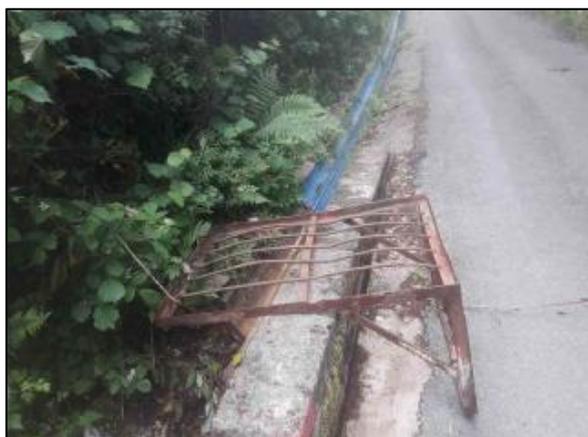
‘Culvert Inlet 2’ was identified to be in poor condition during post event inspections. Figure 21 depicts the damaged debris screen which was caused by mobilised debris washing down the watercourse channel during the storm. Figure 22 depicts the volume of accumulated debris identified within ‘Culvert Inlet 2’ which is considered to have reduced the culvert’s ability to manage the flow of water entering the network, contributing to its surcharge.

**Figure 21:** Damaged debris screen at 'Culvert Inlet 2' following Storm Dennis

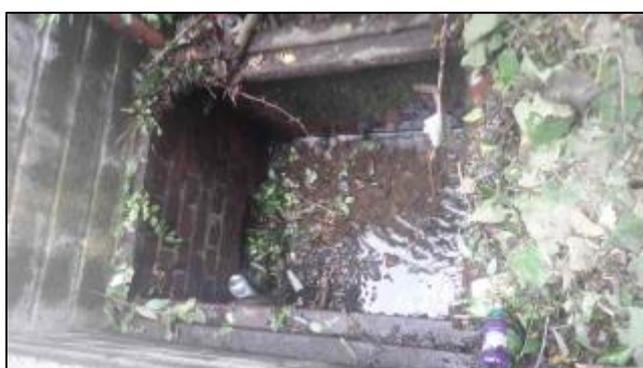
**Figure 22:** Internal condition of 'Culvert Inlet 2' following Storm Dennis

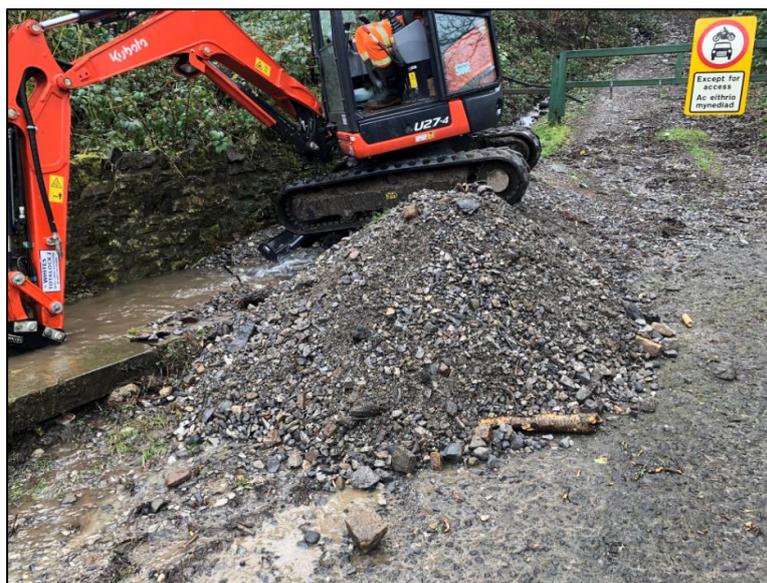
**Figure 23:** Silt and stone removed from the culvert inlets located upstream of the collapse at 'Culvert Section 2' along Cefnpennar Road (captured by RCT's FRM team on 18/02/2020)

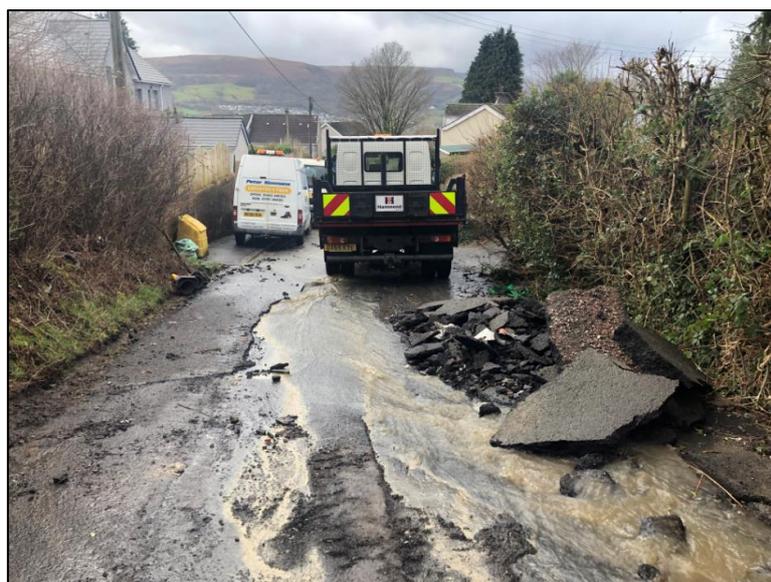
**Figure 24:** Downstream view of the culvert collapse which resulted in water flowing down Cefnpennar Road towards the lower reaches of Cwmbach (captured by RCT's FRM team on 18/02/2020)

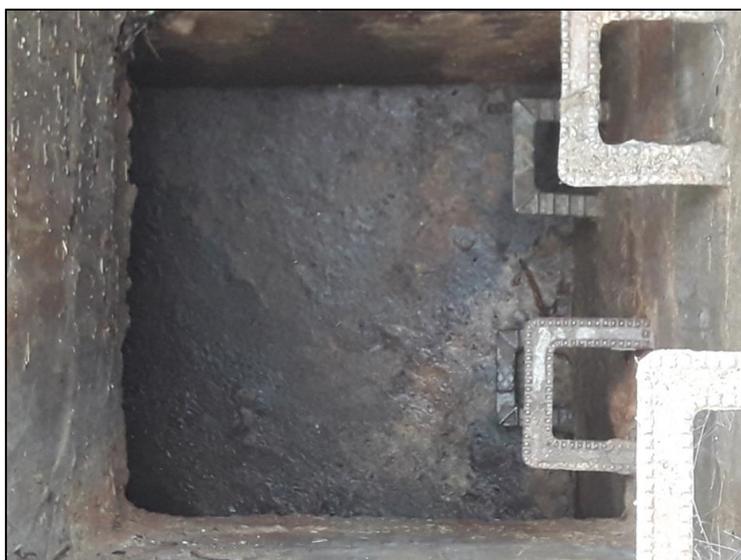
A high volume of silt and settled debris was identified within the culvert network running beneath Cwmbach Industrial Estate. This was assessed as reducing the cross-sectional area of the network by more than 50%. The poor operational condition of the network is considered to have contributed to the surcharging of 'Manhole 3' during the storm event. Figure 25 depicts the volume of silt identified within 'Manhole 3' during surveying and cleansing operations. This debris is assumed to have entered the network from the upper catchment during the storm event.

**Figure 25:** Significant volume of silt identified within 'Manhole 3' during CCTV survey operations (captured in June 2020)

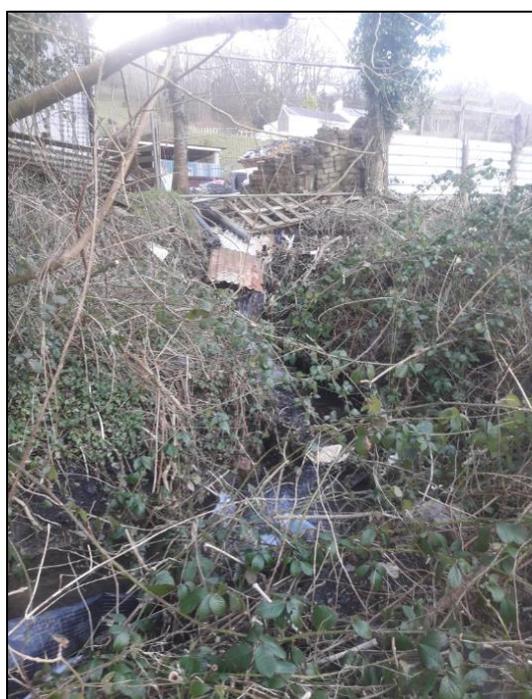
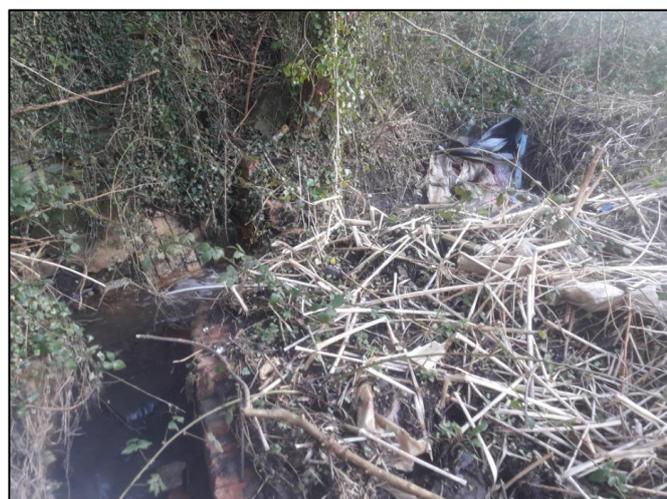
The debris identified within the watercourse is also considered to have contributed to the volume of debris identified within the downstream 'Bryngolwg – Bro Deg' culvert network, however the primary cause of surcharge at 'Manhole 1' and the collapse of 'Culvert Section 1', has been attributed to the poor structural condition of the culvert network.

**Figure 27:** Debris identified within 'Unnamed Ordinary Watercourse 1' during CCTV survey inspections post storm event

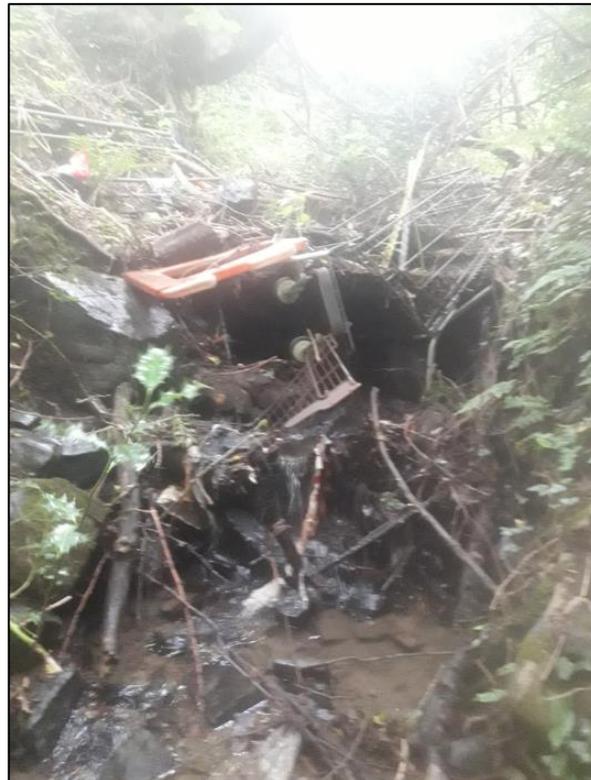
The open watercourse upstream of 'Culvert Inlet 1' was identified to be in very poor condition during post event inspections. Figure 28 depicts the materials and debris identified within the watercourse, which consisted of woody debris in addition to large objects indicative of fly tipping. This debris is considered to have contributed to the blockage and associated reduction in capacity of 'Culvert Inlet 1' to manage the flow of water, resulting in its surcharge.

**Figure 28:** Woody debris and other material within the section of ordinary watercourse upstream of 'Culvert Inlet 1' at Tirfounder Road (captured during post event CCTV survey operations)

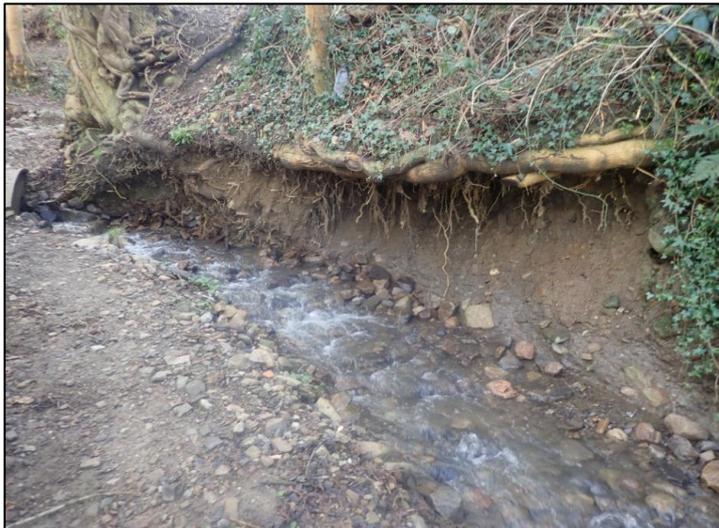
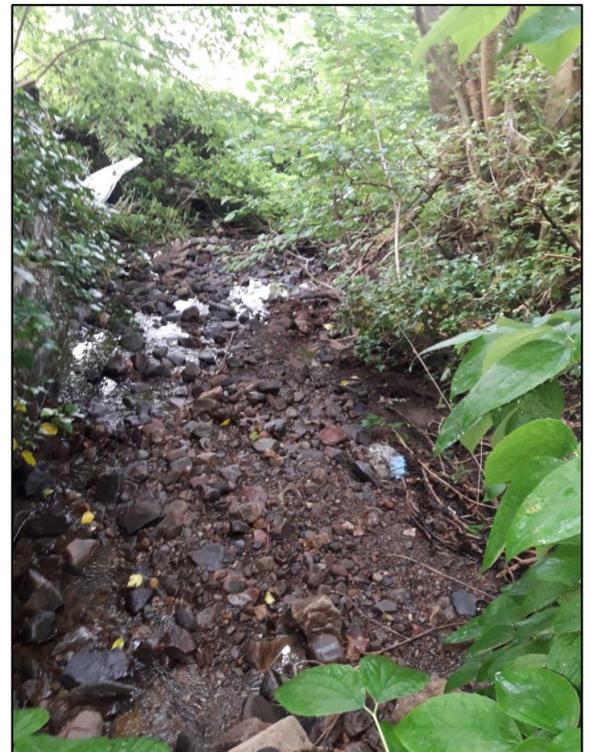
The open watercourse upstream of 'Culvert Inlet 3' was identified to be in poor condition during post event inspections. Figure 29 illustrates areas of heavy embankment scour and areas of debris deposition consisting of large stones which are considered to have been mobilised downstream during the storm event by the fast-flowing water. The evidence does suggest that the identified scouring and deposition of material contributed to the blockage and subsequent surcharge of 'Culvert Inlet 2' during the storm event.

**Figure 29:** Condition of 'Unnamed Ordinary Watercourse 3' showing significant embankment scour (left) and debris deposition within the channel (right) during post event inspections

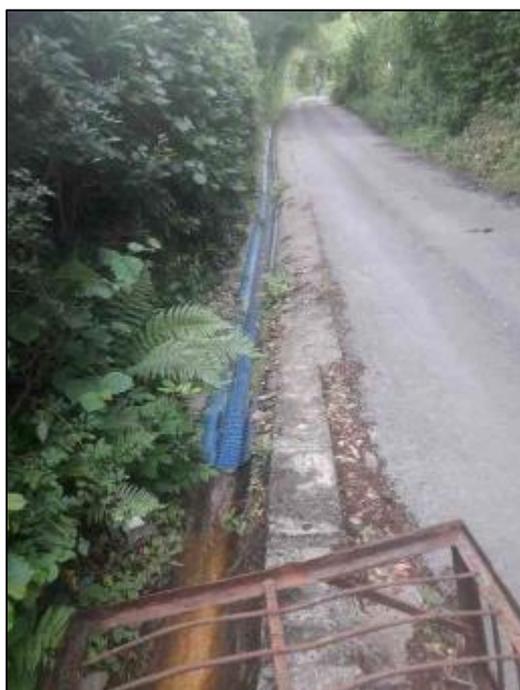
The section of open watercourse upstream of 'Culvert Inlet 2' at Cefnpennar Road consists of a heavily modified channel which runs adjacent to the highway and is partially culverted in sections (see Figure 30).

**Figure 30:** 'Unnamed Ordinary Watercourse 4' upstream of 'Culvert Inlet 2' which runs adjacent to Cefnpennar Road

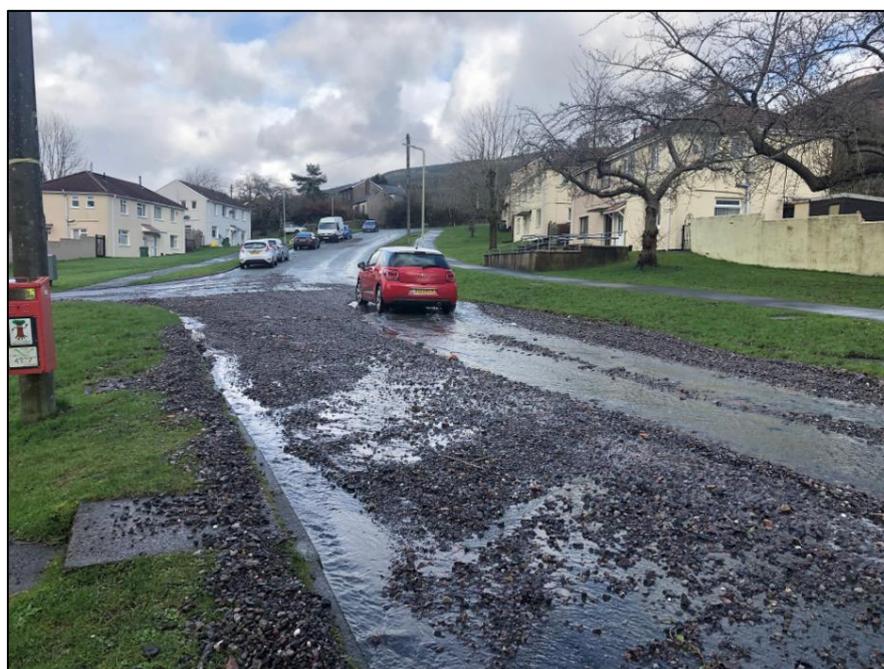
**Figure 34:** Debris deposited along Bro Deg by the surcharging ordinary watercourse and surface water flows during the storm event (image provided by resident)

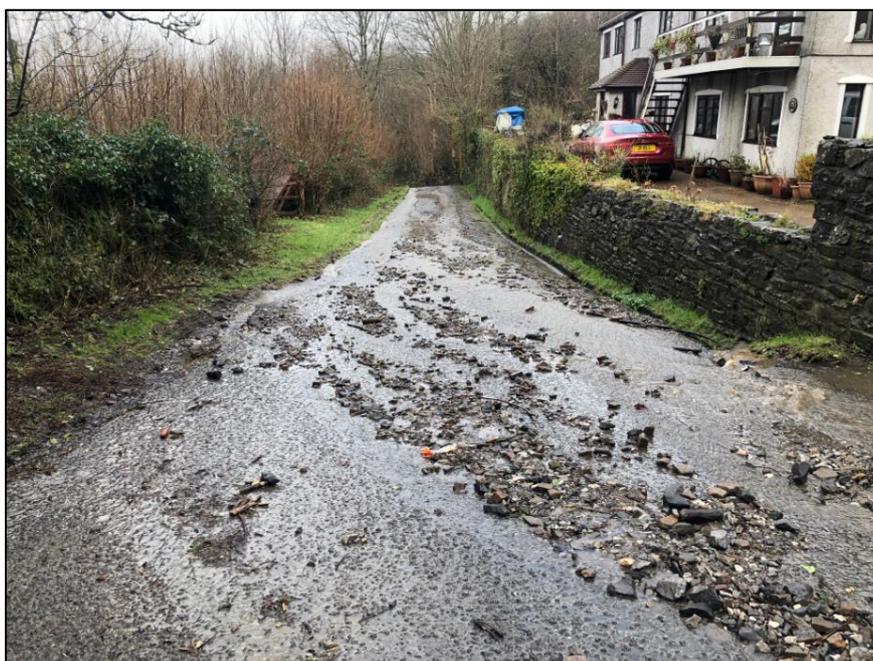
**Figure 35:** Debris deposited along Cefnpennar Road by surcharging watercourse and surface water flows during the storm event (image provided by resident)
