# Flood and Water Management Act 2010

## Section 19 Flood Investigation Report

### Storm Dennis – Flood Investigation Area RCT05 (Abercwmboui & Fernhill)

June 2022

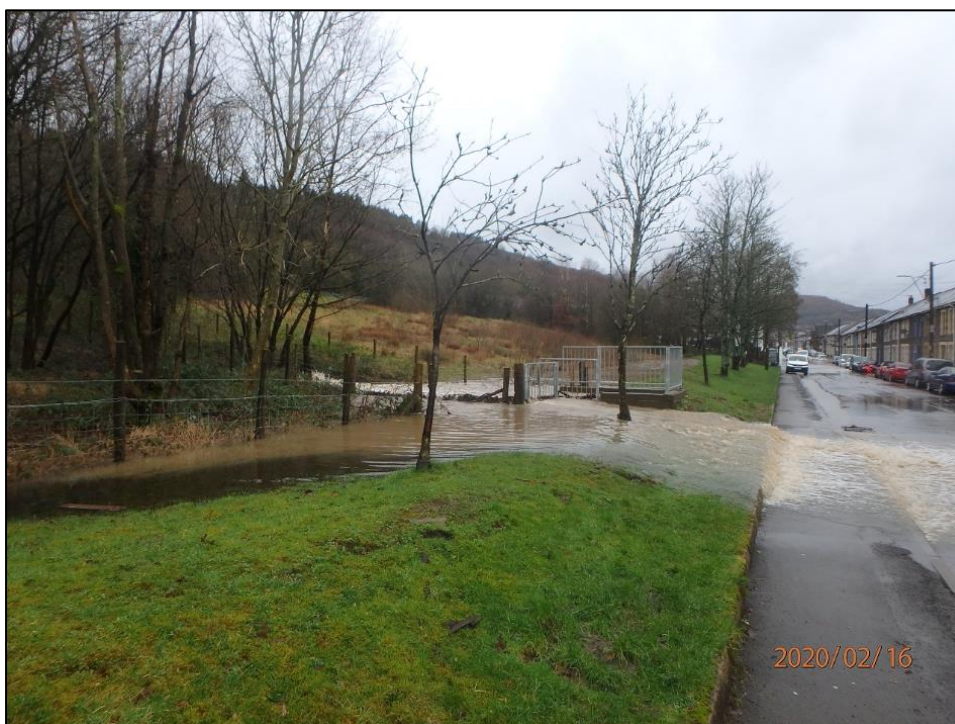
Storm event inspections undertaken by RCT's Flood Risk Management team on 16<sup>th</sup> February identified 'Culvert Inlet 1' as having surcharged at the inlet due to a blockage caused by debris accumulation on the inlet's debris screen. This resulted in water overtopping the inlet structure and flowing in a westerly direction along the highway

towards a series of terraced properties along Bronallt Terrace. Figure 5 shows evidence of 'Culvert Inlet 1' continuing to surcharge on the morning of the 16<sup>th</sup> of February 2020. Properties situated at the eastern edge of Bronallt Terrace avoided the worst of the flooding as the street kerb is slightly raised.

**Figure 5:** 'Culvert Inlet 1' surcharging at the inlet causing water to flow onto the highway and towards properties at Bronallt Terrace (captured by RCT's Flood Risk Management team on 16/02/2020)

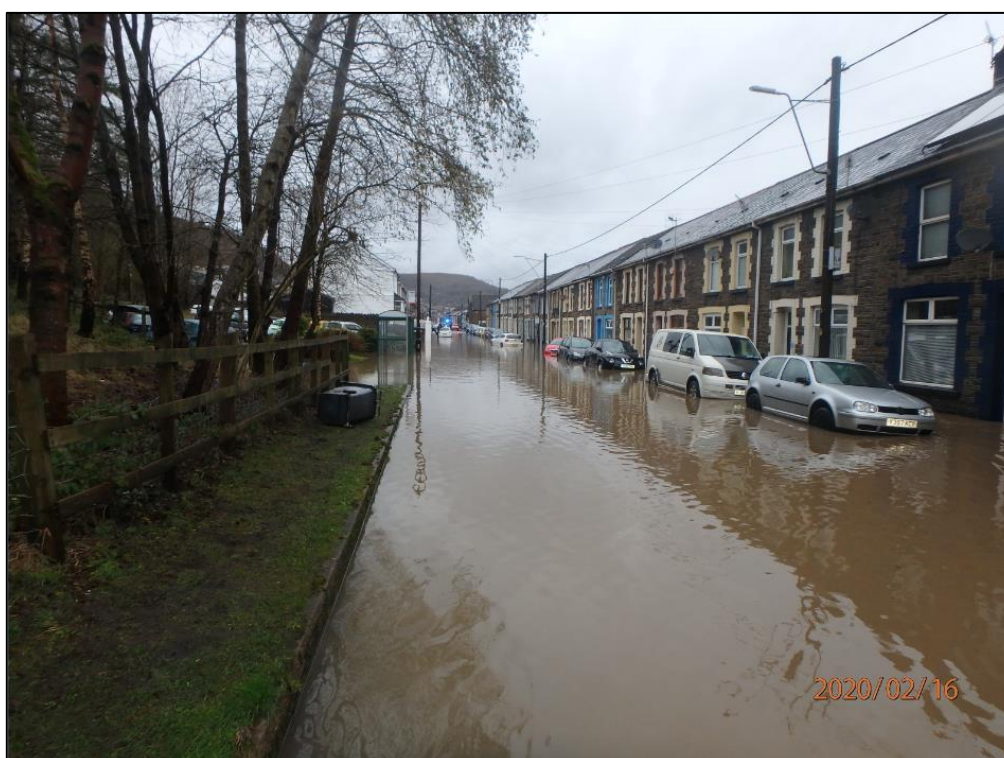
Surface water flowed in an easterly direction along Bronallt Terrace, meeting water flowing west from the surcharged 'Culvert Inlet 1'. Anecdotal reports from residents' state both flow paths met in the middle of the street, causing water to rise up to approximately 1 metre in depth (Figure 6). The capacity of the highway drainage infrastructure within Bronallt Terrace was exceeded by the volume of water, exacerbating surface water flooding to properties along the street.

**Figure 6:** Flooding at Bronallt Terrace (captured by RCT's Flood Risk Management team on 16/02/2020)

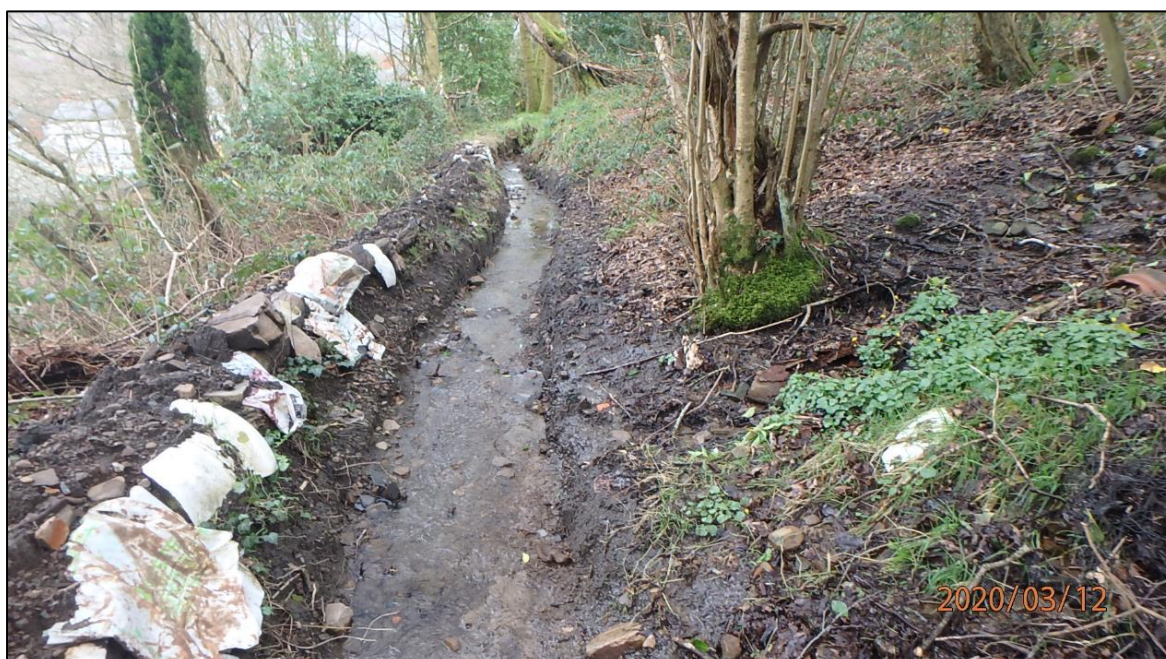
Upon a site inspection of land to the rear of Maple Terrace, it was evident that significant overland flows originating from the steep hillside had caused some minor scouring on the hillslopes and vegetation appeared to have been flattened by overland flows. On review of the hillside, an open ditch to the rear of properties along Maple Terrace was identified (Figure 7). The open ditch generally slopes towards the east of Maple Terrace before being culverted beneath the highway at Mostyn Street ('Culvert Inlet 2', Figure 4).

**Figure 7:** Open ditch that flows to the rear of Maple Terrace (captured by RCT's Flood Risk Management team on 12/03/20)

It is considered that significant overland flows from the hillside to the south of Abercwmboi caused the open ditch to overflow and water to flow towards either end of Maple Terrace where the topography slopes downwards. This resulted in internal

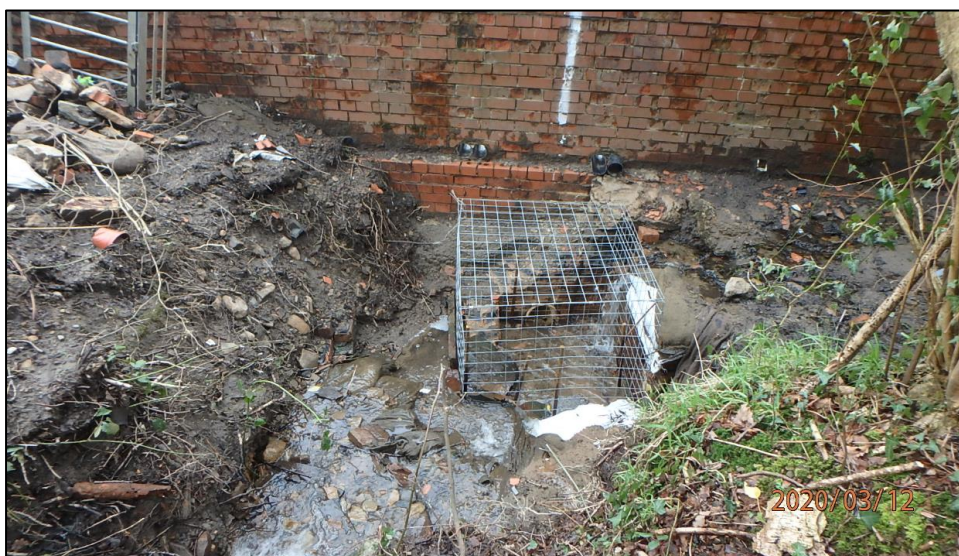
Additional reports of internal residential flooding were confirmed at Tanycoed Terrace, originating from 'Culvert Inlet 2'. 'Culvert Inlet 2' is located behind a retaining wall at the top of Mostyn Street. Anecdotal evidence reports that the debris screen at 'Culvert Inlet 2' became blocked with silt and stone carried by overland flows from the hillside, which caused water to build up behind the retaining wall and flow west towards the rear lane behind Tanycoed Terrace, resulting in internal flooding to at least four residential properties.

**Figure 8:** Mostyn Street culvert inlet (Culvert Inlet 2) following clearance works to remove the blockage (captured by RCT's Flood Risk Management team on 12/03/2020)

RCT carried out emergency clearance works to the inlet and replaced the rusted debris screen with a temporary mesh cage (Figure 8).

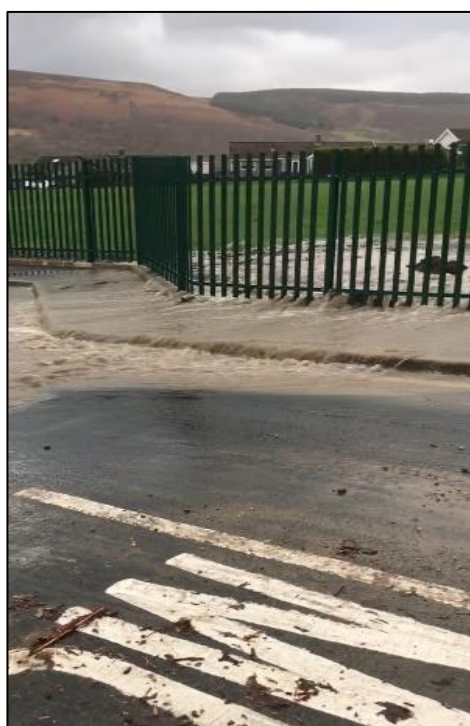
'Culvert Inlet 4' is sourced by flows coming from Sierra Pines and Cwm Alarch Close. The inlet surcharged during the storm event, causing water to overtop and flow downstream towards Glenboi (Figure 10). On its flow path, Glenboi Primary School was internally flooded due to it being located at a low point (Figure 11)

**Figure 10:** Image of 'Culvert Inlet 4' surcharging during Storm Dennis on 16<sup>th</sup> February 2020 (image provided by resident)

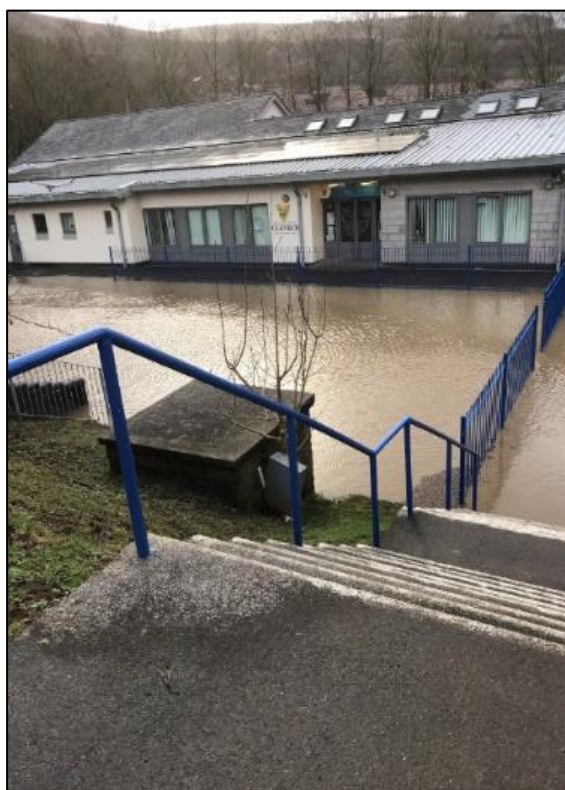
**Figure 11:** Image showing flooding to Glenboi Community Primary School, located opposite ‘Culvert Inlet 4’, during Storm Dennis on 16<sup>th</sup> February 2020 (image provided by resident)

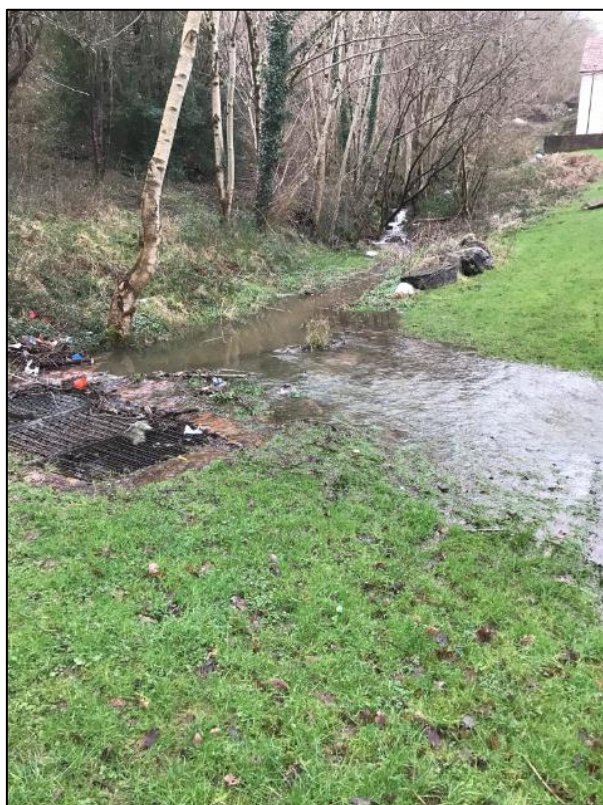
It was identified that 'Culvert Inlet 8' also surcharged during the storm event (Figure 12). Flow from this inlet travelled overland down the steep roads within Fernhill towards Glenboi where water was able to pond due to local topography, namely as Aberdare Road sits several meters higher than Glenboi Road, thereby preventing the conveyance of surface water to the downstream networks.

**Figure 12:** 'Culvert Inlet 8' surcharging during Storm Dennis on 16<sup>th</sup> February 2020 (image provided by resident)

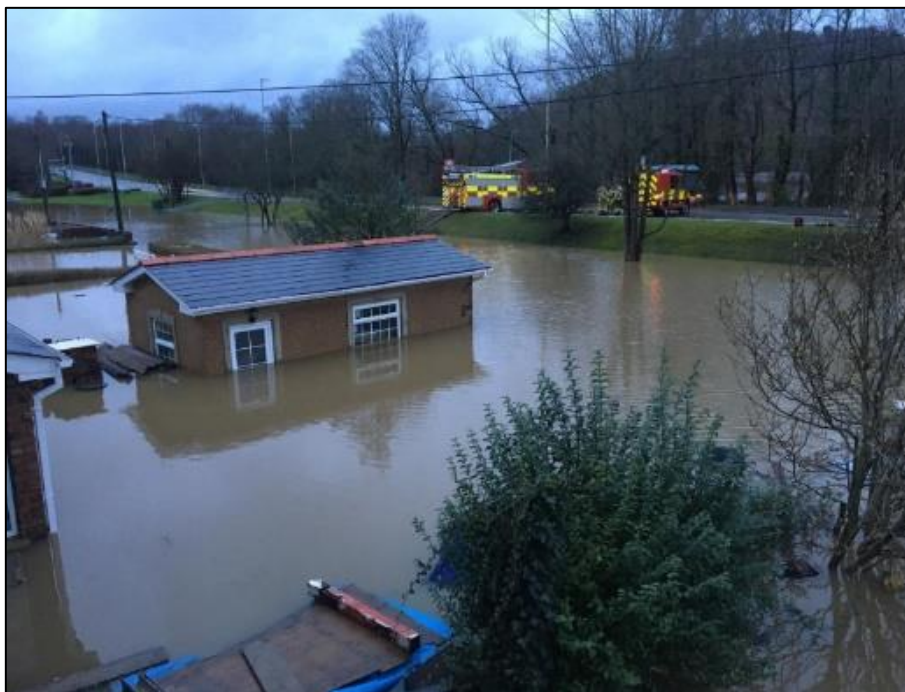
**Figure 13:** Flooding to properties at Glenboi during Storm Dennis on 16<sup>th</sup> February 2020 (image provided by resident)

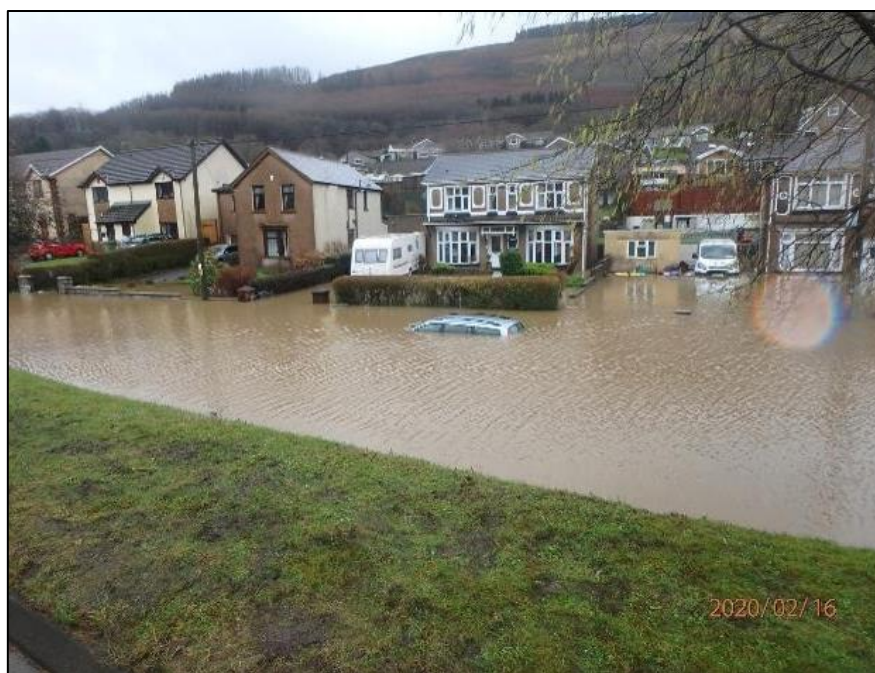
**Figure 14:** Flooding to properties at Glenboi during Storm Dennis on 16<sup>th</sup> February 2020 (image captured by RCT's Flood Risk Management team)

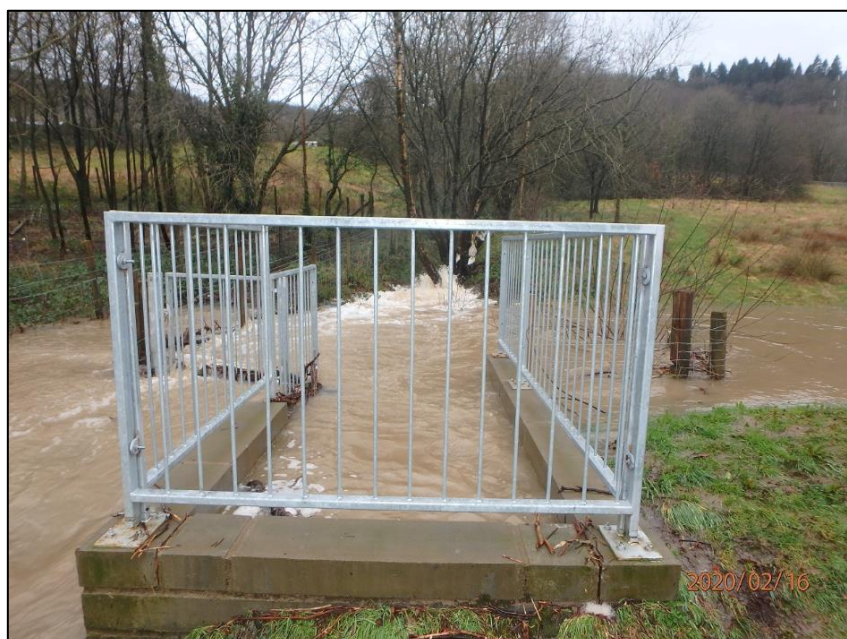
The inlet became blocked with debris during the storm event which reduced the culvert's ability to manage the flow of water, resulting in surcharge (Figure 16). Approximately six tonnes of debris, mostly consisting of stonewash, was removed from the inlet during the storm event (shown in Figure 17) by RCT's Highways and Streetcare Depot, which succeeded in alleviating the flooding.

**Figure 16:** 'Culvert Inlet 1' surcharging during Storm Dennis on 16<sup>th</sup> February 2020 (captured by RCT's Flood Risk Management team)

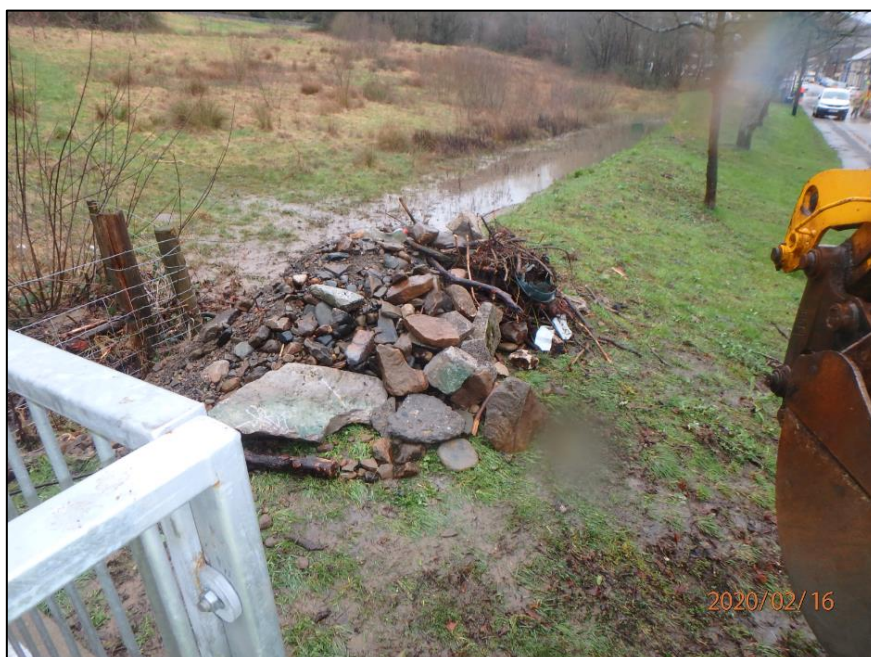
**Figure 17:** Debris removed from 'Culvert Inlet 1' which was identified as surcharging during Storm Dennis on 16<sup>th</sup> February 2020 (captured by RCT's Flood Risk Management team)

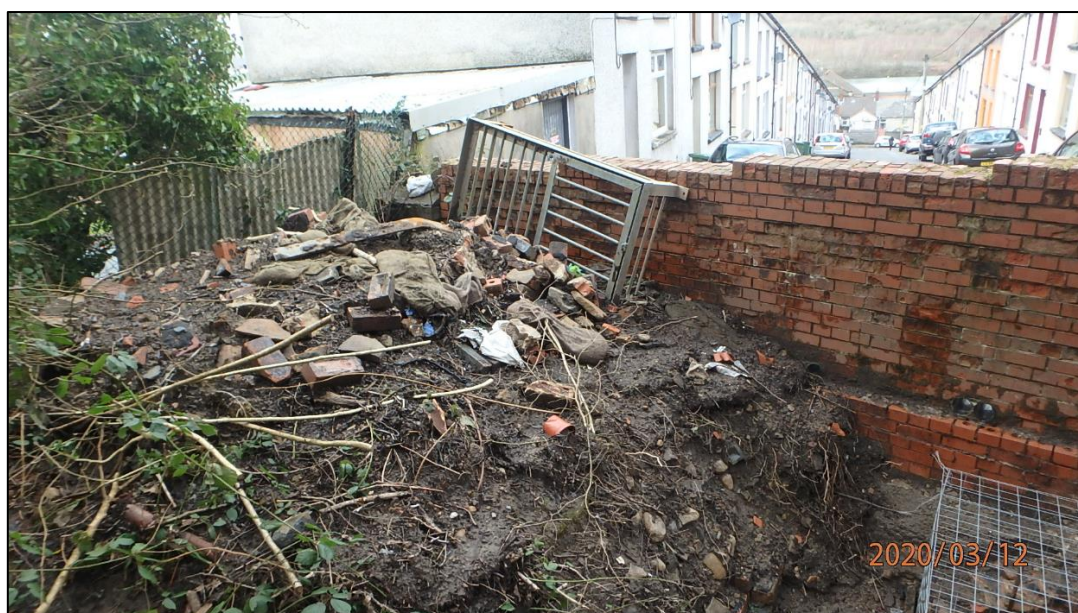
The inlet was identified as blocked with woody debris, scour material and other debris, inclusive of bricks, during post event inspections. Several tonnes of material, including the damaged inlet grill, was removed from 'Culvert Inlet 2' by RCT's Highways and Streetcare Depot post event (Figure 18).

**Figure 18:** Debris and former inlet debris screen removed from 'Culvert Inlet 2' by RCT's Highways and Streetcare Depot following Storm Dennis (image captured by RCT's FRM officer on 12/03/2020)

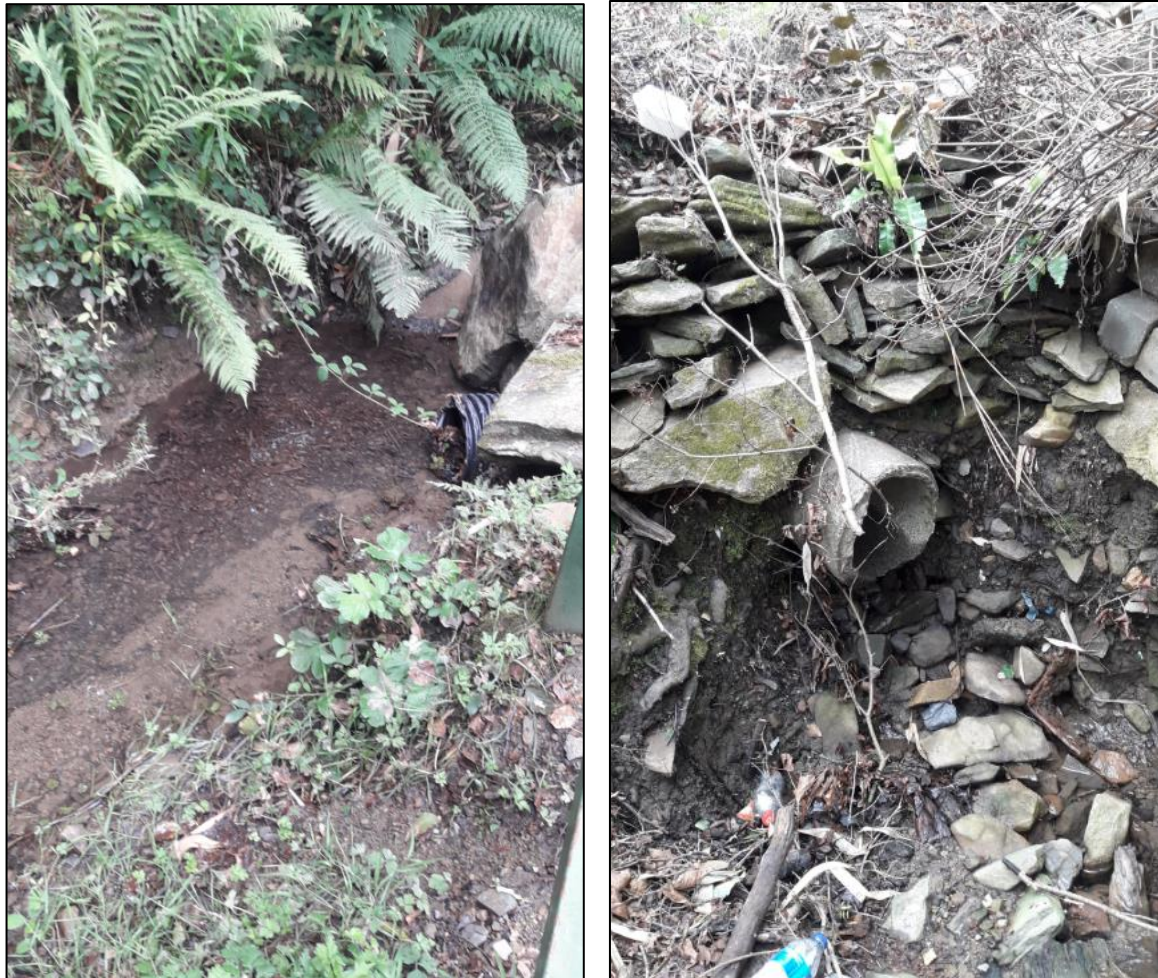
'Culvert Inlet 3' comprises of a 300mm dia plastic pipe which changes to a 300mm dia concrete pipe at a certain point within the network (Figure 20). The outlet concrete structure was identified as damaged following the mobilisation of debris from the hillside which is likely to have contributed to its surcharge. The condition of the network is not however considered the primary cause of flooding. The volume of water entering the network is considered to have overwhelmed 'Culvert Inlet 3', causing the inlet and upstream drainage ditch to back up and overflow onto Sierra Pines.

**Figure 20:** 'Culvert Inlet 3' (left) and outlet (right) at Sierra Pines captured post storm event (images provided by NRW)

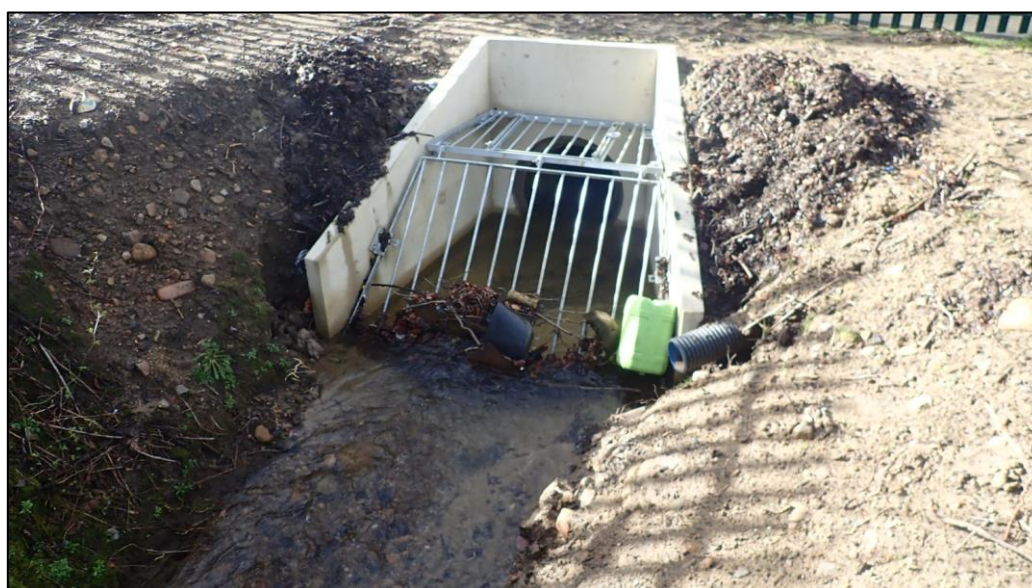
**Figure 21:** 'Culvert Inlet 4' captured before Storm Dennis by RCT's Flood Risk Management team on 13<sup>th</sup> February 2020

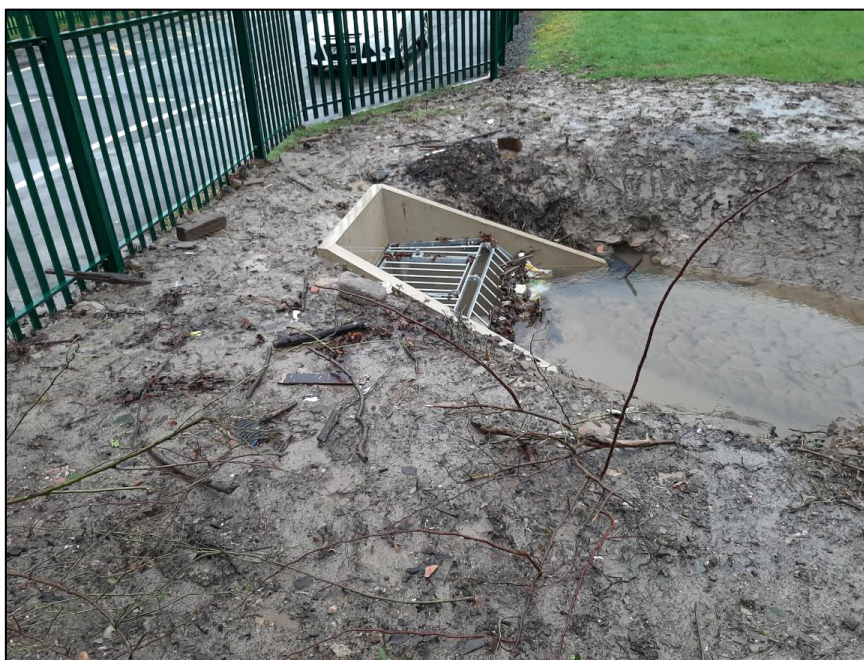
**Figure 22:** ‘Culvert Inlet 4’ captured after Storm Dennis by RCT’s Flood Risk Management team on 21st February 2020

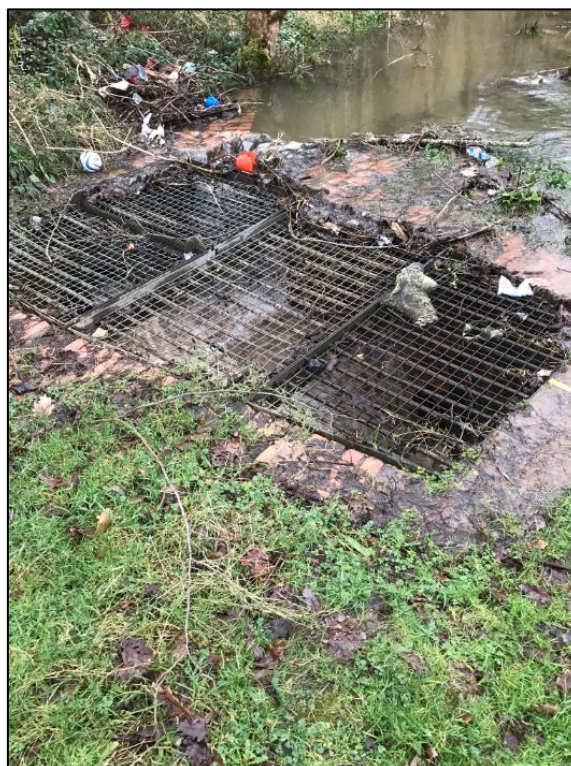
The 'Glenboi' culvert network was assessed as being in very poor condition, with multiple items of debris pulled out of the network following the storm event during the CCTV surveying and cleansing operation. Figure 24 shows the material that was removed from the network. This debris mostly consisted of large objects indicative of fly-tipping. It is considered that the poor operational condition of the network reduced the culvert's ability to manage the flow of water by at least 50%, causing the system to back up and contributing to the surcharging of water at the inlet.

**Figure 23:** 'Culvert Inlet 8' blocked with debris and surcharging during Storm Dennis on 16<sup>th</sup> February 2020 (image provided by resident)

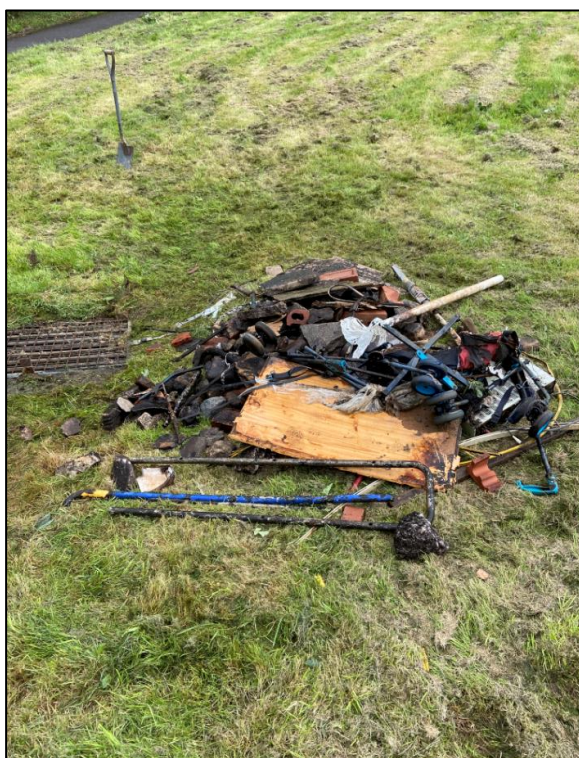
**Figure 24:** Debris removed from the ‘Glenboi’ culvert network following Storm Dennis during CCTV surveying and cleansing operations on 26/08/2020

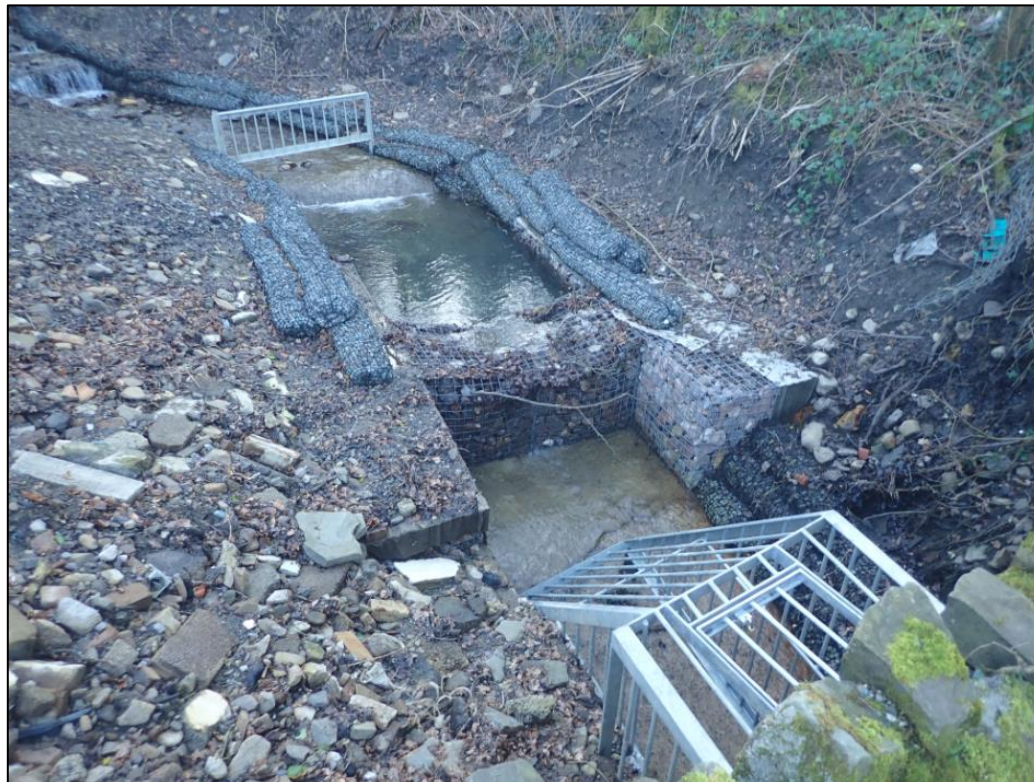
**Figure 26:** Open watercourse and upper catchment debris screens upstream of 'Pitt Cottages East Inlet' prior to Storm Dennis (captured by RCT's Flood Risk Management team on 06/02/2020)

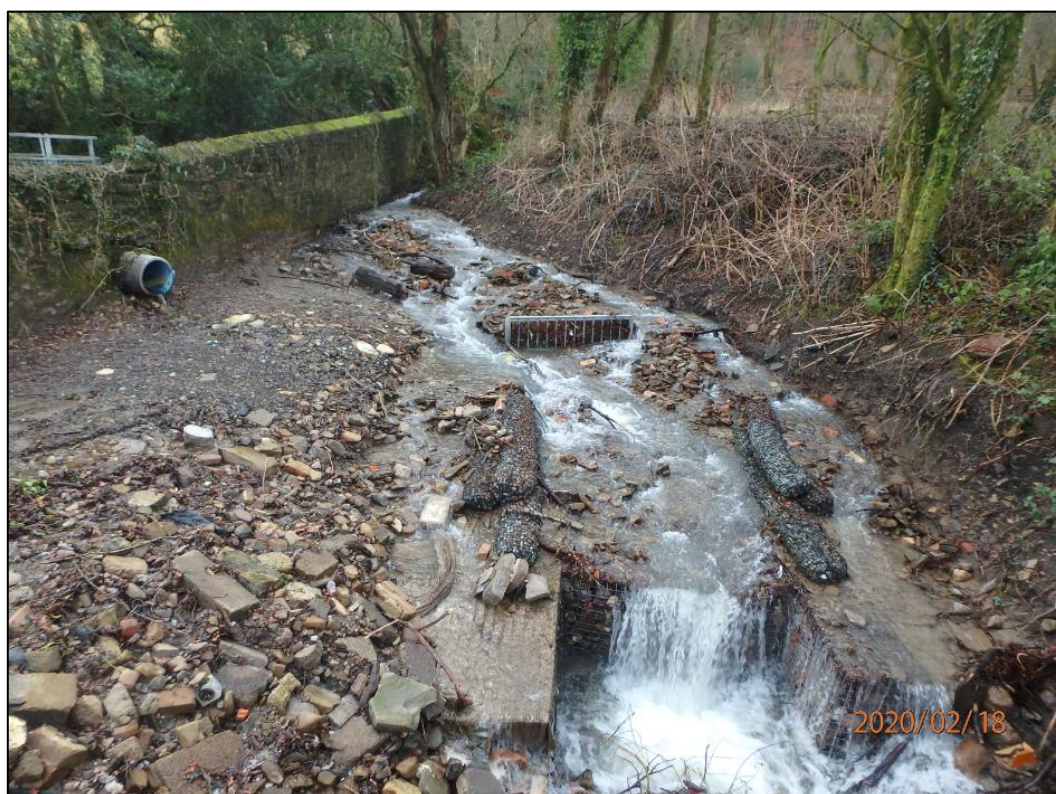
The images below highlight the extreme flows within the unnamed watercourse during the storm event which were able to mobilise and convey a significant volume of scour material downstream towards the 'Pitt Cottage East Inlet'.

**Figure 27:** Open watercourse and upper catchment debris screens upstream of 'Pitt Cottages East Inlet' post Storm Dennis (captured by RCT's Flood Risk Management team on 18th February 2020)

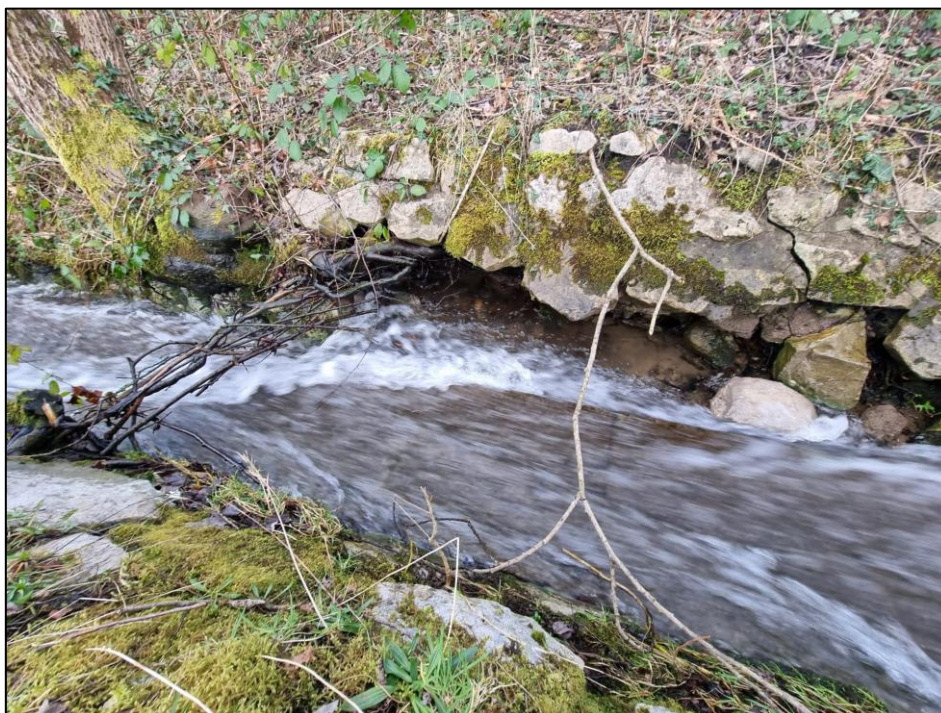
**Figure 28:** Image depicting a small area of scour within the unnamed open watercourse upstream of 'Culvert Inlet 1' (captured by RCT's Flood Risk Management team post Storm Dennis)

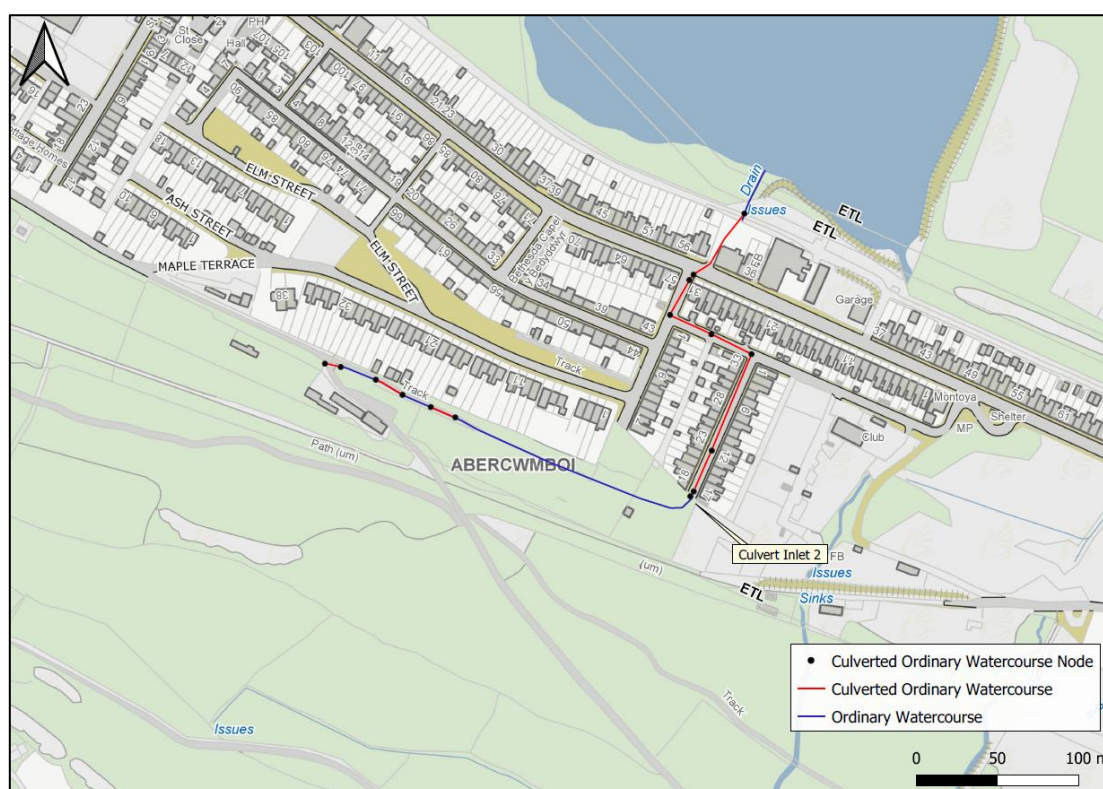
**Figure 29:** Open watercourse identified to the rear of Maple Terrace which enters the 'Mostyn Street' culvert network at 'Culvert Inlet 2'

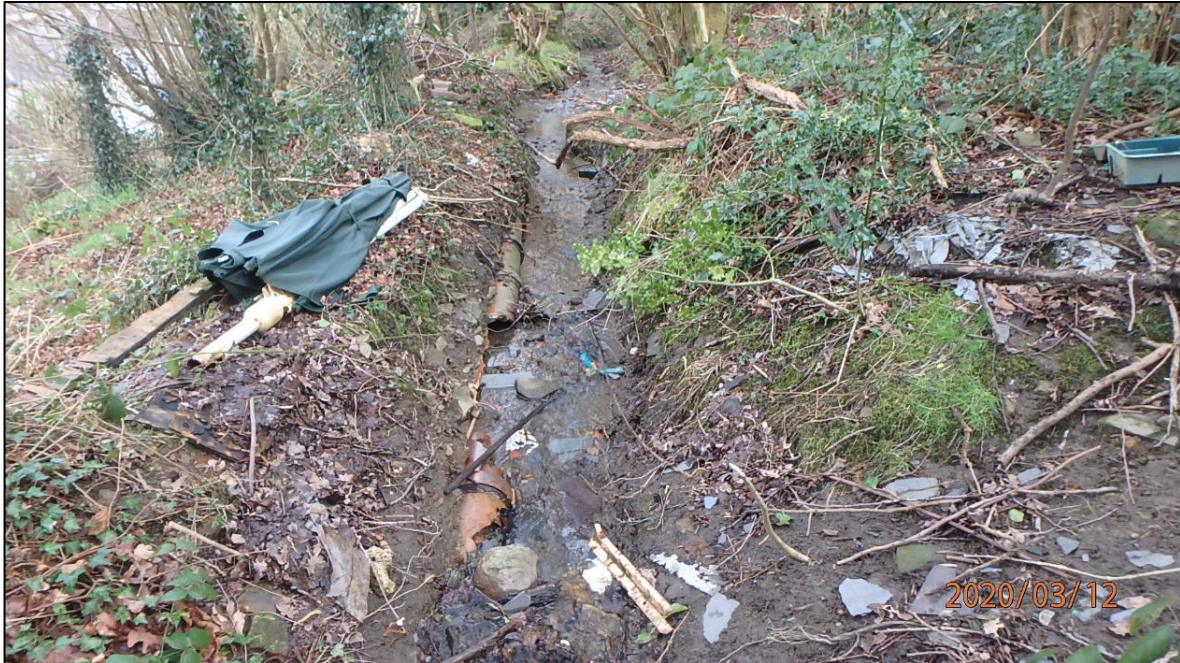
**Figure 30:** Cracked pipework within the open ditch and various pieces of debris within the channel and surrounding area (captured by RCT's Flood Risk Management team on 12/03/20)

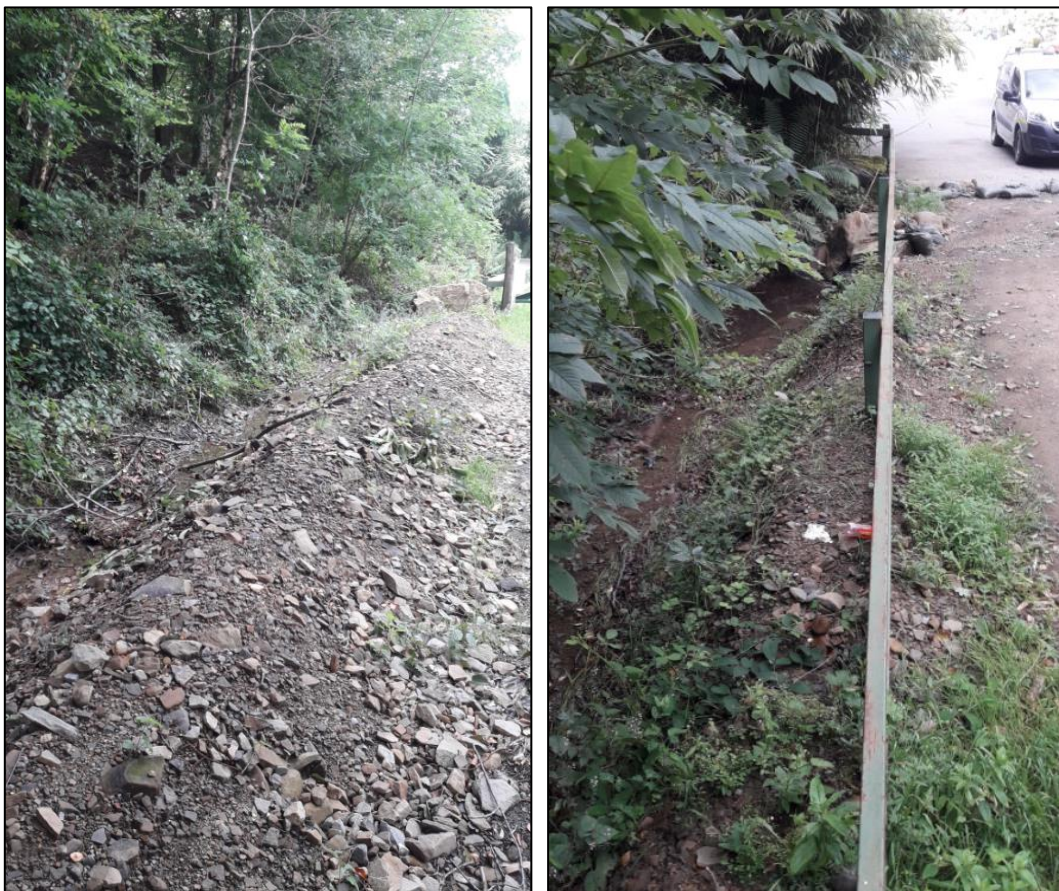
**Figure 31:** Land drainage channel adjacent to the St Gwynno forestry access road which feeds into ‘Culvert Inlet 3’

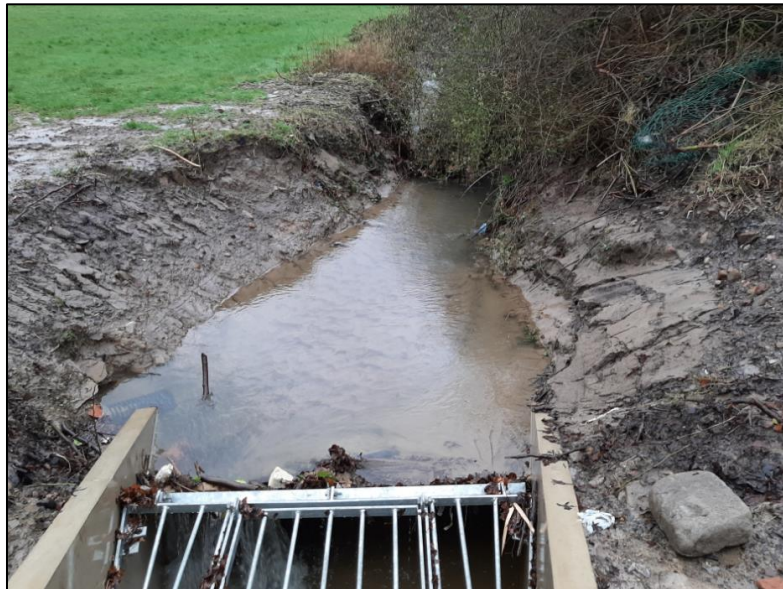
**Figure 32:** Condition of the open watercourse upstream of 'Culvert Inlet 4' captured post Storm Dennis (captured by RCT's Flood Risk Management team on 21/02/2020)

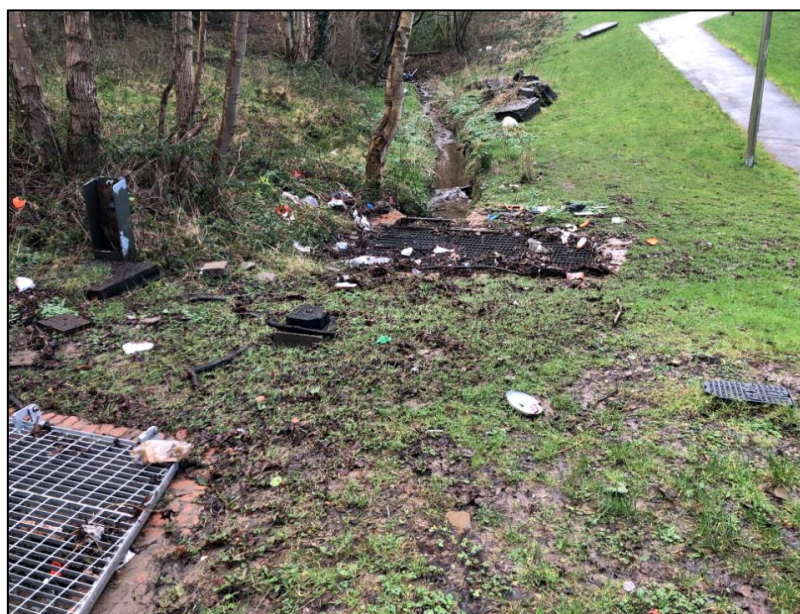
**Figure 33:** Open watercourse upstream of 'Culvert Inlet 8' captured post Storm Dennis (captured by RCT's Flood Risk Management team on 25/02/2020)

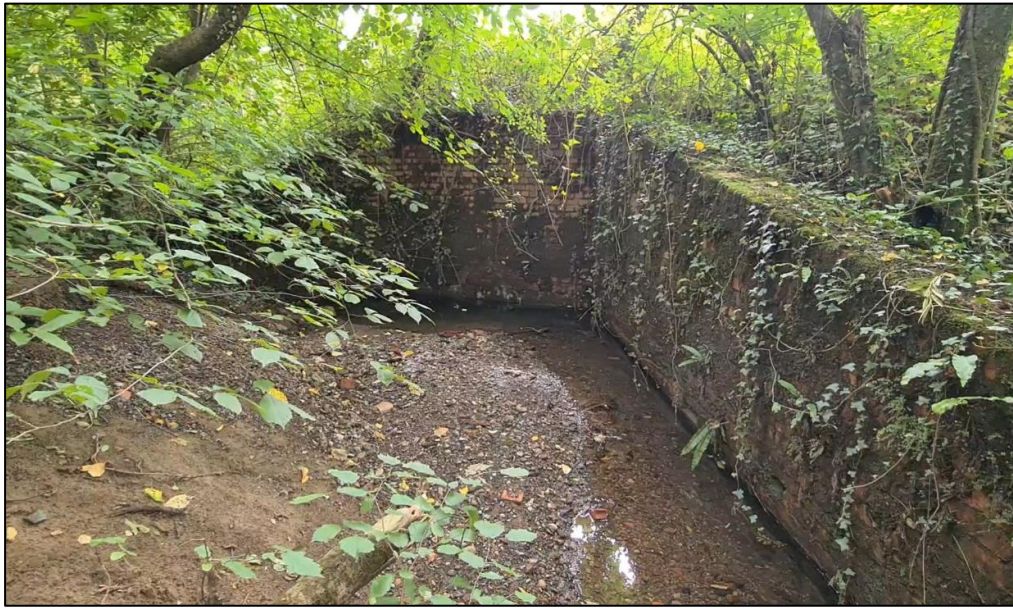
**Figure 34:** Photo of silt accumulation at the Glenboi culvert network outfall pond (captured by RCT during Storm Dennis on 16/02/2020)

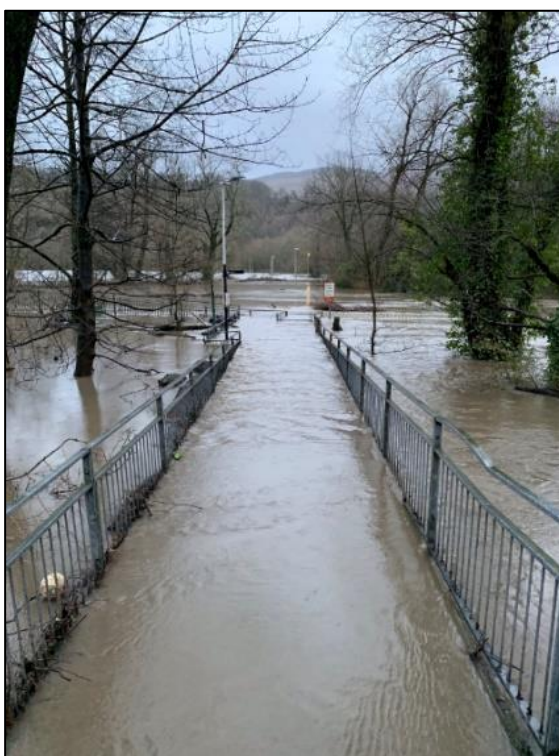
**Figure 36:** Flooding from the River Cynon at Peace Park and Fernhill railway station on 16<sup>th</sup> February 2020 (image provided by resident)

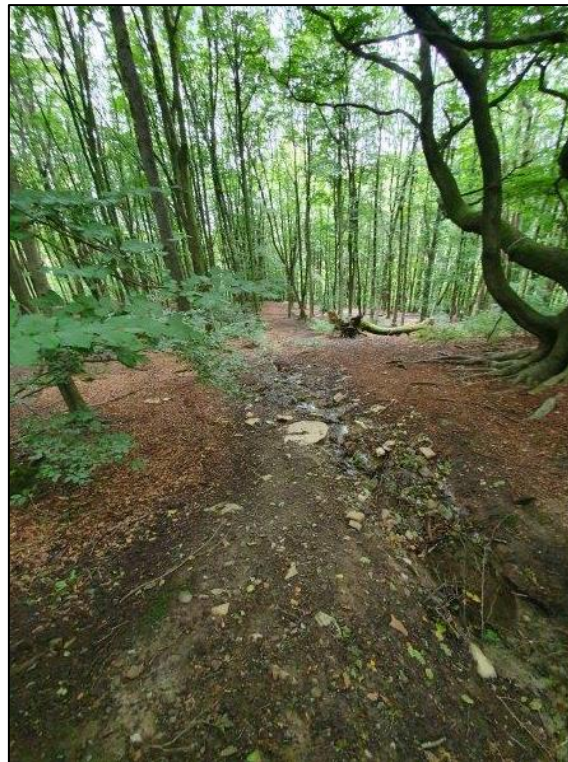
**Figure 39:** Undefined channel below 'Structure 3' which is considered to have directed flow towards 'Structure 7 / Culvert Inlet 3' (image captured by RCT's Flood Risk Management team post storm event)

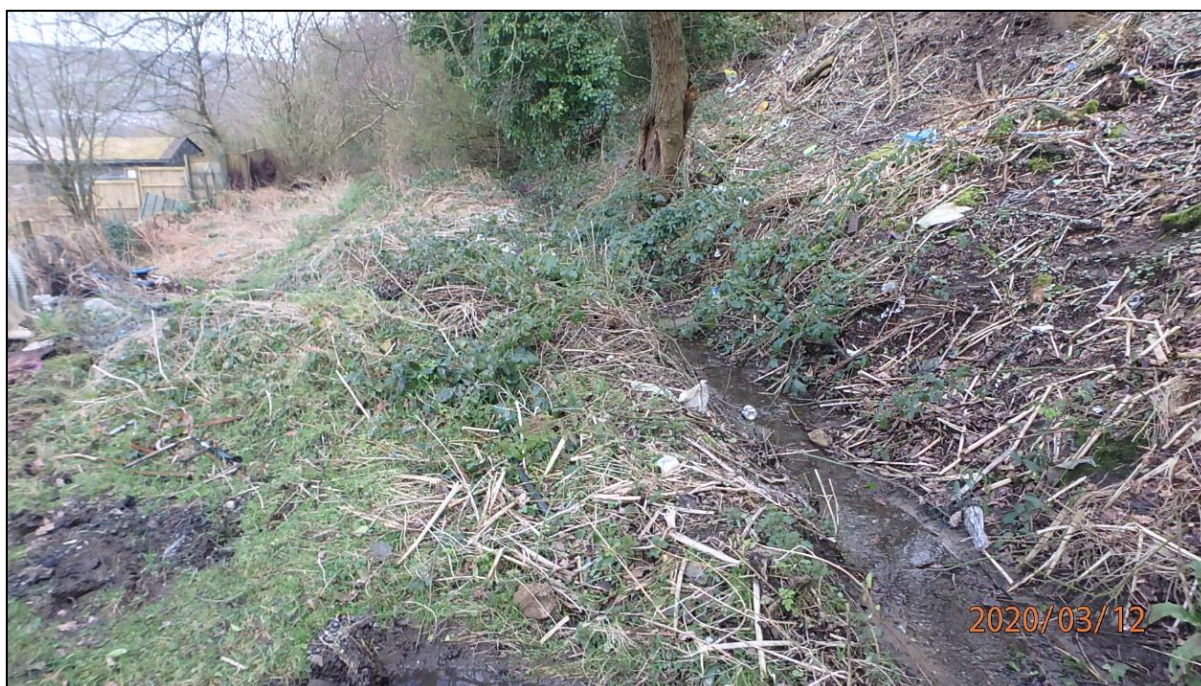
**Figure 40:** Evidence of flattened grass and mobilised debris indicative of overland flows down the hillside behind Maple Terrace during Storm Dennis (captured by RCT's Flood Risk Management team on 12/03/2020)

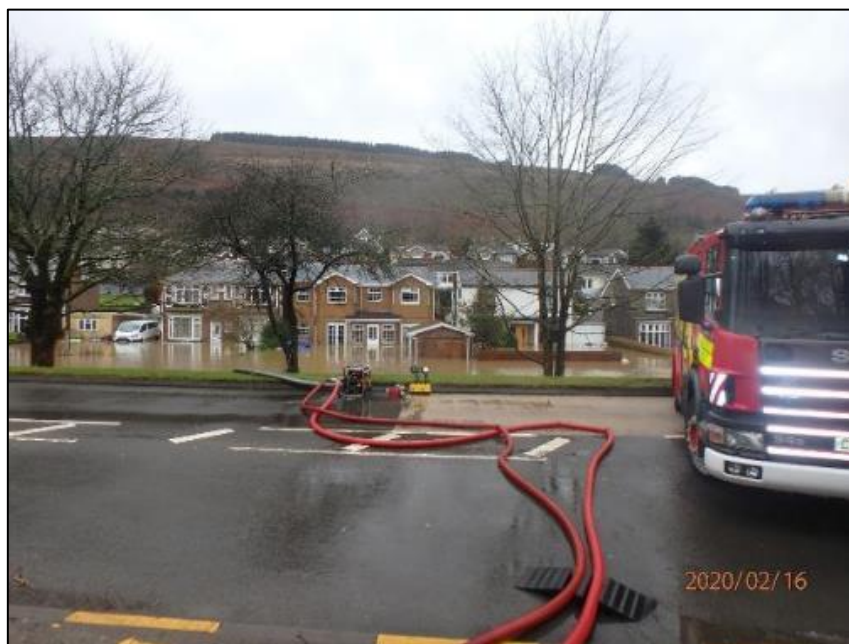
**Figure 43:** Image depicts the flooding at Glenboi and the Fire Service response during Storm Dennis (image captured by RCT's Flood Risk Management team on 16<sup>th</sup> February 2020)
