# Flood and Water Management Act 2010

## Section 19 Flood Investigation Report

### Storm Dennis – Flood Investigation Area RCT06 (Mountain Ash)

October 2022

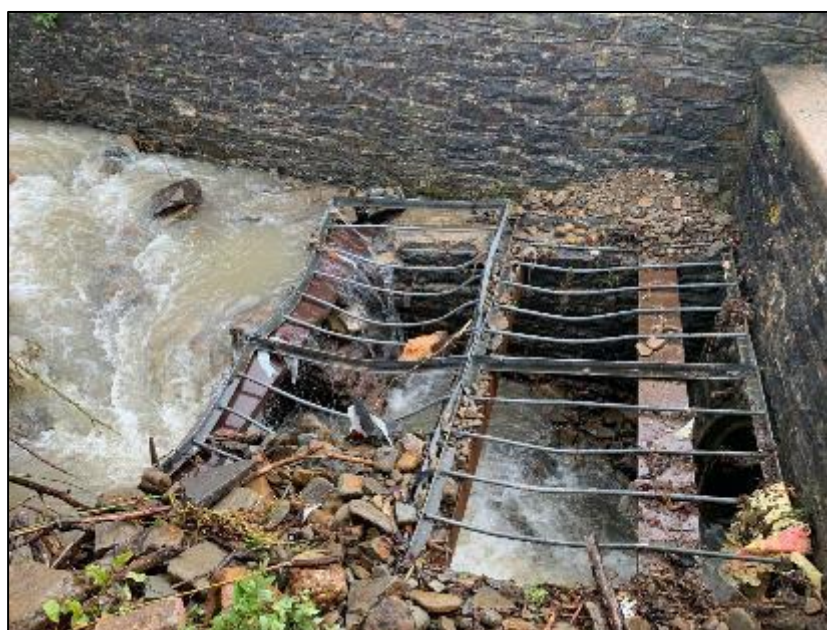
**Figure 6:** Evidence of damage to ‘Culvert Inlet 1’ at Campbell Terrace identified during post storm investigations (captured by RCT’s Flood Risk Management team on 18<sup>th</sup> February 2020)

Upon an inspection of ‘Culvert Inlet 1’ post storm event, the structure was identified as structurally damaged with significant scour material deposited at the inlet structure, indicating that the inlet had surcharged due to blockage during the storm event (see Figure 6).

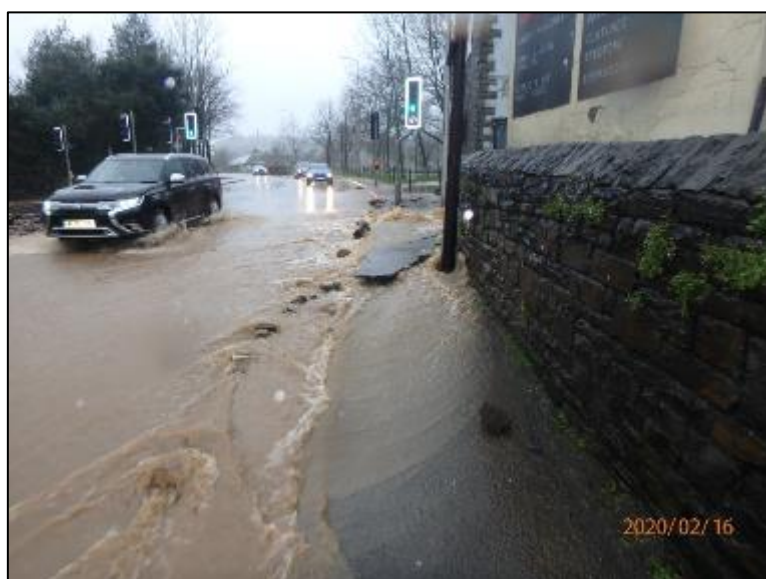
Post event inspections also identified a section of the footpath adjacent to the A4059 (New Road) to have suffered from subterranean hydraulic pressure, i.e., the footpath appears to indicate that water from the culvert network, downstream of ‘Culvert Inlet 1’, erupted through the ground and contributed to the flooding along the highway. The section of damaged culvert is labelled ‘Culvert Section 1’ in Figure 2.

The damaged footpath was observed as discharging water during the storm event and in the days following. Figure 7 depicts ‘Culvert Section 1’ discharging flood water and contributing additional surface water flows along the A4059 highway network on 16<sup>th</sup> February 2020, further exacerbating the flooding of properties associated to ‘Culvert Inlet 1’.

**Figure 7:** Evidence of flood water discharging from a damaged section of footpath adjacent to the A4059 (New Road) and conveying onto the highway during Storm Dennis (captured by RCT officers on 16<sup>th</sup> February 2020)

The obstruction to the debris screen at 'Culvert Inlet 1' caused by the mobilisation of debris within the Nant y Ffrwd watercourse is considered the primary cause of surcharge at 'Culvert Inlet 1' during Storm Dennis. The subsequent poor operational condition of the downstream culvert network caused by the mobilisation of debris is considered the primary cause of surcharge from 'Culvert Section 1' (Figure 7).

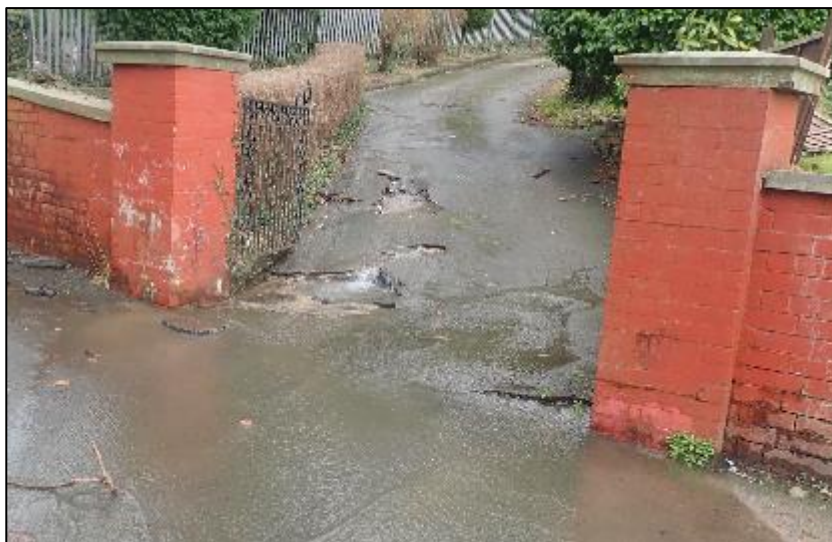
**Figure 8:** Evidence of surface water scour on the driveway of a residential property at Aber-ffrwd Road (Captured by RCT’s Flood Risk Management team during post storm investigations)

The debris identified within the 'Trem y Dyffryn' culvert network was also identified to have caused an ordinary watercourse manhole, downstream of 'Culvert Inlet 2' to surcharge. The manhole is situated on the driveway of a residential property and surcharging overland flows from the manhole resulted in surface scour to the tarmac driveway, as depicted in Figure 8.

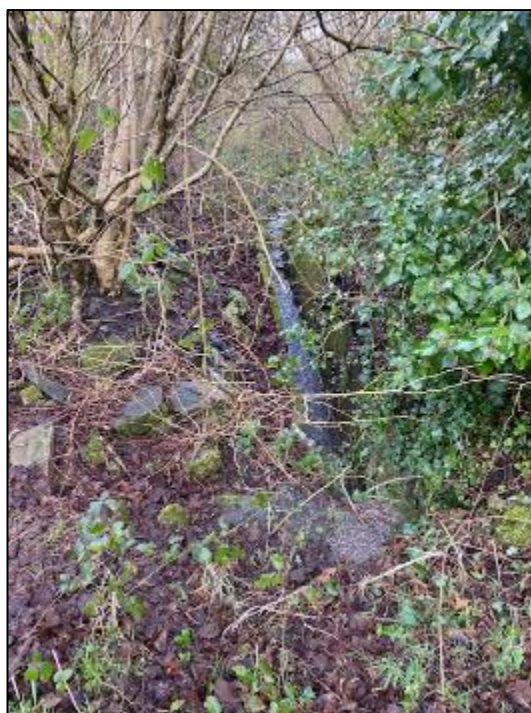
Based upon an inspection of the area of hillside to the rear of Clas-y-Dderwen, an unnamed ordinary watercourse channel was identified. The watercourse (illustrated in Figure 9) showed evidence of overtopping and the surrounding hillside was heavily saturated with areas of standing surface water still present during post event inspections.

**Figure 9:** Evidence of an ordinary watercourse present along the hillside to the rear of Clas-y-Dderwen. (Captured by RCT's Flood Risk Management team during post storm investigations)

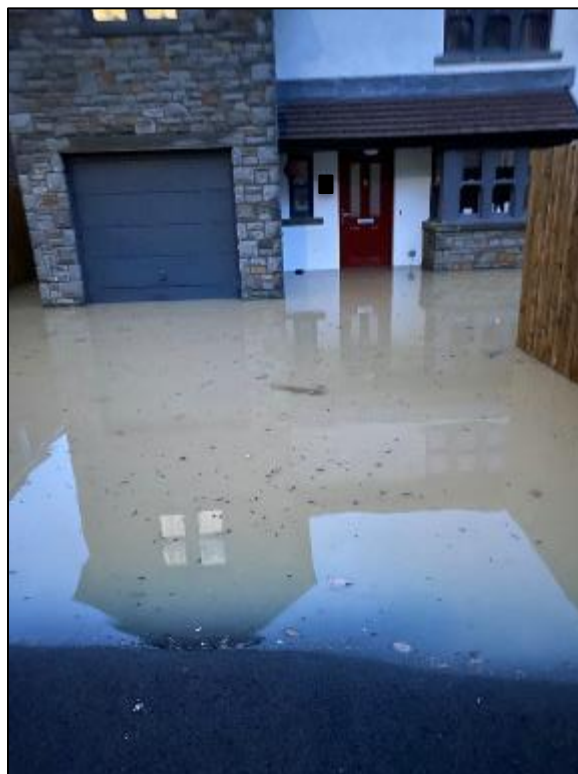
Nine residential properties at Cardiff Road and Usk Villas were confirmed as internally flooded as a result of surface and foul water accumulation within localised low points. One resident reported flooding of over 2 metres within the ground floor of their property as flood water conveyed towards localised low points. Figure 10 depicts the accumulation of flood water and associated flooding to a property at Cardiff Road.

**Figure 10:** Flooding to a residential property at Cardiff Road during Storm Dennis (image provided by resident)

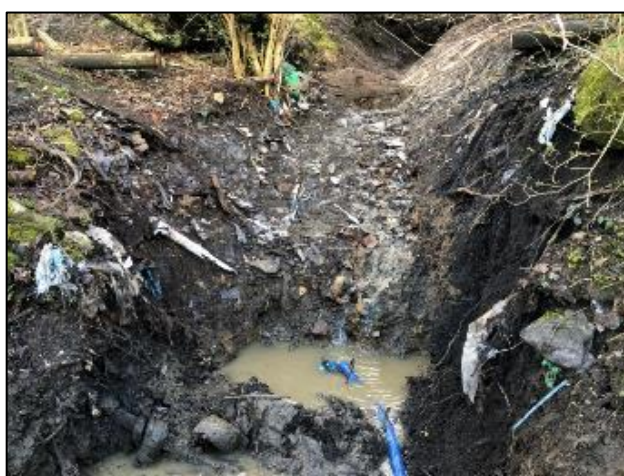
It is considered that the surcharging flows from 'Culvert Inlet 3' overtopped the inlet structure and flowed overland towards 'Culvert Inlet 4'. Water was unable to convey into 'Culvert Inlet 4' due to its poor condition and as a result, surcharging flows conveyed along Pamela Street towards Beadon Street, contributing to the flows from 'Culvert Inlet 3'. Evidence of water pooling on top of the buried culvert inlet is illustrated in Figure 13.

**Figure 13:** Ordinary watercourse channel upstream of 'Culvert Inlet 4' and evidence of ponding water on top of buried 'Culvert Inlet 4' during post event inspections (captured by RCT's Flood Risk Management team)

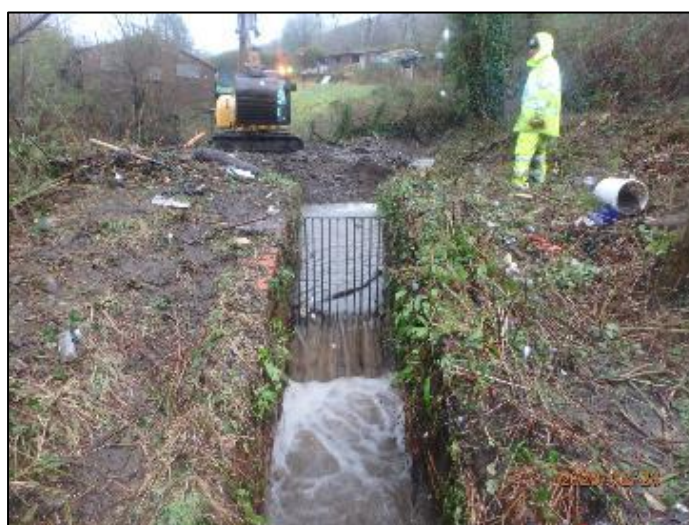
**Figure 14:** 'Culvert Inlet 6' at Bryn lfor during emergency clearance works following Storm Dennis (captured by RCT's Flood Risk Management team on 28<sup>th</sup> February 2020)

Emergency works were carried out by a Council appointed contractor following Storm Dennis to remove the debris from the privately owned 'Culvert Inlet 6' and the upstream section of watercourse (Figure 14). During Storm Jorje on the 29<sup>th</sup> of February 2020, properties at Bryn lfor were impacted a second time following heavy rainfall.

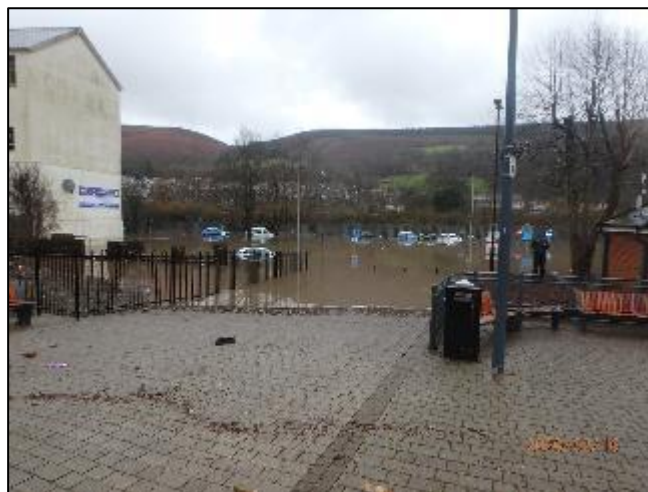
Main river flood water conveyed into the rear of at least 5 non-residential properties on Oxford Street, causing internal flooding to the basement and ground floors of properties. External flood depths of approximately 1 metre were witnessed during the storm event.

**Figure 15:** Wrack Marks identifying the extent of main river flooding within Mountain Ash town centre (captured by RCT's Flood Risk Management department on 16<sup>th</sup> February 2020)

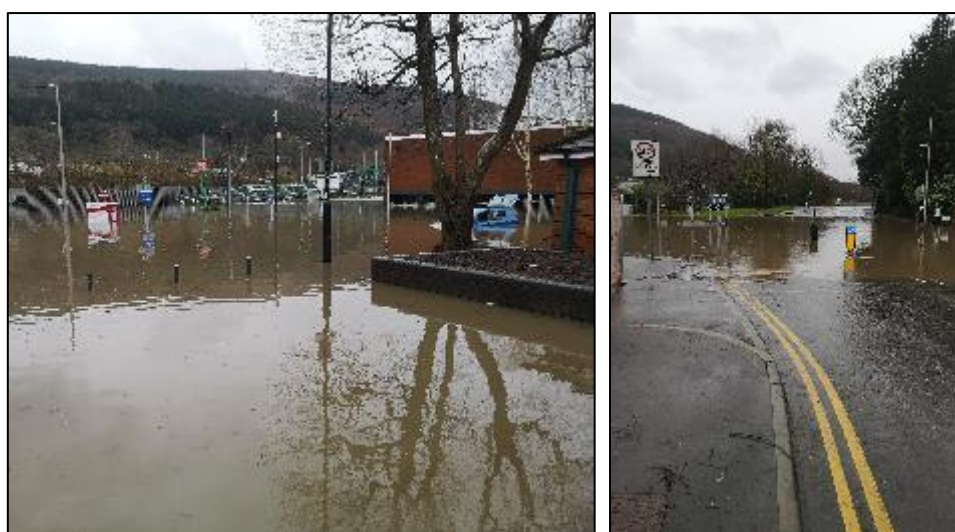
Fluvial flood water conveyed south along Henry Street towards Miskin Road, resulting in significant highway flooding along the B4275, as shown in Figure 16.

**Figure 16:** Evidence of extensive flooding across Mountain Ash town centre, including at Henry Street carpark (left) and Miskin Road roundabout (right) during Storm Dennis

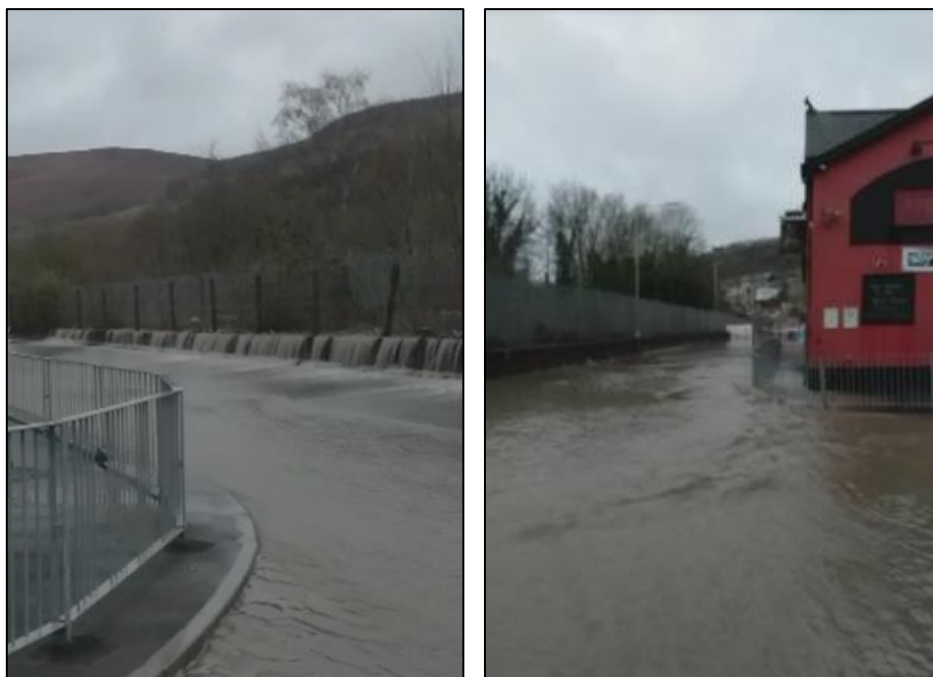
The River Cynon continued to overtop onto the adjacent railway line and conveyed south, resulting in internal flooding to a further 3 non-residential and 3 residential properties at Miskin Road and Bailey Street. Figure 17 depicts the conveyance of fluvial flows onto Miskin Road from the railway line.

**Figure 17:** Evidence of fluvial flows conveying onto Miskin Road from the adjacent railway line.  
(Images provided by a resident)

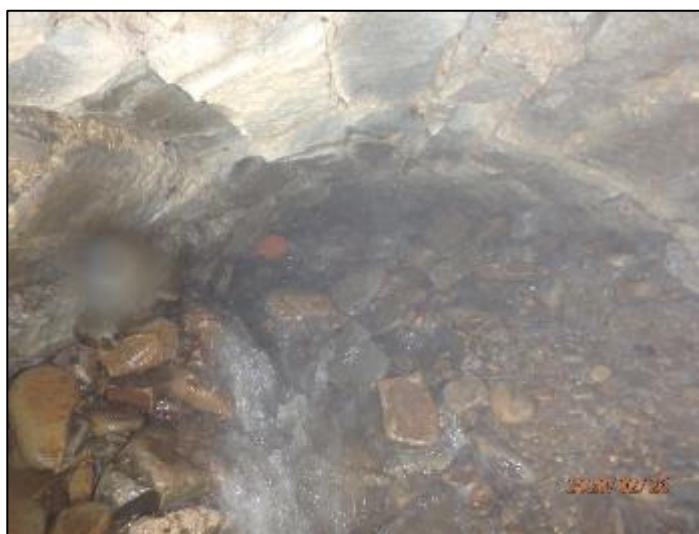
A CCTV survey of the ‘Nant y Ffrwd’ culvert network following Storm Dennis identified significant obstructions present within the network downstream of ‘Culvert Inlet 1’ as a result of settled debris, reducing the culvert’s cross sectional area by up to 95% (Figure 19).

**Figure 19:** Settled debris deposits identified within the 'Nant y Ffrwd Culvert Network' downstream of 'Manhole 1' during CCTV survey, jetting and cleansing operations on 26<sup>th</sup> February 2020

The volume of settled deposits led to operators abandoning the CCTV survey operations. As a result, approximately 150 tonnes of debris was removed from the network during jetting and cleansing operations, allowing a second CCTV survey to be undertaken which revealed some sections of scour and missing stonework within the culvert network. Following emergency works to repair the sections of scour, the network was concluded to be in acceptable structural condition.

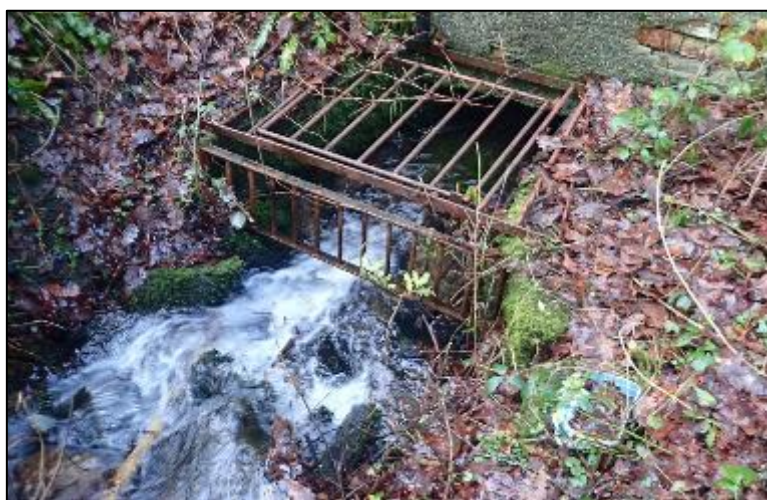
'Culvert Inlet 2' is identified as a privately owned structure and was identified as the primary source of flooding to 5 residential properties at Trem y Dyffryn. First responders described the inlet as blocked with debris, inferring that the inlet became obstructed during the storm event. Figure 20 depicts the condition of the inlet prior to Storm Dennis, free from debris and in acceptable condition however, the inlet is identified as an aged asset.

**Figure 20:** 'Culvert Inlet 2' captured prior to Storm Dennis (captured by RCT's Flood Risk Management team on 13<sup>th</sup> February 2020)

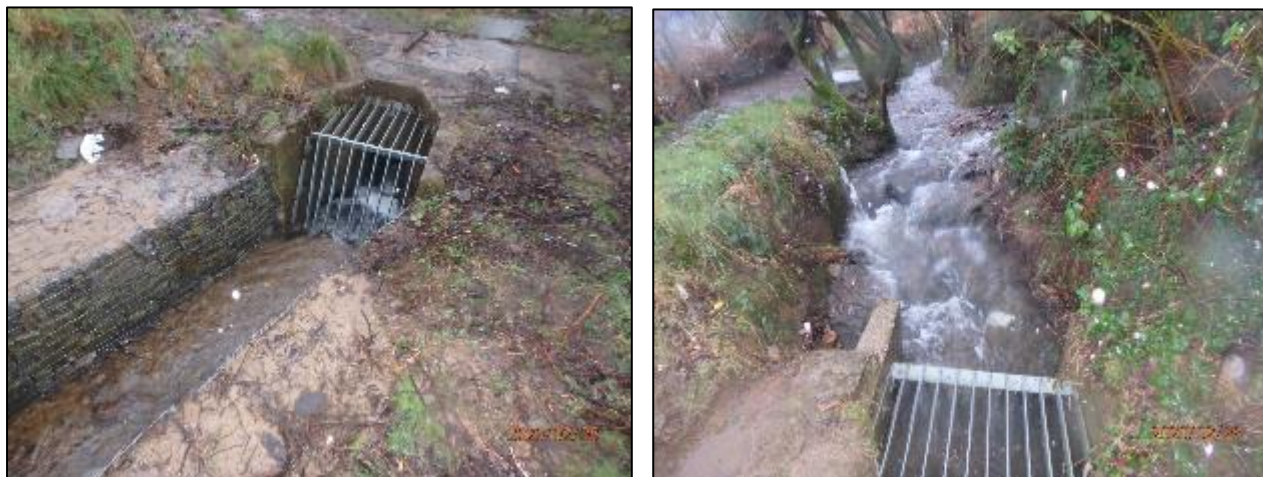
**Figure 22:** ‘Culvert Inlet 3’ (left) and ‘Culvert Inlet 5’ (right) structures captured post Storm Dennis

Both culvert networks associated to ‘Culvert Inlet 3, 4 and 5’ were surveyed in June 2020 following Storm Dennis. The results of which identified no defects within the upper section of the ‘Kingcraft Street Culvert Network’, which suggests that the culvert conditions had minimal influence on the surcharging of ‘Culvert Inlet 5’. A CCTV survey of the ‘Victor Street Culvert Network’ identified some sections of the culvert network to be in poor condition, both structurally and operationally however, the primary cause of surcharge at ‘Culvert Inlet 3’ has been attributed to the blockages at the inlet screen which reduced the inlet’s capacity to manage the inflow of water, resulting in overtopping.

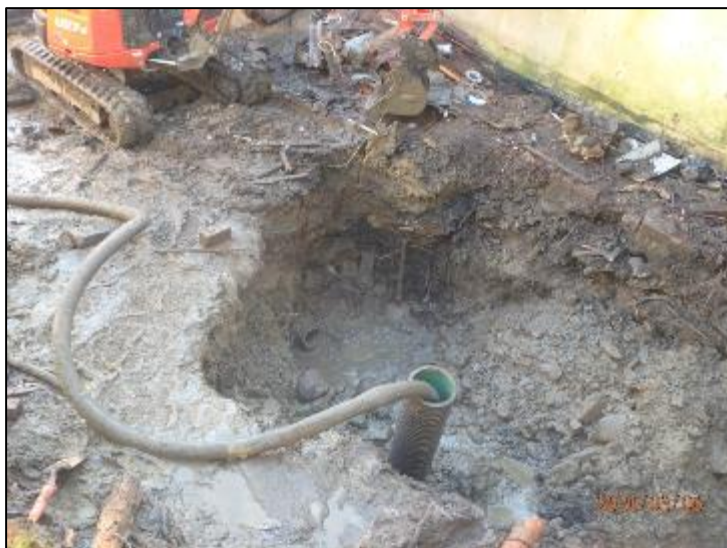
Emergency works were undertaken by RCT Council to excavate the buried culvert inlet which was identified as a small 150mm pipe and identified as a privately owned structure. ‘Culvert Inlet 4’ and the downstream network were assessed as being in poor condition with several sections of collapsed pipework (Figure 23). The condition of ‘Culvert Inlet 4’ and the downstream culvert network is considered to have contributed to the surcharging at this location, however the primary cause of flooding

**Figure 23:** Collapsed culvert pipework downstream of 'Culvert Inlet 4' which was identified as buried during emergency repair works (captured by RCT officers post Storm Dennis)

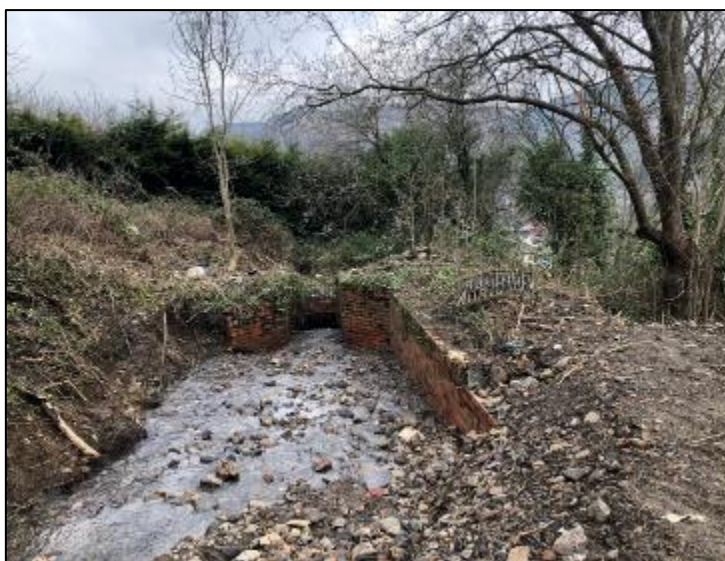
The 'Bryn Ifor Culvert Network' was assessed as being in acceptable condition downstream of 'Culvert Inlet 6', with little settled debris present. The culvert network upstream of 'Culvert Inlet 6' which conveys beneath Llanwonno Road, was observed to be in poor operational condition, with settled debris restricting CCTV operations, indicative of the mobilisation of debris from the upper catchment.

**Figure 24:** Evidence of flattened grass and deposits of debris at 'Culvert Inlet 6' post event (captured by RCT officers)

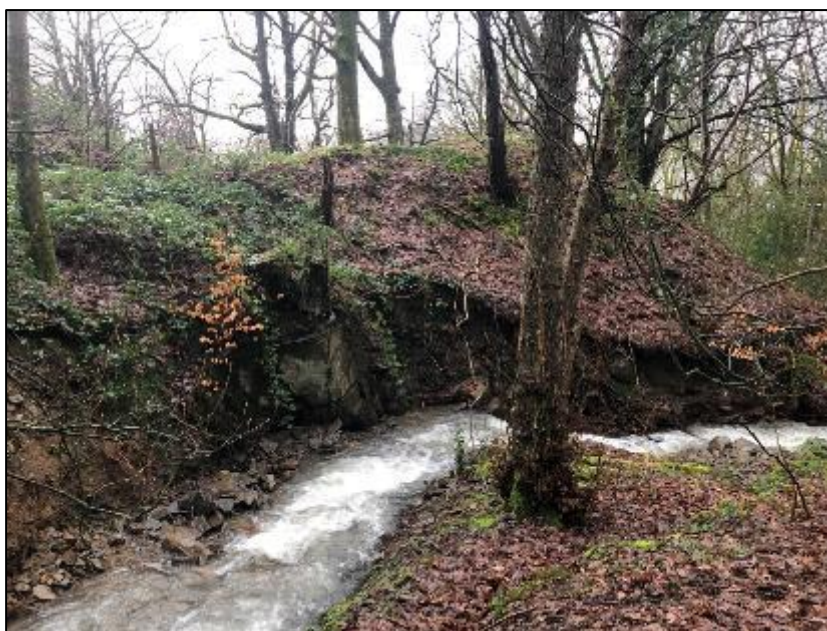
**Figure 27:** Photo of significant embankment scour and undercutting to the Nant y Ffrwd ordinary watercourse within Area 1, Figure 26 (captured by RCT's Flood Risk Management team on 25/02/2020)

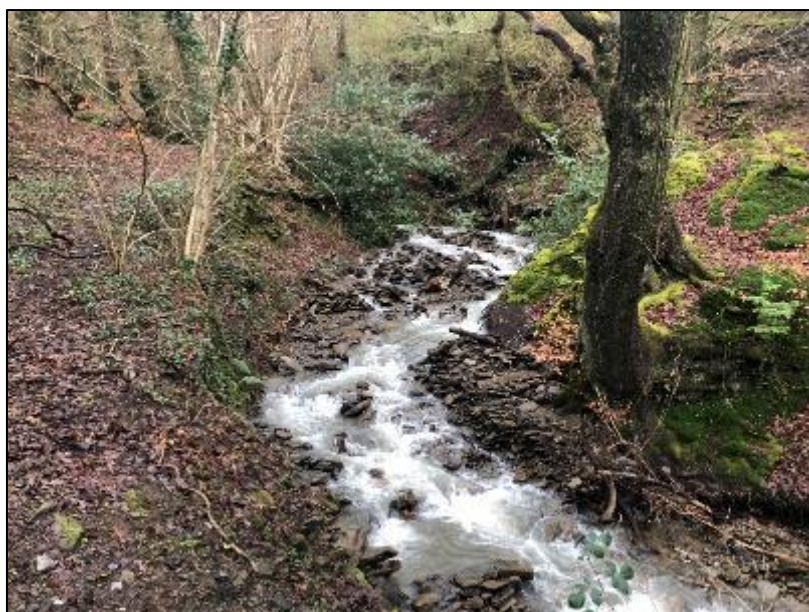
**Figure 28:** Photo of debris deposition within the Nant y Ffrwd ordinary watercourse within Area 1, Figure 26 (captured by RCT's Flood Risk Management team on 25/02/2020)

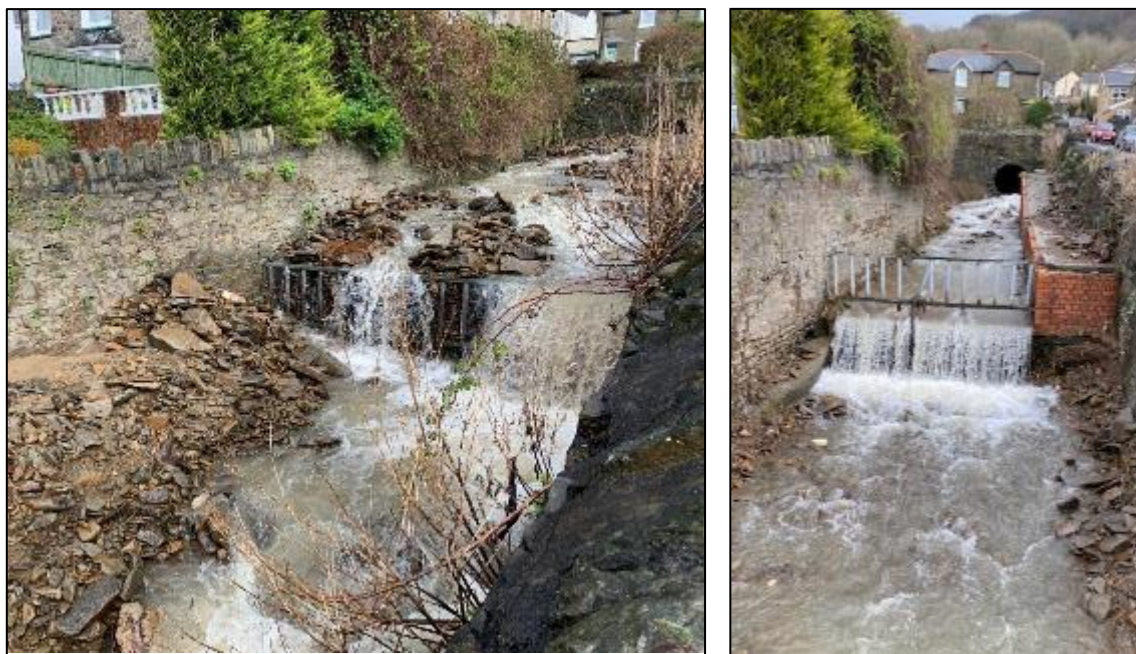
**Figure 29:** A comparison of the Nant y Ffrwd open watercourse channel, adjacent to Allen Street within Area 2, Figure 26, pre (left) and post (right) clearance of debris material (captured by RCT’s Flood Risk Management team on 18/02/2020 (left) and 01/03/2020 (right))

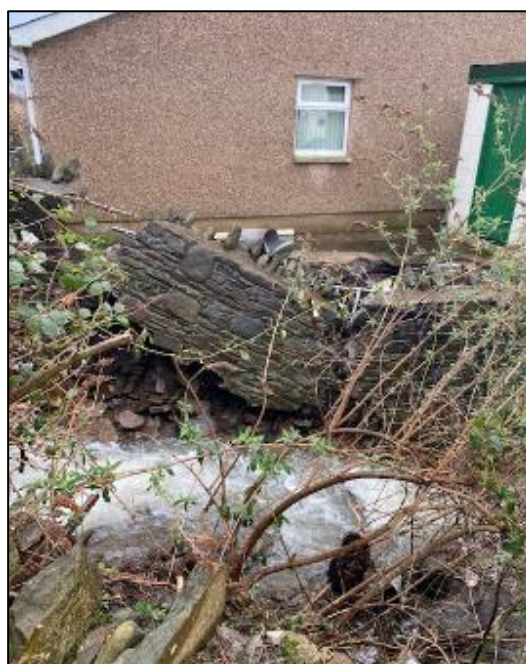
**Figure 30:** Evidence of damaged channel retaining wall within Area 2, Figure 26, of the Nant y Ffrwd ordinary watercourse (captured by RCT's Flood Risk Management team during post storm investigations)

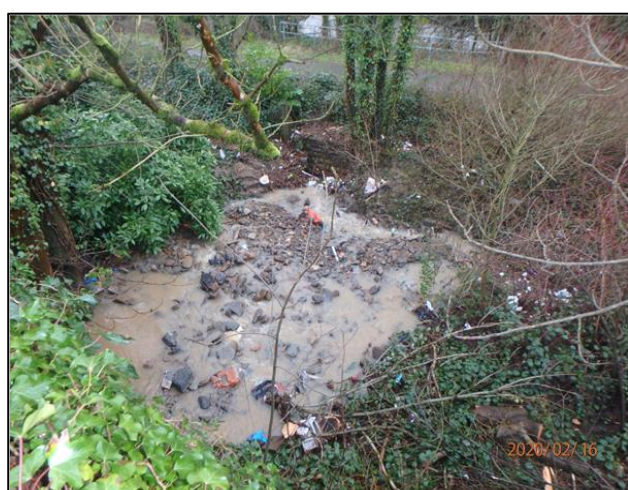
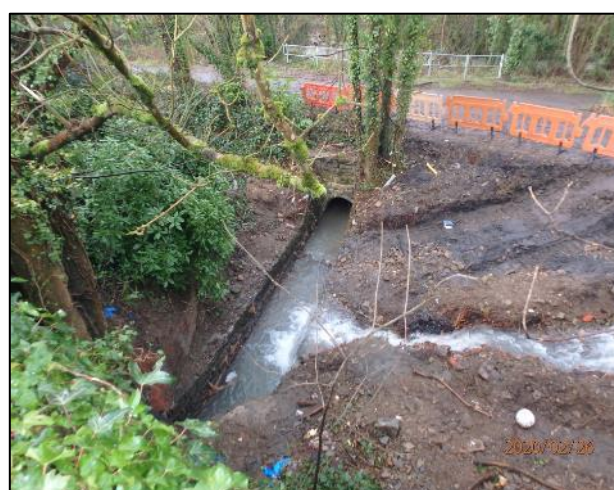
**Figure 31:** Evidence of debris accumulation at the outfall of the 'Nant y Ffrwd Culvert Network' pre (left) and post (right) emergency clearance works (captured by RCT's Flood Risk Management team on 16<sup>th</sup> February 2020)

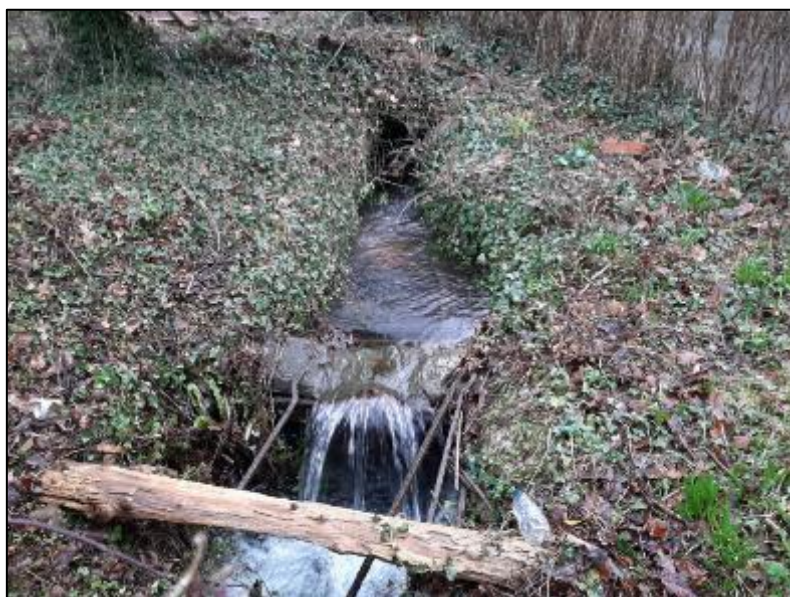
**Figure 32:** 'Unnamed ordinary watercourse 1' upstream of 'Culvert Inlet 2' captured by RCT officers post event

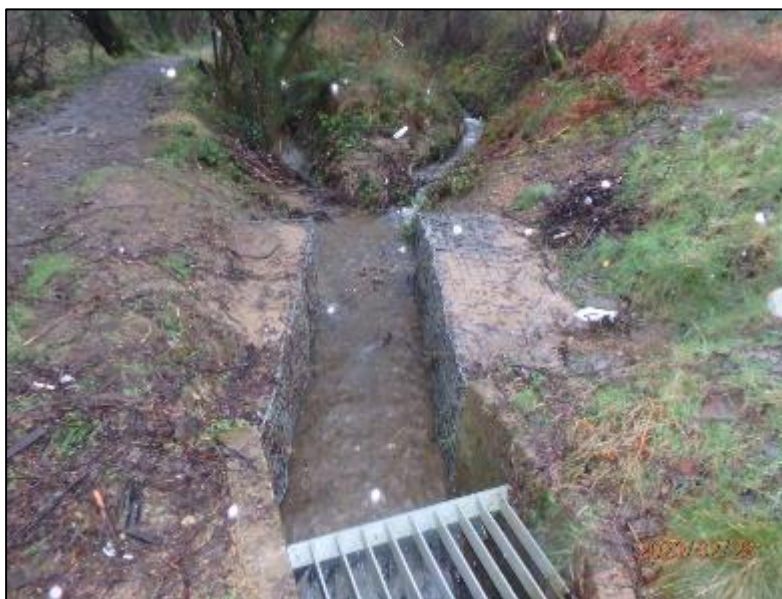
**Figure 33:** 'Unnamed ordinary watercourse 2' upstream of 'Culvert Inlet 3' captured by RCT officers post event

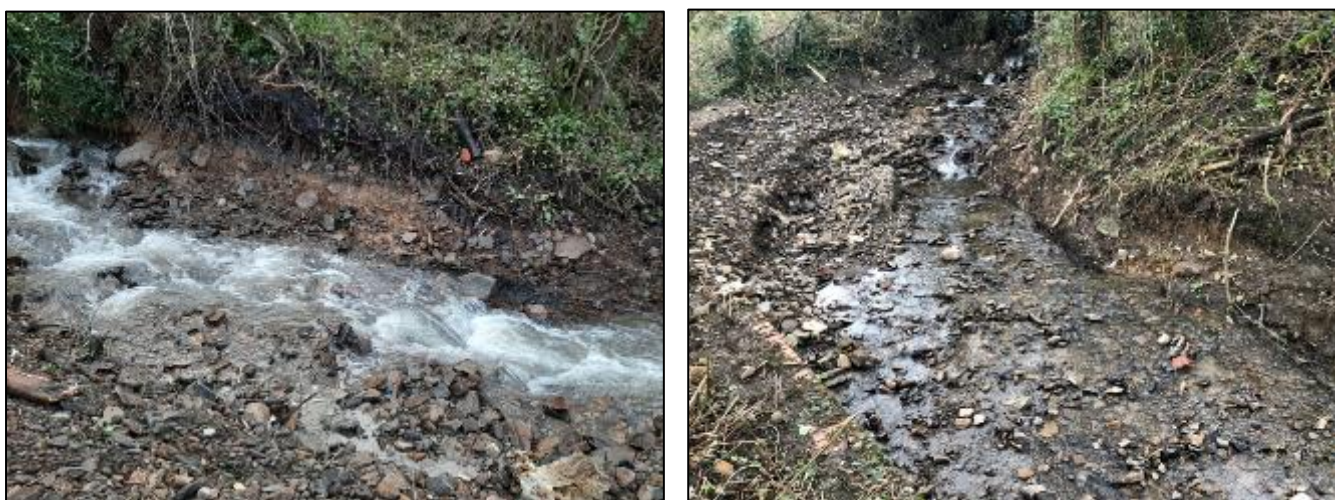
**Figure 34:** Evidence of embankment erosion (left) and deposition of material (right) within ‘unnamed ordinary watercourse 3’ upstream of ‘Culvert Inlet 6’ (captured by RCT officers on 29<sup>th</sup> February 2020)

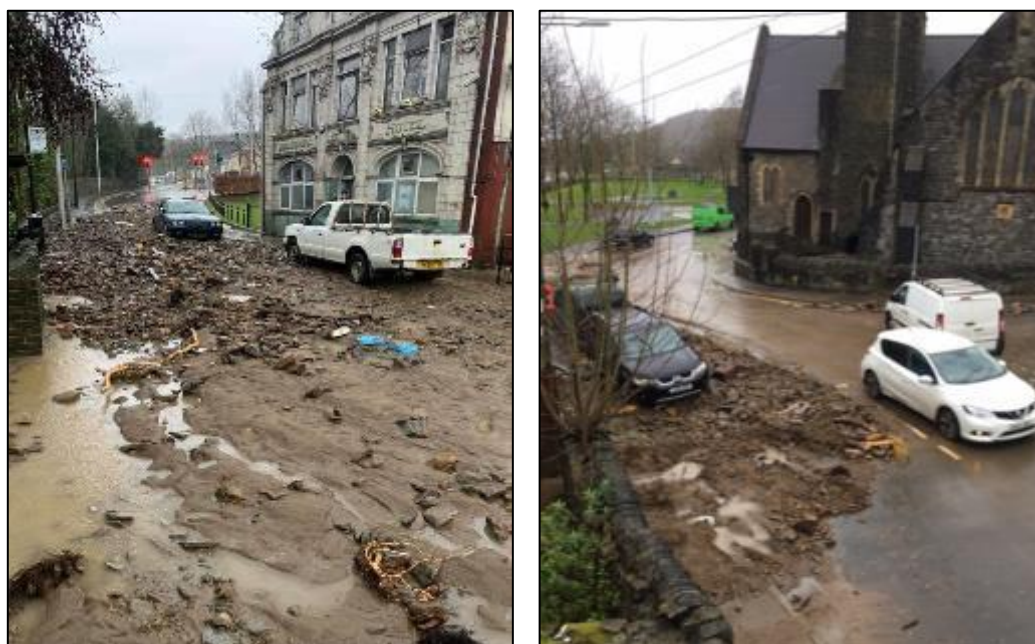
**Figure 40:** Evidence of debris deposited onto Ffrwd Crescent (left) and Campbell Terrace (right) as a result of 'Culvert Inlet 1' associated to the Nant y Ffrwd watercourse surcharging during Storm Dennis (captured by RCT officers during the storm event)

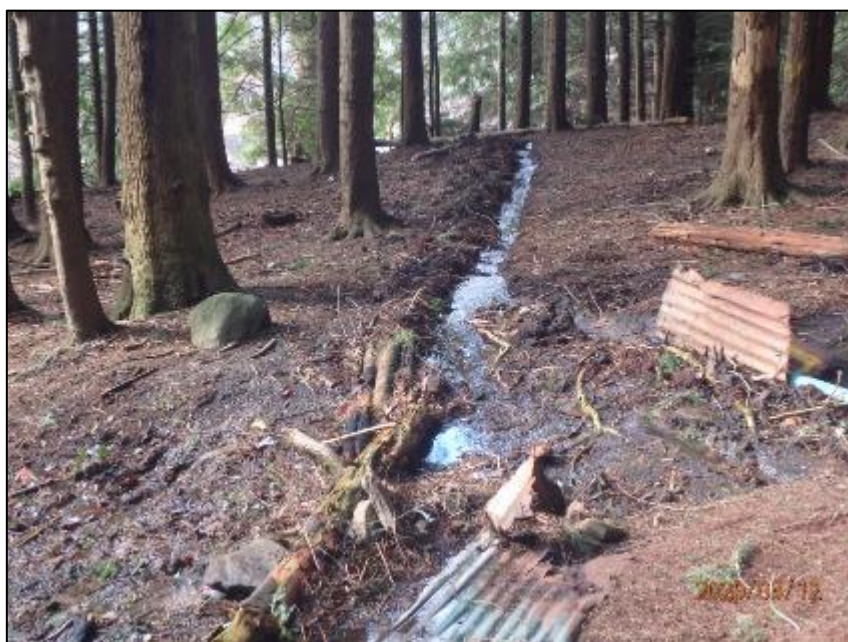
**Figure 42:** Photo of ordinary watercourse channel identified on land to the rear of Clas-y-Dderwen which is considered to have overtopped during Storm Dennis (captured by RCT's Flood Risk Management team on 12/03/3030)
