# Flood and Water Management Act 2010

## Section 19 Flood Investigation Report

### Storm Dennis – Flood Investigation Area RCT19 (Porth)

June 2022

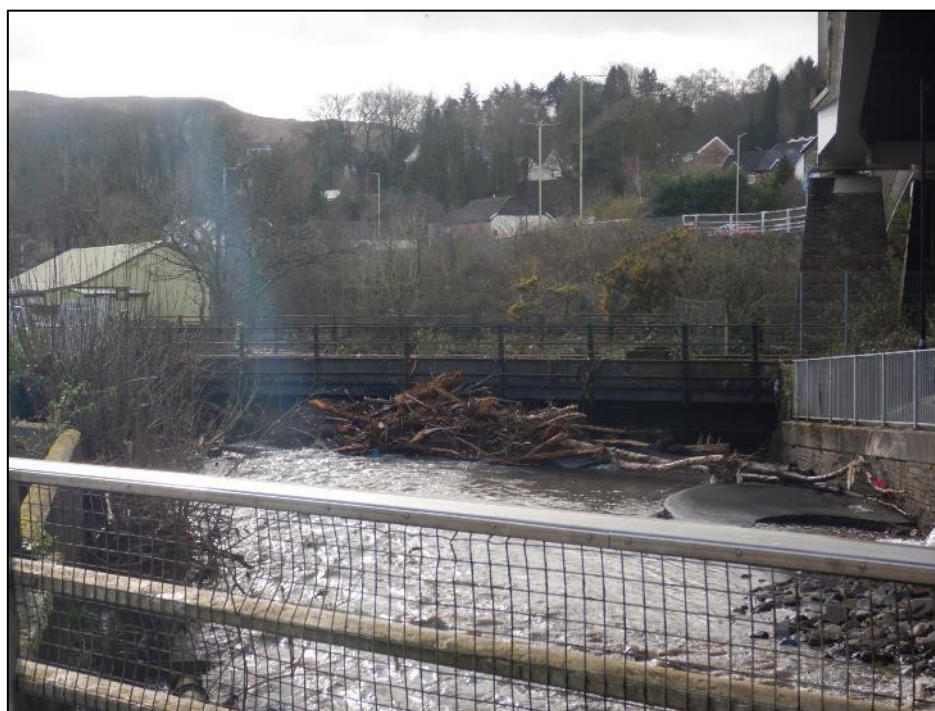
Upon an inspection of the Rhondda Fach River in the days following the storm event, a significant build-up of material was identified within the channel and across the railway bridge adjacent to the B4278 (Rheola Road). Figure 3 depicts the accumulation of material, inclusive of large woody debris, which is considered to have been mobilised by the fast-flowing water during the storm event, causing an impediment of flow at the railway bridge, resulting in water levels within the Rhondda Fach River to rise quickly behind the obstruction and overtopping onto the adjacent embankments.

**Figure 3:** Image of obstruction at Rhondda Fach railway bridge (captured by RCT's Flood Risk Management team on 17<sup>th</sup> February 2020)

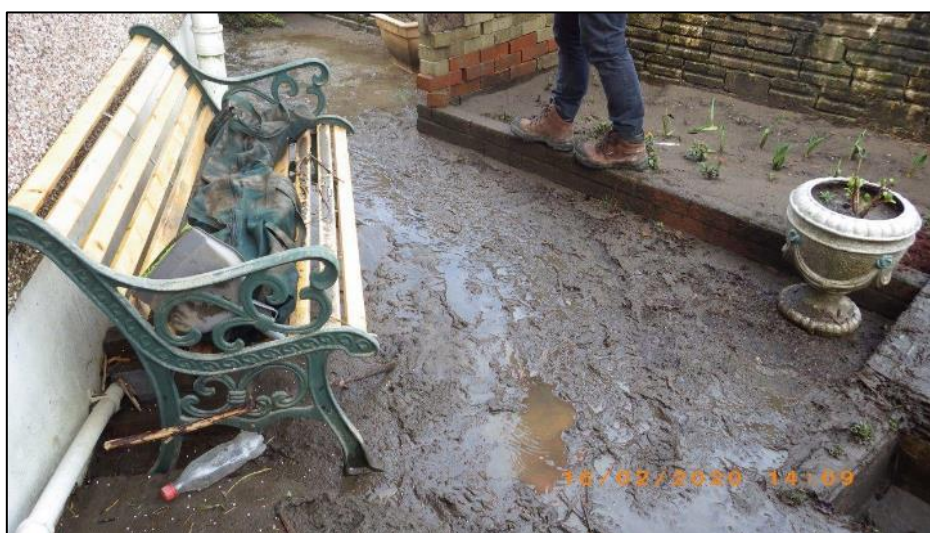
The River Rhondda was also identified to have overtopped at Eirw Uchaf bridge. Two non-residential properties on the northern embankment, adjacent to the main river, were flooded as a result of the overtopping. On the southern embankment, the River Rhondda overtopped the rear retaining walls of several properties at Eirw Road, resulting in internal flooding to 9 residential properties, with flood depths of up to 1.5 metres reported by residents. Figure 4 depicts the mud and silt deposited in the rear gardens of properties at Eirw Road as a result of the overtopping.

**Figure 4:** Image of debris material at a property on Eirw Road (image captured by a DCWW Officer on 16<sup>th</sup> February 2020)

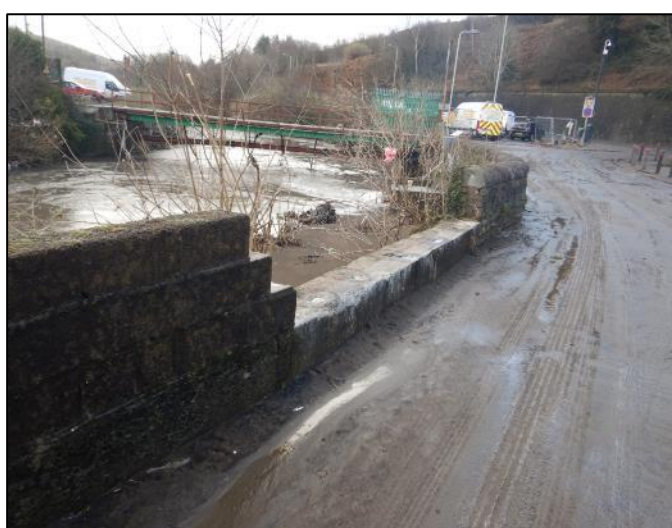
**Figure 5:** 8-metre-long section of collapsed retaining wall (NFD Structure) adjacent to the River Rhondda at Brook Street (image captured by RCT officers on 17<sup>th</sup> February 2020)

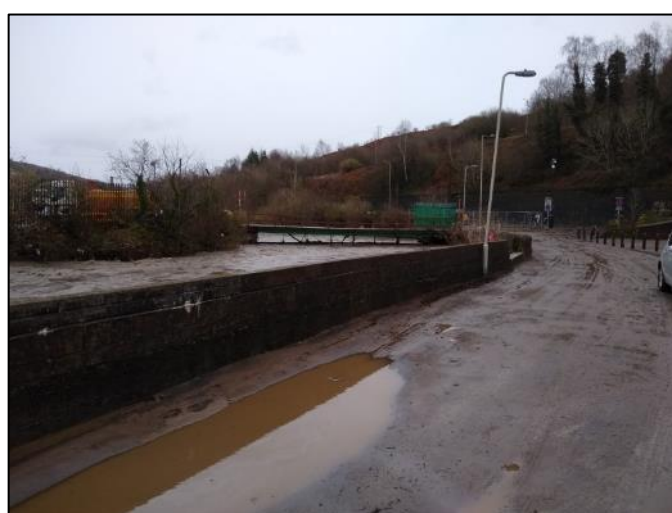
**Figure 6:** Evidence of riverine mud and silt at Brook Street following the overtopping of the River Rhondda during Storm Dennis (image provided by resident and captured on 16<sup>th</sup> February 2020)

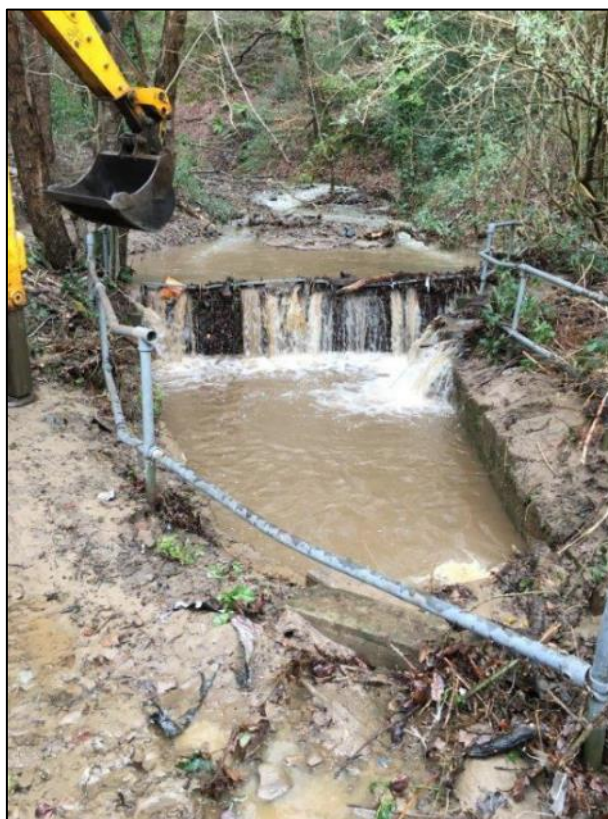
down the hillside. Figure 8 depicts the condition of 'Culvert Inlet 1' during emergency clearance works on 16<sup>th</sup> February 2020. Significant accumulation of debris behind the debris screen and silt deposits within the surrounding area was evident during post event inspections.

**Figure 8:** Post event condition of 'Culvert Inlet 1' which surcharged during Storm Dennis (image captured by RCT's Highway and Streetcare Depot on 16<sup>th</sup> February 2020)

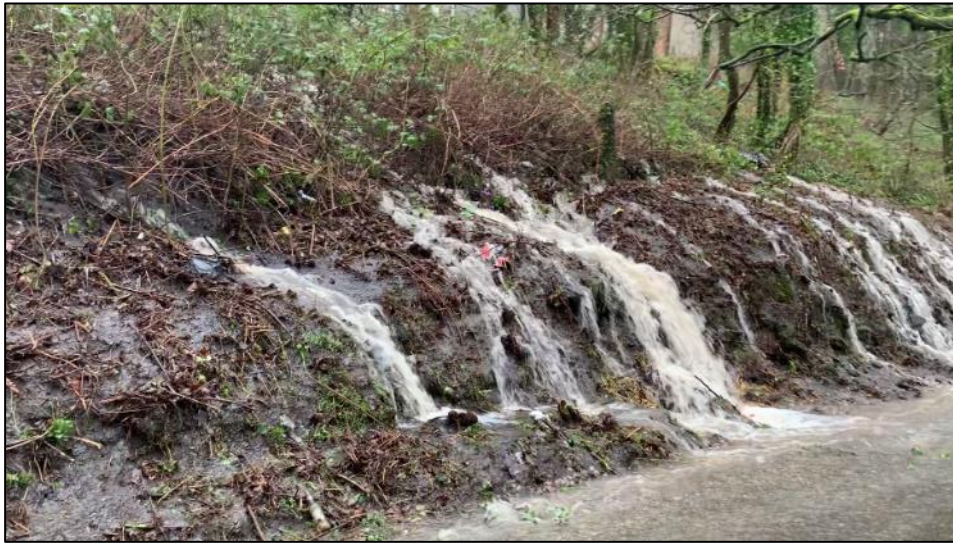
On its course of flow, water overtopped the kerb line at Leslie Terrace and travelled overland down the hillside towards the rear of Llwyncelyn Industrial Estate (Figure 9). Exceedance flows also conveyed along a path leading from Leslie Terrace which runs behind the commercial units at Llwyncelyn Industrial Estate (Figure 10). As a result of the flow paths, water conveyed towards the rear of 4 commercial units within the industrial estate and accumulated within the confined areas surrounding the property thresholds (Figure 11).

**Figure 9:** Overland flow travelling down the hillside from Leslie Terrace and conveying towards the rear of Llwynceilyn Industrial Estate during the storm event (image provided by business owner)

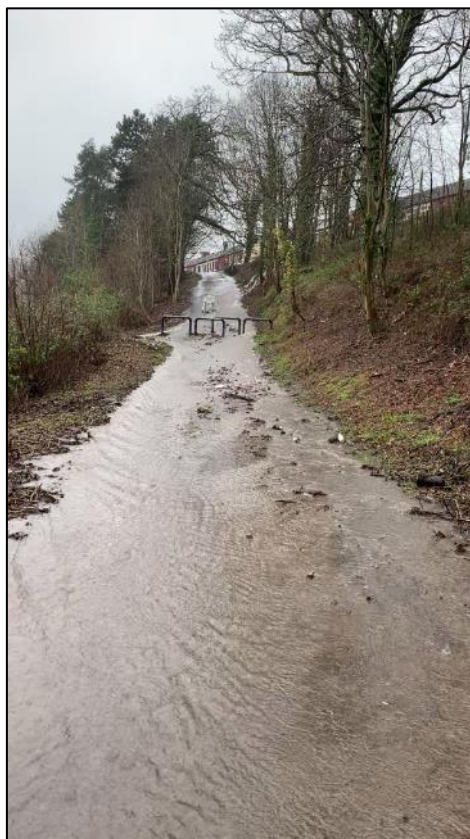
**Figure 10:** Flow path of water along path leading from Leslie Terrace towards the rear of Llwynceilyn Industrial Estate (image provided by business owner)

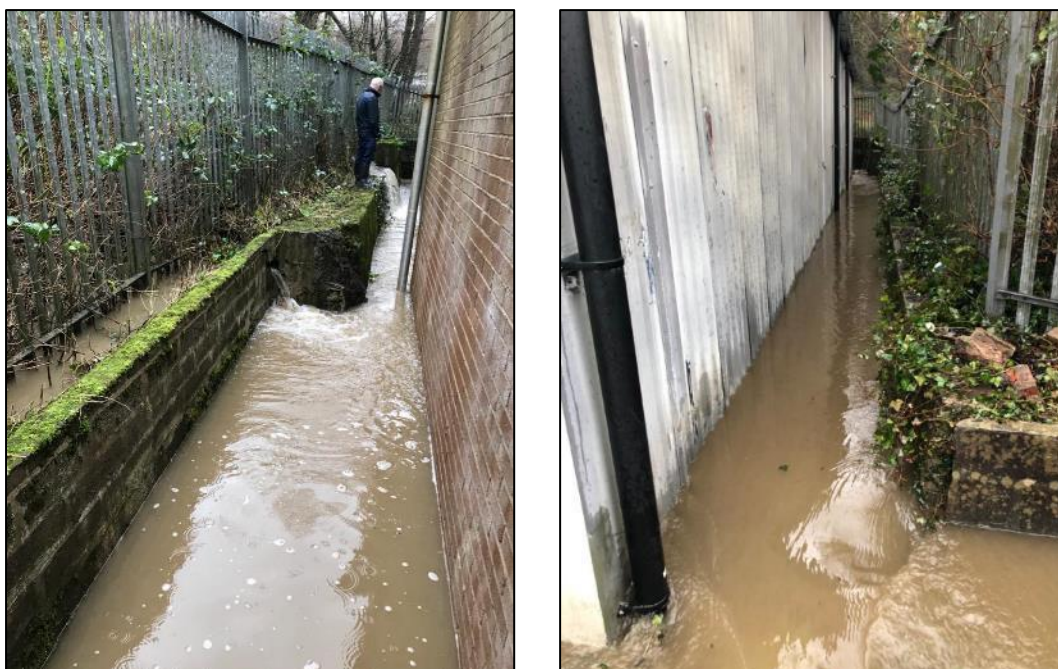
**Figure 11:** Ordinary watercourse and surface water flows causing external flooding to the rear of commercial units at Llwynycelyn Industrial Estate during Storm Dennis (image provided by business owner)

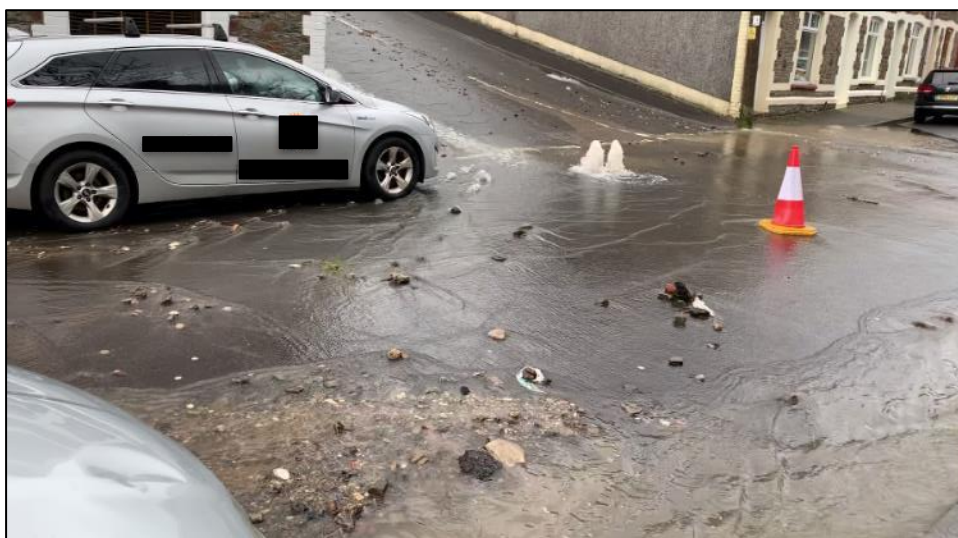
In addition to flows originating from 'Culvert Inlet 1', a surcharging surface water manhole at Leslie Terrace (labelled 'Manhole 1', Figure 7) was also reported by property owners. Video footage provided by residents show evidence of 'Manhole 1' surcharging during the storm event and contributing surface water flows towards the rear of Llwynycelyn Industrial Estate (Figure 12).

**Figure 12:** Evidence of 'Manhole 1' surcharging at Leslie Terrace during Storm Dennis (image provided by business owner)

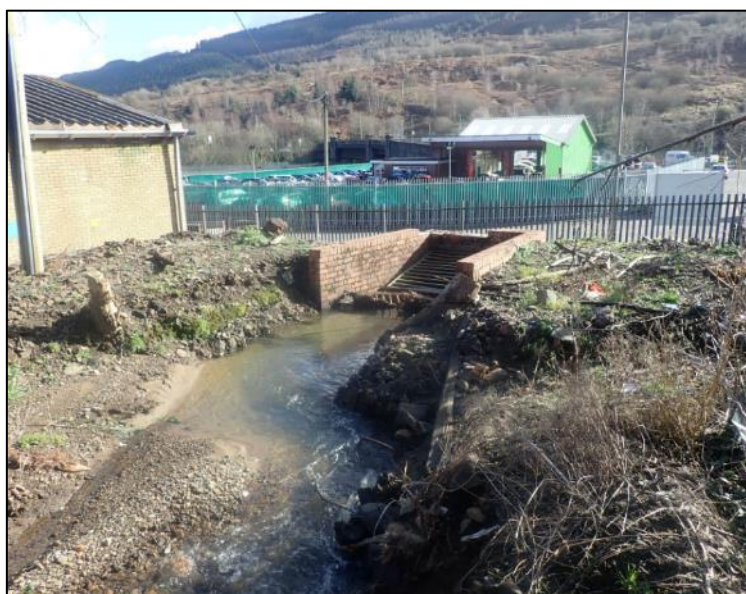
Upon post event inspections, a second culvert inlet, labelled 'Culvert Inlet 2' (Figure 7) was also identified as showing evidence of surcharge. Figure 13 depicts the condition of 'Culvert Inlet 2' post Storm Dennis, with debris noted along the embankments, indicative of the exceedance flows.

**Figure 13:** Post event condition of 'Culvert Inlet 2' which was identified as a source of flooding during Storm Dennis (image provided by business owner)

'Culvert Inlet 2' consists of a 1.5 metre diameter concrete pipe and is identified as a privately owned asset. The inlet debris screen was identified to be in poor condition during post event inspections however, no significant obstructions were identified.

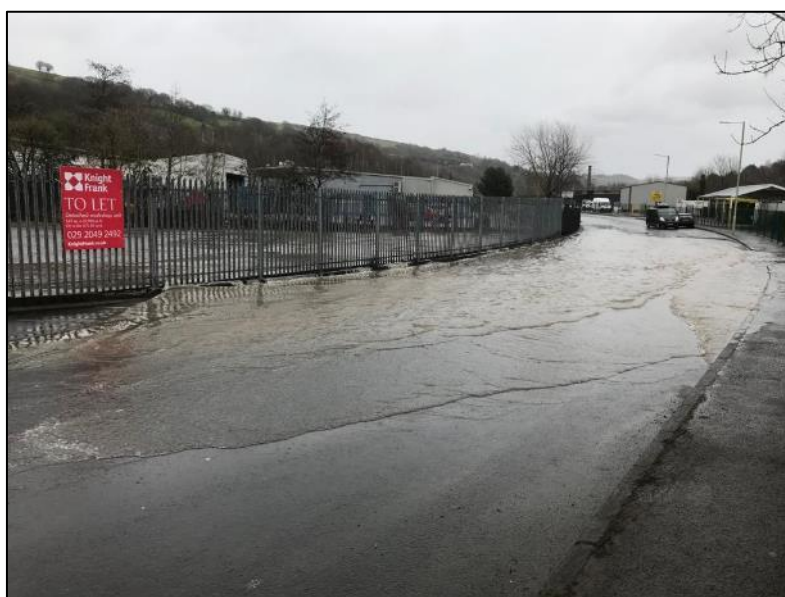
Exceedance flows from 'Culvert Inlet 2' conveyed south towards the B4278 (Llwynceilyn Road), contributing to the flow path from 'Culvert Inlet 1' and 'Manhole 1'. Flood water from the surcharging infrastructure conveyed towards the fronts of properties within the industrial estate and accumulated along the B4278 (Llwynceilyn Road). Internal flood depths of up to 30 centimeres were reported at the impacted commercial properties. Figure 14 depicts surface water accumulation along the B4278 (Llwynceilyn Road) as a result of the surcharging inlets. Internal flood depths of up to 30 centimeres were reported at the impacted commercial properties.

**Figure 14:** Image of ordinary watercourse and surface water flooding along the B4278 (Llwyncelyn Road) during Storm Dennis (image provided by a resident)

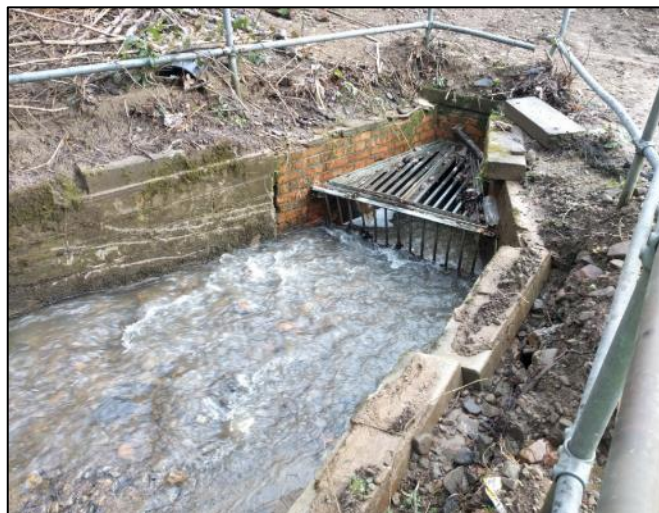
'Culvert Inlet 1' consists of a 0.45 metre wide and 0.6 metre high concrete box culvert with two debris screens bolted to the structure (Figure 16). The inlet is identified as a privately owned asset.

**Figure 16:** Image of 'Culvert Inlet 1' captured by RCT's Flood Risk Management team post event

'Culvert Inlet 1' was identified by first responders as being partially blocked with debris mobilised from the hillside. This debris consisted primarily of natural scour material and small woody detritus which was identified to be obstructing the full width of the upstream debris screen (Figure 8). Both debris screens were identified to be in poor condition, indicating damages caused by mobilised debris occurred during the storm event.

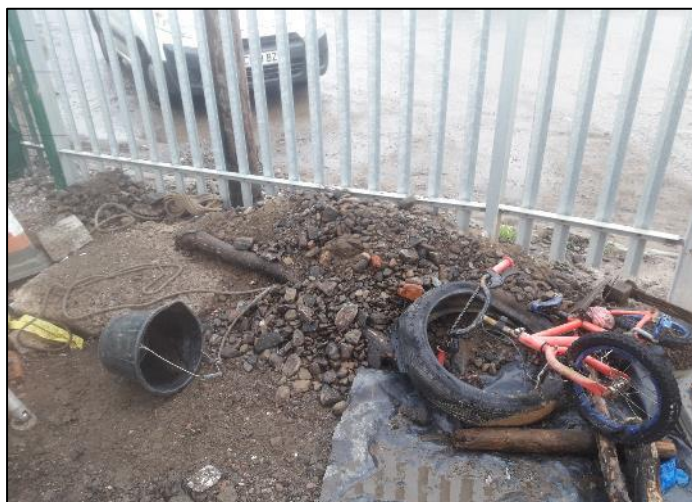
The CCTV survey identified several minor structural defects within the culvert network, in addition to significant obstructions and settled debris downstream of 'Culvert Inlet 2'. Notably, a full-bore blockage was identified downstream of 'Culvert Inlet 2'. Figure 17 depicts the material removed from the culvert network during post event clearance operations. The material consists of natural scour material, in addition to tyres and a children's bicycle, indicative of fly tipping material. The evidence suggests that a majority of the identified material was present in the network prior to the storm event.

**Figure 17:** Material removed from the Nant Llwynceilyn culvert network downstream of 'Culvert Inlet 2' during cleansing operations

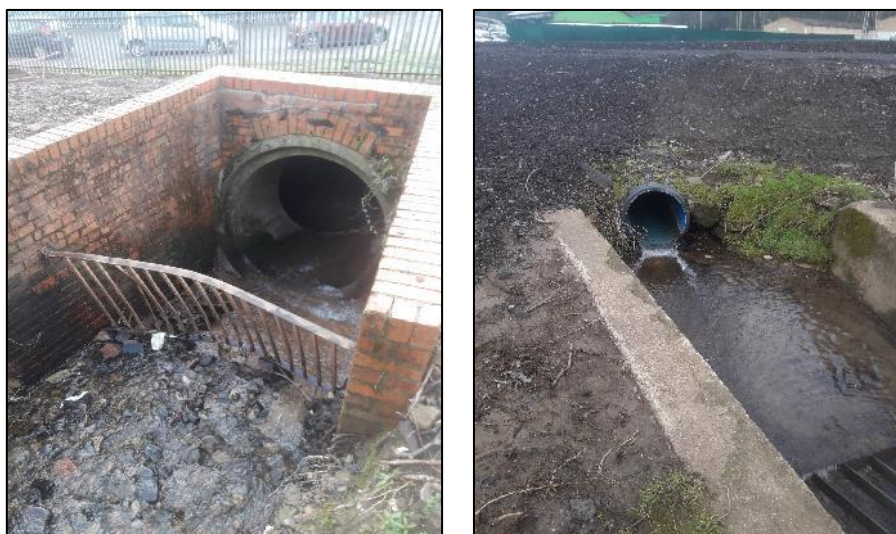
The survey also shows the culvert network downstream of 'Culvert Inlet 2' to change from a circular 1.5 metre diameter concrete section (Figure 18, left) to a circular polyvinyl chloride 600 mm diameter section near to the outfall (Figure 18, right). The significant reduction in culvert pipe diameter suggests that material entering the network at 'Culvert Inlet 2' would have become obstructed at the point of diameter change due to a reduction in capacity.

**Figure 18:** 'Culvert Inlet 2' consisting of a large 1.5 metre diameter concrete pipe (left) and the downstream outlet consisting of a 600mm diameter plastic pipe (captured by external surveying team post event)

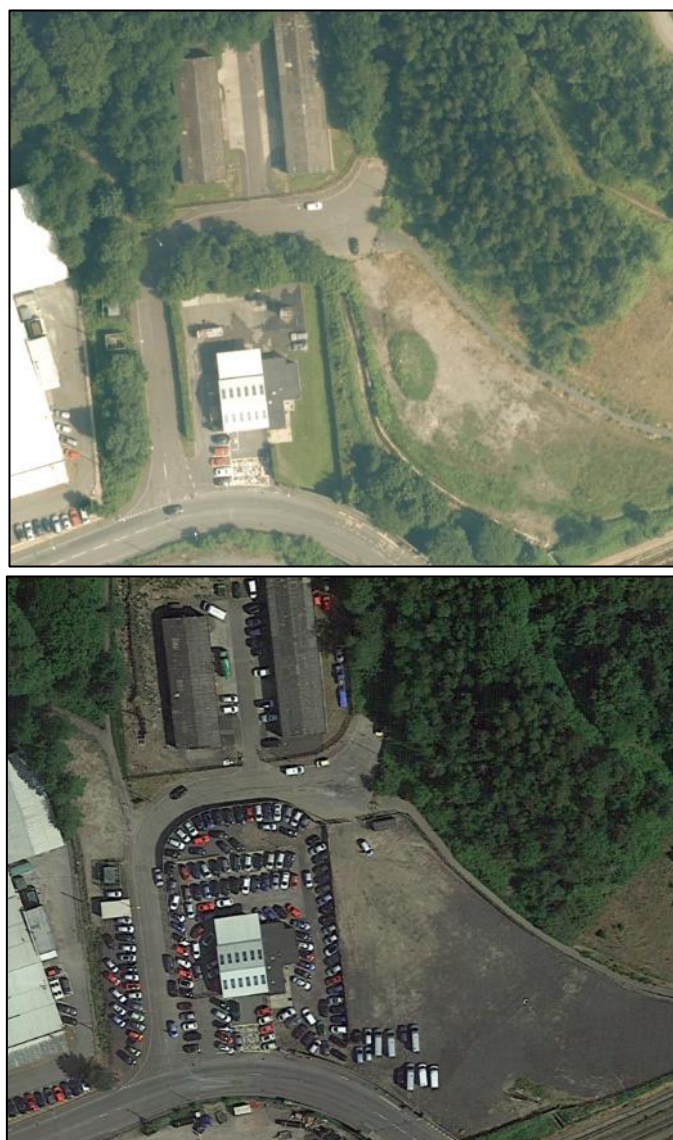
Figure 19 depicts the change in land use at Llwyncelyn Industrial Estate between 2014 and 2020. It can be observed that in 2014 the section of unconsented culvert network downstream of 'Culvert Inlet 2' was originally an open ordinary watercourse channel.

**Figure 19:** Aerial view of Llwynceilyn Industrial Estate in 2014 (top) and in 2020 (bottom)

In response to the identified unconsented culvert section, the Land Drainage Authority regulated the unconsented culvert network, which led to the serving of a Notice under Section 24 of the Land Drainage Act 1991. Following which the landowner set out a proposal to rectify the unconsented works with an appropriately sized culvert barrel that was subject to approval under section 23 of the LDA 1991.

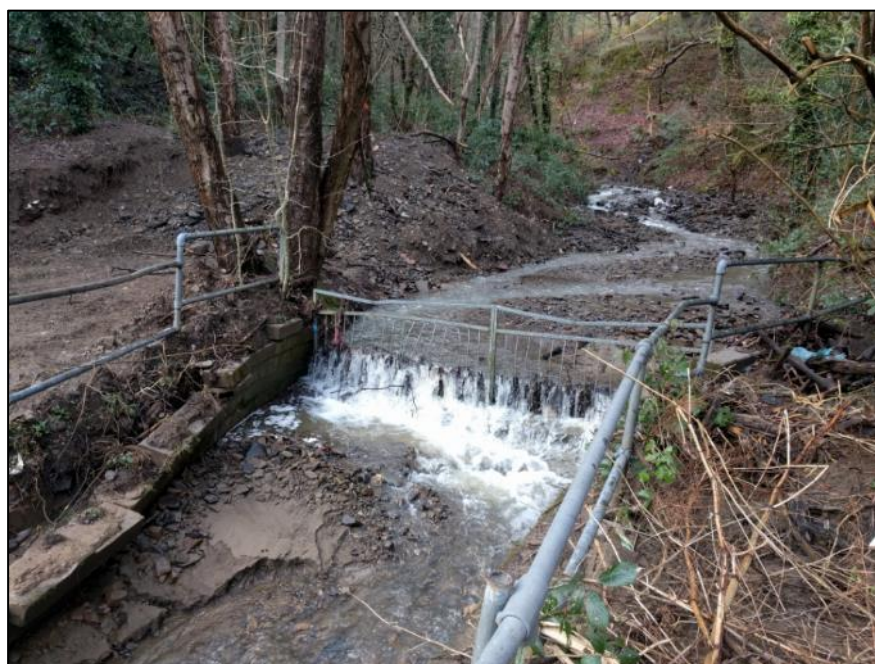
On review of the Nant Llwynceilyn upstream of 'Culvert Inlet 1', several indications of scour across the hillside were observed. The evidence suggests that intense rainfall and resultant surface water and ordinary watercourse flows caused severe erosion of the natural channels, leading to a significant displacement of debris, and sediment transportation within the watercourse itself, which conveyed towards 'Culvert Inlet 1' during the storm event.

Figure 21 shows a significant volume of natural scour material consisting primarily of stone and silt within the ordinary watercourse channel and embankments, indicative of the fast flowing water travelling towards the inlet during Storm Dennis.

**Figure 21:** Upstream view of the Nant Llwynceilyn ordinary watercourse channel (captured by RCT's Flood Risk management team post Storm Dennis)

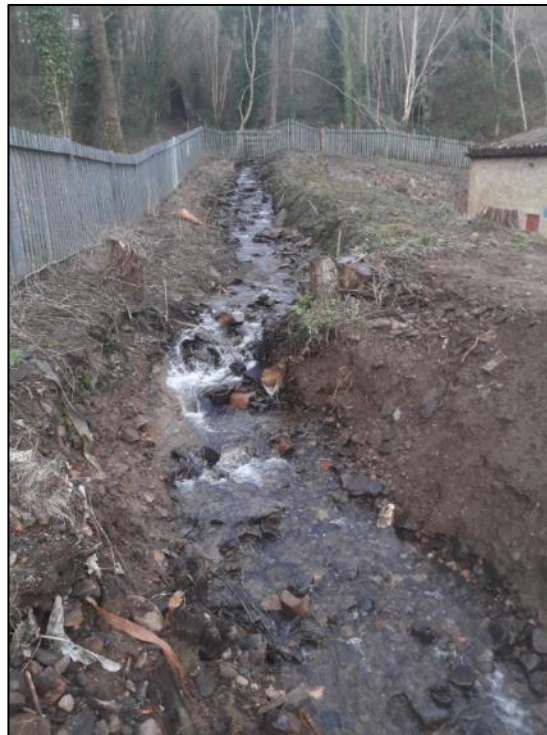
The condition of the Nant Llwynceilyn channel upstream of 'Culvert Inlet 2' was also assessed post event. Figure 22, captured during CCTV surveying operations in March 2020, identifies the watercourse as heavily eroded with evidence of embankment scour exposing bare soil. Natural scour material is also identified along the channel length, indicative of the entrainment of material downstream during the storm event.

**Figure 22:** Nant Llwynceilyn ordinary watercourse upstream of 'Culvert Inlet 2' within Llwynceilyn Industrial Estate (captured during CCTV survey operations post Storm Dennis)

It is considered that the displacement of debris from the upstream open watercourse channel above 'Culvert Inlet 1' contributed to the material observed within the channel upstream of 'Culvert Inlet 2'. This material is considered to have entered the culvert network at 'Culvert Inlet 2', contributing to its surcharging during Storm Dennis.

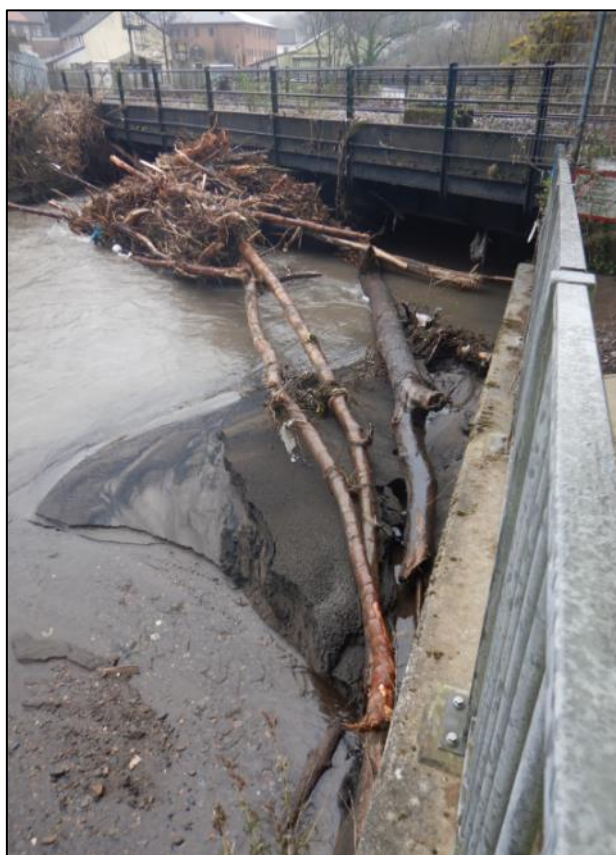
It should be noted that a significant volume of accumulated debris at several bridge structures within RCT19, including at the railway bridge adjacent to the B4278 (Rheola Road) (Figure 27) and at Brook Street bridge, was identified post storm event. The obstruction caused by the accumulated debris is considered to have created a damming effect which contributed to the overtopping of both main rivers upstream of the bridge structures.

**Figure 27:** Accumulated debris within the Rhondda Fach River channel and at Rheola Bridge structure which caused a damming effect to the flow during Storm Dennis (captured by RCT officer on 17<sup>th</sup> February 2020)

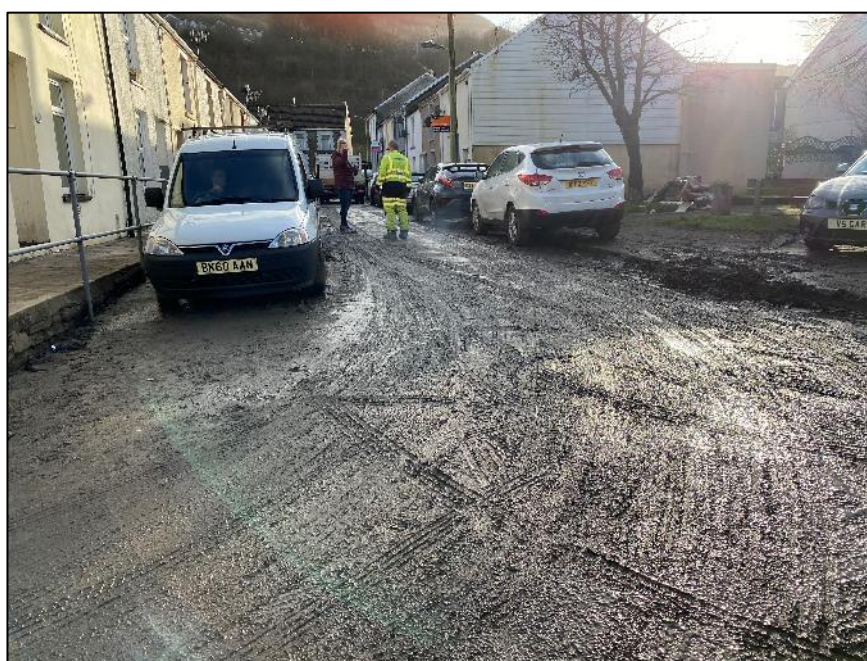
Several streets including Rheola Road, Britannia Street and Brook Street, were observed as flooded during the storm event as a result of the overtopping of the River Rhondda and Rhondda Fach during Storm Dennis. As illustrated in Figure 28, these fluvial flows deposited mud, silt and debris across the investigation area which are assumed to have entered the highway drainage system, leading to blockages and a reduction in the hydraulic capacity of the surface water network.

**Figure 28:** Image of mud, silt and debris deposited onto the highway at Britannia Street as a result of the overtopping of the Rhondda River during Storm Dennis (captured by RCT's Flood Risk Management team on 17<sup>th</sup> February 2020)
