Flood and Water Management Act 2010

Section 19 Flood Investigation Report

Storm Dennis –
Flood Investigation Area RCT20
(Ynyshir)

March 2022

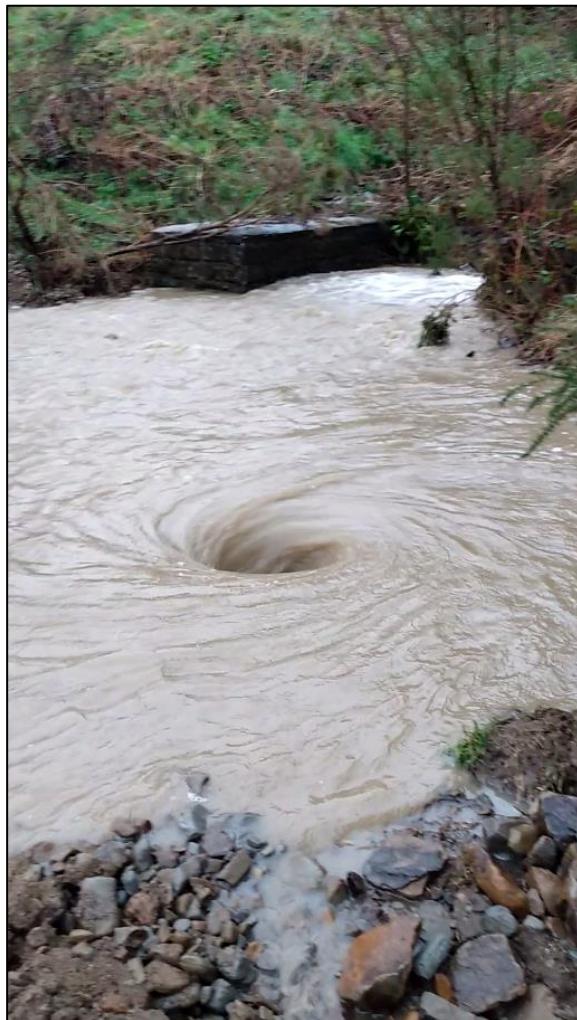
captured by a resident on the 16th February 2020, shows the culvert inlet as fully submerged. The surcharging resulted in the internal flooding of at least four properties, with flood water conveying along the rear access road and entering properties via their rear gardens. Beyond Heath Terrace, flood water carrying mobilised debris conveyed down the adjacent hillside and onto the highway.

Figure 6: Whirlpool above the fully submerged 'Culvert Inlet 2' during Storm Dennis (image provided by resident)

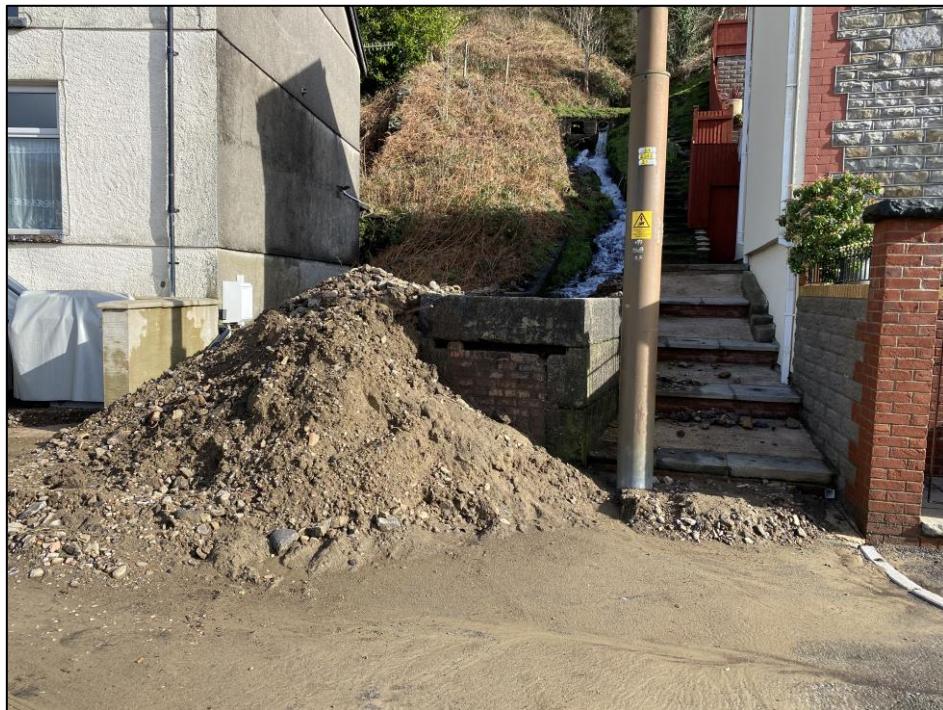
'Culvert Inlet 1' was identified as heavily silted during a site inspection undertaken by RCT's Flood Risk Management team on 17th February 2020, indicating significant mobilisation of scour material occurred during the storm event (Figure 7).

Figure 7: Post storm event photograph of 'Culvert Inlet 1' depicting the displacement of material
(Image captured by a RCT's Flood Risk Management team on 17th February 2020)

Upon an inspection of 'Culvert Inlet 1' post storm event, the structure was identified as heavily silted with significant scour material deposited around the inlet structure, indicating that the inlet had surcharged due to blockage during the storm event (see Figure 7).

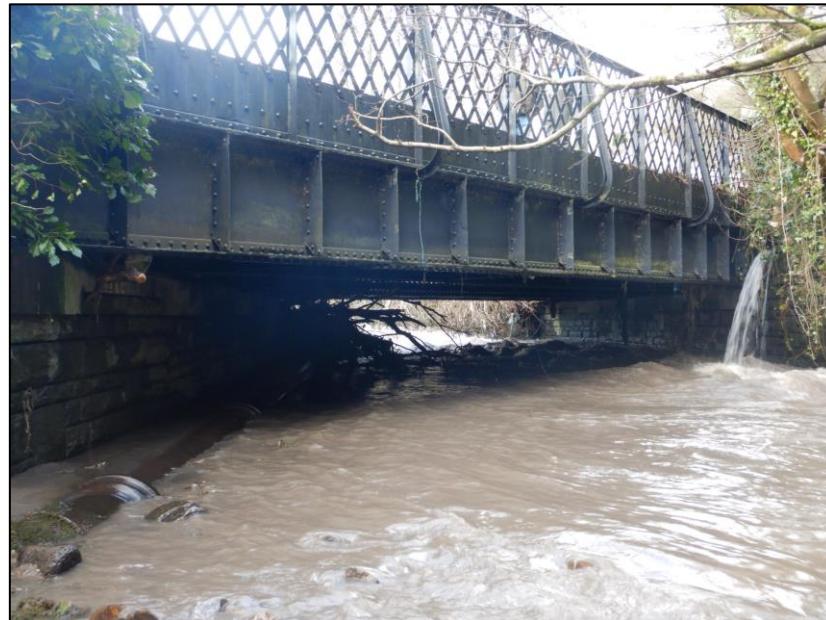
Figure 8: Rhondda Fach River highway bridge connecting Riverside Close and Avon Terrace (Image captured by a RCT Structures officer on 17th February 2020)

This suggests that, whilst unprecedented river levels were recorded in the Rhondda Fach River during Storm Dennis, the primary cause of the overtopping at RCT20 was the obstruction of the river flow caused by woody debris at the highway bridge connecting Avon Terrace and Station Road. This obstruction created a damming effect which resulted in the River Rhondda Fach overtopping its bank upstream.

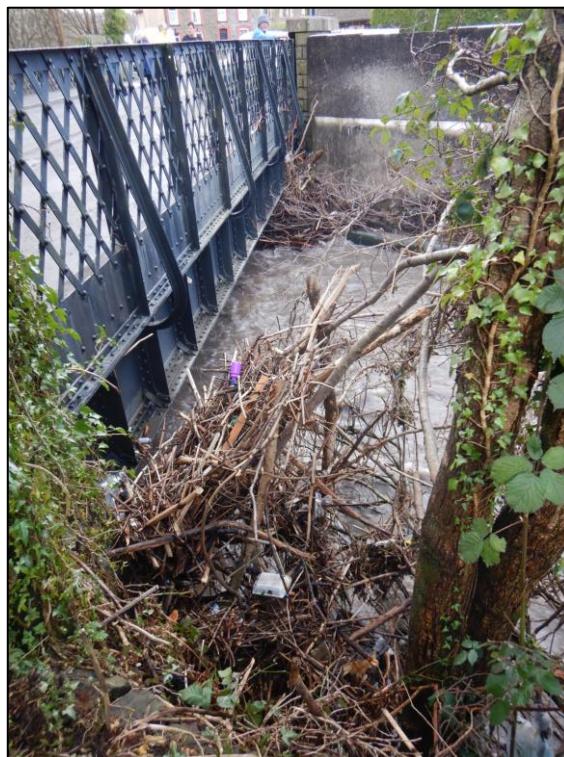
Figure 9: Image capturing accumulated woody debris on the embankment of the Rhondda Fach River behind the highway bridge following Storm Dennis (Image captured by a RCT Structures officer on 17th February 2020)

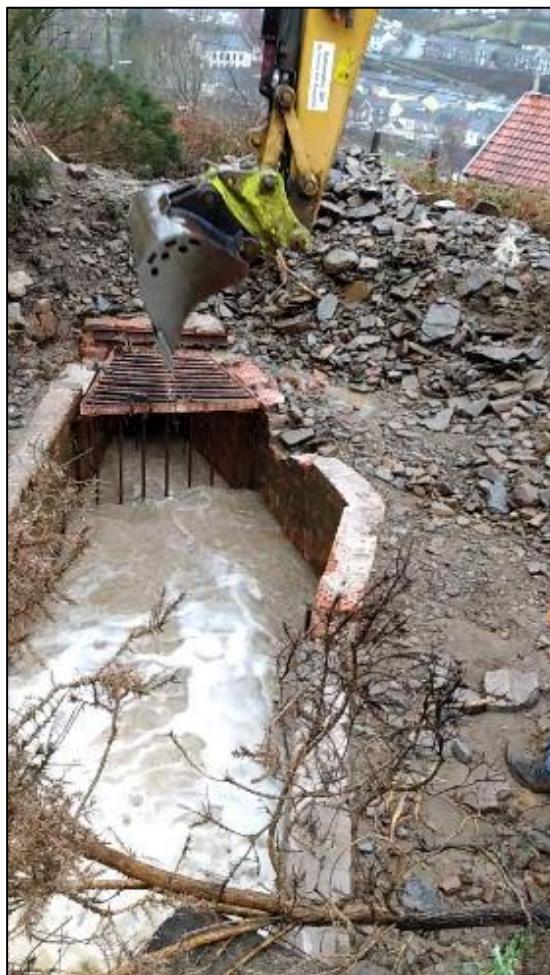
'Culvert Inlet 2' was also identified by first responders as being blocked with a significant volume of debris which mainly consisted of stonewash material mobilised from the hillside. Figure 11 shows emergency clearance works to the culvert inlet carried out by local residents on the 16th February 2020.

Figure 11: 'Culvert Inlet 2' being cleared of debris following Storm Dennis (image provided by resident and captured 16th February 2020)

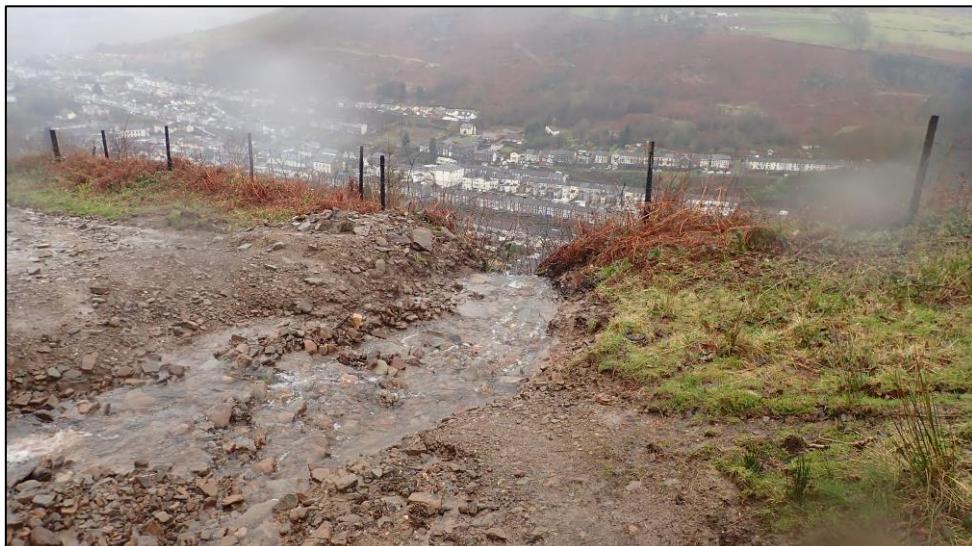
Figure 13: Overland flow travelling across the hillside track towards the hillside upstream of 'Culvert Inlet 1' (captured by RCT's Flood Risk Management team on 19/02/2020)

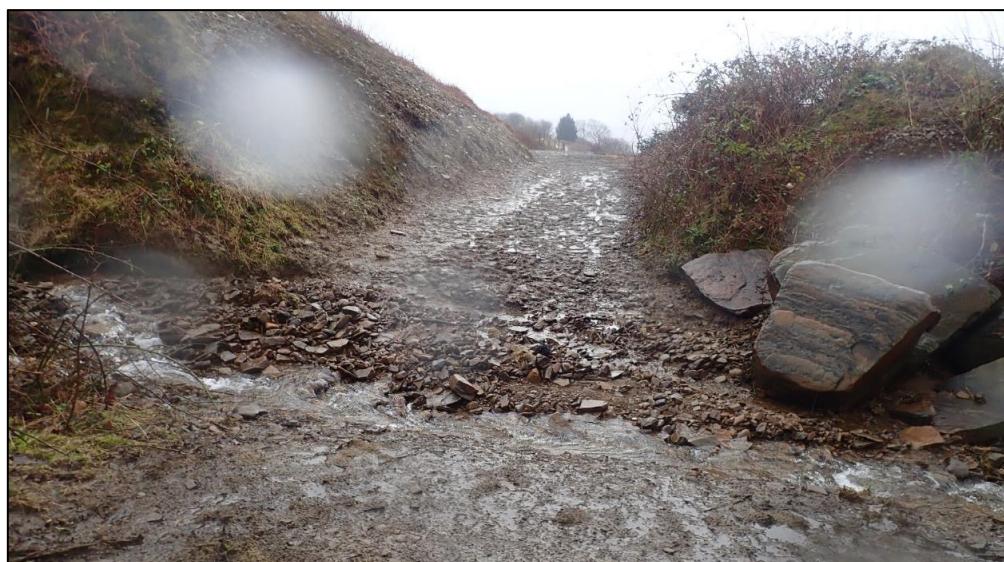
Figure 14: Overland flow and deposition of material across the hillside track above RCT20 (captured by RCT's Flood Risk Management team on 19/02/2020)

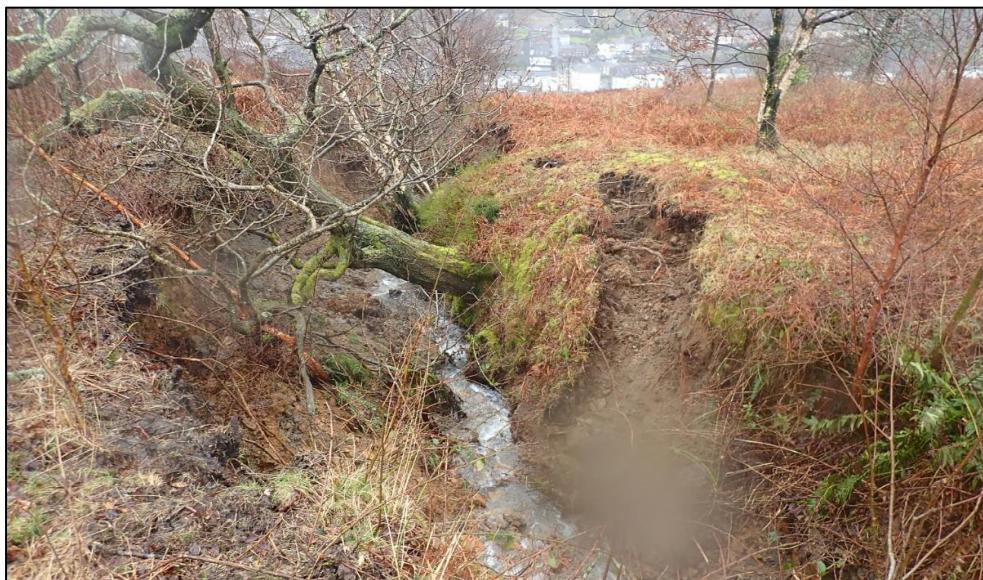
Figure 15: Evidence of eroded embankments within the ordinary watercourse upstream of 'Culvert Inlet 1' (captured by RCT's Flood Risk Management team on 19/02/2020)

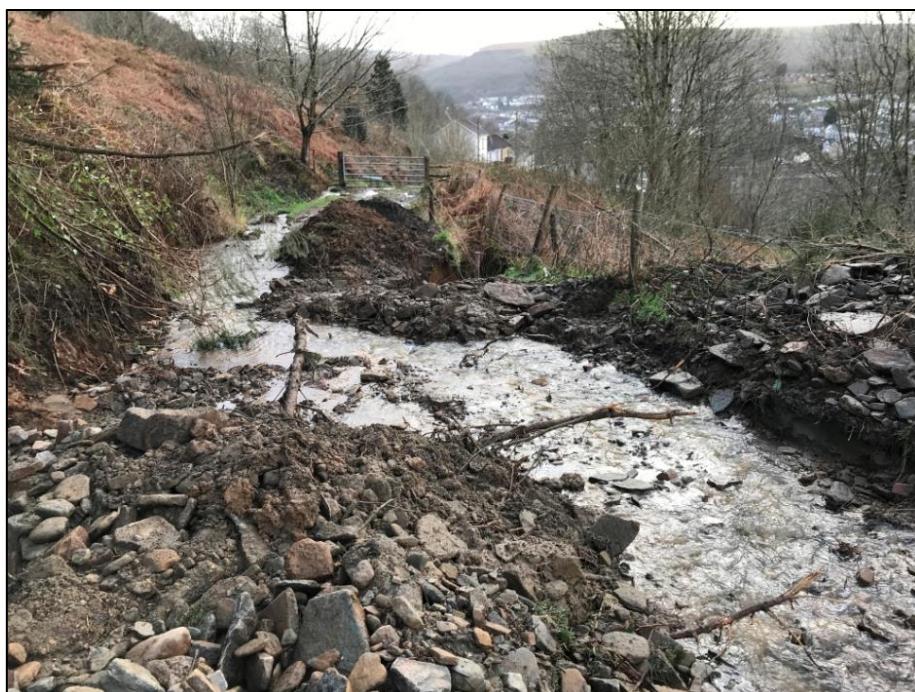
Figure 16: Significant deposition of scoured material along the hillside track above 'Culvert Inlet 2' post Storm Dennis (image provided by resident)

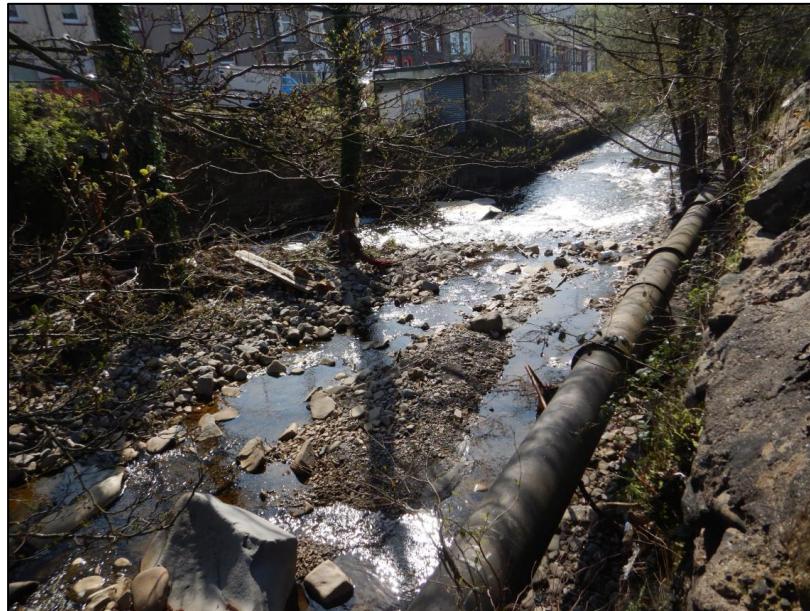
Storm Dennis. Figure 20 identifies deposition of material along the channel bed, inclusive of large stones and smaller sediments, captured during post event inspections of the footbridge upstream of the highway bridge at Avon Terrace. This material is considered to have been influenced by the Tylorstown landslip which occurred during the storm event approximately 3 kilometres upstream of the investigation area and contributed 60,000 tonnes of material towards the valley floor.

Figure 20: Debris accumulation along the channel bed of the Rhondda Fach River upstream of the footbridge between Standard View and Springfield Estate (image captured by RCTs Infrastructure team on 17th February 2020)

It is reasonable to assume that the material identified across the Rhondda Fach riverbed in Figure 20 originated from the landslip however, it is unclear what the condition of the channel bed was pre-Storm Dennis. Although the observed shoaling is not considered to have caused the flooding at RCT20, the entrainment and deposition of debris downstream is indicative of the powerful flows within the Rhondda Fach River during Storm Dennis and is considered to have influenced the water level within the channel, however there is limited evidence to outline this interaction.

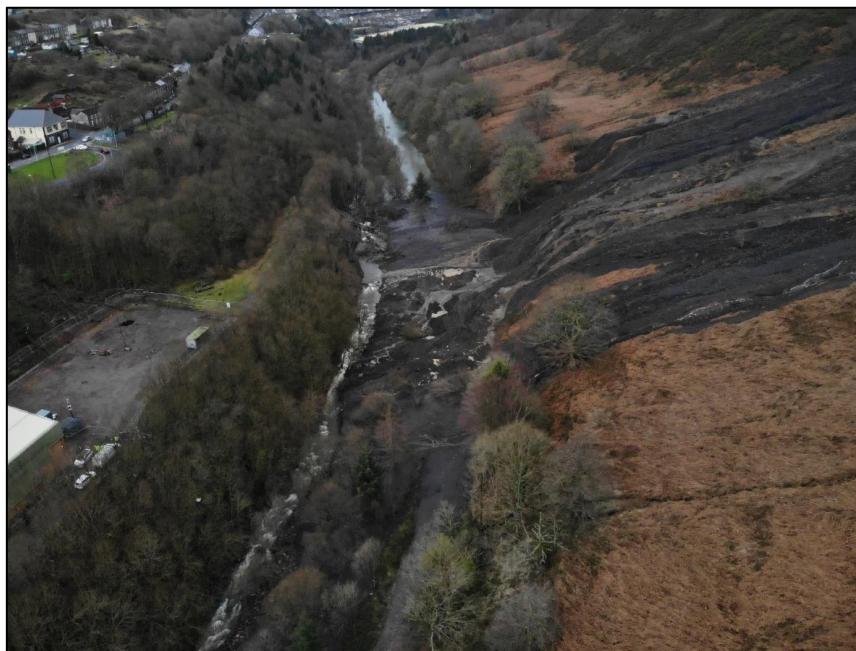
The movement of material at Tylorstown tip was observed to have significantly altered the flow of the Rhondda Fach River. Figure 21 shows how the landslip pushed the flow within the main river to the left, in addition to supplying material into the channel.

Figure 21: Drone image of Tylorstown landslip impacting the flow within the Rhondda Fach River
(image captured by RCTs Infrastructure team on 18th February 2020)

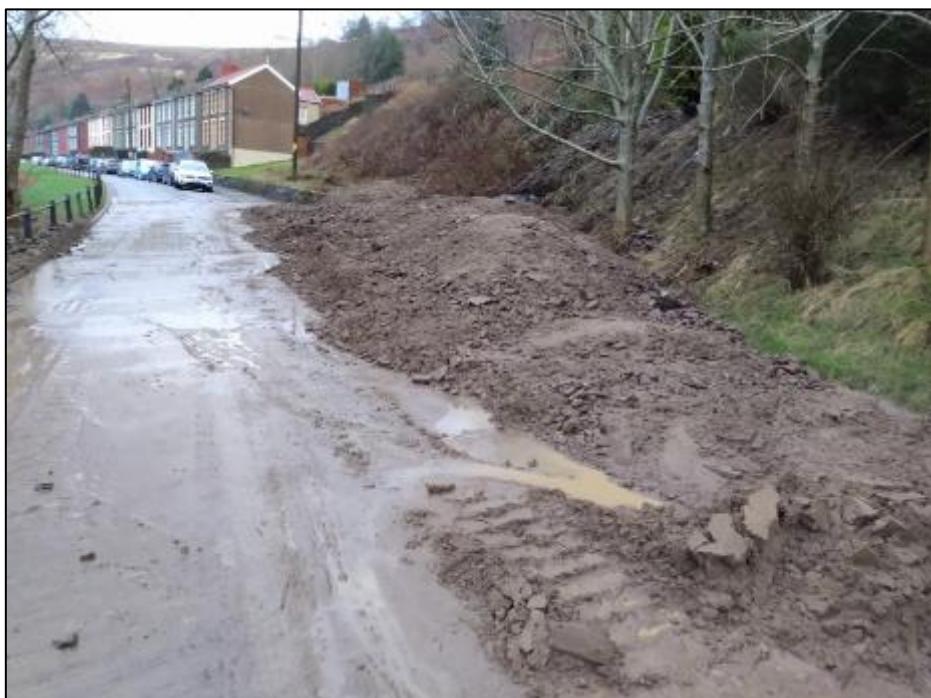
Figure 22: Mud, silt and debris deposited onto the highway at Heath Terrace following the clearance operation of 'Culvert Inlet 2' during Storm Dennis (image provided by resident)

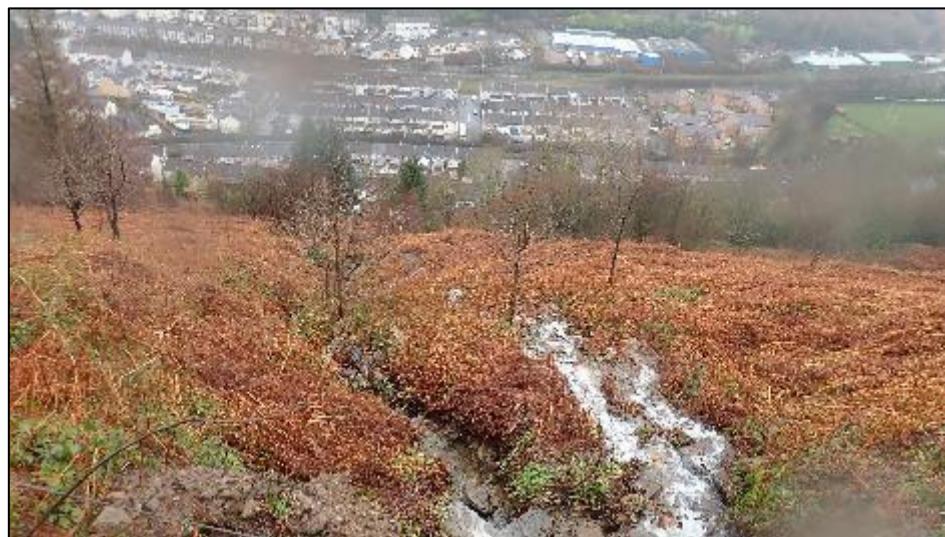
Out-of-bank flows and saturated ground were observed along the hillside in the days following the storm event (Figure 24 and 25). It was evident that in addition to the ordinary watercourse flows conveying down the hillsides above RCT20 during Storm Dennis, significant overland flows had also led to the displacement of natural debris and scour material. This material entered the ordinary watercourse networks across the hillside and was transported downstream towards the culvert inlets above Heath Terrace, contributing to the surcharge of 'Culvert Inlet 1 and 2'.

Figure 24: Overland flows conveying down the hillsides to the east of RCT20 following Storm Dennis
(Image captured by a RCT Flood Risk officer on 19/02/2020)

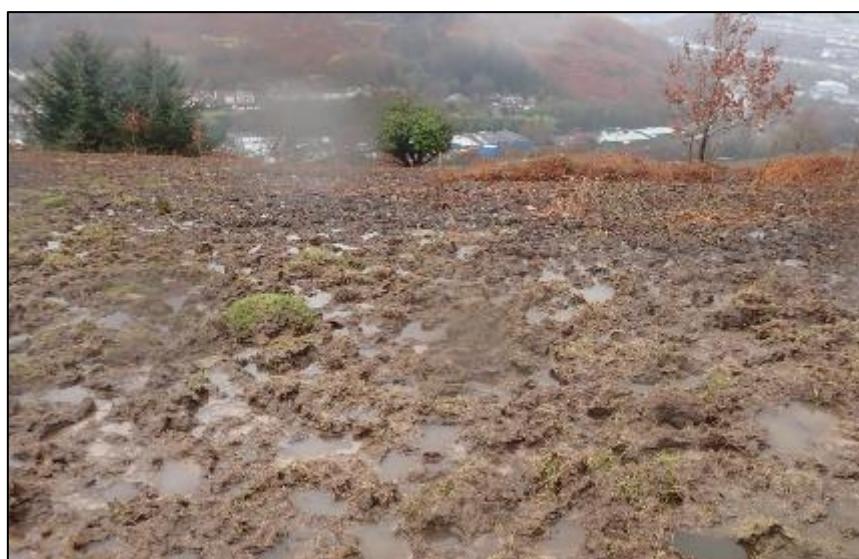
Figure 25: Saturated ground along the hillside above RCT20 post storm event (Image captured by a RCT Flood Risk officer on 19/02/2020)

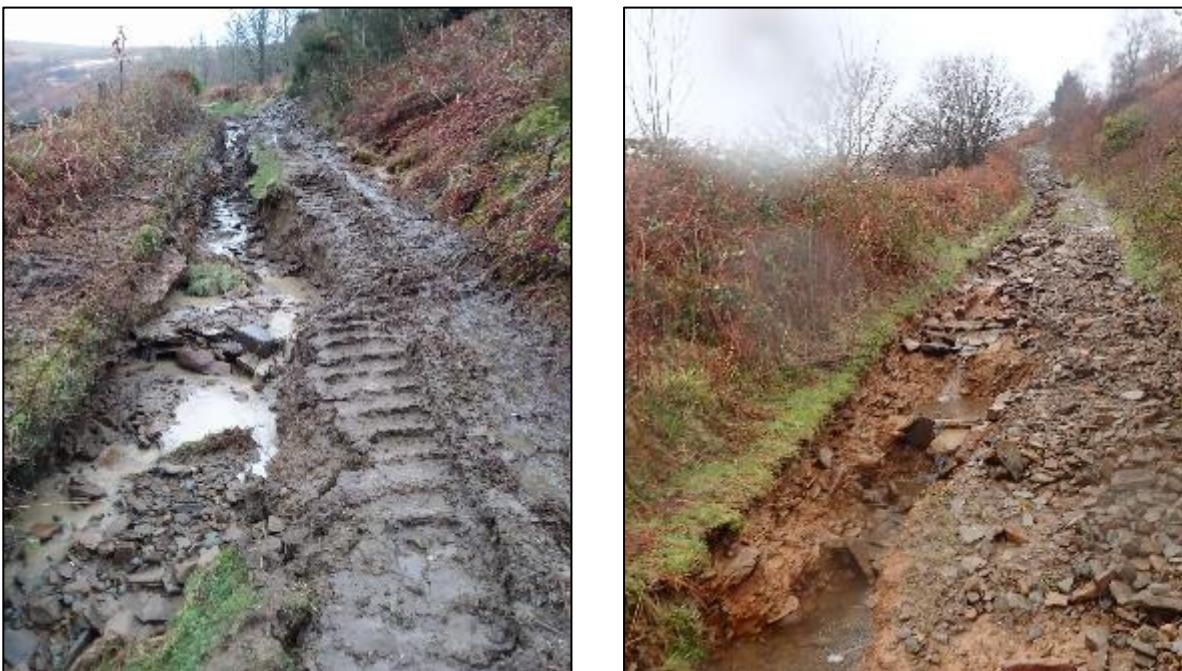
The conveyance of surface water and associated mobilisation of natural debris on bridleways within land above RCT20 was also observed to have caused minor, localised landslips, resulting in further displacement of material (Figure 26).

Figure 26: Displaced material on bridleways along the hillsides east of RCT20 following minor landslips during Storm Dennis (Image captured by a RCT Flood Risk officer on 19/02/2020)
