Section 19 Flood Investigation Report

Flood Investigation Area RCT21
(Blaenllechau & Ferndale)

October 2022

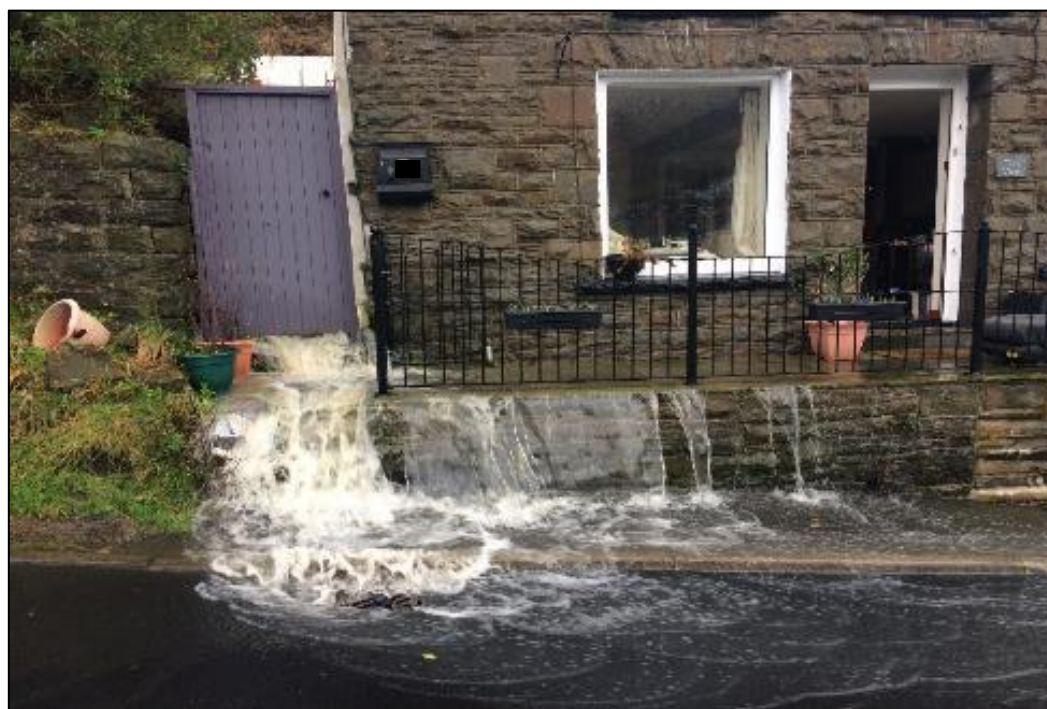
Anecdotal accounts provided by residents of Aberdare Road note that the flood water was observed to originate from a junction of a recently constructed retaining wall and an old stone retaining wall adjacent to a property at Aberdare Road. This flow path resulted in internal flooding to three residential properties at Aberdare Road.

Figure 3 depicts the flow of water discharging from beneath the side garden gate of a property at Aberdare Road and onwards towards the lower reaches of RCT21. Video evidence provided by residents identify water as penetrating through the old stone retaining wall which would suggest that the source of flooding was originating from underground as groundwater.

Figure 3: Pathway of flooding conveying from the side of a property at Aberdare Road and flowing down the steep road during Storm Dennis (image provided by resident)

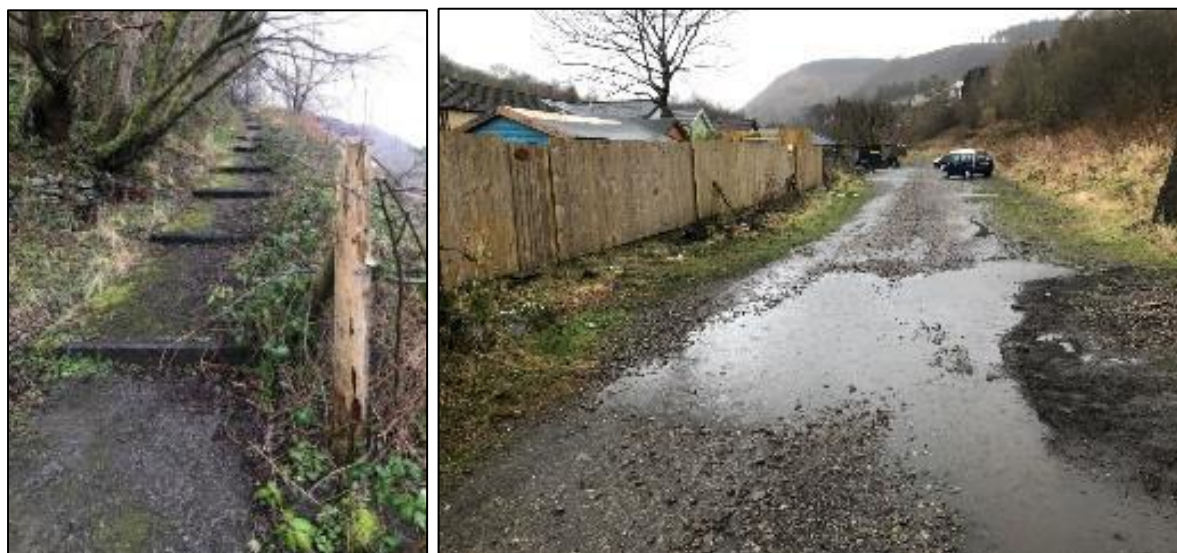
Commercial Street and onwards to Station Road. This flow path also impacted the Taff Street area whereby flood water continued to travel downhill towards lower ground. Figure 4 depicts the steps and path that the water followed, causing surface water to accumulate at the rear lane behind Taff Street properties which resulted in internal flooding to at least one residential property.

Figure 4: Post Event: Steps and path to the rear of Taff Street that the water flowed down during the event (left) and surface water pooling on the lane to the rear of Taff Street (right)

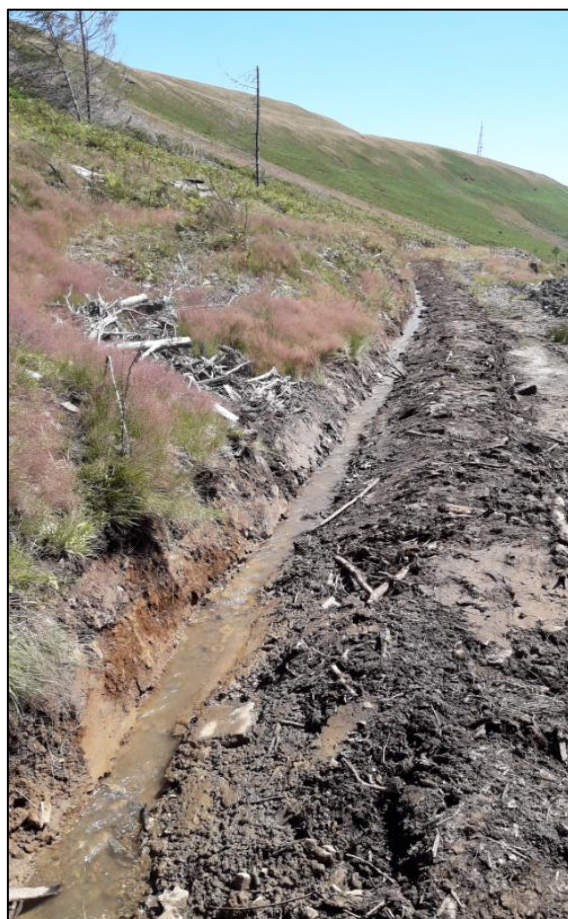
Upon engagement with NRW as land estate manager of the WGWE, it was confirmed that remedial works were undertaken to improve the capacity of the undefined ordinary watercourse / land drainage channel on the topside of the forestry track following Storm Dennis, in August 2020. Figure 7 illustrates the condition of the drainage channel post excavations works.

Figure 7: Image of the undefined ordinary watercourse / land drainage channel on the topside track above Aberdare Road following excavation works carried out by NRW in August 2020

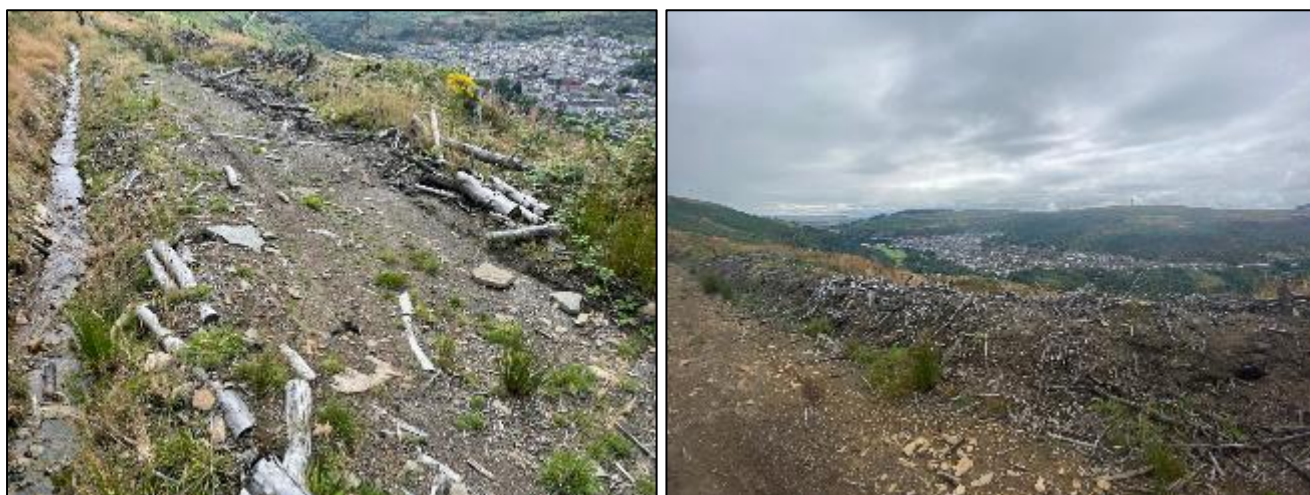
RCT's Flood Risk Management team undertook a site visit following the remedial works and identified evidence of woody material, inclusive of brash, on the eastern side of the track acting as artificial bunds (Figure 8). Evidence of similar woody material was also identified across the hillside above the forestry track. On review of the condition of the undefined land drainage channels it appears that debris had been cleared from the topside track and moved to the side of the track by NRW during post event clearance works

Figure 8: Evidence of woody material piled on the eastern side of the forestry access road, acting as an embankment (captured by RCT officers post NRW clearance works)

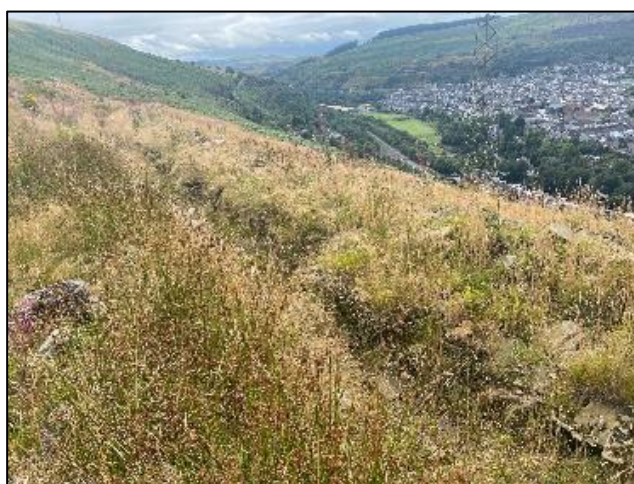
An undefined ordinary watercourse / land drainage channel was also identified below the forestry track (depicted in Figure 8). This ditch typically acts as a cut off feature to channel the overland flows into the adjacent ordinary watercourse, however, it was noted that the channel was heavily vegetated during RCT's site visit (Figure 9).

Figure 9: Drainage ditch identified below the forestry access road upon RCT's site visit

NRW confirmed further clearance works were undertaken in February 2022 to remove the vegetation from the undefined ordinary watercourse channel. It is considered that during the storm event the undefined channel was operating at a reduced capacity to intercept the overland flows coming from the hillside.

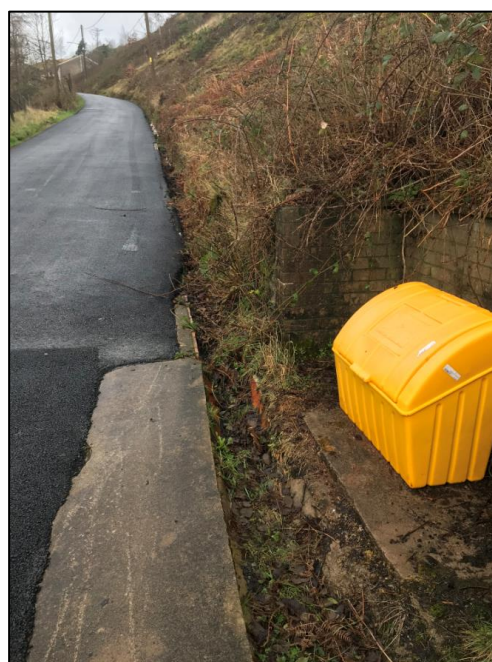
Upon a site inspection of Aberdare Road post storm event, it was reported that the drainage channel which runs adjacent to the highway and discharges into Aberdare Road West culvert network (Figure 5), was operating with little to no flow during the storm event. The highway drainage channel is depicted in Figure 11.

Figure 11: Condition of the highway drainage channel adjacent to Aberdare Road (captured by RCT's Flood Risk Management team on 18th February 2020)

The condition of the highway drainage channel depicted in Figure 11 was observed as heavily vegetated which is considered to have reduced its ability to manage the

surface water flows conveying along the highway from the hillside above Blaenllechau. Despite the poor condition of the highway drainage infrastructure along Aberdare Road limiting the interception of surface water flows during Storm Dennis, it is not considered to have significantly contributed to the primary flooding of properties on Blaenllechau Road and Aberdare Road due to their relative position and lack of opportunity for exceedance flows to reach the rears of these properties.

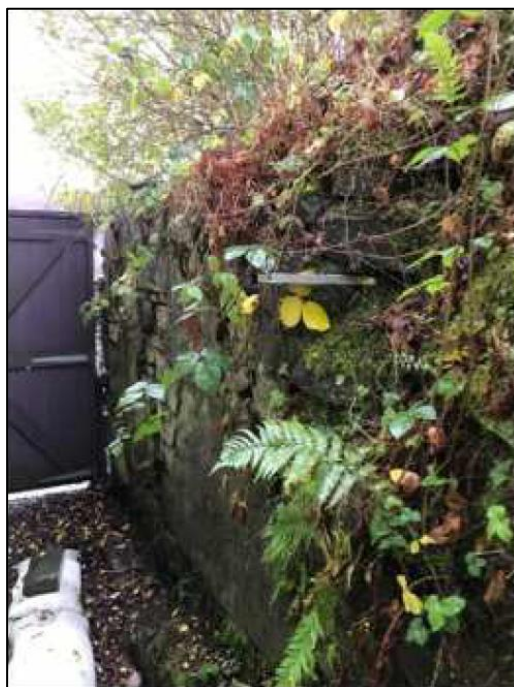
'Retaining Wall 2' primarily retains the hillside material above to prevent it from encroaching over the property boundary. Following Storm Dennis, NRW undertook an inspection of 'Retaining Wall 2' which identified potential structural weaknesses. The mortar in the joints of the wall were identified to have deteriorated over time, as evidenced in Figure 12 which shows vegetation growing in the joints. This has led to

multiple holes and large openings within the wall which is considered to have facilitated overland runoff and groundwater to water to pass through the structure.

Figure 12: Photograph showing visual condition of the 'Retaining Wall 2' adjacent to a property at Aberdare Road

The degraded structural integrity of 'Retaining Wall 2' is considered to have contributed to the discharge of groundwater through the structure, which impacted 3 residential properties at Aberdare Road, in addition to contributing to the surface water flows conveying towards the lower streets of RCT21. The prolonged rainfall experienced during February 2020, however, is considered the primary cause of groundwater flooding during Storm Dennis. The prolonged rainfall caused the hillside to become saturated and led to the rising of the water table from the rocks and soils underground towards the surface.

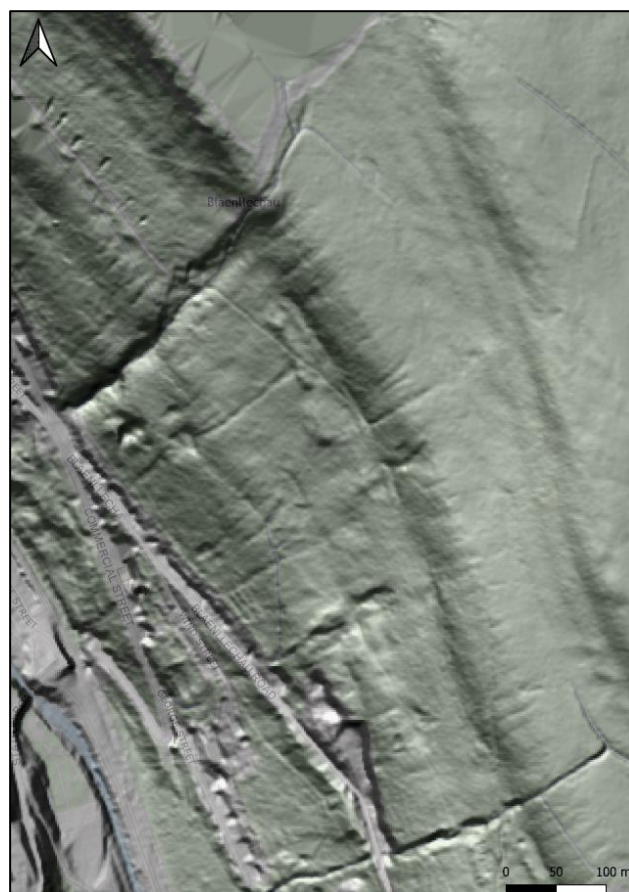
According to available OS data there appears to be no formal drainage arrangements or rill features to intercept and/or direct the flow of surface water towards the ordinary watercourses that drain the hillside of 'Area 2'. Further interrogation of LIDAR data and satellite imagery however, identified multiple channels / rill features that appear to convey towards the rear of properties at Blaenllechau Road. Figure 15 depicts these small channels / rill features across 'Area 2' using LIDAR data.

Figure 15: LIDAR assessment of 'Area 2' indicating small channel / rill features present across the hillside

It is considered that the undefined ordinary watercourse channels identified along 'Area 2' contributed to the conveyance of surface water flows towards the rear of properties at Blaenllechau Road, however, despite this, it is concluded that surface water is largely uncontrolled above Blaenllechau Road which allowed intense rainfall during Storm Dennis to flow overland, in addition to saturating the area of hillside, leading to surface water and groundwater flooding to several properties along Blaenllechau Road.

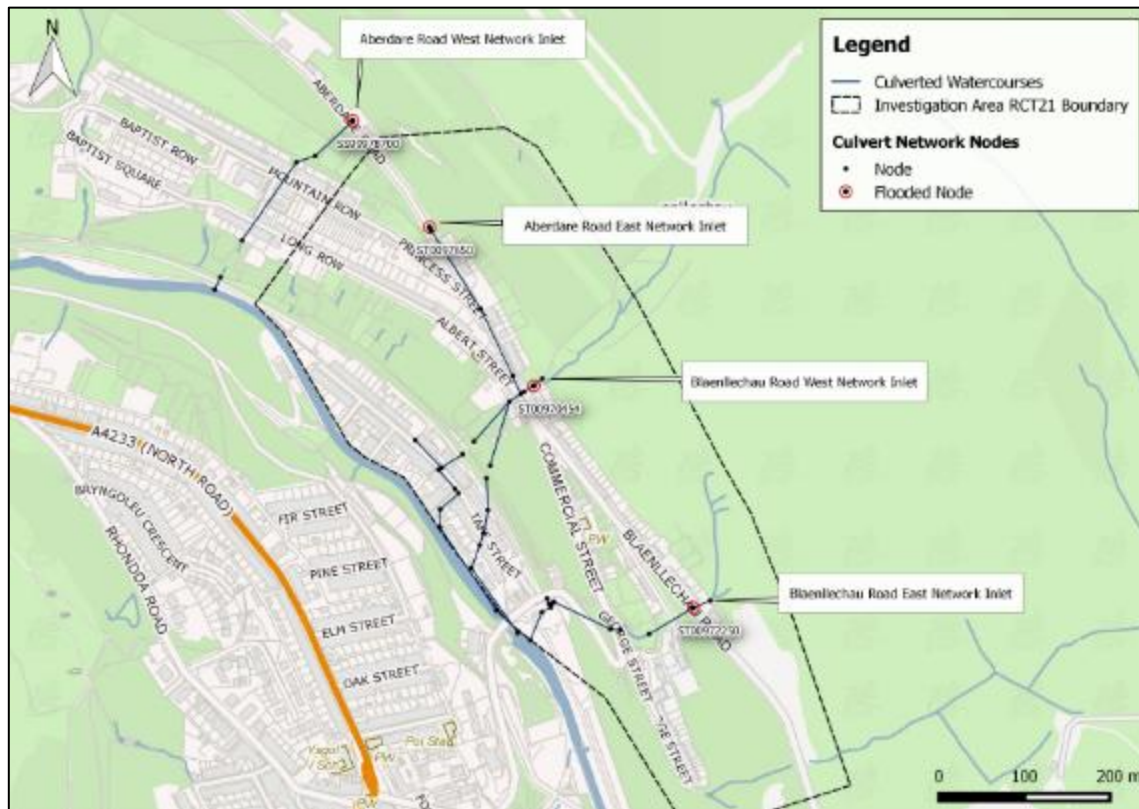
The network is predicted to flood at the nodes highlighted in Figure 17 based on the calculated standards of protection outlined in Table 3. There is however no evidence to verify that flooding did in fact occur anywhere in the modelled culvert systems during Storm Dennis. It is therefore inferred that surface water from the hillside is not draining into the culvert networks as suggested by the hydraulic modelling and is instead finding its own route down the hillside, affecting several properties on its flow path during Storm Dennis.

Figure 17: Map illustrating the modelled outputs indicating which node is predicted to flood based on the estimated return periods in Table 3
