Flood and Water Management Act 2010

Section 19 Flood Investigation Report

Storm Dennis –
Flood Investigation Area RCT14

January 2022

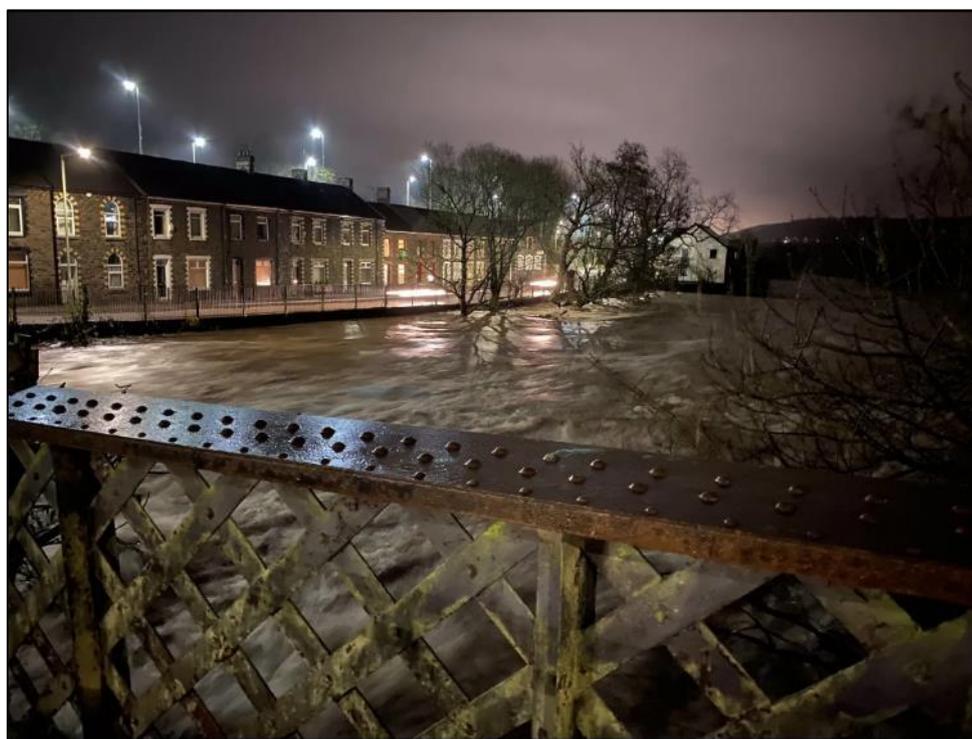
Figure 4: A downstream view of the River Taf at Castle Inn Bridge, Cardiff Road prior to its overtopping during Storm Dennis (Image: Storm Dennis, pontypriddtowncouncil.gov.uk)

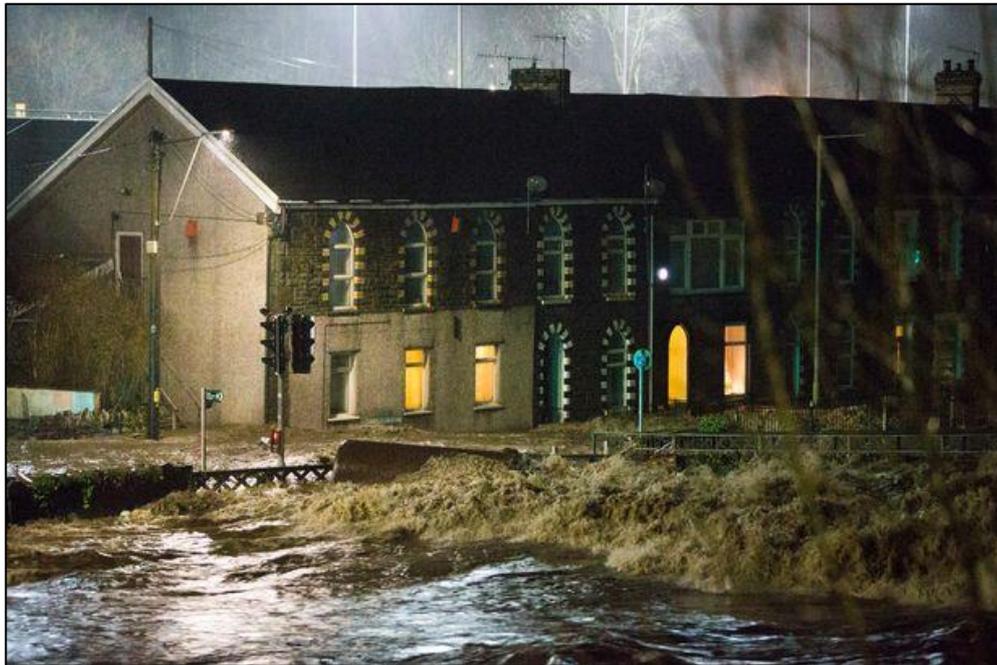
The primary flow pathway was the conveyance of fluvial flood water over the main river’s eastern embankment and onto the A4054 (Cardiff Road) at multiple locations near the Castle Inn Bridge footbridge. Figure 5 illustrates the rapid onset of flooding from the River Taf at Cardiff Road once it had overtopped.

Figure 5: Photo of the rapid onset of flooding from the River Taf at Cardiff Road during Storm Dennis
(Image: Wales Online)

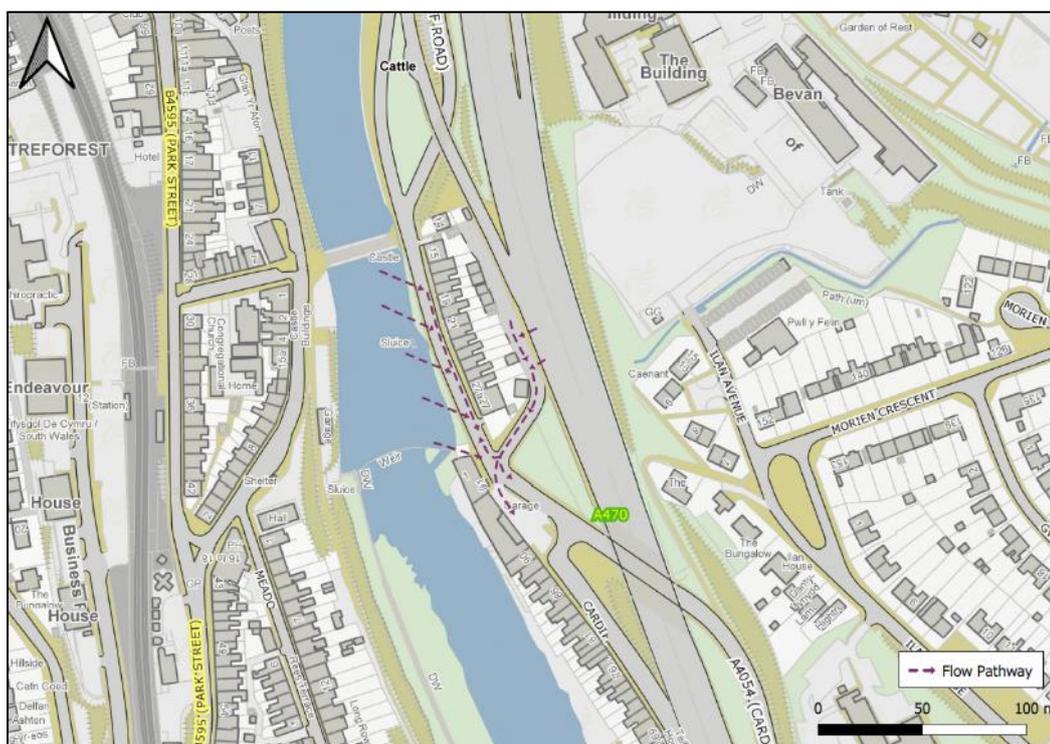
Surface water flooding also occurred as a result of intense rainfall and subsequent pluvial flows. Whilst not as distinct in their impact, the pluvial flows are believed to have contributed to the internal flooding that occurred at Cardiff Road and resulted in external flooding throughout the wider catchment. The pathways of flooding within 'Glyn-taf Rhydyfelin North' sub-catchment have been depicted in Figure 6.

A total of 17 residential and 2 non-residential properties were internally flooded within Glyn-taf Rhydyfelin North during Storm Dennis. All flooded properties were located adjacent to the River Taf along Cardiff Road, highlighting the significant impact of the main river overtopping and the subsequent flooding that occurred in the area.

Figure 6: Flow Pathways that caused internal flooding within Glyn-taf Rhydyfelin North sub-catchment

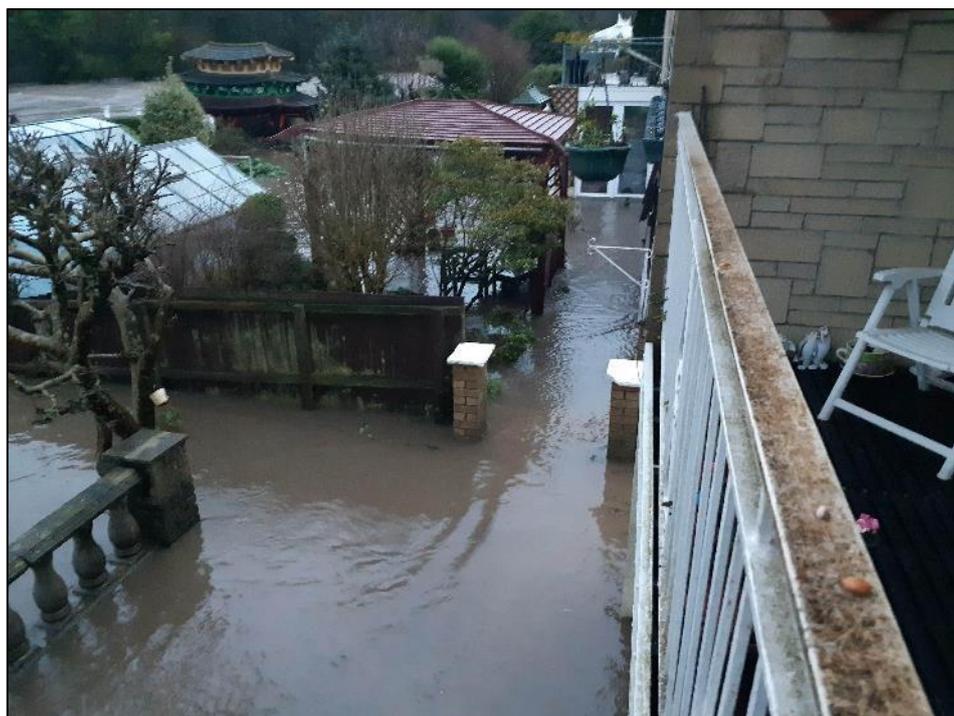
Alike Glyn-taf Rhydyfelin North, the primary source of flooding within the sub-catchment was the overtopping of the River Taf. The primary flow pathway saw flood water convey beyond the eastern riverbank onto De Barri Street and into the rear of properties on Nant Y Dall Avenue, with flood water reaching approximately 1.8 metres in some areas (Figure 7).

Figure 7: Image showing main river flooding to the south of Nant-y-Dall Avenue during Storm Dennis (image provided by resident)

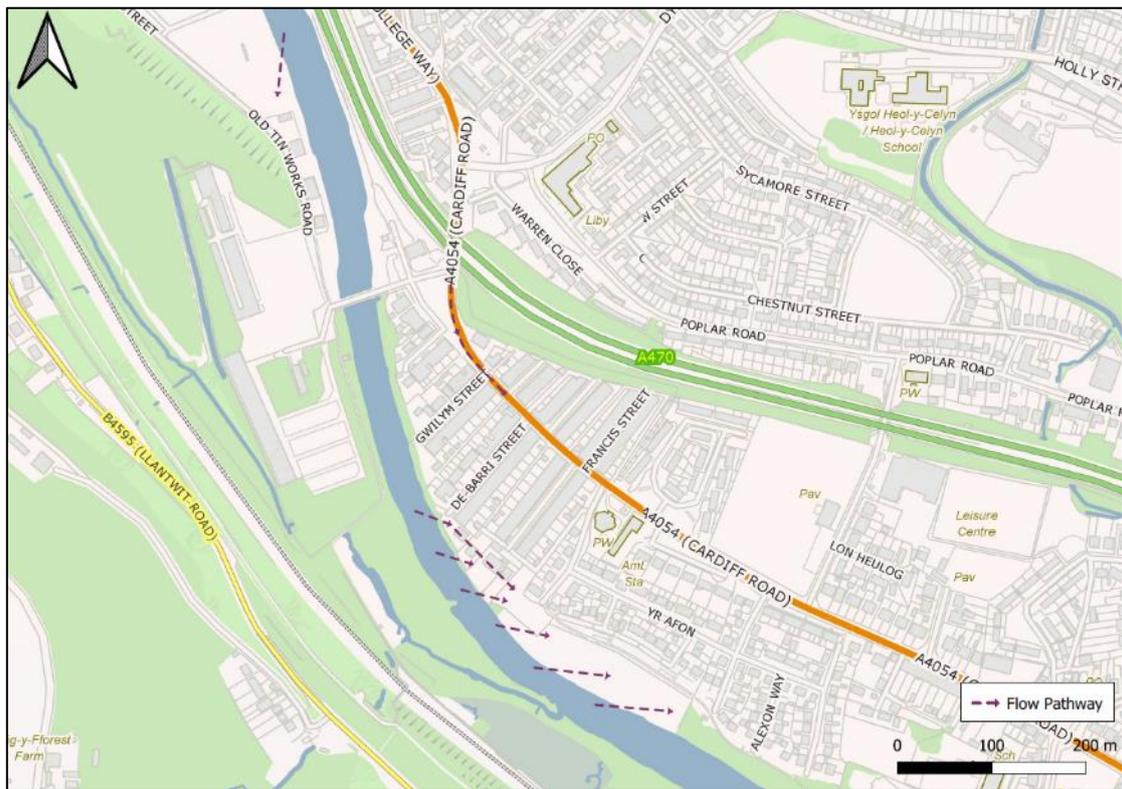
Of the six properties within Glyn-taf Rhydyfelin South that were internally flooded, four were as a result of the River Taf overtopping its banks. The remaining two residential properties that reported internal flooding, one on Owen Street and one on Alexon Way, were flooded by surface water. The pathways of observed flooding within 'Glyn-taf Rhydyfelin South' sub-catchment have been depicted in Figure 8 below.

Owen Street is approximately 130 metres away from the River Taf and, whilst it is possible that fluvial flood water conveyed along the rear of De-Barri Street and into Owen Street, this is unlikely due to the lack of evidence and limited reports of flooding along the conveyance route. Surface water is believed to have accumulated on both Owen Street and Cardiff Road, resulting in the internal flooding of an end-of-terrace property on Owen Street.

The localised accumulation of surface water is believed to have been responsible for the internal flooding of a residential property on Alexon Way. Resident reports during the storm event suggest that the River Taf did overtop its banks south of Ymyl yr Afon (Figure 8); however, evidence suggests that fluvial flows did not convey a large enough distance to internally flood any nearby properties.

Figure 8: Flow pathways that caused flooding within Glyn-taf Rhydyfelin South

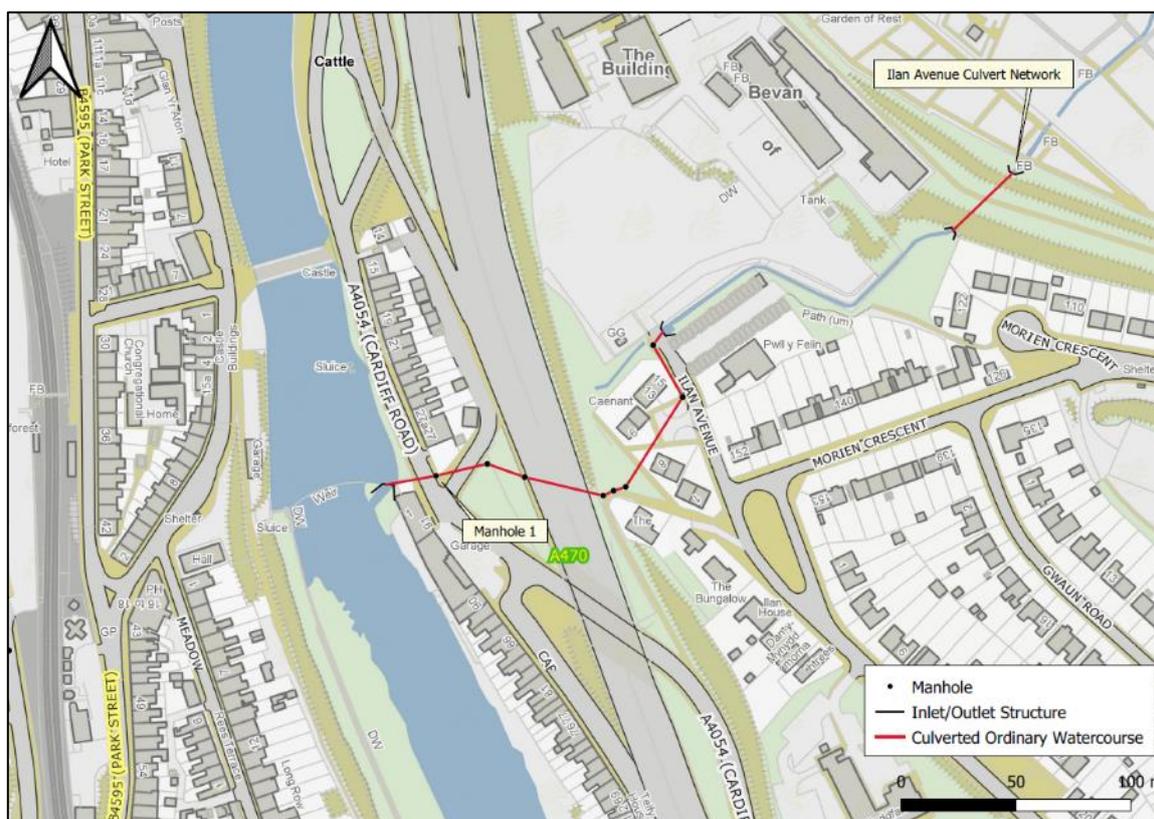
Figure 9: Ilan Avenue culverted ordinary watercourse location plan

There are several unnamed watercourses which drain the upper catchment areas to the east of investigation area RCT14. These watercourses are culverted beneath Glyn-taf before discharging into the River Taf downstream. The most notable culverted watercourse in relation to our investigation is known as 'Ilan Avenue' culvert network which conveys water from the hillside above Glyn-taf Rhydyfelin North sub-catchment, beneath the A470, and discharges into the River Taf at Cardiff Road (illustrated in Figure 9).

Following Storm Dennis, a CCTV survey inspection of the culvert network was undertaken to ascertain both the operational condition of the network and its structural integrity. The survey identified some debris within the Ilan Avenue culvert network, with approximately two tonnes of material being removed from the system following the inspection. Little to no debris was identified at both culvert inlets following the storm event, indicating that the identified debris was already present in the network prior to

the storm event. Due to the lack of pre-storm survey data, it is not possible to conclusively determine whether this debris was present in the system prior to the storm event, if the material entered the system as a result of the exceptional weather conditions, or whether they are influenced by the outfall arrangement into the Main River.

The unnamed ordinary watercourse associated to the 'Ilan Avenue' culvert network water (Figure 9) was inspected post event and found no evidence of recent scour to the channel.

R3B	The LLFA and LDA to investigate the standard of protection and the condition of the culvert structure and network as a whole.
					R3C	The LLFA to jet and cleanse the ordinary watercourse culvert network.

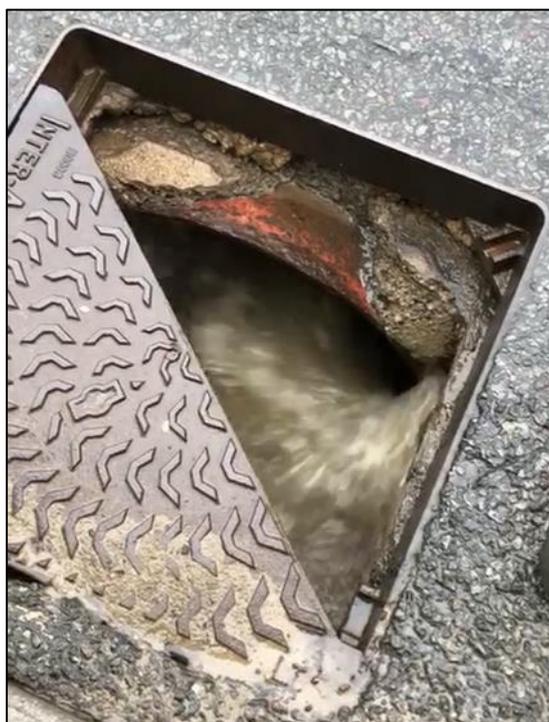
Site inspections undertaken by RCT's Flood Risk Management team during Storm Jorge (February 28th to March 1st) identified a manhole adjacent to the affected properties on Cardiff Road (labelled 'Manhole 1' in Figure 9) surcharging. This resulted in repeat surface water flooding to the external extents of several properties at Cardiff Road.

The surcharging of 'Manhole 1' approximately two weeks after Storm Dennis has been attributed to the raised river levels within the River Taf which prevented water from outfalling from the culverted network and into the River Taf. Figure 10, taken during RCT's site inspection following the receding of flood water, shows 'Manhole 1' surcharging within the chamber.

Figure 10: Photo of 'Manhole 1' surcharging during Storm Jorge (captured by RCT's Flood Risk Management team on 28th February 2020)

Following the observations made at 'Manhole 1' during Storm Jorje, it is considered that the downstream culvert network may have contributed to surface water flooding on Cardiff Road during Storm Dennis; however, the overtopping of the River Taf has been determined as the primary cause of flooding to properties at Cardiff Road in the northern sub-catchment during Storm Dennis.

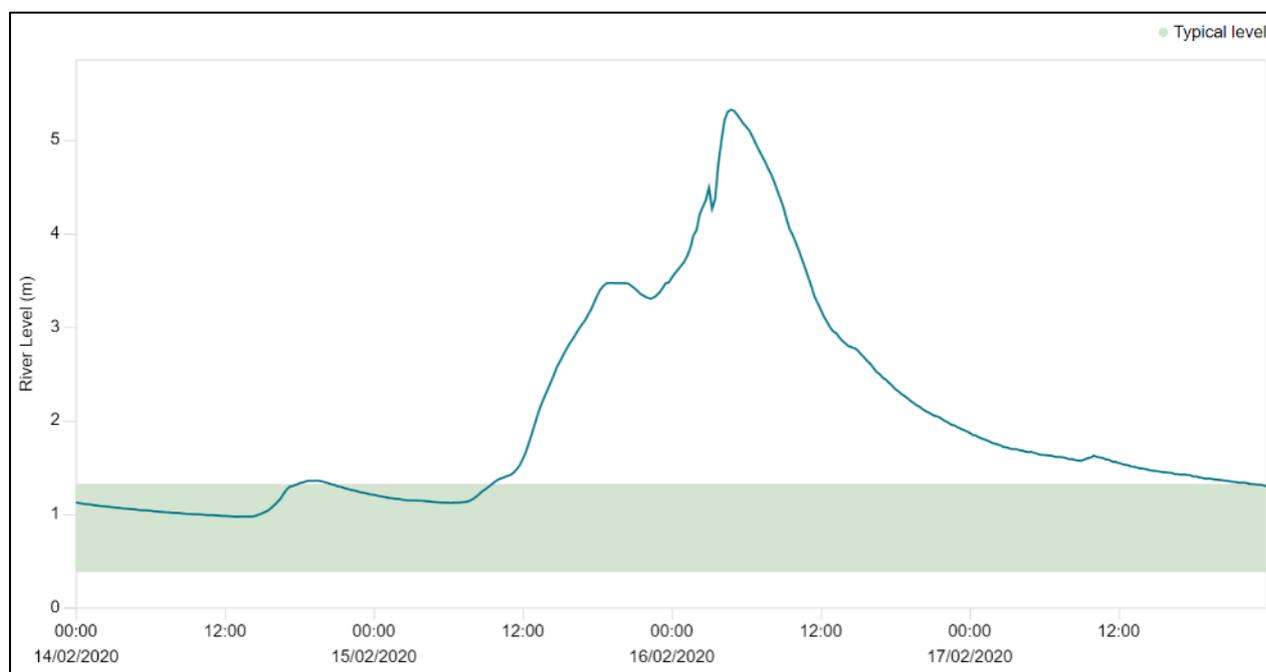
The hydrograph in Figure 12 illustrates the significant rise in the River Taf's levels in response to rainfall between the 14 – 17th February 2020. River level data was captured at NRW's Pontypridd river level gauge, located approximately 750m north-west of the northern boundary of the investigation area.

NRW issued a 'Flood Alert' (indicating possible flooding) for the entirety of the River Taf at approximately 13:30 on the 15th of February; at which point the main river was over 2 metres in depth and continuing to rise at Pontypridd station. At approximately midnight on the 16th February the River Taf began to rise again, reaching a peak river level of 5.32 metres at 04:45 on the 16th of February; the highest level recorded for the River Taf at Pontypridd since 1970.

Figure 12: The River Taf levels at Pontypridd station between the 14th and 17th February 2020 (Natural Resources Wales)

The green bar displayed on the hydrograph shows the typical level of the River Taf at the Pontypridd station, ranging between 0.4 and 1.3 metres. The river level was above this green line for over 48 hours, highlighting the severity of the storm event and its unprecedented nature. At its peak, the River Taf at Pontypridd was almost four meters higher than its average level.

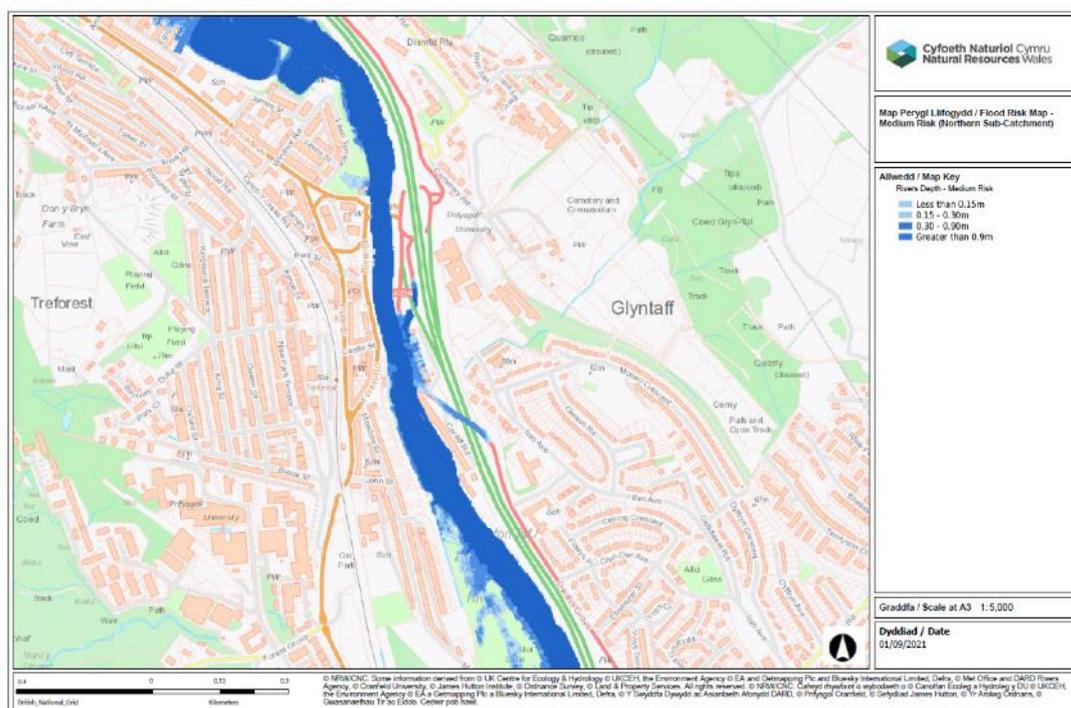
Based on NRW's Flood Hazard maps, flooding to a depth greater than 0.9 metres is predicted along parts of Cardiff Road in the northern sub-catchment (Figure 14), as well as areas south of Nant-y-Dall Avenue in the southern catchment during a medium risk event (Figure 15). Flooding of this depth and greater was observed at these locations during Storm Dennis.

Figure 14: NRW's National Flood Hazard derived map for Medium Risk River Flood Depth in RCT14 Northern Sub-Catchment. Contains Natural Resources Wales information © Natural Resources Wales and database right. All rights reserved

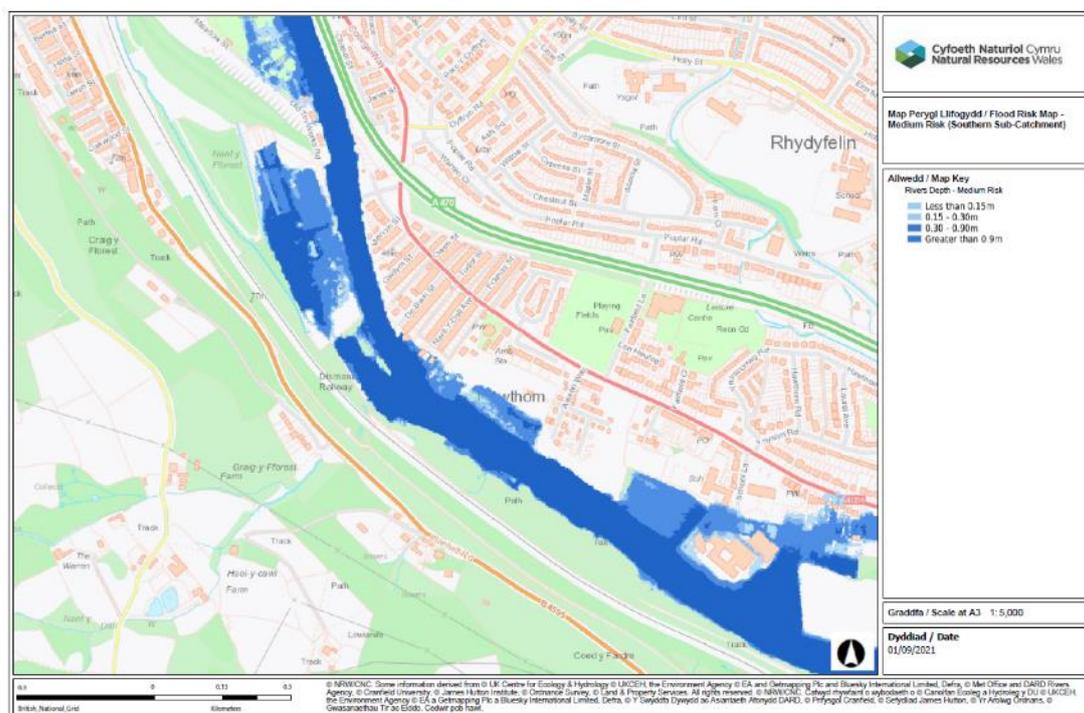
Figure 15 does not identify Alexon Way as an area of main river flood risk, further supporting the notion that fluvial flows did not reach the impacted property. Surface water flooding has been determined as the likely cause of internal flooding at this location.

Figure 15: NRW's National Flood Hazard map for Medium Risk River Flood Depth in RCT14 Southern Sub-Catchment. Contains Natural Resources Wales information © Natural Resources Wales and database right. All rights reserved.

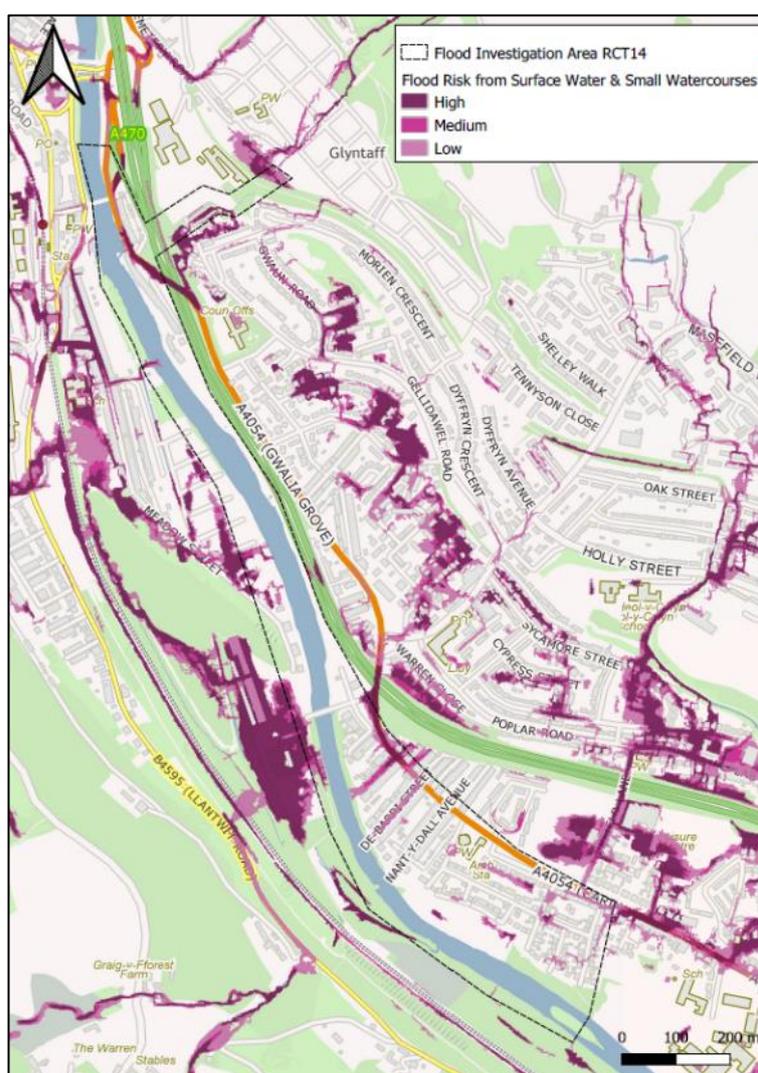
Figure 17: Natural Resources Wales' Flood Risk Assessment Wales (FRAW) map for Surface Water and Ordinary Watercourse flood sources. Contains Natural Resources Wales information © Natural Resources Wales and database right. All rights reserved.

With the exception of Owen Street, which is denoted as an area of medium surface water flood risk in Figure 17, the majority of high and medium surface water flood risk areas which experienced internal flooding were also flooded by the overtopping of the River Taf. This further reinforces the notion that surface water was a secondary influence on the flooding that occurred in RCT14, with areas that were solely impacted by surface water, such as Gwilym Street, primarily experiencing external flooding rather than internal flooding.

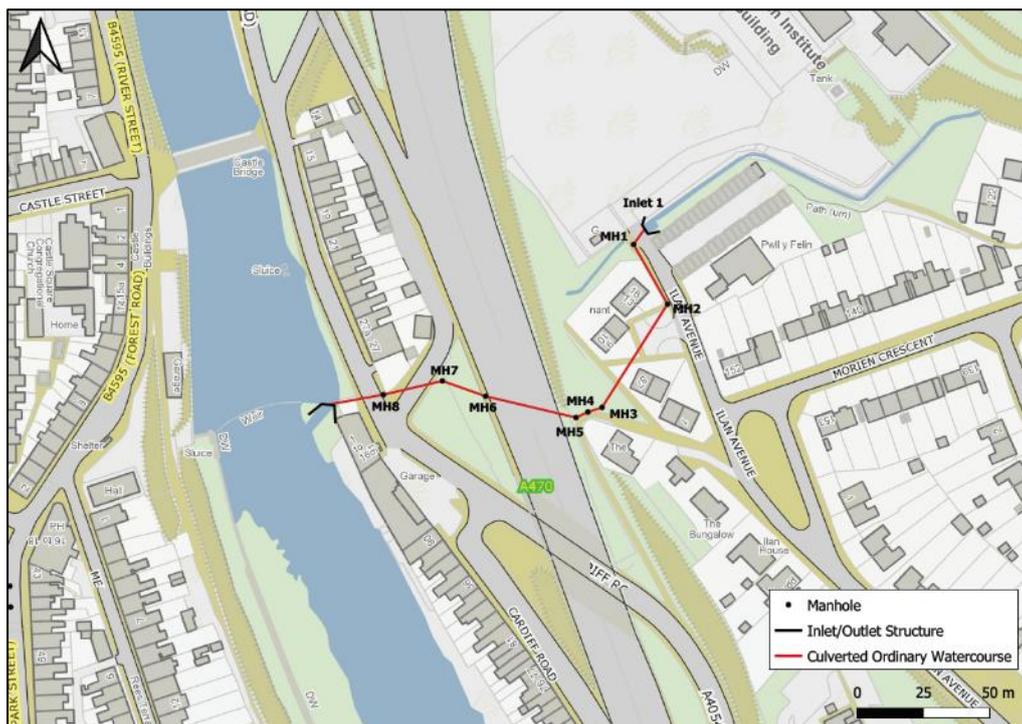
Figure 18: Ilan Avenue culverted ordinary watercourse network with annotated Manhole labels

Whilst the overtopping of the River Taf has been determined as the primary cause of flooding to the majority of properties within RCT14, the capacity of the ‘Ilan Avenue’ culvert network (illustrated in Figure 18) has also been assessed to ascertain its current standard of protection following the observed surcharging of a manhole at Cardiff Road following Storm Dennis (Figure 10).

Culvert Network	Standard of Protection (SOP) – Free Flowing	Standard of Protection (SOP) – Blockage Condition
Ilan Avenue Upstream (Inlet 1 – MH3)	Q200 (0.5% AEP)	Q2 (50% AEP)
Ilan Avenue Downstream (MH4 – MH8)	Q30 (3.3% AEP)	Q2 (50% AEP)

The assessment infers that the upstream section of the network, at the culvert inlet adjacent to Ilan Avenue, has adequate hydraulic capacity to accommodate storm events up to Q200 in free-flowing conditions. This is significantly reduced to Q2 in blockage conditions however, no blockage to the upstream inlets was observed during Storm Dennis.

The capacity of the Ilan Avenue downstream network (which conveys flows beneath the A470 and Cardiff Road) was assessed as having a SOP below current design standards for new culverts as defined by CIRIA C789. This is further reduced to Q2 in blockage conditions.
