Flood and Water Management Act 2010

Section 19 Flood Investigation Report

Storm Dennis – Flood Investigation Area RCT27

November 2021

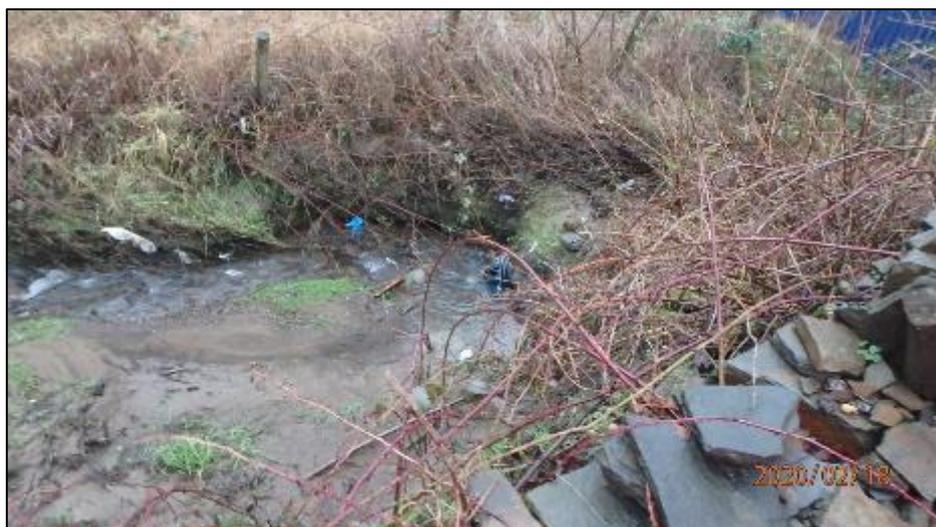
Exceedance flows from both inlets resulted in water conveying through the commercial unit and continuing its pathway east along Abertonllwyd Street.

Figure 5: Evidence of submerged 'Culvert Inlet 1' which surcharged during Storm Dennis (captured by RCT's Flood Risk Management team on 18th February 2021)

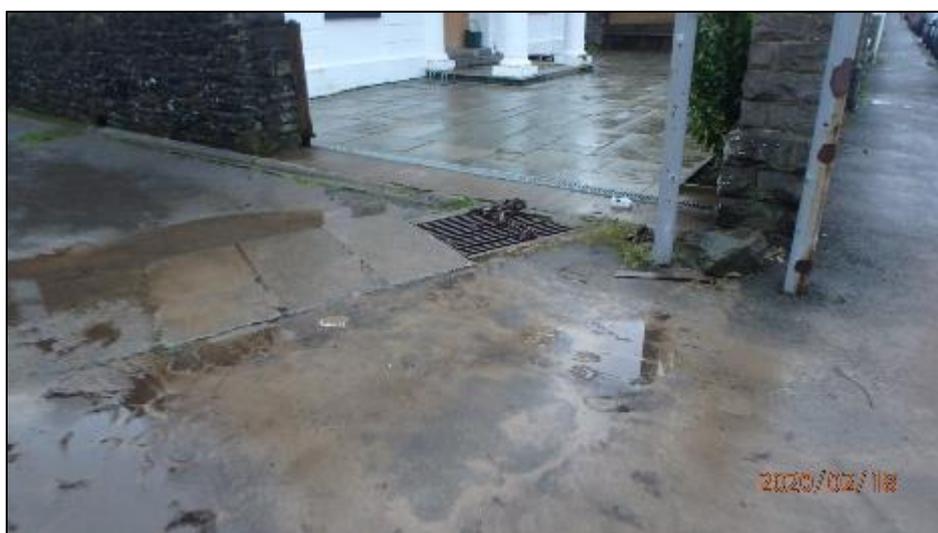
A manhole located downstream of the surcharged inlets (labelled 'Manhole 1' in Figure 4) also showed evidence of surcharge. Exceedance flows from the ordinary watercourse manhole reportedly contributed additional overland flow towards Abertonllwyd Street. Water also conveyed down the path to the rear of Abertonllwyd Street towards Glenrhondda Court and onto Dunraven Street, as depicted in Figure 4.

Figure 6: 'Manhole 1' located at Abertonllwyd Street surcharged during Storm Dennis (captured by RCT's Flood Risk Management team on 18th February 2021)

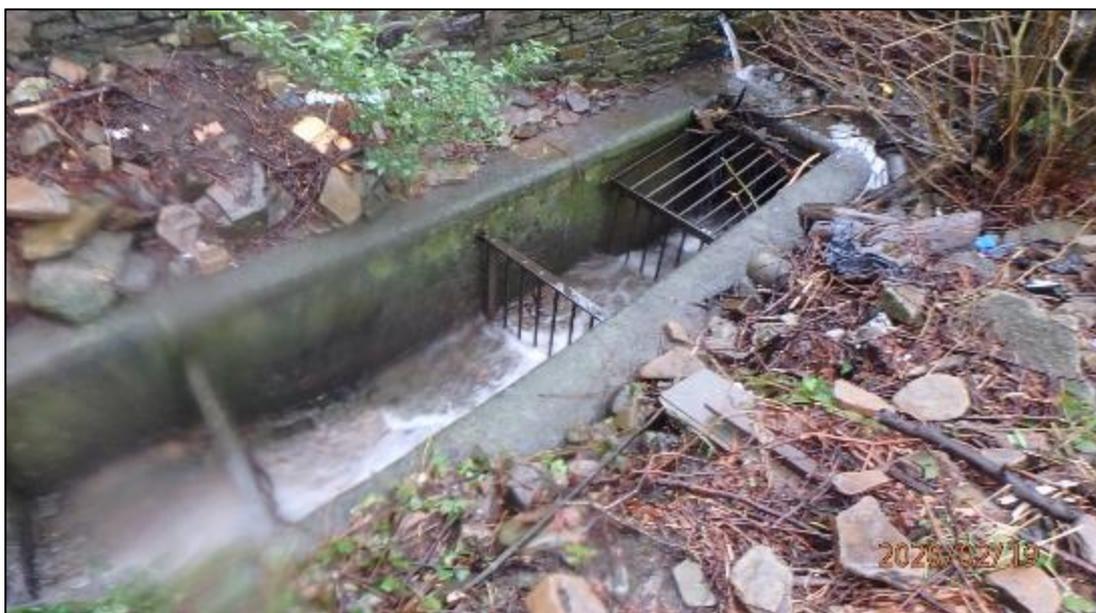
The site inspection also identified evidence of a third surcharged culvert inlet located near Dumfries Street (labelled 'Culvert Inlet 3' in Figure 4). This culvert inlet conveys flows from the Nant Coedcaetylefforest ordinary watercourse. Evidence of cleared debris was identified (Figure 7) post event, indicating that the culvert inlet became blocked during Storm Dennis, resulting in surcharge.

Figure 7: 'Culvert Inlet 3' to the rear of Dumfries Street which surcharged during Storm Dennis (captured by RCT's Flood Risk Management team on 19th February 2021)

Following reports that 'Culvert Inlet 3', which conveys the Nant Coedcaetyllefforest ordinary watercourse beneath Dumfries Street, was a contributing source of flooding to properties at Dumfries and Dunraven Streets, post event inspections were carried out. These inspections found evidence of debris surrounding the inlet structure, indicating that the inlet had surcharged due to blockage during the event (see Figure 7).

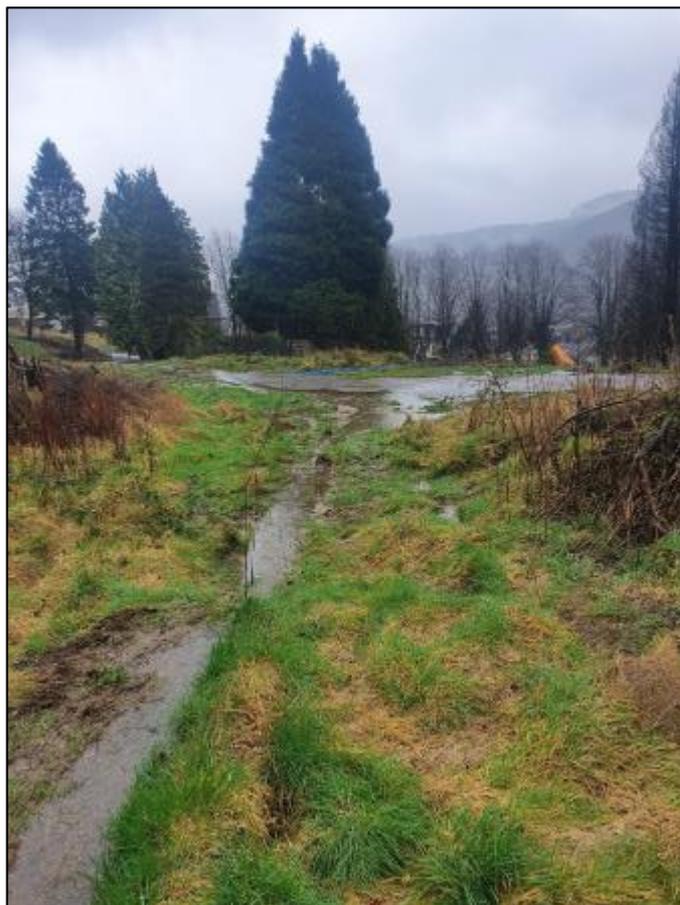
Furthermore, a culvert on private land to the rear of Dumfries Street was identified as fully submerged during RCT's site inspection (Figure 8), which resulted in overland flows travelling along the track road and contributing additional surface water flows towards Dunraven Street during the storm event.

Figure 8: Overland runoff originating from 'Culvert Inlet 4' flowing along the track road to the rear of Dumfries Street (image captured by RCT's Flood Risk Management team post event on 18th February 2020)

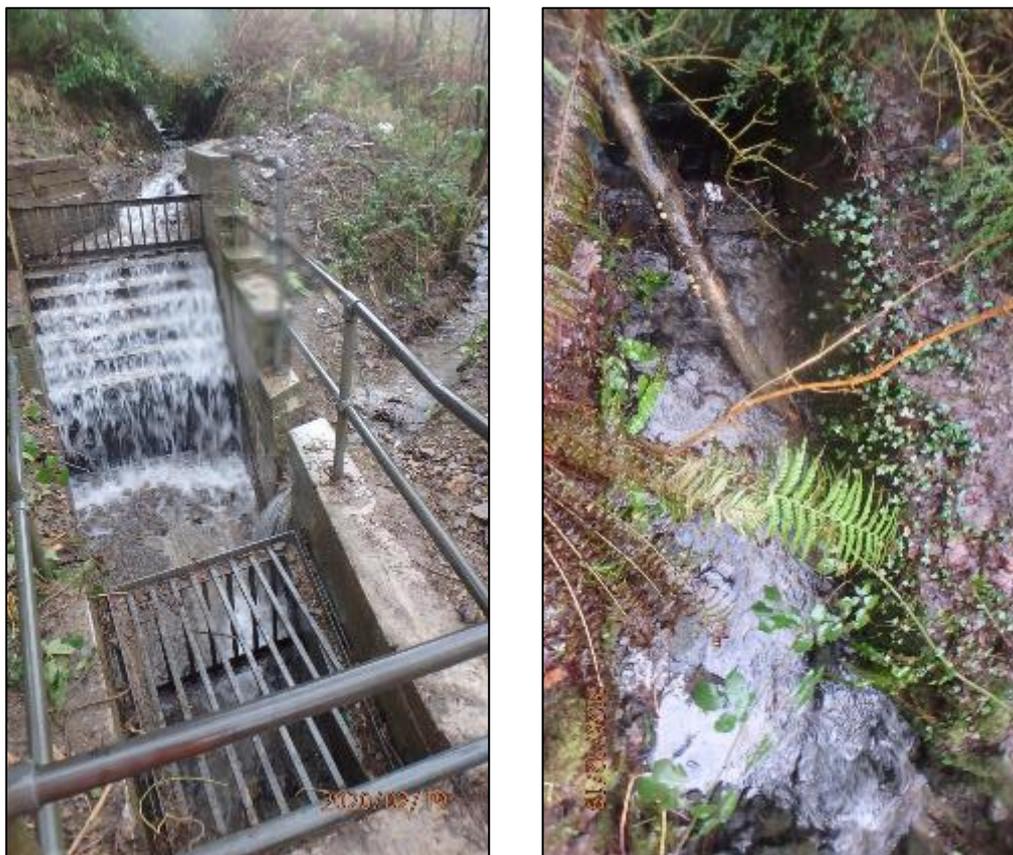
February 2020, two culvert inlets, labelled 'Culvert Inlet 5' and 'Culvert Inlet 6' in Figure 9, located to the north of Ross Rise and Tyn-y-coedcae, showed evidence of surcharge (Figure 10).

Figure 10: 'Culvert Inlet 5' (left) and 'Culvert Inlet 6' (right) located to the rear of Tyn-y-coedcae which surcharged during Storm Dennis (captured by RCT's Flood Risk Management team on 19th February 2020)

Water from both culvert inlets flowed overland towards Tyle Fforest and Ross Rise, with some of the flow channelled via the highway and through the rear gardens of several properties, before discharging back into the Nant Pwll-brwyn ordinary watercourse downstream.

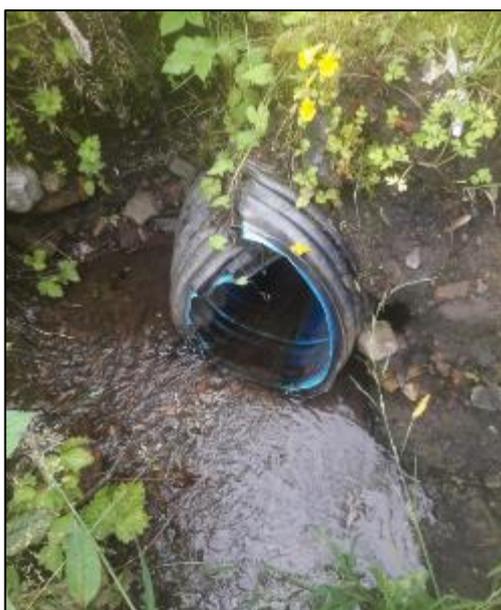
The culvert network length between 'Culvert Inlet 1' and 'Culvert Inlet 2', situated behind New Park Garage, consists of a 450mm plastic pipe which was noted as deformed during CCTV survey operations (Figure 12). Upon site inspections of the inlet during storm event conditions, water is observed to bypass 'Culvert Inlet 1' and flow over the top of the pipework towards 'Culvert Inlet 2'. This flow path is assumed to have occurred during Storm Dennis.

Figure 12: 'Culvert Inlet 1' captured during CCTV survey operations on 30/06/2020

The poor condition of both culvert inlets is considered to have contributed to the surcharging of both inlets.

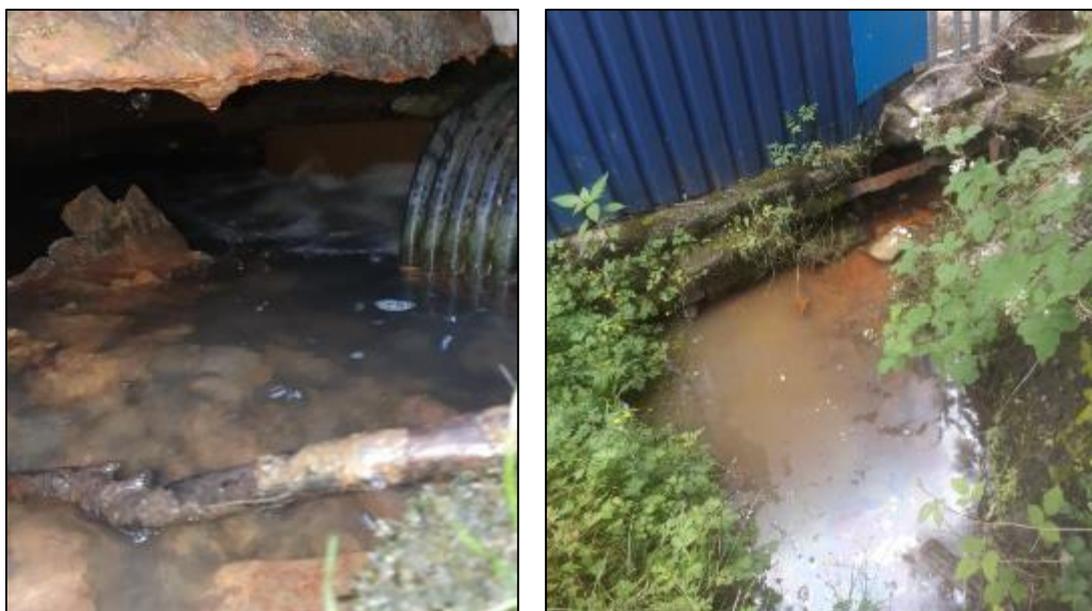
'Culvert Inlet 2' primarily consists of an outfall pipe which discharges underneath New Park Garage (Figure 13). The inlet also receives flow from an ordinary watercourse which runs adjacent to the garage. As depicted in Figure 13, the outfall pipe is relatively level with the surface, resulting in standing water surrounding the inlet.

Figure 13: Outfall pipe entering 'Culvert Inlet 2' (left) and standing water surrounding 'Culvert Inlet 2' (right) (captured during CCTV survey operations on 30/06/2020)

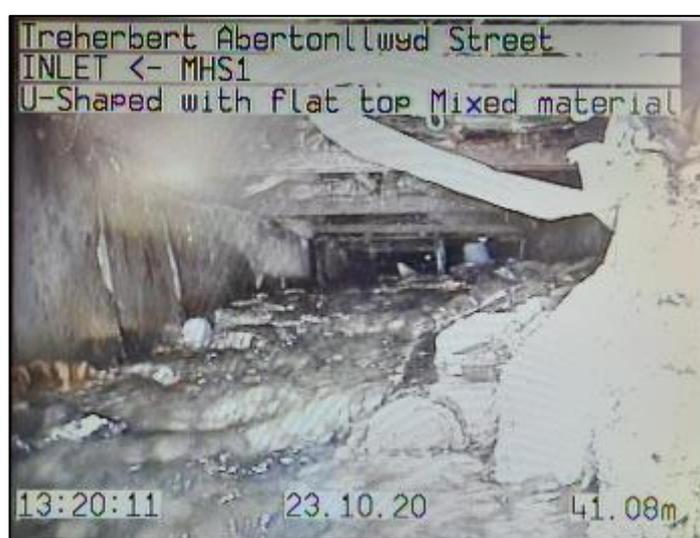
A second Council appointed contractor undertook a further survey of the culvert network on 21st October 2020. The survey had to be abandoned again approximately 27 meters downstream of 'Culvert Inlet 2' due to a high volume of settled debris reducing the networks cross-sectional area by 70% (depicted in Figure 14). This debris is considered to have reduced the culvert's hydraulic capacity to manage the flow of water entering the network, contributing to the surcharging at 'Culvert Inlet 2'.

Figure 14: Internal view of 'Abertonllwyd Street Culvert Network 1' looking up towards 'Culvert Inlet 2' (CCTV survey footage captured 23/10/2020)

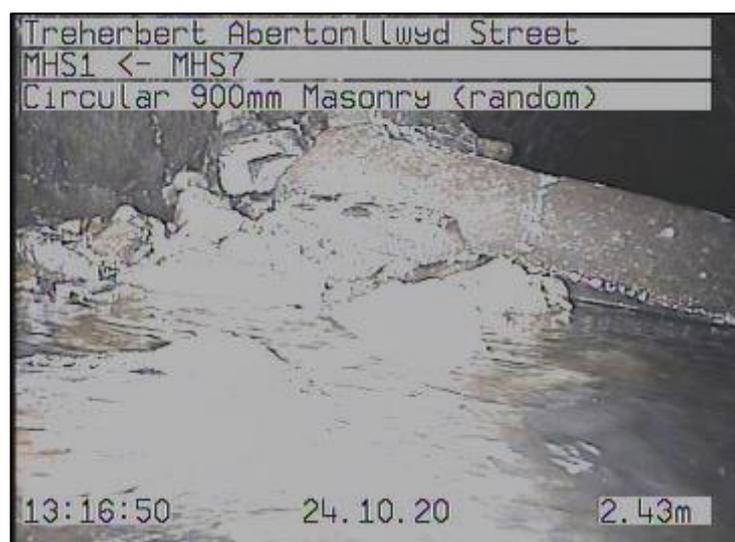
Surcharging at 'Manhole 1' was also identified as a secondary source of flooding to properties at Abertonllwyd and Dunraven Streets during Storm Dennis. Both CCTV survey operations were also abandoned downstream of 'Manhole 1' due to settled deposits and large debris identified within the network (depicted in Figure 15). The culvert network downstream of 'Manhole 1' was also graded as being in very poor structural condition.

Figure 15: Internal view of 'Abertonllwyd Street Culvert Network 1' downstream of 'Manhole 1' (CCTV survey footage captured 24/10/2020)

The poor condition of the culvert network downstream of 'Manhole 1' is considered to have contributed to its surcharging during Storm Dennis. The debris identified within the network is also indicative of the high flow rates which enabled the erosion and transportation of a significant volume of debris from the upper catchment and subsequent deposition within the culvert network during the storm event.

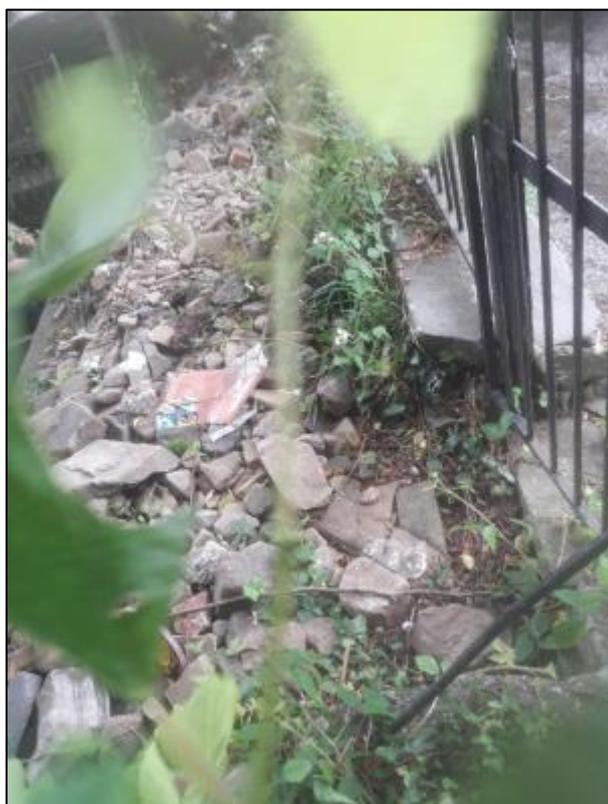
The 'Dumfries Street Culvert Network' was also surveyed to be in poor condition, with significant operational and structural defects identified throughout the network. The volume of settled deposits led to operators abandoning the CCTV survey operations on two occasions. As a result, approximately 5 tonnes of debris was removed from the network (shown in Figure 16).

Figure 16: Debris removed from the 'Dumfries Street Culvert Network' during cleansing operations (image captured on 29/06/2020)

Similarly to the Abertonllwyd Street culvert networks, the debris identified within the Dumfries Street network highlights the strength of the ordinary watercourse flows that would have been travelling down the hillsides above RCT27 and entering the culvert networks during the storm event. Its poor condition is considered to have contributed to the surcharging of 'Culvert Inlet 3', however, the blockage to the inlet structure has been determined as the most significant contributor to the flood flow path along Dumfries and Dunraven Streets during Storm Dennis.

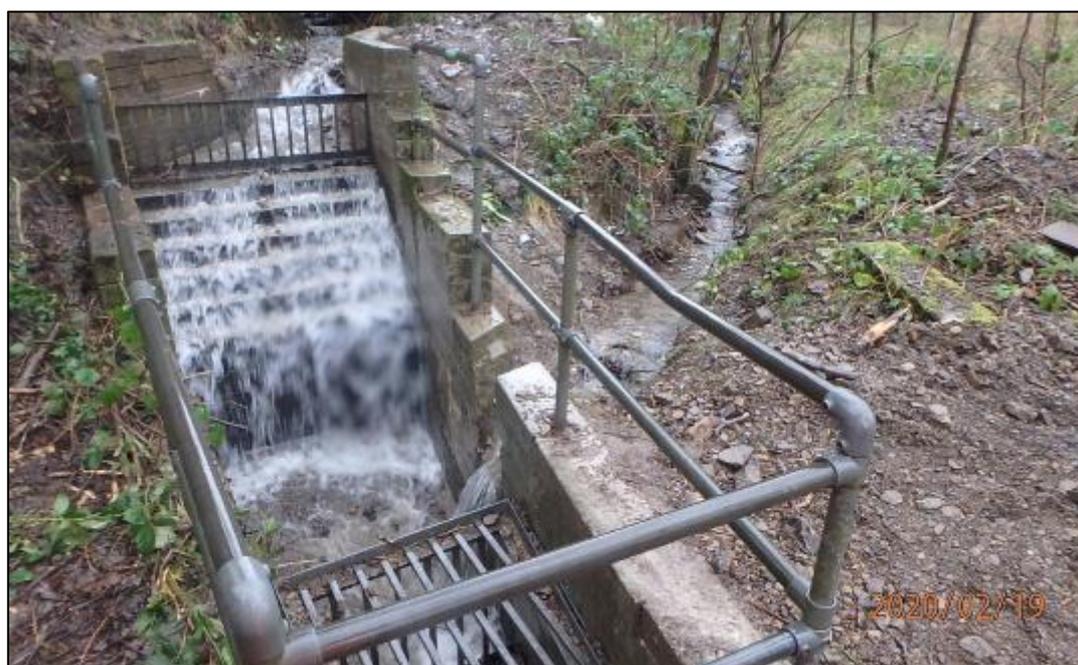
The 'Culvert Inlet 6' structure was identified by first responders as being blocked with debris and was subsequently cleansed. Figure 18 captured post event by FRM officers depicts the inlet following clearance works.

Figure 18: Photo of 'Culvert Inlet 6' captured by RCT's Flood Risk Management team following debris clearance post Storm Dennis (19/02/2020)

The 'Tyn-y-coedcae Culvert Network' downstream of 'Culvert Inlet 6' was surveyed to be in acceptable structural and operational condition, indicating that the blockage to the inlet structure caused by debris was the primary cause of surcharge.

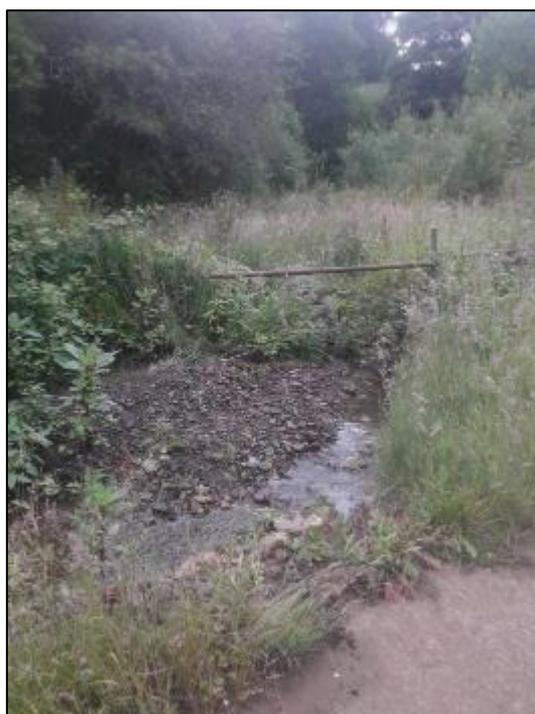
According to on-site officers, several sections of open watercourse upstream of the 'Abertonllwyd Street Culvert Network 1' (Figure 11) had significant build-up of debris within the channels, indicating significant mobilisation of debris occurred during the storm event (depicted in Figure 20). The conveyance of sediment, silt and stone downstream is considered to have contributed to the surcharging of 'Culvert Inlet 1' and 'Culvert Inlet 2' during Storm Dennis. This debris is also considered to have entered the culvert network, contributing to the surcharge of 'Manhole 1' during the event.

Figure 20: Image of debris accumulation within the unnamed ordinary watercourse channel upstream of 'Culvert Inlet 1' (Figure 4) (captured during CCTV operations on 30/06/2020)

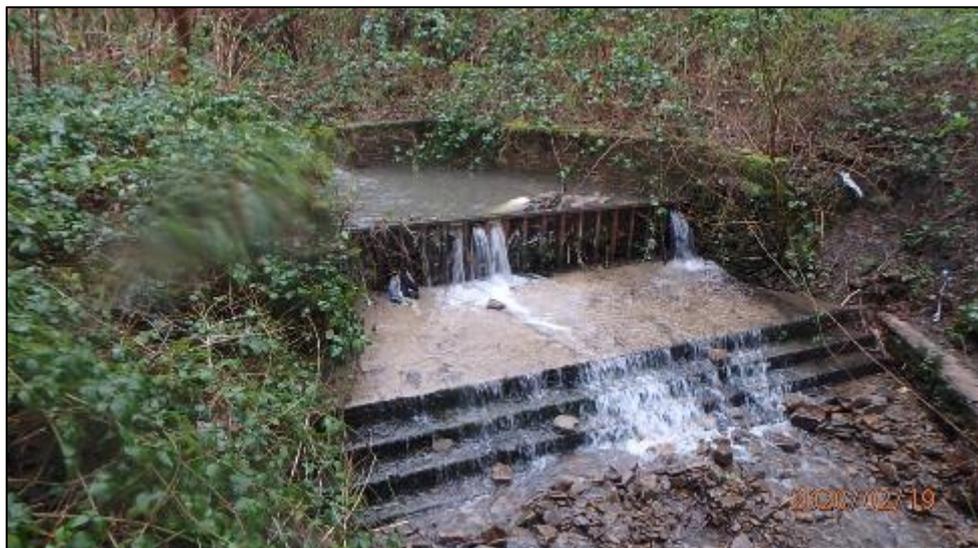
The upstream sections of the Nant Coedcaetylefforest ordinary watercourse (Area 1, Figure 21) showed evidence of debris deposition within the man-made channel, along with significant accumulation of material across the upper debris screens and headwall structure. Figure 22 and 23 depicts the material, which consists of coarse stone, silt and woody debris, within the upper channel. This material is assumed to have been mobilised from the upper reaches above the A4061 (Rhigos Road) and carried downstream by the high flows during Storm Dennis.

Figure 22: Photo of debris deposition behind the upper debris screen of the Nant Coedcaetylleforest ordinary watercourse (captured by RCT's Flood Risk Management team on 19/02/2020)

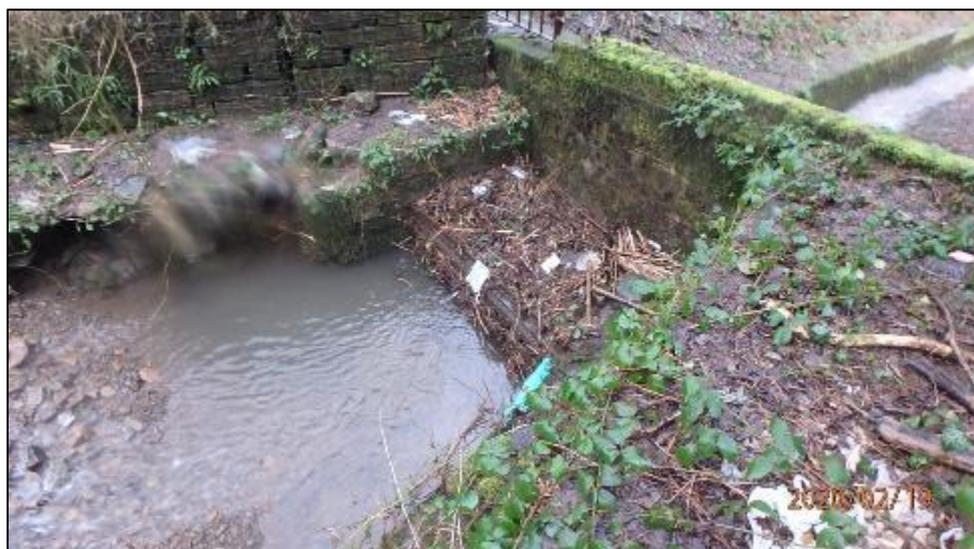
Figure 23: Photo of debris accumulation in the upper reaches of the Nant Coedcaetylleforest ordinary watercourse (below the A4061) (captured by RCT's Flood Risk Management team on 19/02/2020)

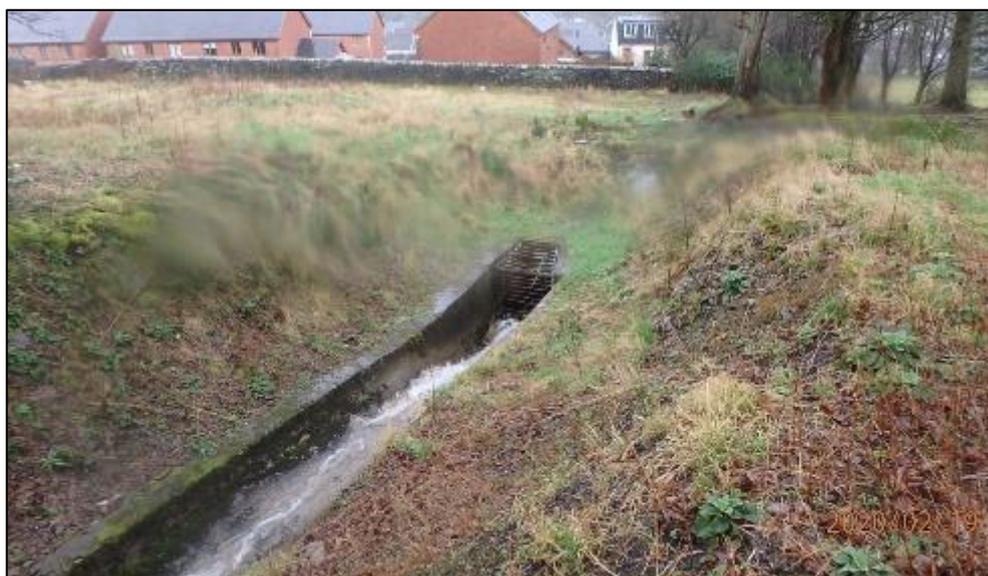
Below the headwall structure, the channel and culvert inlet (Area 2, Figure 21) did not show evidence of debris conveyance or blockage to the inlet, as shown in Figure 24. It is considered that the upstream debris screens at Area 1 succeeded in minimising the volume of debris travelling downstream.

Figure 24: Culvert inlet at Area 2 which conveys the Nant Coedcaetylleforest ordinary watercourse towards Area 3 (captured by RCT's Flood Risk Management team on 19/02/2020)
