Flood and Water Management Act 2010

Section 19 Flood Investigation Report

Storm Dennis – Flood Investigation Area RCT25

July 2021

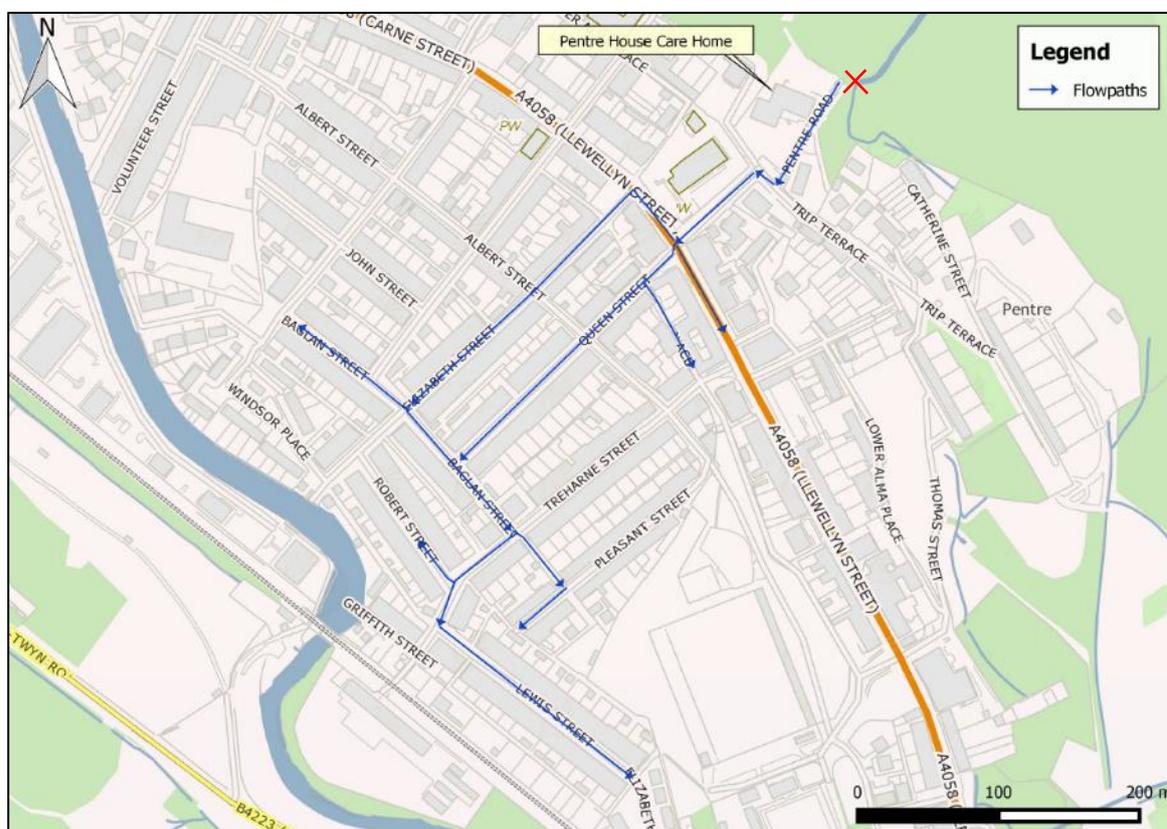
Pentre Road and onto Elizabeth Street and Queen Street (Figure 3), impacting the majority of properties downstream at the base of the valley, particularly properties at Baglan and Lewis Street.

Figure 3: Source and observed flow path of the flood event on the 16th February (Storm Dennis)

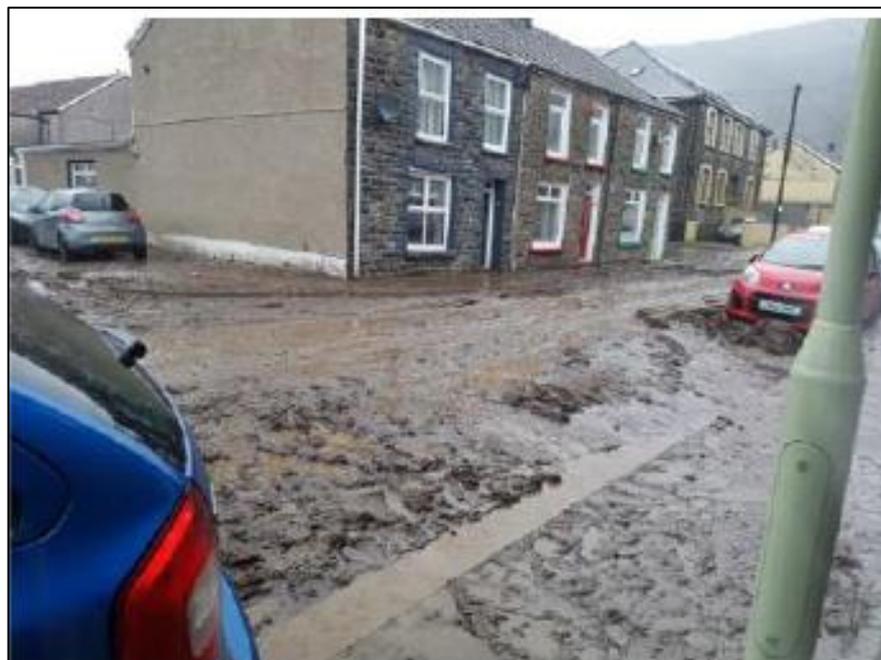
Anecdotal evidence collected during the August 2020 site visit provided evidence of flooding within properties up to 1.3m in depth. Post event photos reveal the severe and long-lasting damage caused by the flooding, with deposits on the streets of Pentre reported to have been transported from the upper catchment and made apparent once the flood water had drained away (Figure 4 and 5). Significant cleansing from a Council

Figure 4: Photo depicts significant deposits post Storm Dennis at Lewis Street captured by FRM officers on 17th February 2020

specialist contractor and the respective Council Highways and Streetcare Depot was carried out to clear both the streets and surface water networks following the storm event.

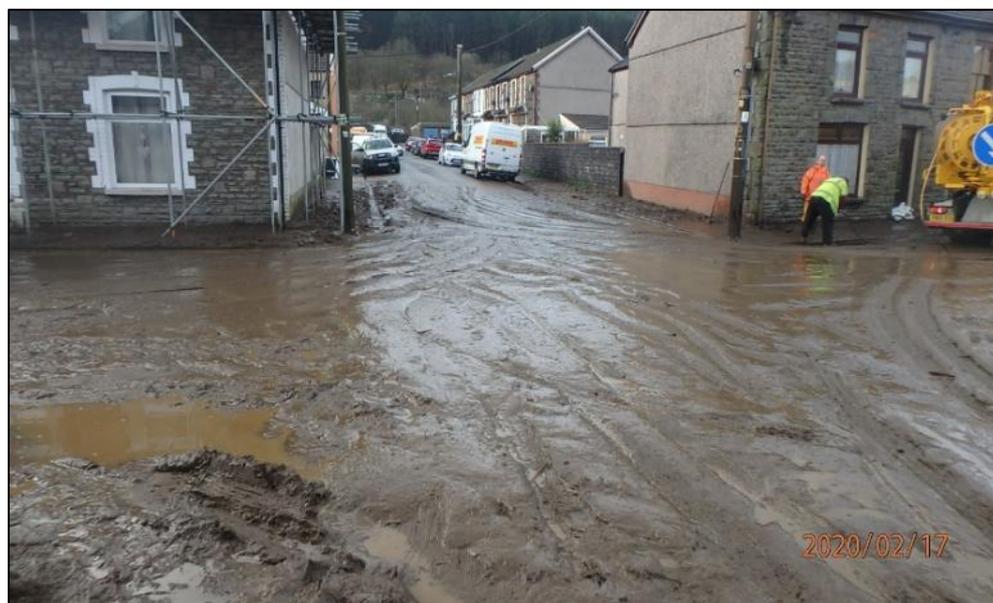
Figure 5: Photo depicts significant deposits post Storm Dennis at Baglan Street captured by FRM officers on 17th February 2020

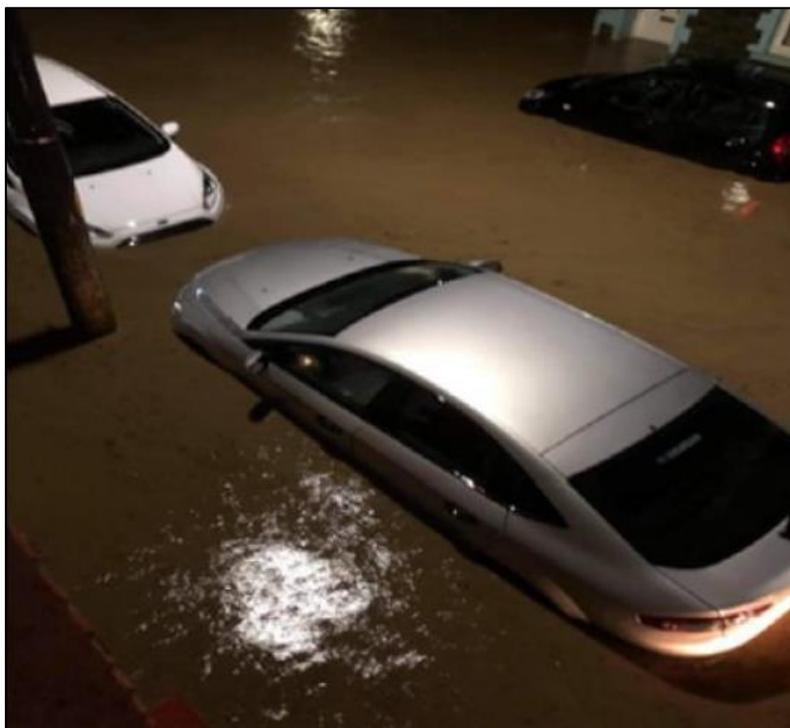
Figure 6: Photo showing severe flooding at Lewis Street, Pentre on 16th February 2020 (image provided by resident)

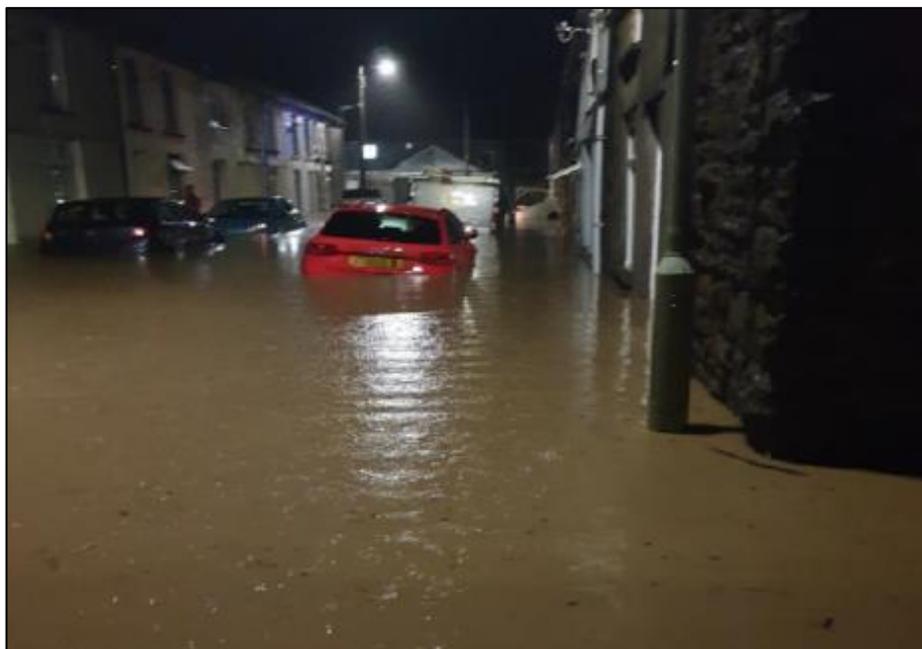
Figure 7: Photo showing severe flooding to the south of Pleasant Street, Pentre on 16th February 2020 (image provided by resident)

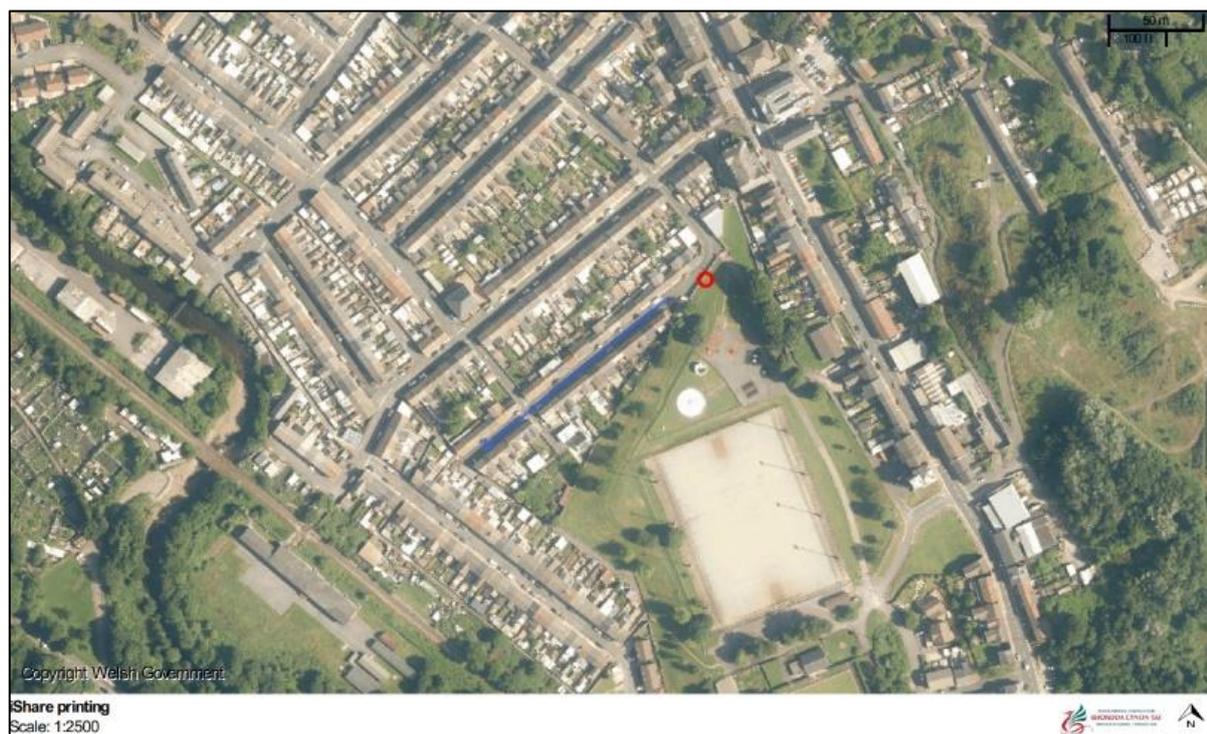
Several properties at Pleasant Street reported repeat internal flooding to residential properties on Thursday 20th February, only four days following the initial flood event during Storm Dennis. Post analysis surveys and questionnaire feedback noted the source of flooding to have originated from a manhole situated within Pleasant Street Park, due to blockages of the Pentre Road culvert network within the park (location shown in Figure 8).

Figure 8: Location plan illustrating the location and flow path of flood water from the manhole within Pleasant Street Park

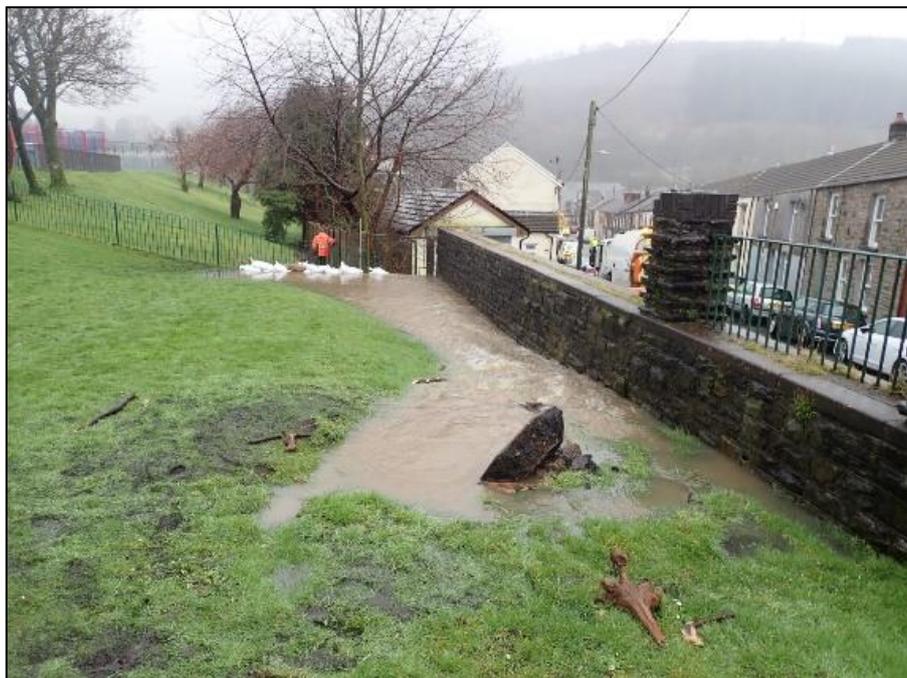
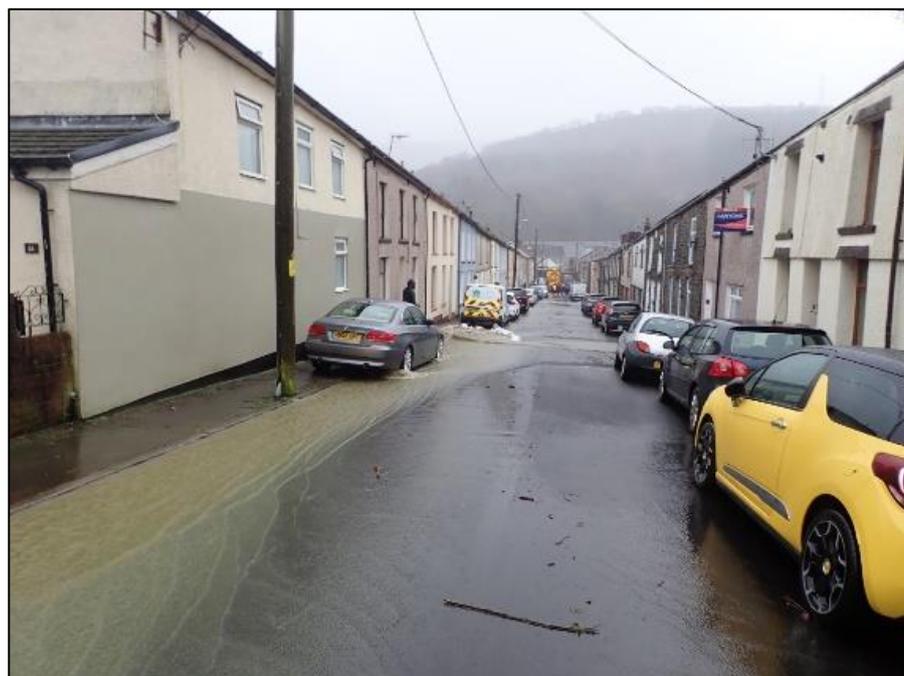
Figure 9: Surcharging manhole within Pleasant Street Park (top) and flow path down Pleasant Street (bottom) taken by RCT's FRM team on 20th February 2020

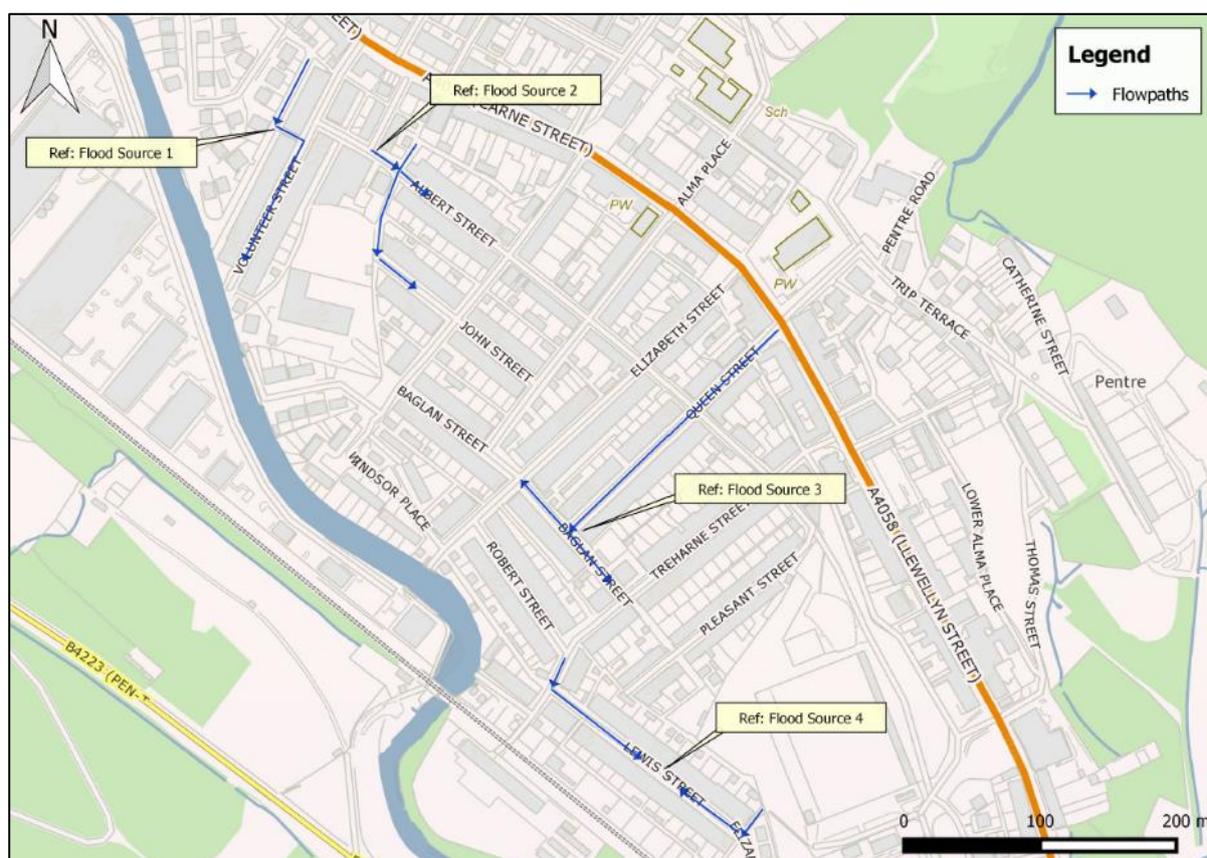
Figure 10: Main sources of flooding on the 17th June 2020 based on anecdotal evidence

Large volumes of water were observed flowing down a lane to the west of Volunteer Street then onto Volunteer Street (Flood Source 1 shown in Figure 10). Surface water travelled along gullies on both sides of Volunteer Street, where a number of properties were impacted internally and/or externally by the flood water. Two manholes were also reported to have surcharged within two residential properties on Volunteer Street, resulting in both properties near the Volunteer Street lane flooding internally.

High volumes of surface water were noted to have accumulated outside the ‘Pentre Legion’ at the junction of Price Street and Albert Street (Flood Source 2 shown in Figure 10). Several manholes surcharged along Albert Street contributing to the flooding. The water passed along Albert Street in an easterly direction towards John Street, causing internal flooding to one property, with water entering from the rear of the property. Several properties on Price Street and Albert Street were also internally flooded from ponding surface water that was unable to drain away.

Intense rainfall caused surface water runoff to travel down the village’s steep roads and accumulate at the bottom of the streets, including Queen Street, Elizabeth Street and Treharne Street (Flood Source 3 shown in Figure 10). The ponding of water led

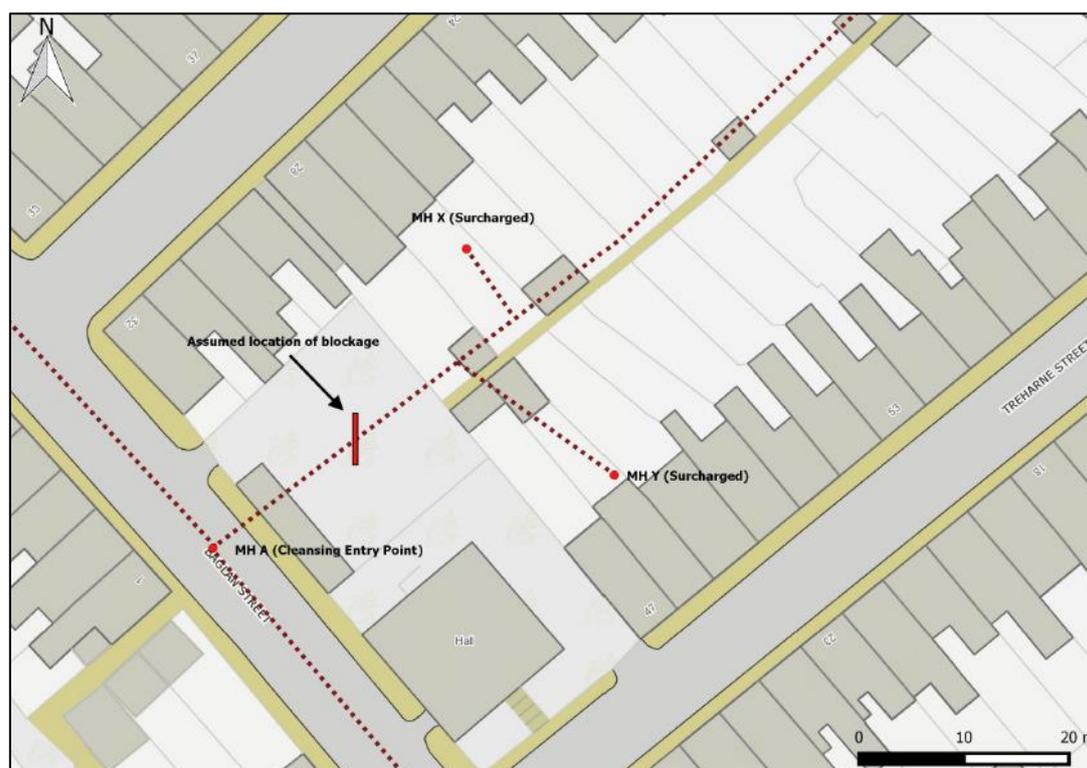
Post event analysis carried out by RCT's Flood Risk Management team identified the primary source of flooding during this event to be two surcharging manholes, caused by an assumed blockage in the combined network as shown in Figure 11. DCWW identified the cause of blockage was linked to misuse of the public sewer.

Figure 11: Location of surcharging manholes causing internal flooding to three properties during the 5th August 2020 flooding event

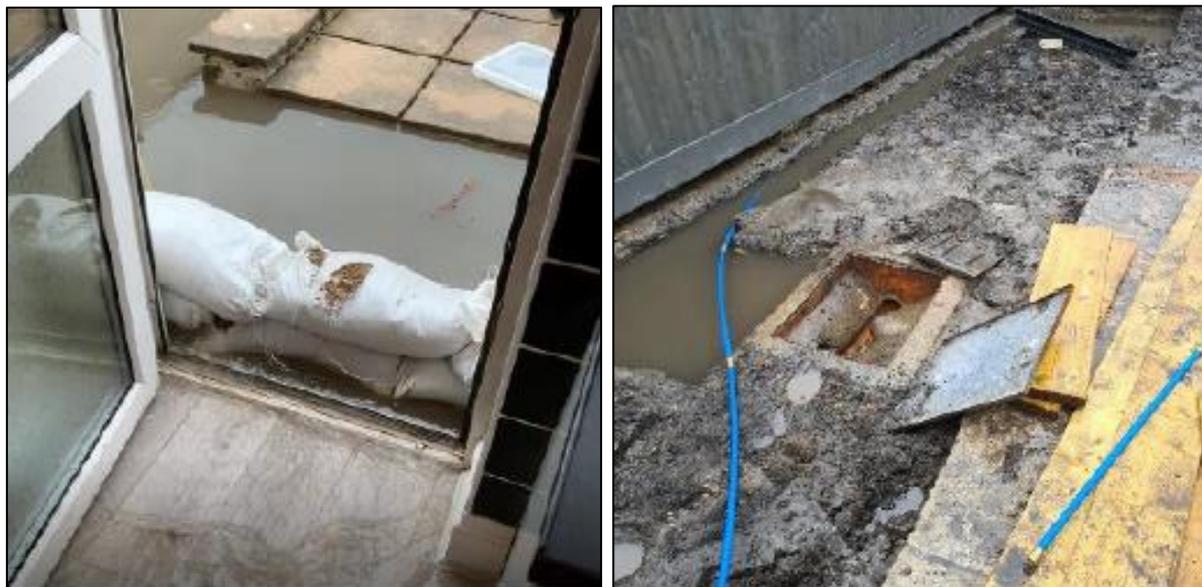
The surcharging manholes proceeded to fill the rear gardens of the affected properties within Queen Street and Treharne Street before entering the properties via the back doors, resulting in three residential properties experiencing internal damage to their property.

Figure 12: Water entering the Queen Street property via the back door (left) and location of surcharging manhole at Treharne Street, causing internal flooding to three properties (right)

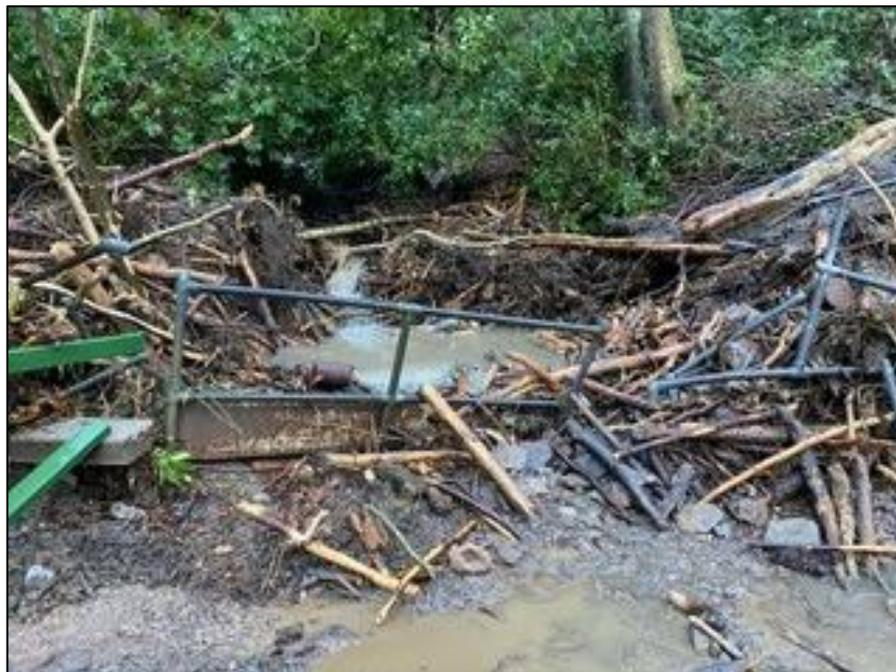
have been blocked by woody debris washed off the mountain side, which severely reduced the hydraulic capacity of the inlet. Upon a review of the hydraulic performance of the inlet without blockage, it was identified as having a standard of protection of 1 in 1000 year. This confirms that the inlet had sufficient capacity to deal with the storm event, but its capacity was significantly reduced due to blockages which ultimately was the primary cause of flooding at Pentre during Storm Dennis. These blockages at the inlet severely reduced the inlet's capacity to manage the flow of water.

Following the first flood event of 2020 that occurred on 16th February (Storm Dennis), the four culvert inlets were inspected by RCT's Flood Risk Management team. The results of which identified that only Pentre Road inlet was found to have been overcome with debris, reportedly having been washed down from the upper catchment, as shown below in Figures 14 - 17.

Figure 14: Photo of Pentre Road culvert inlet captured by RCT's Highways and Streetcare Depot immediately after the storm event (16/02/2020)

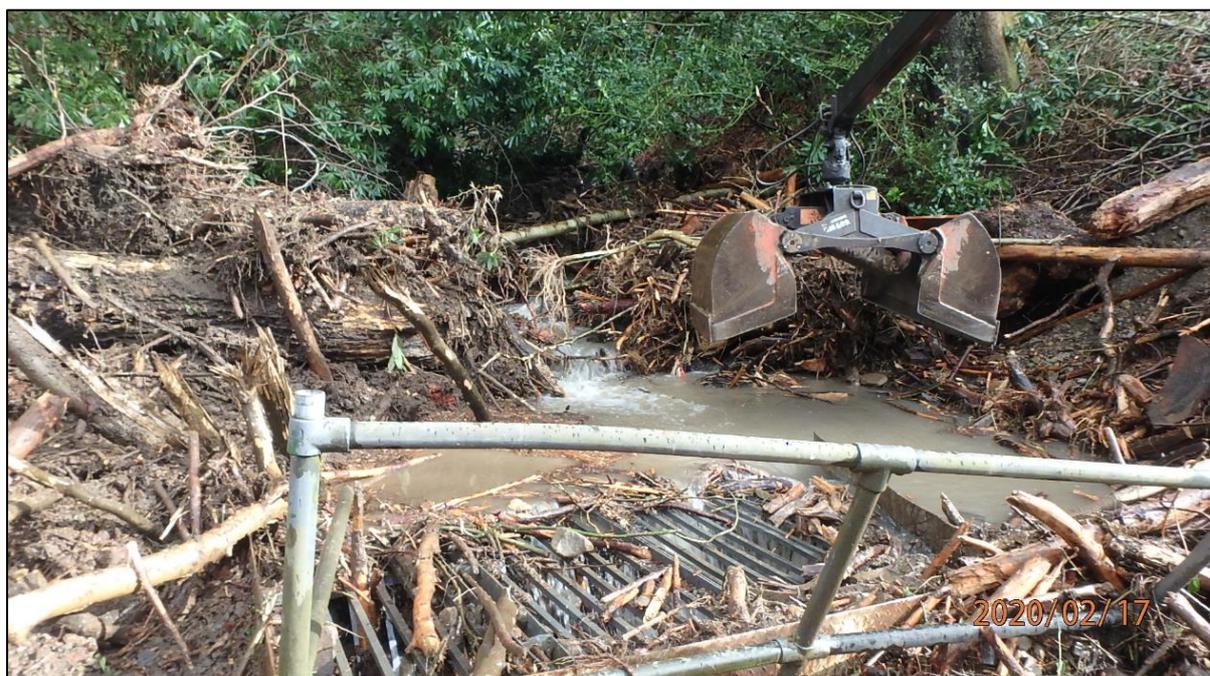
Figure 15: Photo of Pentre Road culvert inlet during works to remove deposited material post Storm Dennis (17/02/2020)

Emergency works commenced post flood event to remove the debris from around the inlet and repair the blocked culvert. An operative from RCT's Highways and Streetcare Depot described the material at the inlet as "trees and logs". A photograph captured by a resident shows evidence of woody debris being transported away from the Pentre Road culvert following initial clearance works (Figure 18). Extensive cleansing of the Pentre Road culvert inlet was carried out during 17th – 21st February.

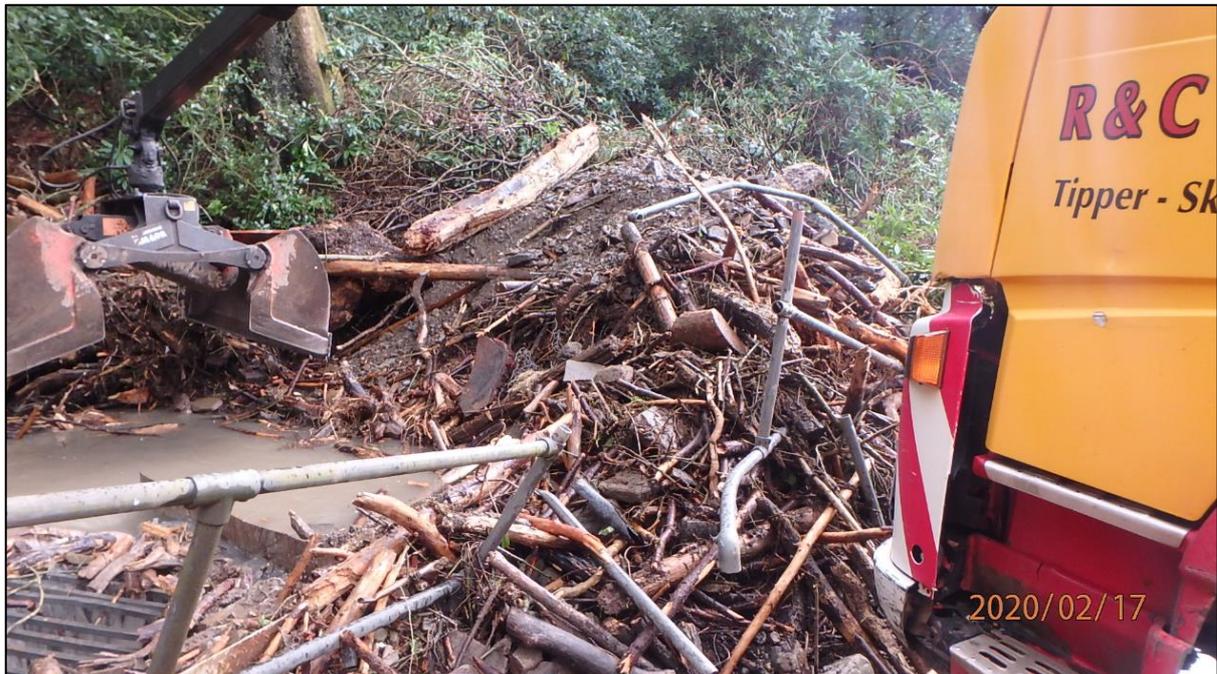
Figure 16: Photo looking across the Pentre Road culvert inlet, showing significant material collected during Storm Dennis (17/02/2020)

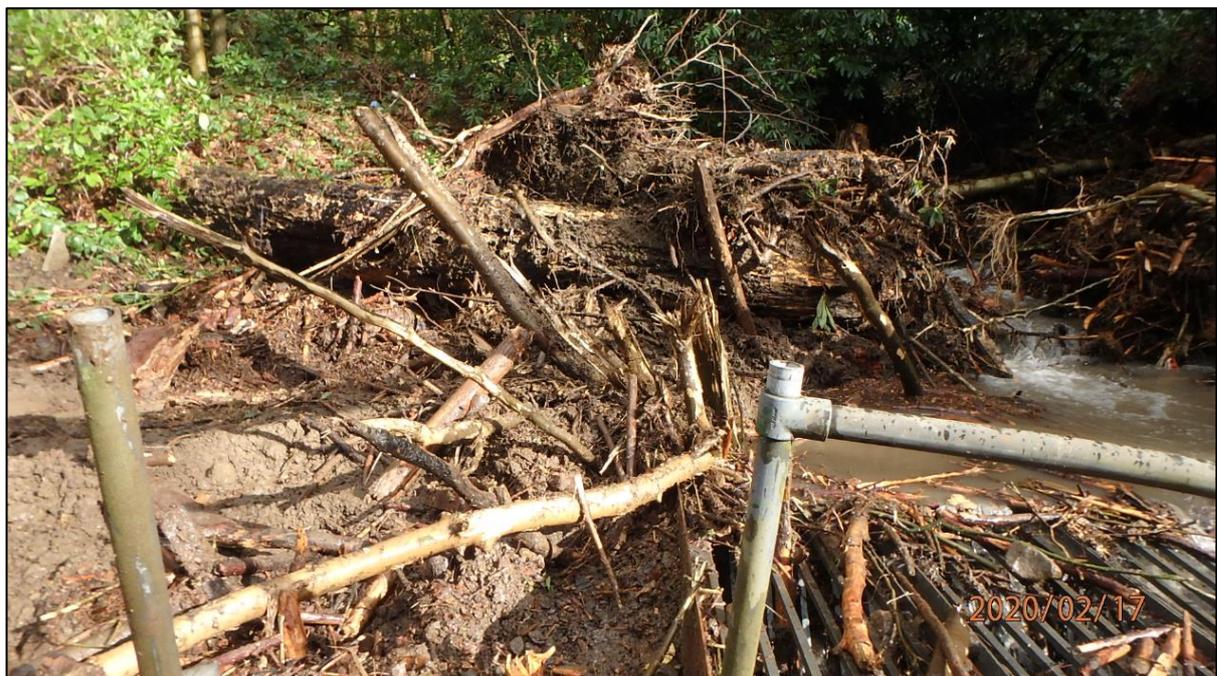
Figure 17: Photo of Pentre Road culvert inlet showing significant woody debris deposition (17/02/2020)

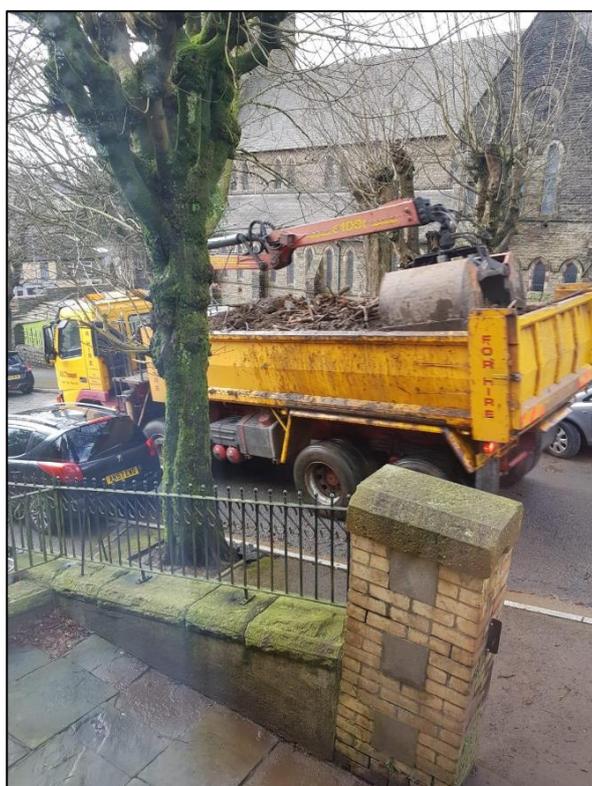
Figure 18: Photo showing woody debris being transported away from the Pentre Road culvert inlet during emergency clearance works (17/02/2020) (image provided by resident)

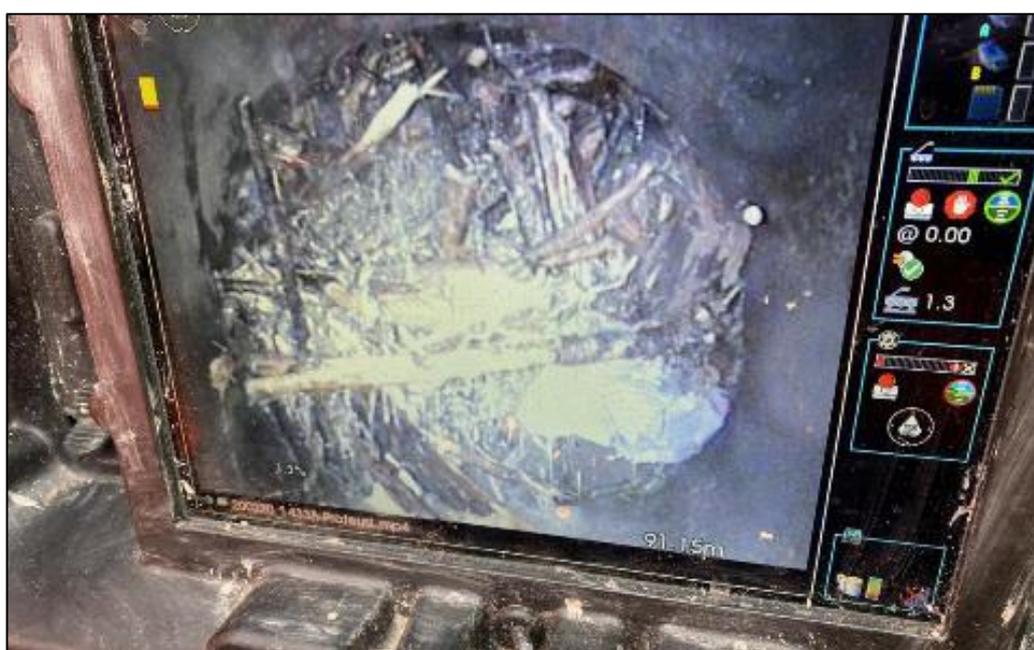
During the repeat flooding event which occurred on the 20th February 2020 impacting several properties at Pleasant Street, residents identified the source of flooding to have originated from a manhole within Pleasant Street park which had surcharged (Figure 9), resulting in water flowing out of the park towards Pleasant Street. A full-bore blockage within the Pentre Road culvert network was identified as the cause of the surcharging manhole, shown in Figure 19 below.

Figure 19: Photo showing full-bore blockage of the Pentre Road network downstream of Pleasant Street Park manhole

The image provides powerful evidence of how the mobilisation of woody debris from Pentre's upper catchment during Storm Dennis made its way into the culvert network, resulting in damages to the carrier line and a reduction in the culvert's ability to manage the flow of water. This resulted in water backing up the system and causing the manhole to surcharge. Significant resources, including the fire brigade, were rapidly deployed by RCT to remove the blockage and stop the properties from flooding in the days following the event.

In response to the debris identified within the inlet and downstream manhole, RCTCBC on the 28th February undertook extensive surveys to ascertain both the operational condition of the culvert network, and its structural integrity. The CCTV survey identified significant defects and blockages throughout the network, as well as settled deposits and stonewash reducing the networks capacity in several sections. The result was a significant operation to clear the internal culvert barrel of debris utilising specialised contractors that utilised; High Pressure Water Jetting, Vacuumation and Manual 'Hand Balling'; exercises to clear the debris from within the culvert network. This exercise lasted several months.

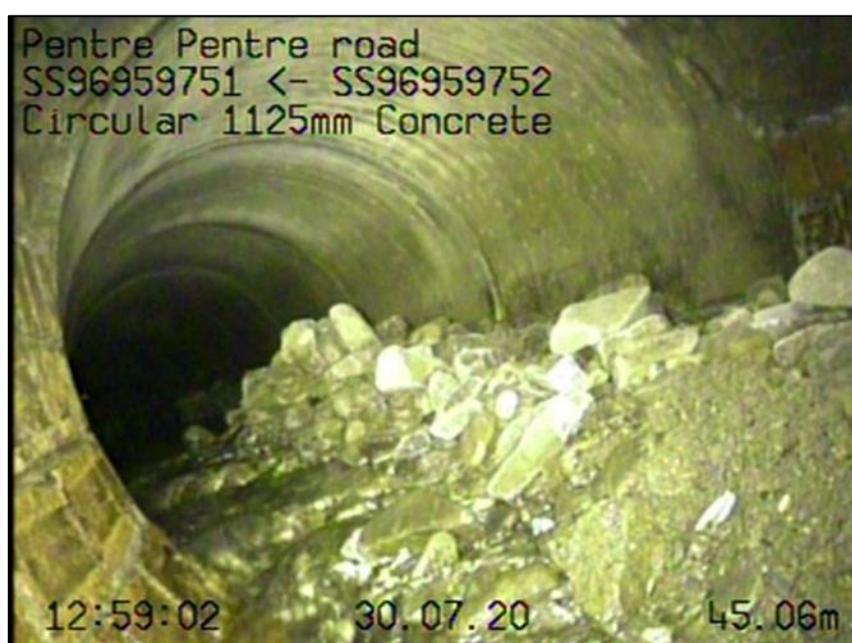
Following the flood event that occurred during the June thunderstorms, the Pentre Road culvert inlet was surveyed again on the 27th June 2020. The survey identified heavy siltation and debris that had re-accumulated in the line after previous cleansing, particularly towards the lower reaches of Pentre where between 20-60% of the network's cross-sectional areas had been lost due to settled debris and stonewash (illustrated in Figure 20). CCTV surveys of the other three networks in Pentre also confirm siltation in lower sections of the network (albeit less severe than the Pentre Road network) where the culvert gradient becomes less steep, resulting in reductions in the hydraulic capacity of the network. A total length of 3.2 km of culverted Ordinary Watercourse was surveyed, mapped and reviewed.

Figure 20: CCTV survey footage showing stone deposits between nodes SS96959751 and SS96959752 of the Pentre Road culvert network

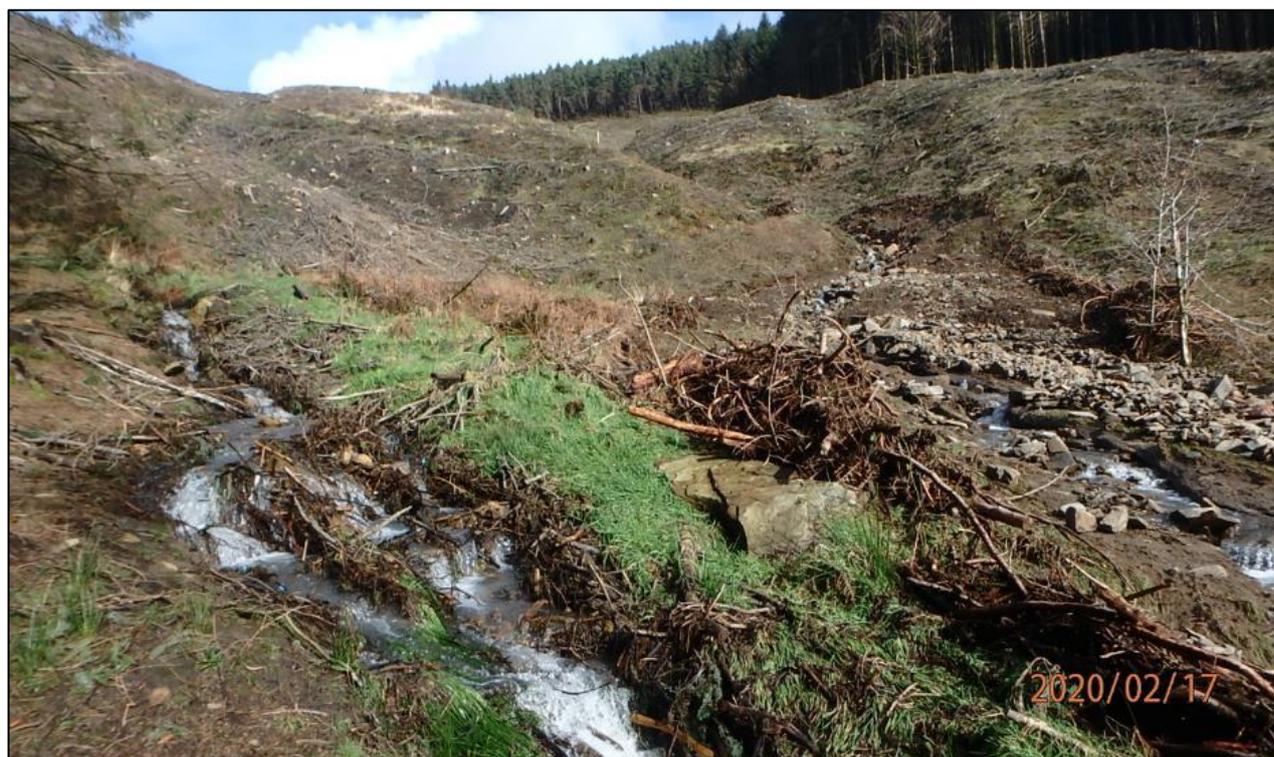
The walkover found significant amounts of woody debris across the upper catchment; an area where recent tree felling activities were carried out by NRW (Figure 22). This woody debris was similar to the debris found at the Pentre Road culvert inlet.

Figure 22: Photo of the felled area in the upper catchment of Pentre (17/02/2020) showing woody debris within the watercourses

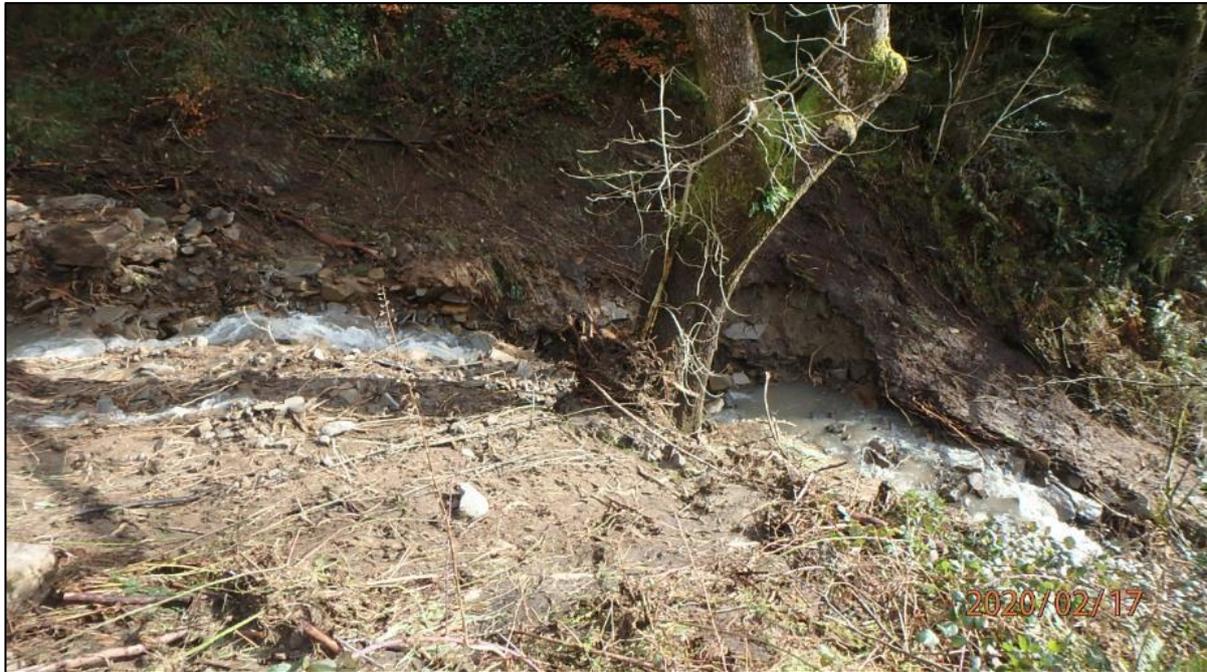
Minor scouring of the embankments of the Nant y Pentre watercourse was evident in sections (Figure 23), however this was expected given the significant flow and volume of water that followed the intense rainfall. Despite this, it is not believed that this scouring significantly contributed to the amount of debris that caused the blockage to the Pentre Road culvert inlet.

Figure 23: Photo of minor scour to the embankments of the Nant y Pentre watercourse in the upper catchment of Pentre (17/02/2020)

The watercourse was found to be in an “unstable condition” based on the amount of erosion observed. JBA conclude that “although the majority of sediment sources observed in the Nant y Pentre catchment were natural (i.e. bank erosion and landslides), it is likely they have been exacerbated by anthropogenic pressures, including land management practices”.

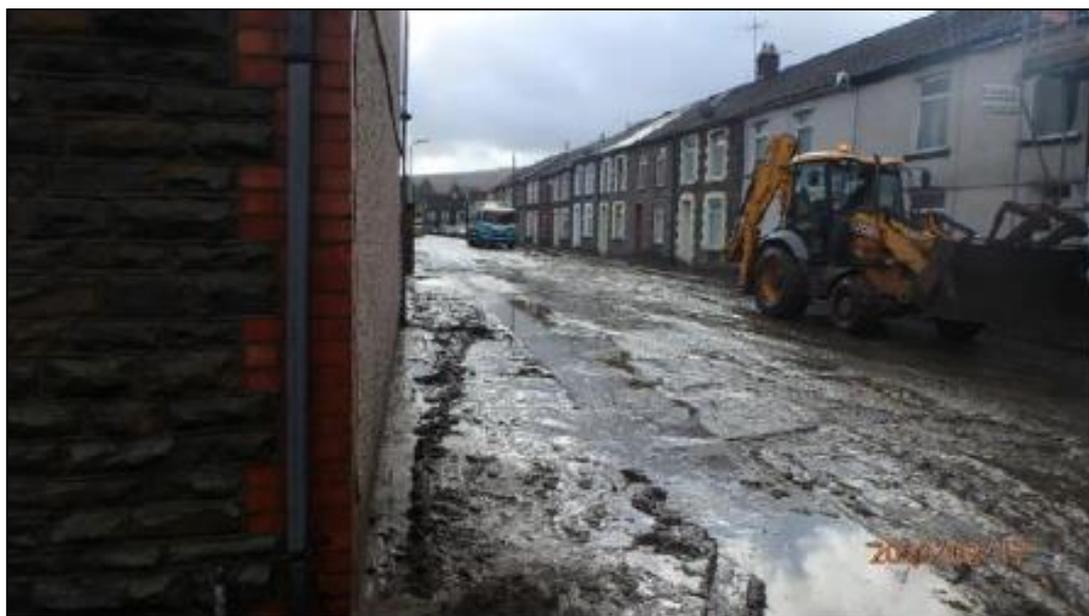
Following Storm Dennis, Pentre was left with widespread deposits of silt, sand and mud across the village which was reported to have been washed off the mountain and carried by the surcharging water through the village during the event. Figure 24 shows the deposits of mud left behind in Pentre once the flood water had drained away.

Figure 24: Photo shows the deposits of mud left behind in Pentre from the flooding during Storm Dennis (17/02/2020)

Widespread deposits on the streets are assumed to have entered the highway drainage system, leading to blockages and reduction in the hydraulic capacity of the surface water network. Evidence received following the repeat flood events in 2020 strongly suggest that there were issues relating to the function of the drainage system in Pentre, due to blockages and/or damage to the network caused by the initial flood event during Storm Dennis. A number of reports also documented manholes surcharging at various locations across the village during all flood events which suggest that the surface water network was also operating at a reduced capacity.

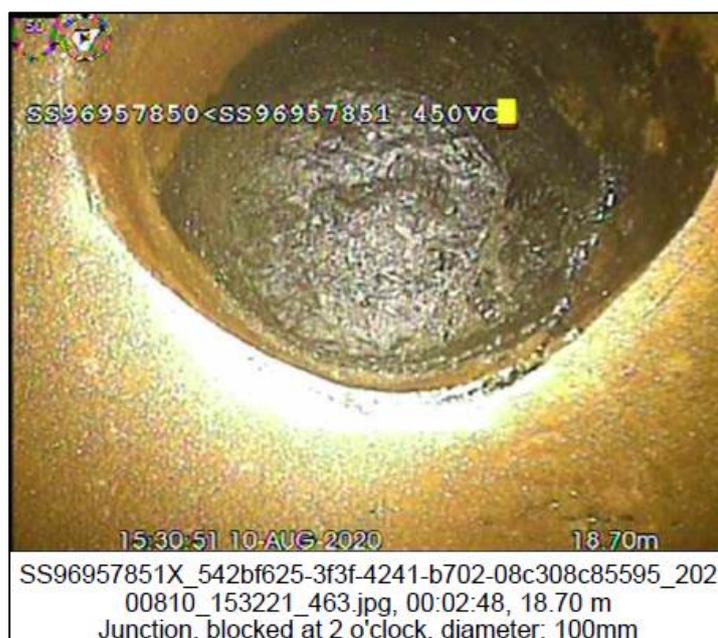
Figure 25 depicts the surface water drainage systems in Pentre, of which there is approximately 5.5 km of highway drainage infrastructure identified. This infrastructure was surveyed and mapped following extensive jetting and cleansing of the network by the Council Highways and Streetcare Depot. CCTV surveys of the highway drainage conditions in Pentre following the February and June storms confirm significant blockages were present, particularly at the Lewis Street storm water network where

the survey had to be abandoned due to two large obstacles blocking the pipe (between manholes SS96957851 and SS96959750, shown in Figure 26).

Figure 26: CCTV footage showing blockage on Lewis Street highway drainage network

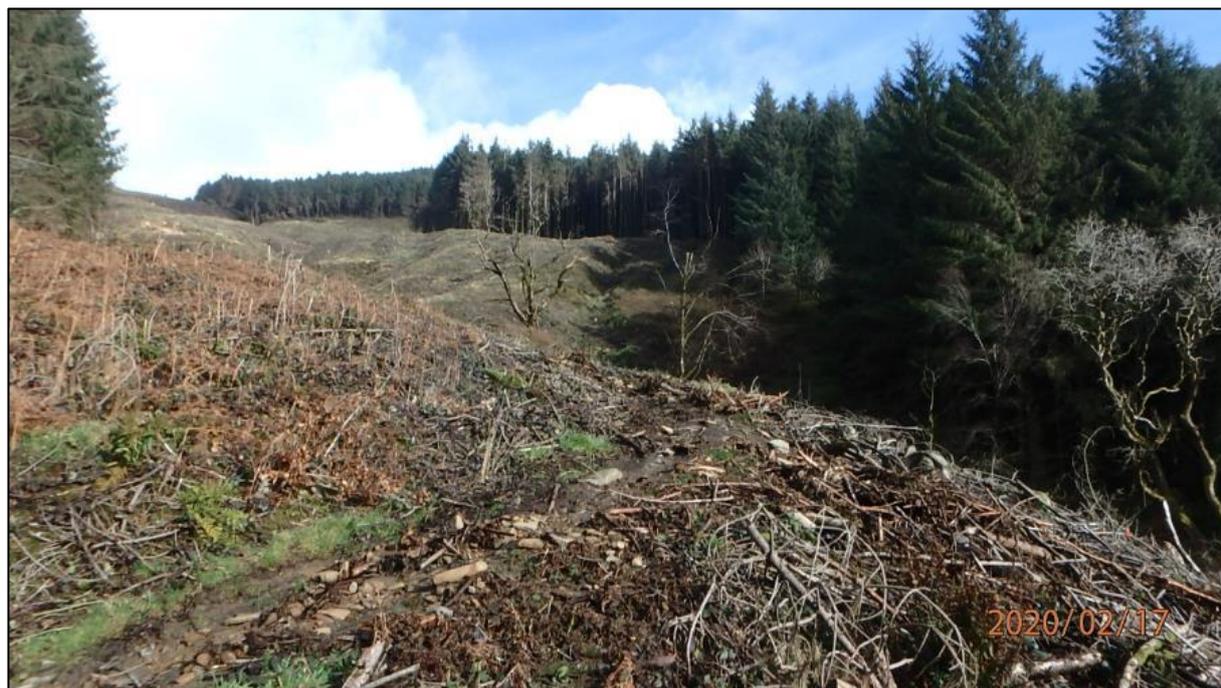
Figure 29: Photo taken by RCT's Flood Risk Management Team on 17/02/2020 showing evidence of woody debris accumulation in the upper catchment of Pentre

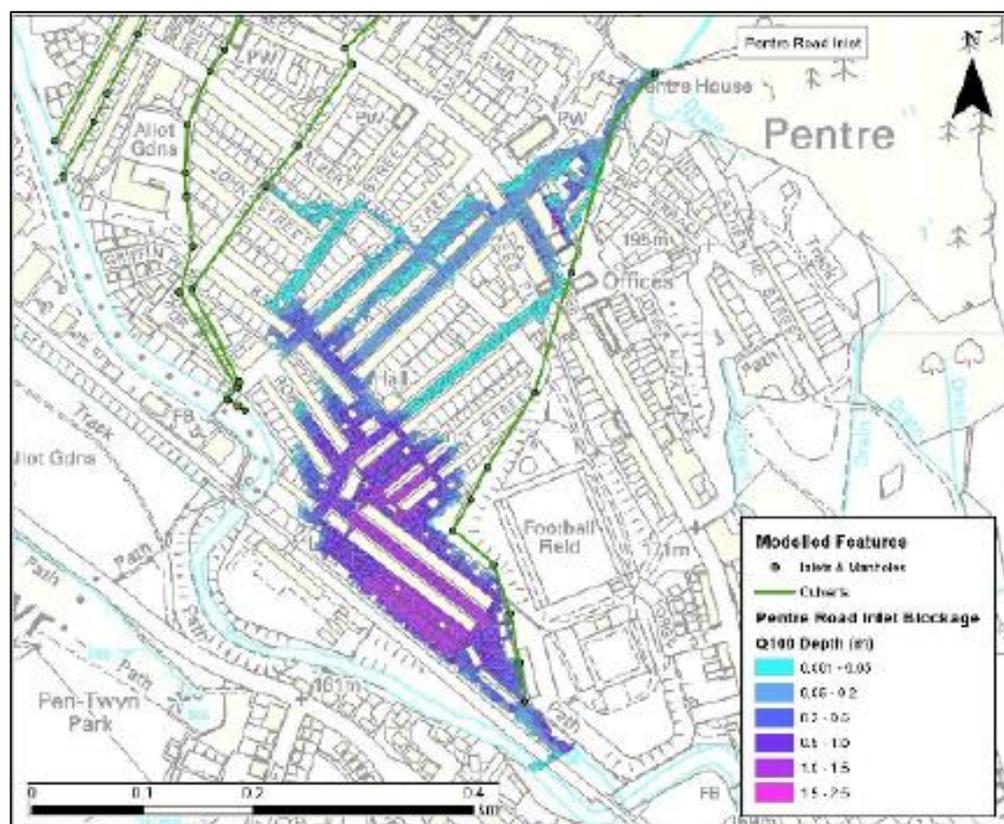
The results of the sensitivity analysis identified no flooding during scenario 1 outlining the capacity of the culvert inlet with no blockage present can accommodate the catchment flows. Scenario 2 however, identified significant flooding as depicted within Figure 31. On review of the impacts of Storm Dennis there is a close correlation with both the flow paths observed and the properties affected during Storm Dennis. This provides verification that the flooding mechanisms observed in Pentre on the 16th February 2020 were related to a blockage of the Pentre Road inlet caused by debris, the majority of which appears to have been as a result of the felling in the upper reaches of Pentre.

Figure 31: Pentre Road inlet blockage model results, Q100 flood event depths (Scenario 2)

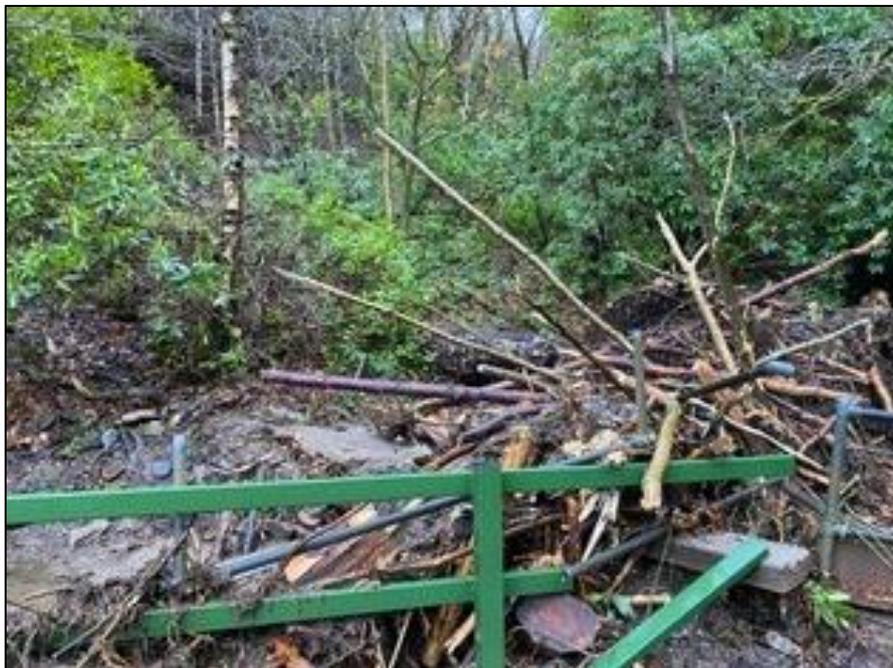
Photo provided by RCT's Highways and Streetcare Depot showing woody debris and damages to the Pentre Road Inlet on 16th February 2020.

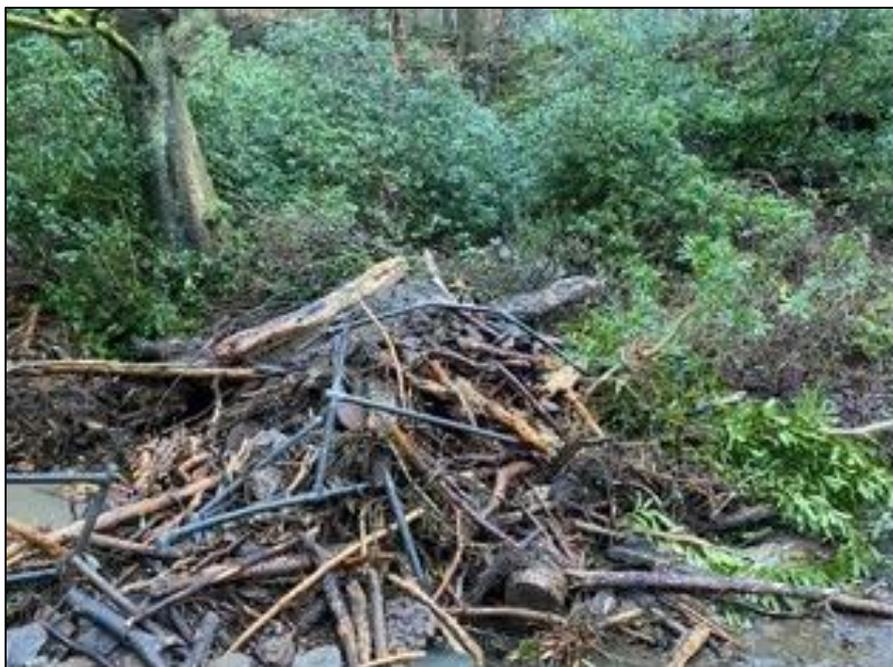
Photo provided by RCT's Highways and Streetcare Depot showing woody debris and damages to the Pentre Road Inlet on 16th February 2020.
