Section 19 Flood Investigation Report

Storm Dennis – Flood Investigation Area RCT26 (Treorchy)

February 2022

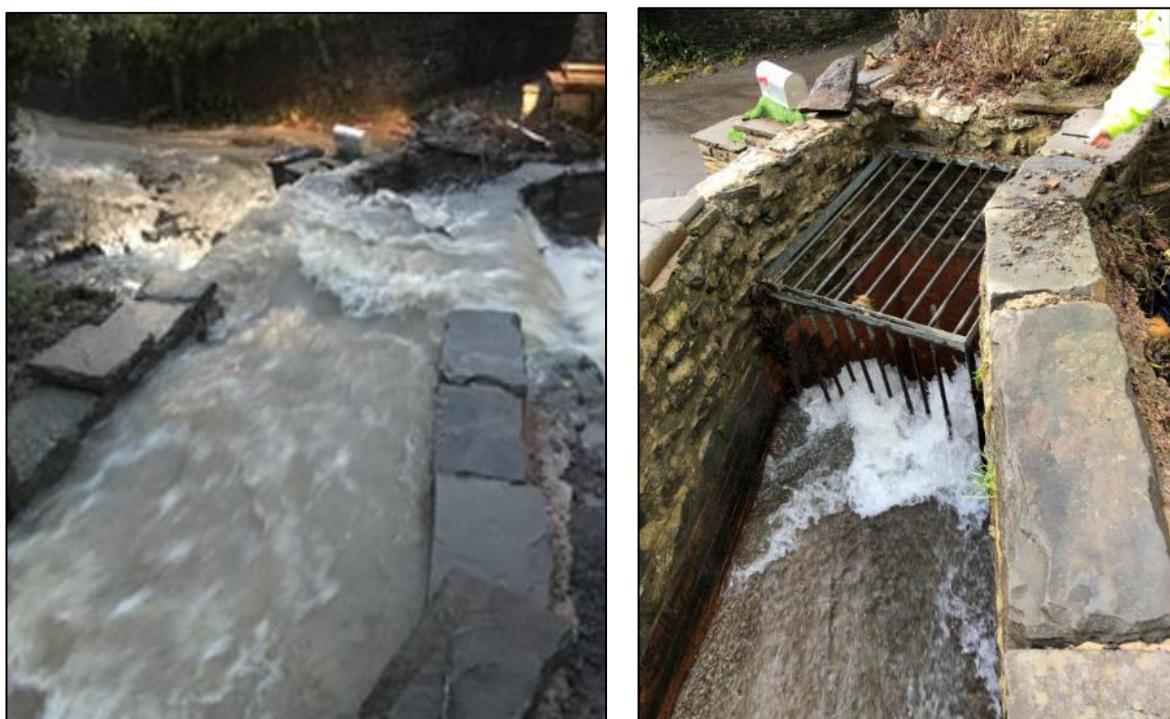
'Culvert Inlet 1' was reported by residents as the primary source of flooding to properties at Dumfries Street, Luton Street and the A4061 (Bute Street / High Street). The inlet is situated approximately 60 metres north of the 'Column Street Culvert Inlet'. The culvert was reported by residents as being "unable to manage the flow of water entering the culvert" during the early hours of the storm event and as a result surcharged. Debris consisting of large stones and silt was also noted by residents to have blocked the inlet debris screen.

Figure 5: Evidence of 'Culvert Inlet 1' surcharging during the storm event and conveying southwards towards Column and Dumfries Streets (left) (image provided by resident), and 'Culvert Inlet 1' post storm event (right) (captured by RCT's Flood Risk Management team on 20th February 2020)

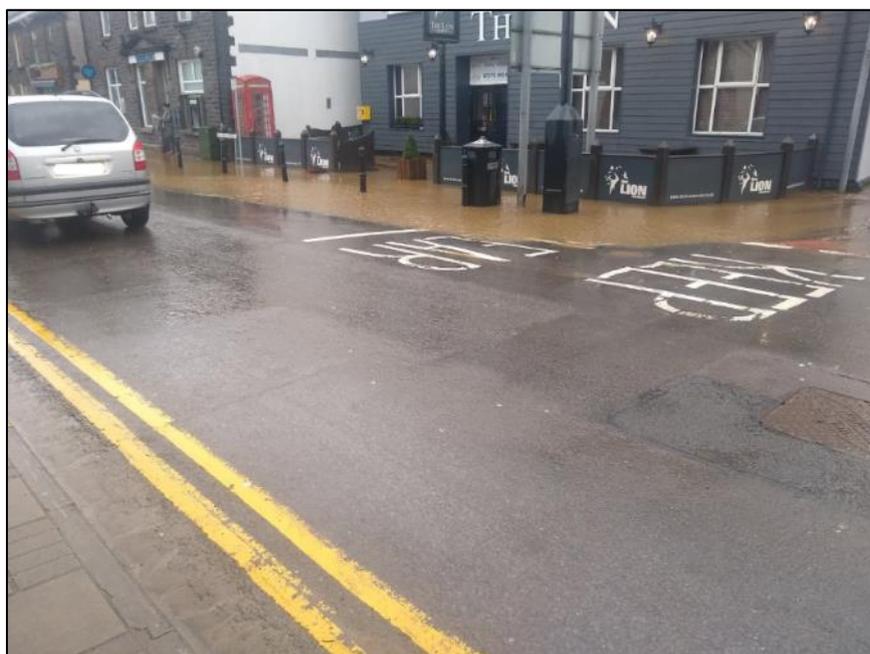
Figure 6: Surface water ponding along the A4061 High Street during Storm Dennis on 16th February 2020 (image provided by resident)

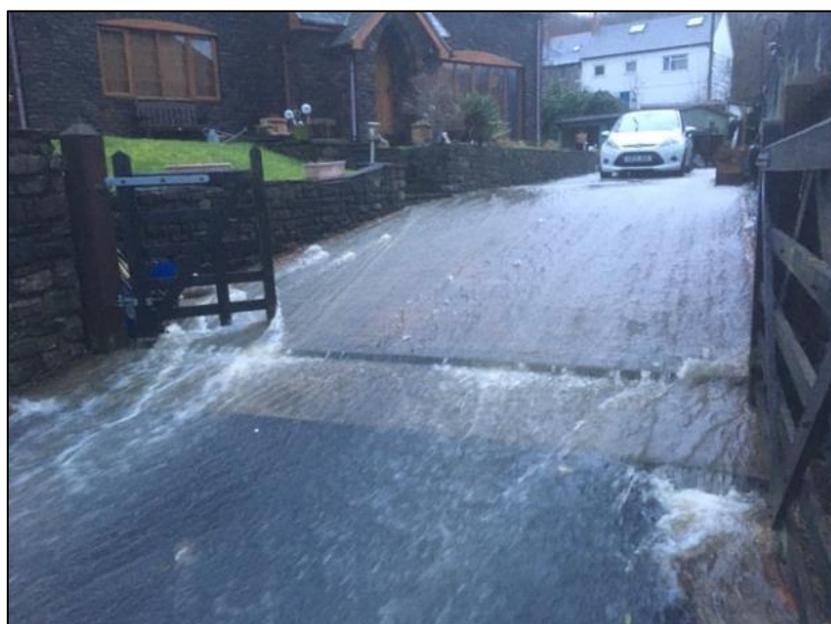
Upstream of 'Culvert Inlet 1', 'Culvert Inlet 2', located north east of Glyncoli Close, was reported to have surcharged during the storm event, causing water to travel through external private property towards Glyncoli Close and flooding 1 residential property (flow path depicted in Figure 7).

Figure 7: Flow path from 'Culvert Inlet 2' conveying towards Glyncoli Close

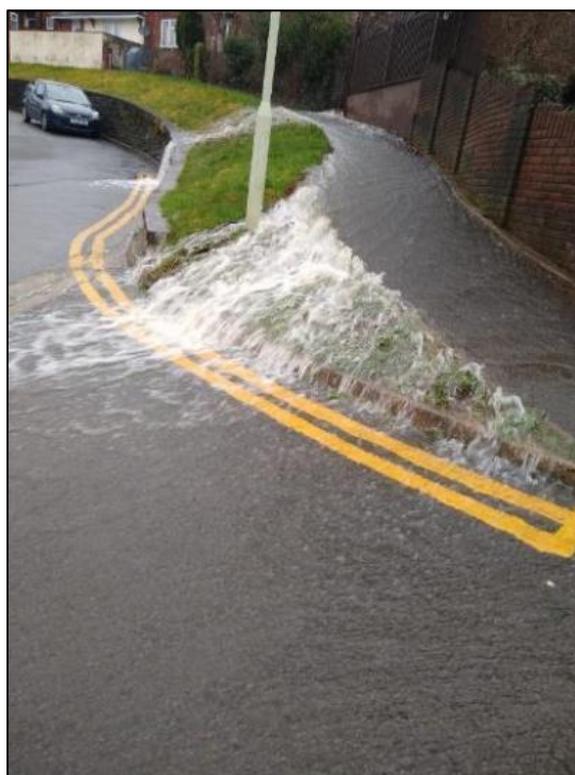
The site inspection also identified evidence of a third surcharged culvert inlet located at Heol Tyle-Du (labelled 'Culvert Inlet 3' in Figure 4). This inlet conveys flows from the Nant Tyle-du ordinary watercourse towards the 'Column Street Culvert Inlet'. 'Culvert Inlet 3' was observed as surcharging by residents during the event, resulting in water conveying down Heol Tyle Du towards Bryn Rhodfa. At a low point along Bryn Rhodfa, water overtopped the kerb line before cascading down the hillside towards the rear of properties at Heol Orchwy. Four residential properties along Heol Orchwy were confirmed as internally flooded as a result of this flow path.

Figure 8: Surcharging flows down Heol Tyle Du from 'Culvert Inlet 3' during Storm Dennis (image provided by resident)

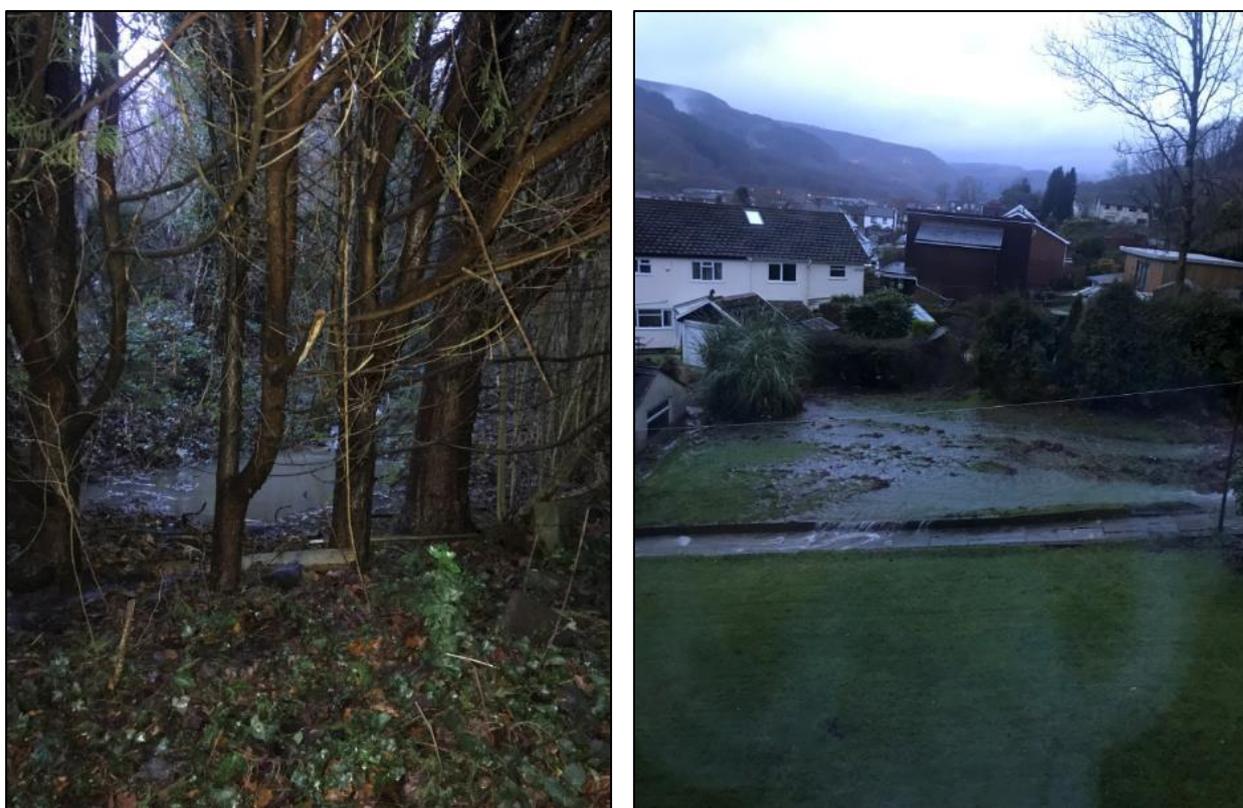
Calls were received by residents at Crosswood Street to report water emanating from a culvert inlet situated north of Crosswood Street. Upon wider inspection of the area and discussions with residents, undertaken by RCT's Flood Risk Management team on 21st February 2020, one culvert inlet, labelled 'Culvert Inlet 4' in Figure 9, showed evidence of surcharge.

Figure 10: Evidence of 'Culvert Inlet 4' surcharging during Storm Dennis (left) and evidence of surcharging flows travelling through the garden of a private property towards the park space downstream (right) (images provided by resident)

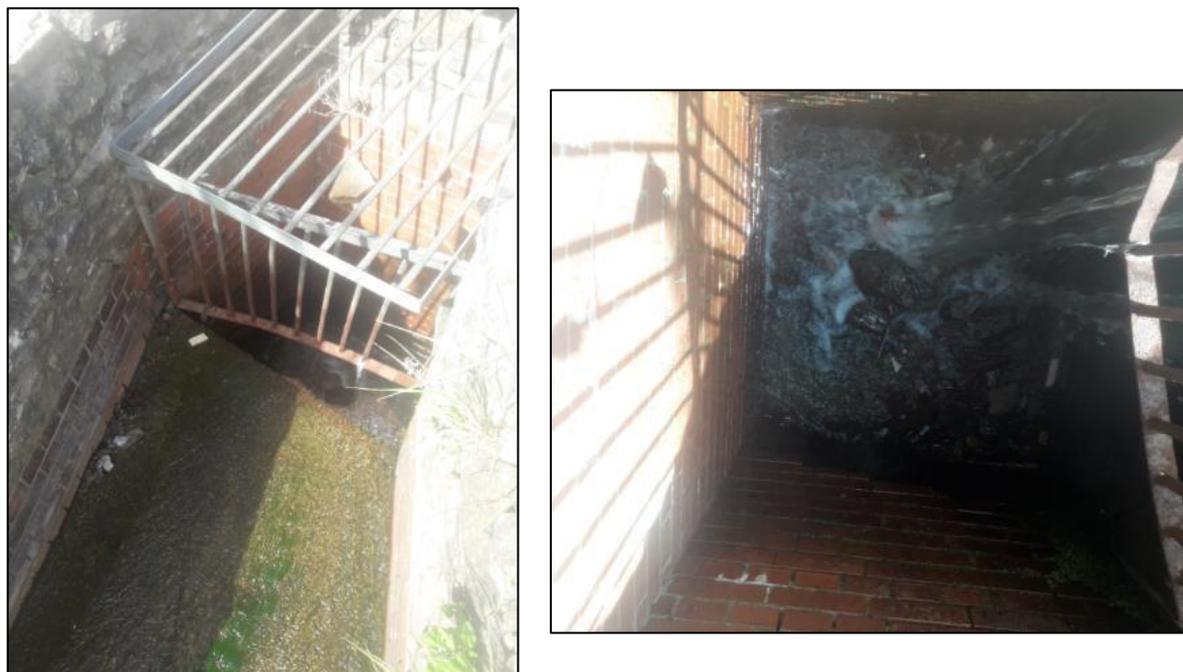
The 'Culvert 1 – Nant Tyle-du' network was surveyed to be in acceptable condition downstream of the inlet however, significant debris was noted to have accumulated within the inlet chamber during cleansing operations (Figure 12, right). The ordinary watercourse entering the culvert network is set much higher than the inlet itself,

allowing smaller debris to pass through the debris screen and build up at the start of the pipe (Figure 12, left).

Figure 12: Image of 'Culvert Inlet 1' captured post event during CCTV surveying operations (30/07/2020) (left) and evidence of debris accumulation within the culvert chamber (right)

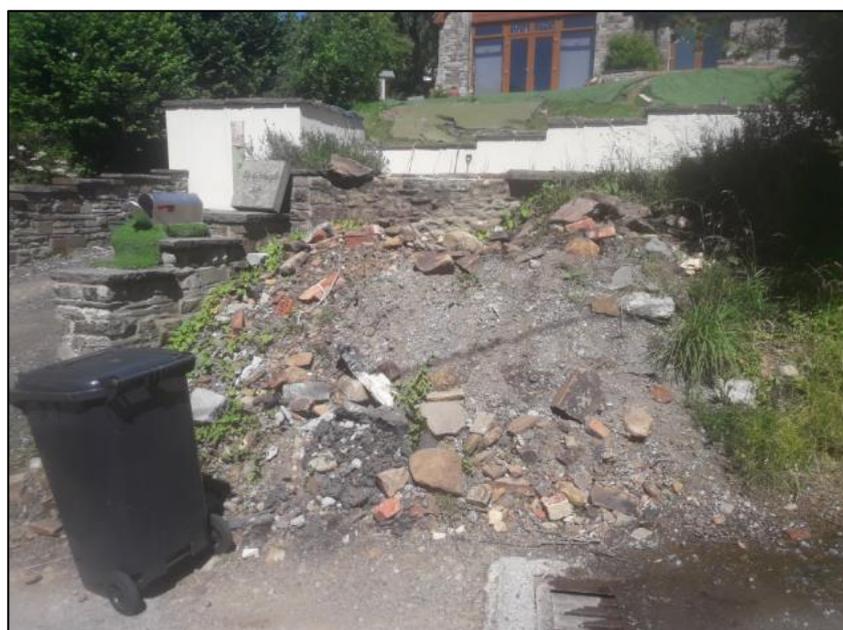
The CCTV survey also noted damages caused to the inlets trash screen, indicating that the inlet suffered significant debris accumulation during the storm event. It was noted by residents and emergency responders that the culvert became blocked with debris during the storm event. It was also noted by residents that tyres were amongst the debris removed from the culvert.

The condition of the inlet structure itself is considered to have contributed to the surcharging at 'Culvert Inlet 1' by allowing some debris to enter the network however, the volume of debris entering the network from the hillside above RCT26 is considered the primary cause of surcharge.

Figure 13: Evidence of debris removed from 'Culvert Inlet 1' post event (captured by Council appointed contractor during CCTV surveying operations on 30/07/2020)

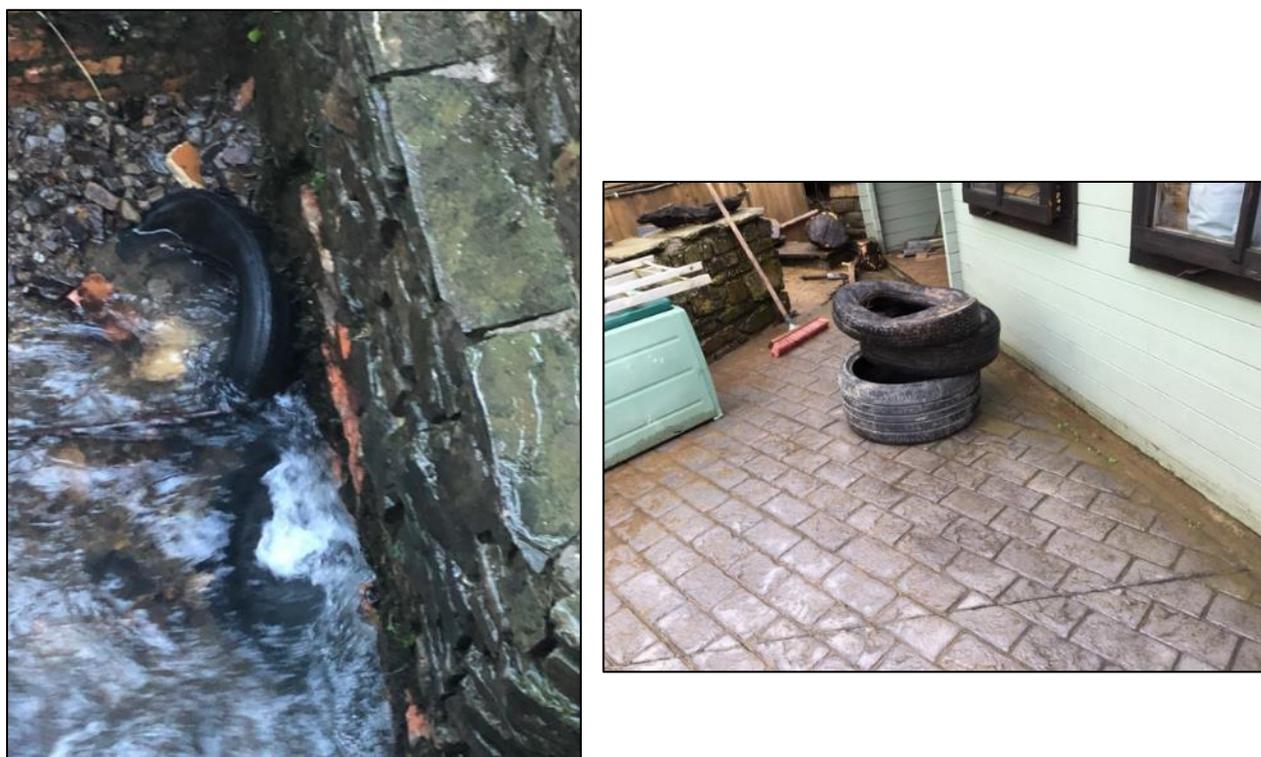
'Culvert Inlet 2' was identified by first responders as being blocked with silt and debris mobilised by the fast-flowing water entering the network during the storm event. Photographs and video footage provided by residents during post event inspections carried out by RCT's Flood Risk Management team on 17th February 2020 show evidence of tyres being manually pulled out of the culvert inlet to manage the flow of water (Figure 14). This material was reportedly washed down from the upstream ordinary watercourse section (described in Section 3.2).

Figure 14: Evidence of debris, inclusive of tyres, causing a blockage to 'Culvert Inlet 2' during Storm Dennis (left) and evidence of the three tyres removed from the inlet by a resident (right) (images provided by resident)

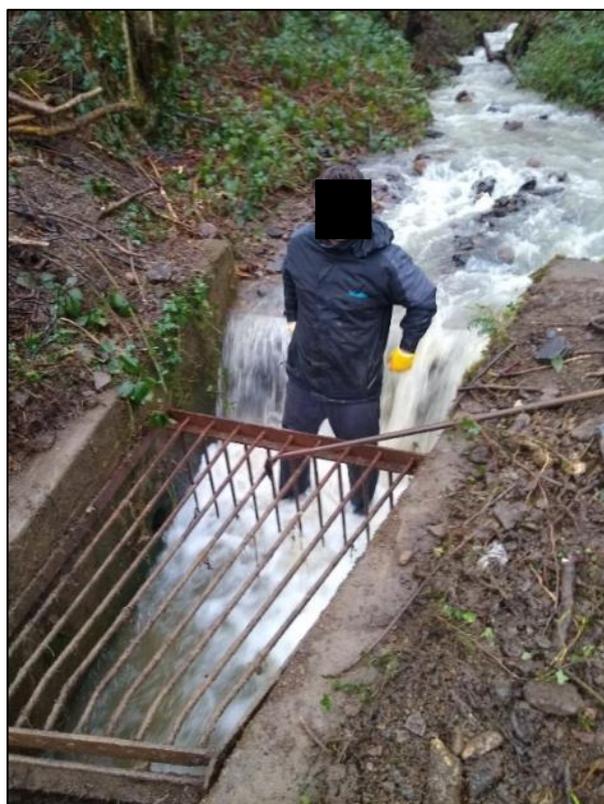
Figure 15: Photo of 'Culvert Inlet 3' following initial debris clearance by local residents on 16th February 2020.

Internal CCTV surveys of the culvert network recorded the culvert as being in poor structural and operation condition with several fractures and broken sections of pipe in addition to loss in cross-sectional area caused by settled deposits. As a result, approximately 2 tonnes of debris was removed from the network during cleansing operations.

The poor condition of the 'Culvert Inlet 3 – Heol Tyle-du' network is considered to have contributed to the flooding however, blockages to the inlet structure which reduced the inlet's hydraulic capacity to manage the flow of water has been determined as the most significant contributor to the observed surcharging during Storm Dennis.

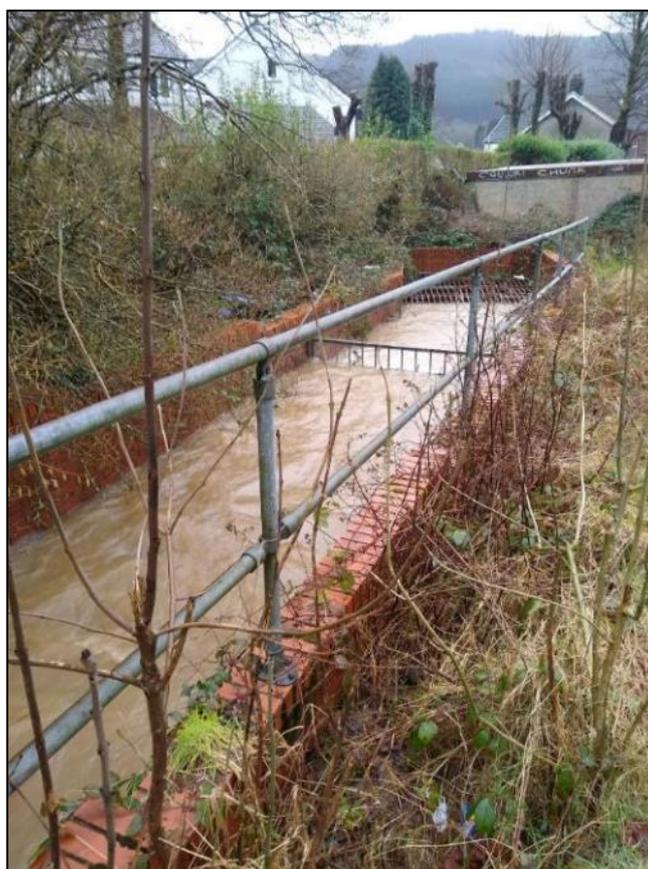
During the storm event, the ‘Column Street Culvert Inlet’ and upstream section of open watercourse was observed as being almost at full capacity (Figure 16). Partial debris accumulation behind the upper debris screen within the open channel were observed by residents however, it was noted that the culvert inlet was still able to manage the flow of water during the storm event (Figure 16).

Figure 16: Column Street open channel and culvert inlet showing high flows (image provided by resident. Captured at 11am on 16th February 2020)

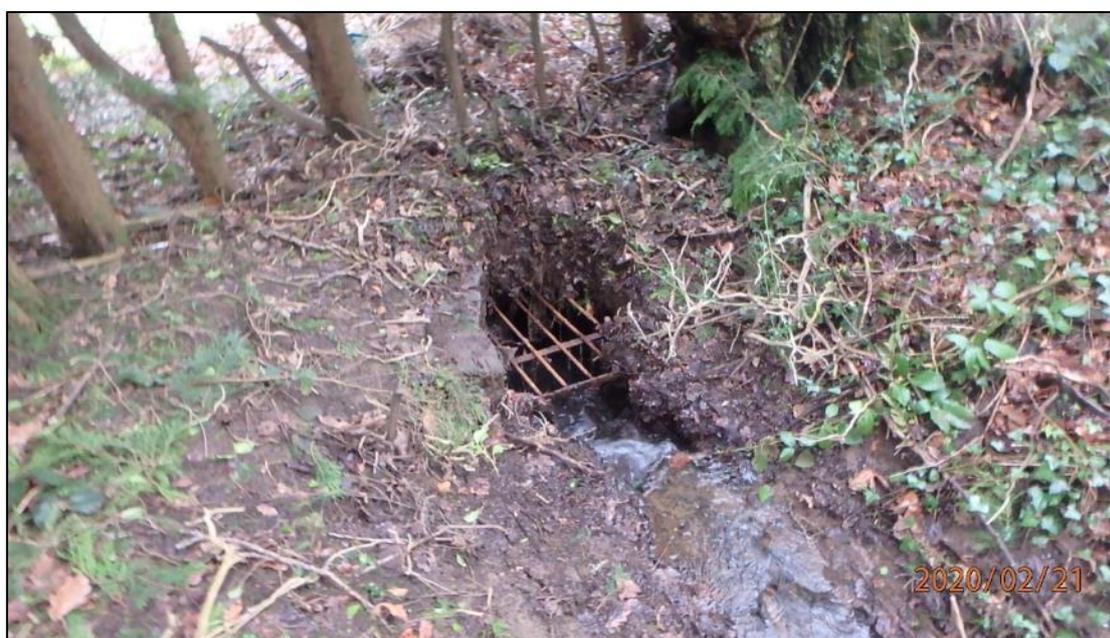
'Culvert Inlet 4' was identified as the source of flooding to one residential property at Crosswood Street. The inlet was inspected by RCT's Flood Risk Management team in the days following the storm event and was found to be in poor condition (Figure 18).

The network downstream of 'Culvert Inlet 4' was unable to be surveyed due to the inlet's poor condition restricting camera access. Furthermore, the area around the inlet structure had been washed away meaning there was no access point on the safety grid to securely carry out the CCTV survey.

Figure 18: Photo of 'Culvert Inlet 4' captured by RCT's Flood Risk Management team post storm event on 21st February 2020

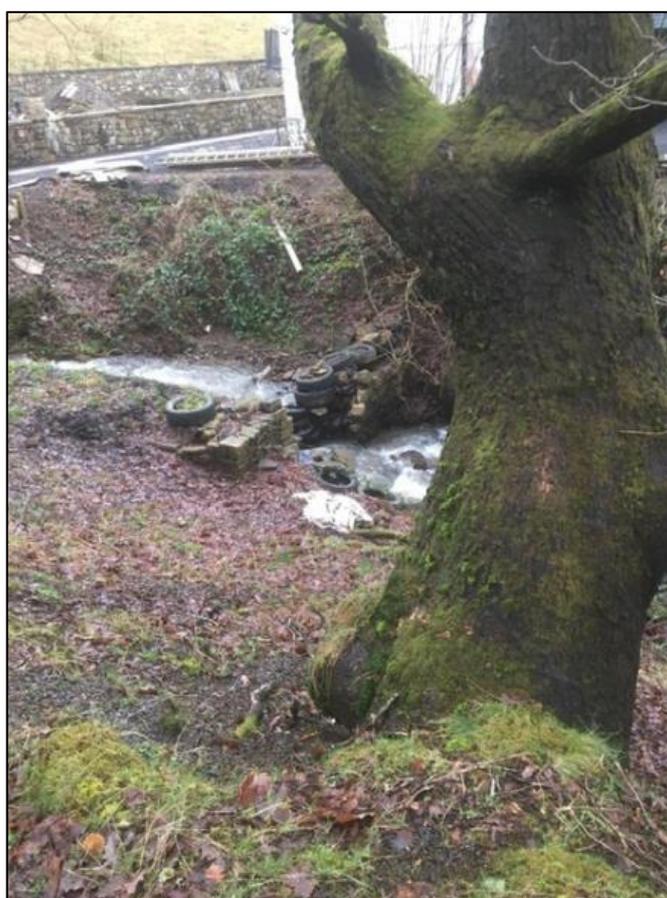
On review of the unnamed open watercourse conditions upstream of 'Culvert Inlet 2', an obstruction was identified within the channel. Evidence of the obstruction, which consisted of a man-made tyre damn across the width of the channel, is shown in Figure 20. This material is considered to have been mobilised downstream during the storm event, contributing to the surcharge of 'Culvert Inlet 2' and 'Culvert Inlet 1' by reducing both inlets' hydraulic capacities to manage the flow of the watercourse.

Figure 20: Image of tyre damn acting as an obstruction to the watercourse upstream of 'Culvert Inlet 2' (captured by RCT's Flood Risk Management team on 17th February 2020)

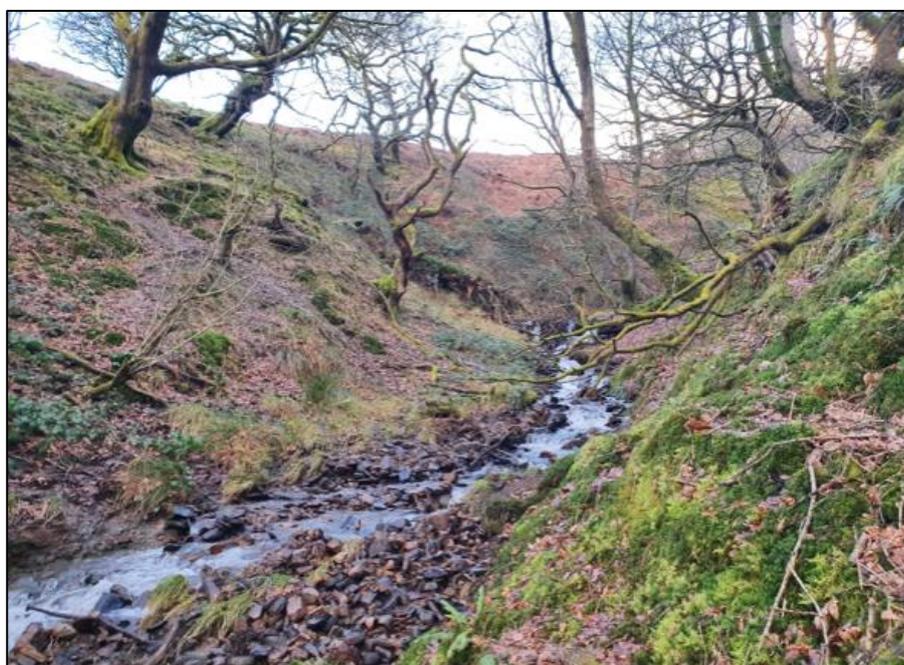
Upstream of the identified obstruction, the unnamed ordinary watercourse channel showed evidence of debris mobilisation within the upper catchment above RCT26 (Figure 21). On review of the type of debris that contributed to the blockages at 'Culvert Inlets 1 and 2', the identified stonewash material depicted in Figures 21 is considered to have been washed down the catchment towards both culvert inlets during the storm event and contributing to its surcharge.

Figure 21: Photo of the unnamed ordinary watercourse upstream of 'Culvert Inlet 2' within the upper catchment (captured by RCT's Flood Risk Management team on 17th February 2020)

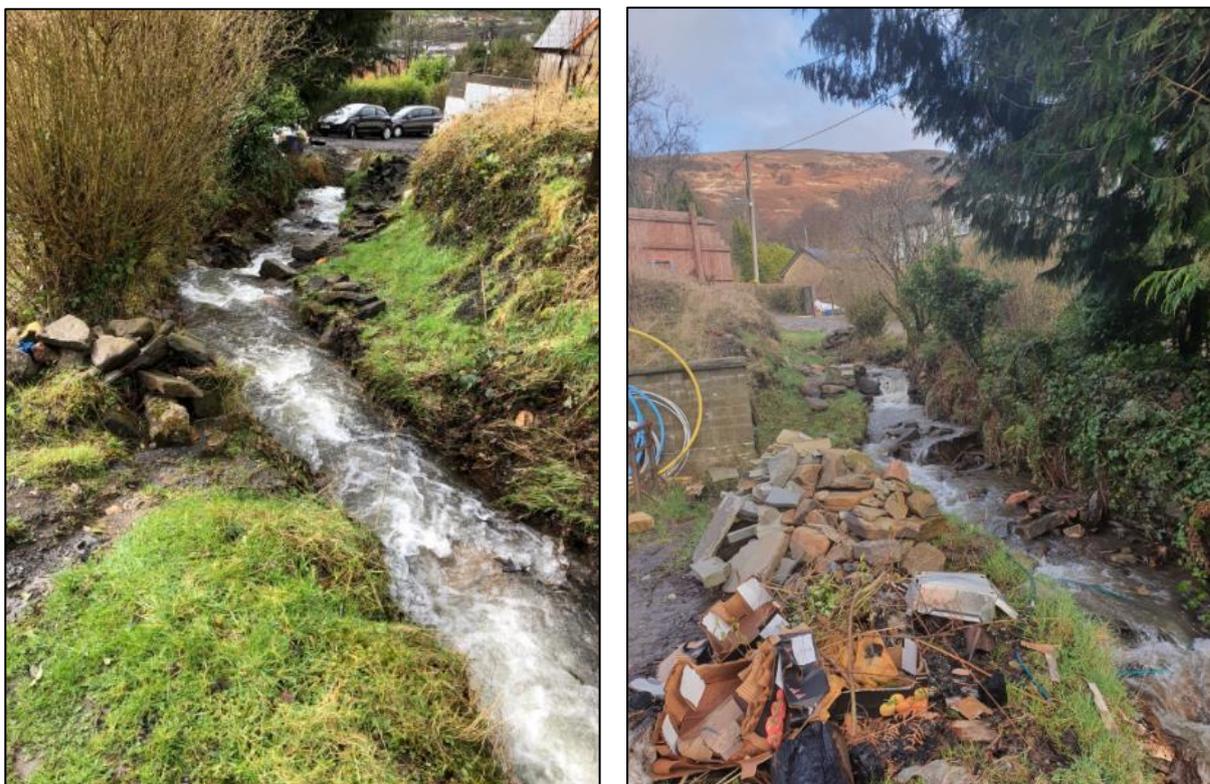
13) consisted of similar stonewash material inclusive of large stones. It is considered that this material was transported from the upper reaches of Treorchy via the unnamed watercourse and contributed to the surcharging of both 'Culvert Inlet 1 and 2'.

Figure 22: Unnamed open watercourse upstream of 'Culvert Inlet 1' showing evidence of large stones within the channel and surrounding embankment area (captured by RCT's Flood Risk Management team on 20th February 2020). Looking downstream towards 'Culvert Inlet 1' (left) and looking upstream towards the outfall of 'Culvert Inlet 2' (right).

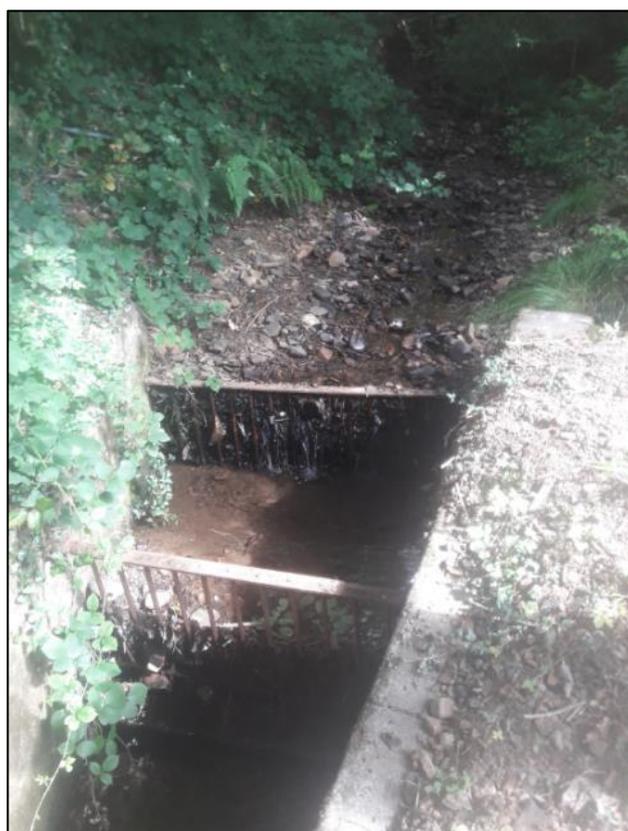
The Nant Tyle-du ordinary watercourse enters the town of Treorchy via 'Culvert Inlet 3' at Heol Tyle-du. On review of the condition of the Nant Tyle-du ordinary watercourse, significant accumulation of natural scour material was evident behind the upper debris screens upstream of 'Culvert Inlet 3' (Figure 23). Figure 23 highlights the extreme flows within the Nant Tyle-du during the storm event which were able to convey a significant volume of scour material downstream towards 'Culvert Inlet 3'.

Figure 23: Photo of significant debris accumulation behind the upstream debris screens above 'Culvert Inlet 3' in the Nant Tyle-du watercourse (captured by a Council appointed contractor on 03/08/2020 during CCTV survey operations)

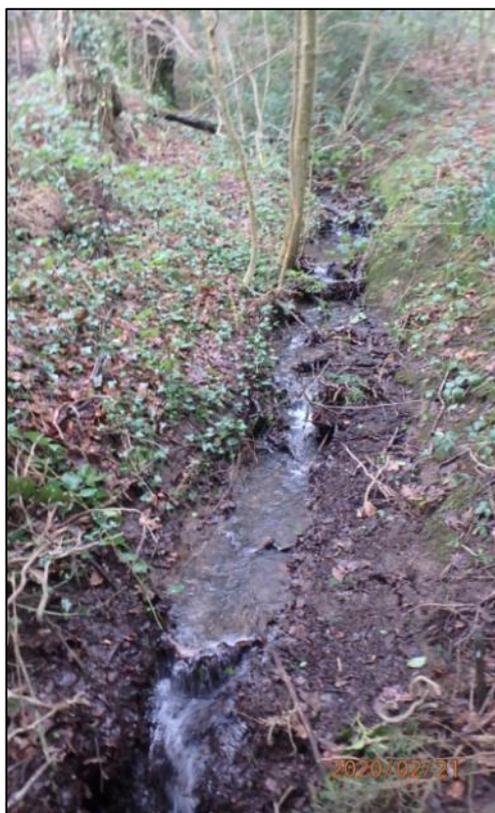
The unnamed ordinary watercourse channel was observed as largely undefined with dense vegetation restricting on-site inspections (Figure 24). The inspecting officer noted minimal evidence of scour and debris deposition within the channel, and debris was not noted at 'Culvert Inlet 4' during post event inspections, indicating that the geomorphic condition of the upstream channel had little impact on the surcharging of 'Culvert Inlet 4'.

Figure 24: Photo of the unnamed ordinary watercourse upstream of 'Culvert Inlet 4' (captured by RCT's Flood Risk Management team on 21st February 2020)

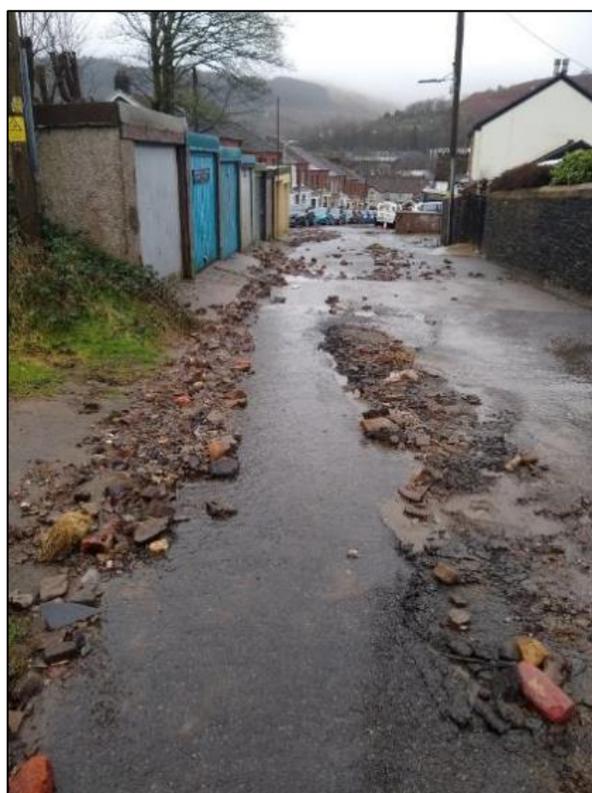
Overland flows from areas of hillside and runoff originating from surcharged culvert inlets across RCT26 resulted in deposition of mud, silt and debris across several streets which is assumed to have entered the highway drainage network via gullies. Evidence of deposited debris along Column Street is indicative of the flow path during the storm event (Figure 27).

Figure 27: Road damage and debris deposited along Column Street by the surcharging ordinary watercourse flows during the storm event (image provided by resident)

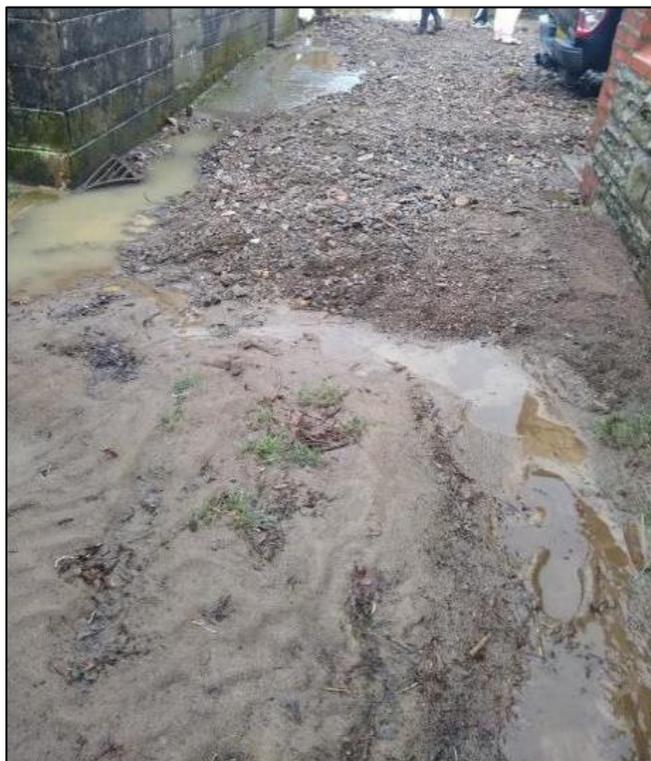
The large quantities of sediment and debris washed onto the streets is also indicative of the high sediment loading from the ordinary watercourses described in Section 3.2.

Figure 28: Photo of deposits of silt and debris left behind at Dumfries Street following the flooding during Storm Dennis (image provided by resident)
