Section 19 Flood Investigation Report

Storm Dennis – Flood Investigation Area RCT18 (Trehafod)

April 2022

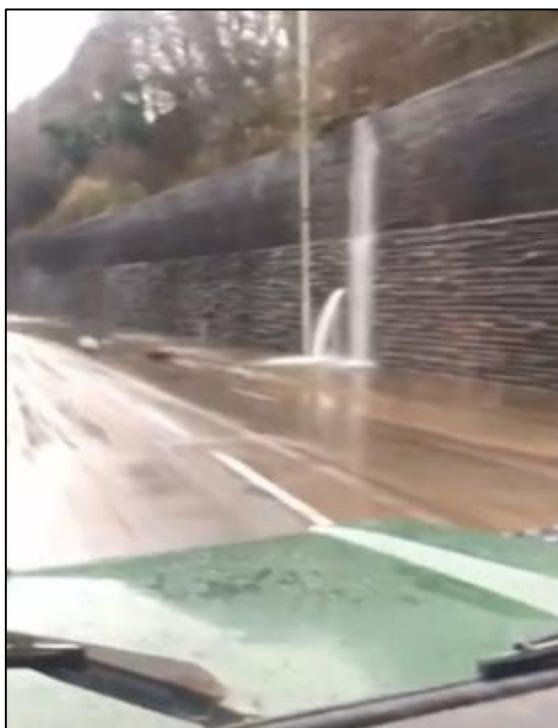
Upon an inspection carried out by RCT's Flood Risk Management officers in the days following the storm event it was reported that a localised landslip resulted in the obstruction of 'Culvert Inlet 1' (shown in Figure 5) to the north of the railway line. The obstruction subsequently led to the surcharging of 'Culvert Inlet 1', resulting in flooding to the railway line and the conveyance of flood water over the retaining wall and onto the highway (Figure 6 and 7).

Figure 6 also shows evidence of water breaching through the lower retaining wall indicating a surcharge of the ordinary watercourse culvert network downstream of 'Culvert Inlet 1'.

Figure 6: Image capturing water overtopping and breaching through the retaining wall below 'Culvert Inlet 1' and the A4058 during Storm Dennis (Source: Social Media)

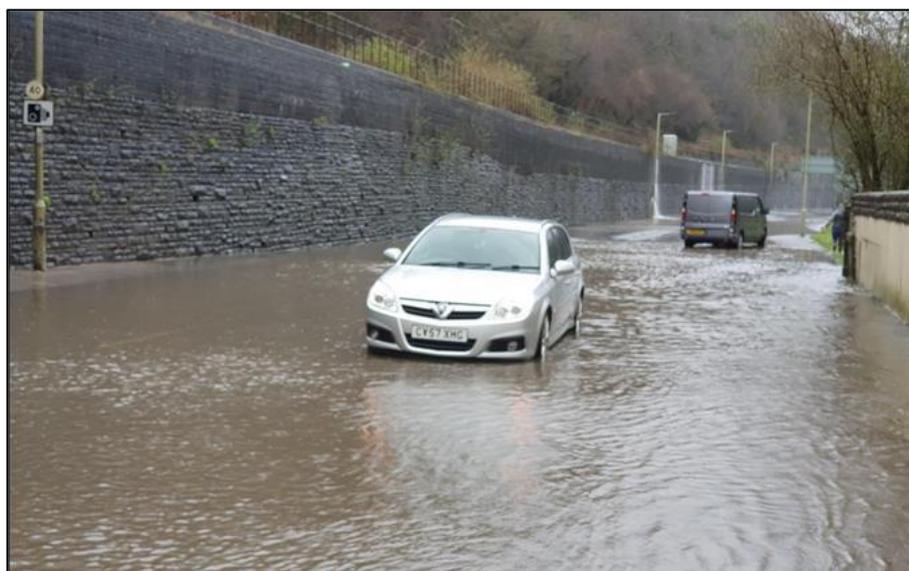
Figure 7: Surface water accumulation along the A4058 near the Trehafod Road junction during Storm Dennis (Source: Social Media)

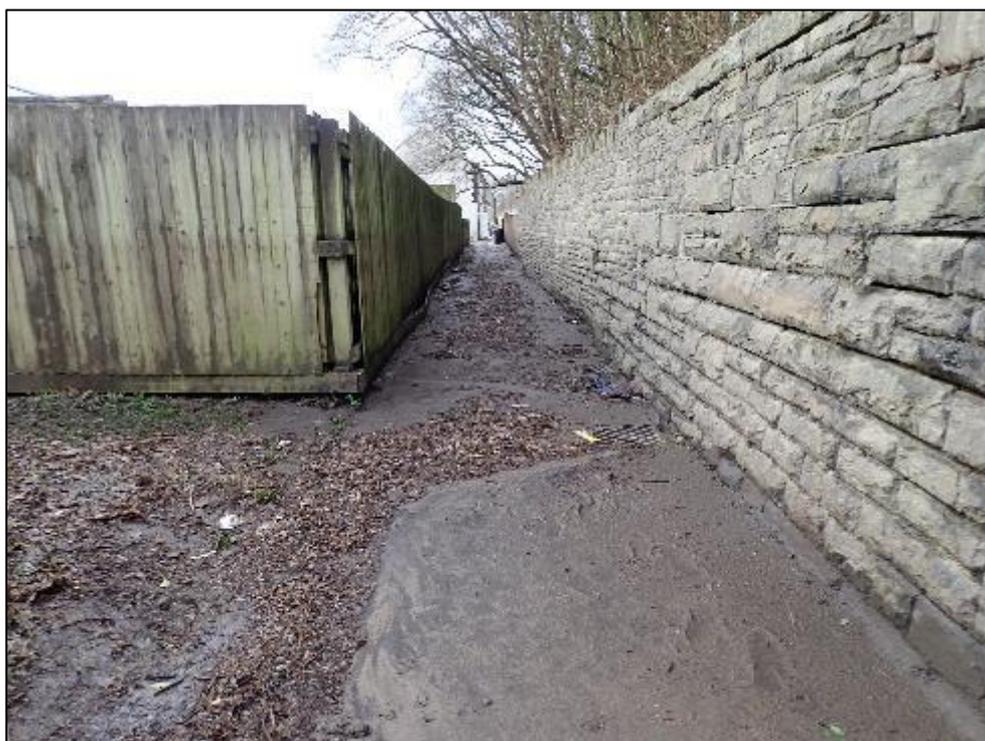
As illustrated in Figure 5, surface water flows accumulated along the A4058 (Gyfeillion Road) and conveyed towards Trehafod Road highway junction before travelling towards Fountain Street via a 50-metre-long pathway connecting the street with the adjacent road. Evidence of silt and debris deposited by the surface water flow path towards Fountain Street is shown in Figure 8.

Figure 8: Image capturing deposited mud and silt on a walkway connecting Fountain Street and the A4058 / Trehafod Road highway junction following Storm Dennis (Captured by a RCT Flood Risk Officer following Storm Dennis)

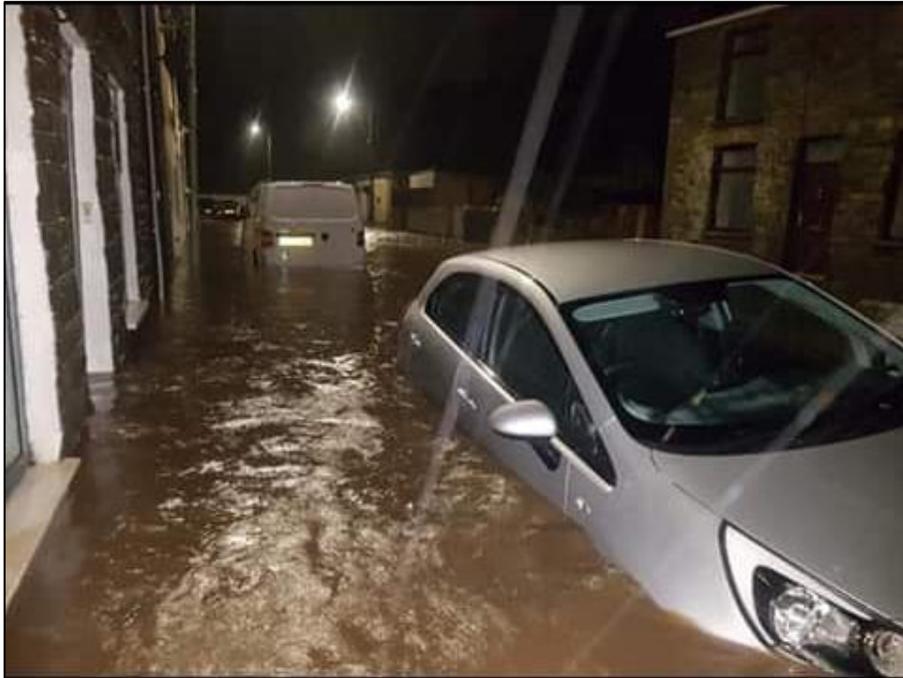
External flooding of up to 1.2 metres and internal flooding of up to approximately 1 metre was reported by the affected residents. Figures 9 and 10 depict the flood depths along Trehafod Road and Afon Street, respectively.

Figure 9: Flooding on Trehafod Road during Storm Dennis (Source: Social Media)

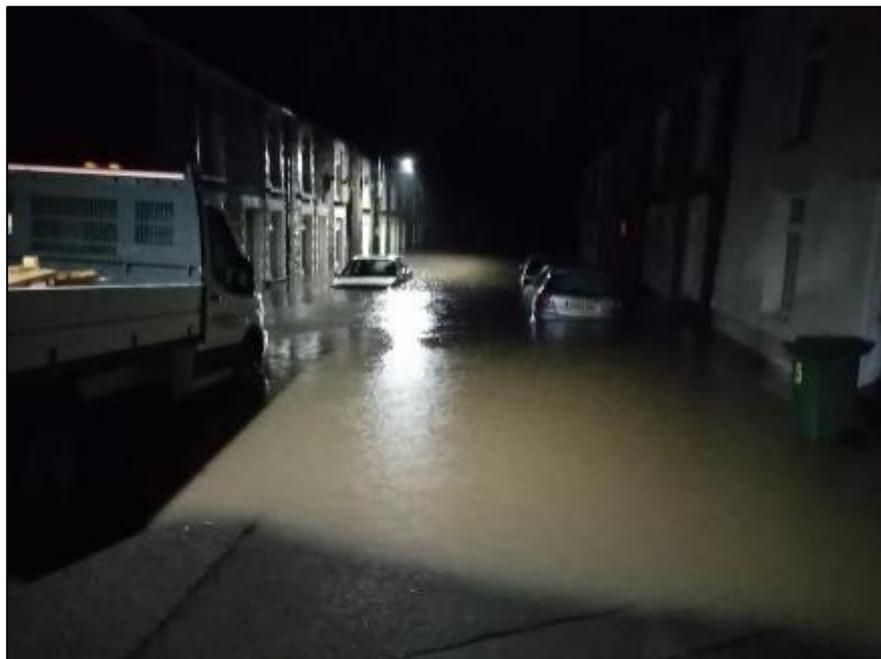
Figure 10: Flooding on Afon Street during Storm Dennis (Source: Social Media)

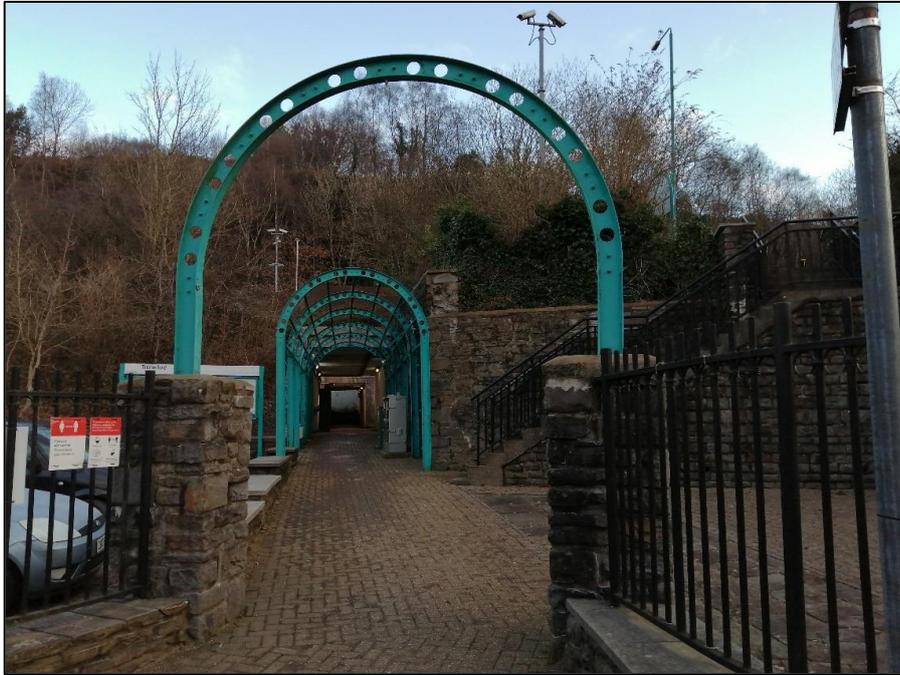
Two residential properties to the west of Trehafod Road also reported internal flooding. Both properties are situated directly opposite a railway underpass (Figure 11) allowing surface water to convey towards the highway and pool at localised low points.

Figure 11: Image capturing the route of surface water runoff towards the west of Trehafod Road
(Captured by a RCT Flood Risk Officer following Storm Dennis)

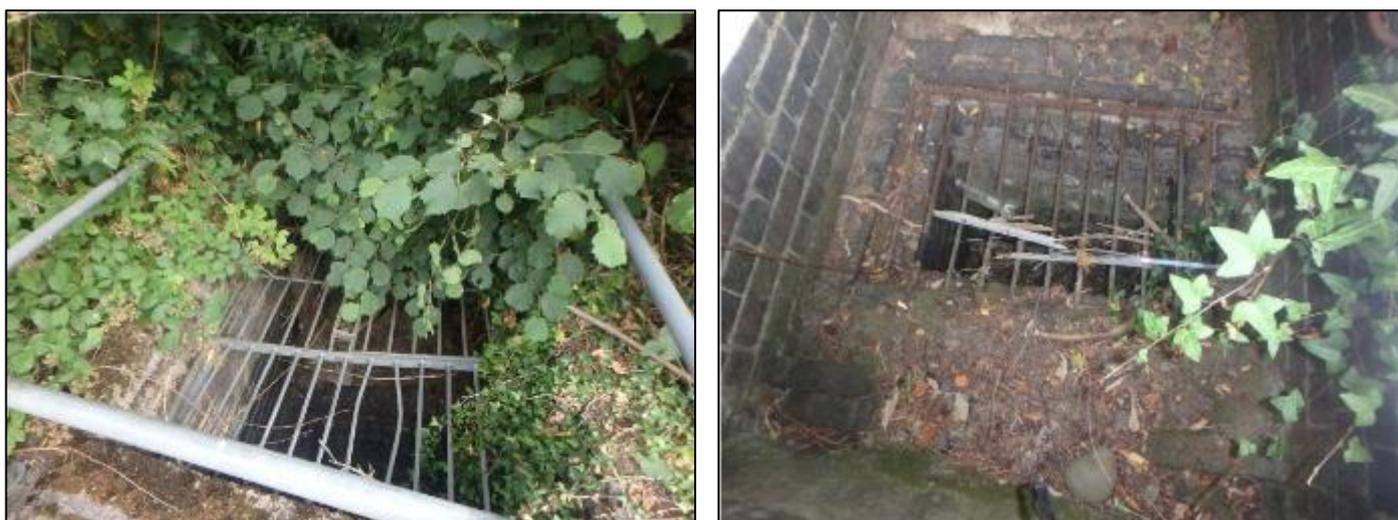
The culvert inspection report provided by TfW on behalf of Network Rail (Completed August 2018), reported no significant defects present at 'Culvert Inlet 1' however it was noted that the internal condition of 'Culvert Inlet 1' structure was unable to be surveyed due to access restrictions.

Based on the inspection photos provided by Network Rail (Figure 13) it is considered likely that the safety grid above the culvert is susceptible to the accumulation of debris (settled deposits and bar damage evident).

Figure 13: Images of 'Culvert Inlet 1' captured during Network Rail's culvert inspection in August 2018

According to the culvert inspection records, recommendations made by Network Rail were not carried out and have been carried over from previous detailed inspections in some cases. One of these recommendations is to "carry out a detailed examination of the culvert using specialist techniques to examine the barrel, to confirm that the structure is still fit for purpose".

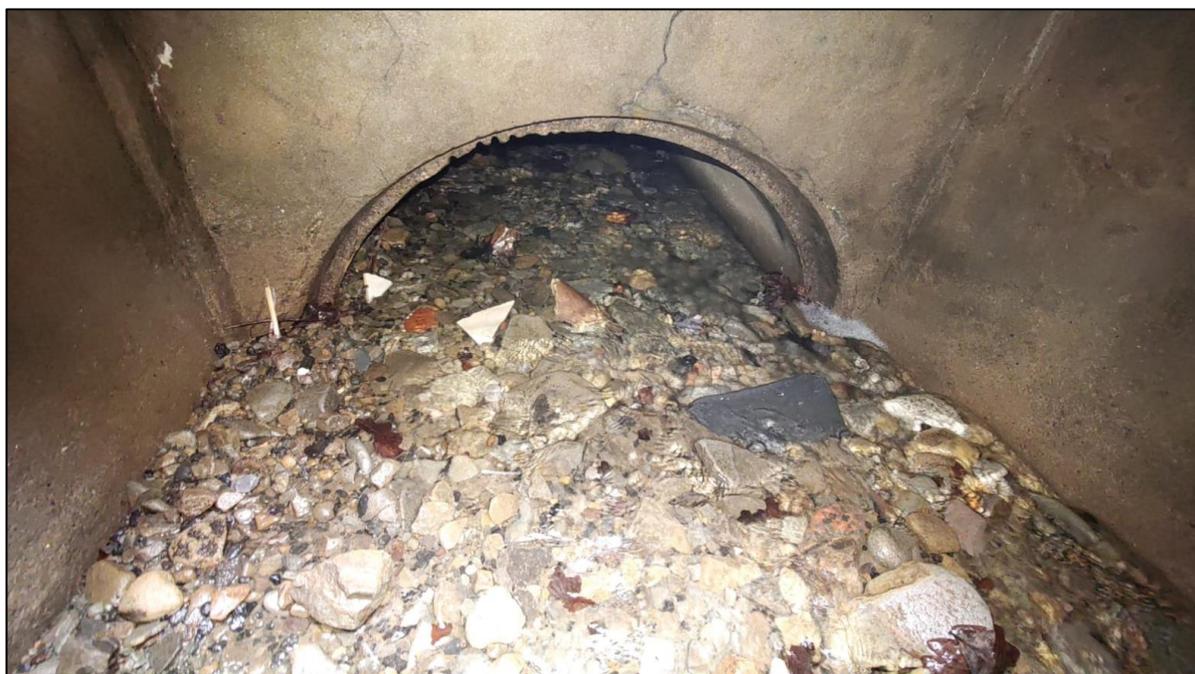
The results however, identified significant debris deposition within sections of the culvert network illustrated in Figure 12. Figure 14 shows the volume of debris, consisting primarily of silt and stonewash, within 'Manhole 1' (highlighted in Figure 12). The debris depicted at 'Manhole 1' shows an 80% reduction in cross sectional area within the culvert network downstream of 'Culvert Inlet 1'. It's not possible to say what debris identified in the survey was mobilised and deposited as a result of the storm event and what had been deposited by previous events however, it is considered that the reported landslip on the hillside above 'Culvert Inlet 1' contributed to the accumulation of debris within the culvert network, and the associated loss in hydraulic capacity to manage the flow of water.

Figure 14: Debris accumulation within the culvert network downstream of 'Culvert Inlet 1' (view looking upstream from Manhole 1) captured post event during CCTV surveying operations

Based on the available evidence presented within this investigation, the significant volume of material within the culvert network downstream of 'Culvert Inlet 1' is considered to have contributed to its surcharge however, in addition to this, debris mobilised from the hillside is also considered to have accumulated at the inlet structure (Figure 13), contributing to the surcharging flows which conveyed over the railway line towards Trehafod Road.

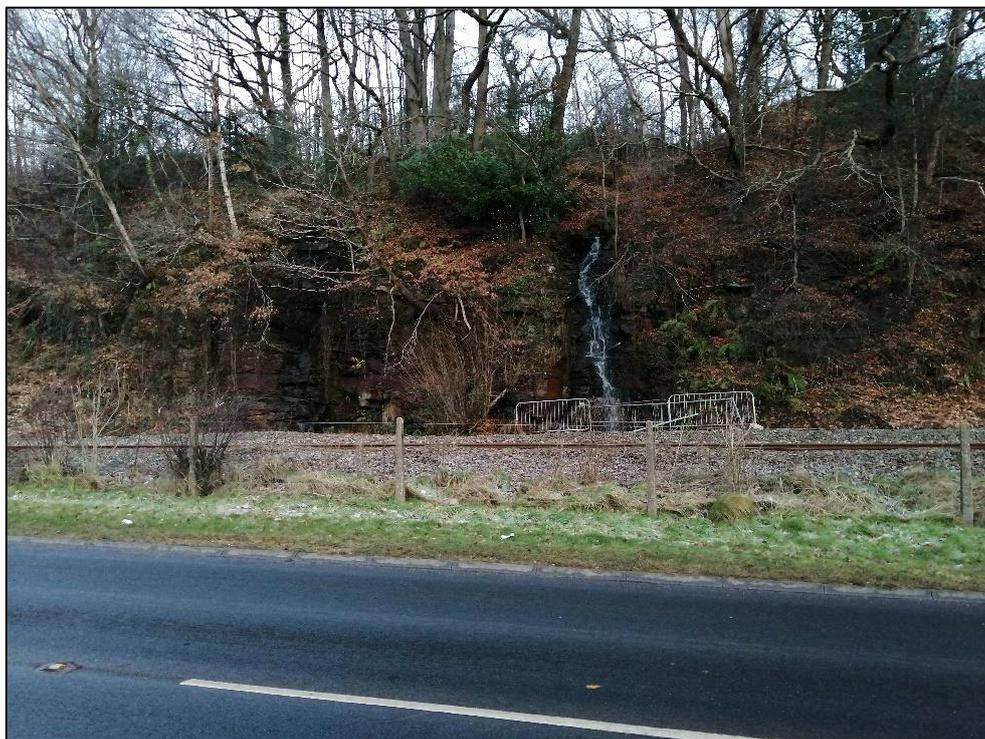
As outlined in Section 2.1, there are several unnamed ordinary watercourses that drain the upper catchment and convey towards the investigation area (Figure 12). The watercourses descend into the culvert inlets as a series of waterfalls above the railway line which runs parallel to the A4058 to the northern perimeter of RCT18 (Figure 15).

Figure 15: An exemplar ordinary watercourse that conveys towards the railway line at the northern boundary of the investigation area in a waterfall formation. (Captured by a RCT Flood Risk Officer)

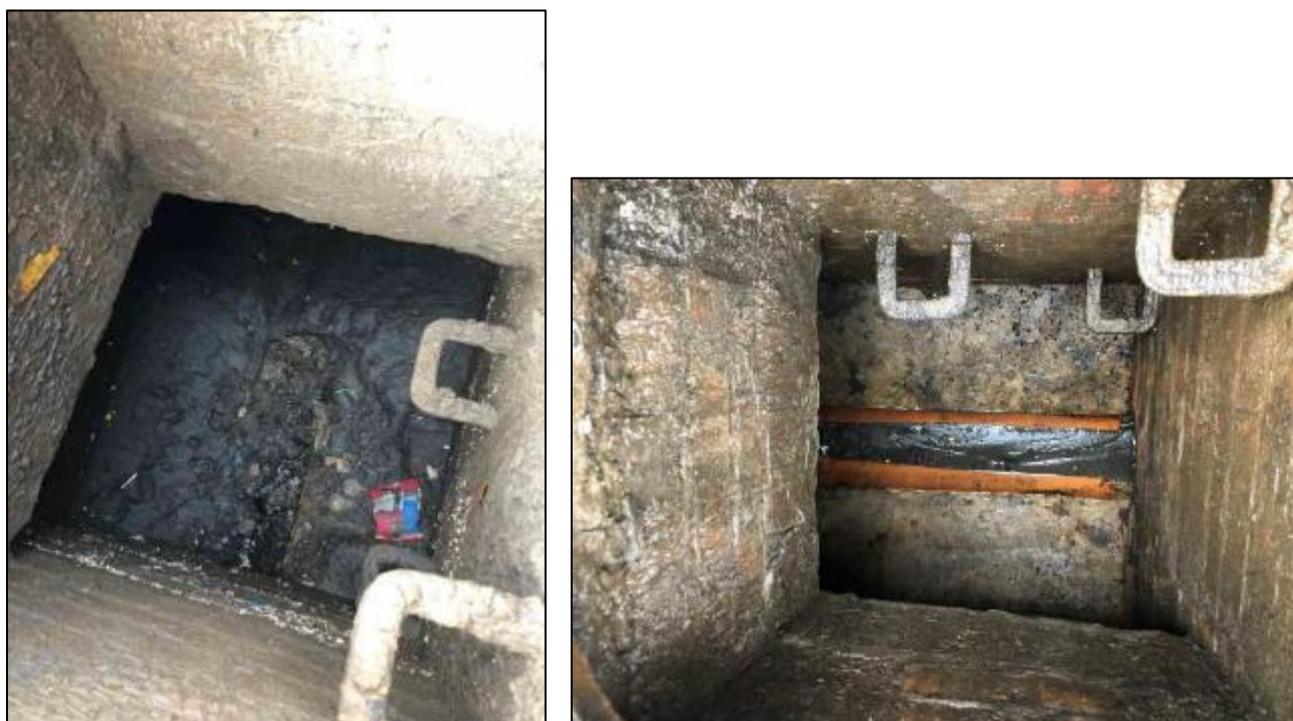
CCTV inspections undertaken post storm event confirm this, with surveys completed on Fountain Street and Trehafod Road identifying large silt and debris deposits within many sections of the highway drainage network. Figure 17 depicts the operational condition of the highway drainage at Fountain Street before and after cleansing operations took place in April 2020. A total of 5 tonnes of silt and debris was removed by a Council appointed contractor during cleansing operations.

Figure 17: Photo of a manhole at Fountain Street captured before (left) and after (right) surveying and cleansing operations during April 2020

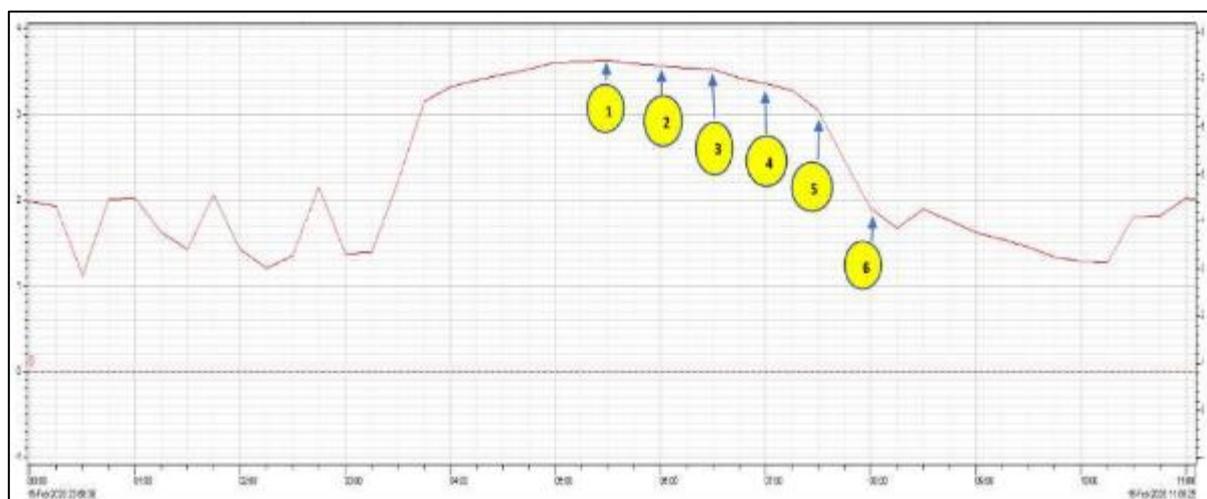
Figure 19 shows the levels within the 'Trehafod Road Pumping Station' during the storm event. This information has been provided by DCWW.

Figure 19: Graph showing pumping station levels at 'Trehafod Road Pumping Station' during Storm Dennis (Supplied by DCWW)

A high-level alarm at the 'Trehafod Road Pumping Station' was received at 03:37 on the 16th February 2020; at which point the level within the pumping station was approximately 2.7 metres according to telemetry data illustrated in Figure 19.
