RCT School Walking Routes Assessment

Blaencwm and Blaenrhondda to Treorchy
Comprehensive School

March 2025

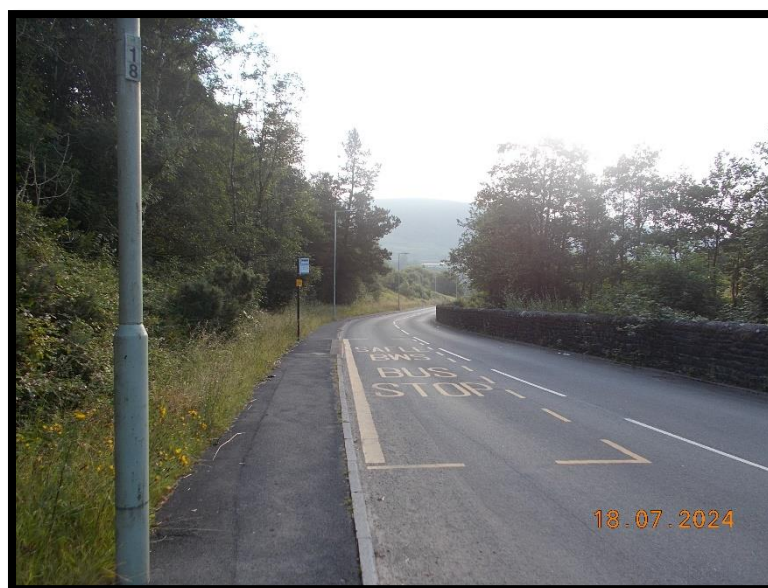
Photograph 4.1 – Northern footway along B4522 Blaen-Y-Cwm Road

- Along the northern footway of Blaen-Y-Cwm Road
 - Discreet sections of footway along the Ynyswen Estate road
 - The lane access to the rear entrance to Treorchy Comprehensive School

- Monitor the condition of overhanging trees and foliage. Where trees and/or foliage overhang or encroach into footways, these areas should be cut back to improve the usable width, sight lines and natural surveillance. In addition to this leaf debris should be removed from footways when required.
- Monitor footway obstructions. Where footways widths continue to be restricted by parked cars, action be taken in conjunction with the appropriate Council Department / local neighbourhood policing teams.

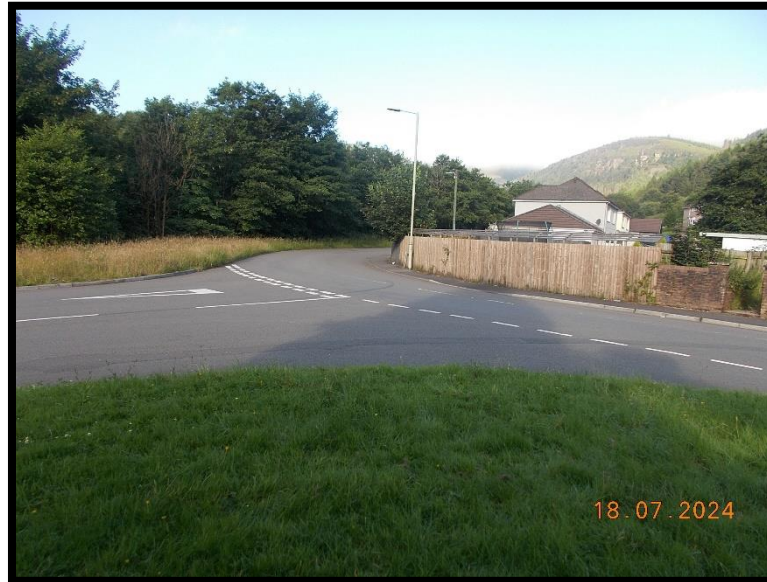
Photograph 4.2 – No pedestrian crossing provisions/potential visibility issues at the wide junction of B4522 Blaen Rhondda Rd and Blaen-Y-Cwm Road

- 8.1.4 There are potential visibility issues/wide crossings at the following locations:
- Potential visibility issues at the junction of Blaen-Y-Cwm Road and Blaenrhondda Road (near Graig-Y-Ddelw), though the crossing can be made more safely further into Blaenrhondda Road at its narrowest point, where visibility of vehicles from Blaen-Y-Cwm Road is noted to be improved.

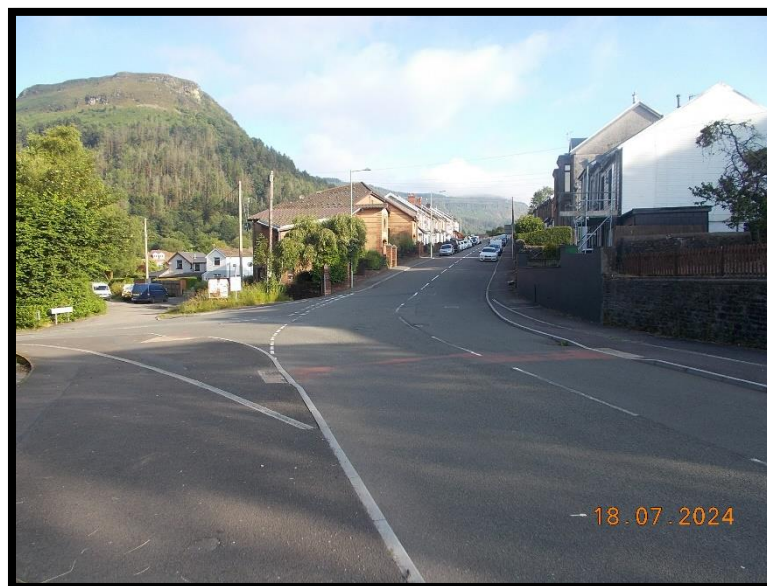
Photograph 4.3 – Uncontrolled crossing on St Albans Terrace near the junction with B4522 Blaen-Y-Cwm Road

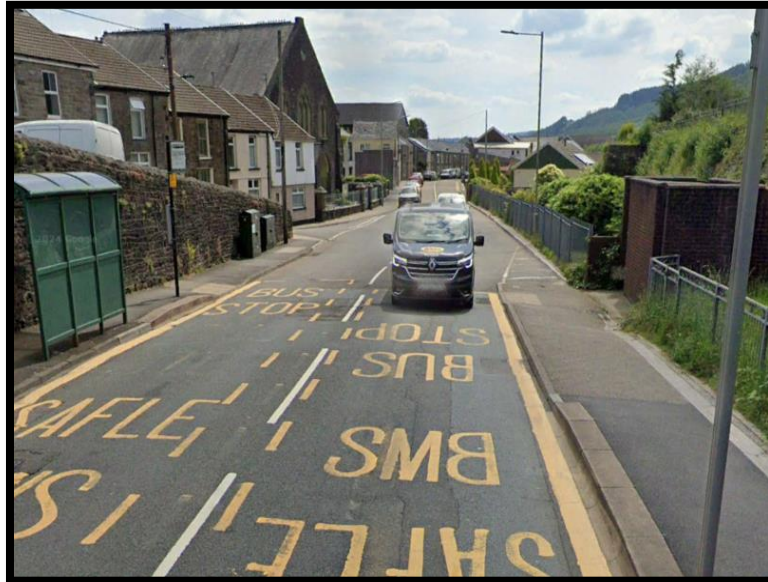
**Photograph 4.4 – Uncontrolled crossing on St Albans Terrace near the junction with
Halifax Terrace**

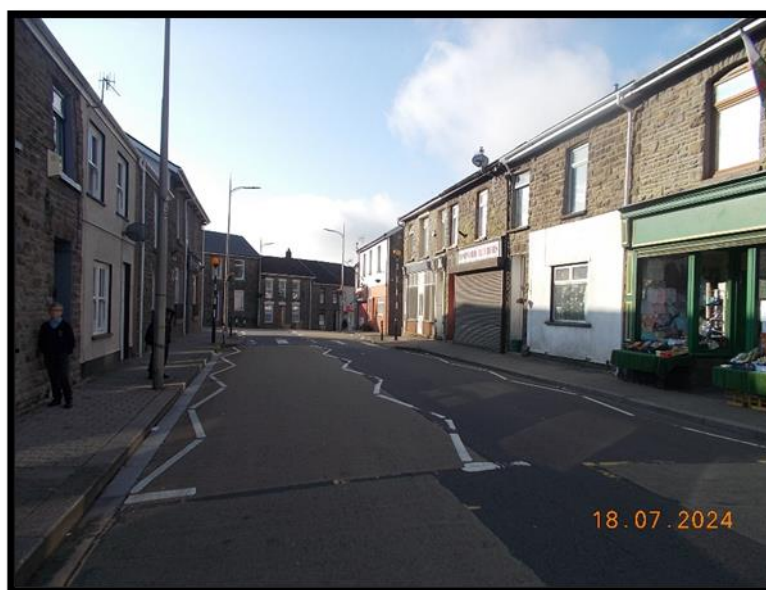
Photograph 4.5 – Zebra crossing outside The Wyndham on Wyndham Road

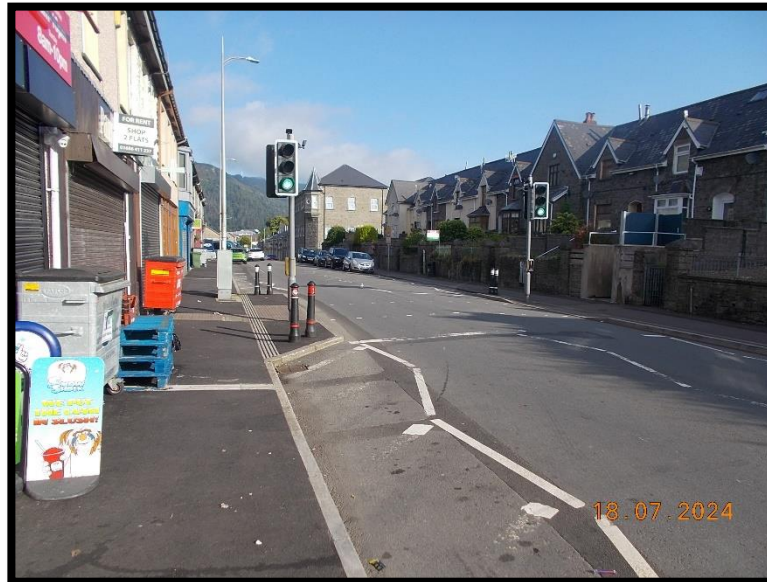
Photograph 4.6 – Signal controlled crossing outside Premier Store on the A4061 Bute Street

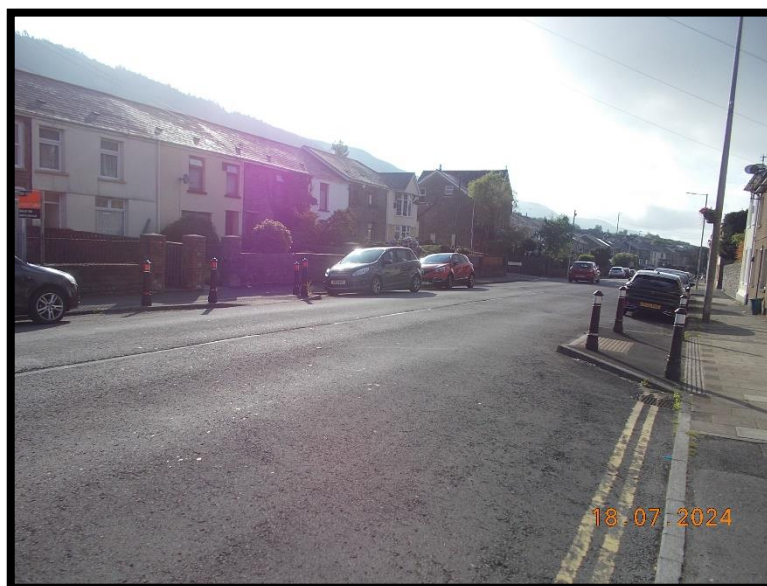
Photograph 4.7 – Uncontrolled crossing outside no.129 Bute Street on the A4061

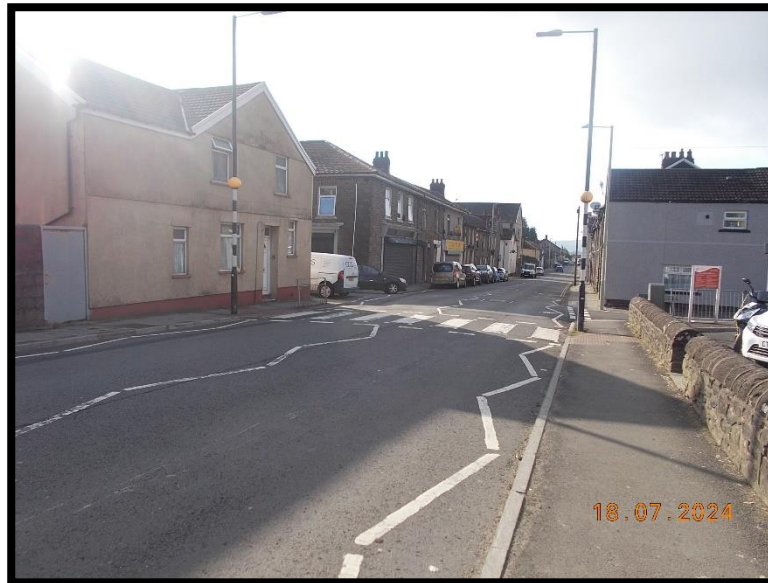
Photograph 4.8 – Zebra crossing opposite the carpark at gateway to Treherbert on the A4061

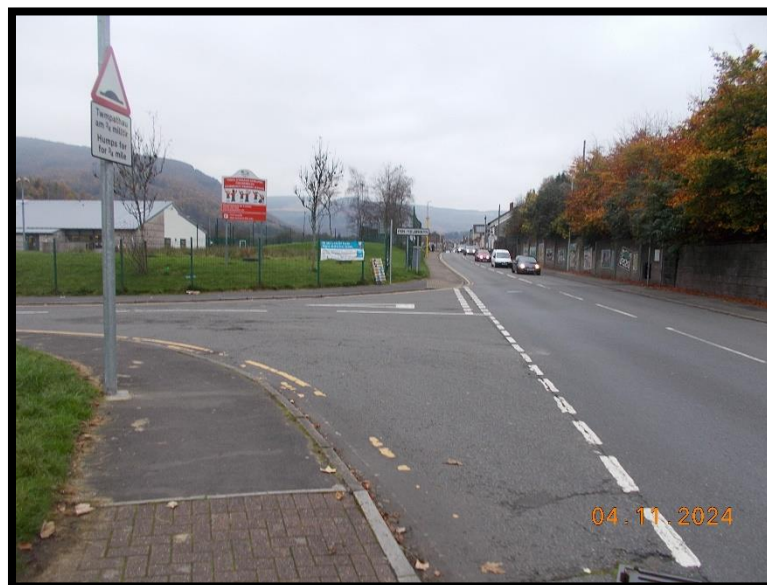
Photographs 4.9 – Wide uncontrolled crossing at the junction of Ynyswen Estate with the A4061 Baglan Street near Penyreglyn Primary School

- Wide crossing distance (circa 25m measured at the give way line) at the junction of Ynyswen Estate Road and the A4061 Baglan Street (near Penyreglyn Primary School), though the crossing can be made more safely further into Ynyswen Road, where crossing distances are shorter.

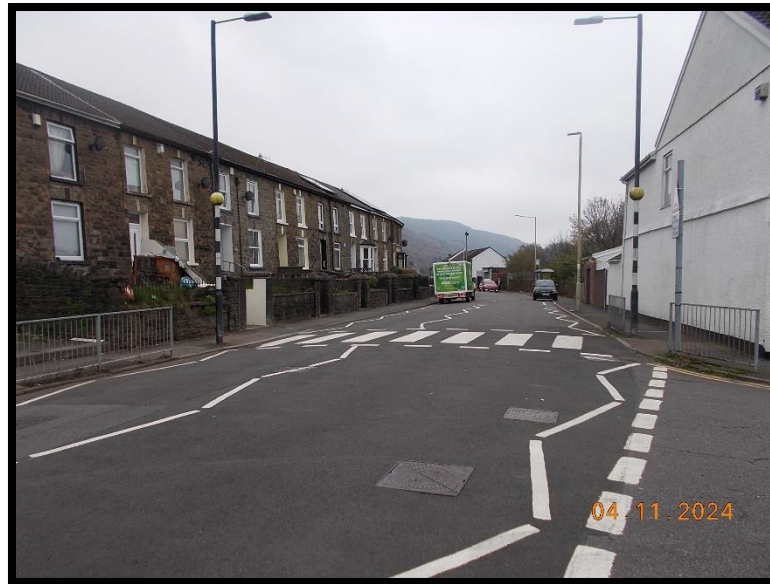
Photograph 4.10 – Zebra crossing near the junction of Ynyswen Estate Road with the A4061 Ynyswen Road

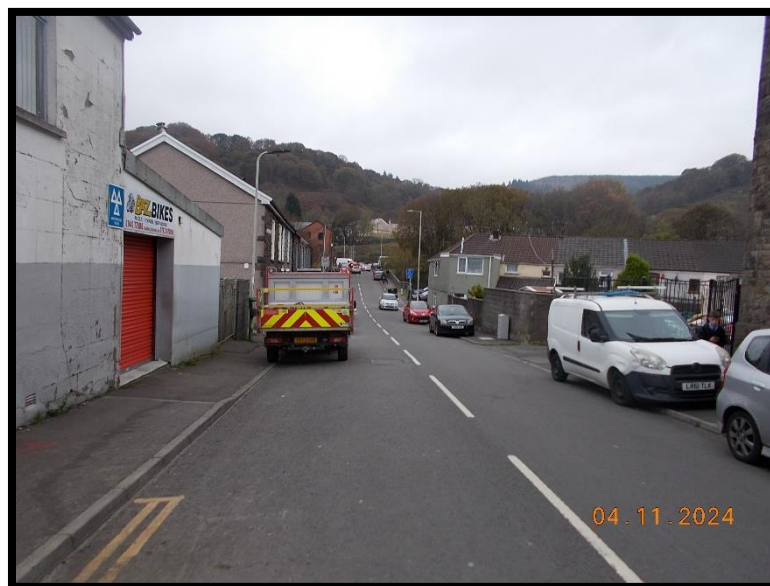
Photograph 4.11 – Parking on footways along Crichton Street into Ynyswen Estate

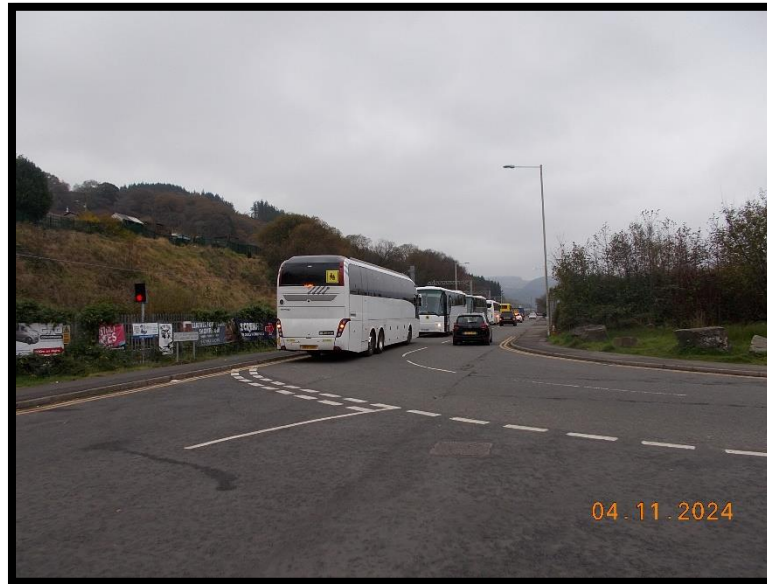
Photograph 4.12 – School bus parking along Ynyswen Estate

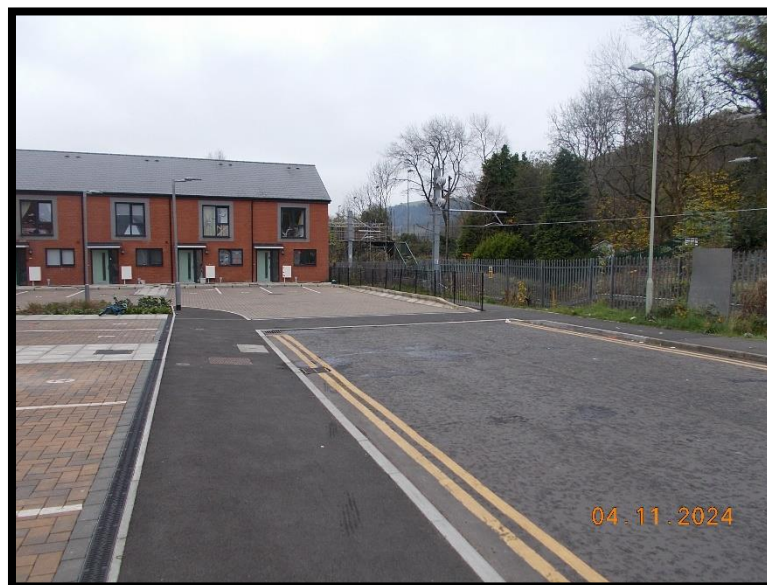
Photograph 4.13 – New footway at the housing development in Ynyswen Estate

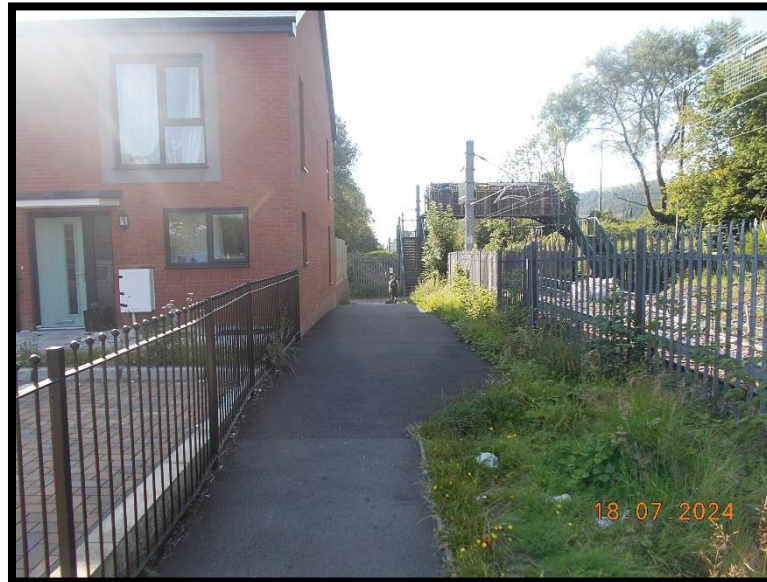
Photograph 4.14 – Footpath from Ynyswen Estate to Tylacoch footbridge over the railway

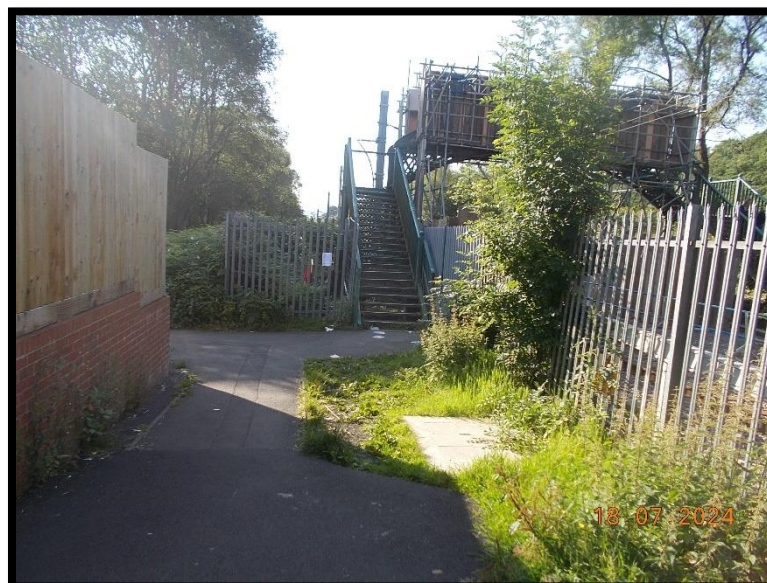
Photograph 4.15 – Tylacoch footbridge approach to rear gate entrance to Treorchy Comprehensive School

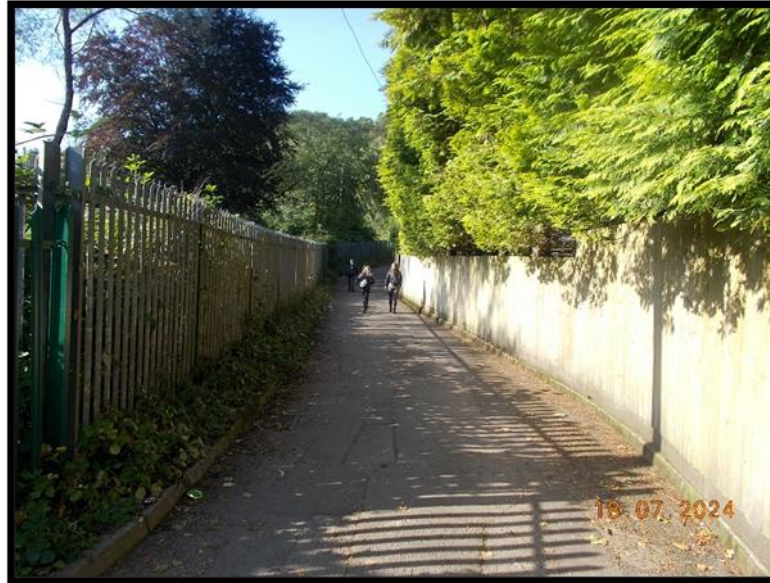
Photograph 4.16 – Overhanging trees on the back lane approach to rear gate entrance to Treorchy Comprehensive School

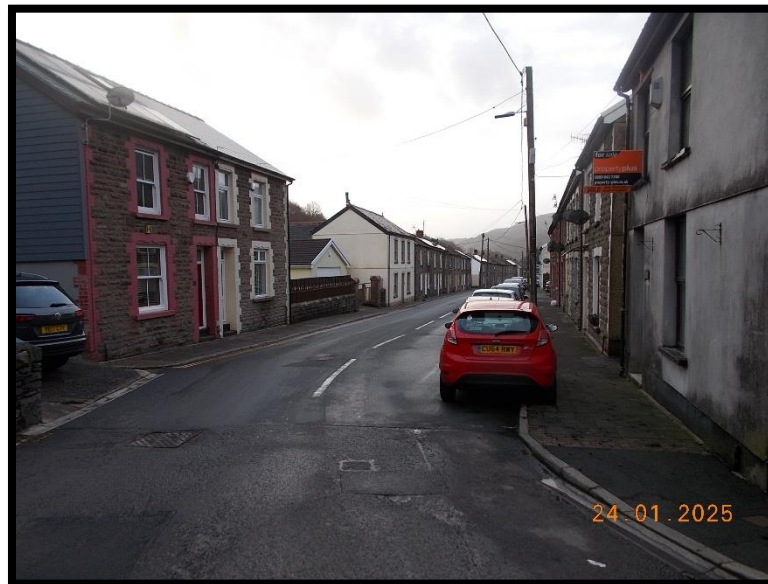
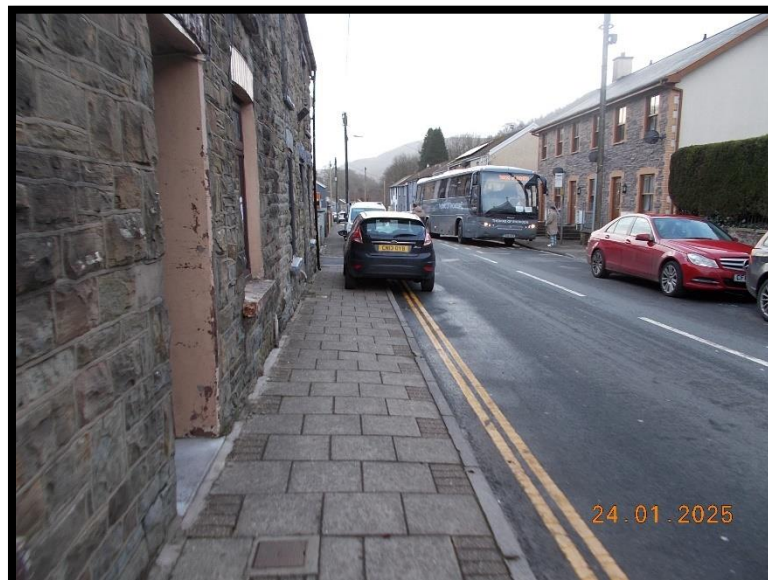
Photograph 4.17 – Vehicles parking on footways along Brook Street

Photograph 4.18 – Vehicles parking on footways along Brook Street

- Monitor footway obstructions. Where footways widths continue to be restricted by parked cars, action be taken in conjunction with the appropriate Council Department / local neighbourhood policing teams.
- Investigate the cause of the surface water ponding in the footway on St Alban's Terrace and provide remedial measures to ensure positive drainage is achieved.

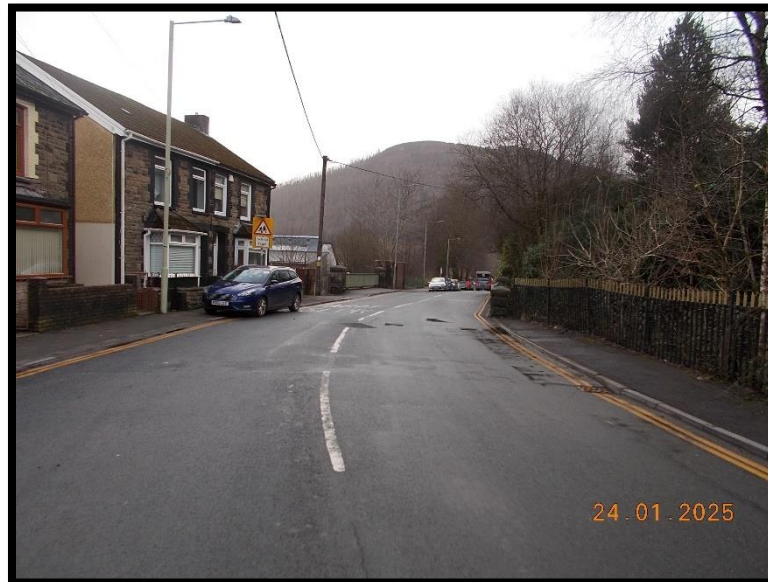
Photograph 4.19 – Abrupt end to the existing footway with restricted forward visibility for vehicles approaching the potential uncontrolled crossing point

8.2.2 There are continuous footways present in reasonable condition along the route. However, the western footway along Brook Street ends abruptly at the bridge on the approach to Pen-Pych Primary School. There is potential for uncontrolled crossing at this location, where it is noted forward visibility to northbound vehicles approaching along Brook Street is limited. However, visibility is improved before reaching this point, with traffic levels noted to be low and adequate gaps in traffic observed to cross the road. See **paragraph 8.2.3** below.

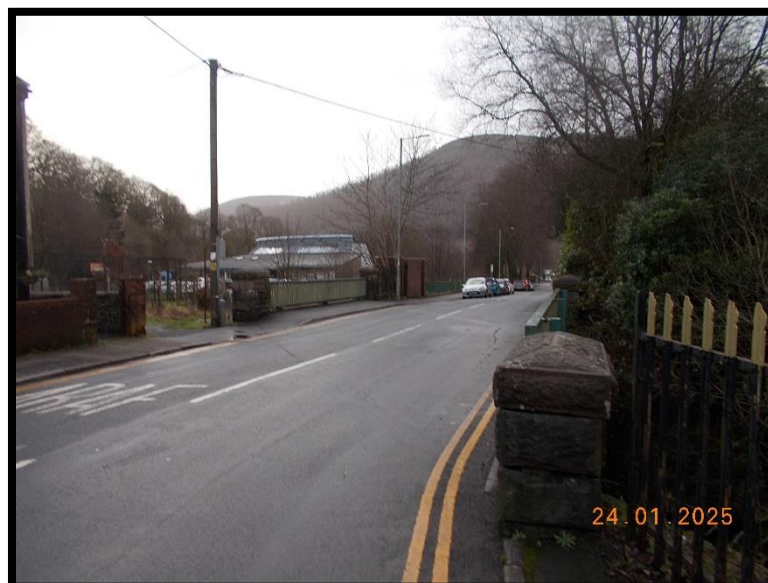
Photograph 4.20 - Restricted forward visibility for vehicles approaching the potential uncontrolled crossing point

- Potential visibility issues at the uncontrolled crossing where the footway ends abruptly (see paragraph 8.2.2 above), which has limited forward visibility to northbound vehicles approaching along Brook Street. It is noted however, the crossing can be made more safely before this point is reached, where visibility to approaching vehicles is improved.
- Wide crossing distance (circa 12m measured either side of the pedestrian refuge island) at the junction of St Alban's Road and Brook Street (near the river bridge). It is noted however, the crossing can be made more safely towards the centre of the bridge, where crossing distances are shorter and visibility to approaching vehicles is improved.

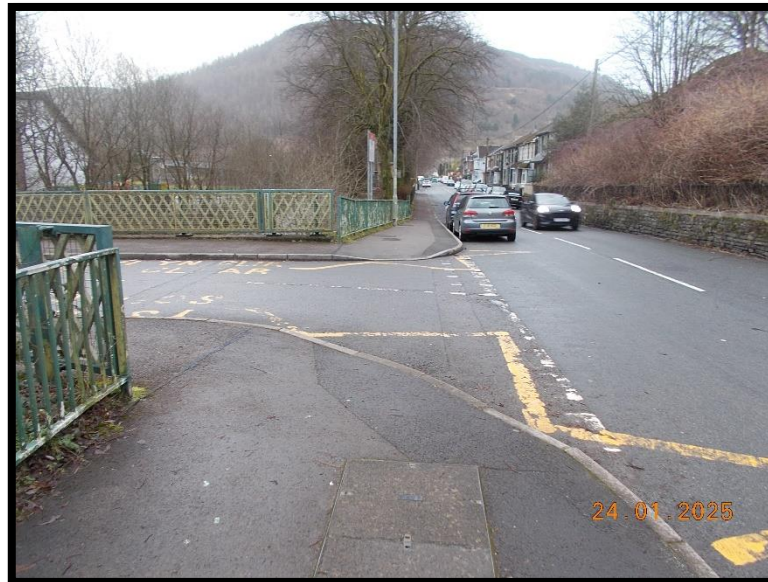
Photograph 4.21 – Uncontrolled crossing point at the entrance to Pen-Pych Primary School

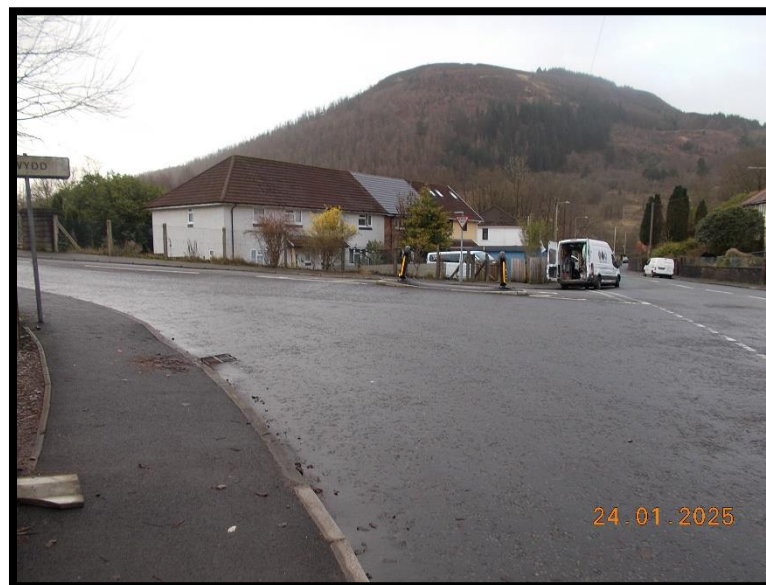
Photograph 4.22 – Uncontrolled crossing point with pedestrian refuge island at the junction of St Alban's Road with Blaenrhondda Road at the river bridge

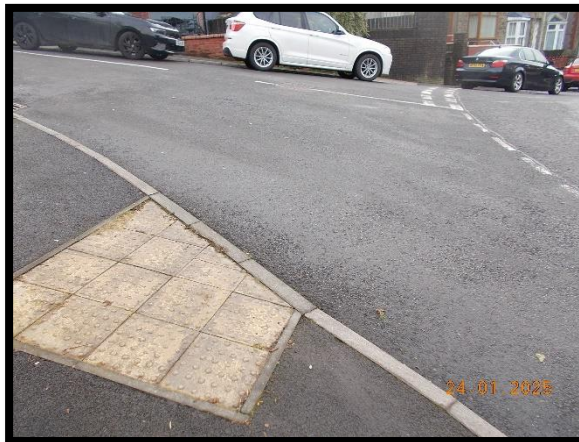
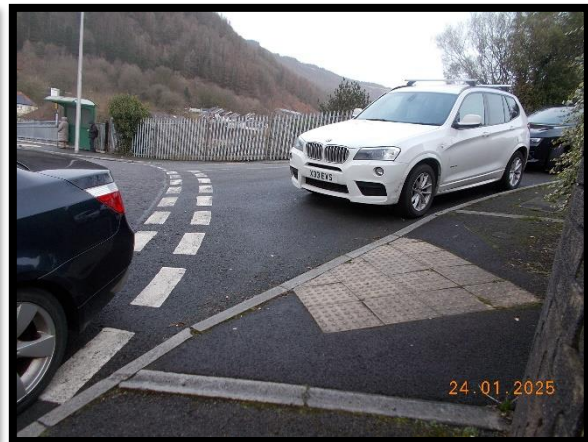
Photographs 4.23 & 4.24 – Uncontrolled crossing point obstructed by on street parking at the junction of Upper St Alban's Road with St Alban's Road

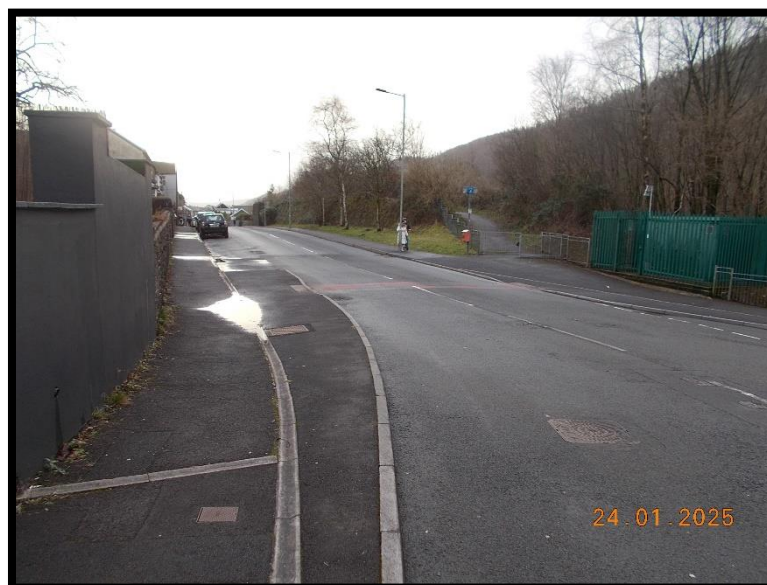
Photograph 4.25 – Surface water ponding in the footway on St Alban's Terrace

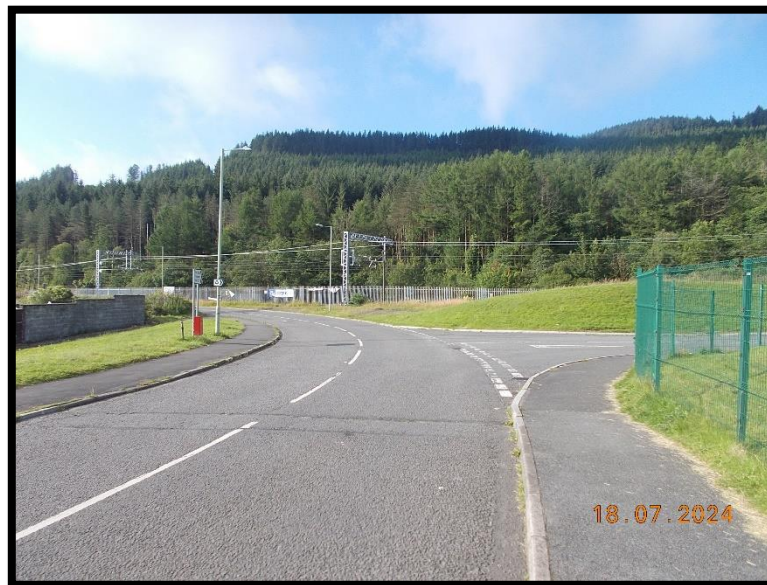
Photograph 5.1 – Uncontrolled crossing point outside Penyreglyn Primary School

The traffic flow and gaps at this location for both AM and PM meet the criteria outlined in the Learner Travel Guidance.

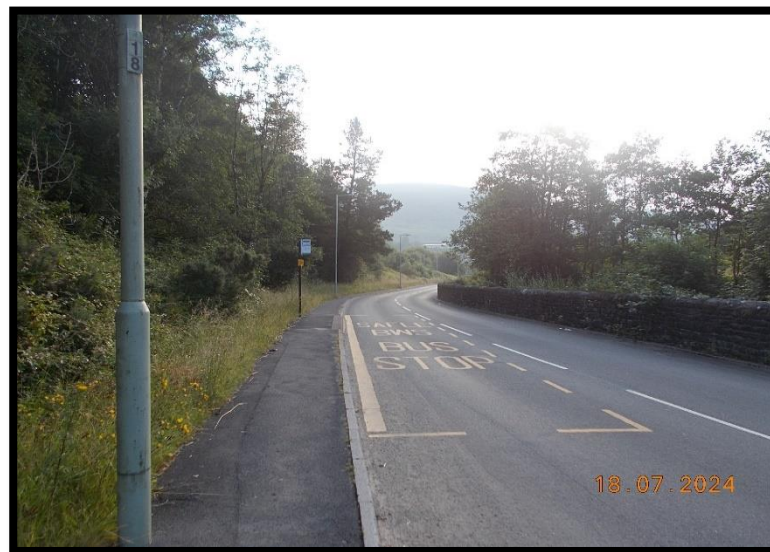
- 6.1 There is a section of footway circa 450m long between Blaen-Y-Cwm Road play area and Graig-Y-Ddelw, **photograph 6.1**, which has no overlooking buildings or natural surveillance, other than by passing traffic or other pedestrians. There is also a rear lane access to Treorchy Comprehensive School, **photograph 6.2**, which again has no overlooking buildings or natural surveillance, other than by other pedestrians. Both routes are available and in daily use by parents and pupils walking locally to / from Pen-Pych Primary and Treorchy Comprehensive Schools. These areas would benefit from vegetation clearance / cutting back of overhanging tree branches to improve pedestrian comfort and lighting levels.

Photograph 6.1 – Blaen-Y-Cwm Rd footway between the play area and Graig-Y-Ddelw

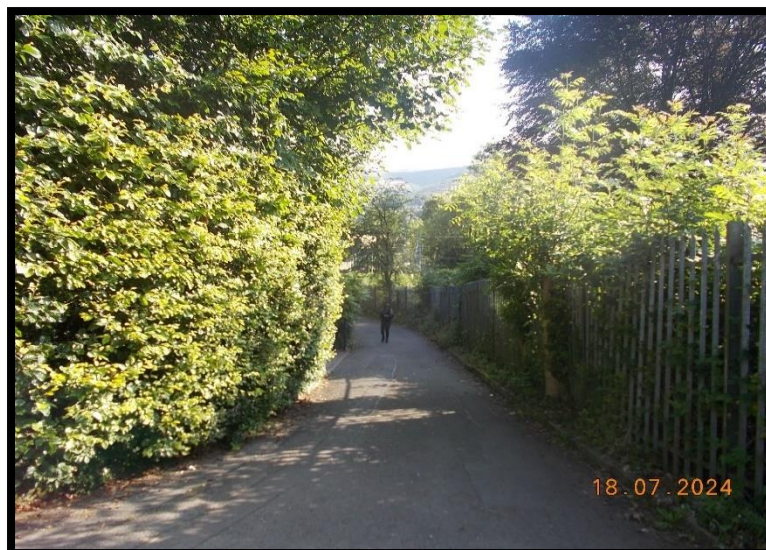
Photograph 6.2 – Back lane approach to the rear entrance of Treorchy Comprehensive School
