# RCT School Walking Route Assessment

## Cross Inn to Bryn Celynnog Comprehensive School

March 2025

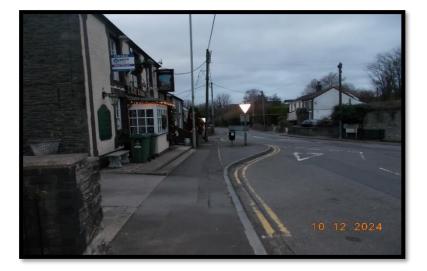
#### Photograph 4.1 – Start of route at Main Road, Cross Inn near the Cross Inn Public House

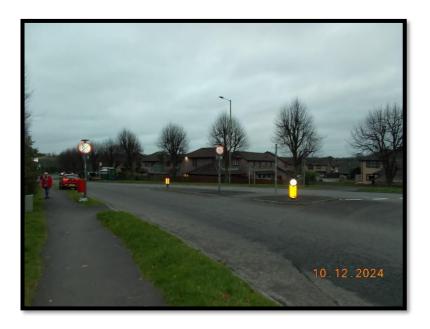
Photograph 4.2 – Uncontrolled crossing (with pedestrian refuge) at the roundabout on Main Road linking to the A473 Church Village Bypass

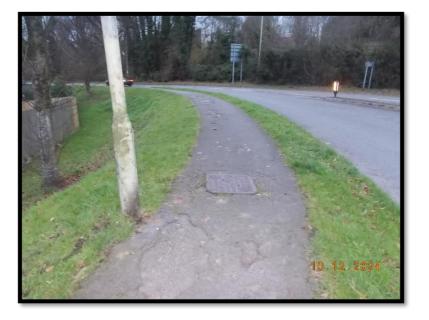
## Photograph 4.3 – Uneven footway surface around manhole cover at the roundabout on Main Road

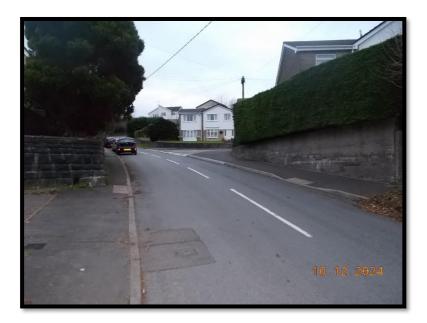
Photograph 4.4 – Localised footway narrowing on the approach to Cardiff Road

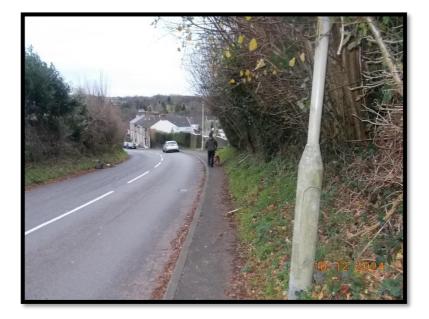
#### Photograph 4.5 – Leaf debris causing localised footway narrowing on Cardiff Road, where pedestrians are required to step into the road to pass one another

- Outside no. 58 Cardiff Road
  - Outside no. 30 Cardiff Road
  - Various locations along Swan Street
  - Outside the Bull Ring General Store
- 8.1.5 It is noted however that the footway along Cardiff Road between nos.46 and 47 is narrowed to less 1.0m locally due to leaf debris and overgrown vegetation. This requires pedestrians to step into the carriageway to pass one another. It is also noted that the verge at the rear of the footway is steep and is not suitable as a 'step-off'. However there does appear to be scope to remove some of the vegetation/leaf debris from the rear of the footway to maximise the usable width and potentially achieve a minimum width of 1.2m.

- > The footway opposite the Cross Keys Public House on High Street.
    - > The frontage of Bullring General Store on High Street.
  - Where trees and/or foliage overhang or encroach into footways, these areas should be cut back to improve the usable width, sight lines and natural surveillance. In addition to this leaf debris and overgrown vegetation should be removed from footways when required to maximise the usable width.

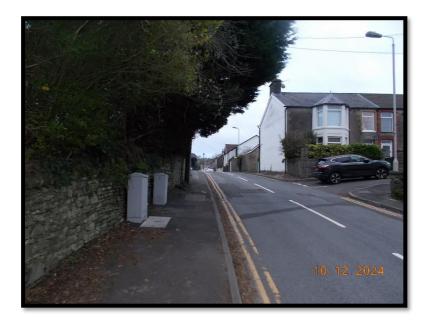
Photograph 4.6 - Overhanging trees causing localised footway narrowing on Cardiff Road

- 8.1.6 There are discrete sections of footway along Cardiff Road and the B4595 Newbridge Road/Llantrisant Road where trees and vegetation overhanging the footway require cutting back to improve route width and pedestrian comfort levels.

- Monitor the condition of overhanging trees and foliage. Where trees and/or foliage overhang or encroach over footways, these areas should be cut back to improve street lighting levels along the route.

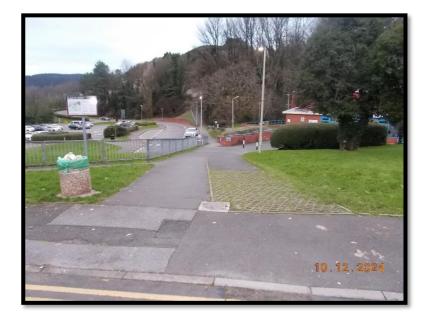
#### Photograph 4.7 – Footway access to Llantrisant Sports Centre from Tir Meibion Lane

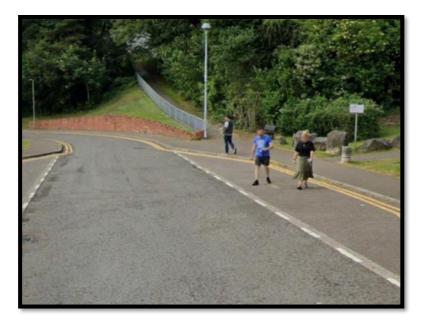
Photograph 4.8 – Footway access through Llantrisant Sports Centre carpark where both walking routes are noted to be available (the entrance footway route is less steep than the ramp access)

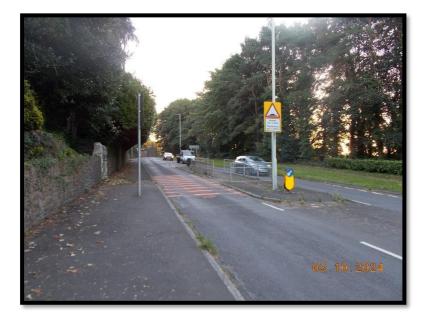
## Photograph 4.9 – Uncontrolled crossing (staggered with pedestrian refuge) on the B4595 Talbot Road, adjacent to Llantrisant Sports Centre

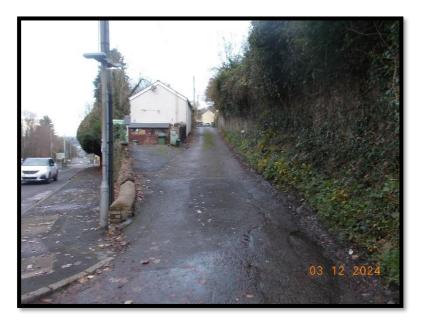
Photograph 4.10 – Lane approach to Old Llantrisant along Insole Terrace off the B4595 Talbot Road, with surface water run-off noted over the entrance to the lane

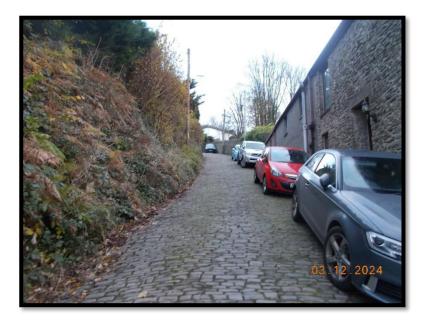
#### Photograph 4.11 – On-street parking along Heol-Y-Beiliau reducing the usable road width, it is noted that traffic flows and speeds are very low with step-off available to let vehicles pass

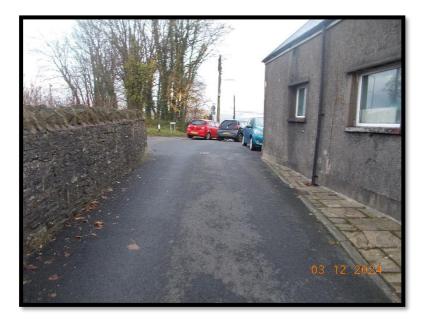
Photograph 4.12 – Discontinuous footway network through Old Llantrisant (School Street) with limited usable road width. It is noted that traffic flows and speeds are very low with step-offs available to let vehicles pass

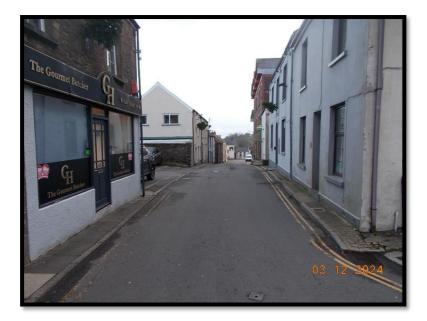
#### Photograph 4.13 – Narrow, disjointed / discontinuous footway network through Old Llantrisant (Swan Street) with limited usable road width. It is noted that traffic flows and speeds are low with step-offs available to let vehicles pass

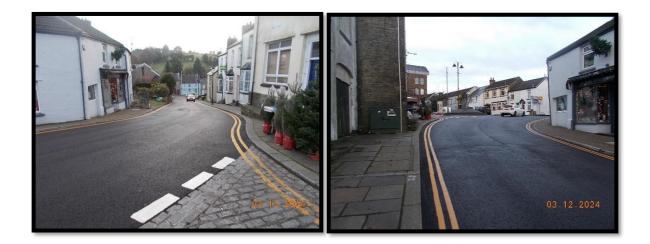
Photograph 4.14 & 4.15 - Narrow, disjointed / discontinuous footway network through Old Llantrisant (High Street). It is noted that traffic speeds are low with good visibility to approaching vehicles. Step-offs are available to let vehicles pass and there are also opportunities to cross to the wider footway; however, these options are currently restricted by shop displays/produce at this location

- 9.1.3 Further enhancements to the walking route *should be undertaken* to improve conditions for route users:
  - Monitor footway obstructions. Where footways are present, widths continue to be restricted by parked cars and shop frontages, action be taken in conjunction with the appropriate Council Department / local neighbourhood policing team. with two locations requiring immediate action at:

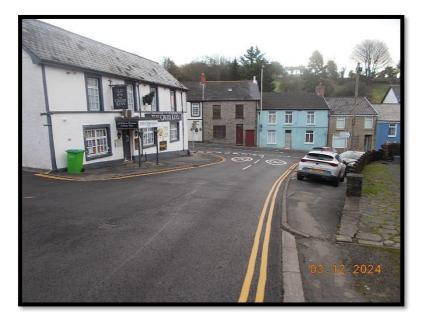
#### Photograph 4.16 - On street parking on footways noted along High Street narrowing the usable width and potentially causing pedestrian crossing safety issues

- 8.1.8 There are localised sections of footway along the length of High Street (opposite the Cross Keys PH) and the B4595 Newbridge Road, where vehicles obstructing footways can impact upon the walking routes. Local neighbourhood policing teams are working with residents to help reduce the risks posed to pedestrians by indiscriminately parked vehicles.

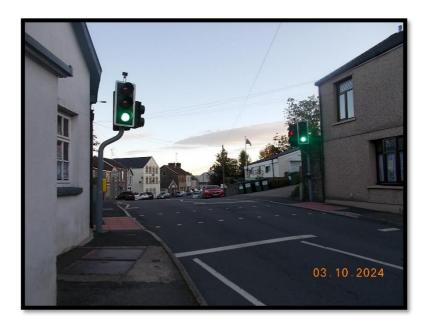
Photograph 4.17 – Signal controlled crossing at The Cross Keys Public House

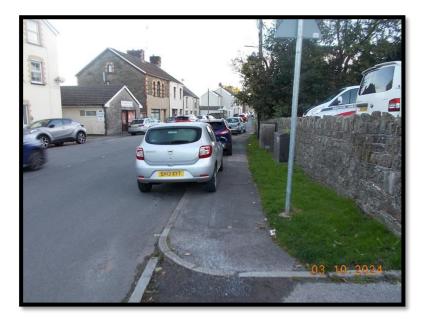
#### Photograph 4.18 – On-street parking reducing the usable width along the B4595 Llantrisant Road, It is noted however that the opposite footway is available

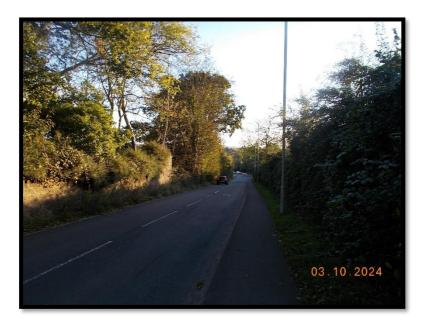
- 4.1.7 In places, vegetation needed clearance to improve the usable footway width and visibility for pedestrians, especially at the B4595 Llantrisant Road, where overhanging trees and vegetation locally reduce the usable width to less 1.0m, with similar conditions noted along Cardiff Road.

Photograph 4.19 – Footway alongside the B4595 Llantrisant Road with overhanging trees and vegetation locally reducing the usable width

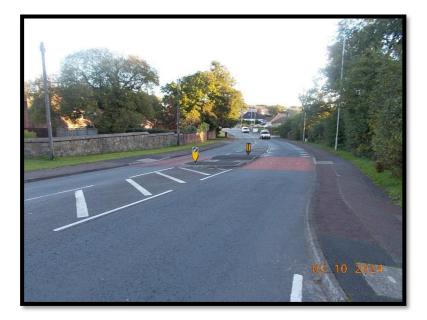
## Photograph 4.20 – Uncontrolled crossing with pedestrian refuge island on the B4595 Llantrisant Road near the junction with Brynteg Lane

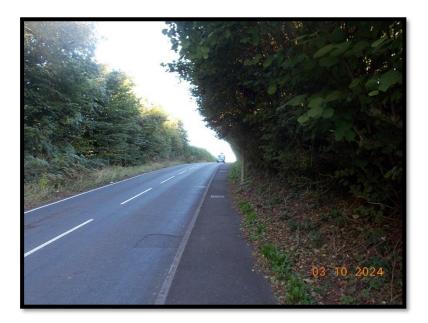
Photograph 4.21 – Overhanging trees and vegetation locally reducing the usable width along the B4595 Llantrisant Road

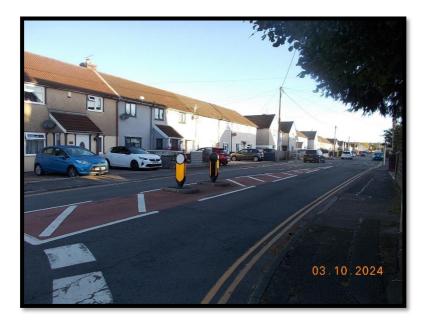
### Photograph 4.22 – Uncontrolled pedestrian crossing with pedestrian refuge island on the B4595 Llantrisant Road

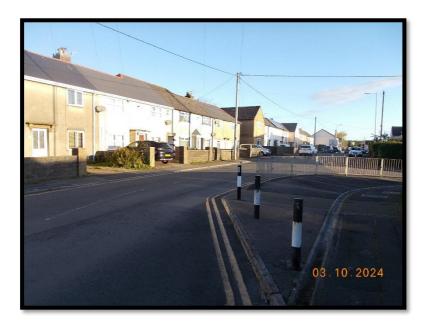
Photograph 4.23 – Uncontrolled crossing with buildout on the B4595 Llantrisant Road

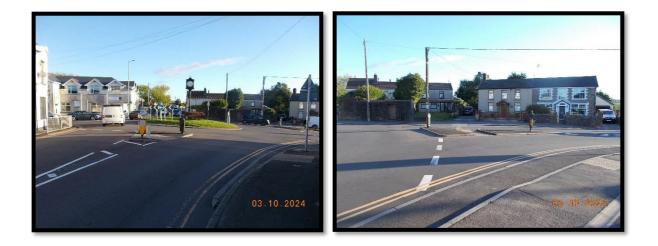
### Photographs 4.24 & 4.25 – Uncontrolled crossings with pedestrian refuges on the B4595 Llantrisant Road and Gwaunmiskin Road approaches to the roundabout

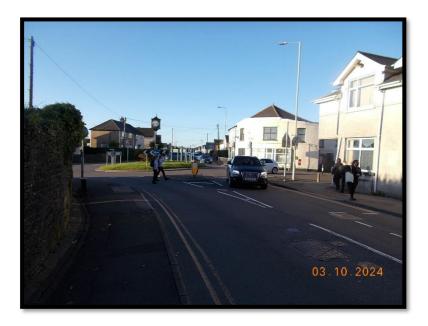
#### Photograph 4.26 – Uncontrolled crossing point on the Penycoedcae Road approach to the roundabout

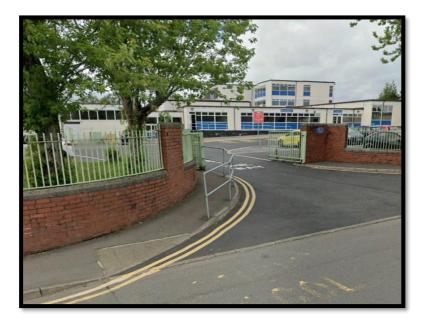
#### Photograph 4.27 – Footway approach to Bryn Celynnog Comprehensive School main entrance
