# RCT School Walking Route Assessment

# Gilfach Goch to Tonyrefail Community School

March 2025

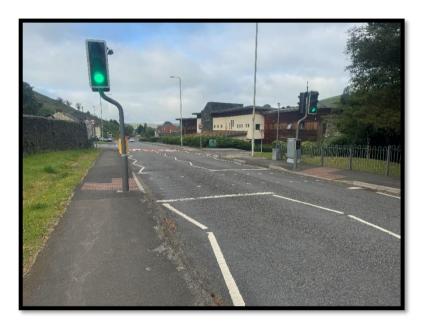
#### Photograph 4.1 – Signalised crossing north of Medical Centre

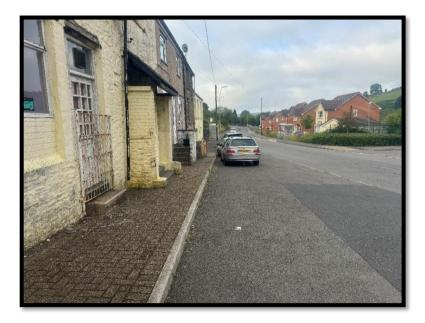
Photograph 4.2 – Short section of footway narrowing along the eastern footway B4564

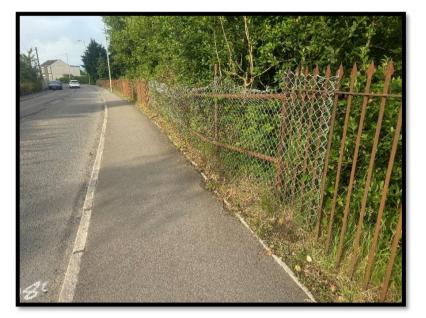
Photograph 4.3 – Overhanging chain-link fence western footway B4564

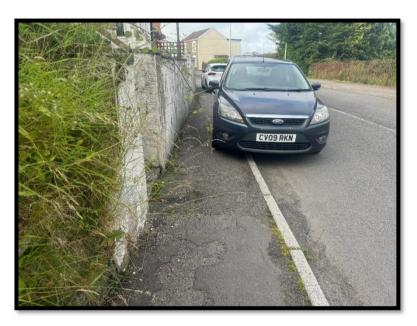
Photograph 4.4 – Parking issues and footway narrowing on eastern footway opposite house no. 3 Gelli Arael Road

5.9.1 Footway in advance of no.3 Gelli Arael Road requires pedestrians to step into or cross the road in advance of the footway narrowing. There are sufficient crossing gaps for pedestrians to cross at this location to achieve connectivity between adjacent footways.

- Assess the stability of the existing fence line opposite Trane Cemetery. Where fencing is deemed unsafe/hazardous this should be replaced.
  - Monitor footway obstructions. Where footways widths continue to be restricted by parked cars, action be taken in conjunction with the local neighbourhood policing teams.

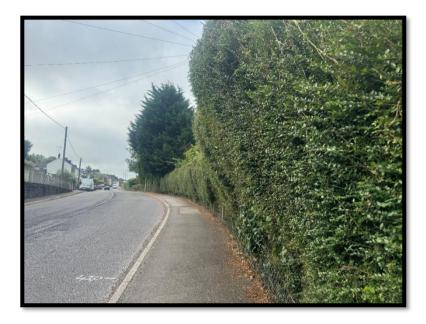
# Photograph 4.5 – Vegetation narrowing along the western footway south of the Barber Room

- Monitor the condition of overhanging trees and foliage. Where trees and/or foliage
    overhang or encroach into footways, these areas should be cut back to improve the
    usable width, sight lines and natural surveillance. In addition to this leaf debris should be
    removed from footways when required.

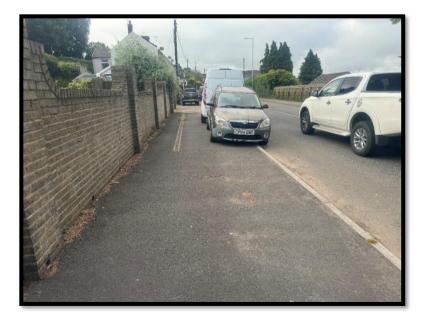
Photograph 4.6 – Parking issues narrowing the usable width on eastern footway opposite no. 57 Gelli Arael Road

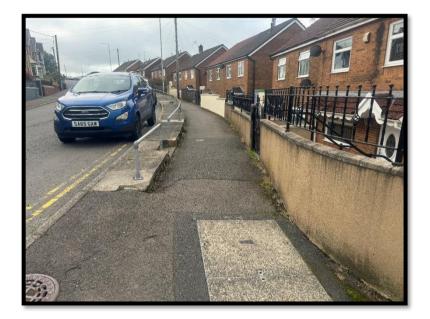
Photograph 4.7 – Grade separated footway north of Wood Street

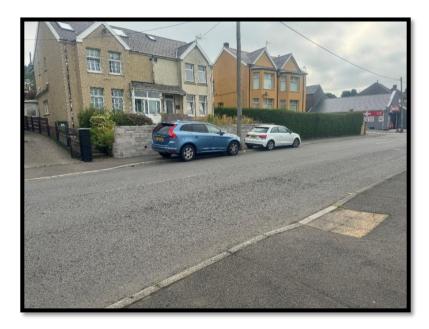
Photograph 4.8 – Uncontrolled crossing point opposite Gilfach Goch Scout Group

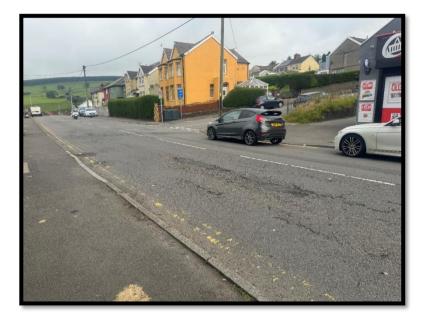
#### Photograph 4.9 – Informal crossing point opposite Family Shopper Cambrian Avenue

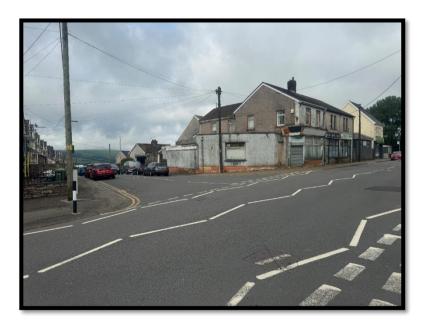
Photograph 4.10 – Wide crossing point with safer crossing further into Thomas Street

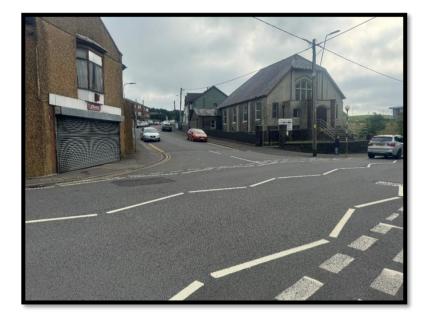
#### Photograph 4.11 – Wide crossing point with safer crossing further into Alfred Street

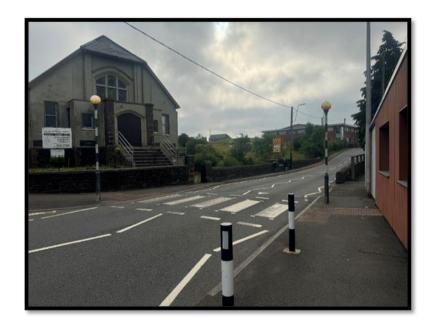
Photograph 4.12 – Zebra Crossing north of Thomas Street

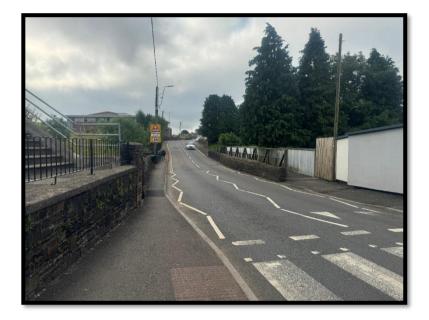
# Photograph 4.13 – Short section of footway narrowing and start of pedestrian footbridge north of Thomas Street

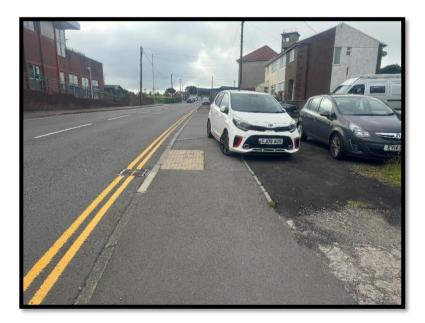
Photograph 4.14 – On footway parking issues at the uncontrolled crossing point opposite Gilfach Goch Community Association

- 8.4 There are uncontrolled crossing points between the eastern and western footway of Cambrian Avenue where vehicles were observed to park on the footway. Whilst visibility here appears to be restricted by parked vehicles and the geometry of the road, the crossing can be made safely in advance of the location where the visibility of vehicles in both directions is meets the criteria of the Learner Travel guidance. The local neighbourhood policing teams are also working with residents to help reduce the risks posed to pedestrians by indiscriminately parked vehicles.

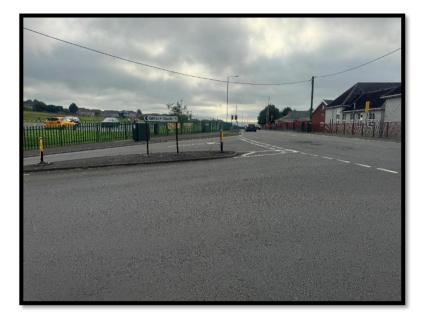
# Photograph 4.15 – Wide junction crossing between eastern and western footways at the junction of the B4564 Cambrian Avenue with the A4093

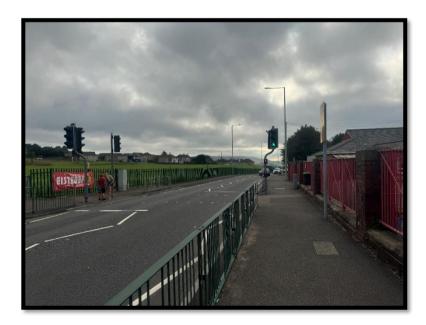
Photograph 4.16 – Signal controlled crossing opposite Hendreforgan Primary School

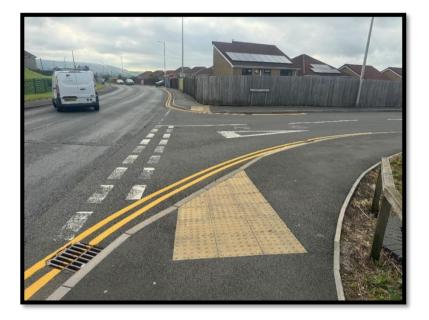
#### Photograph 4.17– Uncontrolled Crossing at Trem Y Griffin

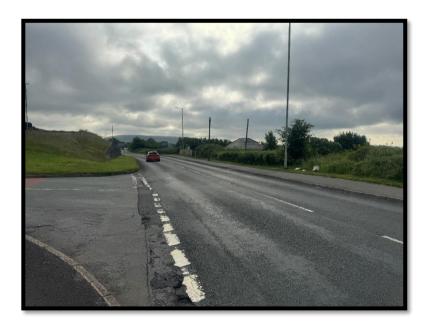
Photograph 4.18 – End of western footway at Heol Y Mynydd

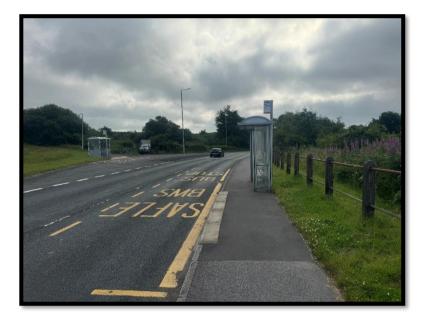
# Photograph 4.19 – Need for uncontrolled pedestrian crossing between bus stops on A4093

- Provide an uncontrolled crossing (drop kerbs and tactile paving) between the two bus stops on the A4093.
  - Review the concrete post and tubular steel rail fencing along the narrow sections of footway on the A4093 with a view to the removal of further sections of tubular stees rails. This will help improve the availability of pedestrian 'step-offs' into the rear verge area. It is noted however this can only be undertaken safely where the verge is stable and not undermined at the boundary fence line, see **paragraph 8.5** for further details.

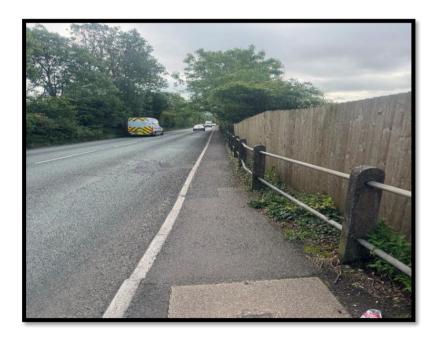
Photograph 4.20 – Eastern footway narrowing on A4093 (40mph)

- 8.5 There is a localised section of footway on the A4093 (40mph section) where the majority of the footway measures at circa 1.1m to 1.4m width, with a 300-400mm grassed verge between the back of footway and the property boundary close boarded fence. A suitable width footway was available (with step-offs to the rear) for the most part of the route. However, over two sub-sections of approximately 10m long (downhill section) and 50m long (uphill section) respectively within this length of route, the footway width reduces to circa less than1.0m. A property boundary fence is located at the back of footway in these areas which prevented pedestrians from stepping into the verge. This is currently managed by pedestrians giving way to pass one another.

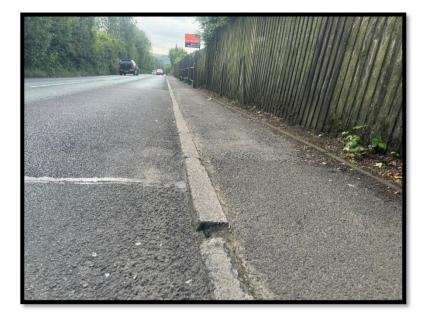
# Photograph 4.21 - Eastern footway flush kerbs on A4093 (40mph) and footway narrowing to circa 1.0m

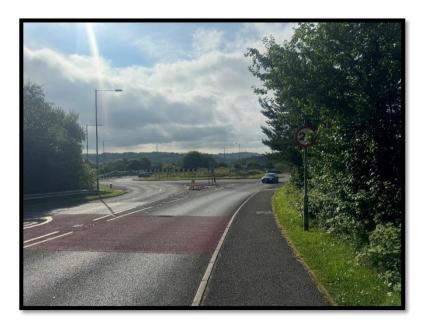
Photograph 4.22 - Uncontrolled crossing point between A4093 and B4278

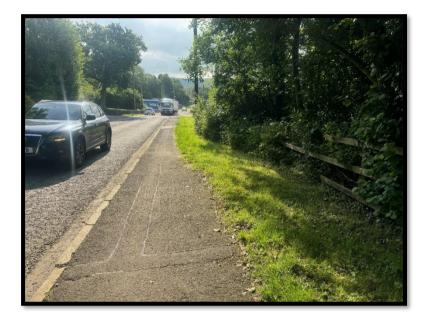
#### Photograph 4.23 - Localised footway narrowing with vegetation encroachment on the B4278

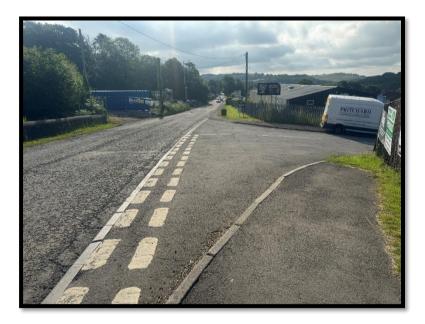
Photograph 4.24 – Reduced visibility issues at uncontrolled crossing point on the junction of the fencing supplier's unit and Gilfach Road, it is noted however that traffic flows are very low entering the unit

- 8.7 The uncontrolled crossing point across Gilfach Road Junction (entrance to Tyre Trax) is approximately 30m wide, with limited visibility but very low use. This is currently managed by pedestrians proceeding with caution across the junction. Vehicle flows are very low, ranging between 34 and 76 vehicles per hour, with between 380 and 519 gaps of 6 seconds per hour.

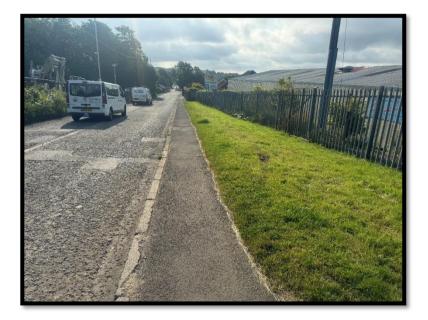
#### Photograph 4.25 - Narrow footway with verge opposite Trax Tyres

- 8.8 The southern footway link from the entrance into Tyre Trax and up to the Worcester Court junction is approximately 900mm in some locations, which may require pedestrians to cross to the other side of the road to avoid the narrow footway.

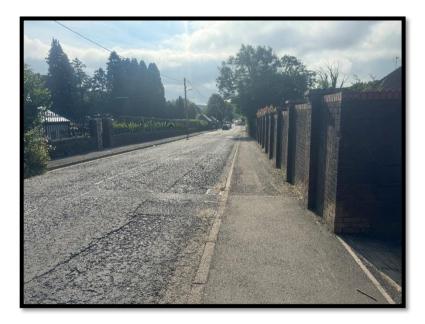
Photograph 4.26 – Uncontrolled crossing between northern and southern footway

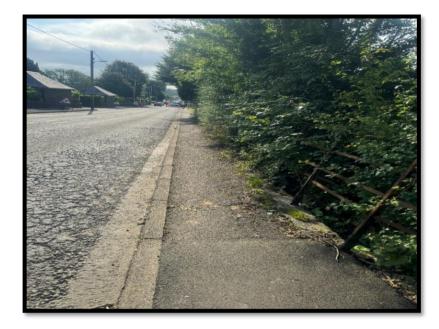
# Photograph 4.27 - Narrow footway with overgrown vegetation and a failing fence line along back of the southern footway opposite Trane Cemetery

- 8.9 Trees and vegetation were observed to be overhanging sections of the footway throughout the route as identified in Section 4. Opposite Trane Cemetery, the existing fence had failed in places, exposing pedestrians potentially to a level difference hidden by vegetation. It would be prudent to repair the fence line to address the hazard and mitigate the risk.

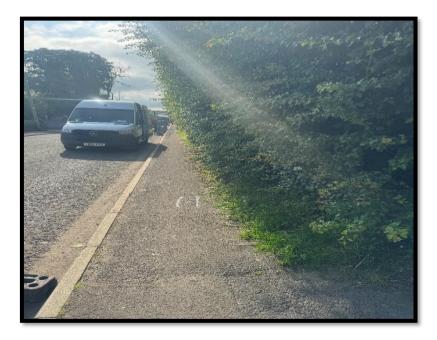
Photograph 4.28 - Narrow footway and overgrown vegetation restricting the usable width on the southern footway north of Dan Y Fron

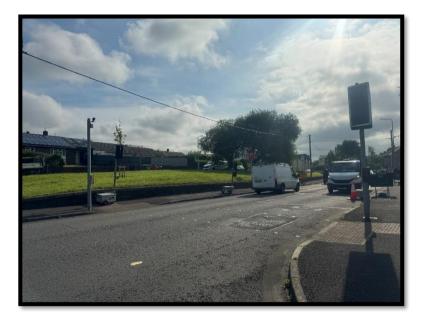
#### Photograph 4.29 – Signalised crossings between Worcester Court and Bryngolau

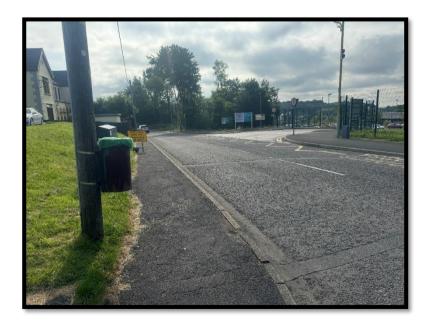
Photograph 4.30 – Footway leading to Tonyrefail Community School

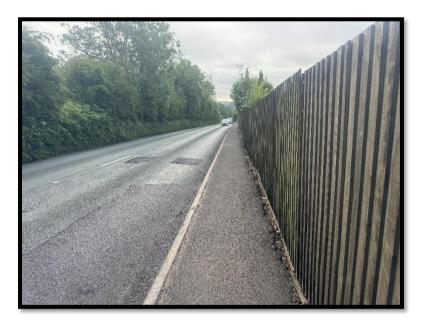
6.1 The section of footway along the 40 mph section of the A4093 between Heol Y Mynydd and Gilfach Road has no overlooking buildings (the adjacent properties are blocked by the rear boundary fences) or natural surveillance for circa 500m, other than by passing traffic or other pedestrians, see **photograph 6.1** below.

Photograph 6.1 – Limited natural surveillance along the 40mph section of the A4093 between Heol-Y-Mynydd and Gilfach Road
