# RCT School Walking Routes Assessment

Porth Community School and Williamstown  
to Tonyrefail Community School

March 2025

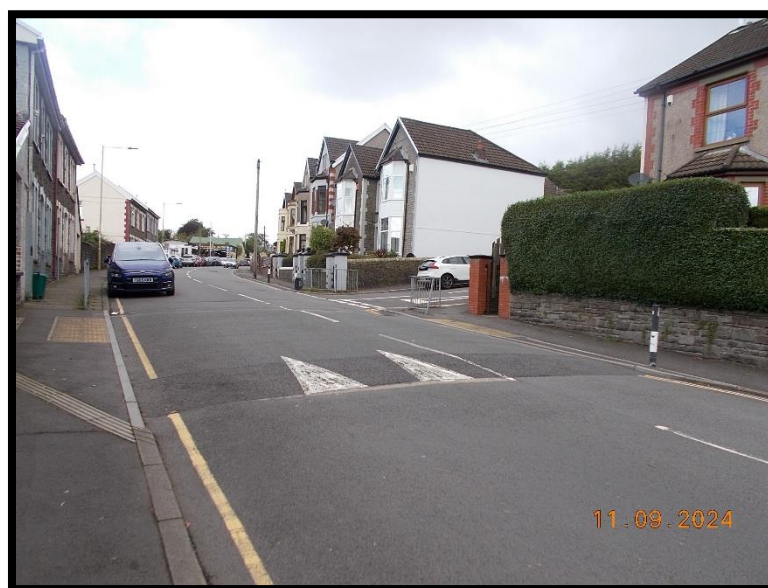
**Photograph 4.1 – Uncontrolled raised crossing (road hump) at the junction access to Porth Community school**

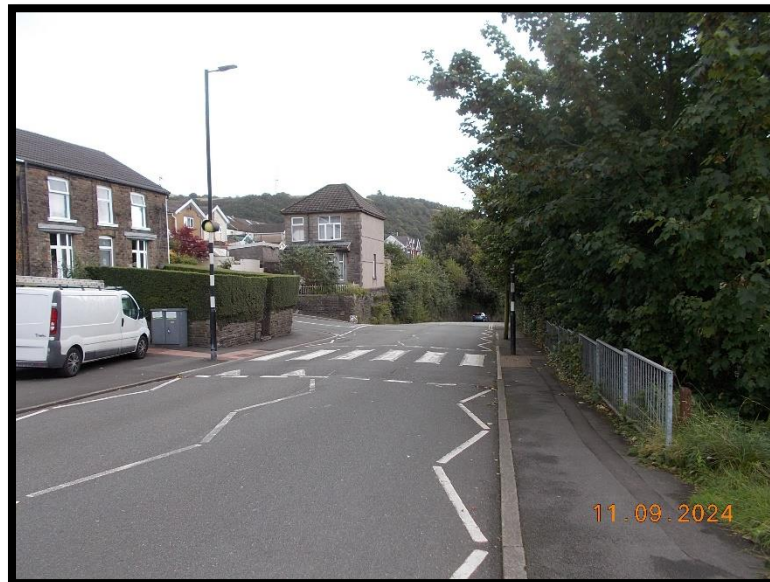
**Photograph 4.2 – Zebra Crossing near the junction of Mount Pleasant Road with the B4278 Cemetery Road, with over hanging tree branches obscuring the Belisha beacon head**

- Monitor the condition of overhanging trees and foliage. Where trees and / or foliage overhang or encroach into footways these areas should be cut back to improve sight lines and natural surveillance. In addition to this leaf debris should be removed from footways when required.
- Monitor footway obstructions. Where footway widths continue to be restricted by bin bags and parked cars, action be taken in conjunction with the appropriate Council Department / local neighbourhood policing teams.

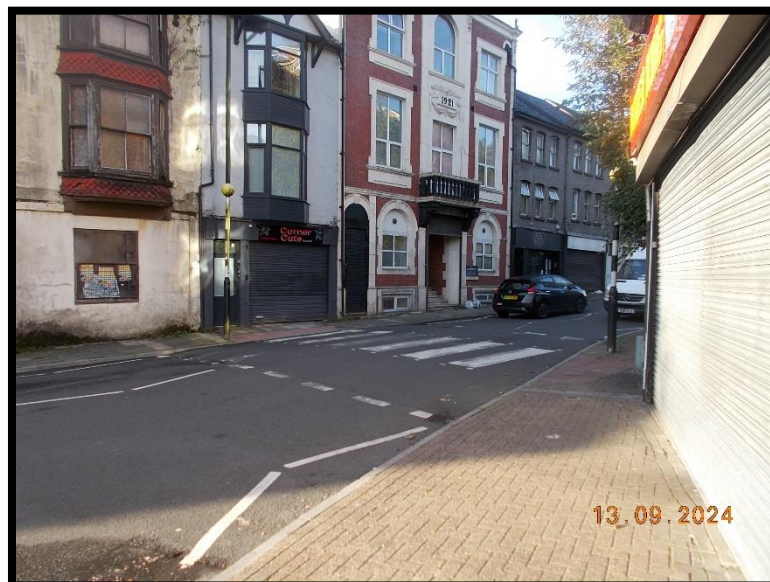
**Photograph 4.3 – Zebra controlled crossing outside Doner King & Pizzanos on Tynewydd Square**

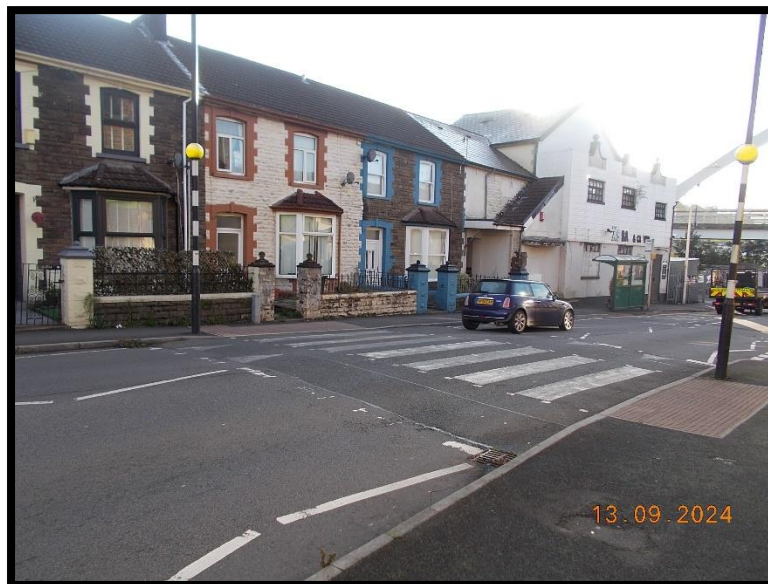
**Photograph 4.4 – Zebra controlled crossing outside the Tynewydd Hotel on Aberrhondda Road**

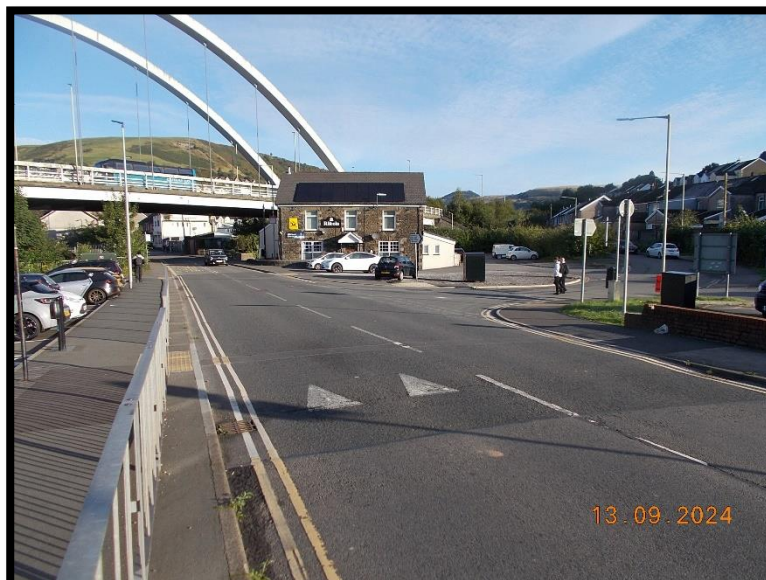
**Photograph 4.5 – Raised uncontrolled crossings either side of the minor junction on Rheola Road**

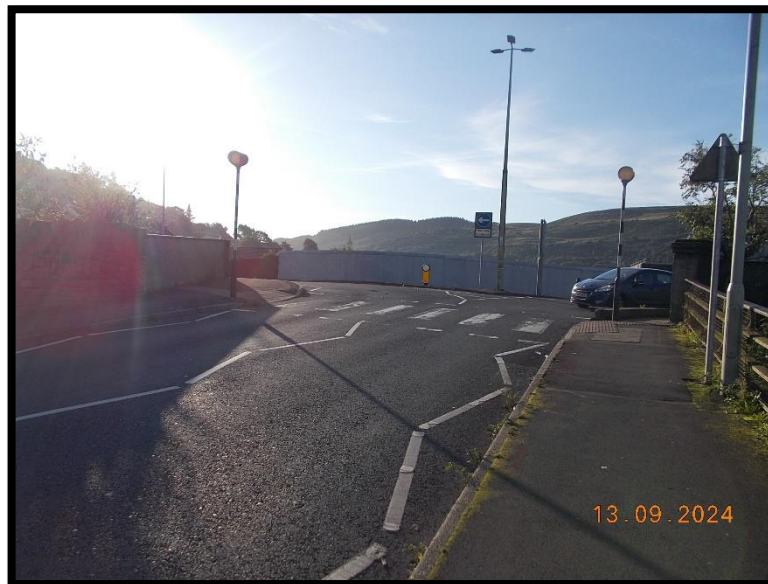
**Photograph 4.6 – Zebra controlled crossing at the junction of Rheola Road with the B4278**

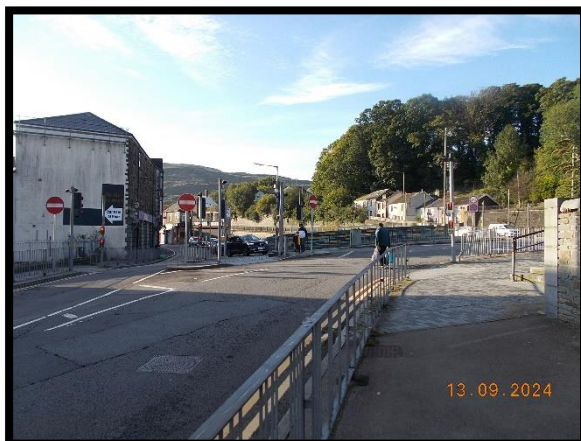
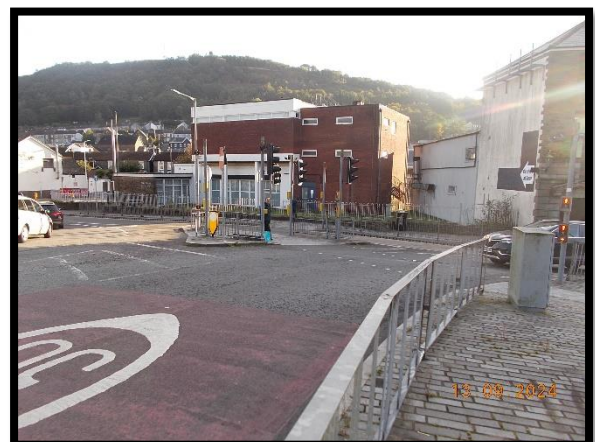
**Photographs 4.7 & 4.8 – Signalised controlled crossings at the junction of Porth Street with the B4278**

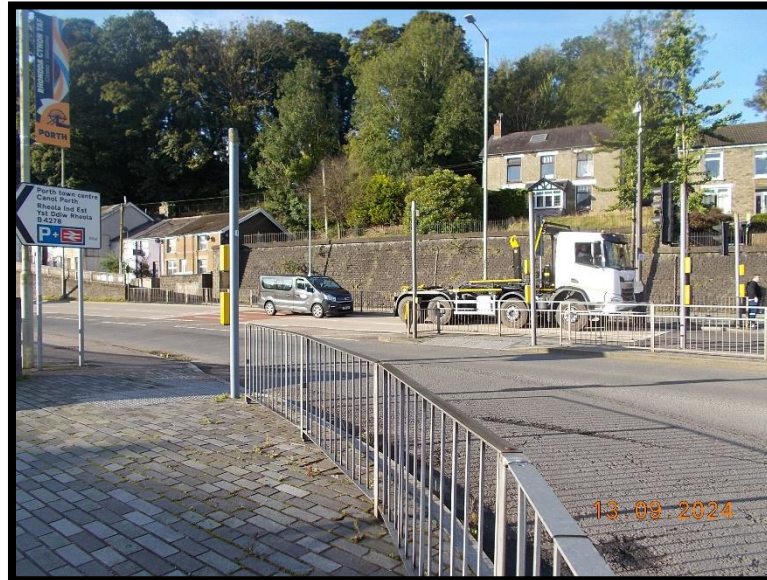
**Photograph 4.9 – Staggered signalised controlled crossings at Porth Square crossing the A4058**

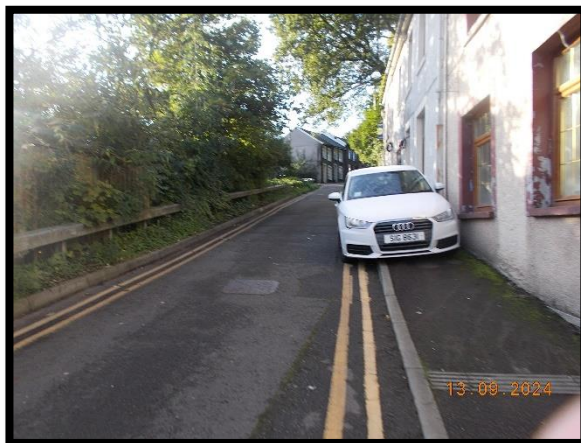
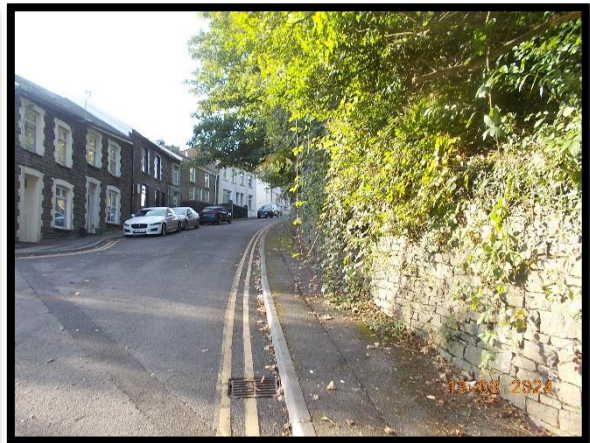
**Photographs 4.10 & 4.11 – Parking on footways and overgrown vegetation reducing the usable footway width along High Street cul de sac**

- 8.1.5 There are localised sections of the route where the footway width is reduced by refuse sacks, and wheelie bins, which may require pedestrians to give way to pass one another. Vehicles obstructing footways can also impact upon walking routes, but the local neighbourhood policing teams are working with residents to help reduce the risks posed to pedestrians by indiscriminately parked vehicles.

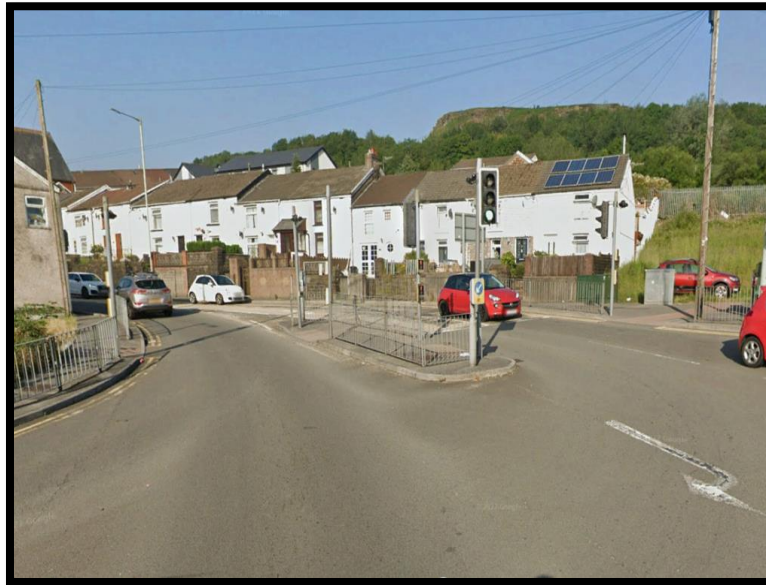
**Photograph 4.12 – Staggered signalised controlled crossings at the junction of High Street and Bedw Street with the A4233 High Street**

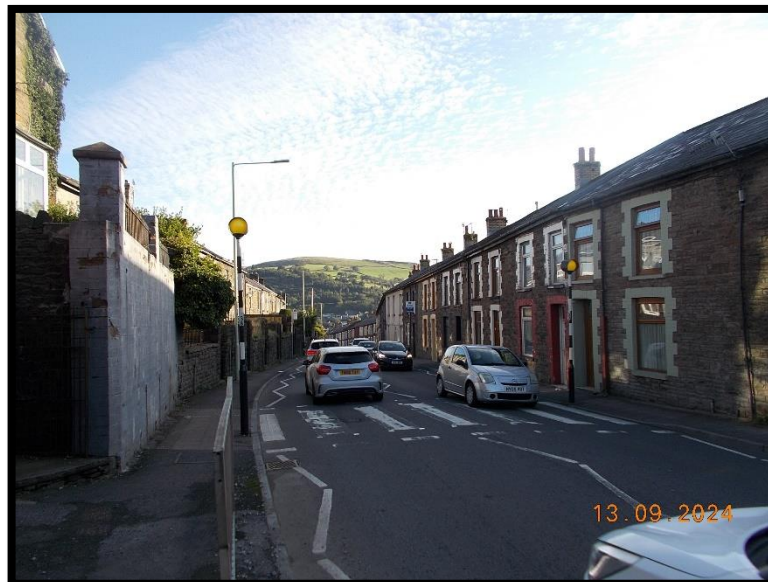
**Photograph 4.13 – Zebra crossing outside no.79 High Street on the A4233**

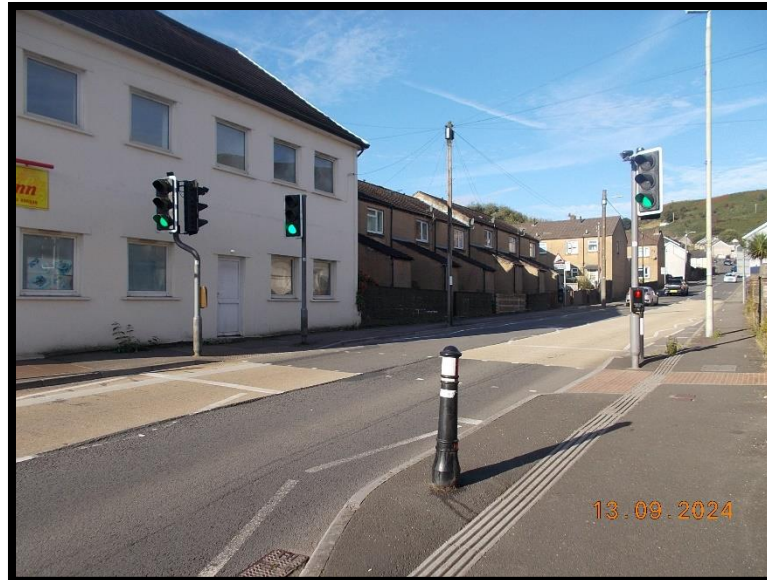
**Photograph 4.14 – Signalised controlled crossing on the A4233 High Street near the junction entrance to Ysgol Gyfun Cwm Rhondda**

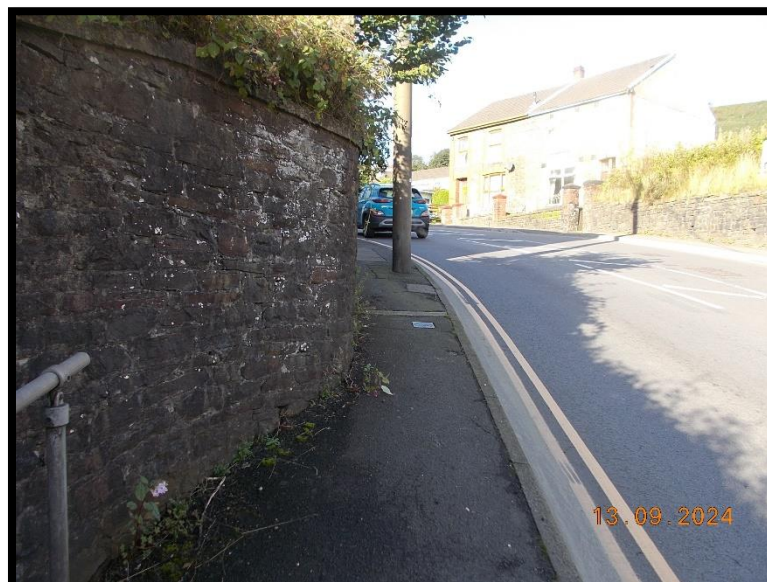
**Photograph 4.15 – Localised footway narrowing at telegraph poles along the A4233 High Street**

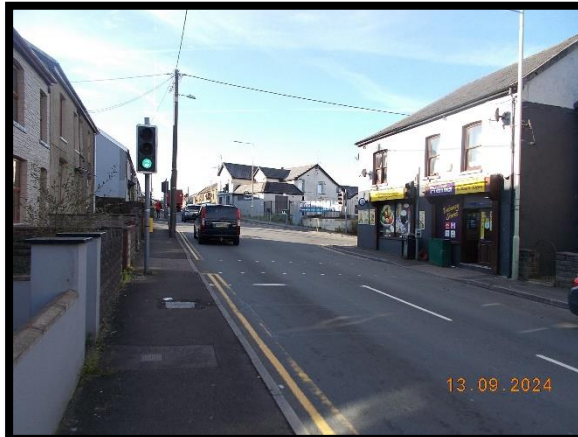
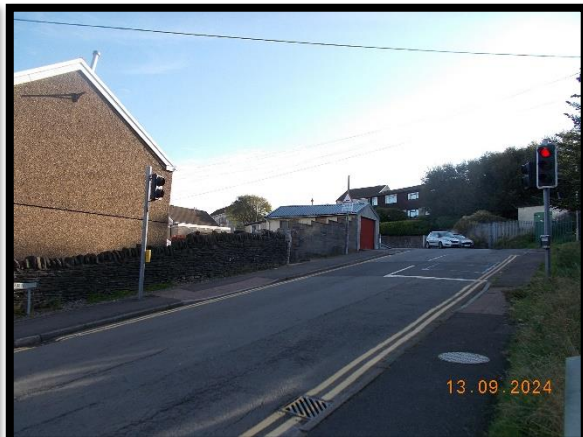
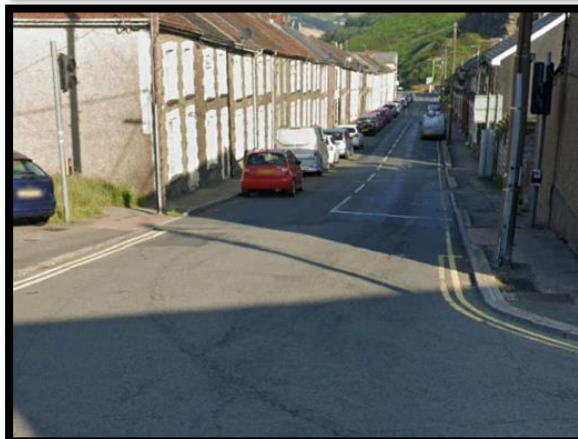
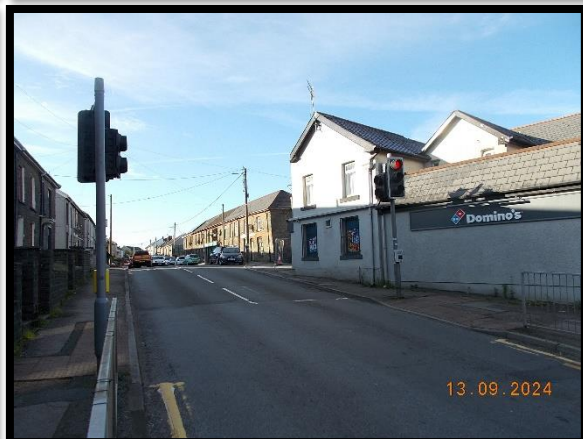
**Photographs 4.16, 4.17, 4.18 & 4.19 – Signalised controlled crossings at the 4 arm junction of Brocks Terrace and Rhiwgarn Road with the A4233 Trebanog Road**

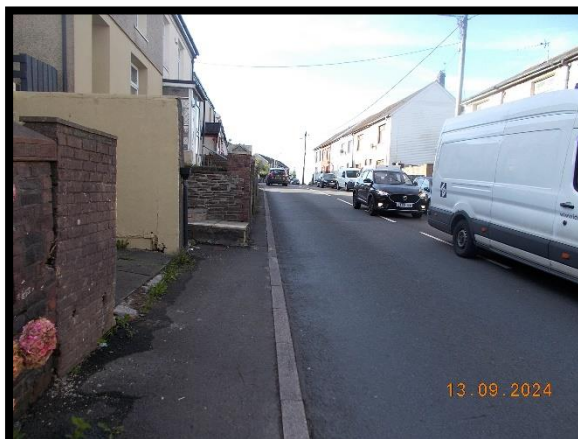
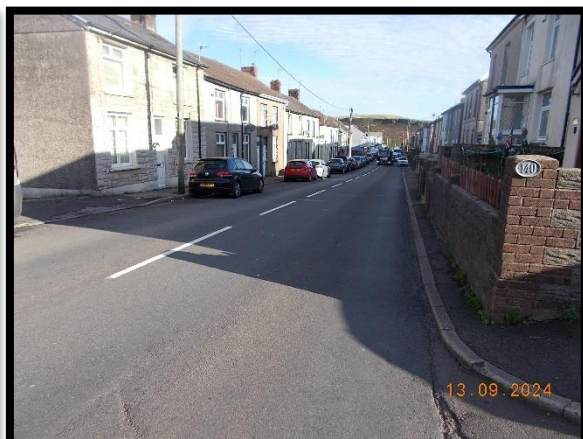
**Photographs 4.20 & 4.21 – Localised footway narrowing along the A4233 Trebanog Road**

- 8.1.3 A footway narrowing is present on the A4233 outside nos. 138 to 140 Trebanog Road, where the eastern footway narrows to circa 0.4m. As a result, pedestrians will either be required to step into the carriageway or cross the road at this location to achieve connectivity between adjacent footways. Traffic counts were undertaken at this location, with counts carried out between 07:30 and 08:30 and 15:15 and 16:15, with a revisit undertaken on a different day in the morning, where the traffic count was the highest, as detailed in Section 5. The traffic flows and gaps for both AM and PM times did not meet the criteria outlined in the Learner Travel Guidance. As such further pedestrian improvement measures will be required before this section of the route is deemed as 'available'.

9.1.1 In its current condition the Main Route in its entirety, does not meet the criteria to be considered available to walk in line with the Learner Travel guidelines. This is due to the narrowing footpath between nos. 138 to 140 Trebanog Road, highlighted in section 8.1.3 of this report.

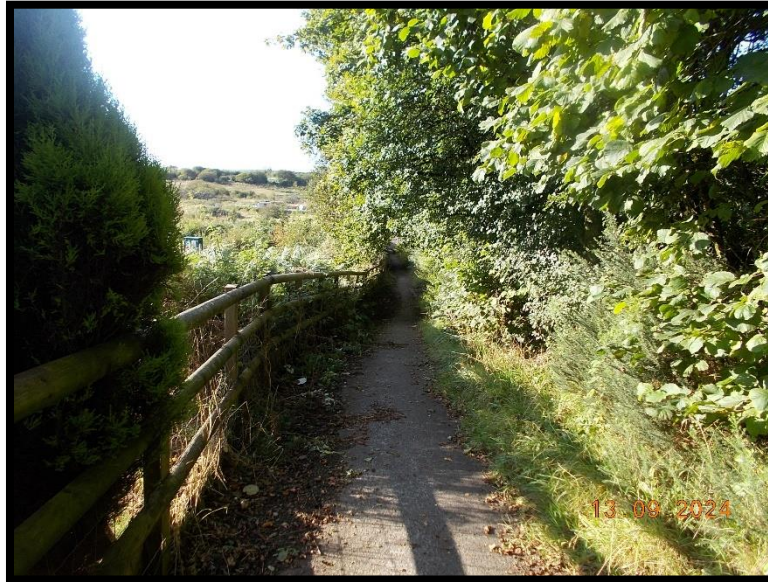
**Photograph 4.22 – Unlit footpath link with overhanging tree branches between the  
A4233Trebanog Road and Collena Road**

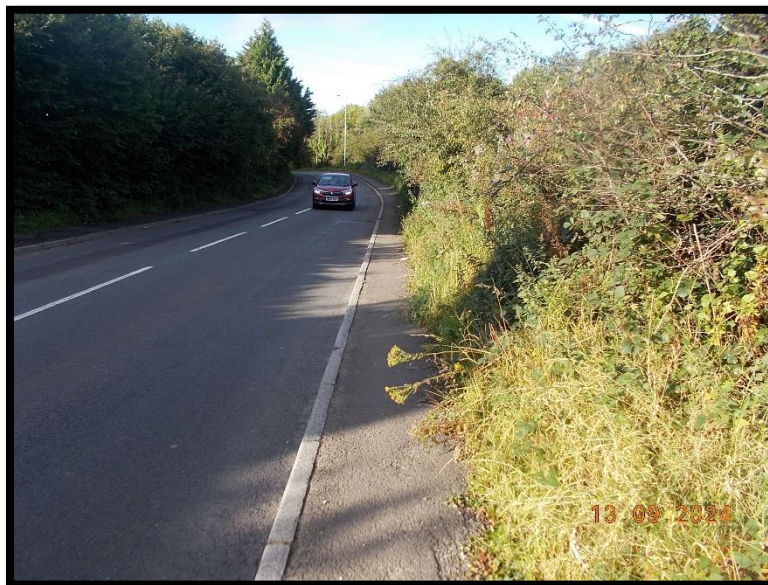
**Photograph 4.23 – Overhanging tree branches and vegetation reducing the usable footway width along Collena Road**

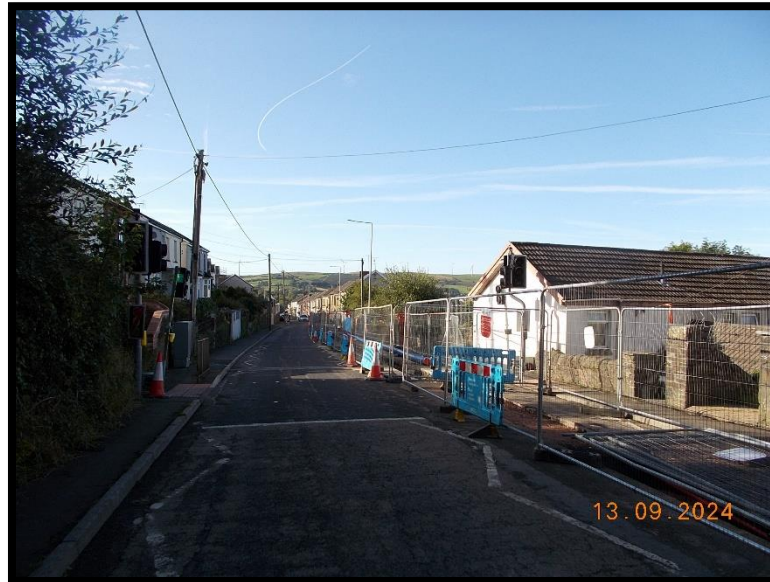
**Photograph 4.24 – Signal controlled crossings outside no. 68 Collena Road (temporarily closed at the time of the site visit due to ongoing road works)**

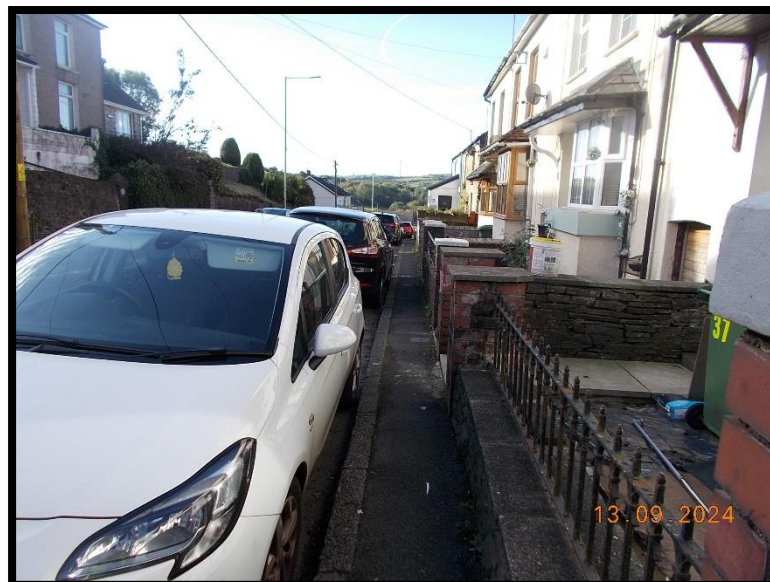
**Photograph 4.25 – Localised footway narrowing along Collena Road**

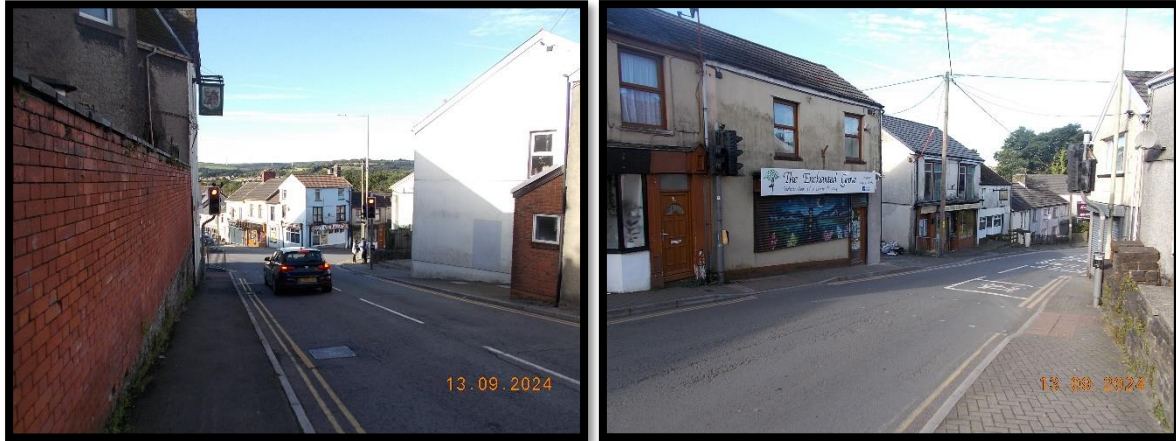
**Photographs 4.26 & 4.27 – Signal controlled crossings at the 4 arm junction of Collena Road, Mill Street, Waunrhydd Road and High Street (Collena Road and Waunrhydd Road arms shown).**

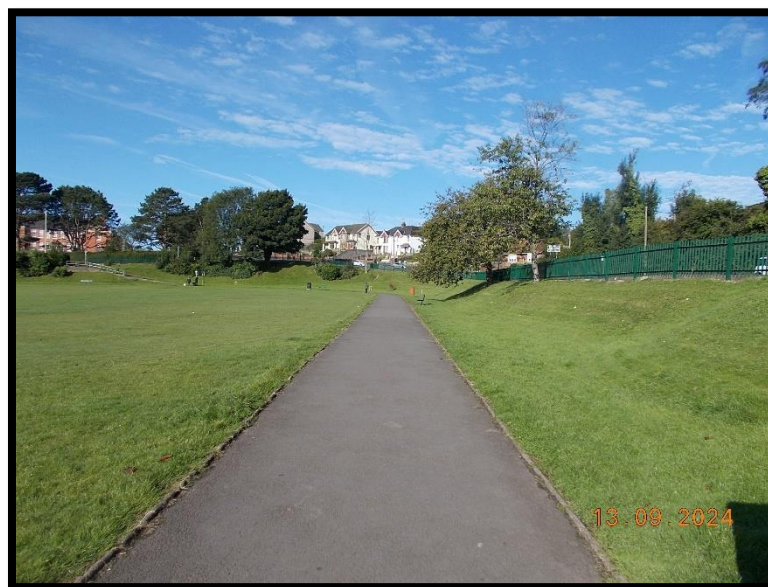
**Photographs 4.28 – Active Travel footpath through the playing fields adjacent to the leisure centre**

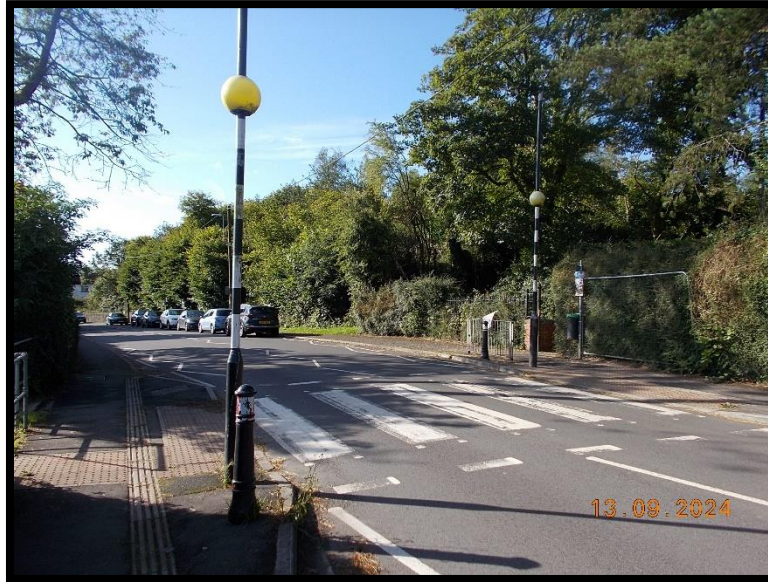
**Photograph 4.29 – Zebra crossing outside Tonyrefail Community School eastern entrance off Tynybryn Road**

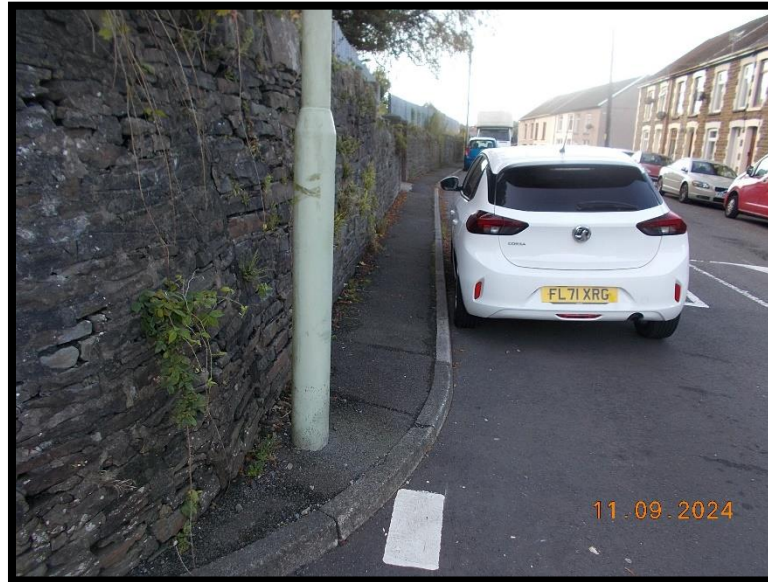
**Photograph 4.30 – Narrow footway widths along the northern footway on Amos Hill, it is noted however that the southern footway is available.**

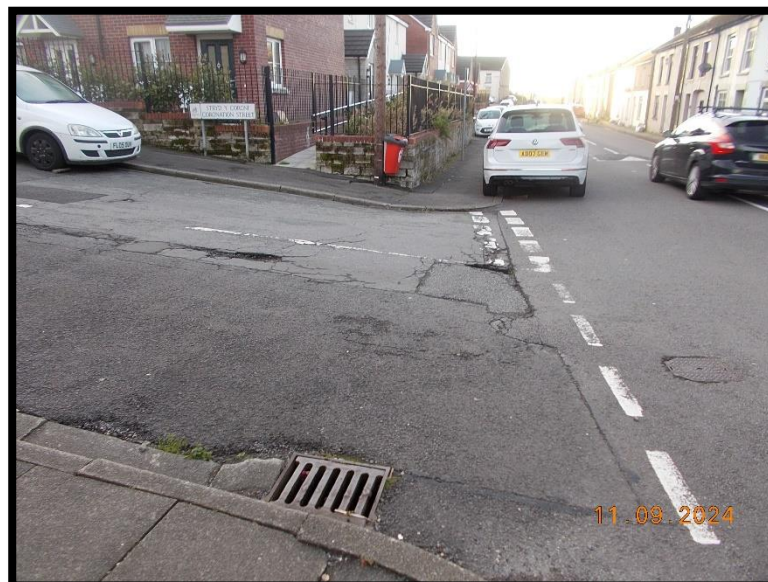
**Photograph 4.31 – Uneven road surface at the junction of Coronation Street with Arthur Street**

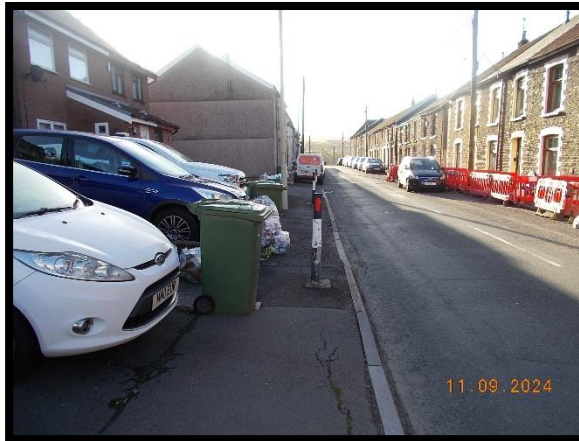
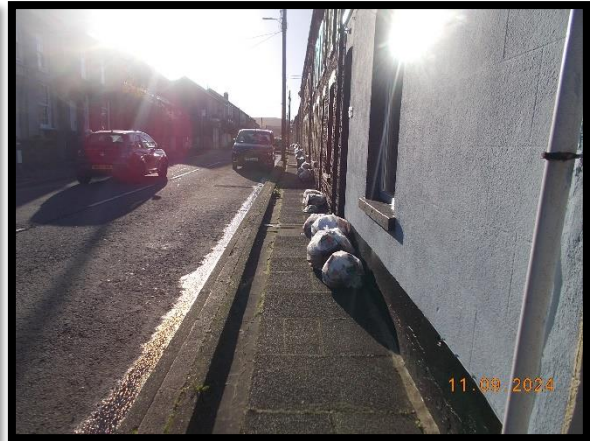
**Photograph 4.32 & 4.33 – Refuse/recycling bags reducing the available footway width along Mountain Road**

8.2.3 There are localised sections of the route where the footway width is reduced by bin bags and wheelie bins, which may require pedestrians to give way to pass one another. Vehicles obstructing footways can also impact upon walking routes, but the local neighbourhood policing teams are working with residents to help reduce the risks posed to pedestrians by indiscriminately parked vehicles.

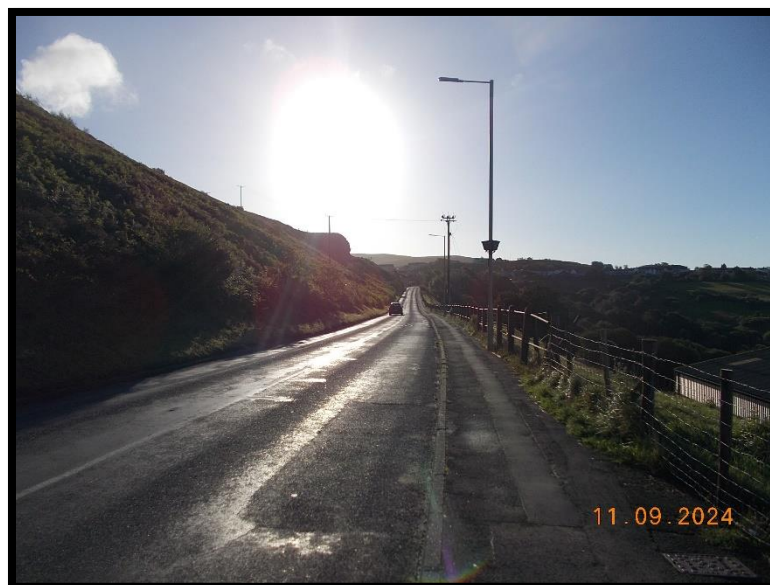
**Photograph 4.34 – Southern footway along Edmondstown Road leading to Trebanog**

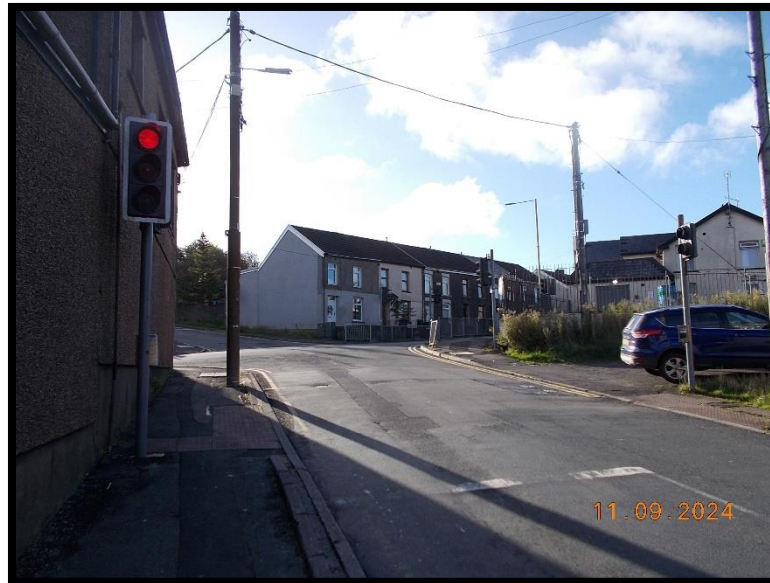
**Photograph 4.35 – Signal controlled crossings at the 4 arm junction on Brocks Terrace (Sub Route joins the Main Route)**

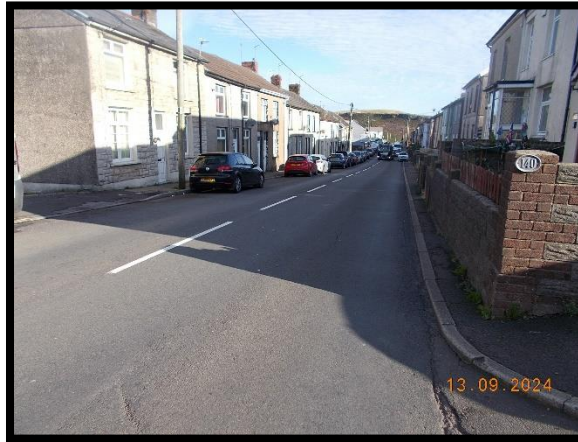
- 5.9.1 On the approach to the footway narrowing on the A4233 outside nos. 138 to 140 Trebanog Road, pedestrians may be required to cross the road to achieve connectivity between adjacent footways. Whilst traffic flows appeared heavy during the time of the assessment, visibility is good. Crossing opportunities need to be assessed.

- 5.12.1 **Location – the approach to the footway narrowing on the A4233 Trebanog Road (near house no.140) - 04/12/2024**
- ❖ **AM:** 1073 vehicles per hour, heavy traffic flow. Gaps of 6 seconds during each 5-minute periods only totalled 32 gaps over the 1-hour period.

- ❖ **PM:** 1054 vehicles per hour, heavy traffic flow. Gaps of 6 seconds during each 5-minute periods only totalled 7 gaps over the 1-hour period.
- 5.12.2 **Location – the approach to the footway narrowing on the A4233 Trebanog Road (near house no.140) - 05/12/2024**

- ❖ **AM:** 1039 vehicles per hour, heavy traffic 840>. Gaps of 6 seconds during each 5-minute periods only totalled 24 gaps over the 1-hour period.

**The traffic flows and gaps at this location for both AM and PM did not meet the criteria outlined in the Learner Travel Guidance. Gaps do not allow for safe step-offs or crossing at this point, and as a result this area will be subject to further review and recommendations for improvement works.**

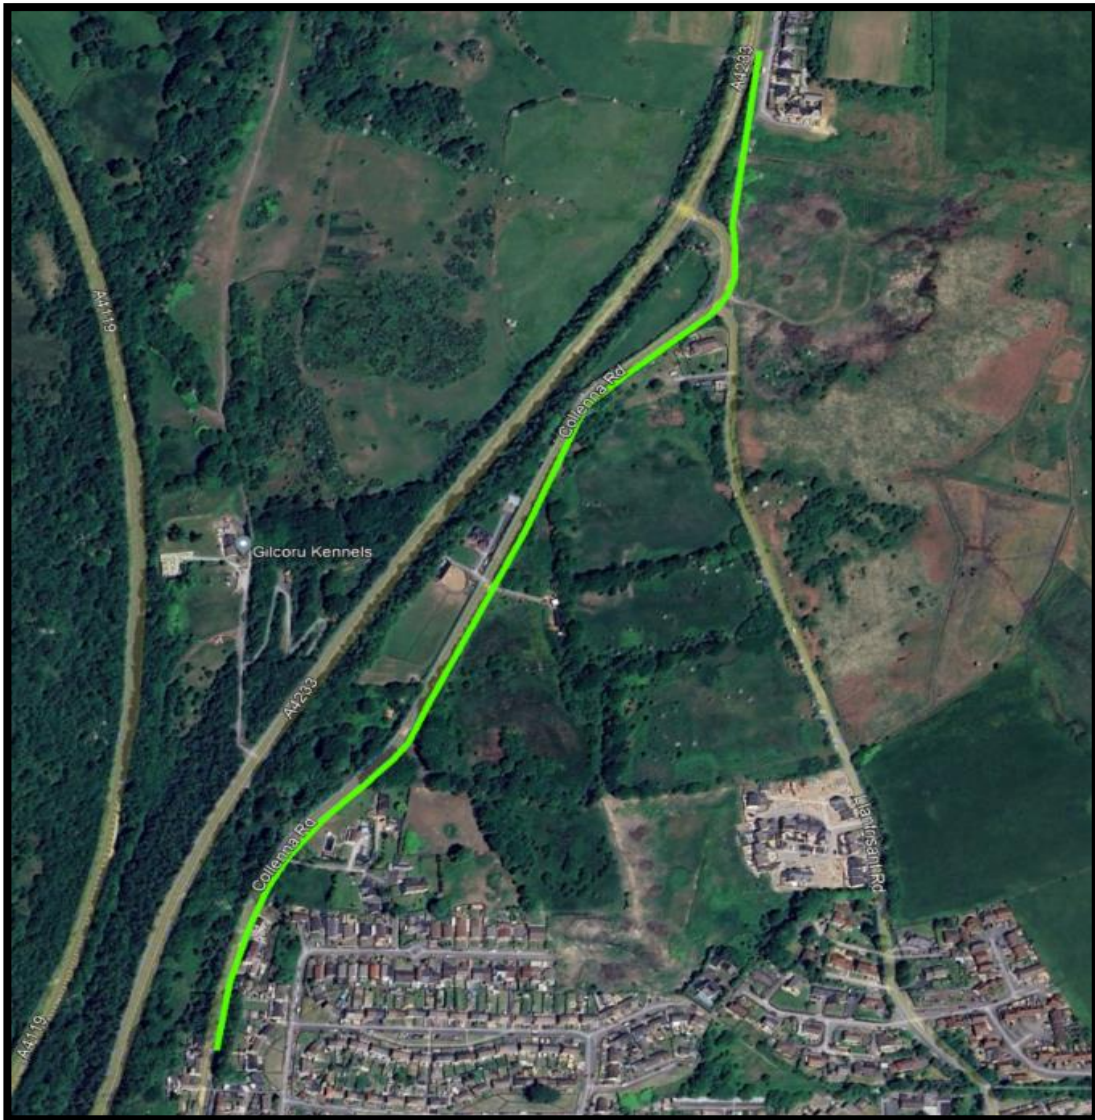
**Image 6.1 – Trebanog Road to the north of Tonyrefail along Collena Road**

- 6.1 There is a section of footpath along the **Main Route** for circa 900m, between the residential cul de sac on Trebanog Road and the northern extents of Tonyrefail along Collena Road. Whilst there is little or no overlooking buildings or natural surveillance other than by other pedestrians and passing vehicles, these sections (from Olive Terrace southwards) are available and in daily use by parents and pupils walking between Trebanog and Ysgol Gynradd Gymraeg Tonyrefail or Tonyrefail Community School. This footpath would benefit from tree and vegetation clearance to improve pedestrian comfort and lighting levels and improve the usable width, see **Image 6.1** below.
