RCT School Walking Route Assessment

Routes to Bryn Celynnog Comprehensive
School and Ysgol Garth Olwg

March 2025

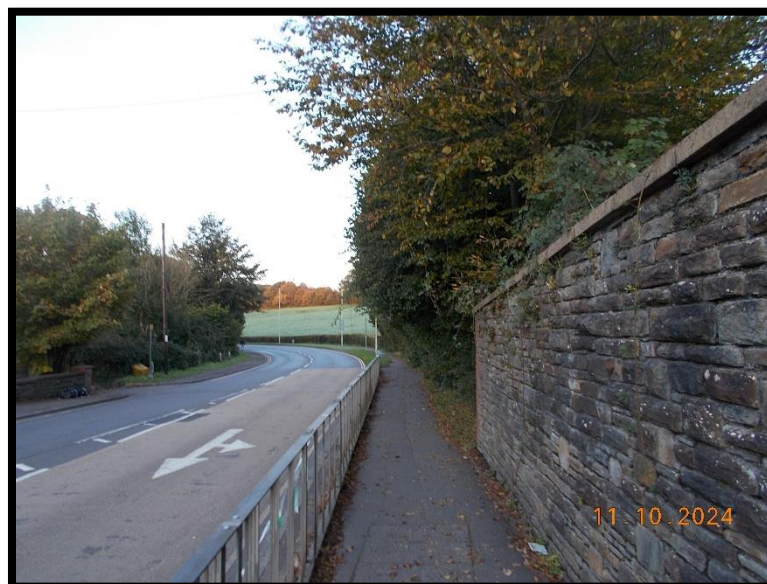
Photograph 4.8 – Footway along the B4595 Main Road adjacent to Garth Olwg School restricted by overhanging trees and vegetation

- Monitor the condition of overhanging trees and foliage. Where trees and/or foliage overhang or encroach into footways, these areas should be cut back to improve the usable width, sight lines and natural surveillance. In addition to this leaf debris should be removed from footways when required.

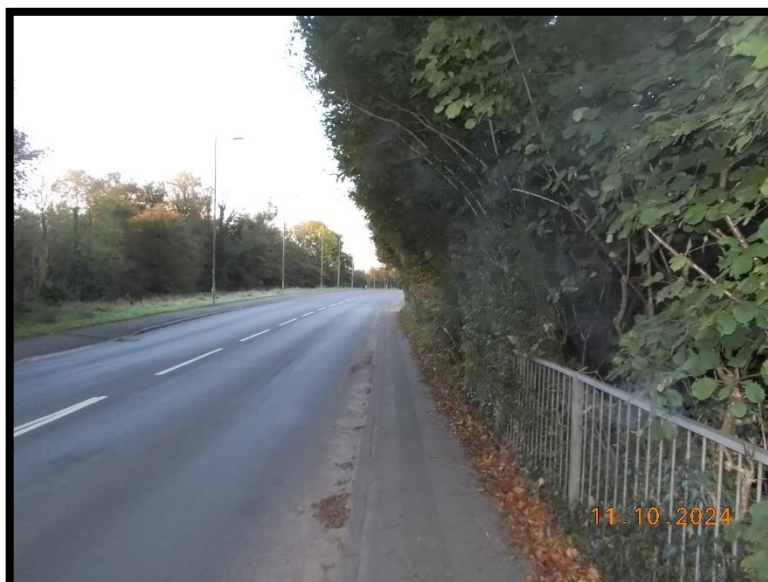
Photograph 4.10 – Footway along the B4595 Main Road to the west of St Davids Avenue, width restricted by overhanging trees and vegetation

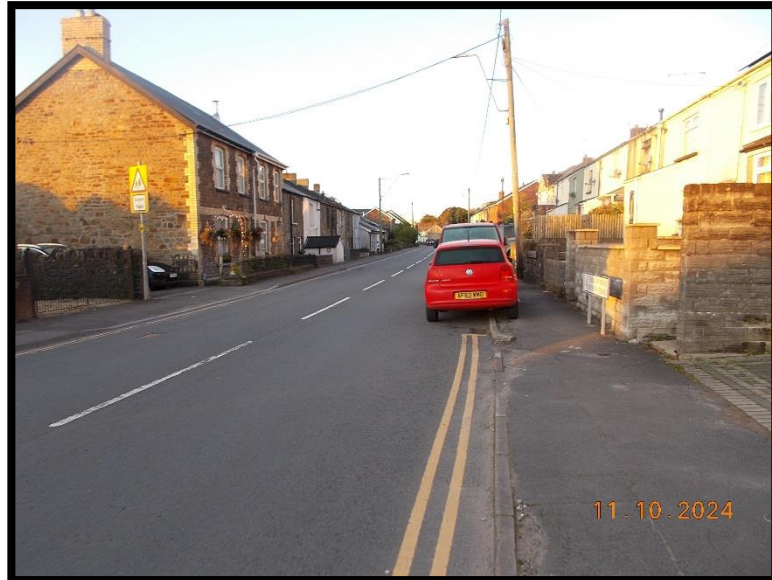
Photograph 4.14 – On street parking reducing the usable width along the B4595 Llantrisant Road at Gwynfryn Terrace, with the opposite footway being available.

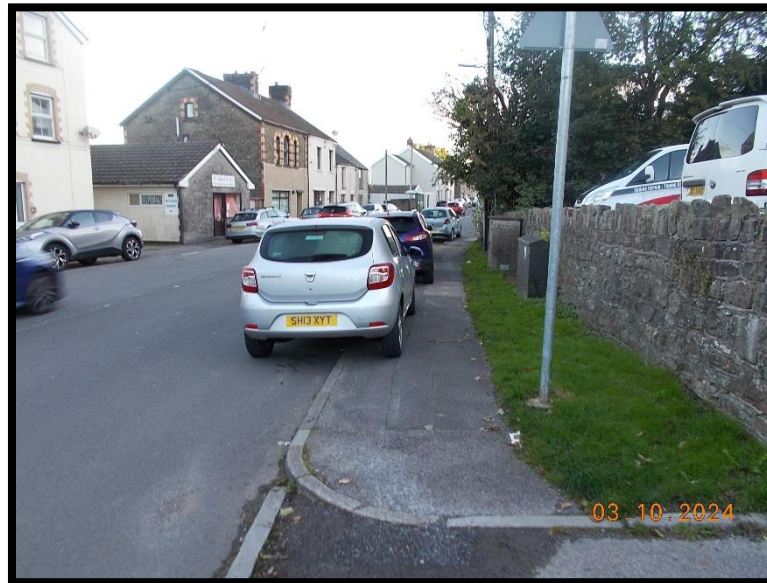
Photograph 4.16 – On street parking reducing the usable width along Bryn Terrace on the B4595 Llantrisant Road

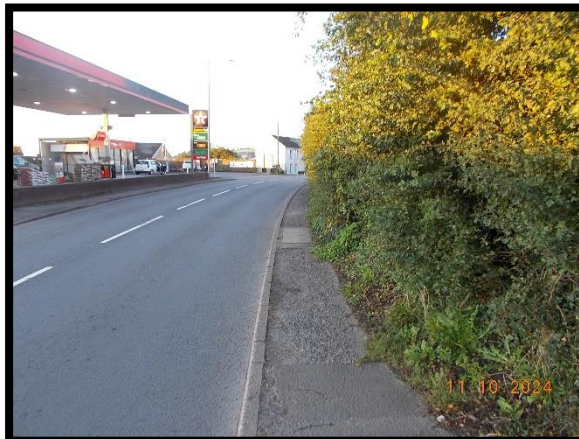
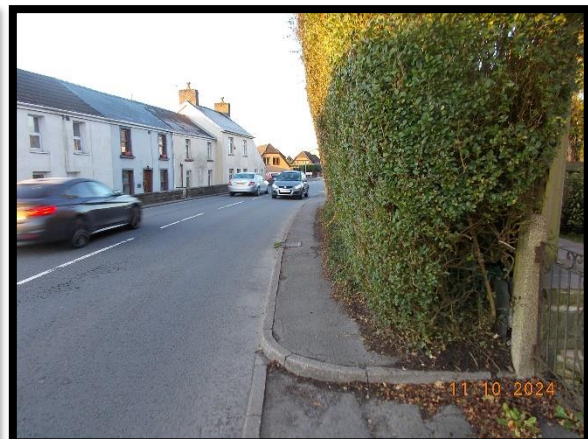
Photograph 4.17 & 4.18 – Footway near the Texaco Garage along the B4595 Llantrisant Road, with overhanging trees and vegetation narrowing the usable footway width

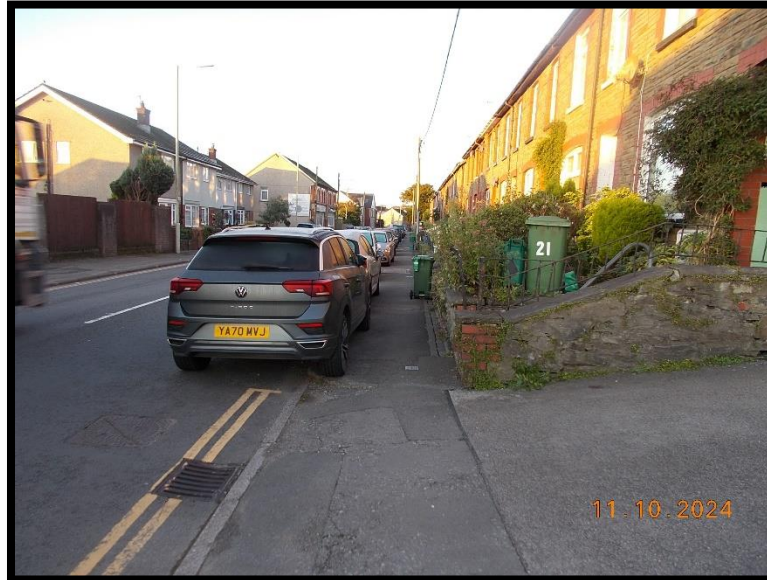
Photograph 4.19 – On street parking reducing the usable width on Llest Terrace along the B4595 Llantrisant Road

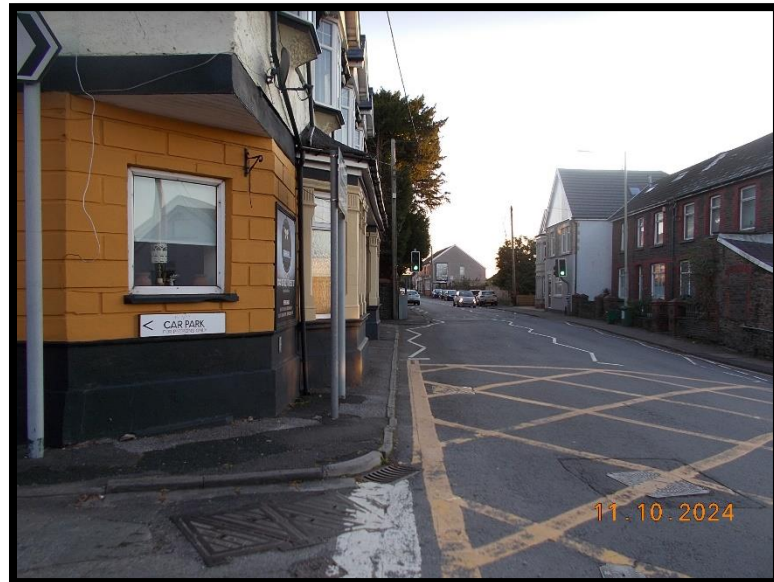
Photograph 4.21 – Narrow footway circa <0.5m outside The Gurkha Nepalese Restaurant, with the opposite footway being wider and available

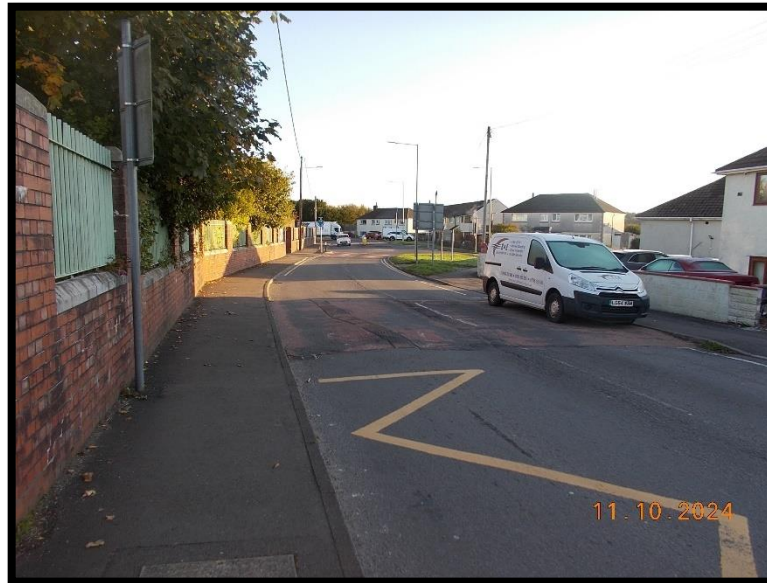
Photograph 4.28 – Uncontrolled crossing link over the existing speed hump (near the school exit) obstructed by on-street parking

- Enhance pedestrian crossing facilities to improve both footway connectivity and pedestrian crossing safety on the approaches to the school entrances. On-street parking makes crossing the road more difficult in front of the school. This is likely to be further exacerbated when potentially larger groups of school children are walking this route. It is recommended that tactile paving be provided at this location to guide pedestrians to the available crossing point, and that parking restrictions put in place to ensure crossing points remain clear and usable.

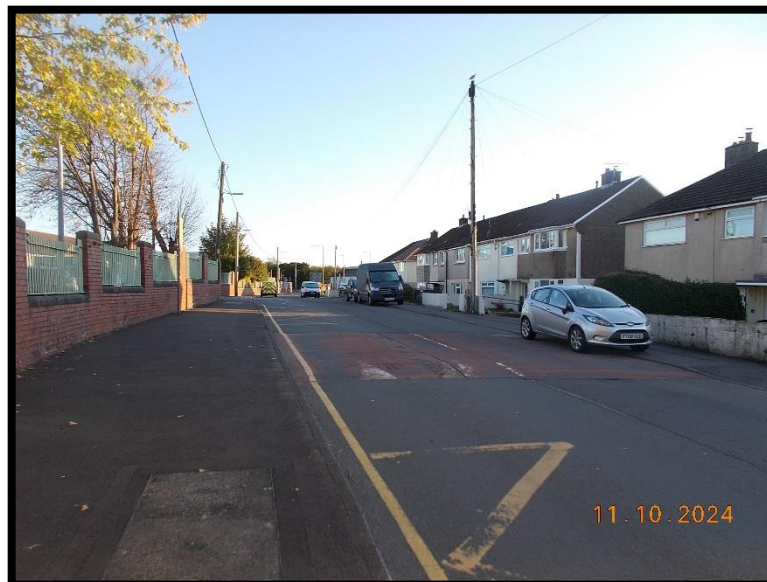
Photograph 4.29 – Uncontrolled crossing link over the speed hump (near the school entrance) obstructed by on-street parking

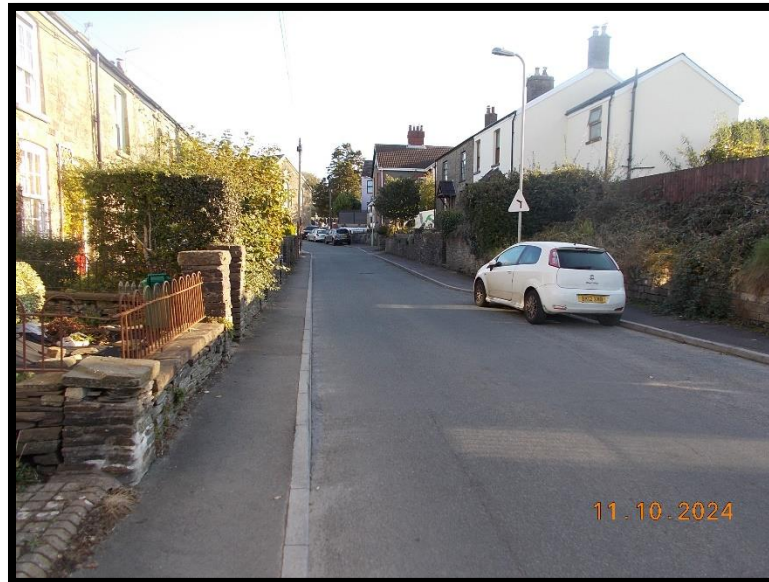
Photograph 4.36 – Narrow footways along Ffordd-Y-Capel at circa <1.0m width. This road was noted to have low vehicle and pedestrian flows during the time of the assessment

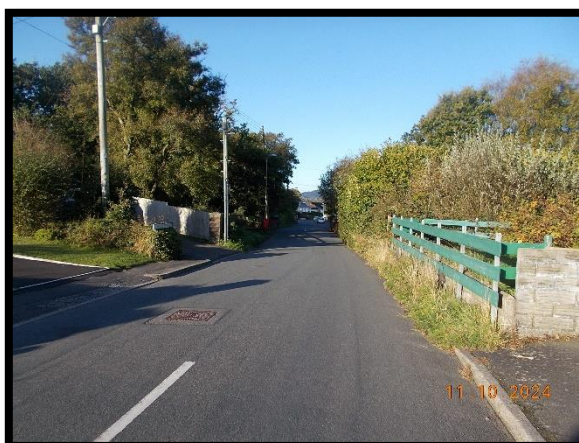
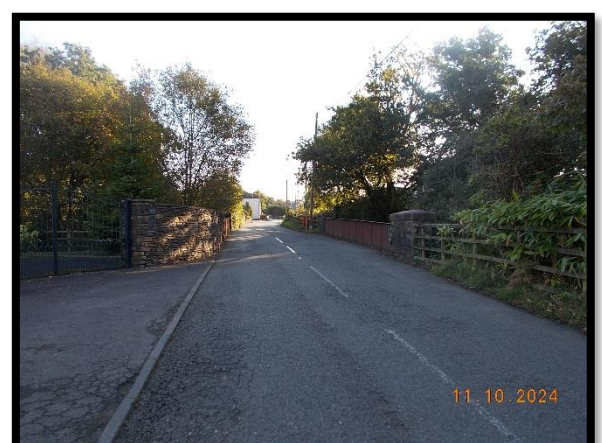
- 4.3.3 The footways (both sides of the carriageway) end abruptly at the interface of Heol-Y-Ffynon and Heol Dowlais in Efail Isaf, where the route crosses over the former railway. This leaves a gap of circa 30m with no footways present across the bridge. This area was noted to be quiet with low traffic and pedestrian flows during the walkover assessment.

Photographs 4.37 & 4.38 – Former railway bridge at the interface of Heol-Y-Ffynon and Heol Dowlais in Efail Isaf, with no footways present or step-offs available requiring pedestrians to walk along the carriageway to continue. This road was noted to have low vehicle and pedestrian flows during the time of the assessment

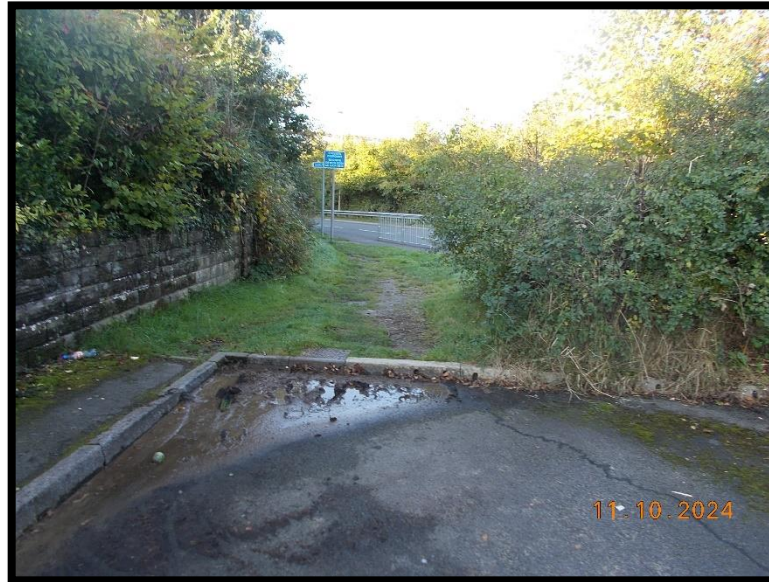
Photograph 4.39 – End of footway bituminous surface at the interface of Heol Dowlais with the A473 overbridge

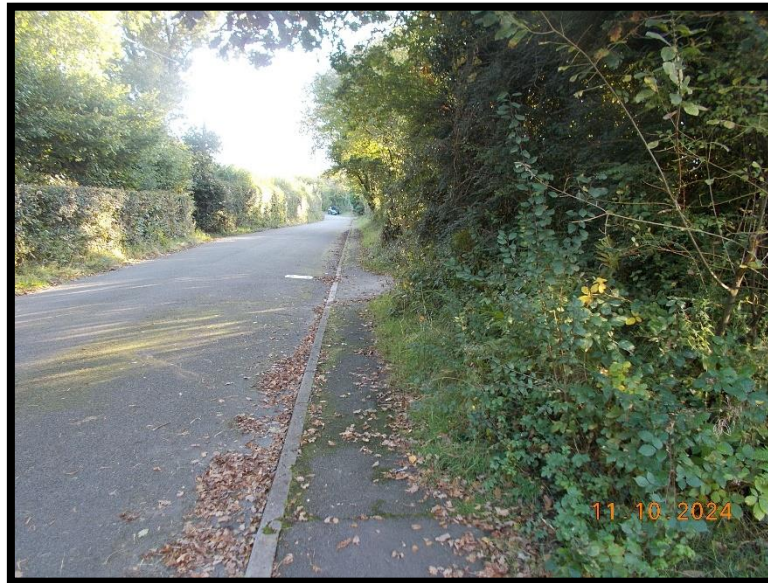
Photograph 4.41 – Footway along the Heol Dowlais with overhanging trees and vegetation narrowing the usable footway width. Vehicle flows were low during the time of the assessment

- Monitor the condition of overhanging trees and foliage. Where trees and/or foliage overhang or encroach into footways, these areas should be cut back to improve the usable width, sight lines and natural surveillance. In addition to this leaf debris should be removed from footways when required.

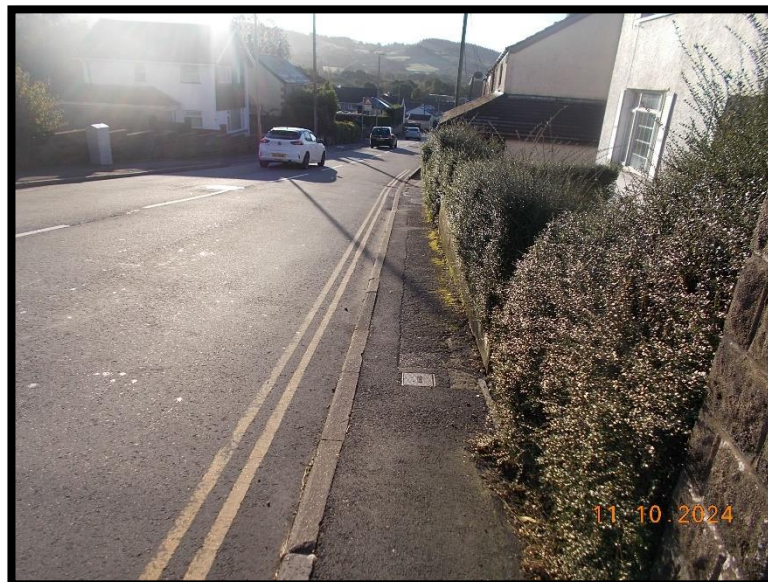
Photograph 4.44 – Narrow section of footway on Crown Hill near the junction with Llantrisant Road

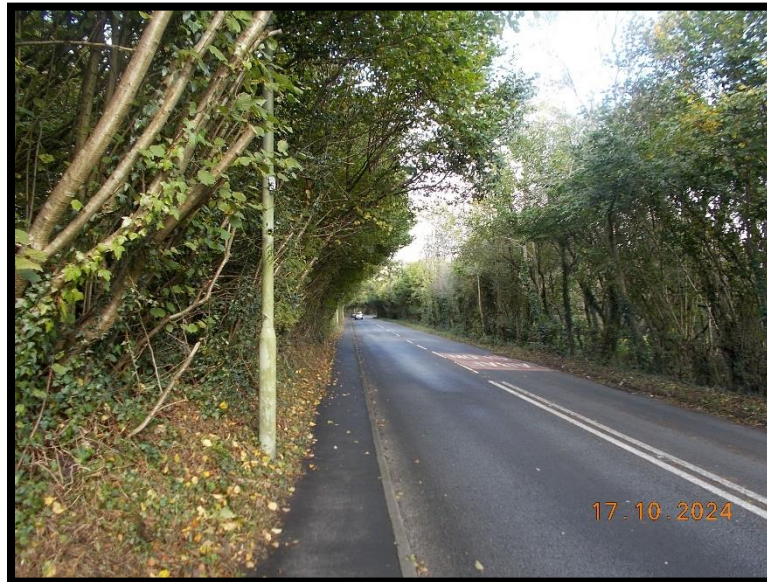
Photograph 4.48 – Footway along the B4595 Llantrisant Road with vegetation narrowing the usable width

- Monitor the condition of overhanging trees and foliage. Where trees and/or foliage overhang or encroach into footways, these areas should be cut back to improve the usable width, sight lines and natural surveillance. In addition to this leaf debris should be removed from footways when required.

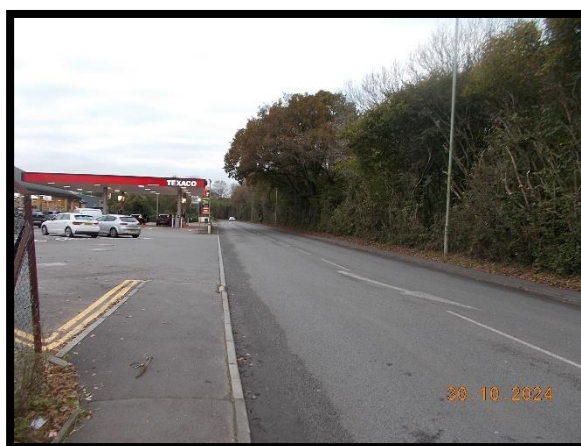
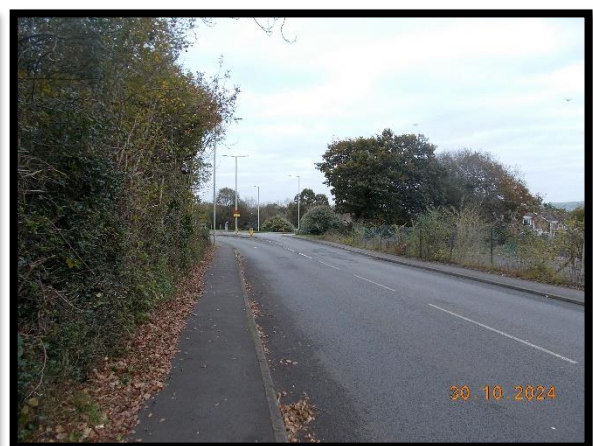
Photographs 4.49 & 4.50 – Undefined crossing location on the B4595 Llantrisant Road where visibility and recorded Gap Analysis are in line with Learner Travel Guidance

- Enhance pedestrian crossing facilities to highlight the optimum crossing location between the Texaco garage and roundabout at the entrance to Ffordd Glas-Y-Dorlan. Where pedestrian gap analysis has identified this as a Learner Travel guidance compliant crossing location. It is recommended that drop kerbs and tactile paving be provided at this location to guide pedestrians to the available crossing point.

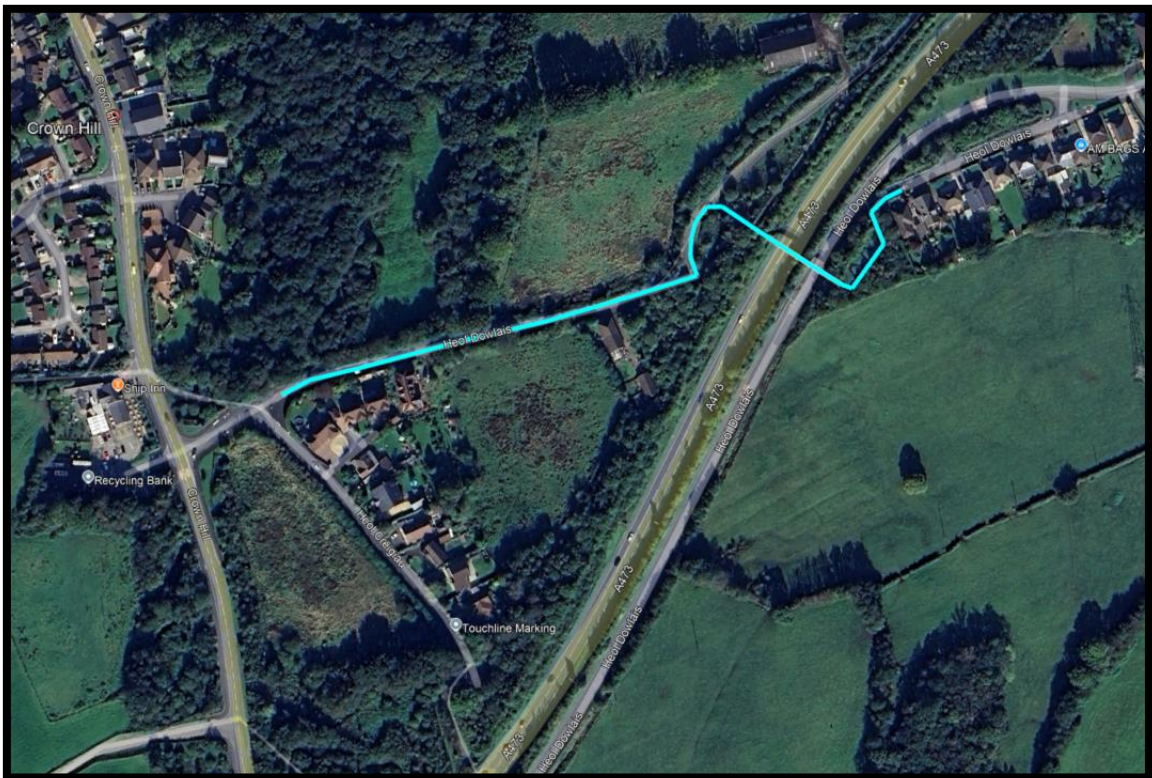
- 6.1 There are short sections of shared use footway that link to bridges over the Church Village Bypass, as well as circa 440m along Heol Dowlais, between the junction with Heol Creigiau and Heol Dowlais (west of the A473 overbridge) on **Sub Route 1**, where there is little or no overlooking buildings or natural surveillance, other than by other pedestrians and a few passing vehicles, see Image 6.1 below. These sections are available and in daily use by parents and pupils walking between Efail Isaf and Maesybryn and Ysgol Garth Olwg primary schools. The links to the A473 overbridges would benefit from vegetation clearance to improve pedestrian comfort and lighting levels.

Image 6.1 – Heol Dowlais along the National Cycle Network / CVBP Community Route
