# RCT School Walking Route Assessment Report

Routes to Ysgol Afon Wen and Cardinal  
Newman Catholic School

March 2025

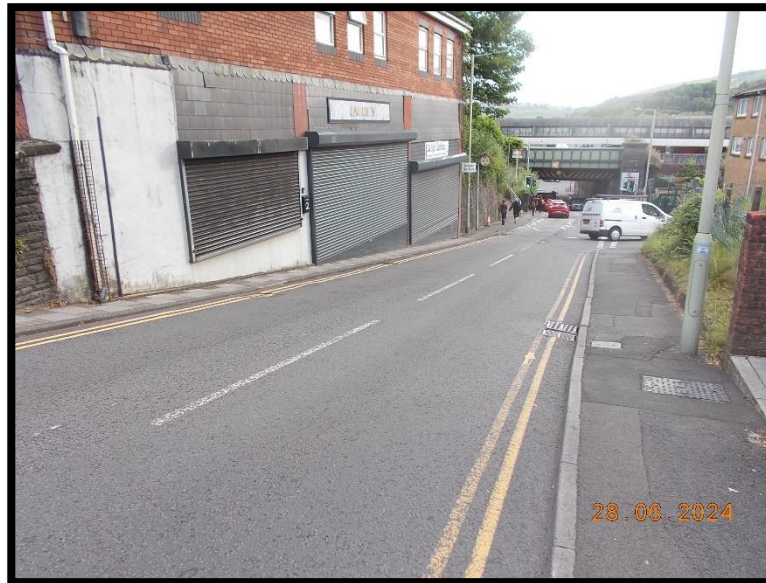
**Photograph 4.1 – Narrow footway <1.0m along High Street on the approach to the signalised crossings (western footway), it is noted that the opposite footway is available.**

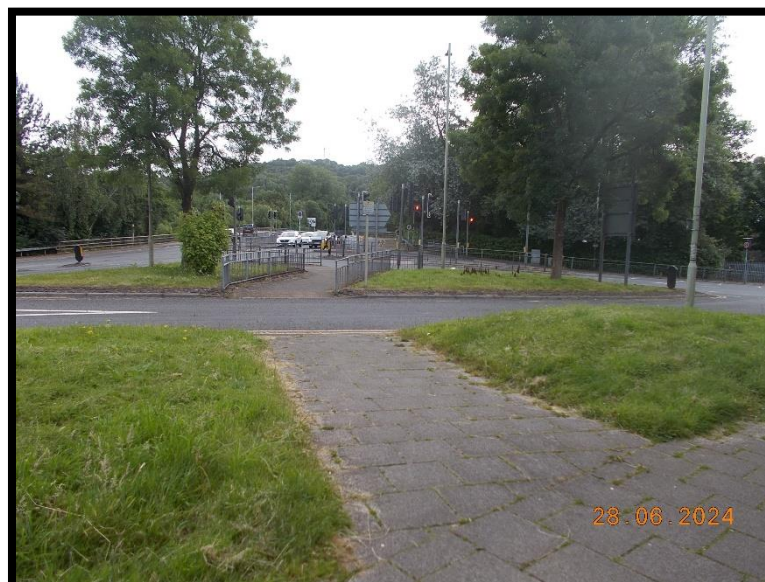
**Photograph 4.2 – A4058 Broadway/B4595 Broadway junction pedestrian uncontrolled and signalised controlled crossings**

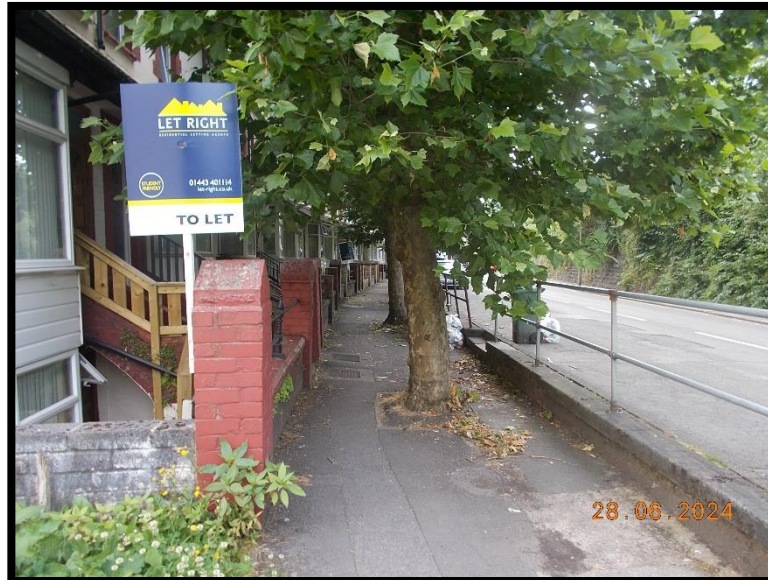
**Photograph 4.3 – B4595 Broadway northern footway narrowing and tree line, refuse sacks and wheelie bins were also noted to decrease the useable footway width along the Broadway**

- 8.1.1 The route lies within 30/20mph speed limits.
- 8.1.2 There are continuous sections of footway present in reasonable condition along the route.
- 8.1.3 Trees are overhanging the footway along B4595 Broadway which require cutting back to improve route width and pedestrian comfort levels.

- Monitor the condition of overhanging trees and foliage. Where trees and or foliage overhang or encroach into footways, these areas should be cut back to improve sight lines and natural surveillance. In addition to this leaf debris should be removed from footways when required.
- Monitor footway obstructions. Where footways widths are restricted by black bags and parked cars, action to be taken in conjunction with the appropriate Council Department / local neighbourhood policing teams.

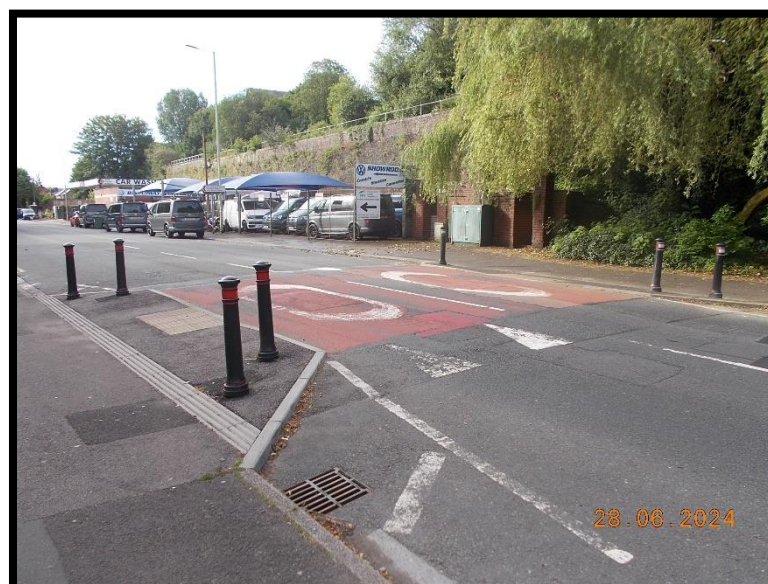
**Photograph 4.4 – B4595 Broadway uncontrolled raised crossing point**

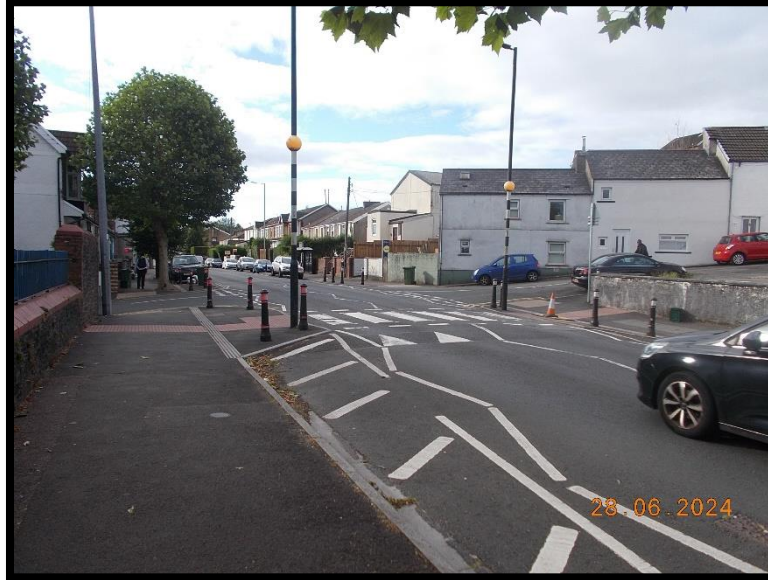
**Photograph 4.5 – Raised Zebra Crossing with crossing patrol outside Parc Lewis School**

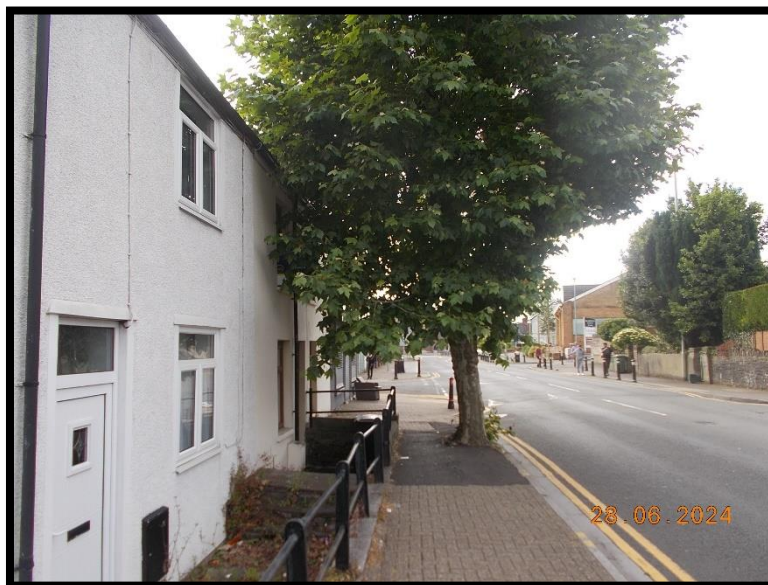
**Photograph 4.6 – Overgrown tree/vegetation and uneven footway surface over tree roots**

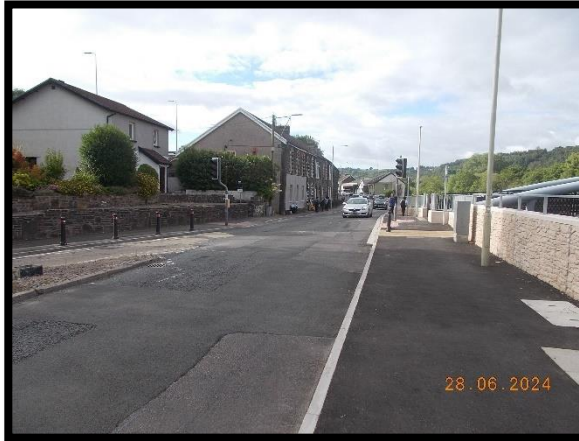
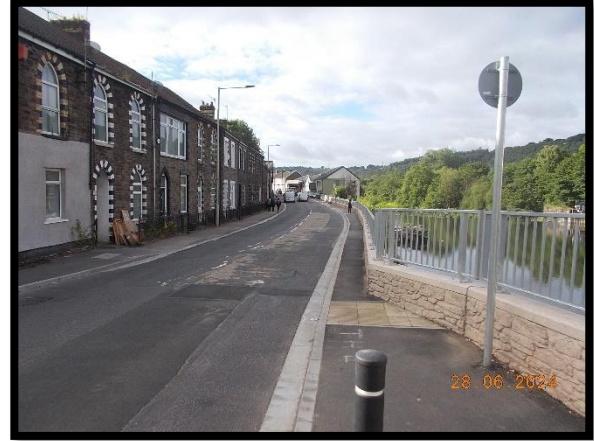
**Photograph 4.9 & 4.10 – Active Travel Route signalised crossing and narrow footway on the A4054 Cardiff Road**

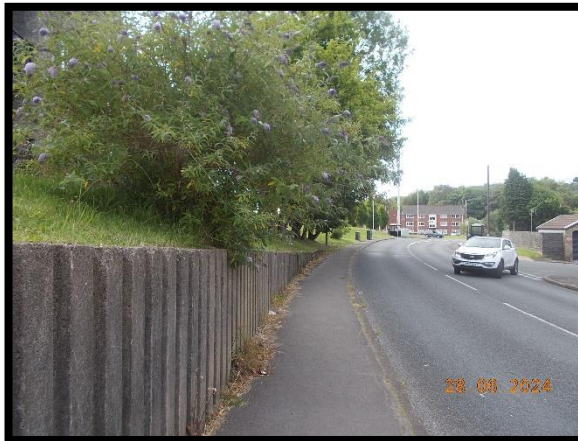
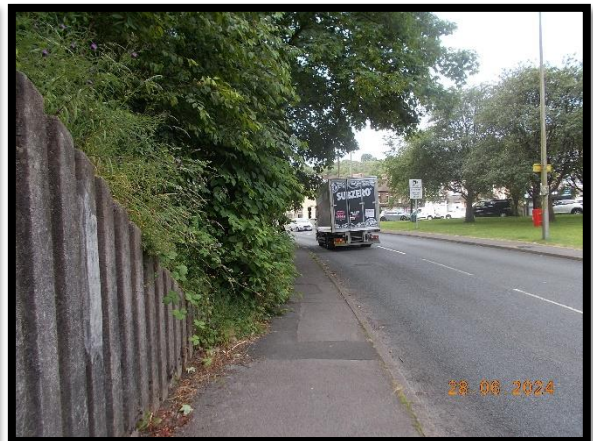
**Photograph 4.13 & 4.14 – Overgrown vegetation restricting footway widths along the A4054 College Way**

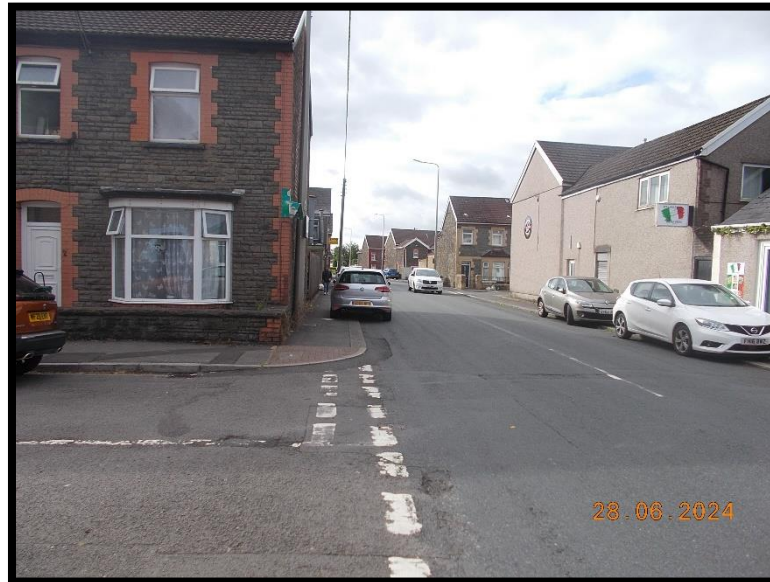
**Photograph 4.15 – On-street parking restricting footway widths along A4059 Cardiff Road**

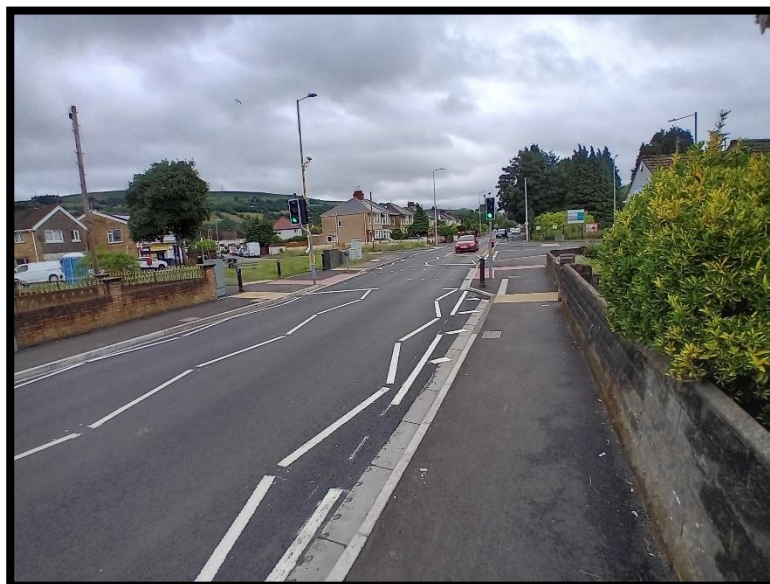
**Photograph 4.16 – New Toucan Crossing at Ysgol Afon Wen**

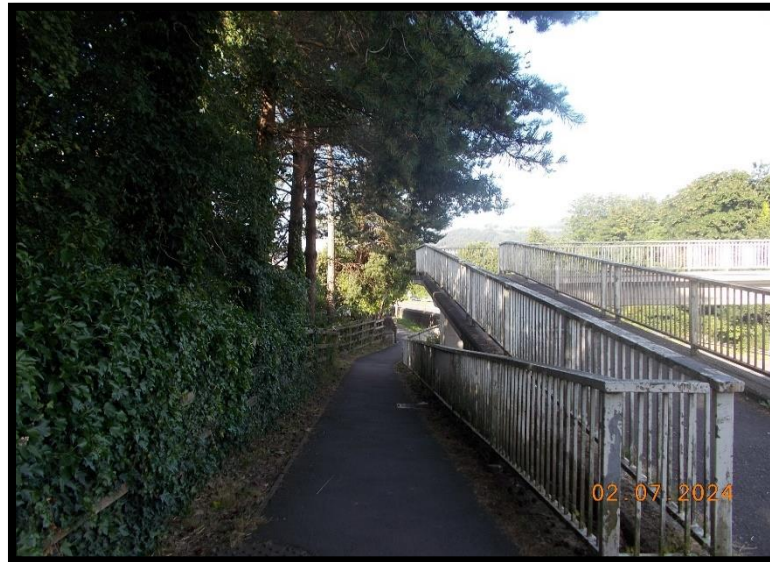
**Photograph 4.19 – Overhanging trees along A470 overbridge ramp to Coedpenmaen Close**

- 8.2.1 The route lies within 30/20mph speed limits.
- 8.2.2 There are continuous sections of footway present in reasonable condition along the route.
- 8.2.3 Trees are overhanging the footpath between Coedpenmaen Primary School and A470 overbridge. Ongoing tree maintenance is required. This footpath is also showing early signs of failure.

- Monitor the condition of overhanging trees and foliage. Where trees and or foliage overhang or encroach into footways, these areas should be cut back to improve sight lines and natural surveillance. In addition to this leaf debris should be removed from footways when required.
- Monitor footway obstructions. Where footways widths are restricted by black bags and parked cars, action to be taken in conjunction with the appropriate Council Department / local neighbourhood policing teams.

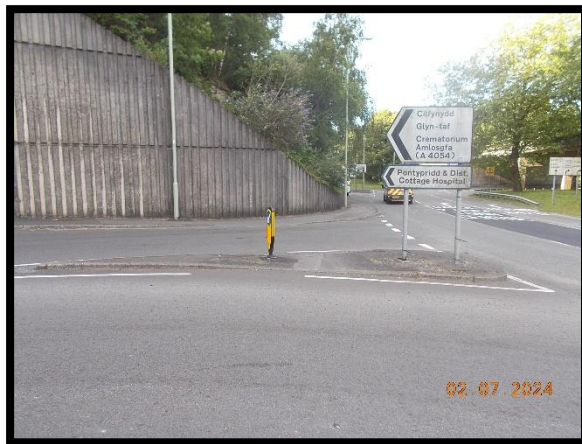
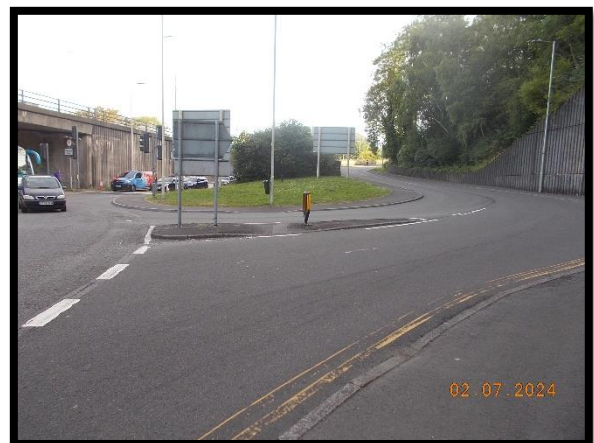
**Photograph 4.20 & 4.21 – Uncontrolled crossing at the junction of A4054 with Bridge Street**

- 8.2.4 There is a narrow pedestrian refuge island on the crossing of Bridge Street gyratory. Surveys have been undertaken to confirm there are other opportunities to cross Corn Stores Hill that comply with Learner Travel guidance. It should be noted that an alternative 'available' route exists from Central Square, Trallwn via Middle Street, South Street, Llanover Street, Bridge Street, Taff Street and High Street to join the main route at Broadway. This route offers an alternative to walking over the footbridge to Coedpenmaen Road and crossing Corn Stores Hill, with signal controlled pedestrian phases as the route enters and leaves Pontypridd Town Centre.

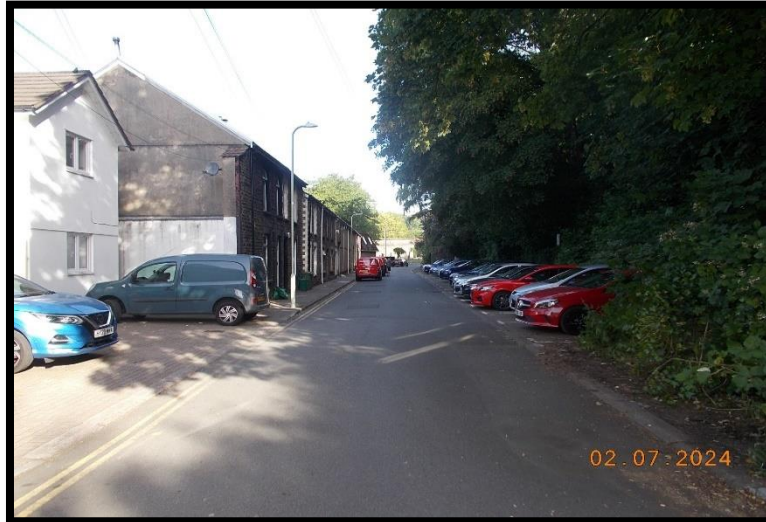
**Photograph 4.22– Ynysangharad Road footway and step-offs**

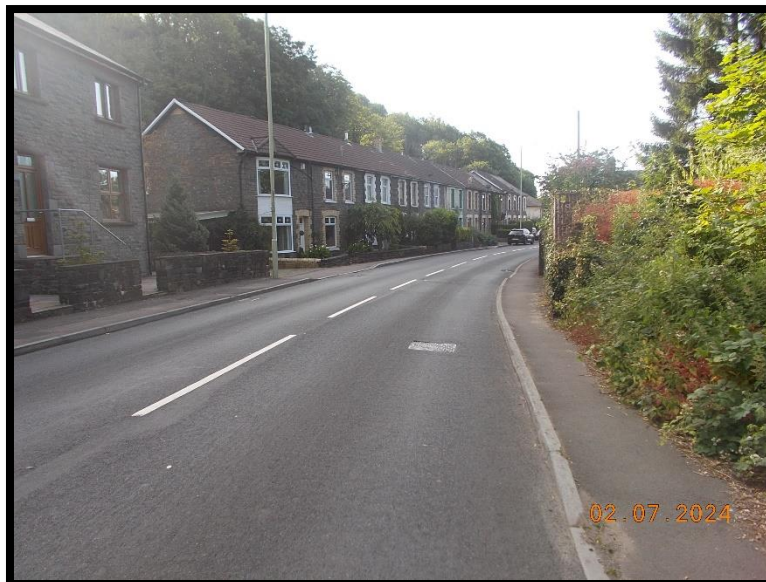
**Photograph 4.23 – Footway narrowing due to vegetation overgrowth on Pentrebach Road**

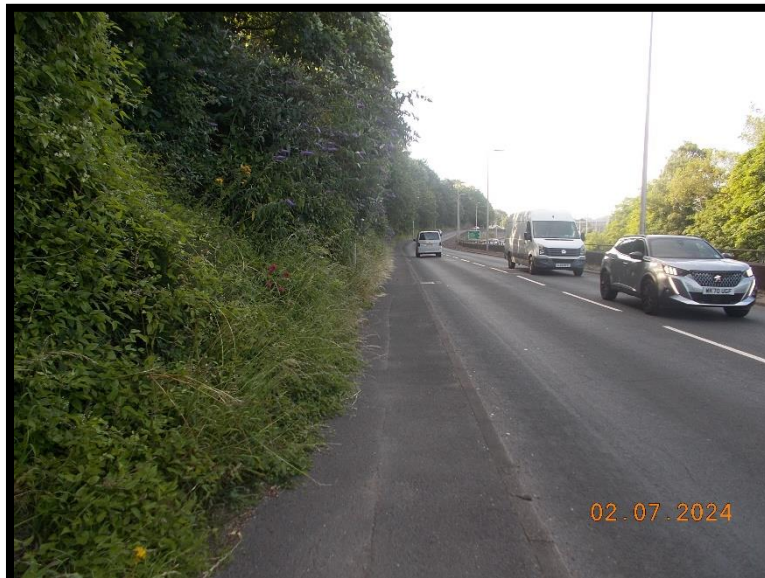
**Photograph 4.25 – Pentrebach Road eastern footway to Glyntaff vegetation overgrowth**

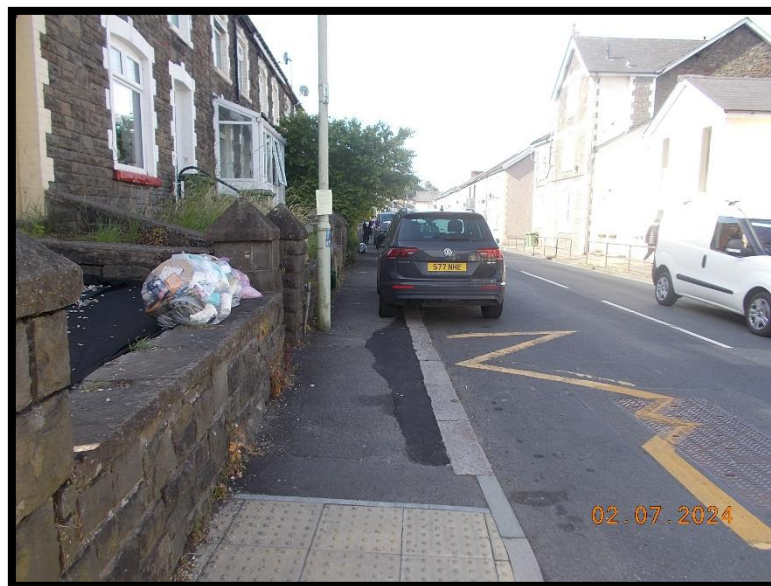
**Photograph 4.27 – Merthyr Road vehicles parked on eastern footway at the approach to YGG Pont Siôn Norton School**

- 8.3.1 The route lies within a 20mph speed limit.
- 8.3.2 There are continuous sections of footway present in reasonable condition along the route.
- 8.3.3 There are localised sections of footway along the length of the A4054 Merthyr Road, where vehicles are obstructing footways which impacts upon walking routes. Local neighbourhood policing teams are working with residents to help reduce the risks posed to pedestrians by indiscriminately parked vehicles.

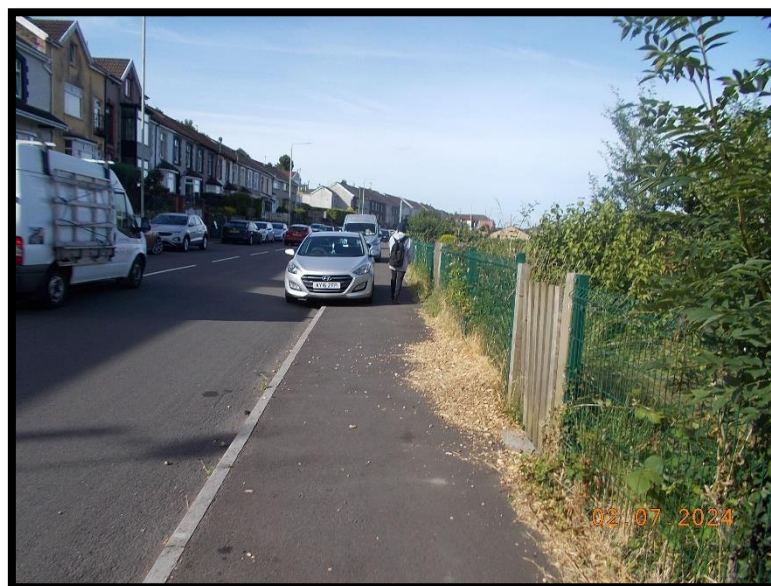
**Photograph 4.28 – Merthyr Road at the allotment gardens vehicles parked on footways**

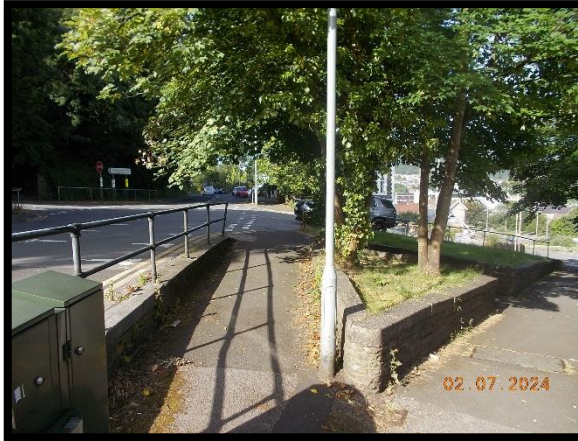
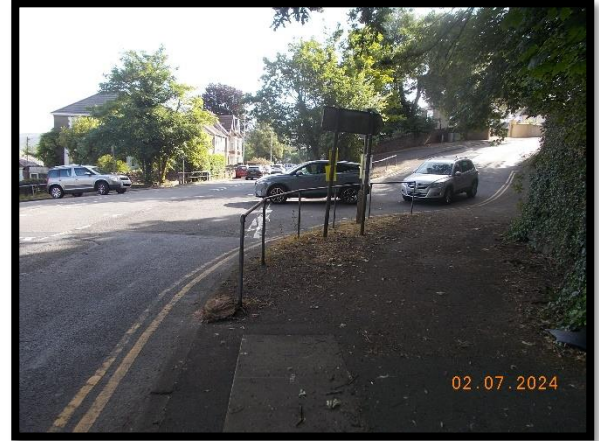
**Photographs 4.29 & 4.30 – A4054 Junction with Merthyr Road footway and overhanging trees**

- Monitor the condition of overhanging trees and foliage. Where trees and/or foliage overhang or encroach into footways, these areas should be cut back to improve the usable width, sight lines and natural surveillance. In addition to this leaf debris should be removed from footways when required.
- Monitor footway obstructions. Where footways widths are restricted by bin bags and parked cars, action be taken in conjunction with the appropriate Council Department / local neighbourhood policing teams.

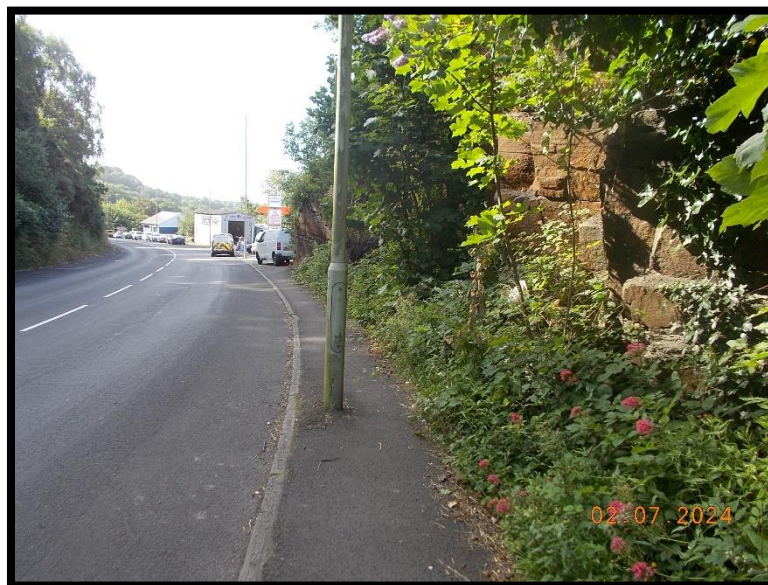
**Photograph 4.31 – A4054 Merthyr Road Western footway narrowing due to vegetation**

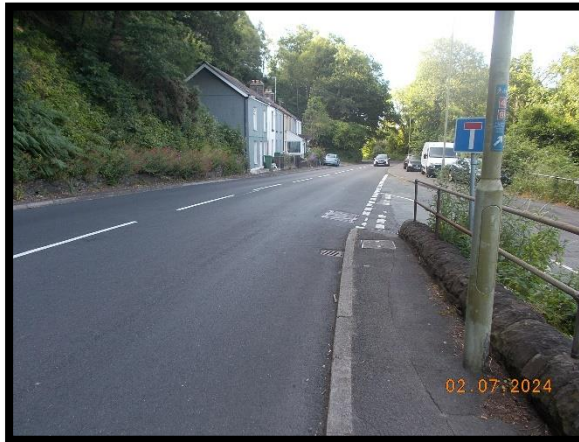
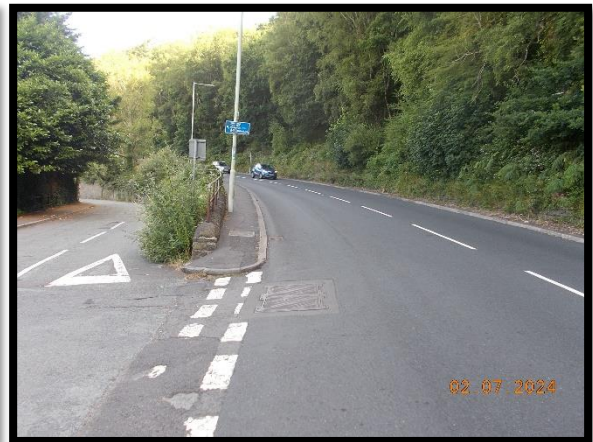
**Photographs 4.31 & 4.32 – Narrow footway on the approach to Ynysangharad Road  
Junction with A4054 Merthyr Road**

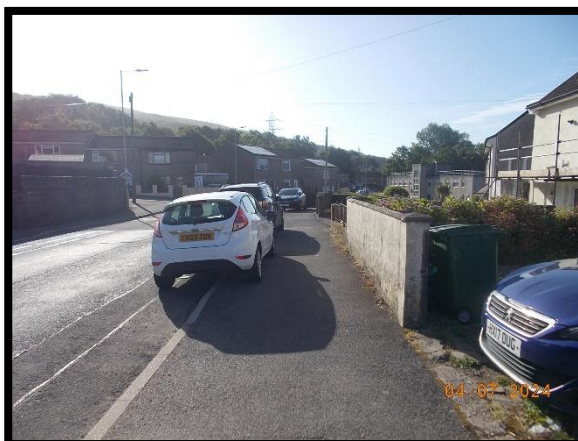
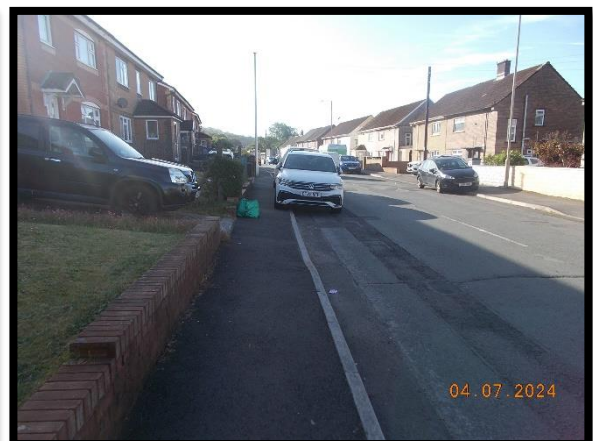
**Photographs 4.33 & 4.34 – Holly Street vehicles parked on footway**

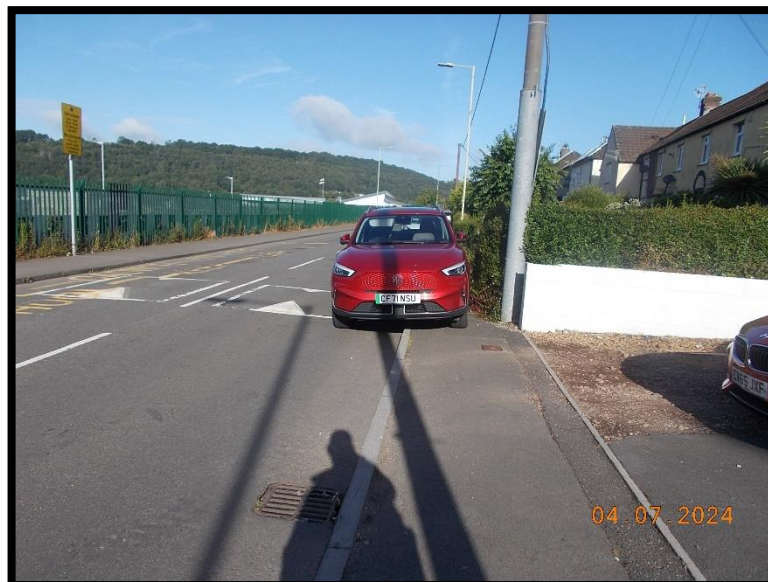
**Photographs 4.36 – Holly Street vehicles parked on footways**

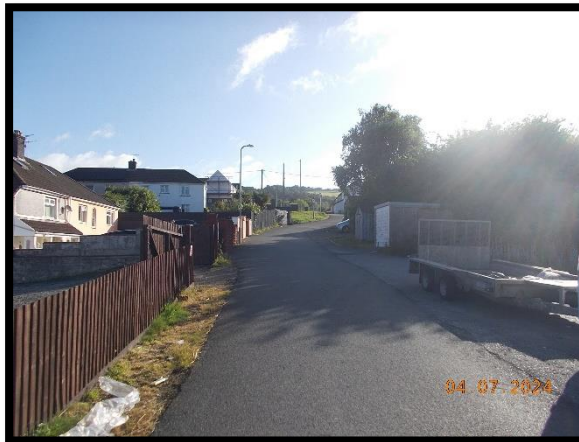
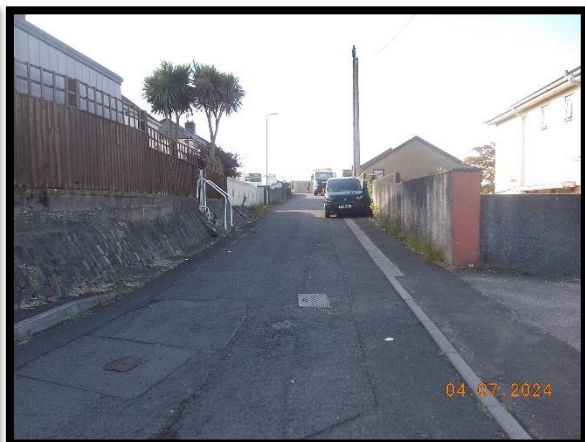
**Photograph 4.36 & 4.37 – Lime Street cut-through to Holly Street with step-offs**

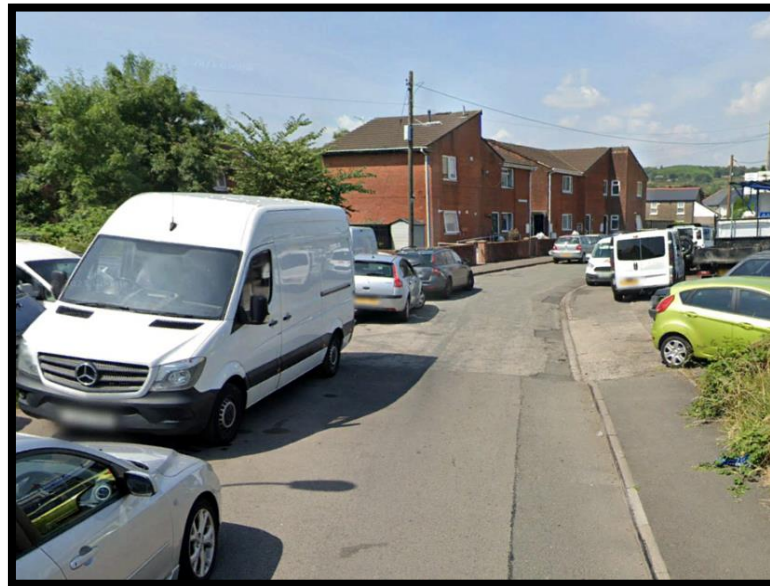
**Photograph 4.39 – Glyndwr Avenue vehicles parked on footways**

- 8.4.1 The route lies within a 20mph speed limit.
- 8.4.2 There are continuous sections of footway present in reasonable condition along the route.
- 8.4.3 There are localised sections of footway along Glyndwr Avenue where vehicles are obstructing footways which impact upon walking routes. Local neighbourhood policing teams are working with residents to help reduce the risks posed to pedestrians by indiscriminately parked vehicles.

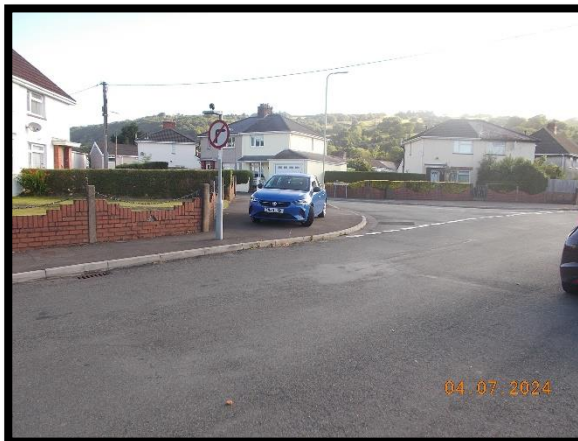
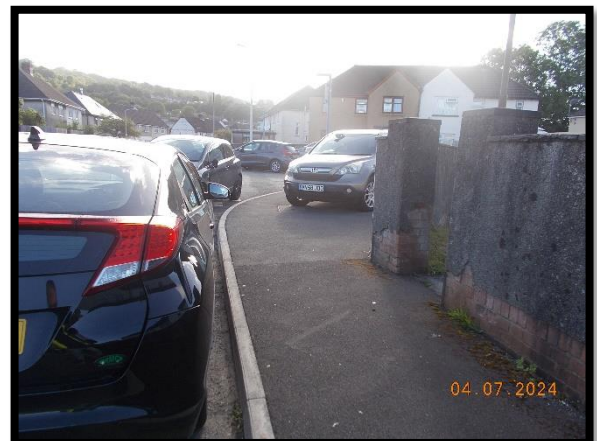
**Photograph 4.40 & 4.41 – Glyndwr Avenue vehicles parked on footways**

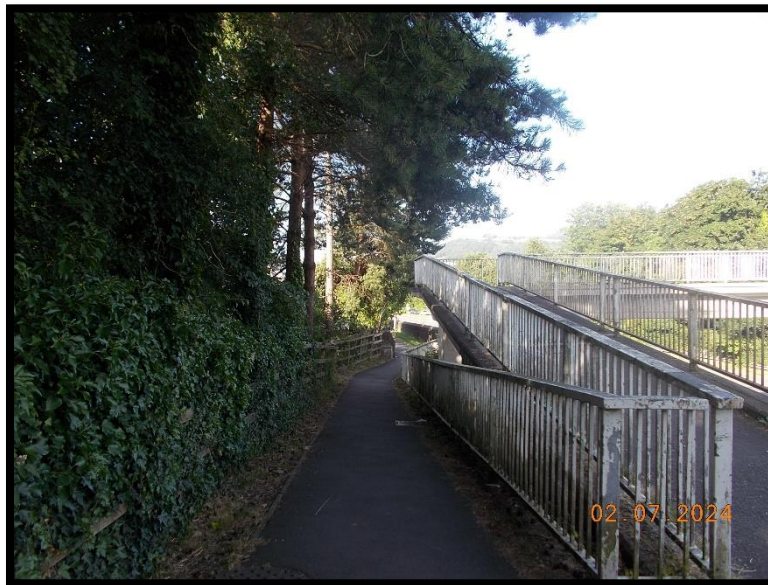
- 6.1 There is a short section of ramp/footpath between Foundry Place and Coedpenmaen Primary School that uses the footbridge to cross the A470. It has no overlooking buildings or natural surveillance, other than by other pedestrians, but it is available and in daily use by parents and pupils walking between Trallwn and Coedpenmaen Primary School. The footpath to the rear of Coedpenmaen Primary School would benefit from vegetation clearance to improve pedestrian comfort and lighting levels, see **photograph 6.1** below.

**Photograph 6.1 – Sub Route 1 - A470 Overbridge to the rear of Coedpenmaen Primary School**

- 8.2.12 A section of the route between Foundry Place and Coedpenmaen Primary School that uses the footbridge to cross the A470, has no overlooking buildings or natural surveillance but is well used by pedestrians. It should be noted that an alternative 'available' route exists from Central Square, Trallwn via Middle Street, South Street, Llanover Street, Bridge Street, Taff Street and High Street to join the main route at Broadway. This route offers an alternative to walking over the footbridge to Coedpenmaen Road and crossing Corn Stores Hill, with signal-controlled pedestrian phases as the route enters and leaves Pontypridd Town Centre.
