RCT School Walking Route Assessment Report

Routes to Ysgol Bro Taf

March 2025

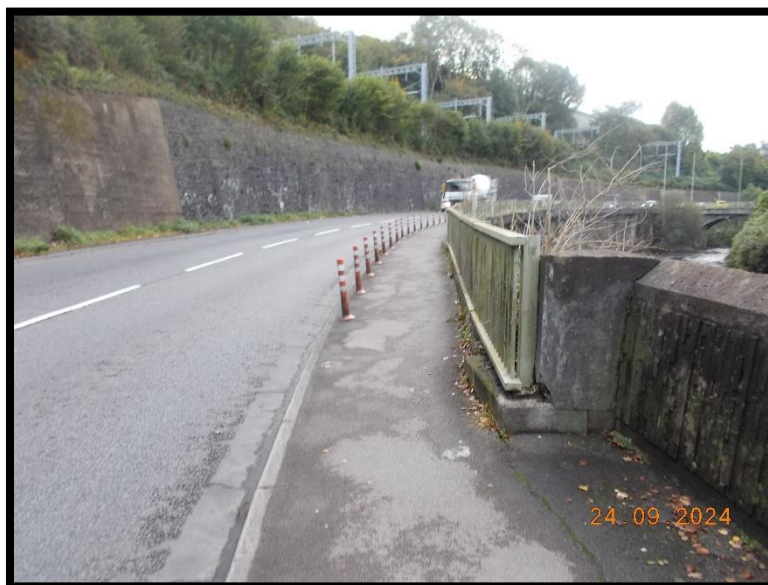
Photograph 4.2 – A4058 Hopkinstown Road reduction in available footway width

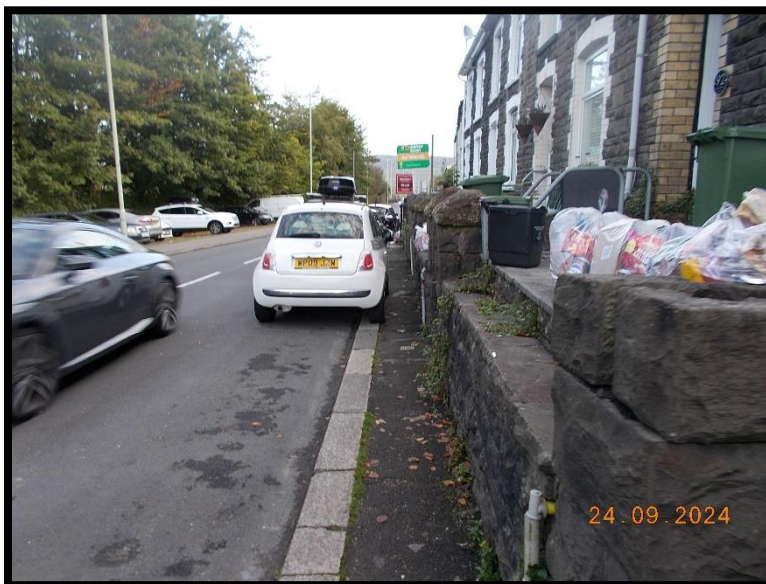
Photograph 4.16 – On street parking further reducing the already narrow usable width along the A4054 Merthyr Road. With the opposite footway being wider and available, there are plenty of opportunities with good visibility to cross over at each approach to this narrowing.

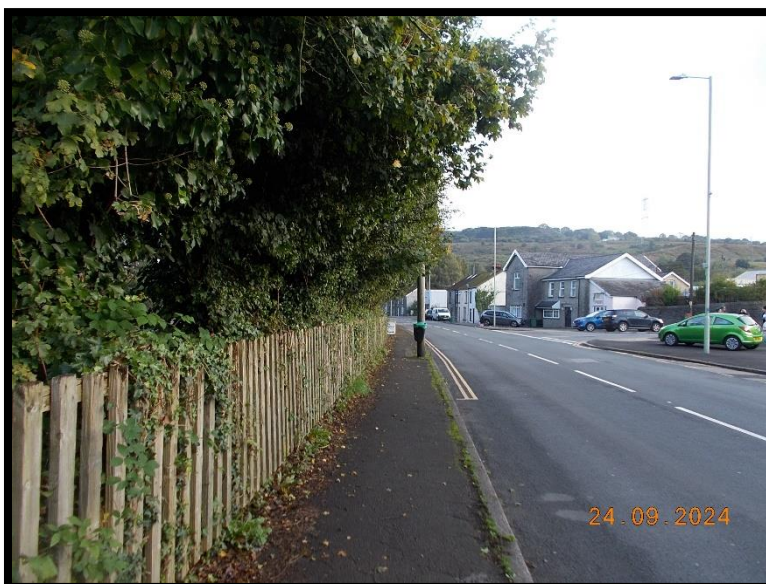
Photograph 4.17 – Overhanging tree branches along the A4054 Merthyr Road, at the approach to the A470 overbridge

- Monitor the condition of overhanging trees and foliage. Where trees and or foliage overhang or encroach into footways these areas should be cut back to improve sight lines and natural surveillance. In addition to this leaf debris should be removed from footways when required.
- Monitor footway obstructions. Where footways widths are restricted by bin bags and parked cars, action be taken in conjunction with the appropriate Council Department / local neighbourhood policing teams.

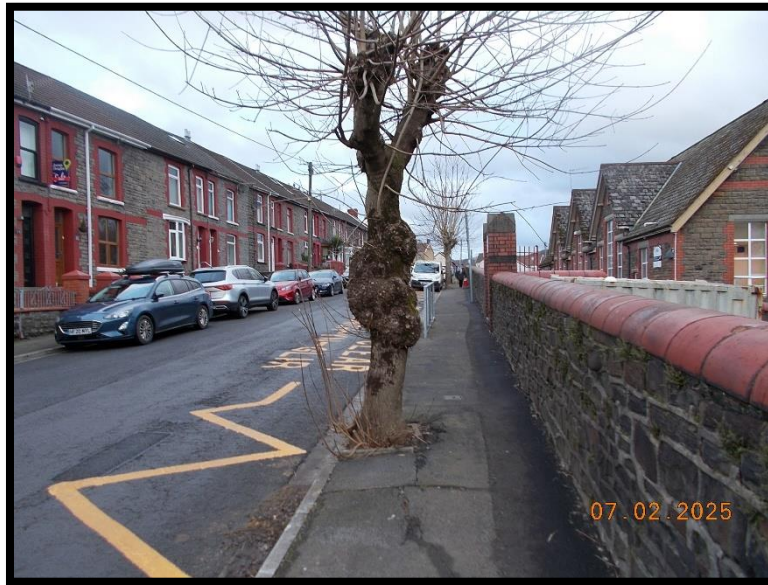
Photograph 4.23 – Localised footway narrowing with uneven footway profile due to tree planting outside Maes Y Coed Primary School

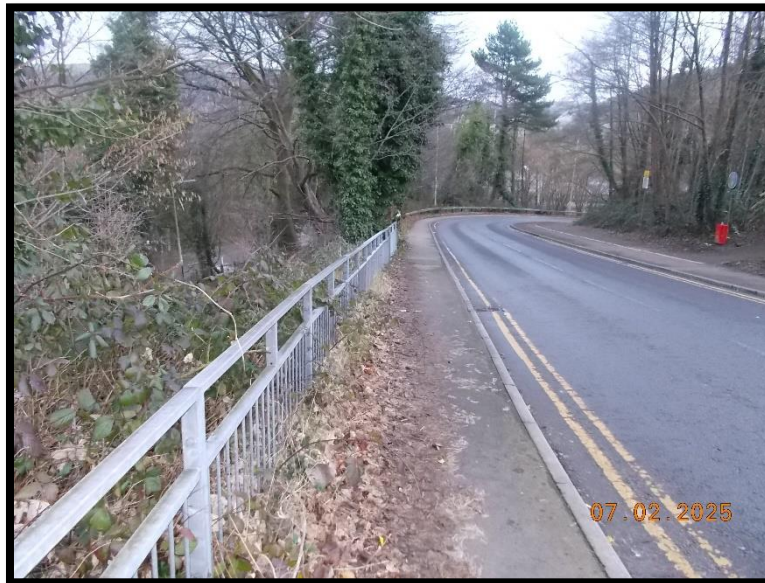
Photograph 4.25 – Leaf debris narrowing the usable footway width on the link to Sardis Road

8.2.4 At the footway link between Maesycod Road and Sardis Road leaf debris clearance is required from the back of footway to maximise the footway width and improve pedestrian comfort levels. It is noted that there is an available footway on the opposite side of the road.

- Monitor the condition of overhanging trees and foliage. Where trees and/or foliage overhang or encroach into footways, these areas should be cut back to improve the usable width, sight lines and natural surveillance. In addition to this leaf debris should be removed from footways when required.

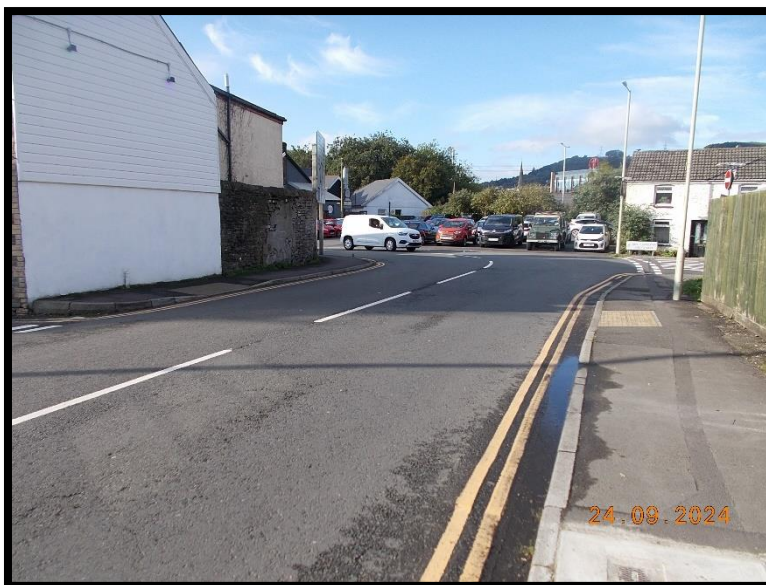
Photograph 4.33 – Uncontrolled crossing point on South Street, with reduced visibility to approaching vehicles from West Street

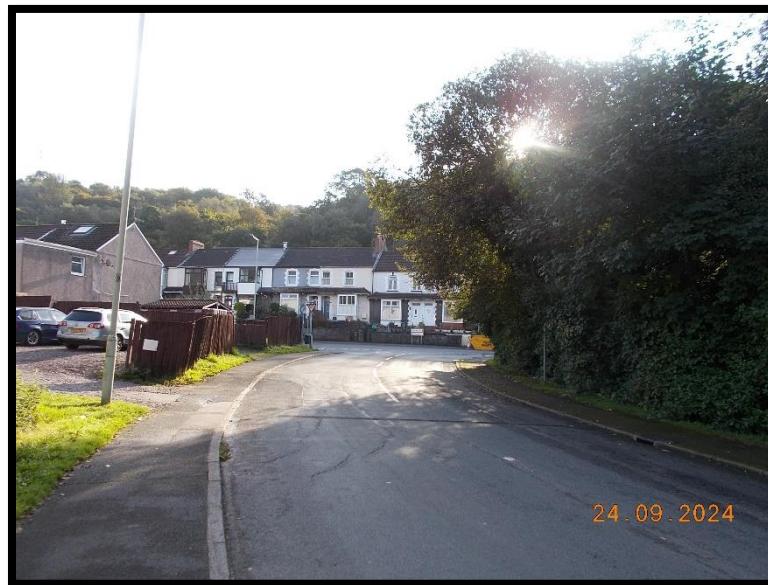
**Photographs 4.35 – Overhanging trees at the junction entrance to Coedpenmaen
Road from the A4054 Merthyr Road**

- Monitor the condition of overhanging trees and foliage. Where trees and/or foliage overhang or encroach into footways, these areas should be cut back to improve the usable width, sight lines and natural surveillance. In addition to this leaf debris should be removed from footways when required.

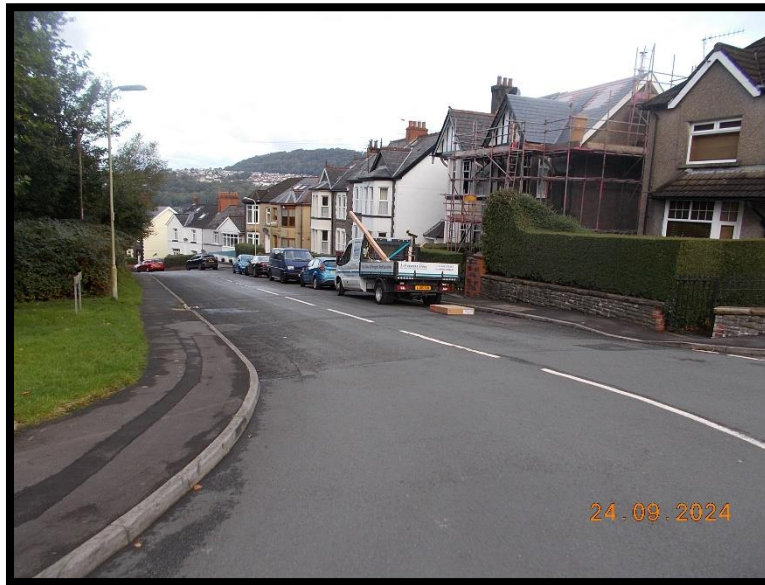
Photograph 4.36 – Footways along Common Road with on street parking along the northern footway

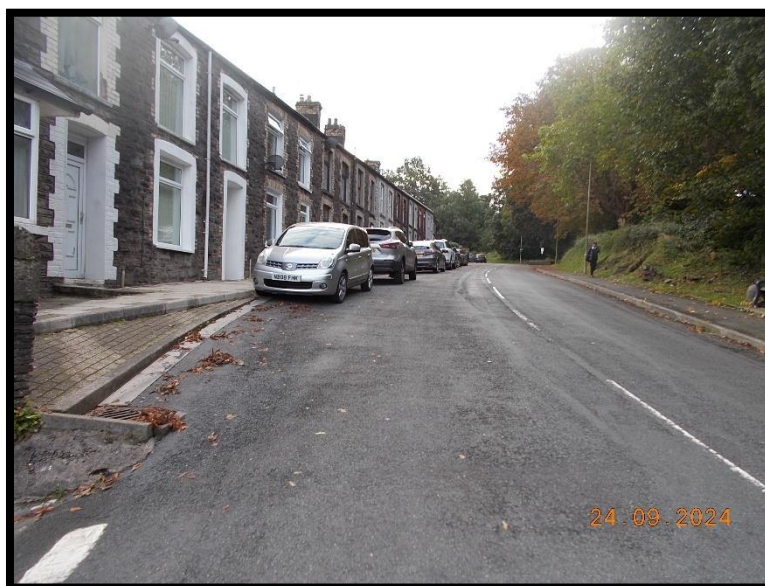
Photograph 4.37 – Footways along Common Road with overhanging trees on the southern footway

- Monitor the condition of overhanging trees and foliage. Where trees and/or foliage overhang or encroach into footways, these areas should be cut back to improve the usable width, sight lines and natural surveillance. In addition to this leaf debris should be removed from footways when required.

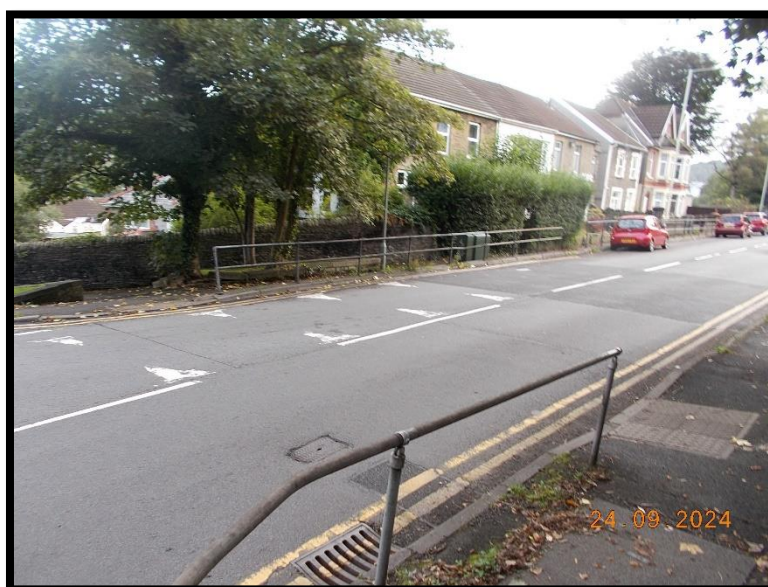
Photographs 4.39 – Uncontrolled crossing near the junction of Corn Stores Hill /Common Road and the A4054 Merthyr Road, with overhanging trees
