# RCT School Walking Route Assessment

Tonypandy / Pontygwaith / Trealaw to  
Ysgol Gyfun Cwm Rhondda

March 2025

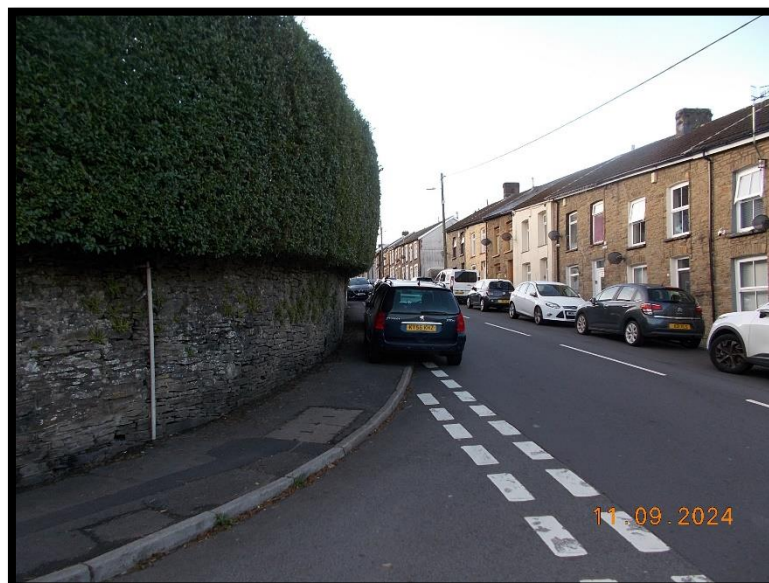
**Photograph 4.11 – On-street parking restricting footway widths along Amos Hill Penygraig**

- 8.1.1 There are continuous sections of footway present in reasonable condition along the route.
- 8.1.2 There are localised sections of the route where the footway width is reduced by bin bags, and wheelie bins, which may require pedestrians to give way to pass one another. Vehicles obstructing footways can also impact upon walking routes, but the local neighbourhood policing teams are working with residents to help reduce the risks posed to pedestrians by indiscriminately parked vehicles.

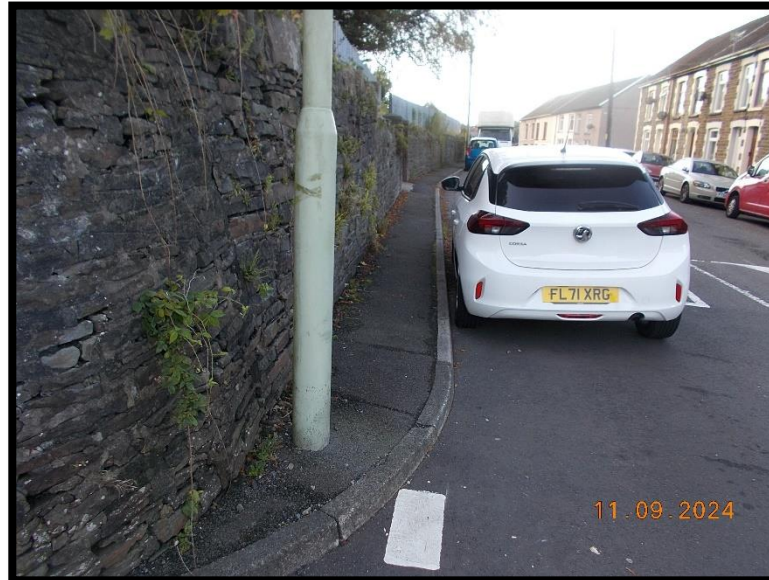
**Photograph 4.12 – Narrow footway widths along the northern footway on Amos Hill, it is noted however that the southern footway is available.**

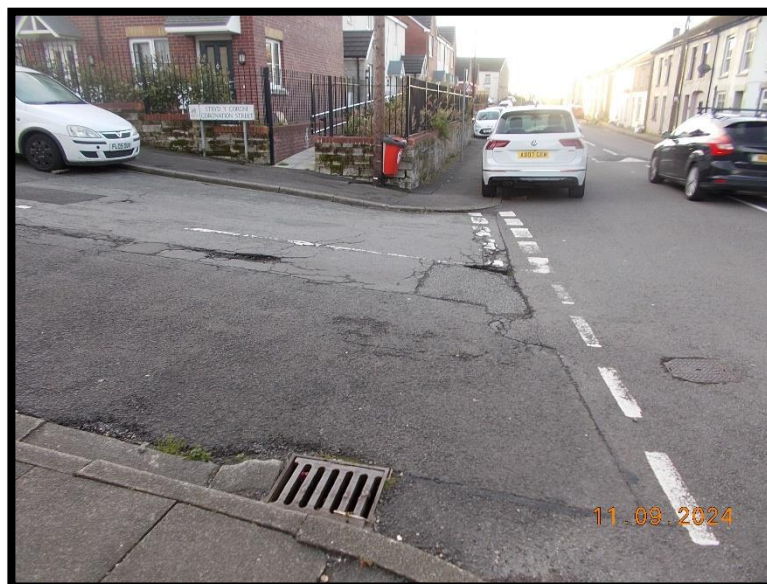
**Photograph 4.13 – Uneven road surface at the junction of Coronation Street with Arthur Street**

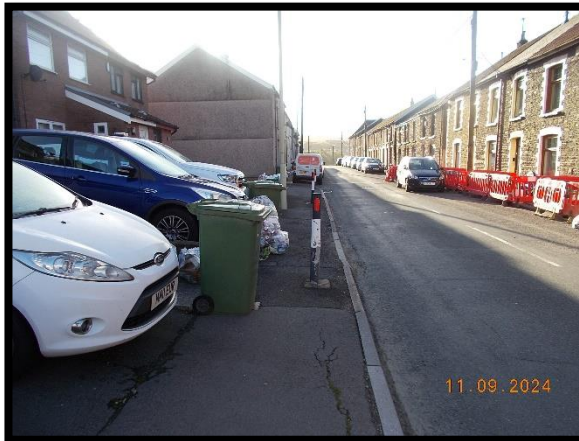
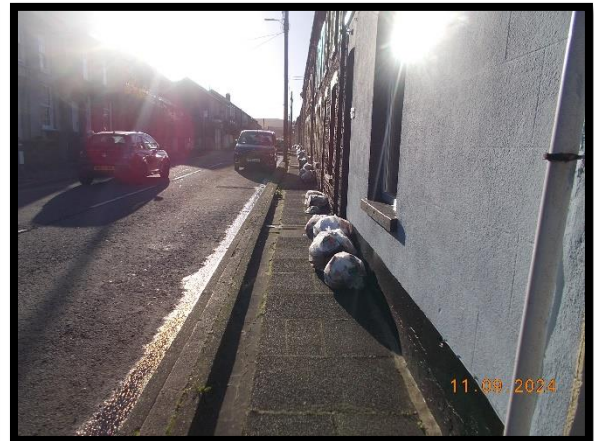
**Photograph 4.14 & 4.15 – Refuse/recycling bags reducing the available footway width along Mountain Road**

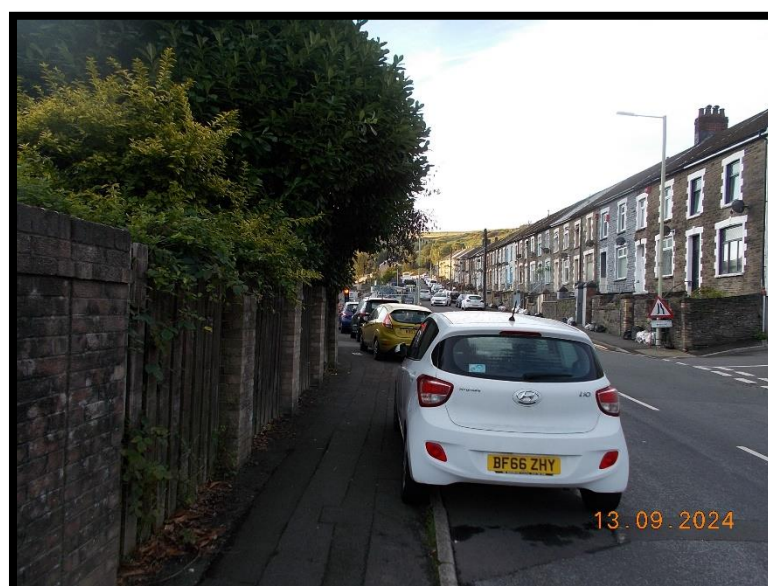
**Photograph 4.20 – On-street parking and overgrown vegetation reducing the usable width along Brewery Road**

- Monitor the condition of overhanging trees and foliage. Where trees and or foliage overhang or encroach into footways these areas should be cut back to improve the usable width, sight lines and natural surveillance. In addition to this, leaf debris should be removed from footways and shared use routes when required.
- Monitor footway obstructions. Where footways widths are restricted by bin bags and parked cars, action to be taken in conjunction with the appropriate Council Department / local neighbourhood policing teams.

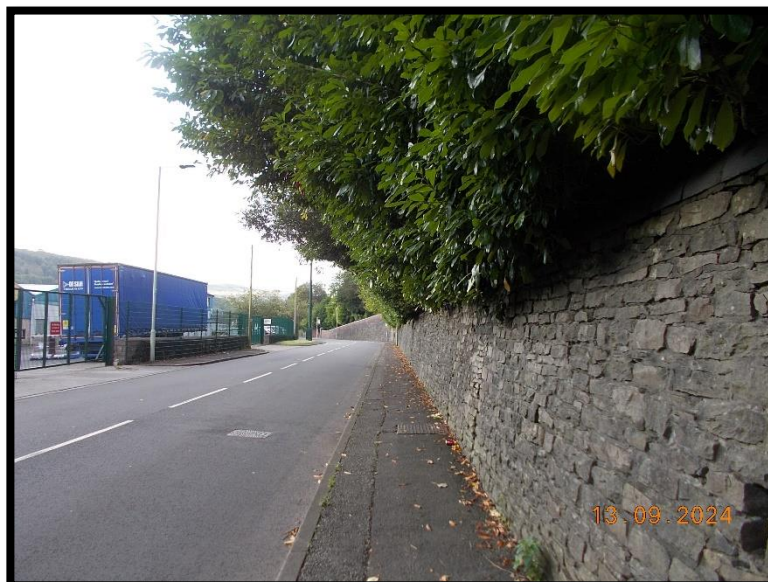
**Photograph 4.28 – Overhanging tree branches and vegetation along Ynysir Road**

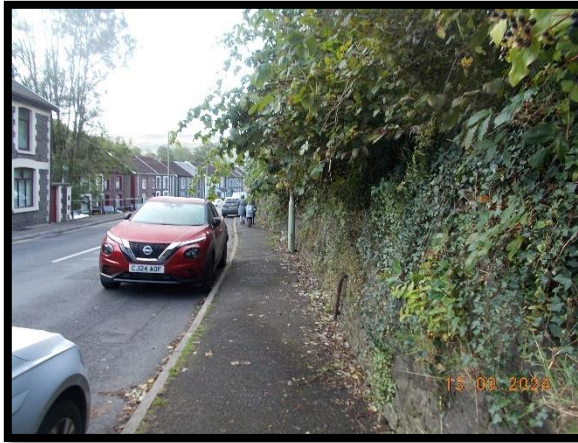
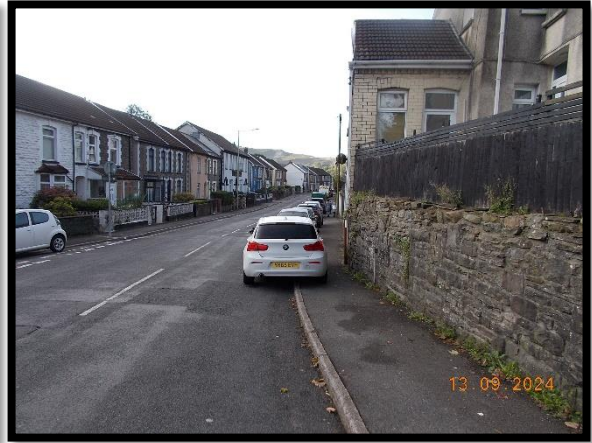
**Photograph 4.31 & 4.32 – Overhanging vegetation and on street parking restricting footway widths along Ynysir Road**

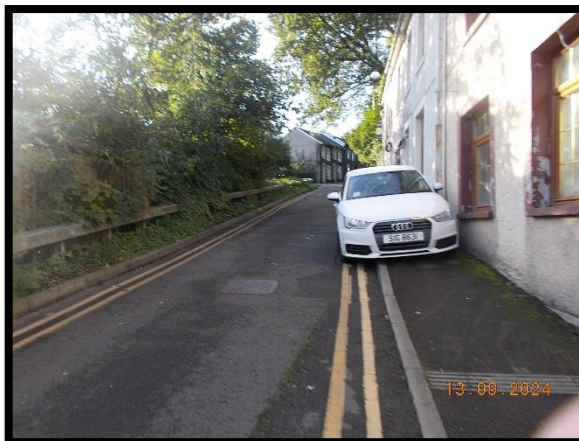
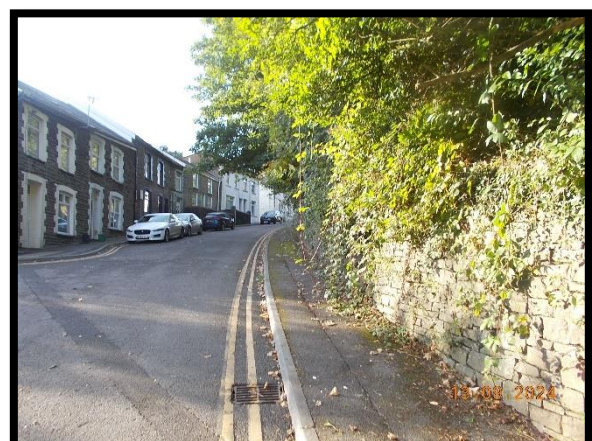
**Photographs 4.40 & 4.41 – On-street parking and overgrown vegetation reducing the usable footway width along High Street cul de sac**

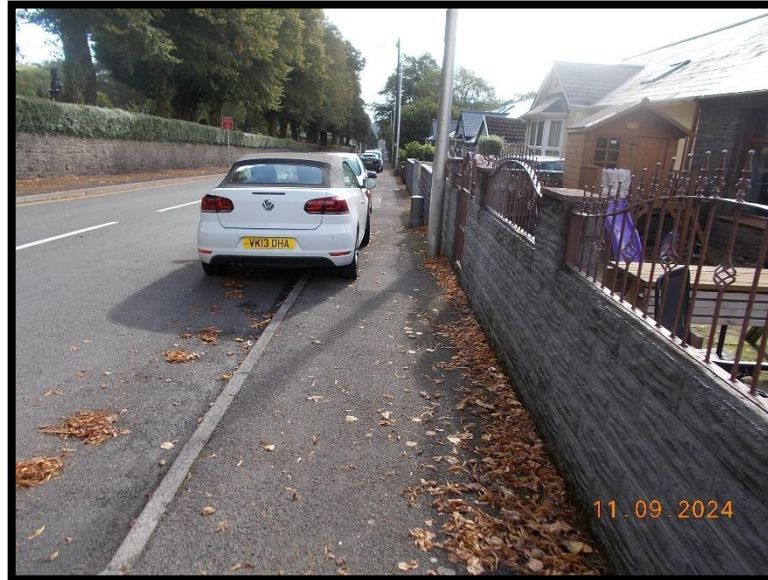
**Photograph 4.48 – On street parking reducing the usable footway width along the B4278 Brithweunydd Road**

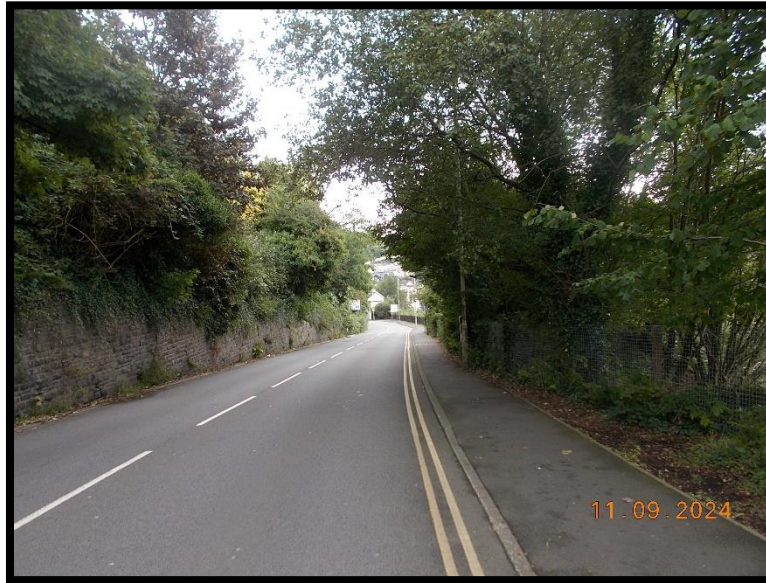
**Photograph 4.52 – Overhanging tree branches on the footway leading to Tynewydd Square on the B4278 Cemetery Road**

- Monitor the condition of overhanging trees and foliage. Where trees and/or foliage overhang or encroach into footways, these areas should be cut back to improve the usable width, sight lines and natural surveillance. In addition to this leaf debris should be removed from footways when required.
- Monitor footway obstructions. Where footways widths continue to be restricted by bin bags and parked cars, action to be taken in conjunction with the appropriate Council Department / local neighbourhood policing teams.

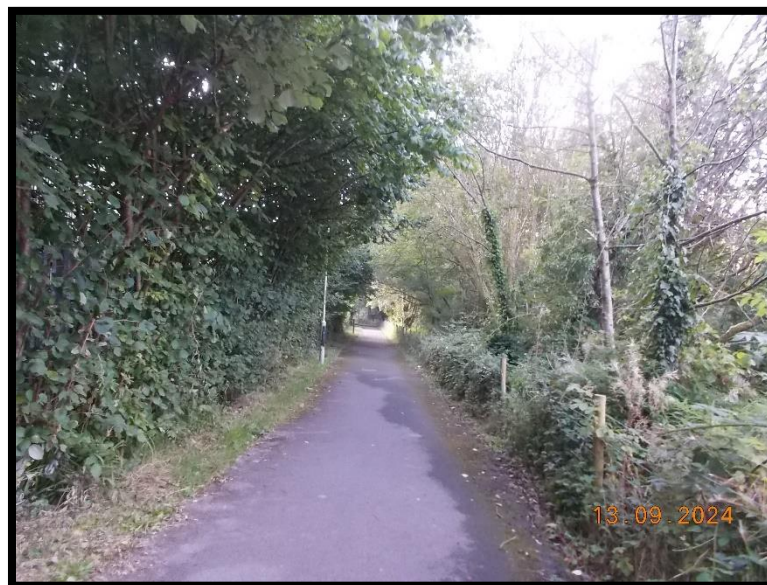
- 6.1 There is a short section circa 380m long of shared use footpath along the Rhondda Fach Trail between the access to Howdens Joinery and the A4233 overbridge link to Ynyshir. trees and foliage are overhanging the shared use footpath reducing lighting levels. This could be viewed as isolated by some pedestrians. This is compounded as there are no overlooking buildings or natural surveillance, other than by other pedestrians. It is noted however this route is currently available and in daily use by parents and pupils walking from lower Wattstown and Ynyshir to Porth Community School. The shared use footpath would benefit from vegetation clearance to improve pedestrian comfort and lighting levels, see **photograph 6.1** below.

**Photograph 6.1 – Sub Route 1 – The Rhondda Fach Trail between Howdens Joinery and the A4233 Overbridge**

- 8.2.1 There are continuous sections of footway present in reasonable condition along the route.
- 8.2.2 Trees and vegetation are overhanging the shared use footpath along the Rhondda Fach Trail between the Howdens joinery junction and the A4233 overbridge link to Ynyshir, reducing lighting levels. Overhanging tree branches and vegetation are also encroaching into footways along other sections of the route, narrowing footway widths to circa 1m. These may require pedestrians to give way to pass one another. Vegetation along the route would benefit from ongoing maintenance.

8.28 A section of the route along the shared use footpath on the Rhondda Fach Trail between the Howdens joinery junction and the A4233 overbridge link to Ynysir has no overlooking buildings or natural surveillance and may be viewed as isolated by some pedestrians. It should be noted that an alternative 'available' route exists from the Howdens Joinery junction, along Aberllechau Road to the roundabout with the A4233. This route offers an alternative to walking over the footbridge to Ynyshir Road, with pedestrian refuge islands at the roundabout to assist pedestrians to cross, though surveys may be needed to confirm that there are sufficient gaps in the traffic.
