RCT School Walking Route Assessment

Trehafod to Porth Community School

March 2025

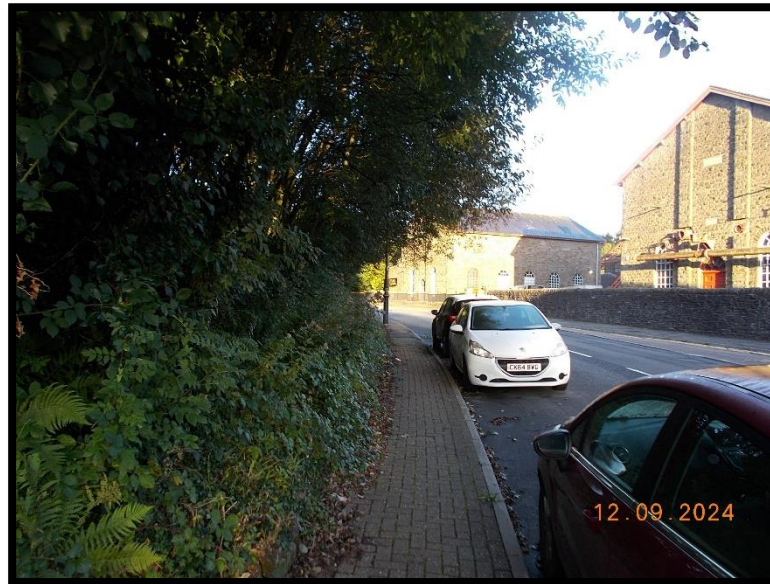
Photograph 4.2 – Overhanging tree branches and vegetation along the footway

- The western footway along Coedcae Road opposite the Welsh Coal Mining Experience.
- The footway approach to the Zebra crossing along the B4278 Cemetery Road, near the junction with Mount Pleasant Road.

- Monitor the condition of overhanging trees and foliage. Where trees and/or foliage overhang or encroach into footways, these areas should be cut back to improve the usable width, sight lines and natural surveillance. In addition to this leaf debris should be removed from footways when required.
- Monitor footway obstructions. Where footways widths continue to be restricted by parked cars, action be taken in conjunction with the appropriate Council Department / local neighbourhood policing teams.

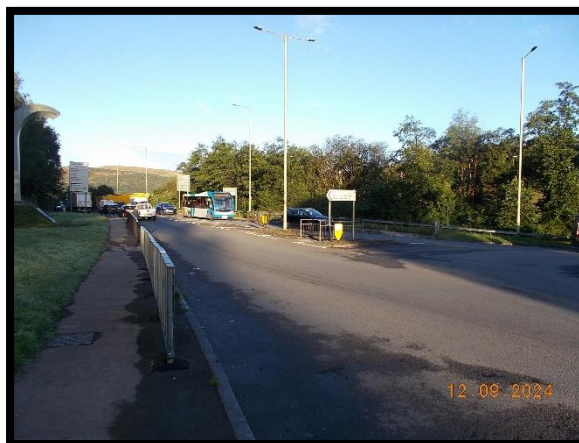
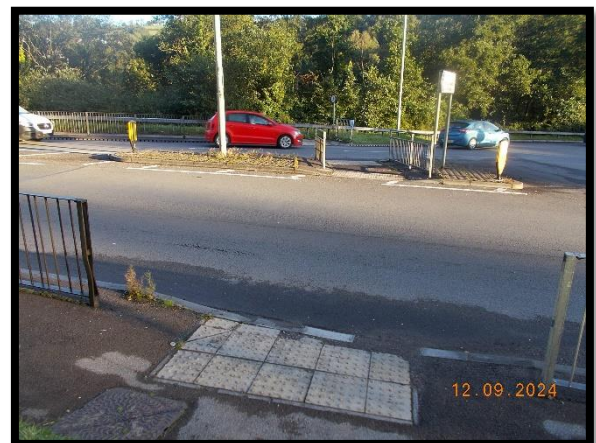
Photographs 4.3a & 4.3b – Uncontrolled crossing (pedestrian refuge) at the roundabout on the A4058 with Coedcae Road with heavy traffic flows

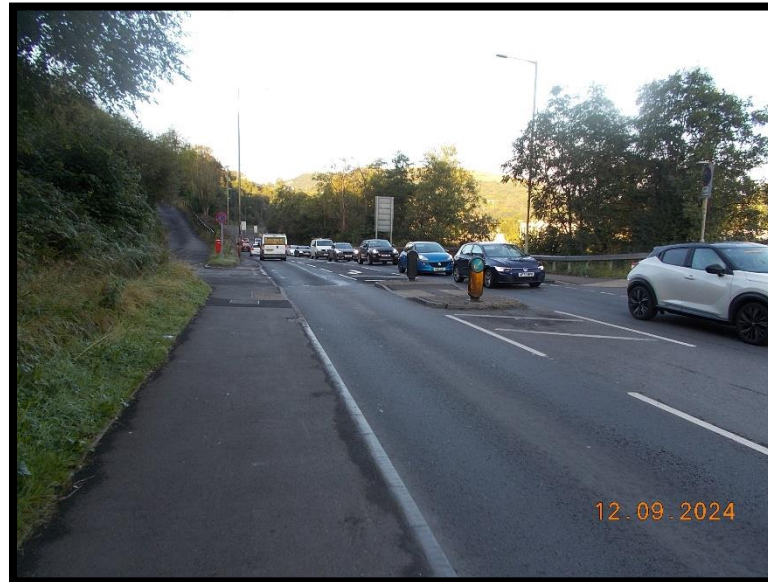
Photograph 4.4 – Uncontrolled crossing (pedestrian refuge) on the A4058 with heavy traffic flows and queueing

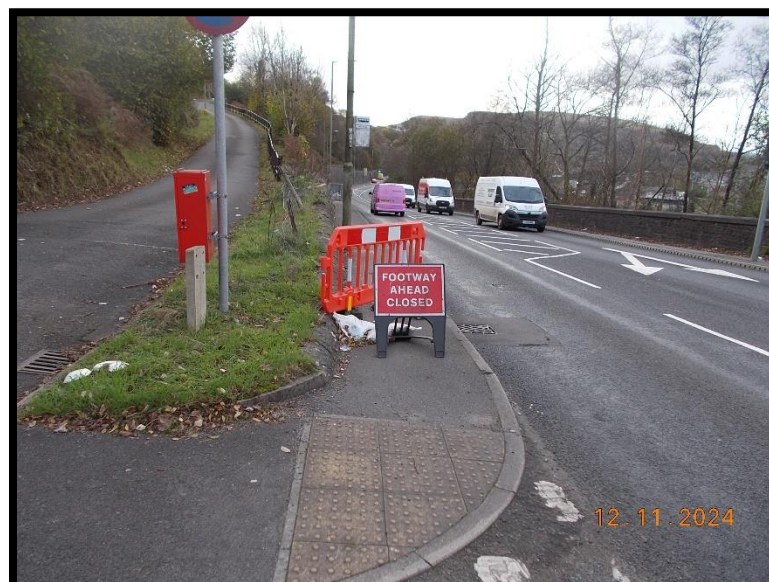
Photograph 4.5 – Footway closed along the A4058 due to retaining wall repairs (the *Temporary Alternative Route* will be in place until these works are completed)

- The southern footway along the A4058 between the Heritage Park roundabout and Eirw Road junction is temporarily closed due to retaining wall repair works. This loss of footway is key to the proposed route, as currently, it cannot be by-passed safely.
- The southern footway along the Pontypridd Road between River Terrace junction and S & F Motors Ltd is currently closed due to redevelopment works. This can be by-passed by using the existing controlled crossings.

- Undertake/complete the retaining wall repairs to the south west of the junction of the A4058 and Clifton Row. Remove the footway obstruction that prevents pedestrians from walking along the A4058 to / from the signal controlled crossing south west of Eirw Road.

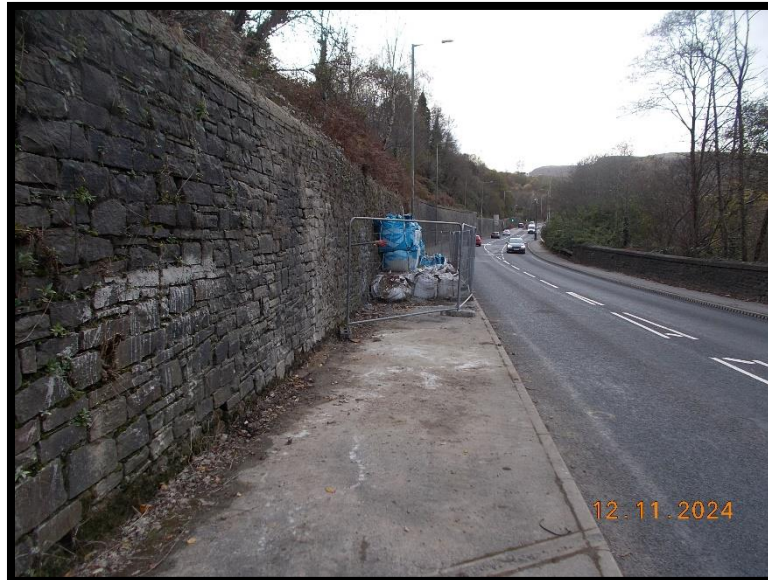
Photograph 4.6 – Footway closed along the A4058 due to retaining wall repairs (the *Temporary Alternative Route* will be in place until these works are completed)

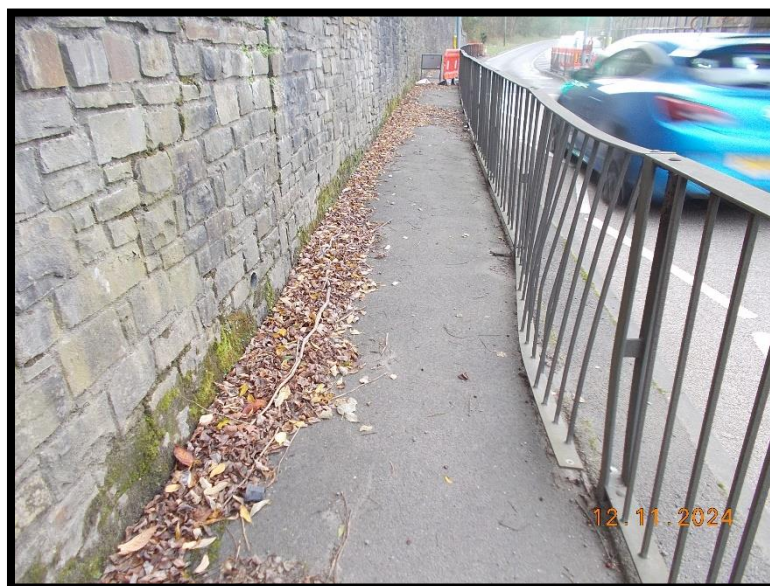
Photograph 4.7 – Section of damaged pedestrian guardrail on approach to signalised crossing on A4058 (repairs to be undertaken prior to re-opening of the footway)

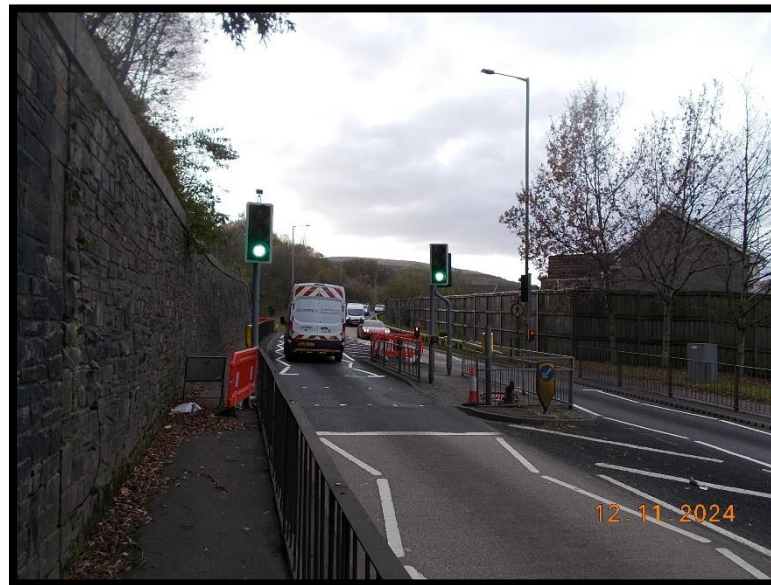
**Photograph 4.8 – Signalised crossing on the A4058 near the junction with Eirw Road
(footway currently closed due to retaining wall repair)**

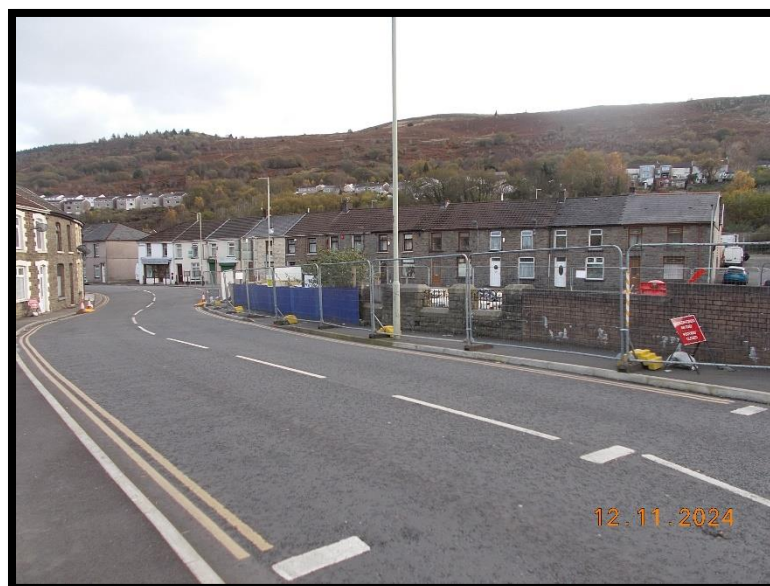
Photograph 4.11 – Footway closure due to ongoing development near the junction of River Terrace with Pontypridd Road

- Complete the works adjacent to the southern footway along Pontypridd Road between River Terrace junction and S & F Motors Ltd, which is currently closed due to redevelopment works. This can be bypassed by using the existing controlled crossings.
- Undertake repairs to the damaged section(s) of pedestrian guardrail on the approach to the signalised crossing over the A4058 to access Eirw Road, see photograph below.

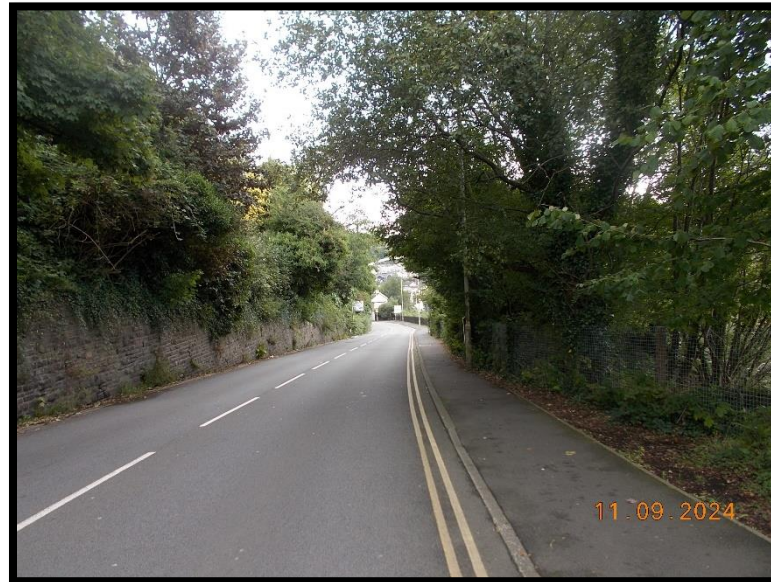
Photograph 4.23 – Overhanging tree branches along the B4278 Cemetery Road

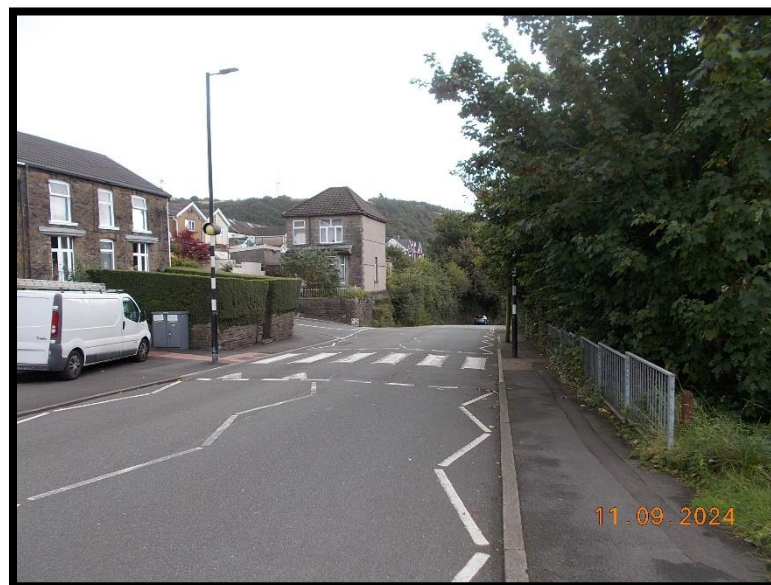
Photograph 4.24 – Zebra crossing on the B4278 Cemetery Road near the junction with Mount Pleasant Road, with Belisha Beacons partially obscured by tree branches.

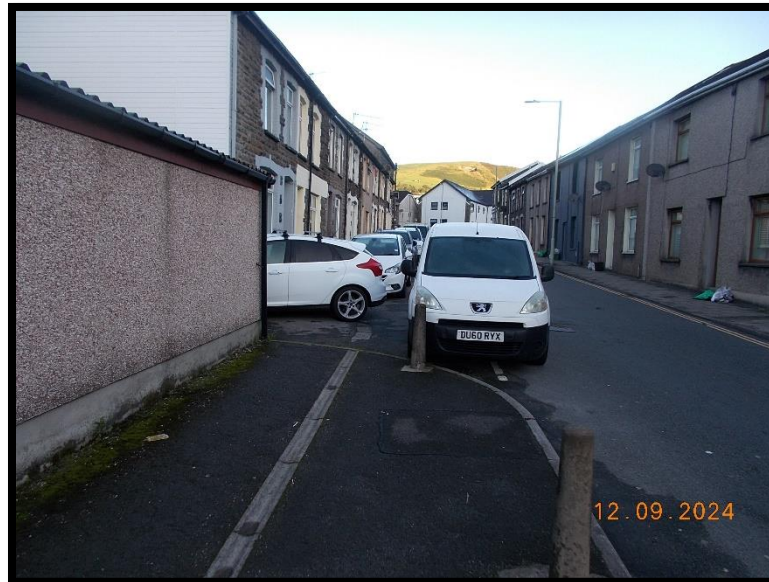
Photograph 4.37 – Cars parked on footway outside no. 116 on the B4278 North Road, restricting footway access

8.4 There are discrete sections along the B4278 North Road and Coedcae Road where vehicles parked on footways restricts the usable footway width. Vehicles obstructing footways can also impact upon walking routes, but the local neighbourhood policing teams are working with residents to help reduce the risks posed to pedestrians by indiscriminately parked vehicles.

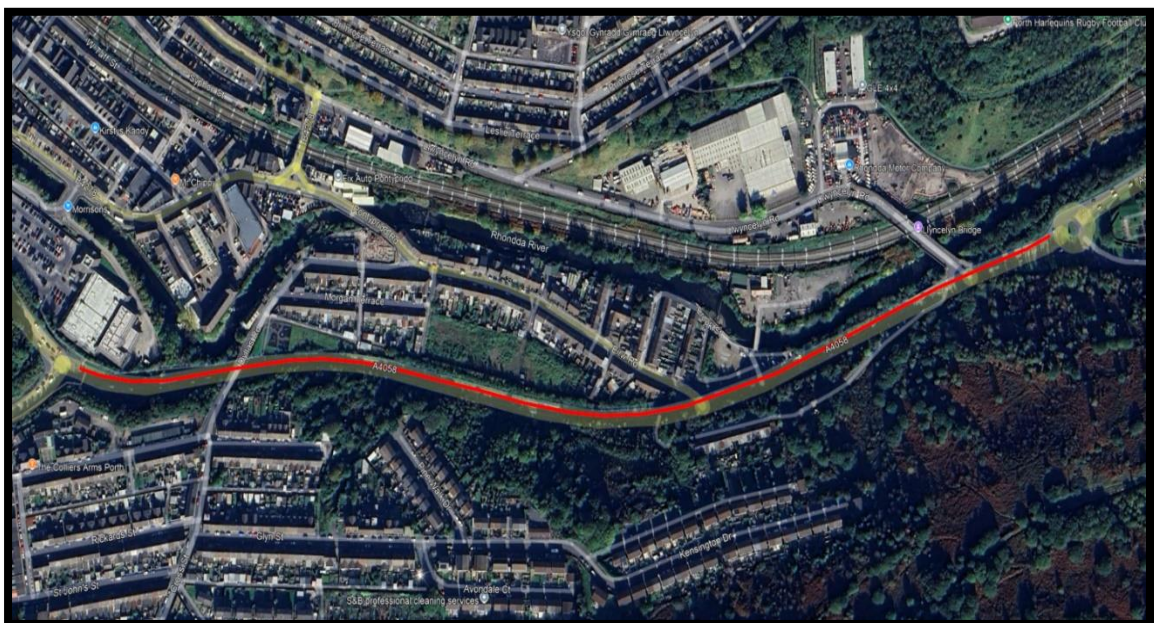
8.10 Traffic flows along the A4058 were noted to be high during the time of the survey. Where eastbound vehicles were observed to be **queuing back** westwards from the roundabout at the Heritage Park (and slow moving beyond on the bypass), to the signal controlled junction opposite the Morrisons store. This resulted in vehicles queueing across and potentially blocking the uncontrolled crossing points at both the Heritage Park Roundabout and near the junction with Llwynceilyn Road.

Image 8.1 – Vehicle queueing issues along the A4058 between the Heritage Park roundabout and the signalised junction opposite the Morrisons store
