RCT School Walking Routes Assessment

Ynysboeth to Mountain Ash
Comprehensive School

March 2025

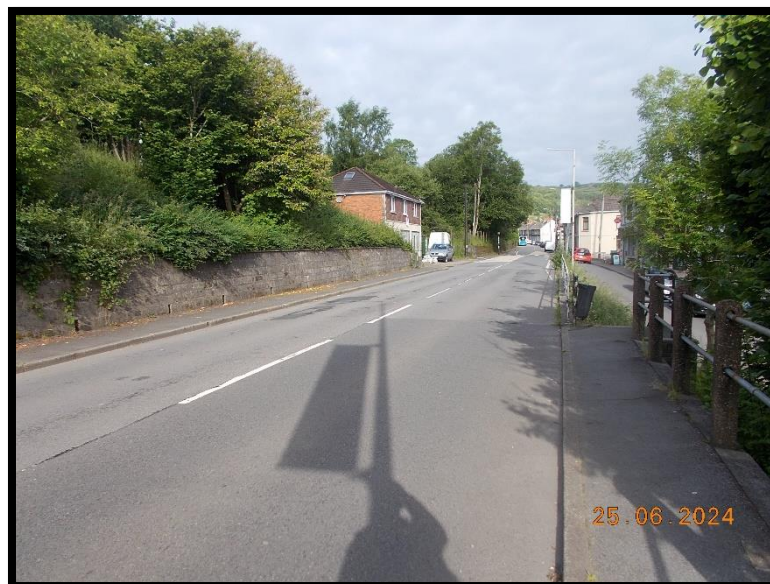
Photograph 4.1 - Steps at the junction with Walsh Street (northern footway)

- 5.9.1 The narrow footway in advance of the steps on the approach to the junction the B4275 with Walsh Street where there is a potential need for pedestrians to cross at this location to achieve connectivity between adjacent footways to avoid the narrow footway and steps.

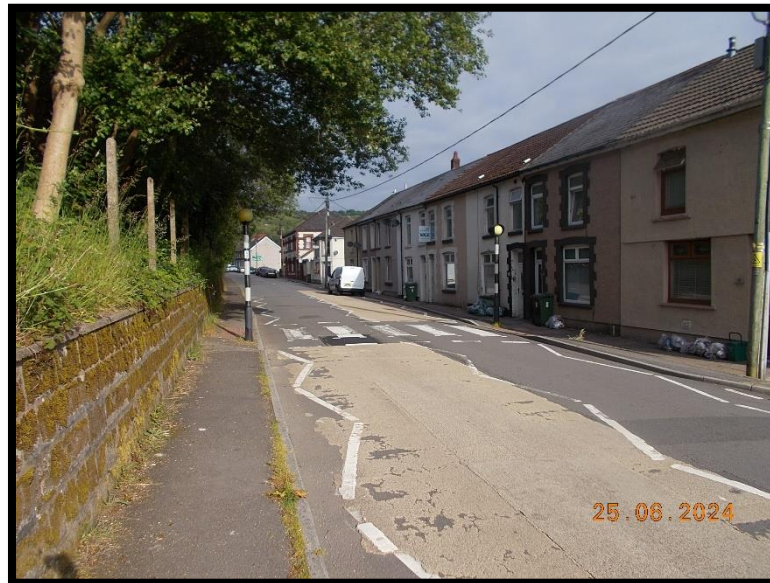
Photograph 4.2 – Zebra Crossing west of the junction with Walsh Street

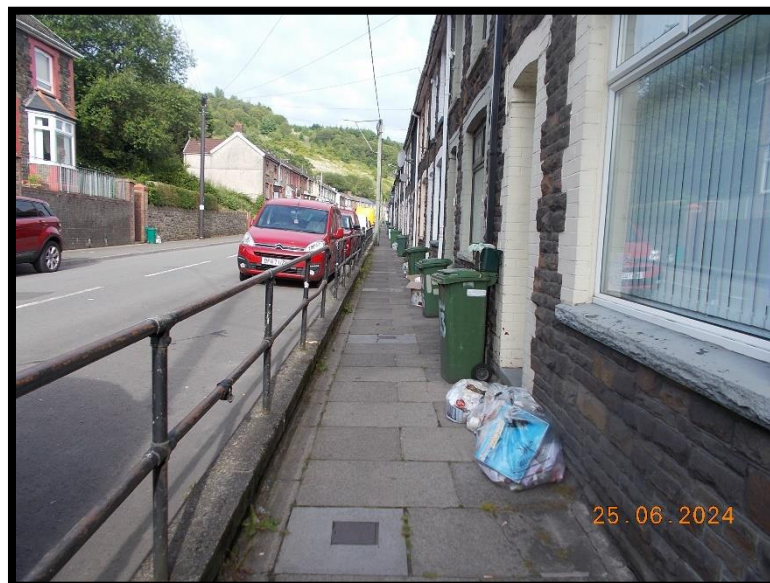
Photograph 4.3 – Pentwyn Avenue northern footway on refuse collection day

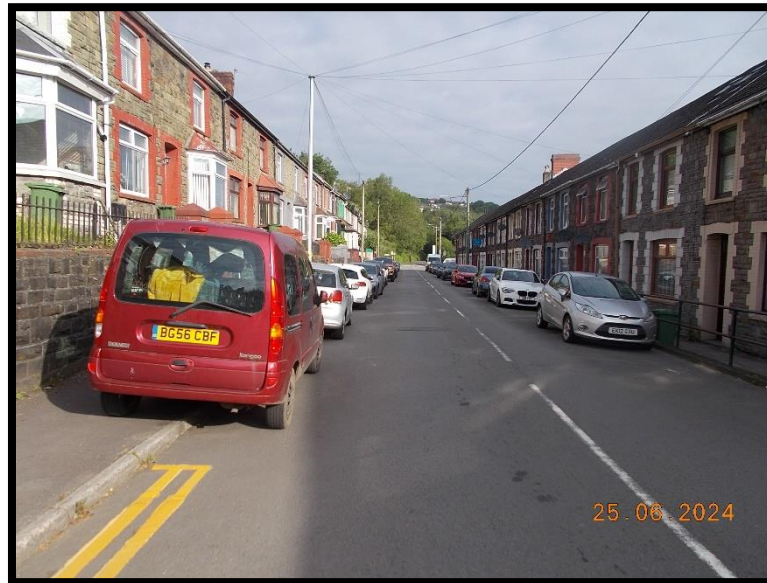
Photograph 4.4 – Pentwyn Avenue southern footway on-street parking issues

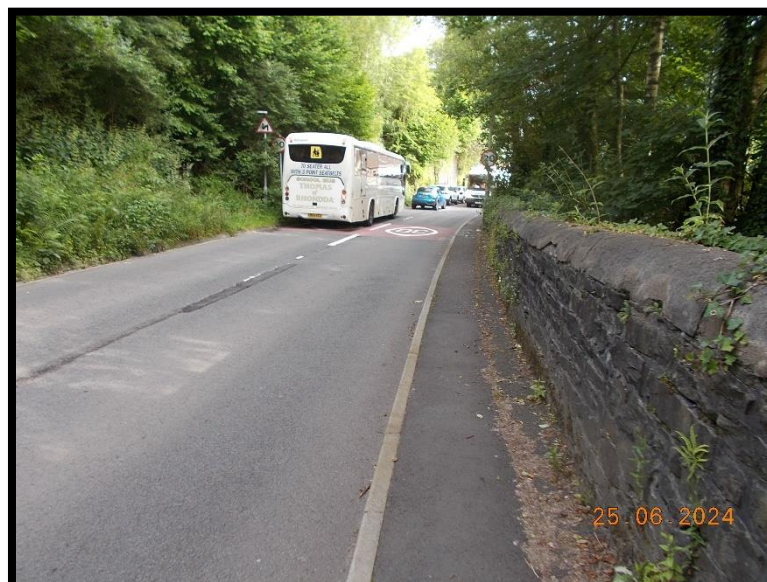
Photograph 4.5 – B4275 Pentwyn Avenue approach to Vaughan Terrace with footway narrowing on the approach to the bend

- 8.1.1 The route lies within 30/20mph speed limits.
- 8.1.2 There are continuous footways present in reasonable condition along the route.
- 8.1.3 There is a section of narrow footway along the eastern side of the B4275 Abercynon Road (between Pentwyn Avenue and Vaughan Terrace) with no adjacent footway or 'step offs' present. Whilst pedestrians may be required to step into the carriageway to pass one another at this location, vehicle flows are low (230 vehicles per hour in the morning and 267 in the afternoon) with a total of 325 gaps of 6 seconds per hour in the morning and 352 in the afternoon. On the approach to Vaughan Terrace, as the road bends sight lines are reduced and this is compounded by a change in speed limit from 20mph to 30mph on exiting Vaughan Terrace, with vehicles likely to be accelerating into Abercynon Road. In addition to this, recorded traffic speeds are noted to be significantly above the posted limits, at 39.1mph Northbound towards Mountain Ash and 37.7mph Southbound towards Ynysboeth.

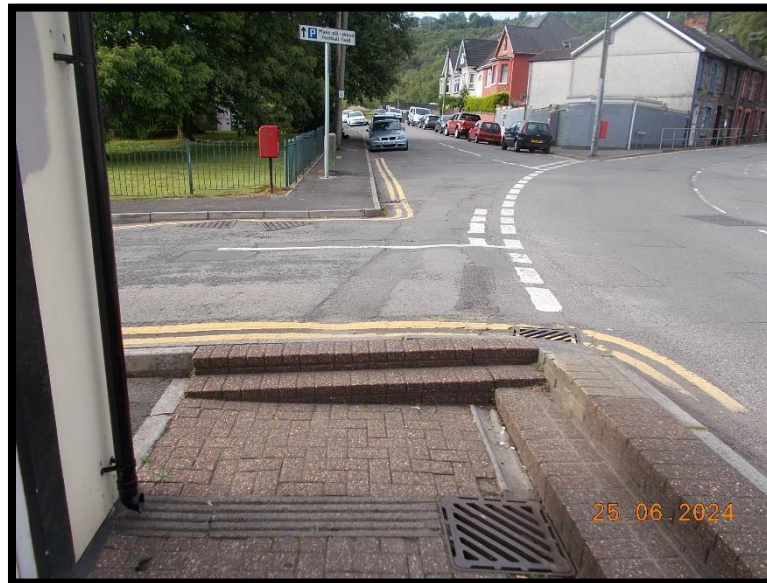
Photograph 4.6 – Wide ‘desire line’ crossing at the junction of Rheola Street with Vaughan Terrace

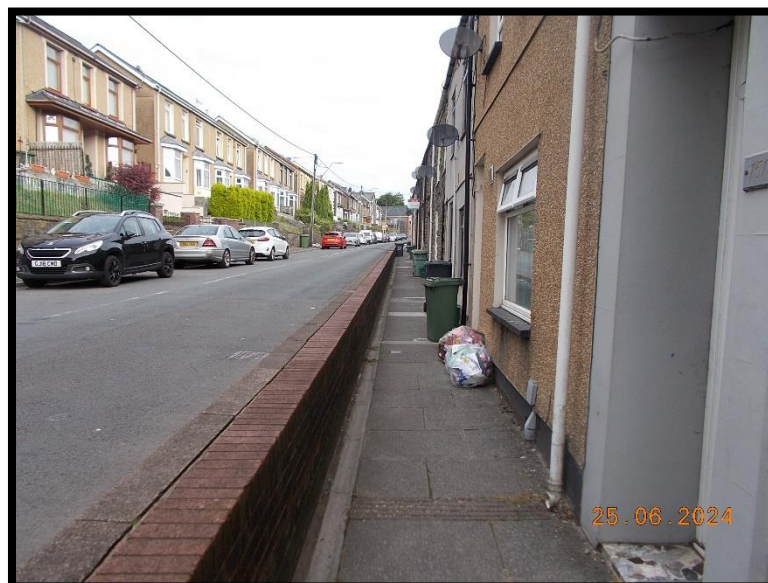
Photograph 4.9 – B4275 Penrhiwceiber Road Eastern Footway on Refuse/Recycling Collection Days

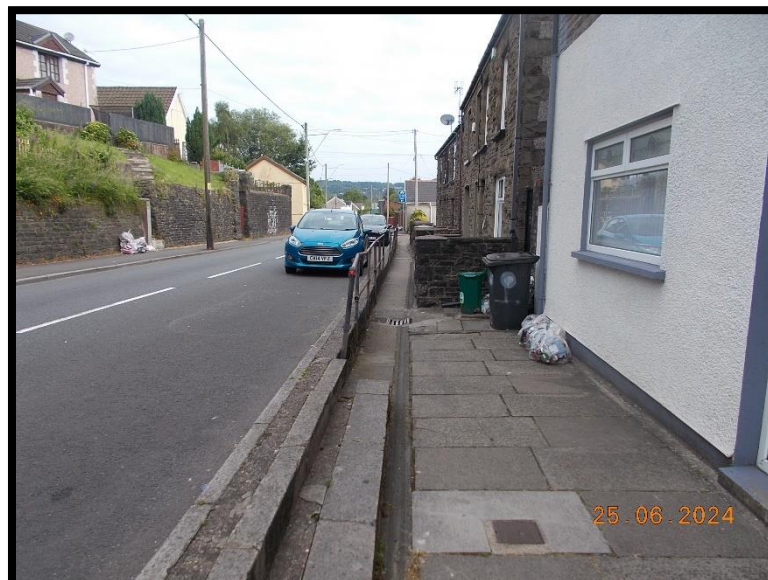
Photograph 4.11 – B4275 Penrhiwceiber Road Eastern Footway Narrowing

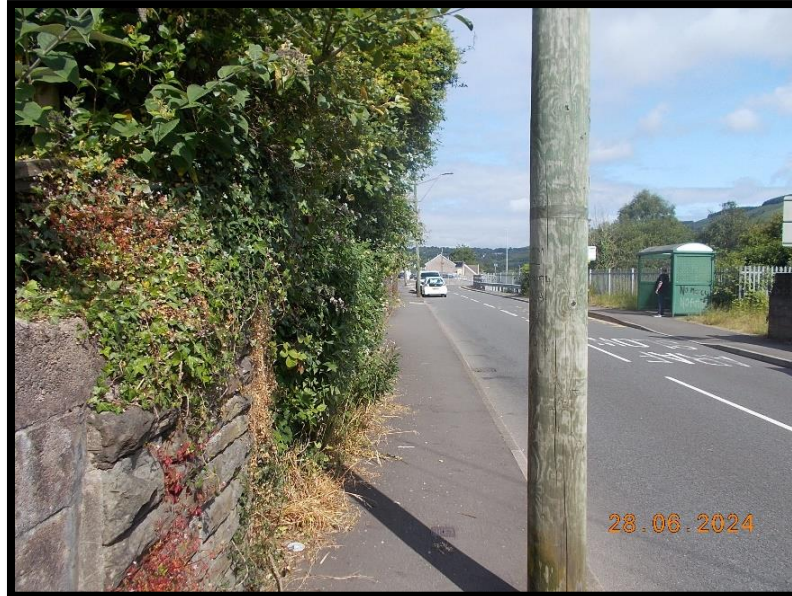
Photograph 4.12 – B4275 Penrhiwceiber Road western footway, vegetation narrowing the footway on the approach to the Cross Valley Link Road.

- Monitor the condition of overhanging trees and foliage. Where trees and or foliage overhang or encroach into footways these areas should be cut back to improve sight lines and natural surveillance. In addition to this, leaf debris should be removed from footways when required.
- Monitor footway obstructions. Where footway widths continue to be restricted by bin bags and parked cars, action be taken in conjunction with the appropriate Council Department / local neighbourhood policing teams.

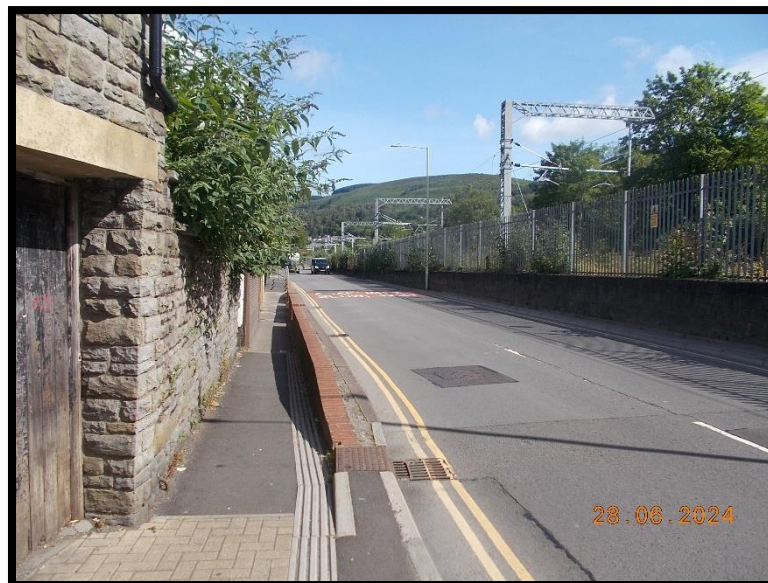
Photograph 4.13 – Short section of footway narrowing on the B4275 Miskin Road

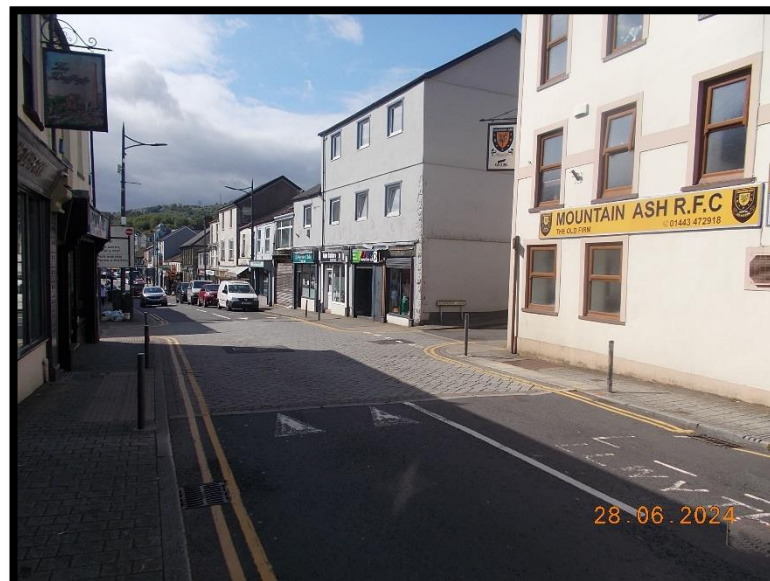
Photograph 4.15 – Uncontrolled raised crossing point in Mountain Ash Town Centre

- 8.2.3 Trees were observed to be overhanging discrete sections of the footway along Llanwonno Road.
- 8.2.4 There is a convoluted walking route at the signalised junction of Pryce Street and the B4275 (through Mountain Ash town centre), which requires pedestrians to walk away from the junction to a raised crossing point to cross safely.

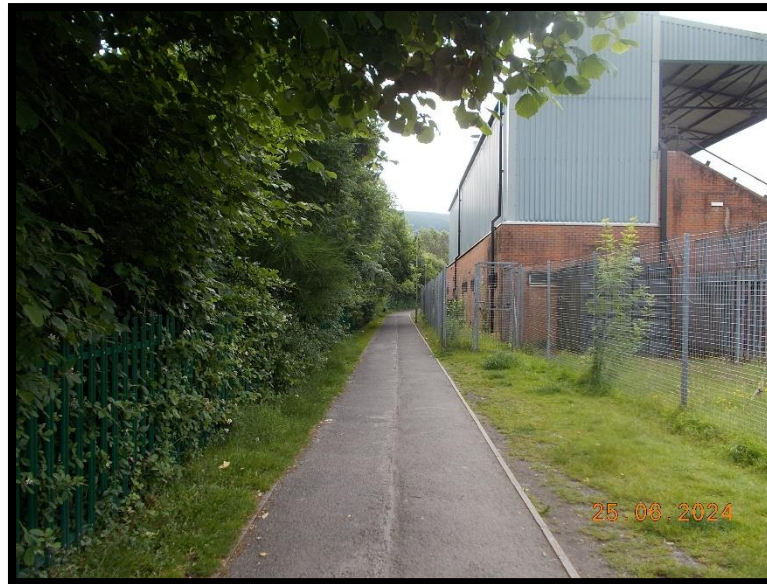
Photograph 4.18 – Footway link behind Mountain Ash RFC main stand area

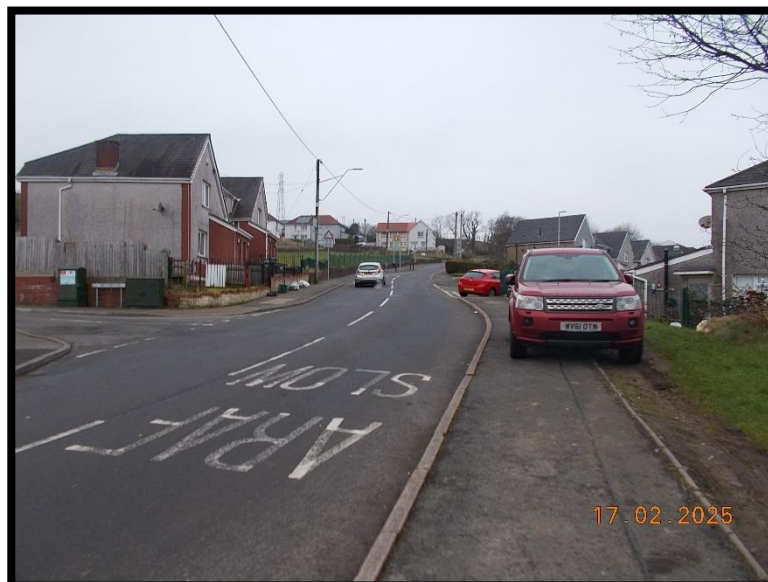
Photograph 4.26 – Parking on footways reducing the usable width at Ash Grove

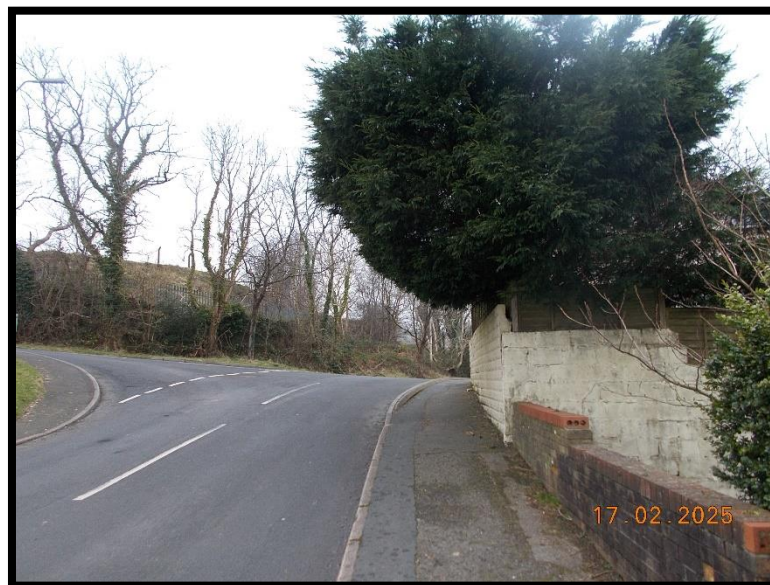
Photograph 4.28 – Overhanging tree branches near the interface of Hawthorn Terrace and Llanwonno Road

- Monitor the condition of overhanging trees and foliage. Where trees and or foliage overhang or encroach into footways these areas should be cut back to improve sight lines and natural surveillance. In addition to this, leaf debris should be removed from footways when required.
- Monitor footway obstructions. Where footway widths continue to be restricted by bin bags and parked cars, action be taken in conjunction with the appropriate Council Department / local neighbourhood policing teams.

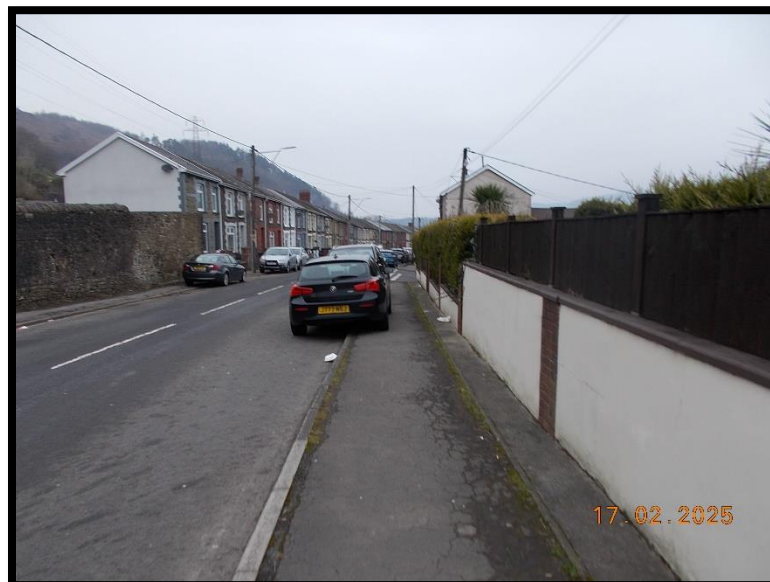
Photograph 4.30 –Parking on footways reducing the usable width on Llanwonno Road

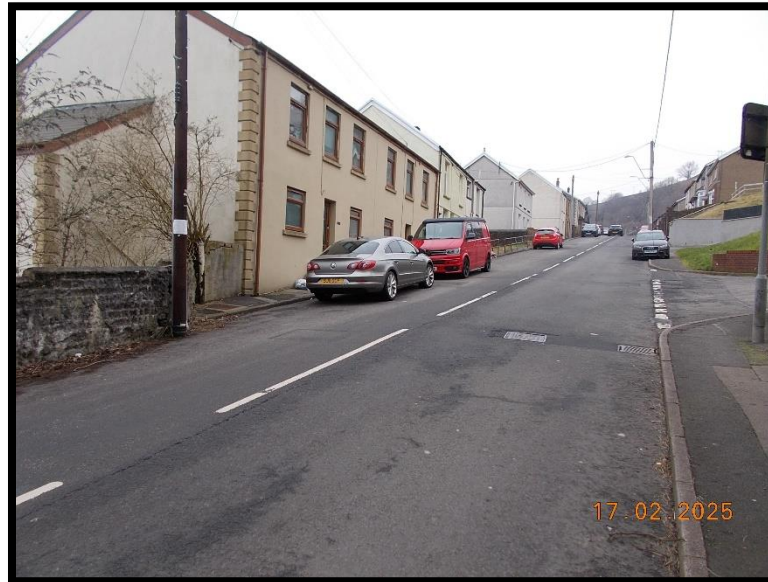
Photograph 4.31 – Footway on Llanwonno Road only available on one side

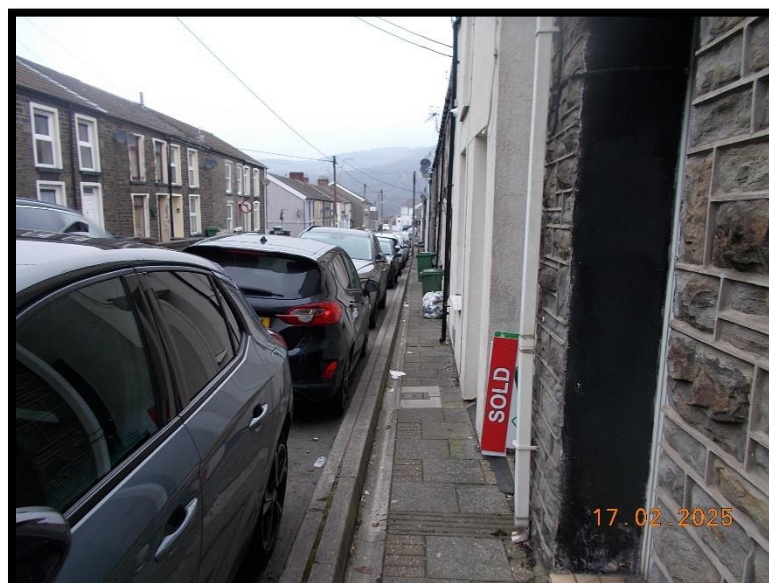
Photograph 4.32 – Localised narrowing to the footway by refuse bins on Llanwonno Road reducing the available footway width

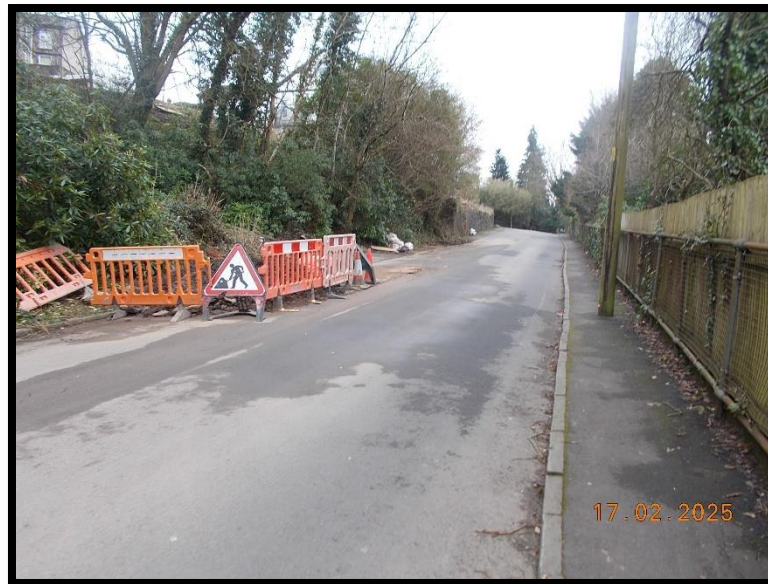
Photographs 4.34 – Footway along Harris View where pedestrians are required to cross to achieve connectivity, traffic speeds and flows were noted to be very low

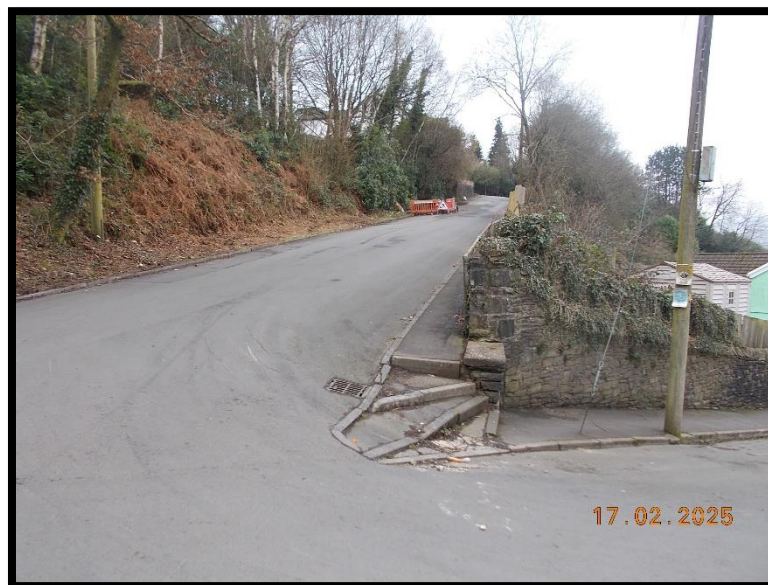
Photographs 4.35 – Steps along the footway of Harris View

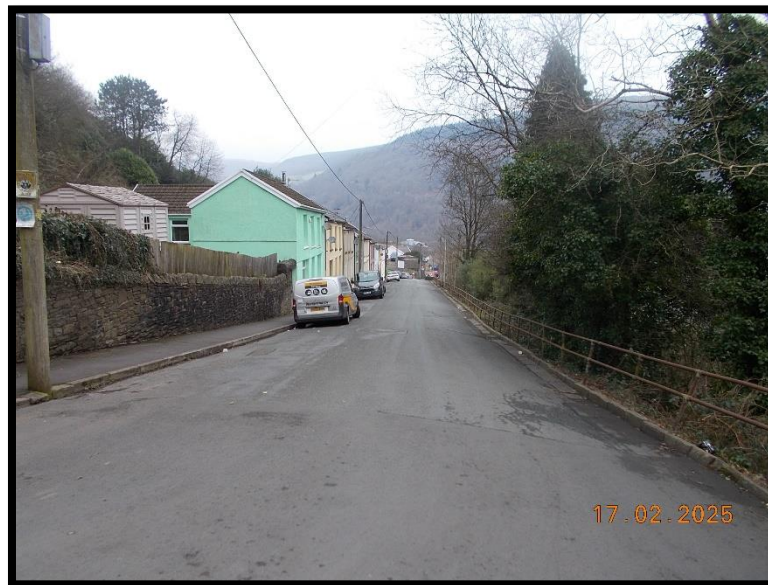
Photographs 4.36 – Footway along the western side of Harris View only

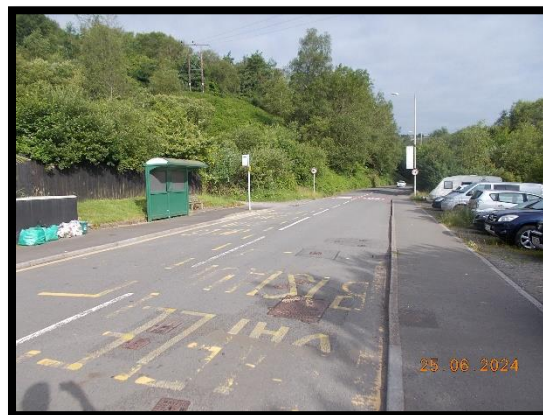
- 5.9.2 Near the bus stop to the north of no.92 Pentwyn Avenue where there is a need for pedestrian to cross to achieve connectivity between adjacent footways.

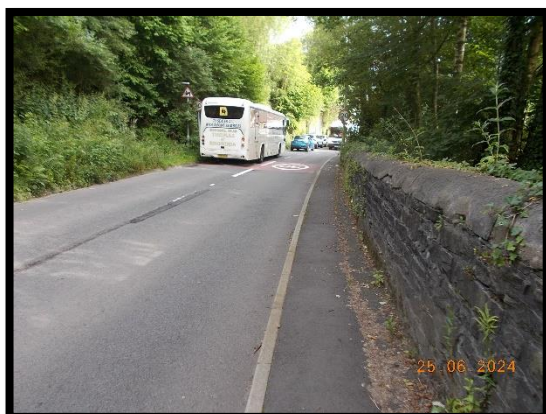
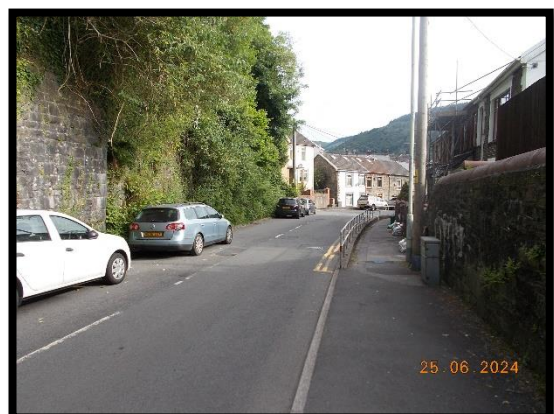
- 5.9.3 Along the southeastern side of the B4275 Abercynon Road (between Pentwyn Avenue and Vaughan Terrace), there is no adjacent footway or 'step off' present. Due to the narrow footway width in places (circa 1.0m), pedestrians may have to step into the carriageway to pass one another on the footway approach to Vaughan Terrace. This is further exacerbated due to limited forward visibility to approaching vehicles at the bend.

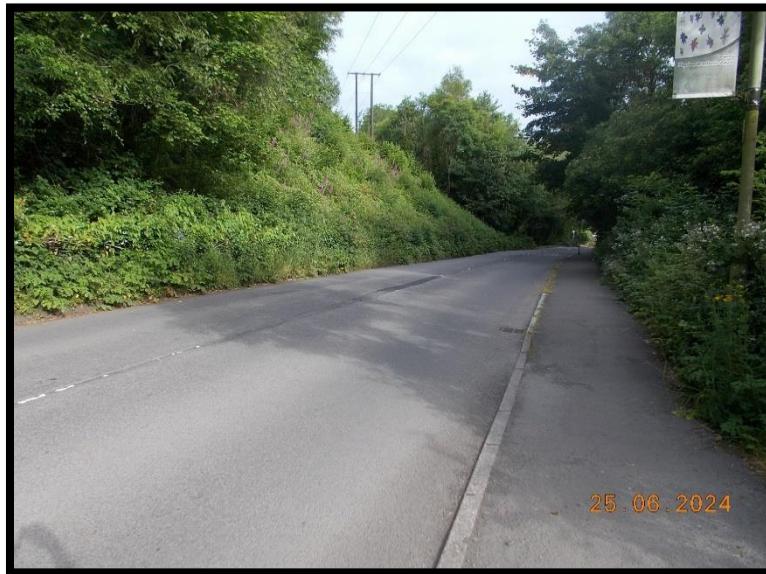
- 6.1 The section of footway along the B4275 between Pentwyn Avenue and Vaughan Terrace has no overlooking buildings (apart from a garage which may not be open during travelling times) or natural surveillance for circa 500m, other than by passing traffic or other pedestrians. A section of footway on Llanwonno Road also has no overlooking buildings or natural surveillance, other than by passing traffic or other pedestrians, see **photographs 6.1 and 6.2** below. There is also a short section of footway behind the stand at the rugby field which would benefit from vegetation clearance to improve pedestrian comfort and lighting levels, see **photograph 6.3**.

Photograph 6.1 – B4275 Abercynon Road Footway - Pentwyn Ave to Vaughan Terrace

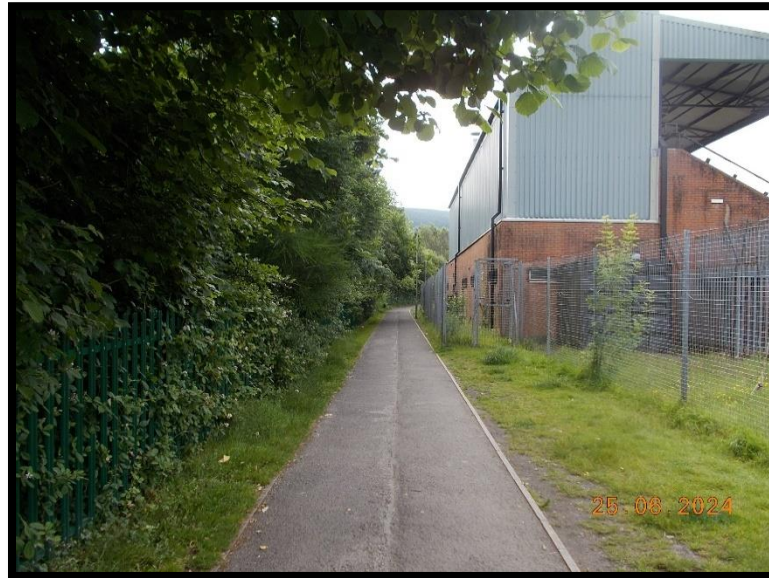
Photograph 6.3 – Footpath Located Behind Mountain Ash RFC Main Stand
