RCT School Walking Route Assessment

Ysgol Afon Wen / Cardinal Newman
Catholic School / University of South Wales
to Ysgol Garth Olwg

March 2025

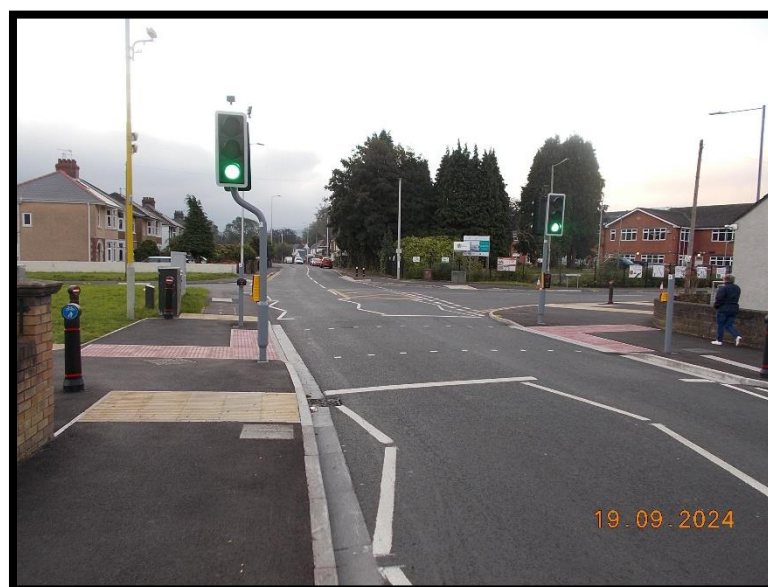
Photograph 4.1 – Signal controlled crossing at Ysgol Afon Wen

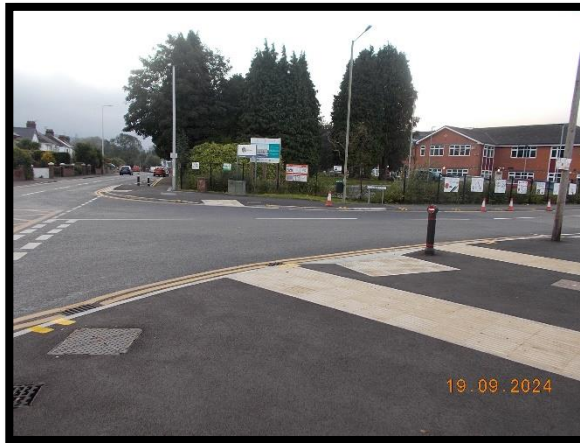
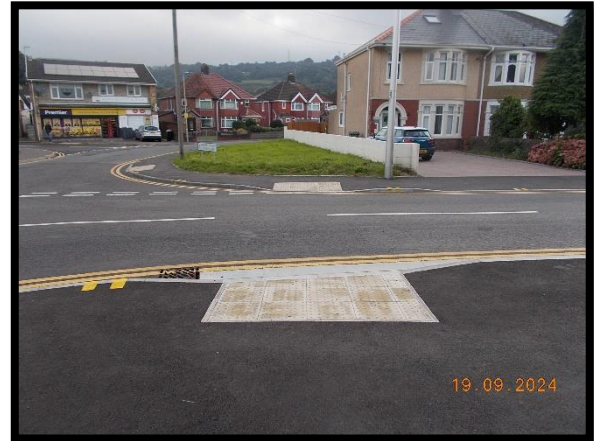
Photograph 4.2 & 4.3 – Uncontrolled crossing points at Ysgol Afon Wen entrance

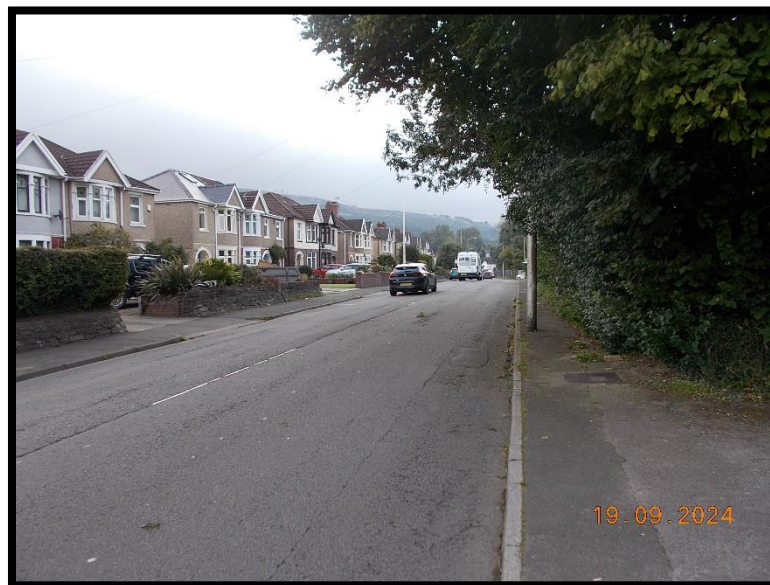
Photograph 4.4 – Overhanging vegetation along the A4054 Cardiff Road

- Monitor the condition of overhanging trees and foliage. Where trees and/or foliage overhang or encroach into footways, these areas should be cut back to improve the usable width, sight lines and natural surveillance. In addition to this leaf debris should be removed from footways when required.
- Monitor footway obstructions. Where footways widths are restricted by parked cars, action be taken in conjunction with the appropriate Council Department / local neighbourhood policing teams.

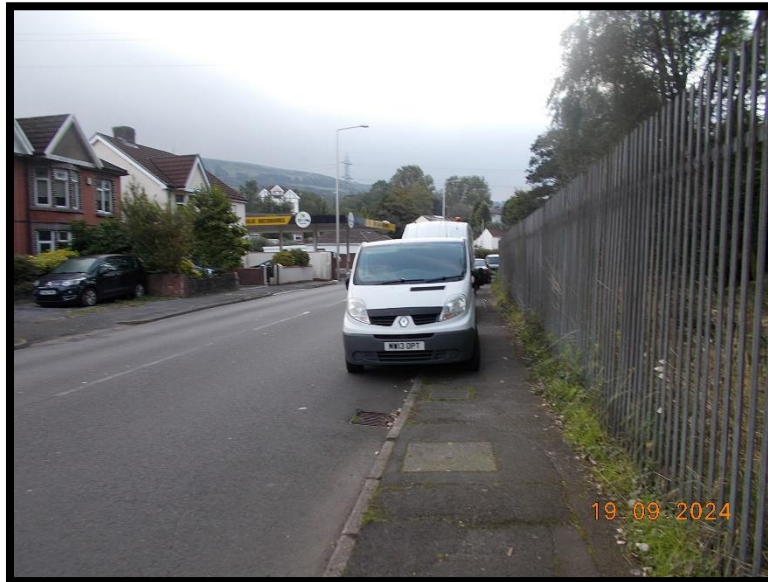
Photograph 4.5 – On-street parking issues outside no.6 Cardiff Road on the A4054

Vehicles obstructing footways can impact upon walking routes, but the local neighbourhood policing teams are working with residents to help reduce the risks posed to pedestrians by indiscriminately parked vehicles.

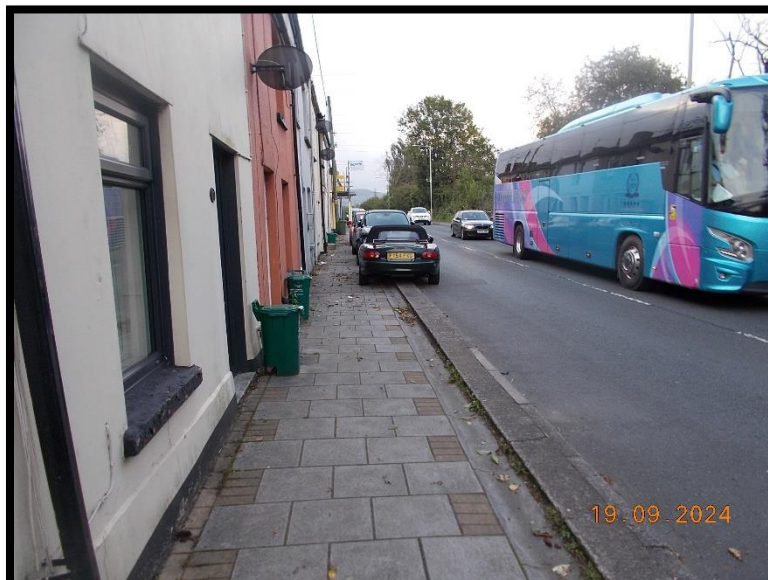
Photograph 4.6 – On-street parking issues along Williams Place on the A4054 Cardiff Road

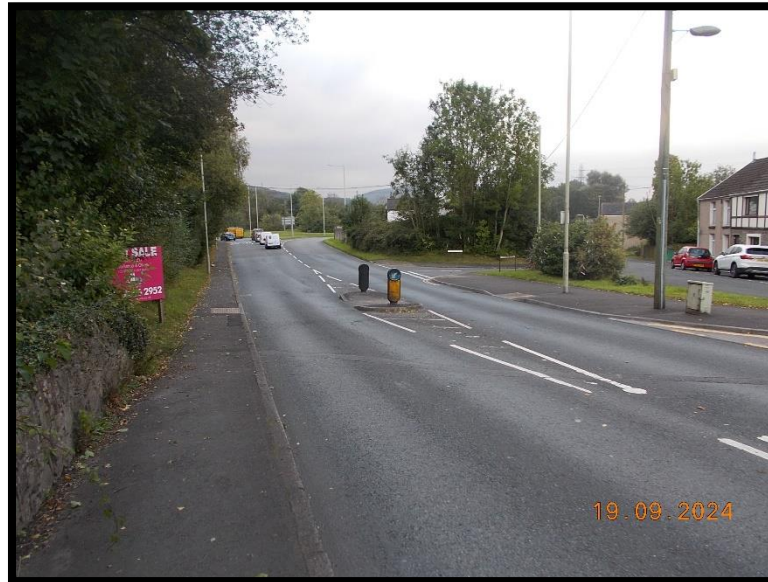
Photograph 4.7 – Uncontrolled crossing (pedestrian refuge) across the A4054 Cardiff Road to link into Williams Place

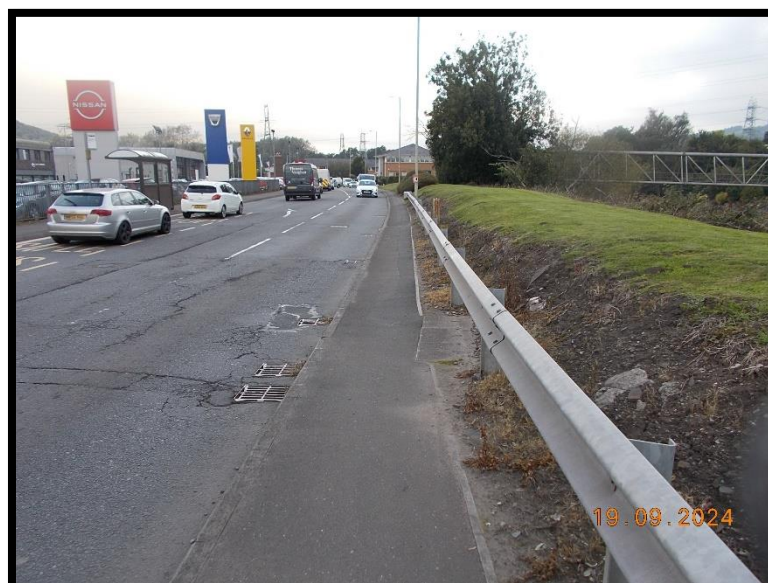
Photograph 4.8 – Footway along the A473 Tonteg Road

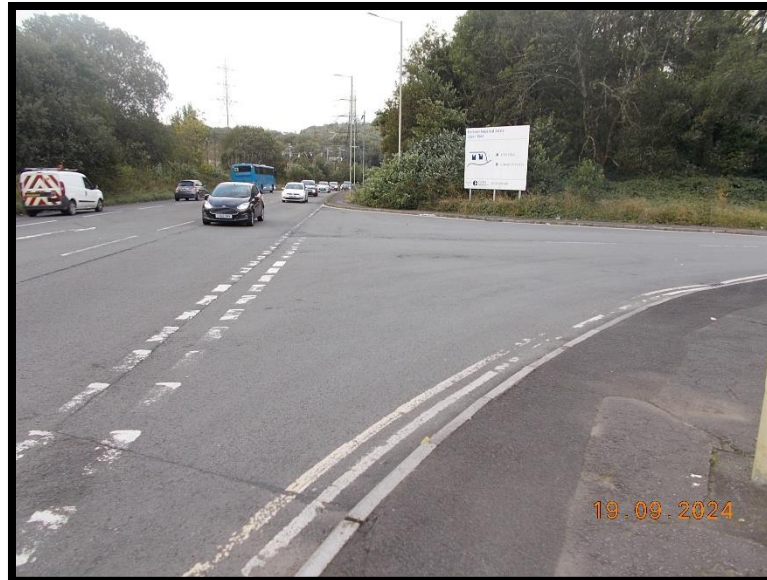
Photograph 4.9 – Wide junction crossing at the entrance to the garage forecourt on the A473 Tonteg Road, with overgrown vegetation on the southern footway

- 8.1.4 There is a wide road crossing at the junction entrance to Treforest Industrial Estate / Esso garage on Tonteg Road, where pedestrians are required to cross to achieve connectivity between adjacent footways. Visibility is good and traffic flows were low during the time of the assessment, such that crossing opportunities met the criteria outlined in the Learner Travel Guidance.
- 8.1.5 There are sections along the routes where parking on footways restricts the usable footway width:
- **Main Route** - Along the A4054 Cardiff Road opposite the dis-used garage forecourt.
 - **Main Route** - Along the A4054 Cardiff Road at Williams Place.

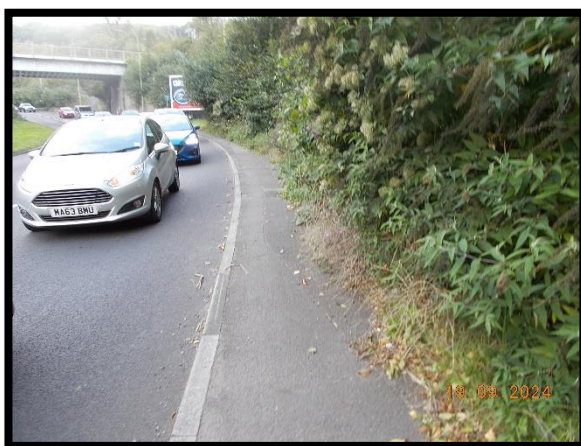
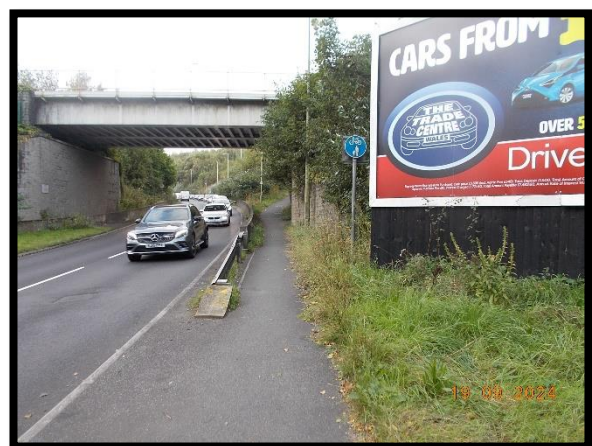
Photographs 4.10 & 4.11 – Overgrown vegetation on the shared use footway along the A473 Tonteg Road, reducing the usable width

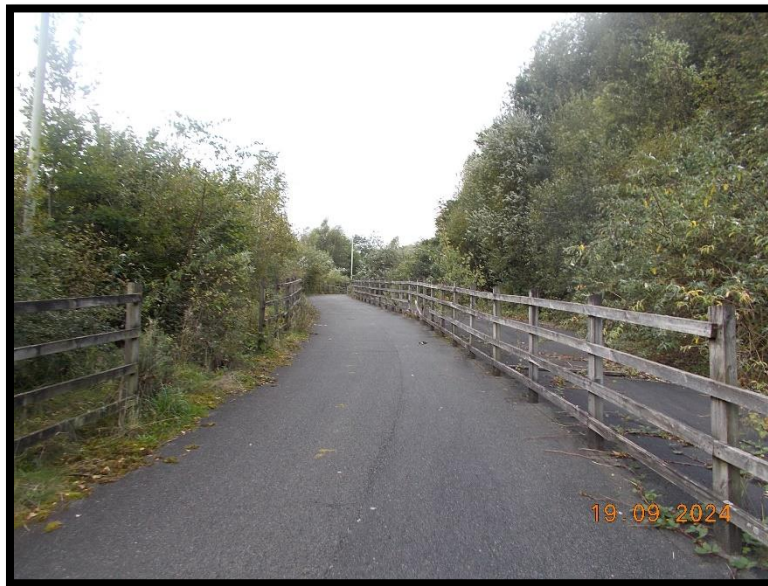
Photograph 4.12 – Lit Active Travel footpath linking the A473 Tonteg Road to Main Road

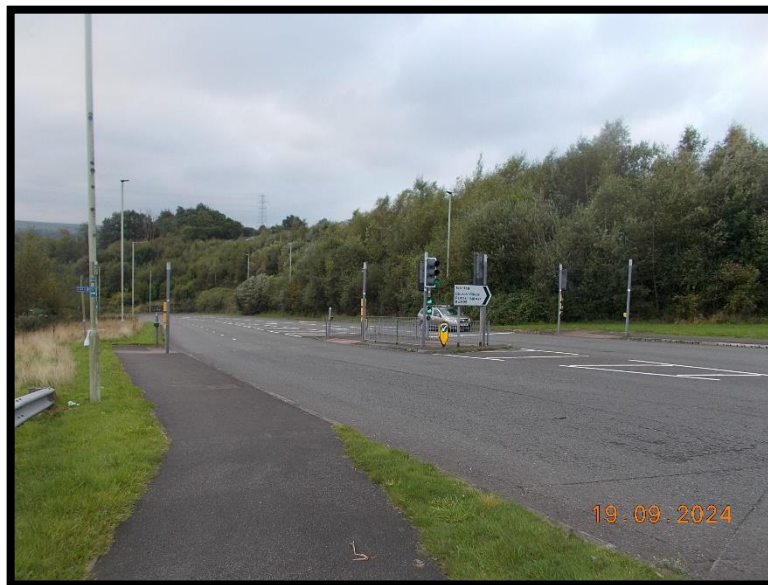
Photograph 4.13 – Signal controlled crossing across Main Road leading to Tonteg Road

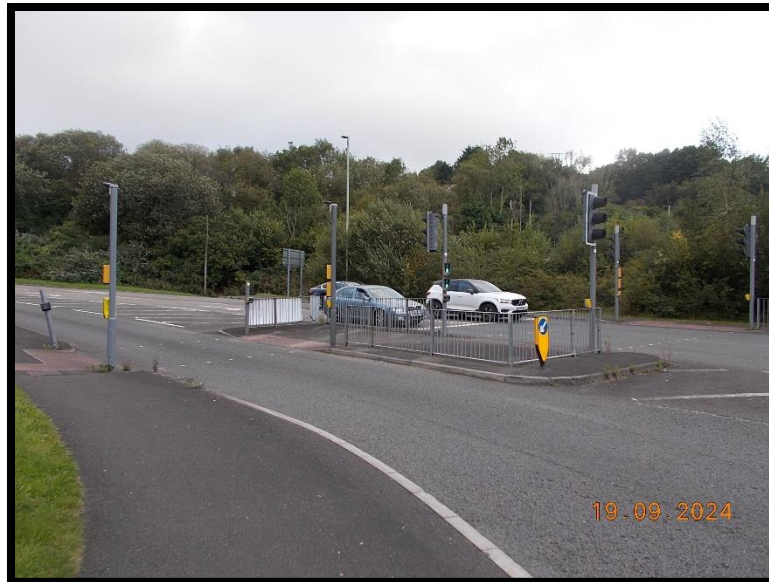
Photograph 4.14 – Signal controlled crossing at the junction of Tonteg Road with Main Road (bottom of the hill)

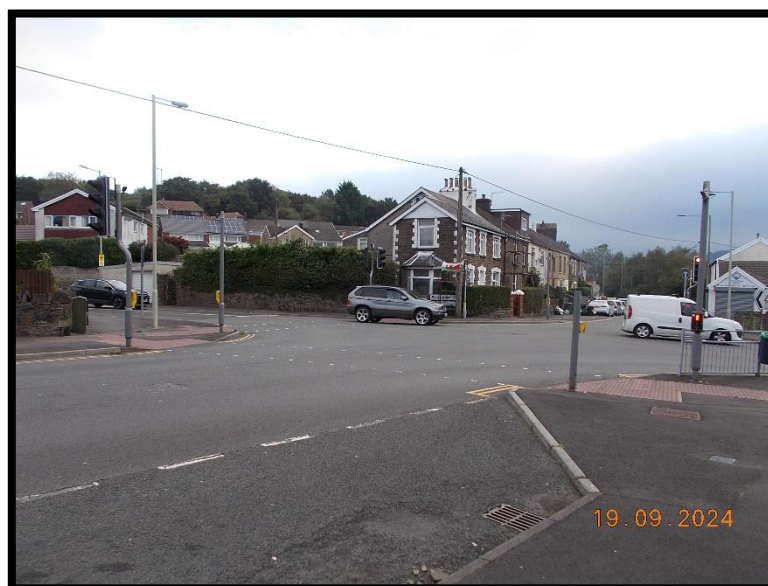
Photograph 4.15 – Signal controlled crossing at the junction of Tonteg Road with Main Road (top of the hill)

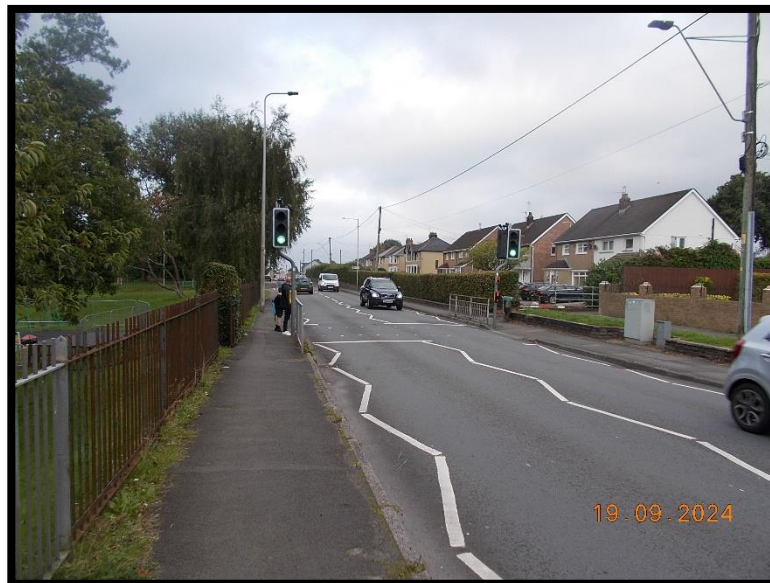
Photograph 4.16 – Signal controlled crossing on Main Road linking to Tonteg Park

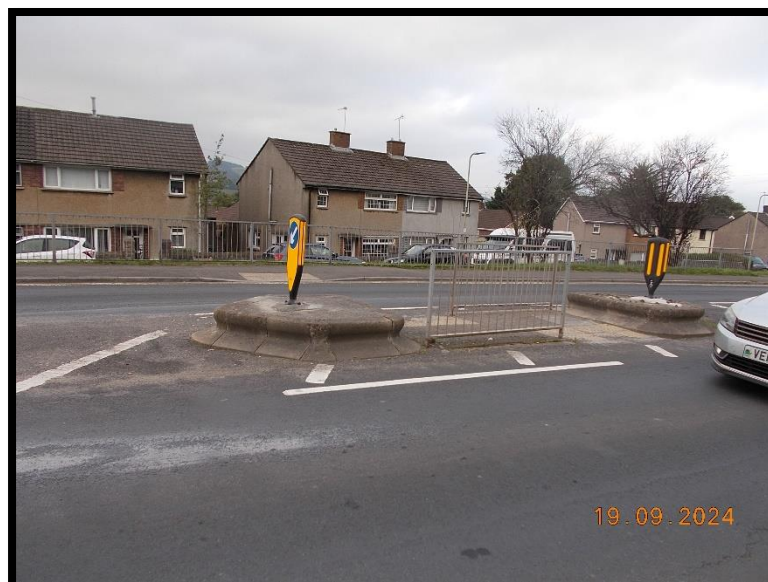
Photograph 4.17 – Uncontrolled crossing (staggered pedestrian refuge) outside no.12 Hollybush Villas on Main Road

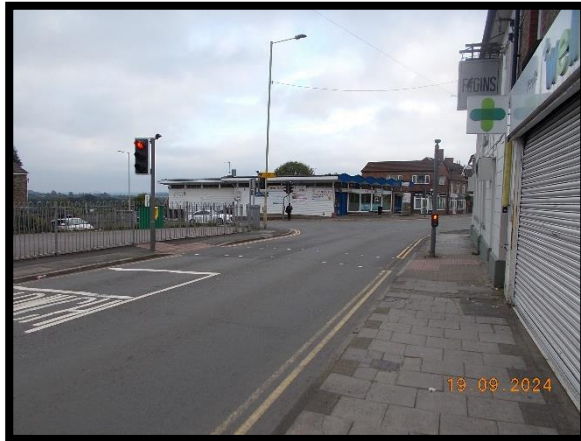
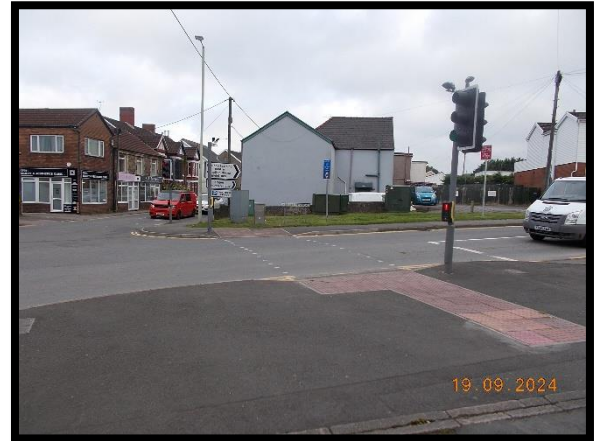
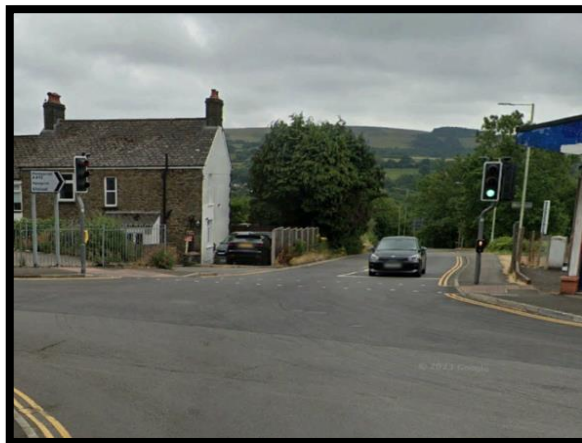
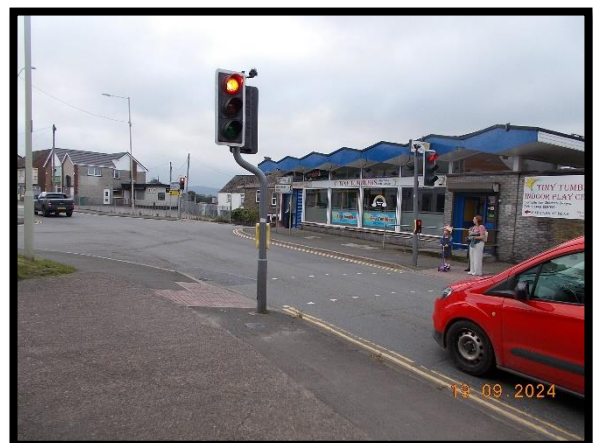
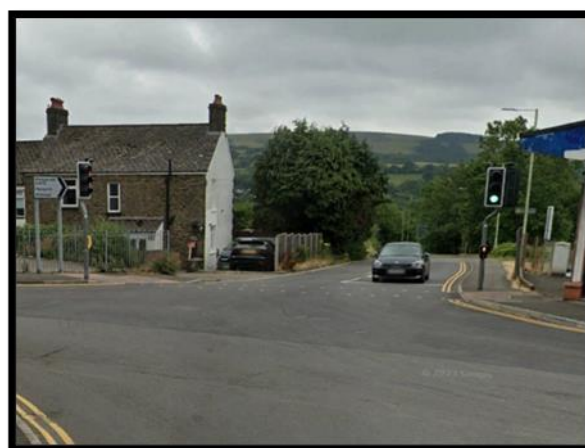
Photograph 4.18, 4.19, 4.20 & 4.21 – Signal controlled crossing points at the 4 arm junction of St Iltyds Road and Station Road with Main Road

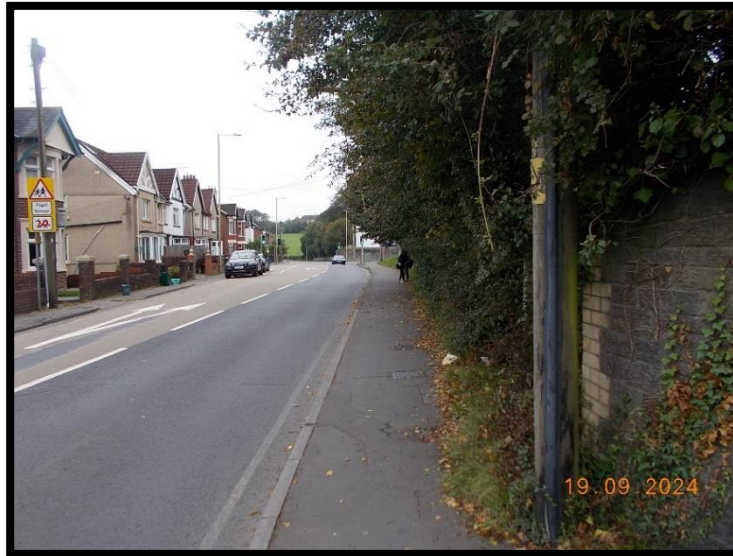
Photograph 4.22 – Overhanging vegetation on the footway approach to Ysgol Garth Olwg

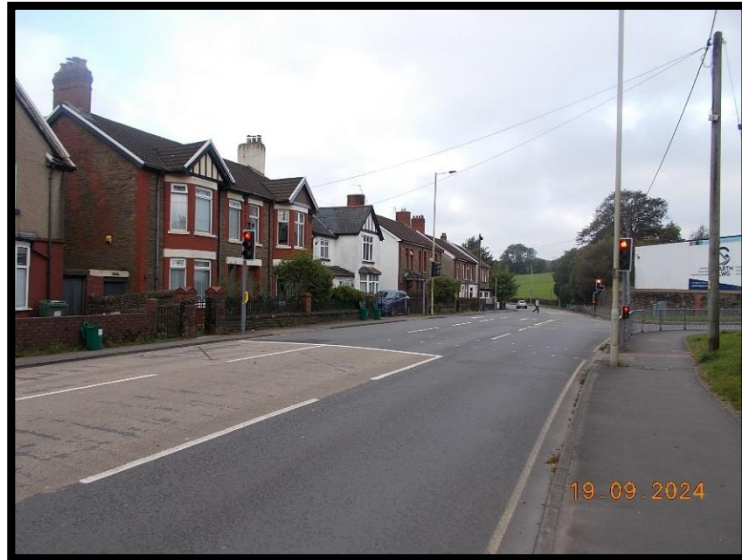
Photograph 4.23 – Signal controlled crossing on the approach to Ysgol Garth Olwg

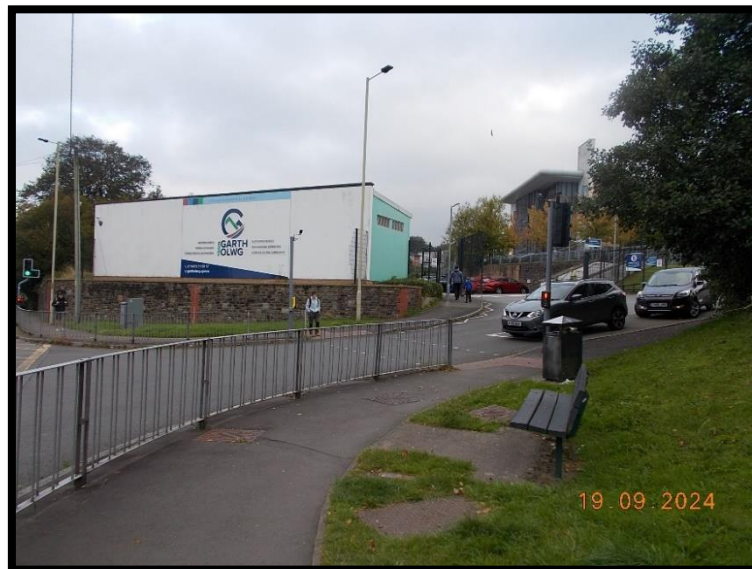
Photograph 4.24 – Signal controlled crossing at the entrance to Ysgol Garth Olwg

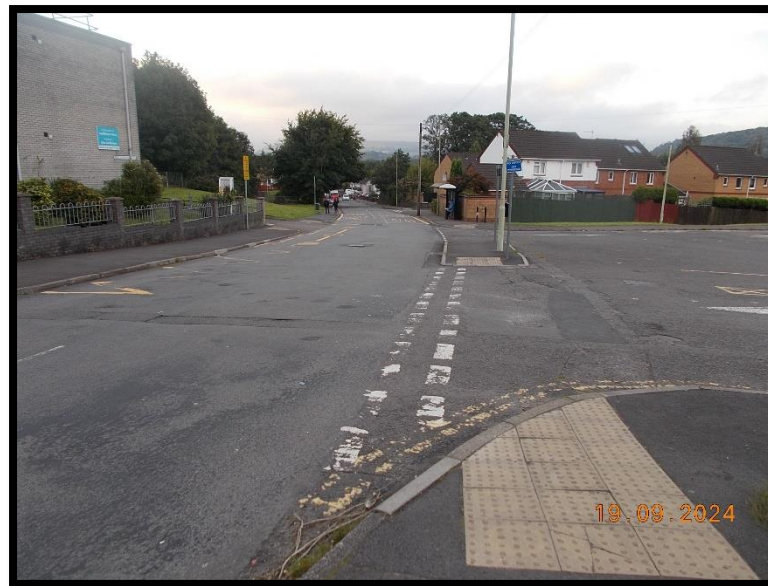
Photograph 4.25 – Uncontrolled crossing at the entrance to Cardinal Newman Catholic School

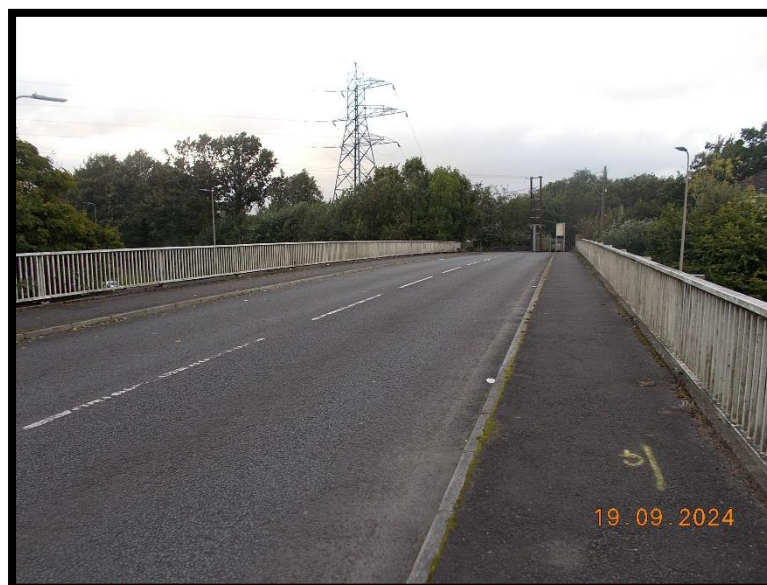
Photograph 4.26 – Footways over the A470 overbridge along Dynea Road

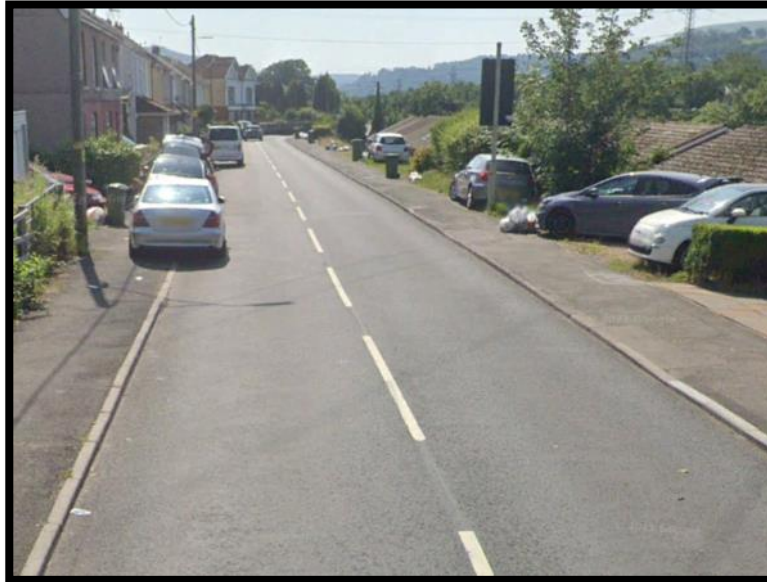
Photograph 4.27 – On street parking along Dynea Road narrowing the usable footway width

8.2.3 There are localised sections of the route where the footway width is reduced by vehicles parking on them. This can impact on impact upon walking routes, but the local neighbourhood policing teams are working with residents to help reduce the risks posed to pedestrians by indiscriminately parked vehicles.

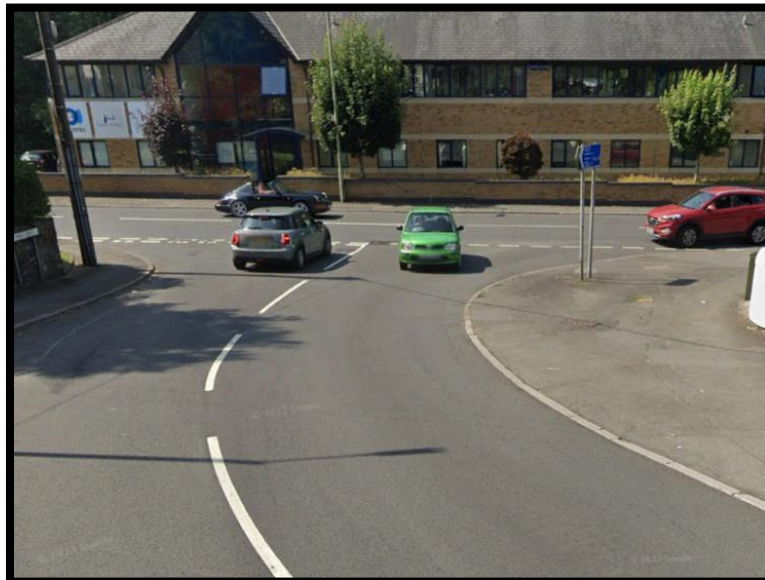
Photograph 4.28 – The junction of Dynea Road narrowing the usable footway width where it joins the A4054 Cardiff Road

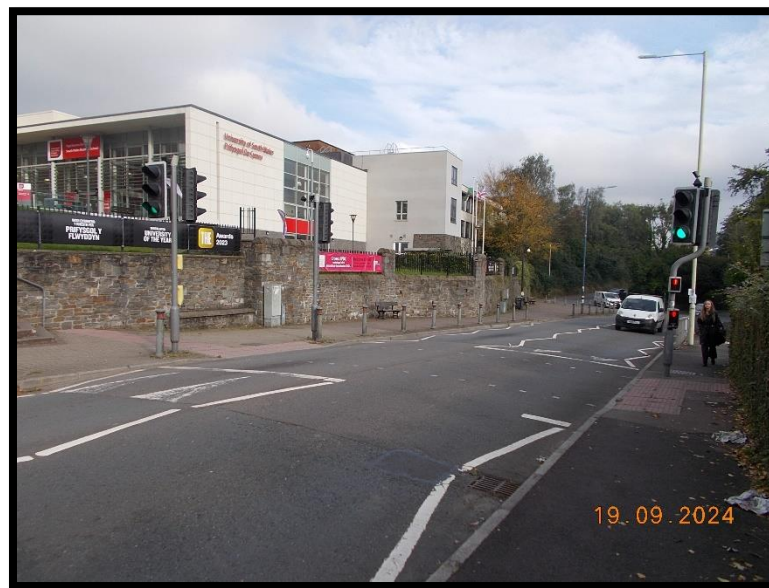
Photograph 4.29 – Signal controlled crossing outside the University of South Wales building

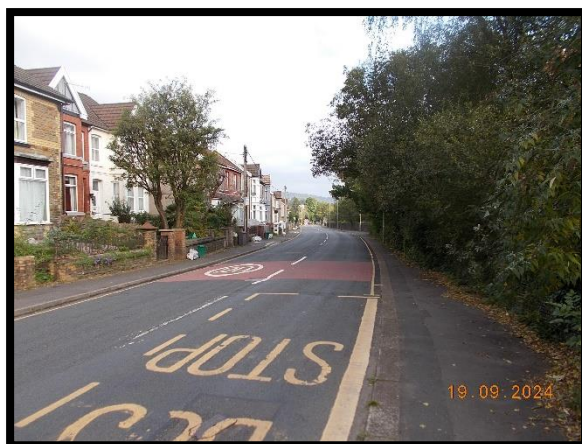
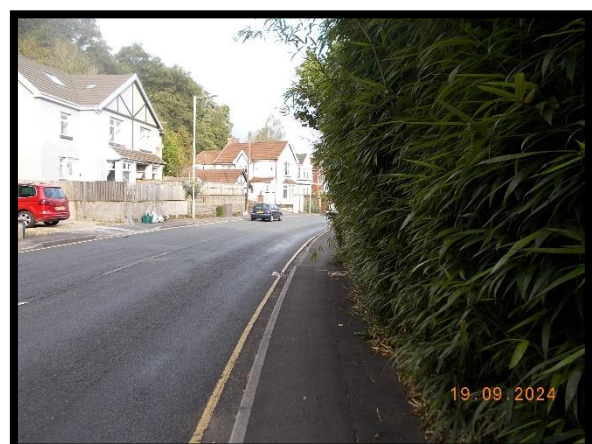
Photograph 4.30 & 4.31 – Overhanging vegetation narrowing the usable footway width along the B4595 Llantwit Road

- Monitor the condition of overhanging trees and foliage. Where trees and/or foliage overhang or encroach into footways, these areas should be cut back to improve the usable width, sight lines and natural surveillance. In addition to this leaf debris should be removed from footways when required.
- Monitor footway obstructions. Where footways widths are restricted by parked cars, action be taken in conjunction with the appropriate Council Department / local neighbourhood policing teams.

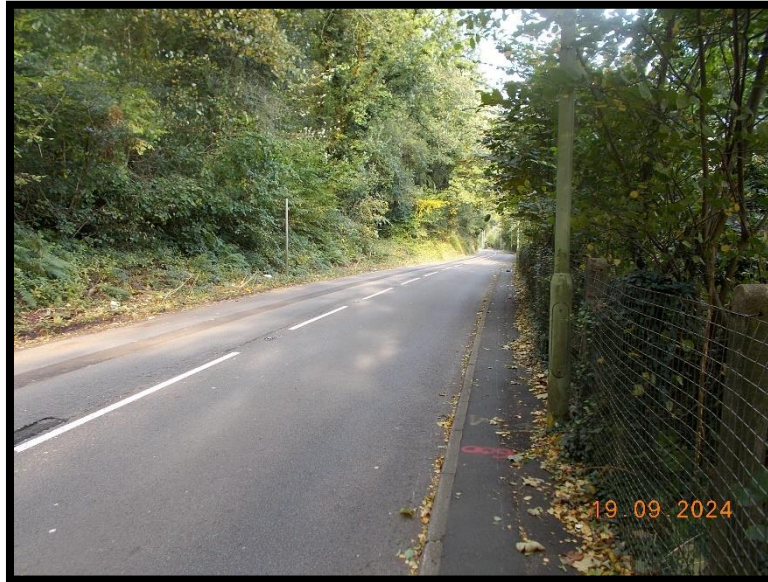
Photograph 4.32 – Localised footway narrowing at lighting columns and overhanging vegetation along the B4595 Llantwit Road within the 40mph speed limit

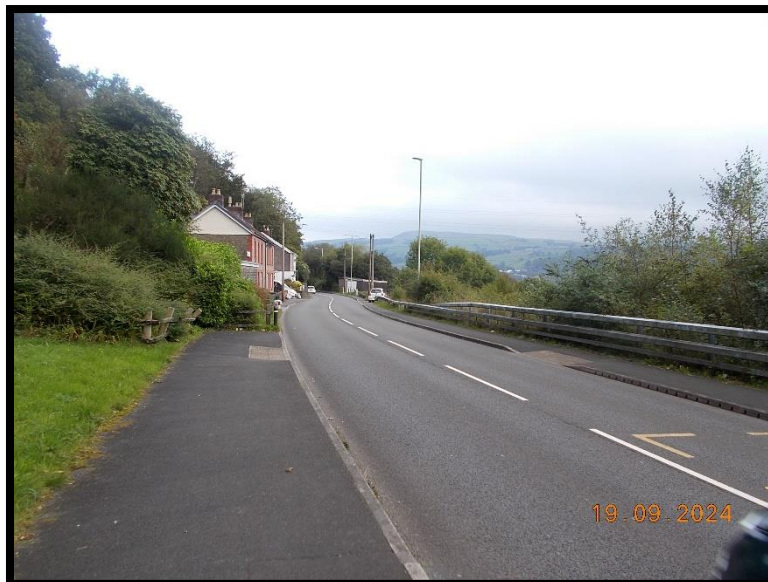
Photograph 4.33 – Uncontrolled crossing point linking Llantwit Road to Main Road along the B4595

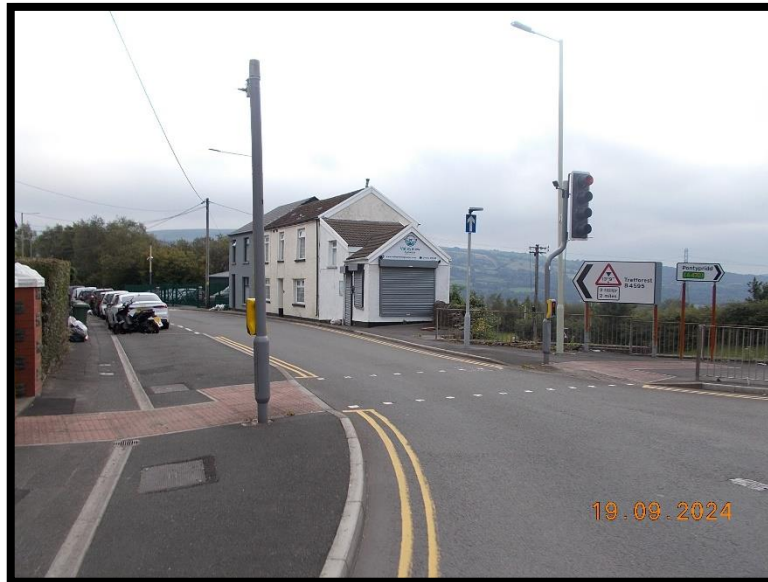
Photograph 4.34 – Signal controlled crossing point at the 4 arm junction of Church Road & Tonteg Road with Main Road (Main Road arm)

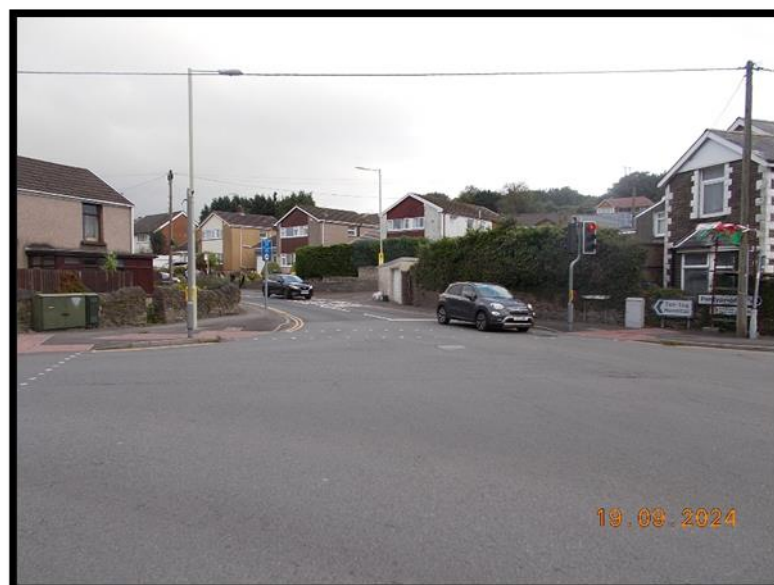
Photograph 4.35 – Signal controlled crossing point at the 4 arm junction of Church Road & Tonteg Road with Main Road (Church Road arm), where Sub Route 2 joins the main route

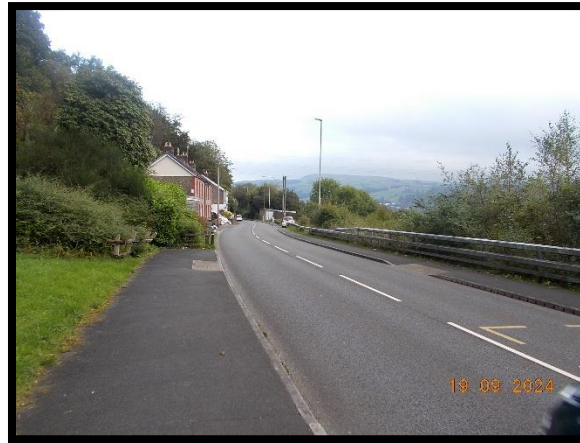
- 5.9.1 There is an uncontrolled pedestrian crossing on **Sub Route 2** linking either side of the B4595 Main Road, where pedestrians are required to cross to achieve connectivity between adjacent footways. Whilst traffic flows appeared low to medium during the time of the assessment (road works were being undertaken with temporary traffic management in place) and visibility is good, approach speeds appeared higher than the 30mph posted limit (possibly due to the open rural nature of the road), and crossing opportunities needed to be assessed.

- 5.12.1 **Location – B4595 Main Road on the approach to the uncontrolled crossing point near the Three Horseshoes Bus Stop – 11/11/2024**
- ❖ **AM:** 693 vehicles per hour, medium traffic flow. Gaps of 6 seconds during each 5 minute period ranged from 6 to 15, with a total of 150 gaps over the 1 hour period.

- ❖ **PM:** 611 vehicles per hour, medium traffic flow. Gaps of 6 seconds during each 5 minute periods ranged from 10 to 23, with a total of 187 gaps over the 1 hour period.

- ❖ **AM:** 845 vehicles per hour, medium to heavy traffic flow. Gaps of 6 seconds during each 5 minute period ranged from 8 to 15, with a total of 130 gaps over the 1 hour period. (an increase in traffic was noted due to congestion on the A470, however there were still plenty of gaps to allow safe crossing).

The traffic flows and gaps at this location for both AM and PM meet the criteria outlined in the Learner Travel Guidance.

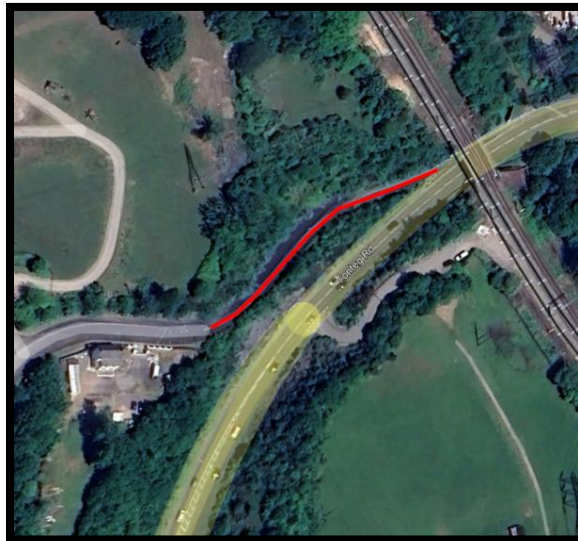
Image 6.1 – Section of shared use route between Tonteg Road and Main Road

- 6.1 There is a section of shared use footpath on the **Main Route** for circa 100m, after the railway overbridge on the A473 Tonteg Road. This section has little or no overlooking buildings or natural surveillance, other than by other pedestrians. This footpath would benefit from tree and vegetation clearance to improve pedestrian comfort, its usable width and lighting levels, see **Image 6.1** below.”.

8.1.10 There is a section of shared use footpath between Tonteg Road and Main Road where the footpath has little / no overlooking buildings or natural surveillance, other than by other pedestrians. This footpath would benefit from tree and vegetation clearance to improve pedestrian comfort, lighting levels and maximise the usable width.

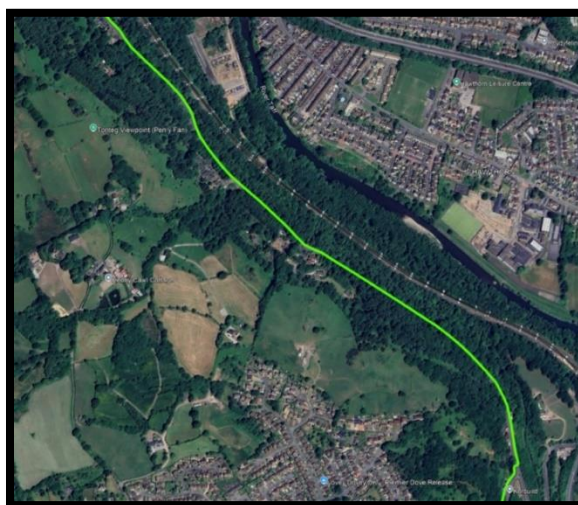
Image 6.2 – The B4594 Llantwit Road / Main Road between Treforest and Tonteg

- 6.2 There is a section of isolated footway on **Sub Route 2** for circa 1600m between the residential area at Treforest, heading south / south east along the B4595 Llantwit Road and Main Road. This section has little or no overlooking buildings or natural surveillance, other than by the occasional property, other pedestrians and passing vehicles, see Image 6.2 below.
