Tylorstown Landslip Phase 4

BS5837:2012 Tree Survey, Arboricultural Impact Assessment.

May 2021

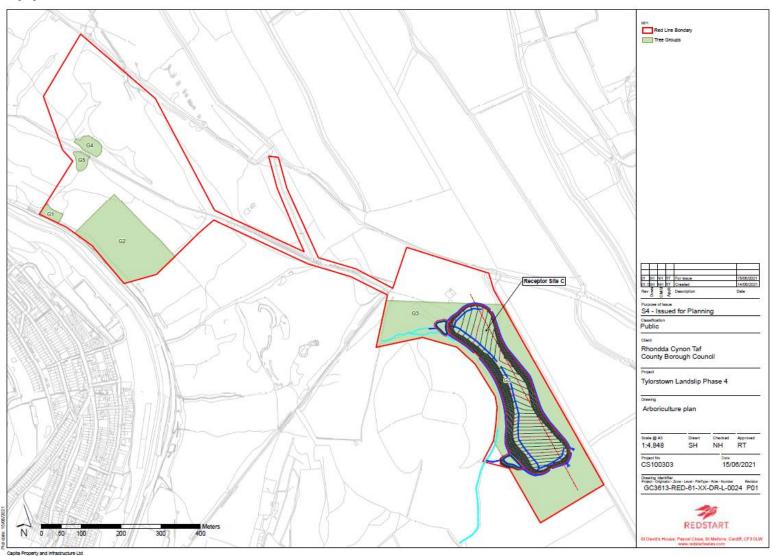
Appendix 2 – Aboricultural Plan

- 2.1.3. The surveyed trees are shown on the Arboricultural Plan attached as Appendix 2.
