# Coedely A4119 Dualling

## BAT SURVEY REPORT

Doc Ref: G2895-RED-30-XX-RP-L-0012

**A4119 Coedely Dualling  
Bat Survey Report**

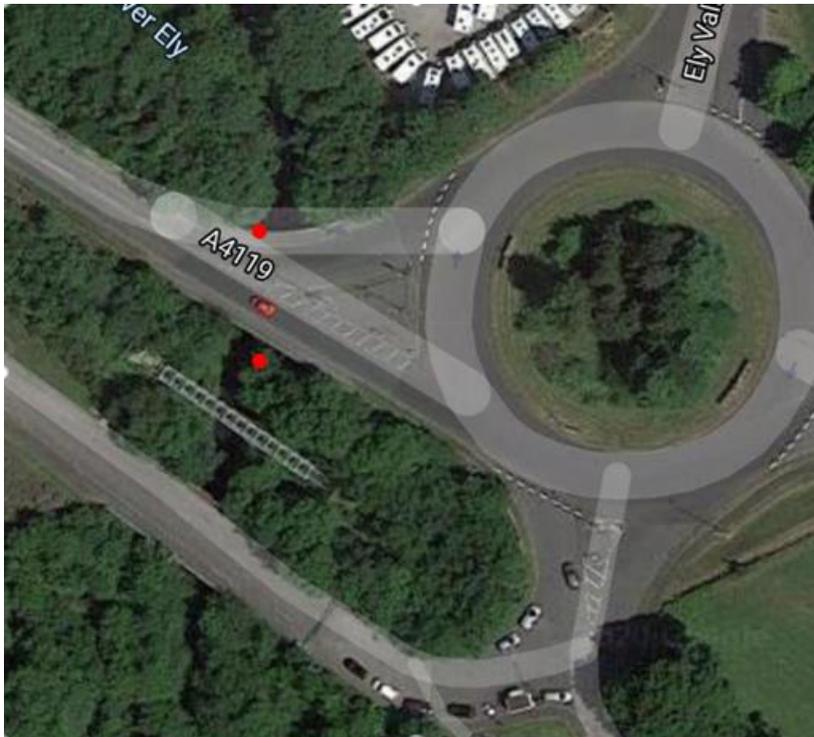
A pair of surveyors was positioned at locations on either side of the bridge with clear views under the bridge. Each pair of surveyors had a handheld SSF Bat2 detector and an Anabat passive bat detector to record the bat activity.

Surveyor positions are shown in the Figure 2.

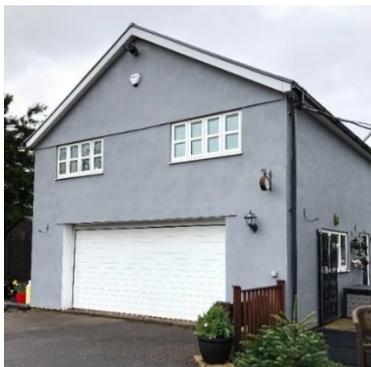
#### **Photograph 2:** Building 1A

A two-storey garage (Building 1A) was located within the grounds of the residential property Building 1. The garage had rendered, well maintained walls and well maintained UPVC windows and doors, fascias, soffits and a slate roof. Potential access points included gaps into a soffit box, wall cavity and between roof tiles and the roof and was therefore considered to have a moderate potential for roosting bats.

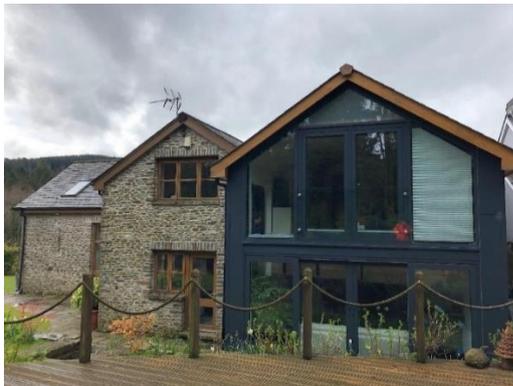
### **Photograph 3: Building 2**

A converted barn residential property (Building 2) is located to the east of Building 1. The building is a 2-storey construction with stone walls, slate roof, slit windows, Velux windows, steel-framed extension, timber soffit boxes, fascias and clay ridges. The building was relatively well maintained but due to the number of potential access points within the features listed above was considered to have a moderate potential to support bat roosts.

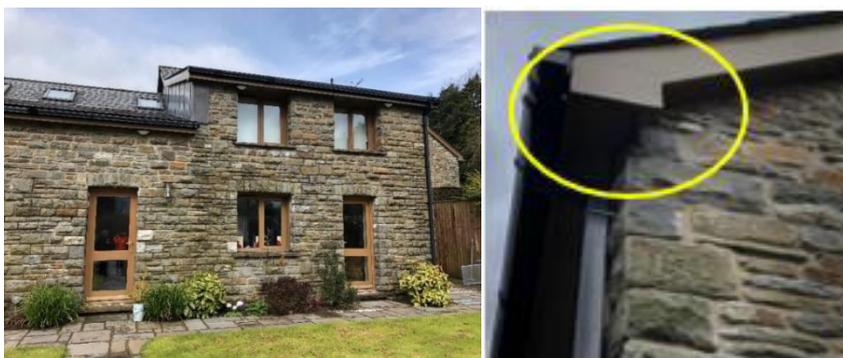
Building 3 is a converted barn residential property. The property has stone walls, a pitched slate roof, clay ridges, gable ends, lead flashing and Velux windows. Potential access points into soffit boxes and between windows and stone walls were noted.

Photographs 5 and 6: Building 3 and roost location identified during great crested newt survey (circled in yellow).

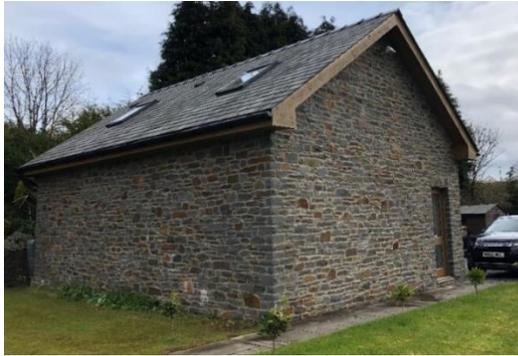
**Photograph 4:** Building 4

Building 4 is a 2-storey detached garage. The stone building had a slate roof with Velux windows and timber fascia and soffit boards. The building was relatively well maintained but due to the number of potential access points was considered to have a moderate potential to support bat roosts.

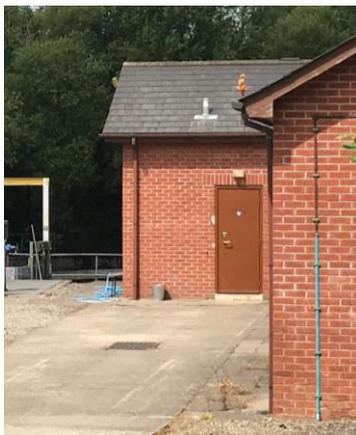
**Photograph 7:** Building 5

Building 5 was a small L-shaped brick pump house building with a slate roof, wooden soffits, wooden doors and grilled windows. The building was assessed as being of moderate potential for roosting bats.

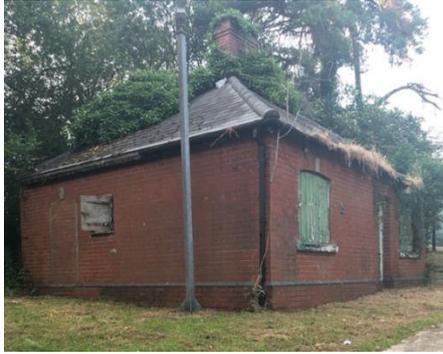
**Photograph 8:** Building 6

A derelict welfare building was located within the water treatment plant on the eastern side of then A4119. The disused building was a one-storey structure with a collapsed ceiling, brick walls, chimney, shuttered windows and a slate roof. The building was approximately 7 m x 6 m, was constructed in 1912. Potential bat access points included missing slates, gaps in ridge tiles, broken shutters, an open porch and holes between the soffits and the brick work. The building was assessed as having high potential for roosting bats.

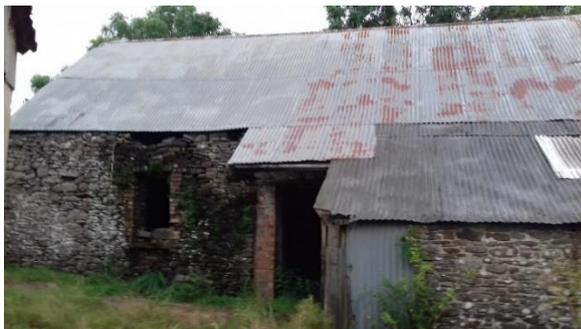
Photograph 9: Building 7A

Building 7A was a stone barn with a metal sheet roof with an extension on the southern end (Building 7B). Numerous gaps in the masonry were present with some large stones missing completely. The metal sheet roof was loosely attached to the structure with multiple gaps between the wall and roof and also along the ridge. The masonry walls were in poor condition with many areas of missing mortar. The majority of windows and doors in the building were permanently open. Exposed concrete lintels were present above all doors, with timber lintels above windows, there were numerous gaps around the lintels. The building was assessed as having high potential to support roosting bats due to the numerous gaps and openings and the presence of exposed beams.

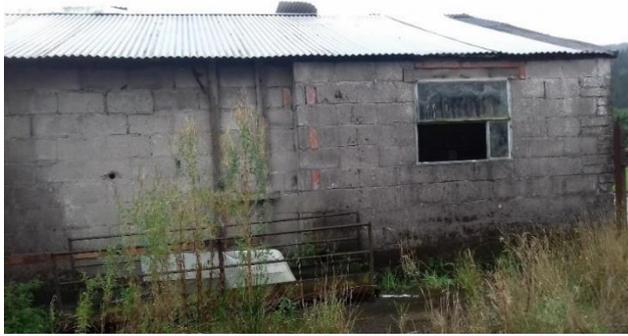
**Photograph 10** – Building 7B

Building 7B was a breeze-block rendered building with a slightly pitched metal roof that was found to be in a poor-condition. An open window was located on the southern side and there were various other openings into the building from missing block work to gaps within the metal sheeted roof. A timber lintel was present above the walls on the western aspect above which were multiple openings. Internal walls were rendered, and a part of the building had a ply wood roof with large holes in it. The rear wall of the building was in a state of collapse. The building was assessed as having low-moderate roosting potential. The building was assessed as having moderate roosting potential.

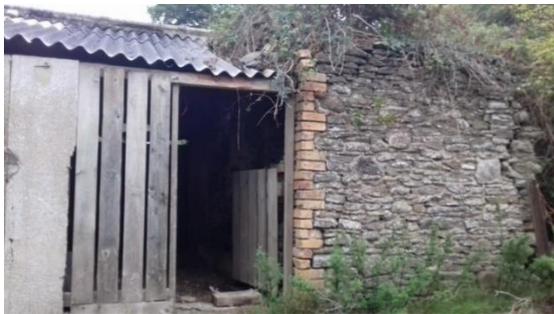
### **Photograph 11:** Building 7C

Building 7C was a stone shed building with a metal roof and vegetation growing through. There was free access to the interior of the building due to the collapsed state of the building and the metal roof was attached loosely to the masonry walls with large gaps present. The building was assessed as having a moderate potential to support roosting bats.

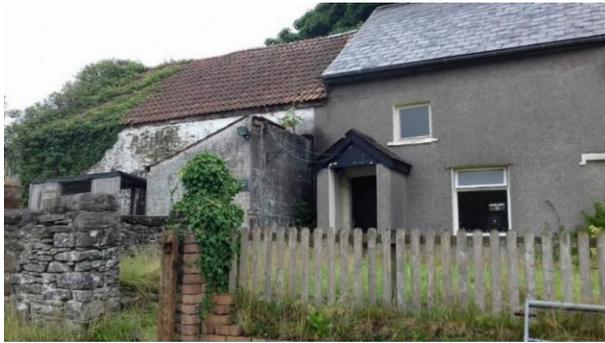
### **Photograph 12:** Building 7D

Building 7D was a 2-storey farmhouse with rendered walls, a slate roof, wooden soffits, lead flashing, a porch on the southern aspect and a chimney on the eastern end. The building was empty at the time of inspection, but the farmhouse side of the building was found to be in a fairly good condition, although there were some gaps within the slates and soffits and some of the windows had been left open. Attached to the western side of the farmhouse was a stone barn which was found to be in a state of disrepair. This section of the building had dense ivy growing from it, open windows and an open door on the western side and a large hole / missing tiles in the slate roof on the northern side. The building was therefore assessed as having an overall high potential for roosting bats.

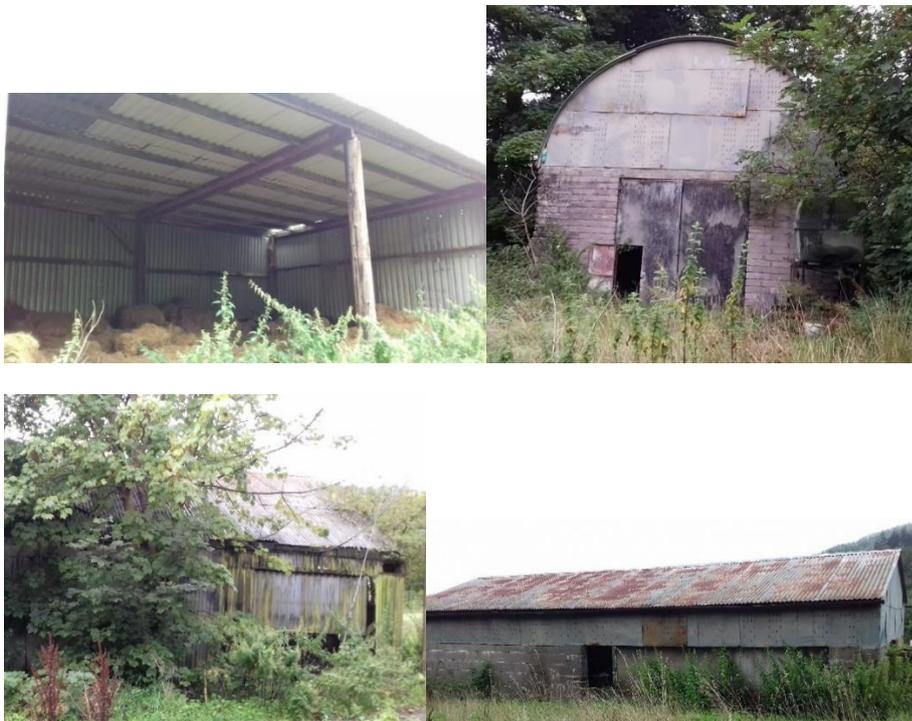
Four additional, primarily metal outbuildings were identified around the farmhouse grounds. All four buildings were assessed as having a low potential to support roosting bats.

Photographs 13, 14, 15 and 16 – Buildings 7E (top left), F (top right), G (bottom left) and H (bottom right)

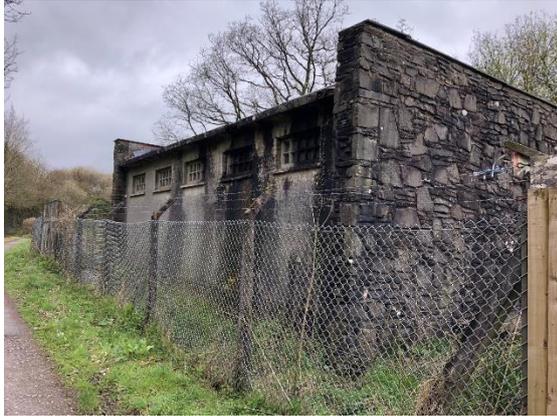
**Photograph 17:** Building 8

A detached single storey outbuilding (Building 8) which was possibly a former telephone exchange but is currently being used for storage and as housing for a small number of chickens. The building was a rendered brick construction, slate roof with clay ridges and stone features on each end. Bat droppings (likely pipistrelle and a possible brown long-eared) were identified on top of debris within the building. The open door at the north-western end of the building meant that bats could be using the building as a night perch. The building was assessed as having a high potential for roosting bats.

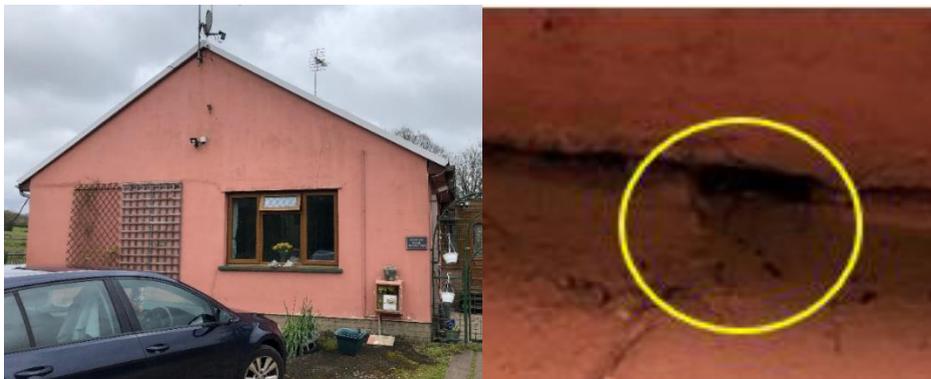
Building 9 is a likely 1970's detached single-storey occupied bungalow. The brick building had rendered walls, convex tile roof and solar panels on the western elevation. The windows and doors were PVC and the fascia's, soffits and gables were timber. A single bat dropping was identified stuck to the wall on the eastern side of the building. The building was assessed as having a high potential for roosting bats.

Photographs 18 and 19: Buildings 9 and bat dropping identified during assessment survey

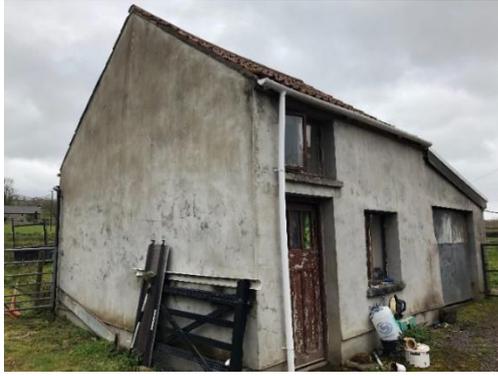
**Photograph 20:** Building 9A

Building 9A was a 2-storey stone building with a pitched, tiled roof and timber framed windows. Many suitable roosting features including gaps underneath the roof tiles and open windows providing access into the building resulted in an assessed of high potential for roosting bats.

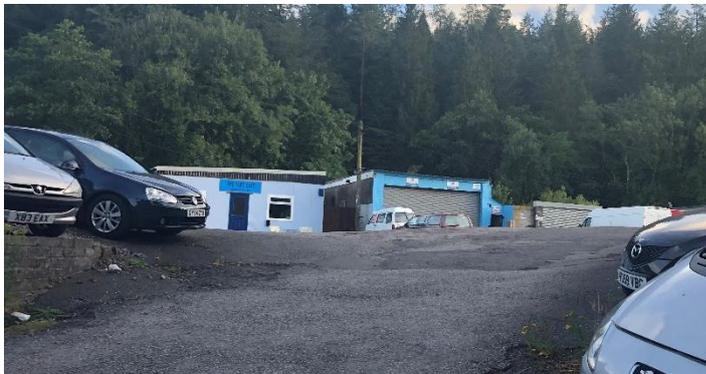
**Photograph 21:** Building 10

Several small single-storey, pre-fabricated commercial units and garages including a café, car repair and salvage businesses offered negligible potential for roosting bats due to the lack of potential features.

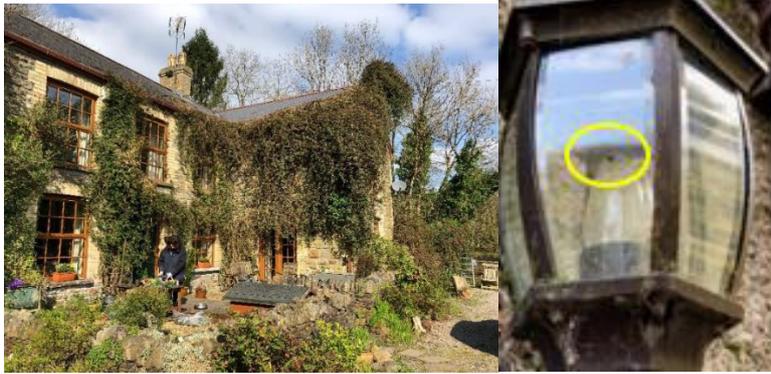
**Photographs 22 and 23:** Building 11 and bat dropping identified during assessment (circled in yellow)

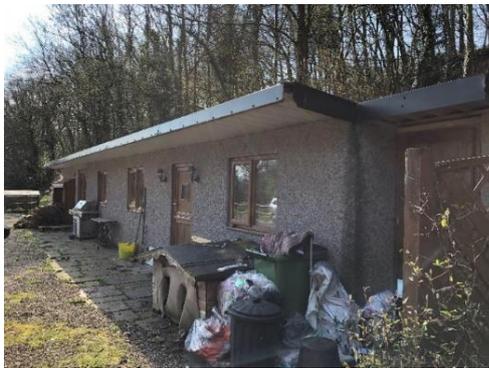
**Photograph 24:** Building 11A

Building 11A was an outbuilding associated with Signalman’s Cottage. It was a single storey block-built building with UPVC windows and doors and slate sheet roof. The building was assessed as having a low potential for roosting bats.

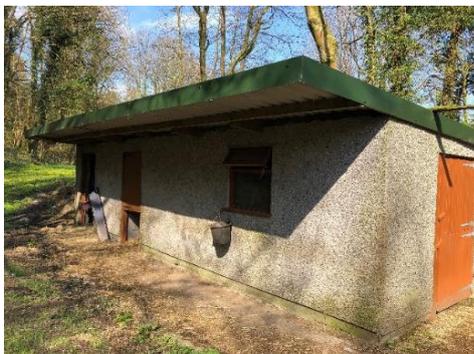
**Photograph 25:** Building 11B

Building 11B was a stable building to the north the Signalman’s Cottage. It was a block-built, single skin, one-storey building with a steel-sheet roof. The building was assessed as having a negligible potential for roosting bats.

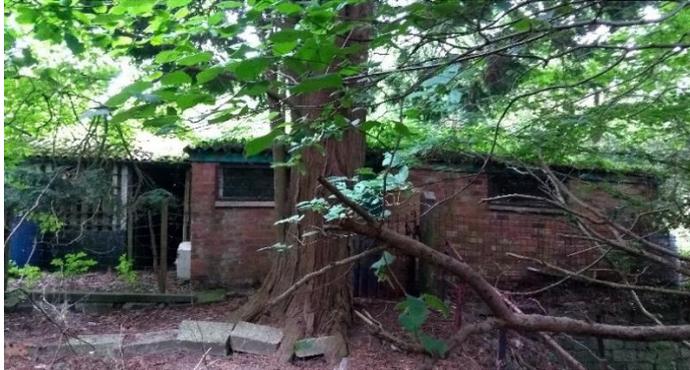
**Photograph 26 – Building 12**

building was a single-story brick (partially rendered) structure with glass windows often covered by metal guards and a corrugated asbestos roof. The closed eastern side of the building had wooden soffits and a brick chimney. Potential access points included open wooden doors, broken windows, gaps underneath ridge tiles and behind soffit boards. The building was assessed as having high potential for roosting bats.

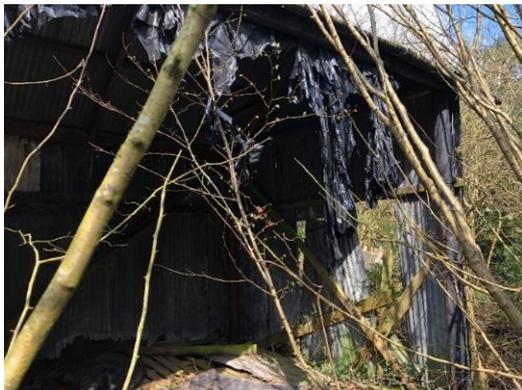
**Photograph 27 – Building 13**

A derelict barn (Building 13) was noted behind the derelict outbuilding Building 12. The barn was a metal construction and was completely open on the southern side. The barn was assessed as having negligible roosting potential but could be used for feeding / shelter during the night. The building was not in use and was surrounded by dense scrub.

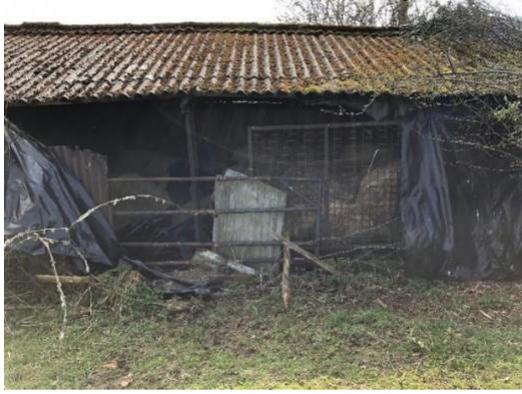
**Photograph 28 – Building 14**

A hay barn (Building 14) was noted within farmland to the north-west of Building 12. The barn was a metal construction and negligible roosting potential but could be used for feeding and/or shelter during the night.

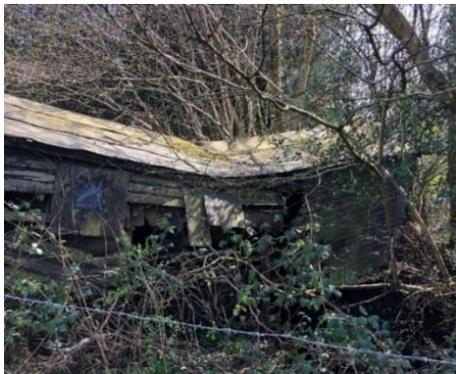
Three wooden sheds (Building 15) were noted within an agricultural field to the along the eastern side of the carriageway, above Culvert 3. The sheds were in a state of disrepair and had **negligible** potential for roosting bats.

**Photograph 29:** Wooden shed (Building 15) located over the eastern entrance of Culvert 3

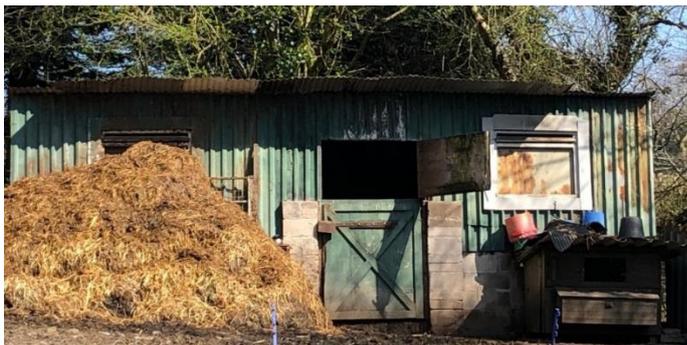
**Photograph 30:** Building 16

A metal stable block (Building 16) was noted within a pig-grazed field adjacent to the water treatment plant and within 10 m of the A4119. The building had negligible potential to support bat roosts.

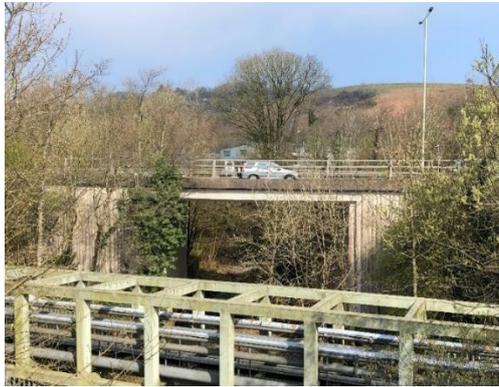
#### **Photograph 31 – Bridge 1**

The A4119 crosses the River Ely immediately north of the Coed Ely roundabout. The bridge was a concrete slab construction with no obvious roosting features visible. The bridge was assessed as having negligible bat roosting potential but due to the presence of the surrounding high-quality habitats (e.g. woodland, River Ely) for commuting and foraging routes for bats it is likely that bats will be active in the vicinity of the bridge.

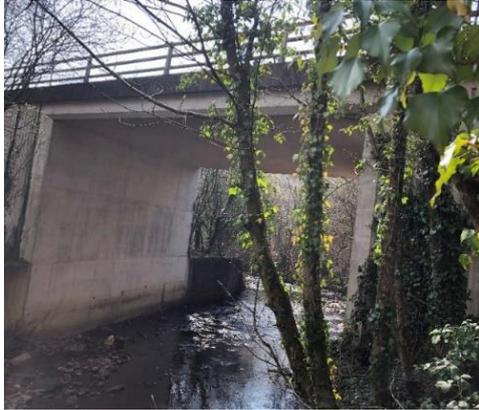
#### **Photograph 32: Bridge 2**

An un-named road leading to a large area of colliery spoil crosses over the River Ely to the west of the Coed Ely roundabout. The bridge was a concrete slab construction with no obvious roosting features visible. The bridge was assessed as having negligible bat roosting potential but due to the presence of the surrounding high-quality habitats (e.g. woodland, river) it is likely to offer suitable commuting and foraging routes for bats it is likely that bats will be active in the vicinity of the bridge.

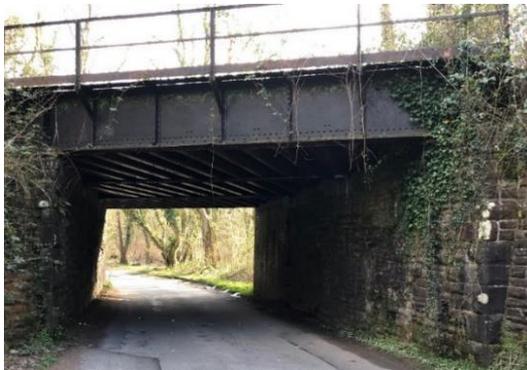
**Photograph 33:** Bridge 3

A bridge located over Smilog Road was noted to the north-west of the Scheme. The bridge had masonry and brick walls and a steel deck. The underneath of the structure was found to be in a good condition, but the wing-walls had small, shallow gaps and crevices with some light ivy cover. The bridge was assessed as having an overall low potential for roosting bats.

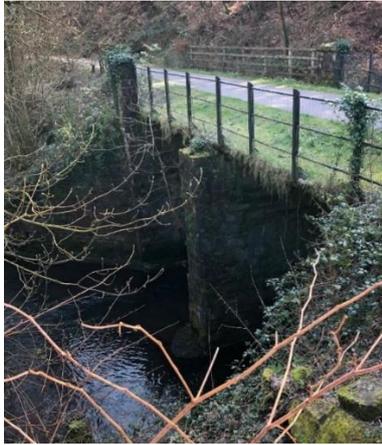
**Photograph 34:** Bridge 4

This was a two-span masonry bridge carrying a public footpath over the River Ely. A number of gaps between the masonry block work of the abutments and supporting pillars and between the metal deck and supporting pillars / abutments were noted by surveyors, but the underneath of the structure could not be directly accessed due to the steep embankments either side.

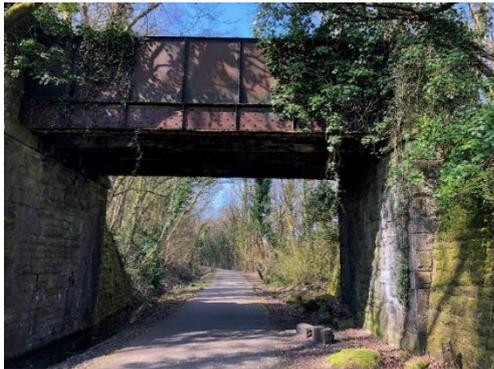
**Photograph 35:** Bridge 5

A former railway bridge crossing over a cycle path was noted to the south-west of the Fire and Rescue Headquarters roundabout. The bridge was a stone construction with a metal deck. The stonework was found to be in a good condition and the pointing was in good order, however, the associated wing-walls had some small shallow gaps and weep-holes. The backs of the bearing shelves underneath the deck could not be seen by the surveyors but could potentially offer night-feeding perches for species such as lesser horseshoe bats. The location of the bridge is likely to increase the suitability for bats due to it being a 'pinch-point' along the wooded cycle-path and within 25 m of the River Ely. The bridge was assessed as having low suitability for roosting bats.

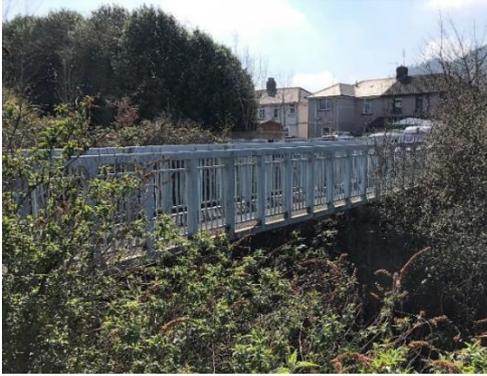
**Photograph 35:** Bridge 6

A small metal footbridge over the River Ely to the south of the Scheme was noted. The bridge was assessed as having negligible potential for roosting bats due to the steel construction and lack of suitable features. Bats are highly likely to be foraging and commuting underneath (along the River Ely) and there was potential for roosting within the reinforced sections of the river walls.

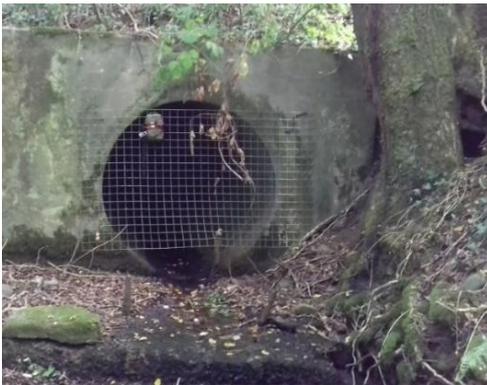
**Photograph 36:** Western entrance of Culvert 1

The most northern culvert (Culvert 1) comprised brick construction on the eastern side and concrete construction on the western side. It was approximately 1 m in diameter. The culvert had mesh fitted over the western entrance which had been put in place by the landowner to prevent their dogs escaping through it. The culvert had negligible potential for roosting bats due to the lack of suitable features and the presence of the mesh guard.

The existing culvert will need to be opened (currently covered with a wire mesh to prevent dogs accessing it) and widened to at least 3 x 3 m. This will provide a dark corridor for lesser horseshoe bats and other bats known to be roosting in buildings nearby (pipistrelles, brown long-eared) due to the existing tree line / connecting woodland and hedgerows. A 4.5 x 4.5 m would be more likely to be used by pipistrelle bats, but as this species is more likely to cross the road at height it is considered less vulnerable than other species. Bats (including lesser horseshoes) will need to be channelled to this location through vegetation and/or fencing.

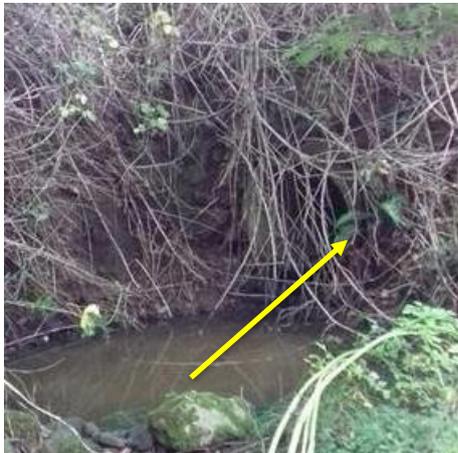
**Photograph 38:** Western entrance of Culvert 2 (entrance identified with yellow arrow)

Culvert 2 was a small (approximately 600 mm) pipe running underneath the A4119. The stream bed leading to the culvert slopes from east to west and was either shallow or dry dependent on the time of year.

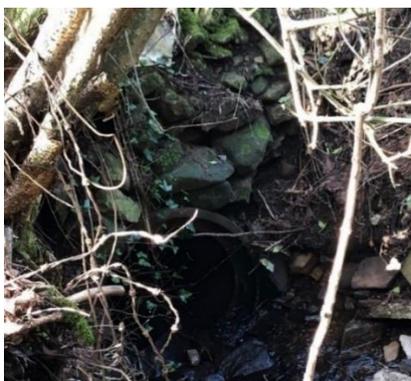
**Photograph 39:** Eastern entrance of Culvert 3

A concrete culvert was located underneath the A4119 to the north of the Dwr Cymru Welsh Water compound. An un-named stream runs through the culvert from agricultural fields on the northern side of the carriageway to a sloped valley between a privately-owned pig grazed field and the boundary fence of the water treatment plant. The culvert was approximately 0.5 m in diameter. The eastern side of the culvert has associated brick walls along the water channel which were found to be in a state of disrepair. Old derelict 'shed' buildings and other farmland debris (see Photograph 29) were located on top of the culvert at this location. The concrete culvert running underneath the road was found to have a negligible potential for roosting bats, but the associated brick walls were assessed as low potential.

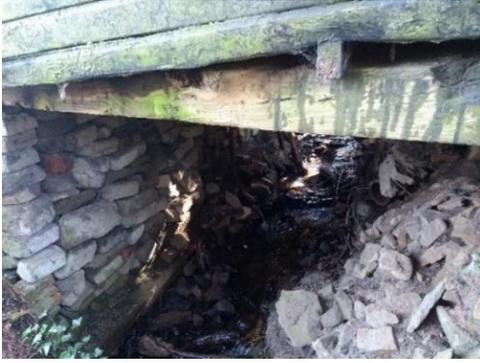
**Photograph 40:** Stone walls associated with the eastern entrance of Culvert 3 (note Building 15 located on top)

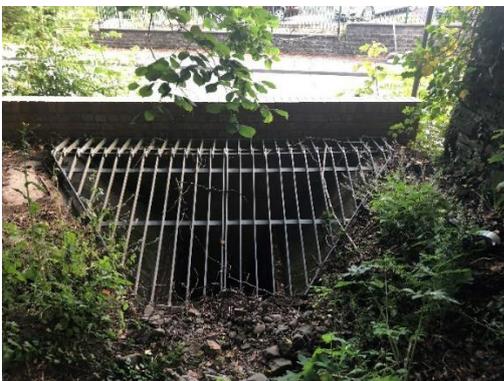
**Photograph 42:** Metal gate over dry culvert on eastern side of the carriageway

A dry culvert (Culvert 4) was located to the south of the Scheme.

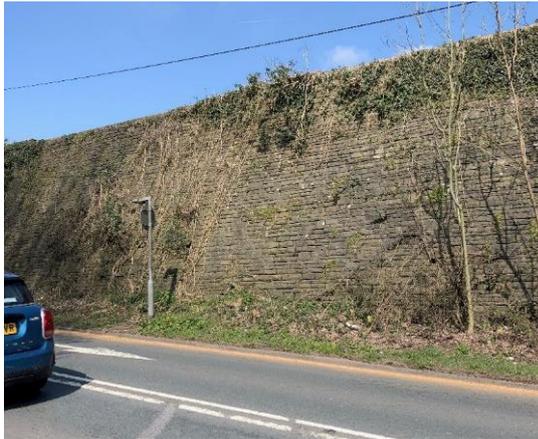
**Photograph 43:** Retaining wall (Wall 1)

A brick retaining wall (Wall 1) was located along the eastern carriageway towards the southern end of the scheme. The retaining wall had numerous gaps (particularly at the most northern end where it was in a state of disrepair) but was situated directly adjacent to the A4119. The saplings growing in front of the structure is likely to restrict access and constant heavy traffic flow cause disturbance and present risk for emerging bats. The retaining wall was therefore assessed as having low bat roosting potential.

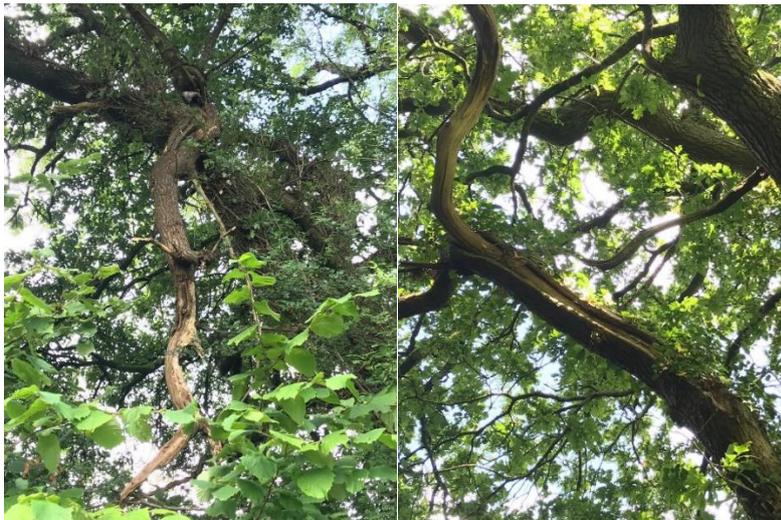
**Photographs 44 and 45:** Oak trees (Trees 2 and 5 respectively) with moderate roosting potential

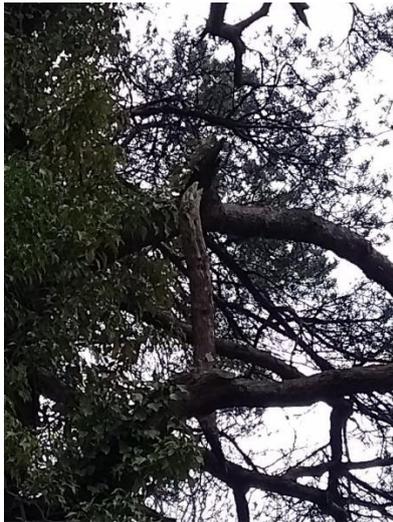
Two mature trees (Trees 7 and 8) were identified either side of the entrance to the Dwr Cymru Welsh Water owned land on the eastern side of the A4119. Both trees had ivy coverage, Tree 7 had a knot hole approximately 10m high and small splits in the bark and Tree 8 had a broken limb at approximately 15m high. Both trees were assessed as having low potential to support bat roosts.

**Photograph 46** – Scot's pine (Tree 7) with low bat roost potential

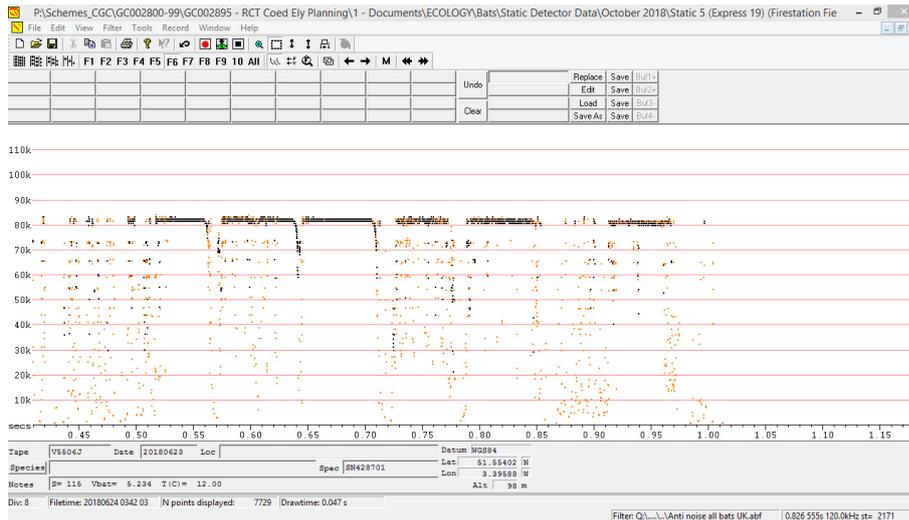
Figure 3: Sonogram of the greater horseshoe bat call on Analoow software.

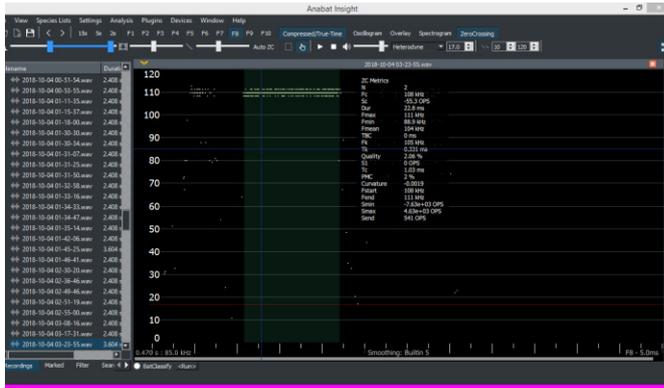
Figure 4: Lesser horseshoe sonogram Static 6 using Anabat Insight software

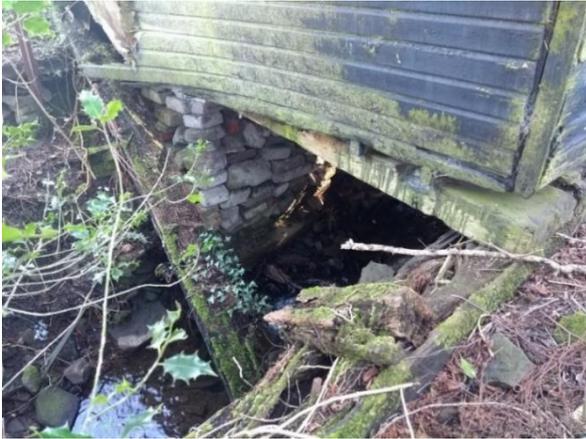
Photograph 2: Existing culvert to the north of the Welsh Water Compound (taken from the eastern side of the A4119)

There is an existing culvert on the same vegetation lines as the identified lesser horseshoe roost in Building 12. Two emergence surveys were carried out by Capita ecologists in 2018 on Culvert 3 and the associated stone wall but only a limited amount of bat activity was recorded (common and soprano pipistrelles only) (it is likely surveyors did not identify lesser horseshoes due their directional calls as they have otherwise been recorded regularly in this area).

Due to the close location of the lesser horseshoe recordings including the two known roosts (Buildings 7D and 12) it is considered, that this is the optimum location for the underpass / crossing point for this species. The culvert would need to be cleared as it is partially covered by farmland debris including an old shed building and a 3 x 3 m box culvert installed. The bats will need to be channelled to this location through earthworks, vegetation and/or fencing.

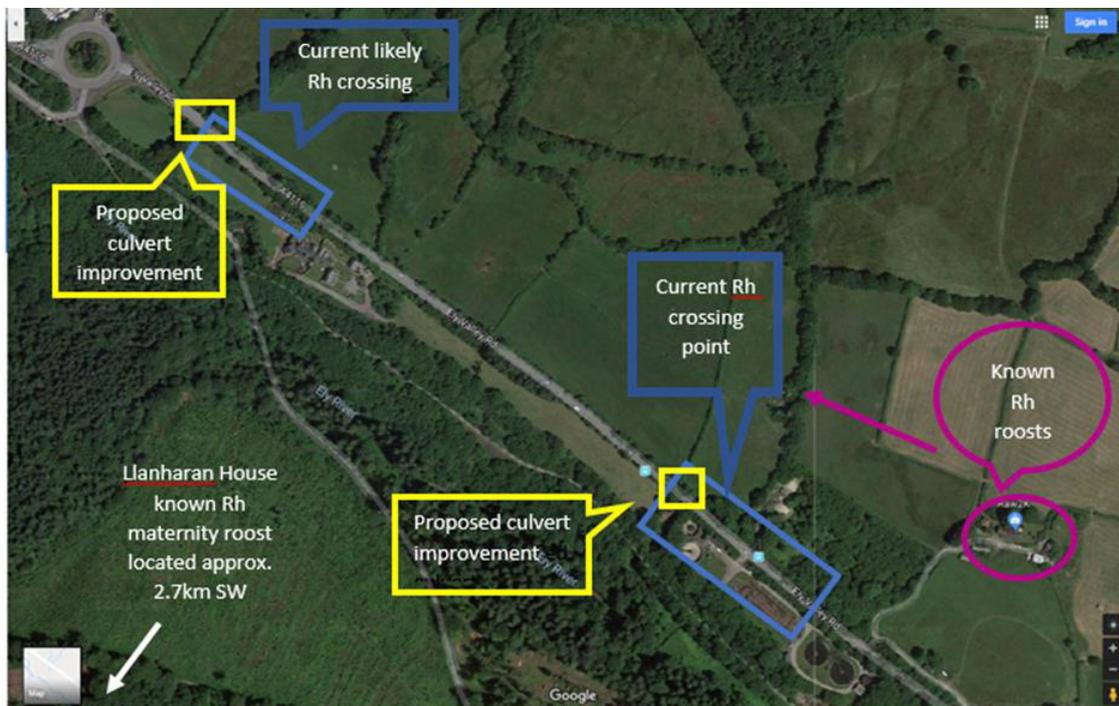
The locations of the proposed culvert improvements in relation to the Scheme and the existing lesser horseshoe bat crossing points are illustrated in Figure 5.

Figure 5: Aerial map illustrating the locations of existing and proposed crossing points (and known lesser horseshoe (Rh) roost locations).

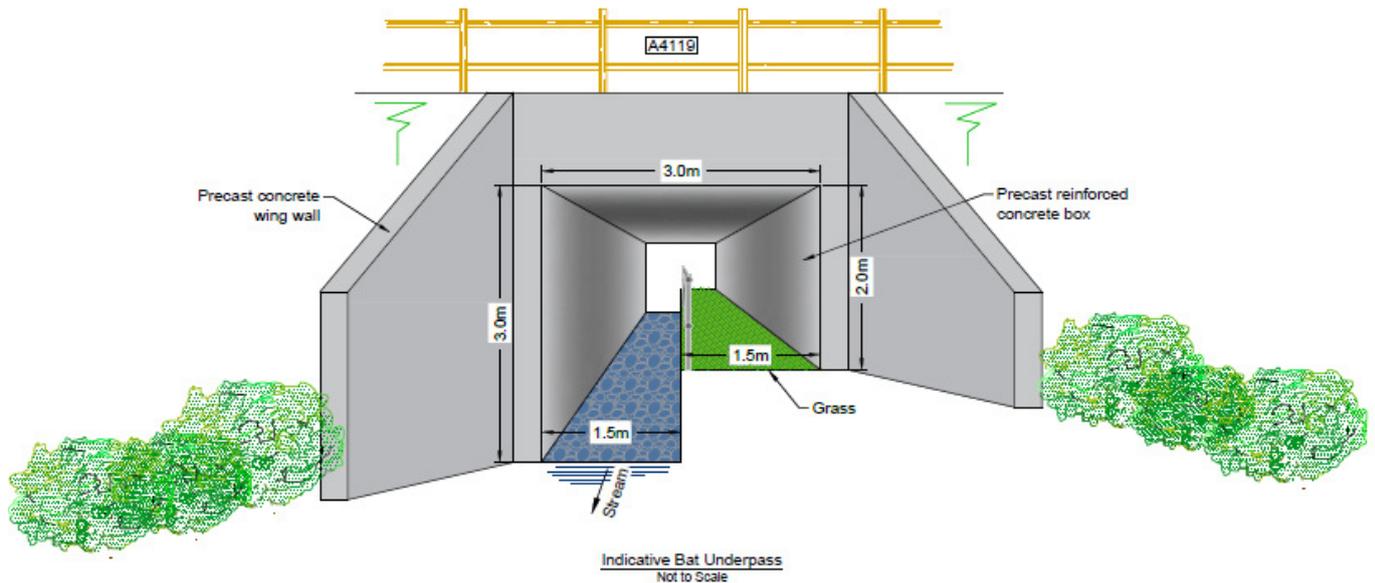
Figure 6: Indicative design for bat underpasses running underneath the A4119.
