COED ELY A4119 DUALLING PLANNING DORMOUSE SURVEY

Doc Ref: GC2895-RED-30-XX-RP-L-006

Coed Ely A4119 Dualling Planning

Dormouse Survey

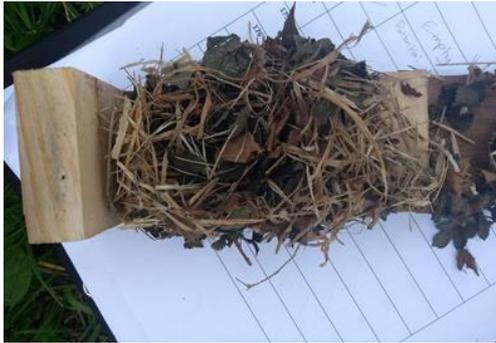
Photograph 1: Dormouse nest recorded, grid ref: ST0315685072, in August 2019

Two suspected dormouse nests were recorded in the third tube check in July 2018, but both were in early stages of building and therefore positive identification was not possible at this stage. The records were located within the same hedge, bordering an agricultural field on the north side of the A4119, at a distance approximately 350 m from the existing carriage way. These nests were present in the nest tubes in subsequent visits in August and September 2018 and were fully constructed with shredded plant material and green leaves and were confirmed as unoccupied dormouse nests (shown in Photograph 1).

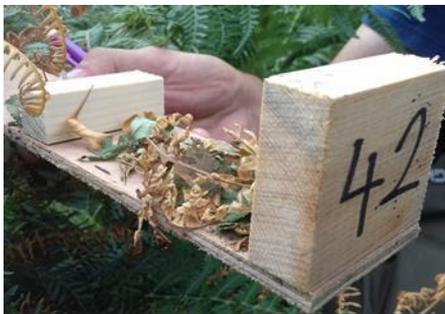
Photograph 2: Start of probable dormouse nest, grid reference: ST0254185173, August 2018

A further nest was identified in a tube (see Photograph 2) approximately 60 m north east of the A4119 carriage way during the fourth tube check in August 2018. The tube contained green leaves and shredded plant material and was considered to probably be the early stages of a dormouse nest. The nesting material was still present in the tube at the time of the fifth tube check in September 2018, but construction had not progressed any further and a definite identification of dormouse nest was not possible.

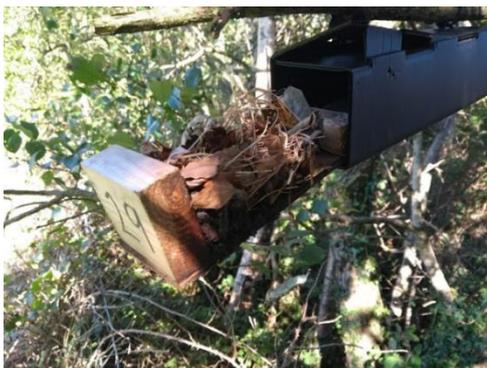
Photograph 3: A dormouse nest constructed of shredded plant material and green leaves in nest tube 29, September 2018

During the fifth tube check on September 2019 two further nests were recorded. A dormouse nest constructed of shredded plant material and green leaves was recorded in nest tube 29 (see Photograph 3), approximately 150 m from road and a probable dormouse nest, constructed of shredded plant material in nest tube 107, an approximate distance of 230 m from the road (see Photograph 4).

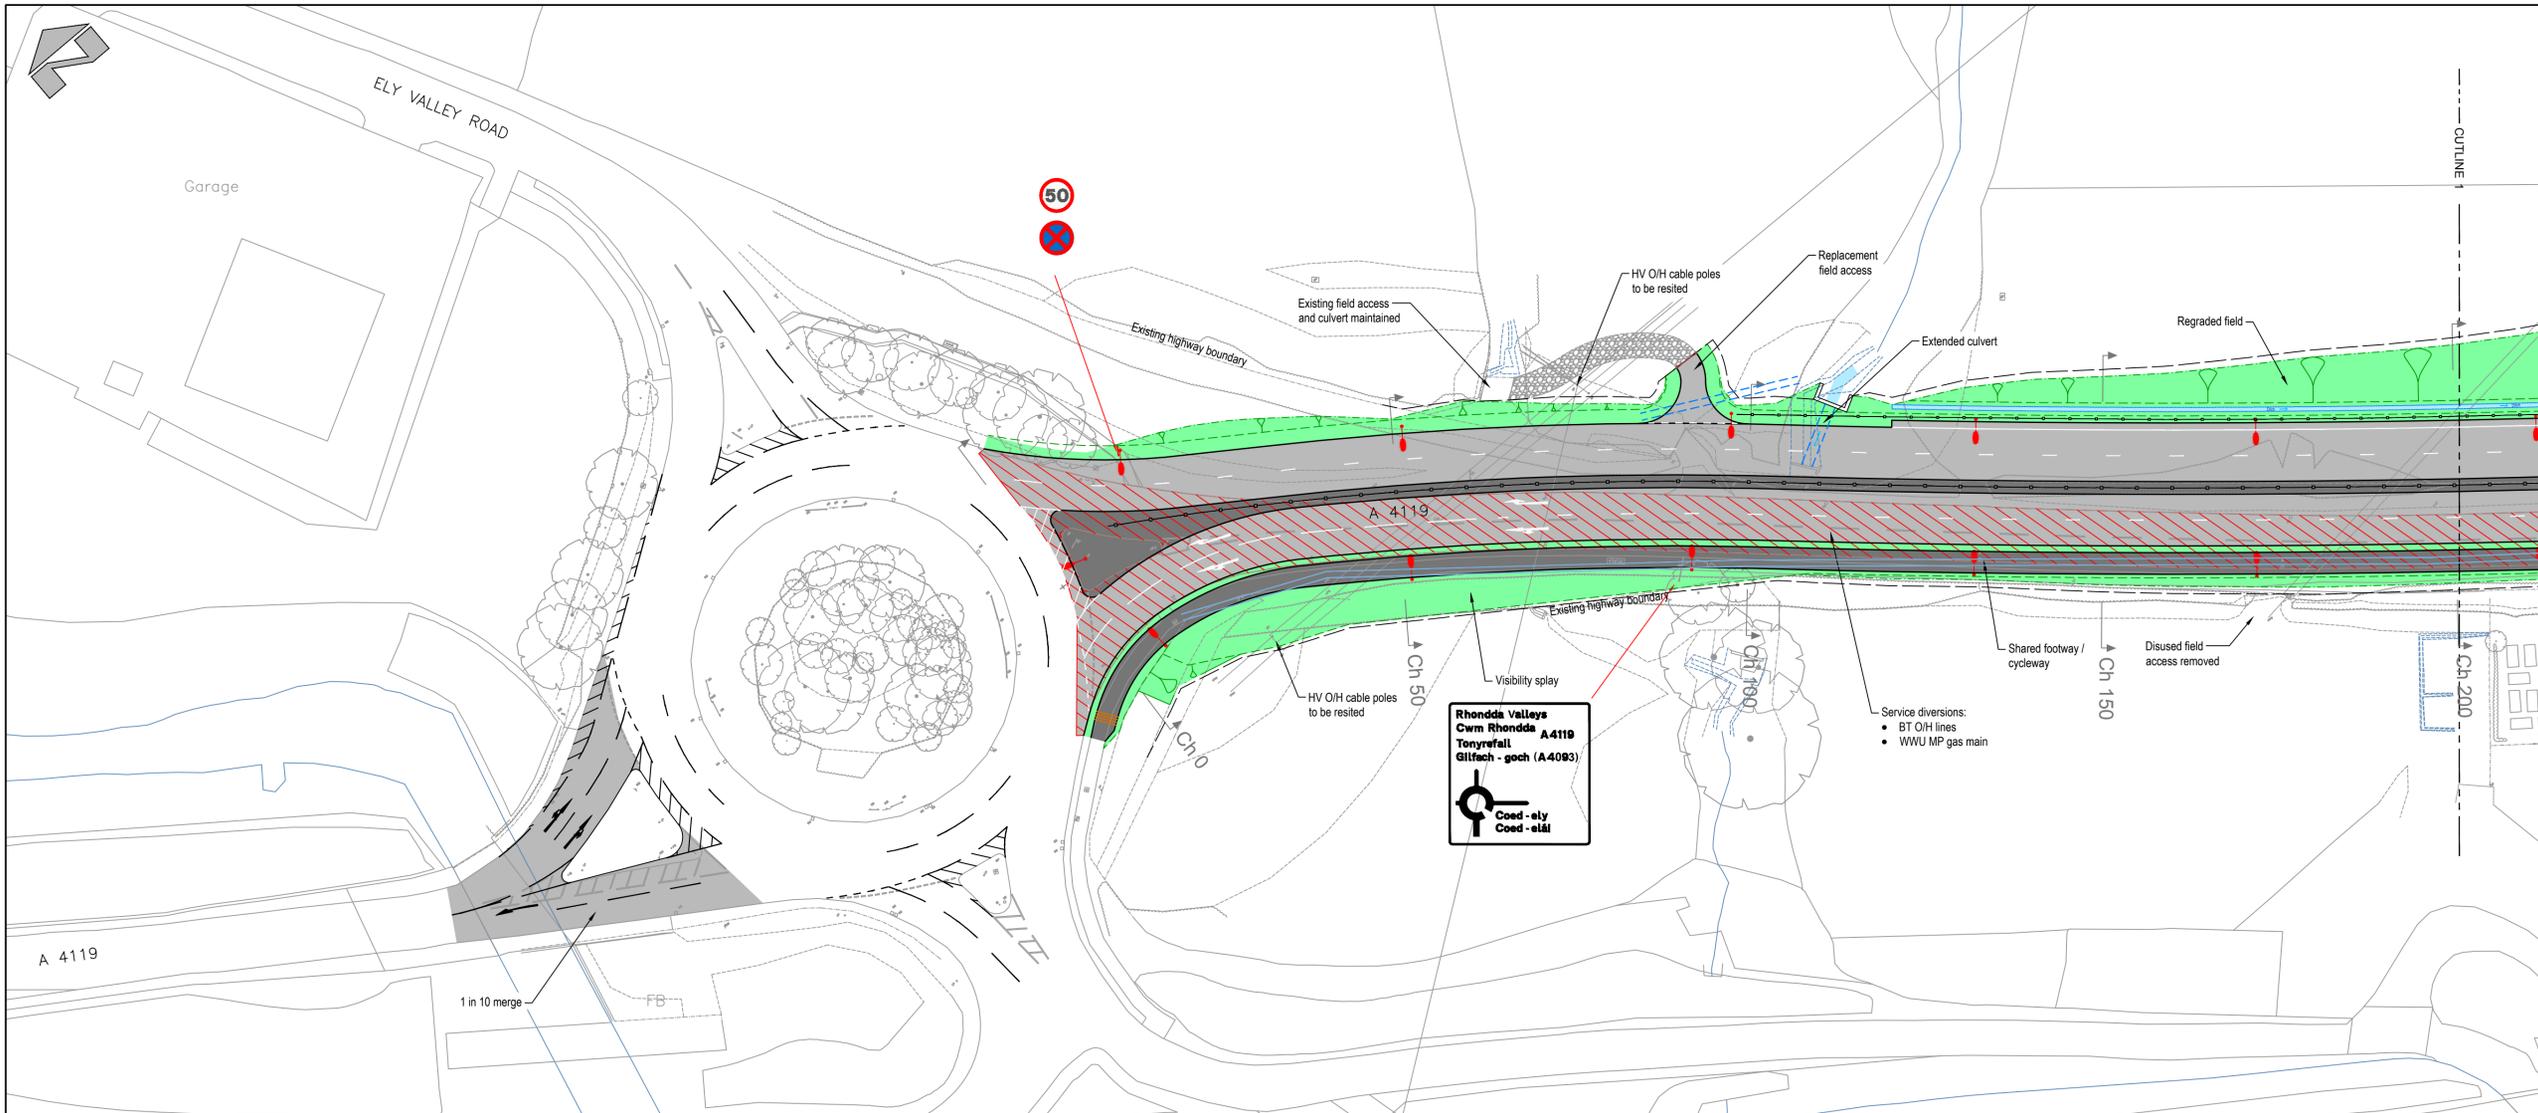
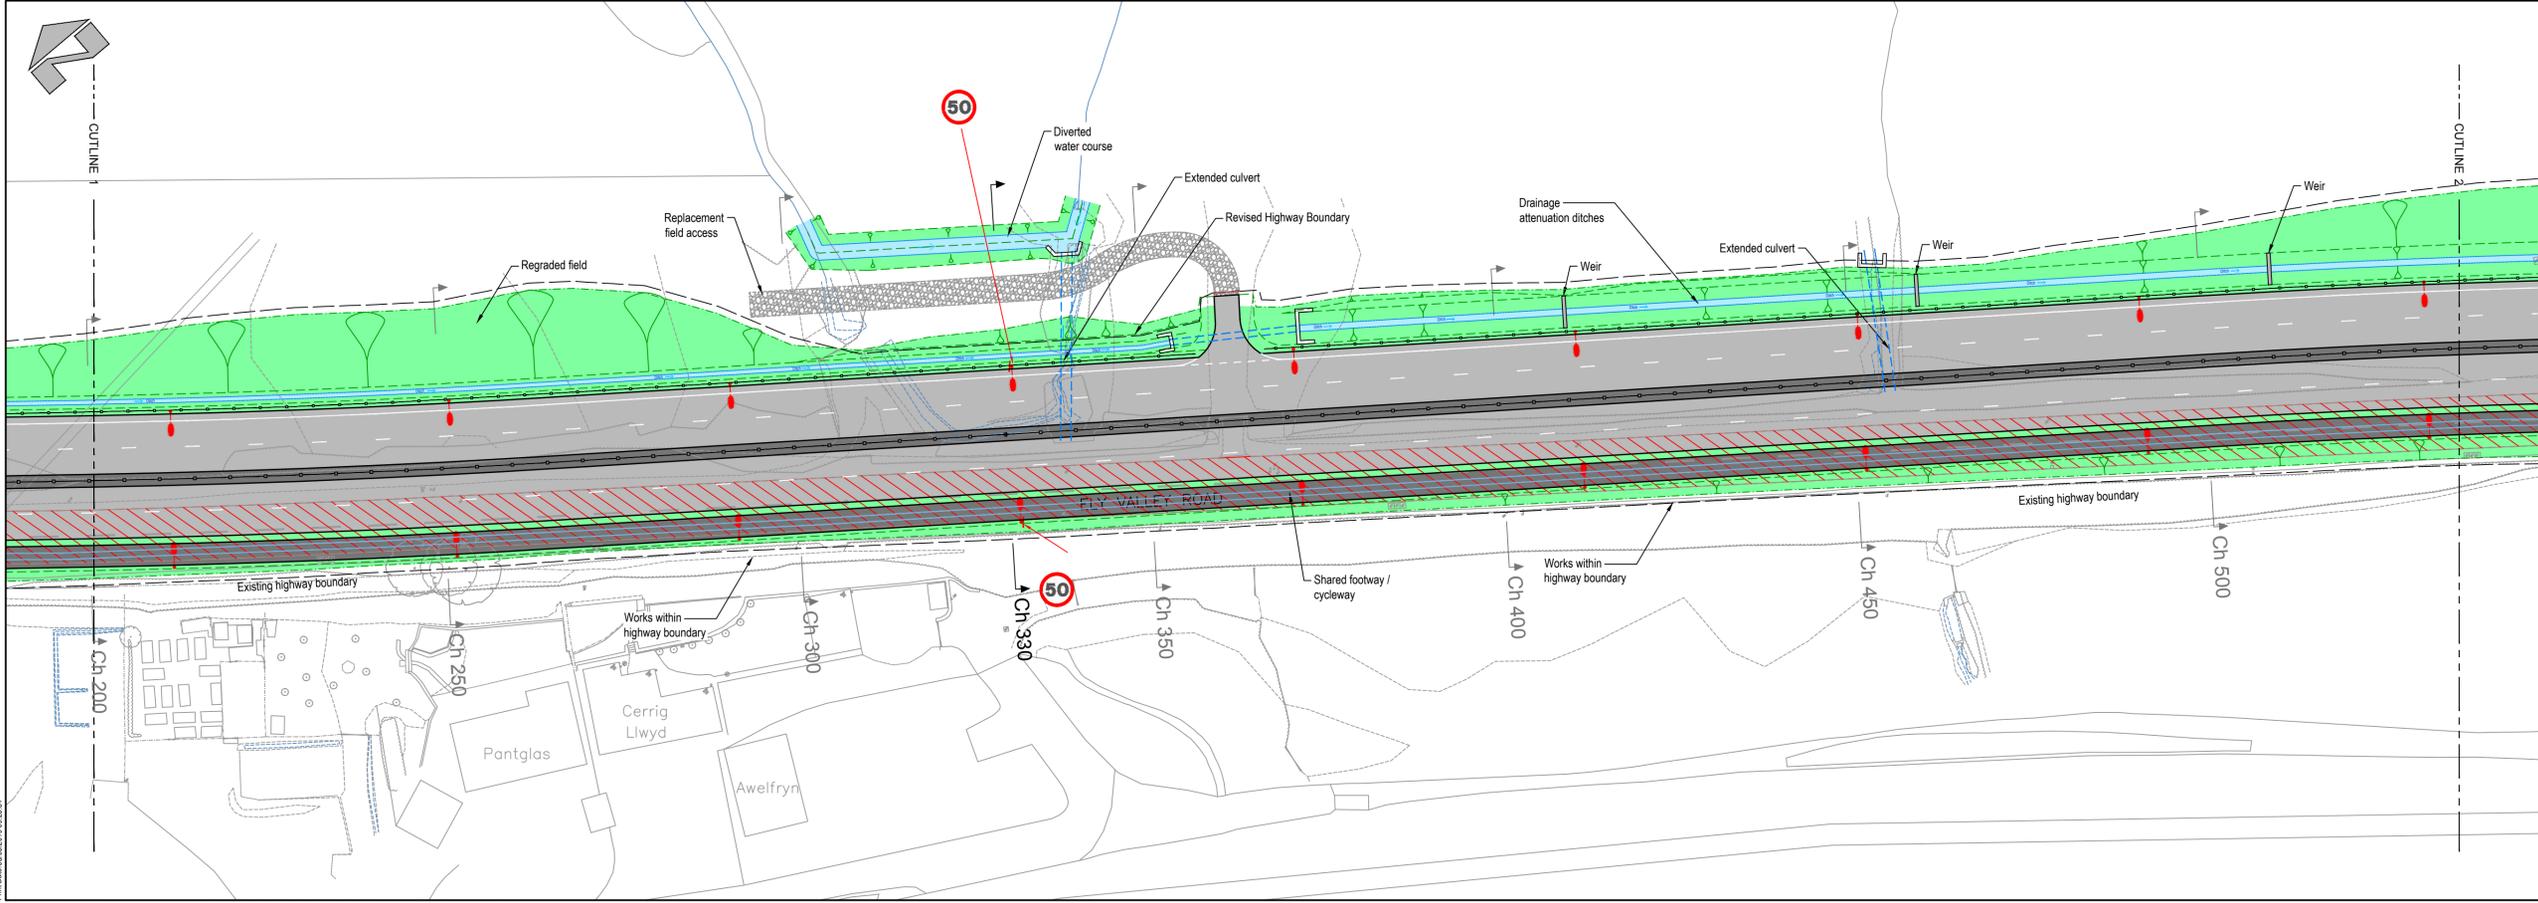
Drawing
**Planning Application
General Arrangement
(Sheet 1 of 3)**

- Widening the existing carriageway from a single carriageway to dual carriageway. This will be achieved by both online and offline widening.
- Site Clearance – To facilitate the widening, site clearance will need to take place on both sides of the existing road.
- Associated drainage and infrastructure works.

The proposed scheme is shown on the general arrangement Drawing GC2895-RED-61-XX-DR-C-102 – 104.

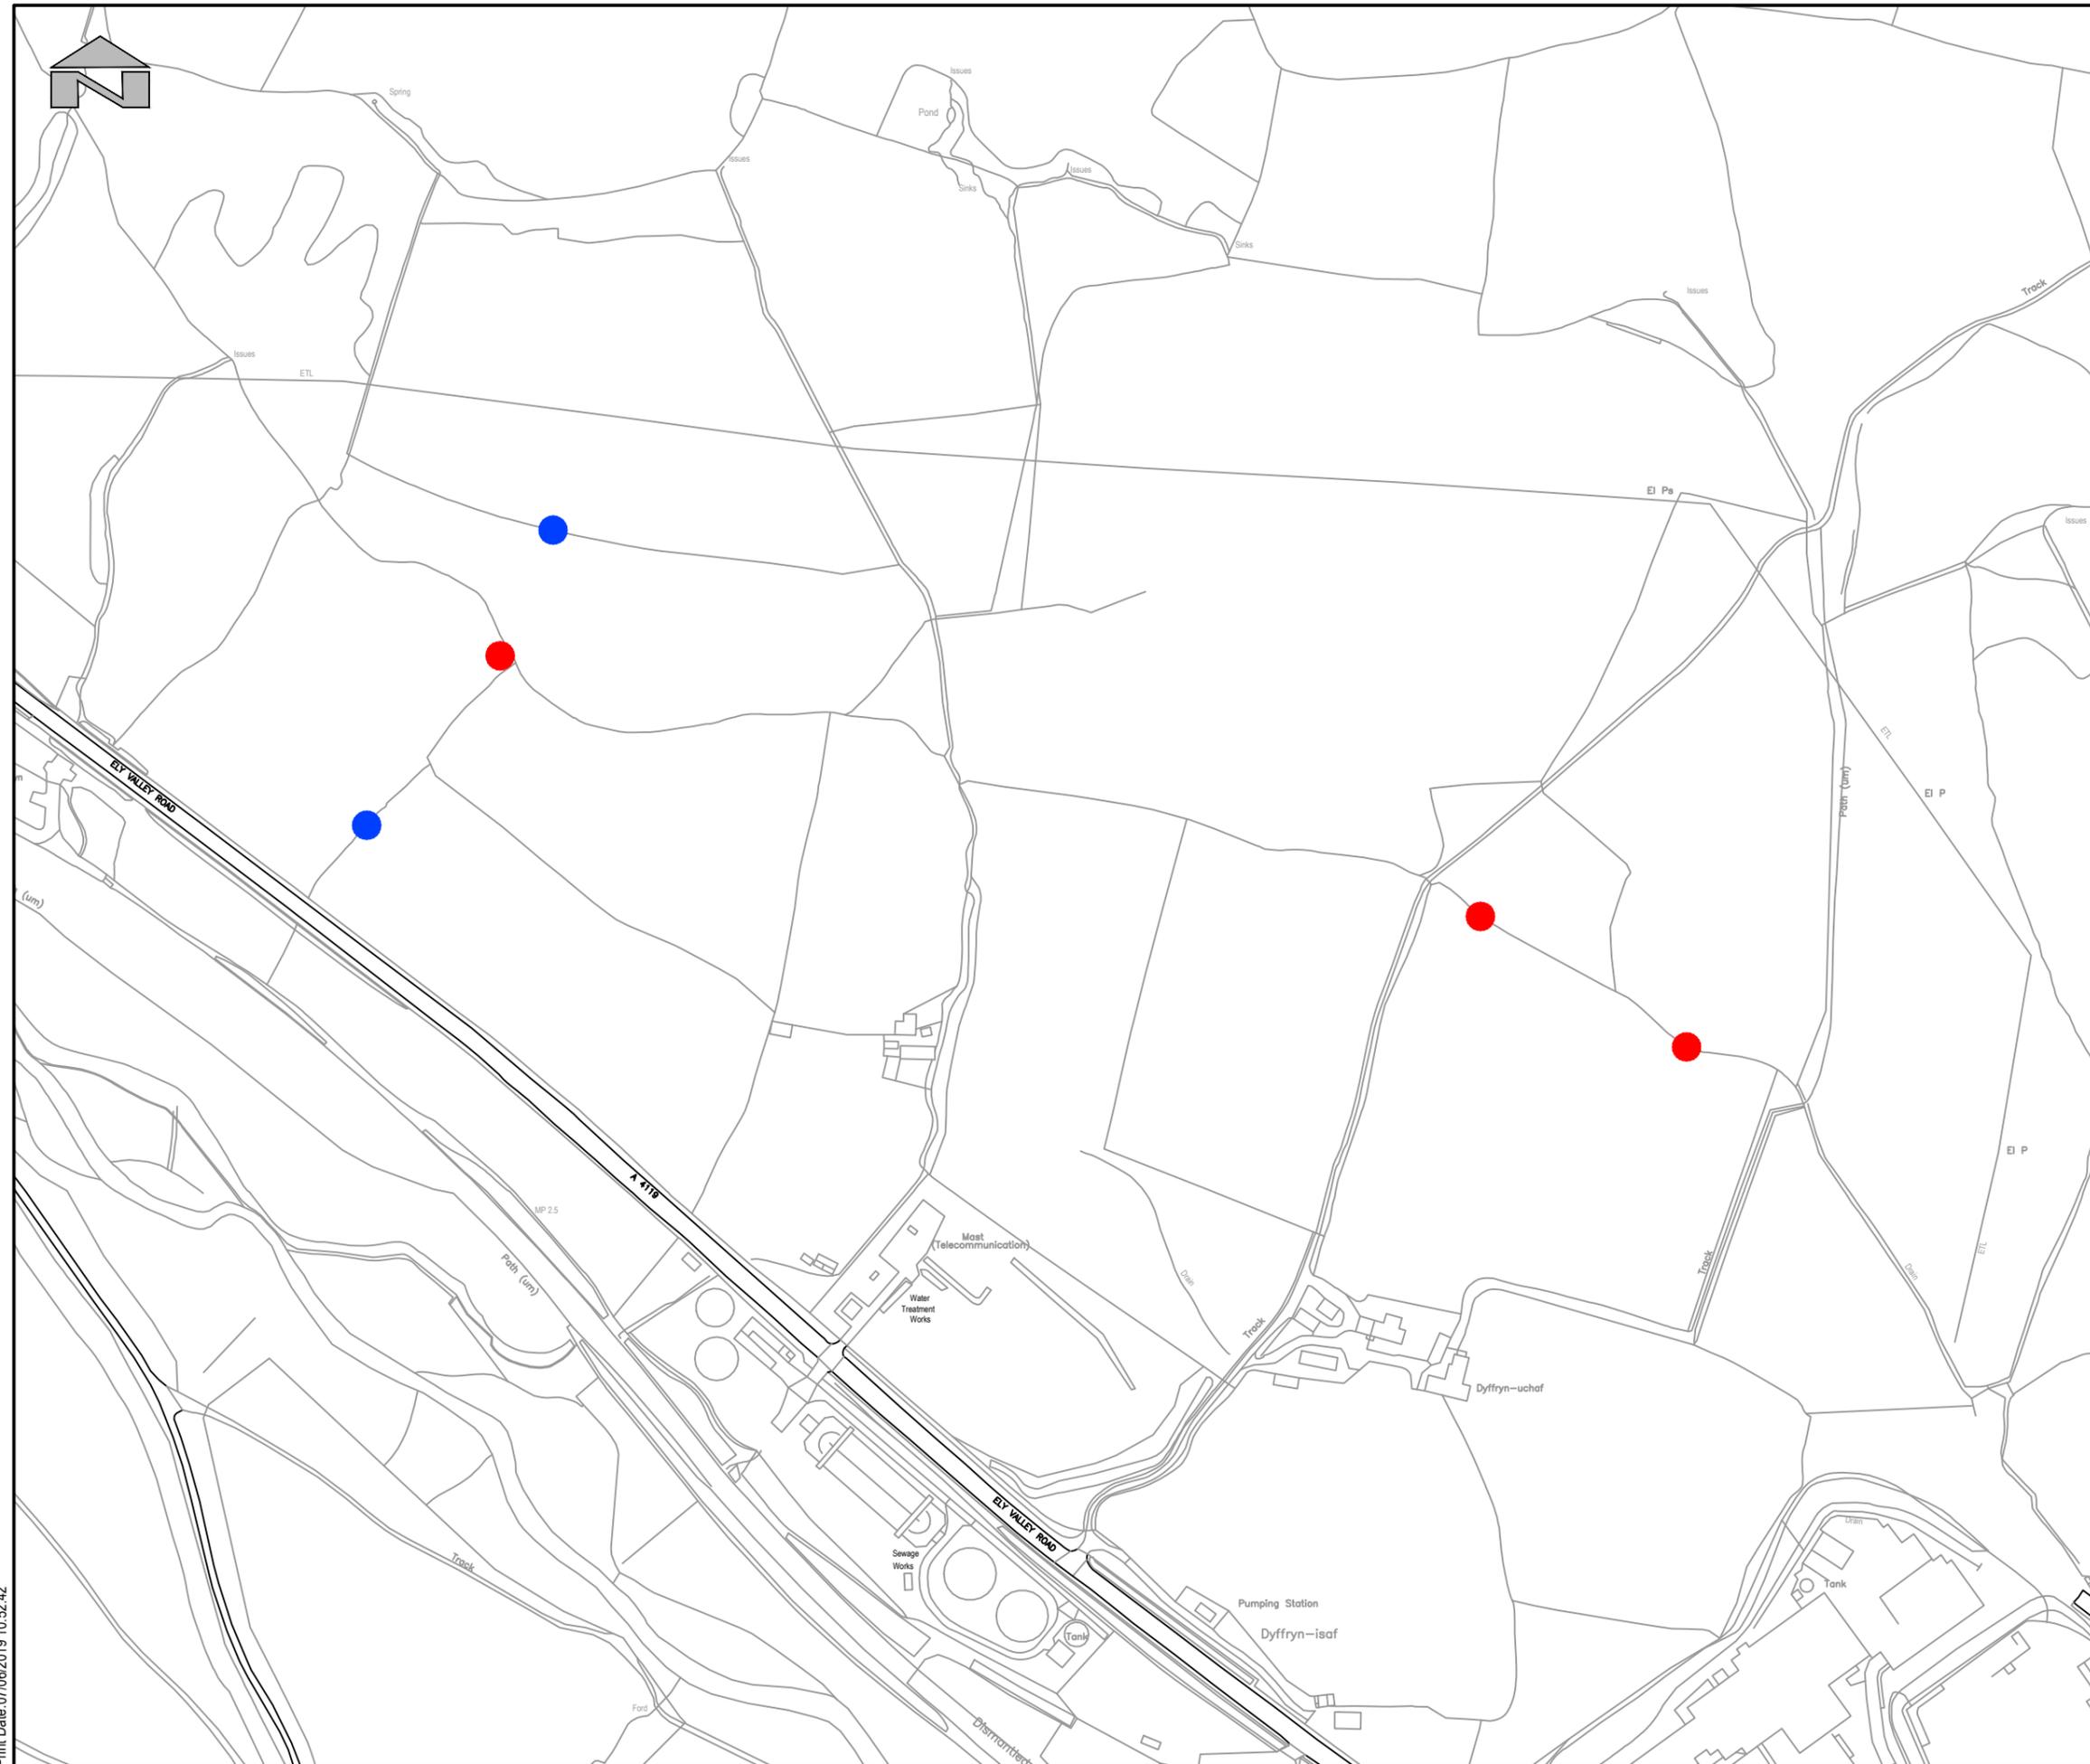
Drawing
Dormouse Survey Results

All locations of dormouse nests and probable dormouse nests are shown on Drawing GC2895-RED-74-XX-DR-C-0024. The confirmed dormouse nests were between 150 – 350 m from the road, and one of the two probable nests recorded was much closer, at approximately 60 m from the carriageway.

- Dormouse Nest
- Probable Dormouse Nest

Evidence of dormouse was identified within the hedges to the north of the A4119, with three dormouse nests and two probably dormouse nests being recorded during the survey. The dormouse nests were between 150 – 350 m from the road, and one of the two probable nests recorded was much closer, at approximately 60 m from the carriageway.

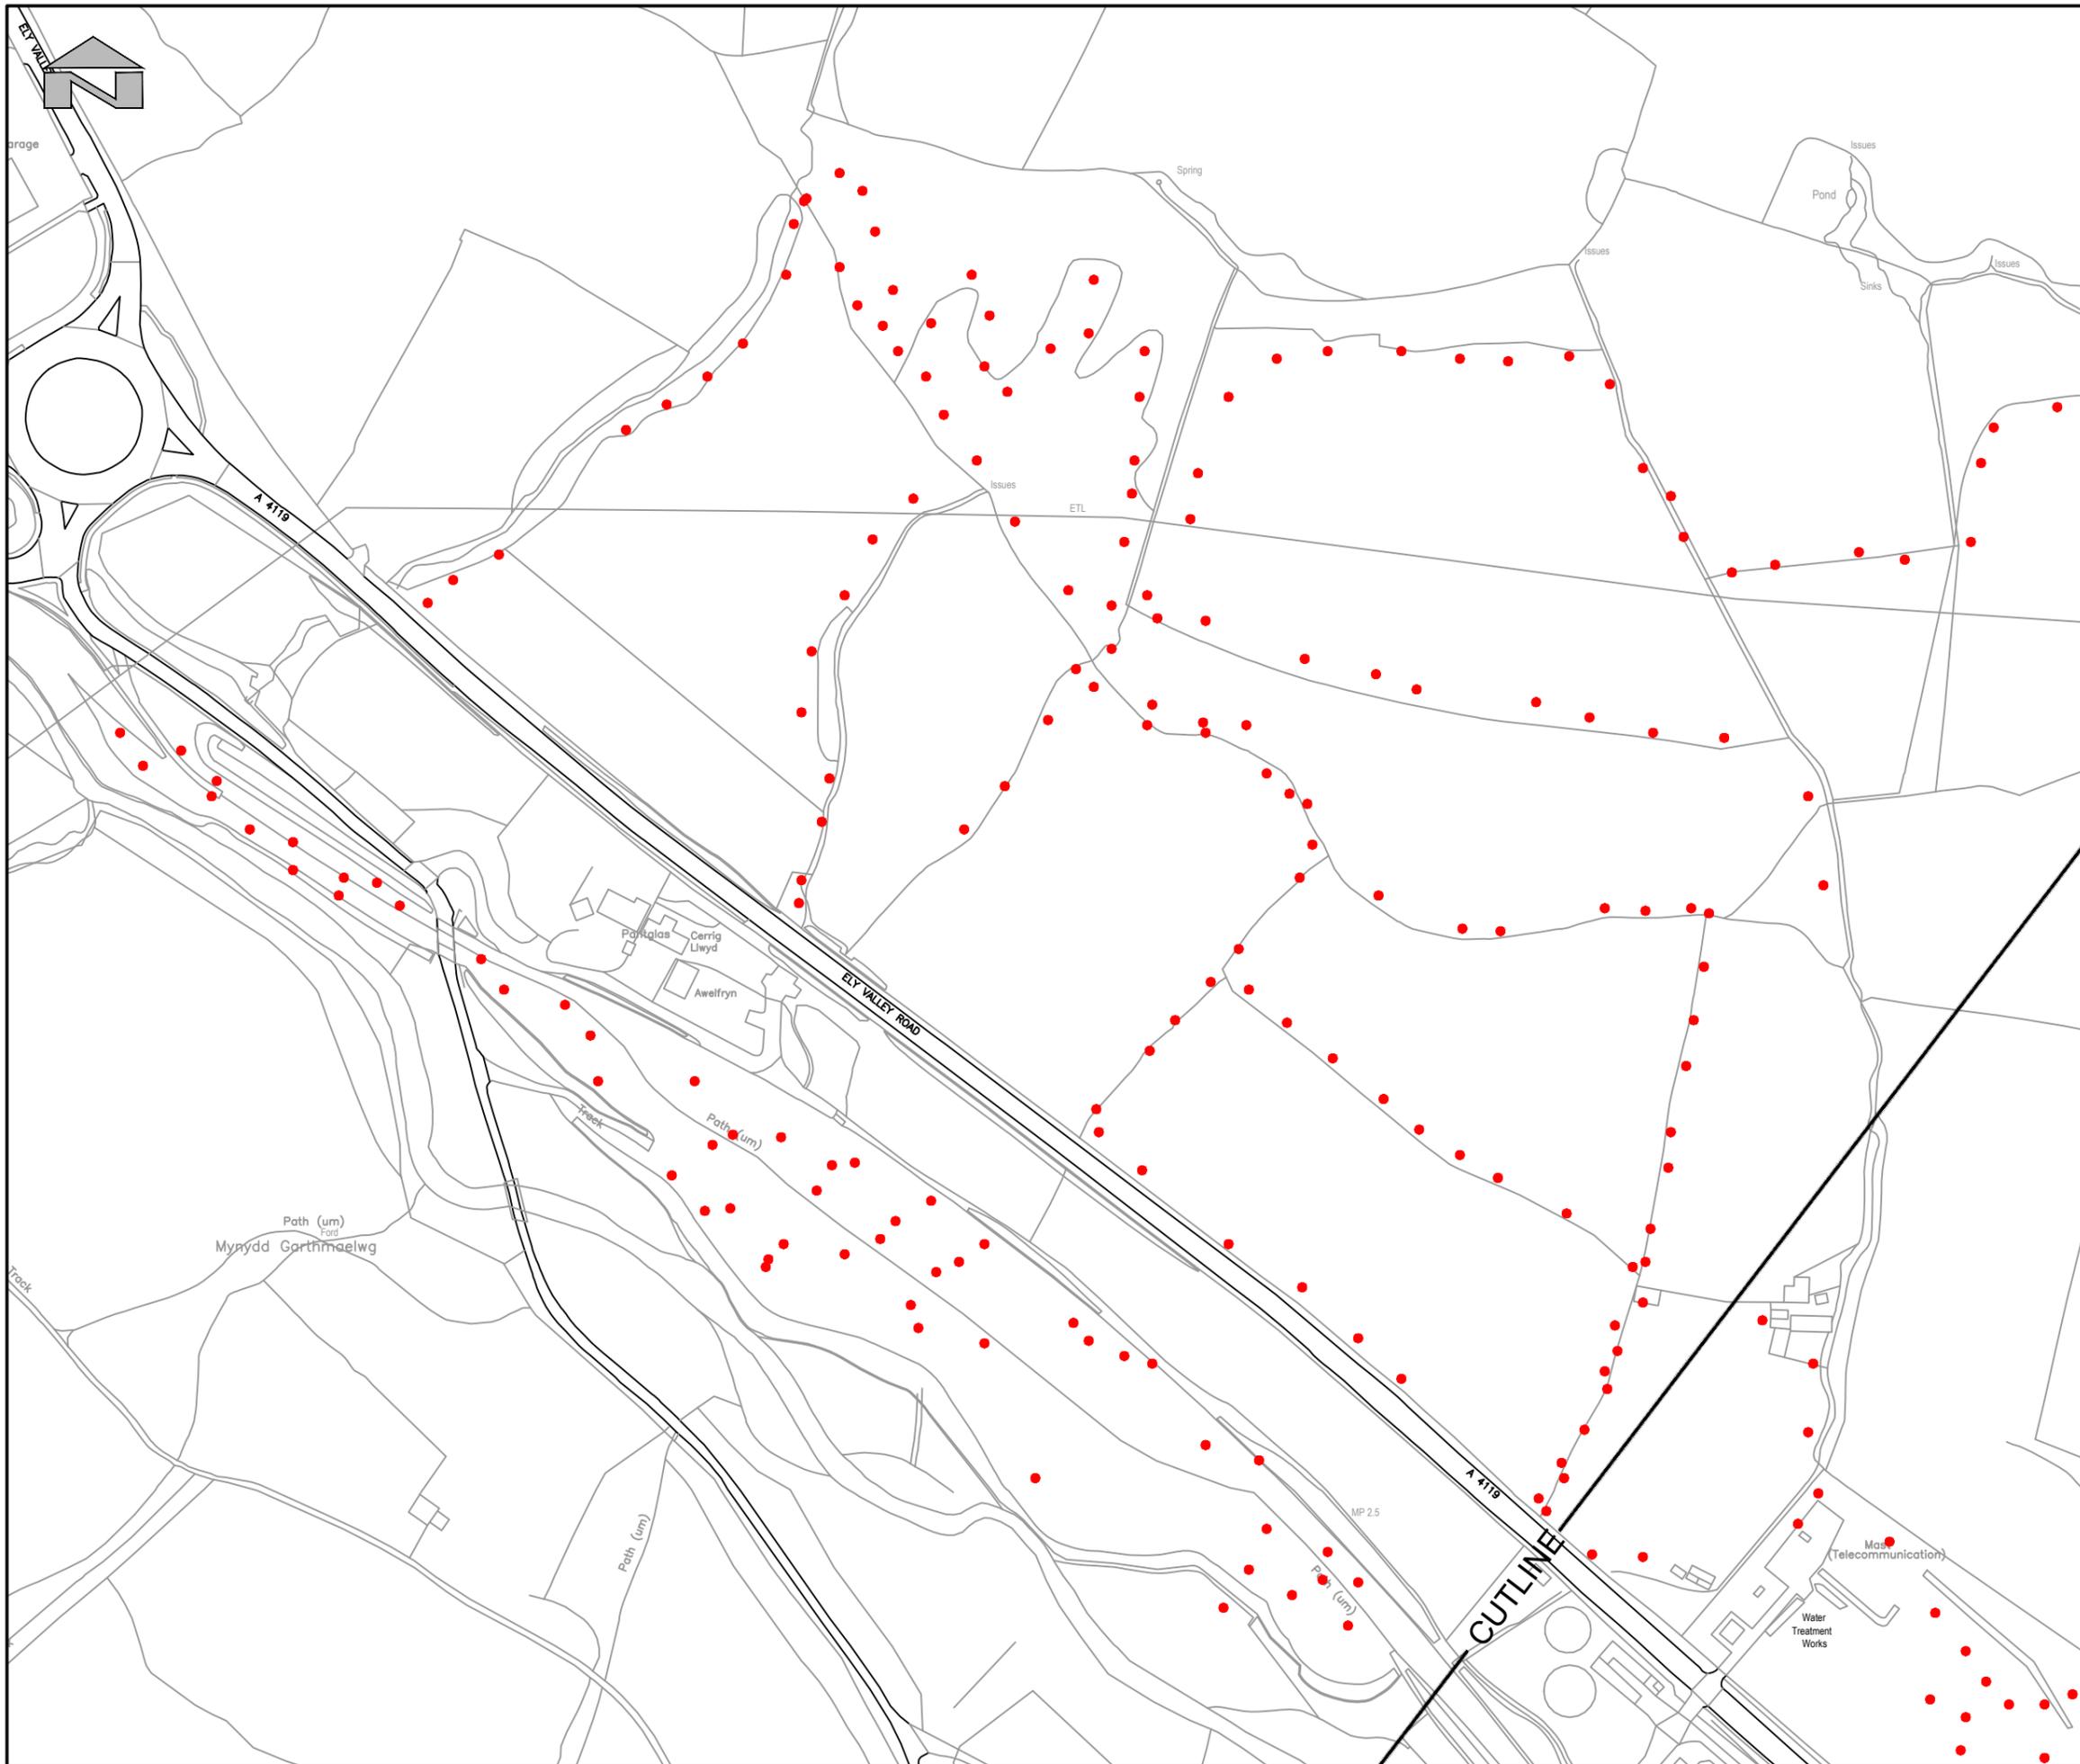
Drawing
**Location of Dormouse Survey Tubes
 Sheet 1**

A total of 275 nest tubes were installed on 20th and 23rd April 2018, approximately a month before the first survey visit, in order to allow dormouse time to find and nest in the tubes before the first survey visit. Each nest tube was given a number and its location recorded on a handheld GPS unit. The location of the nest tubes is shown on Drawing GC2895-RED-74-XX-DR-C-0025.

Nest tubes were fastened to horizontal tree branches and within hedges and scrub at heights between 1 – 2 m using plastic cable ties. Tubes were positioned with the entrance of the tube orientated towards the centre of the tree or hedge and angled slightly downwards to prevent water collecting within the tube. Nest tubes were installed at approximately 20 m intervals where possible.
