# **Flood and Water Management Act 2010**

## **Section 19 Flood Investigation Report**

**Storm Dennis –  
Flood Investigation Area RCT11  
(Pontypridd)**

**January 2022**

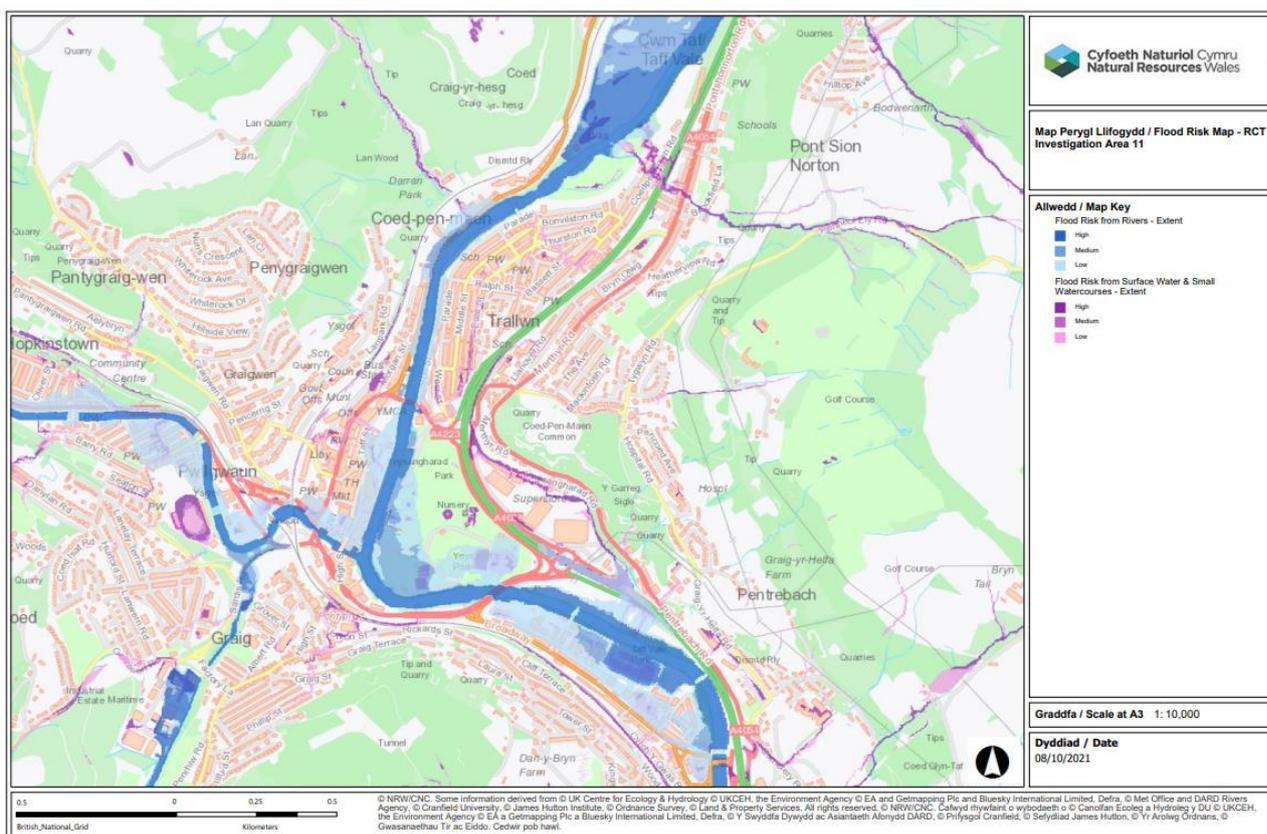
NRW's Flood Risk Assessment Wales (FRAW) maps indicate that there are areas of low to high flood risk from both the main river and surface water and ordinary watercourse sources within the investigation area. This is illustrated in Figure 2, which is an excerpt from the FRAW maps.

**Figure 2:** Natural Resources Wales' FRAW map for rivers and ordinary watercourse and surface water flood risk at RCT11. Contains Natural Resources Wales information © Natural Resources Wales and database right. All rights reserved

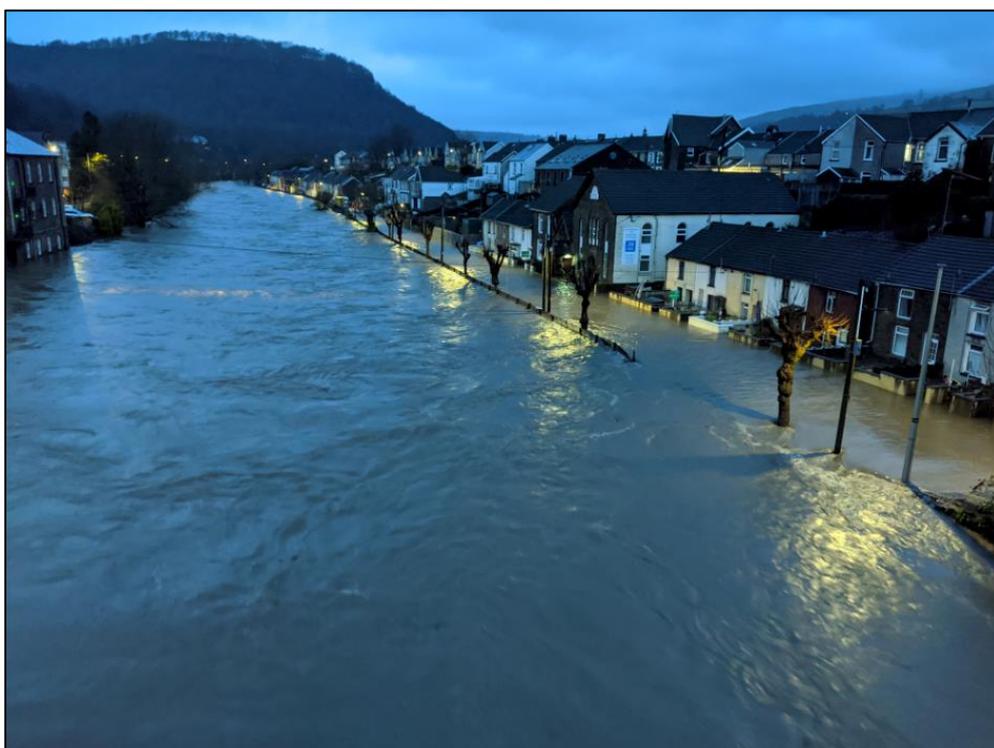
The primary flow paths observed north of Bridge Street remained confined to areas immediately adjacent to the River Taf. Berw Road, on the western embankment, and Sion Street, on the eastern embankment, suffered severe flooding following the overtopping of the River Taf (Figures 3 and 4). A total of 82 receptors, including two commercial properties, were internally flooded across both streets, with reported flood depths of up to 1.8 metres. Post-event inspections also identified significant mud and debris deposition, along with the displacement of several cars along both highway networks.

**Figure 3:** Image of the River Taf overtopping its eastern embankment onto Sion Street during the early hours on Sunday 16<sup>th</sup> February 2020 during Storm Dennis (image provided by resident)

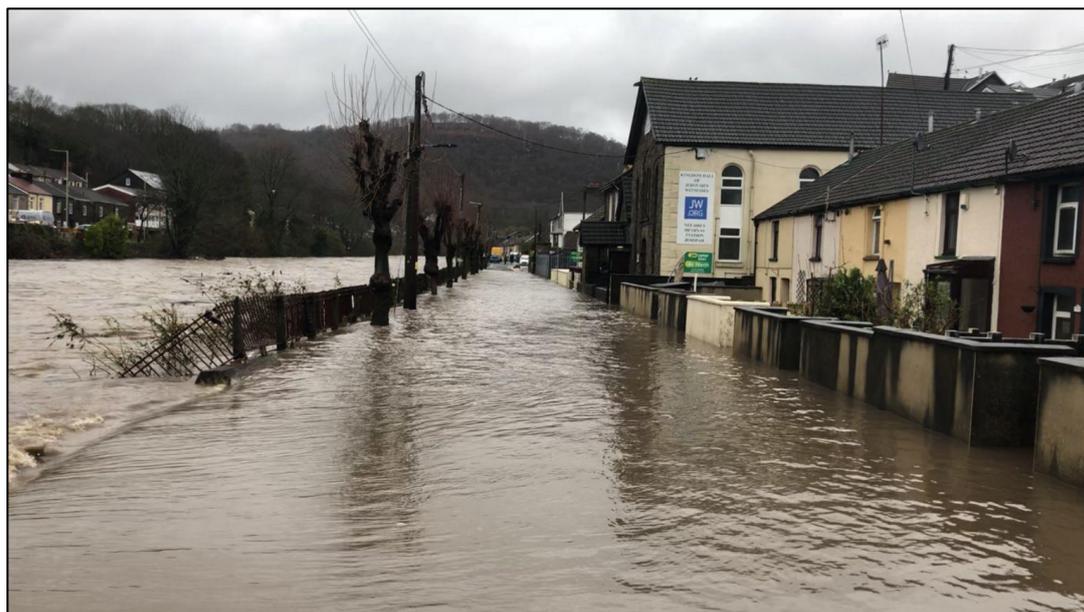
**Figure 4:** Flooding at Sion Street following Storm Dennis (Image: BBC News)

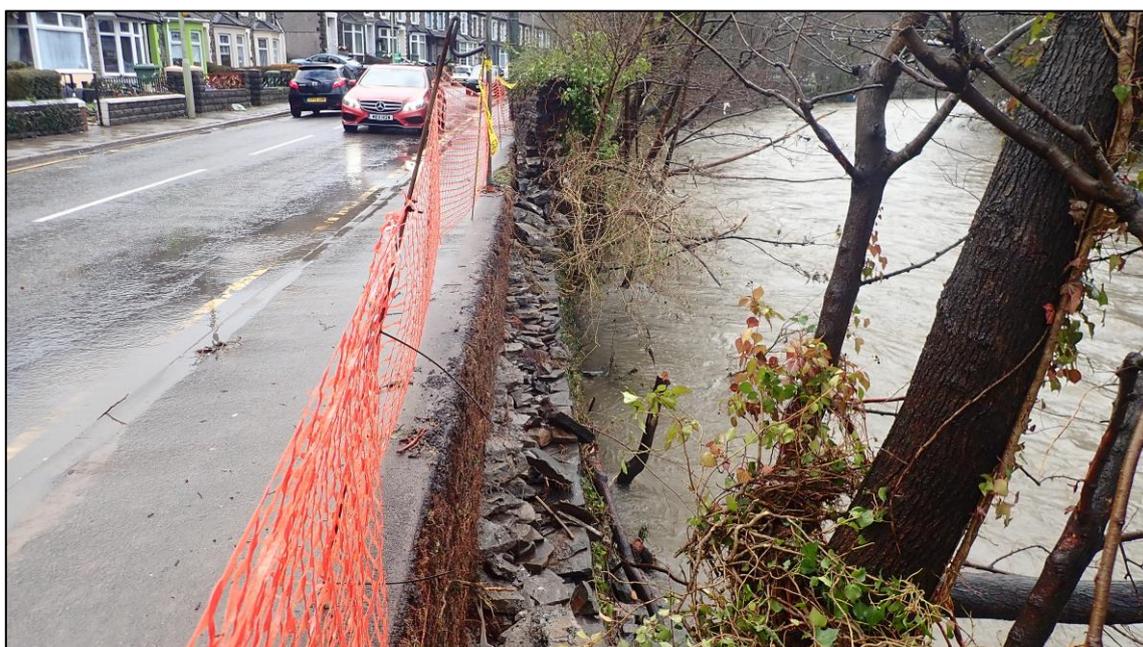
Anecdotal information provided by residents indicate that the River Taf overtopped its embankment at several locations along both streets, however it was noted that the overtopping initially occurred in those areas without concrete retaining walls. The resultant fluvial flooding contributed to the partial collapse of retaining walls (Classified as Non-Flood Defence (NFD) Structures) at several locations further downstream during the storm event (Figure 5 and 6).

**Figure 5:** Collapsed river wall (NFD) on Berw Road following Storm Dennis (captured by RCT's Flood Risk Management team on 17<sup>th</sup> February 2020)

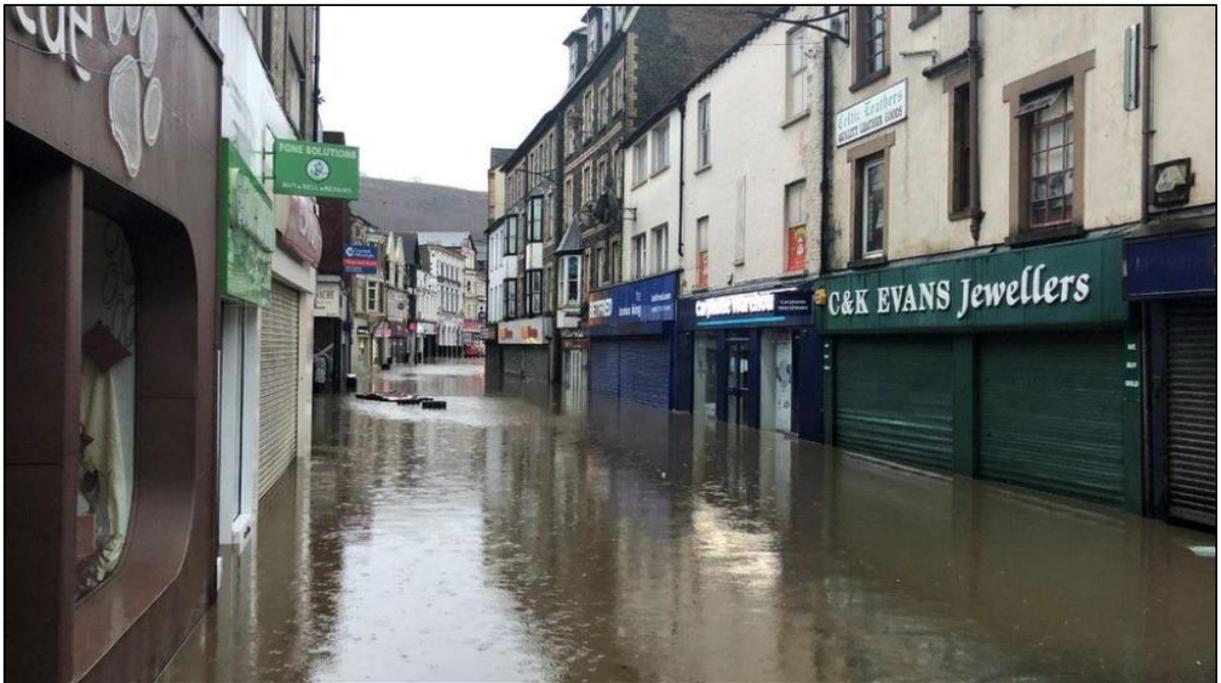
**Figure 7:** Flooding to commercial properties on Taff Street following Storm Dennis (Image: BBC News)

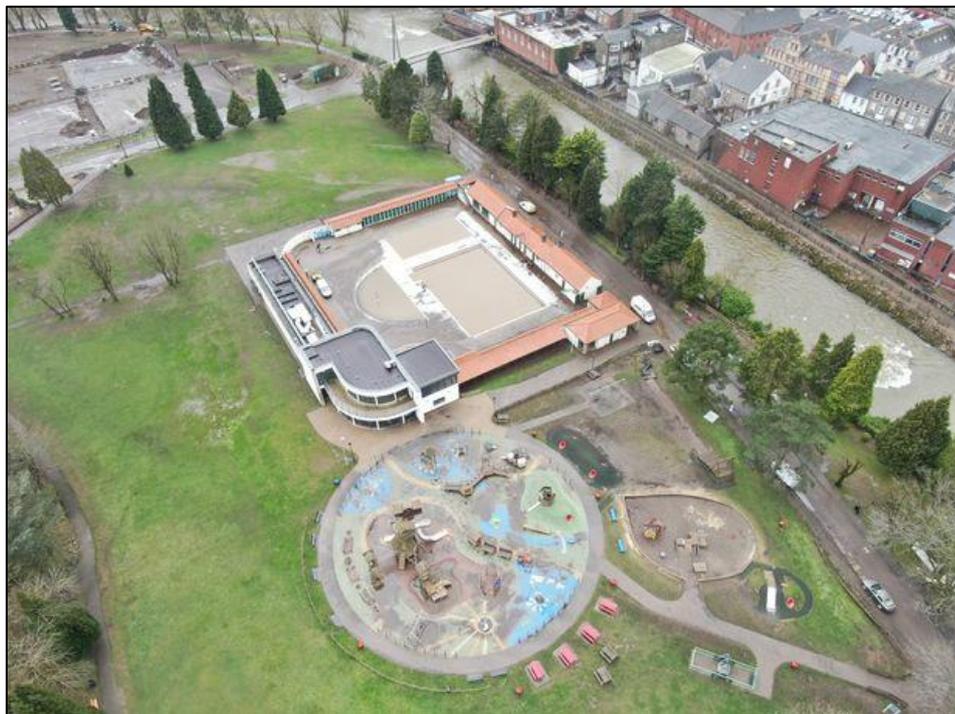
**Figure 8:** Image showing the flood damage to the National Lido of Wales at Ynysangharad Park following Storm Dennis (Image: Jonathan Lawrence/WalesOnline)

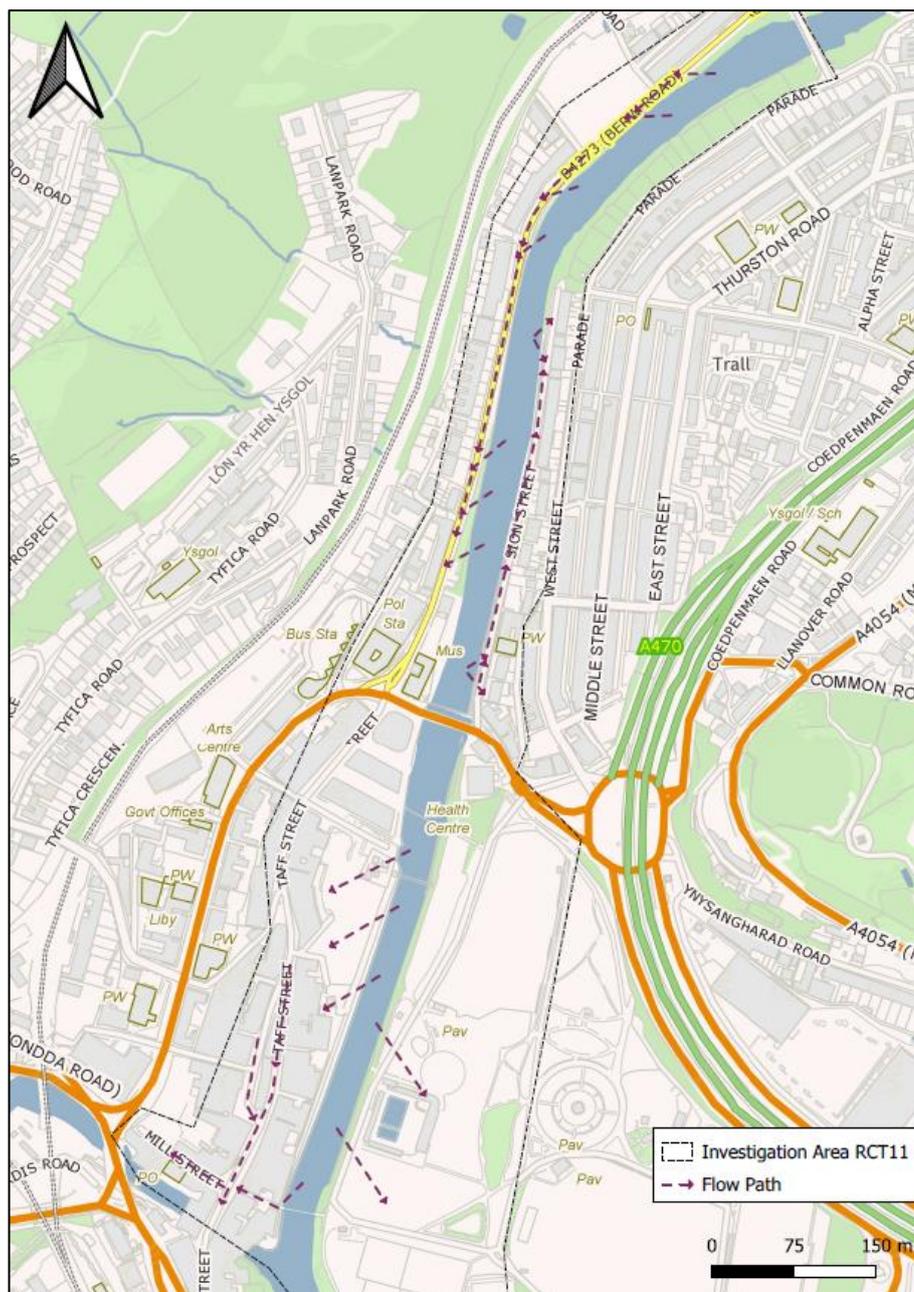
As illustrated in Figure 9, the River Taf overtopped immediately adjacent to Gas Road Car Park, resulting in the internal flooding of nearby properties as fluvial flows conveyed into the rear basements of buildings on Taff Street. Further south, flood water entered properties from both the rear and the front as fluvial flows conveyed over 100 metres from the River Taf onto Taff Street and Mill Street. Flood depths of up to 1 metre were recorded throughout Taff Street and Mill Street as flood water accumulated for several hours at localised low points.

The indicative flow paths and points of overtopping within the investigation area are illustrated in Figure 9.

**Figure 9:** Indicative flow paths observed at RCT11 during Storm Dennis

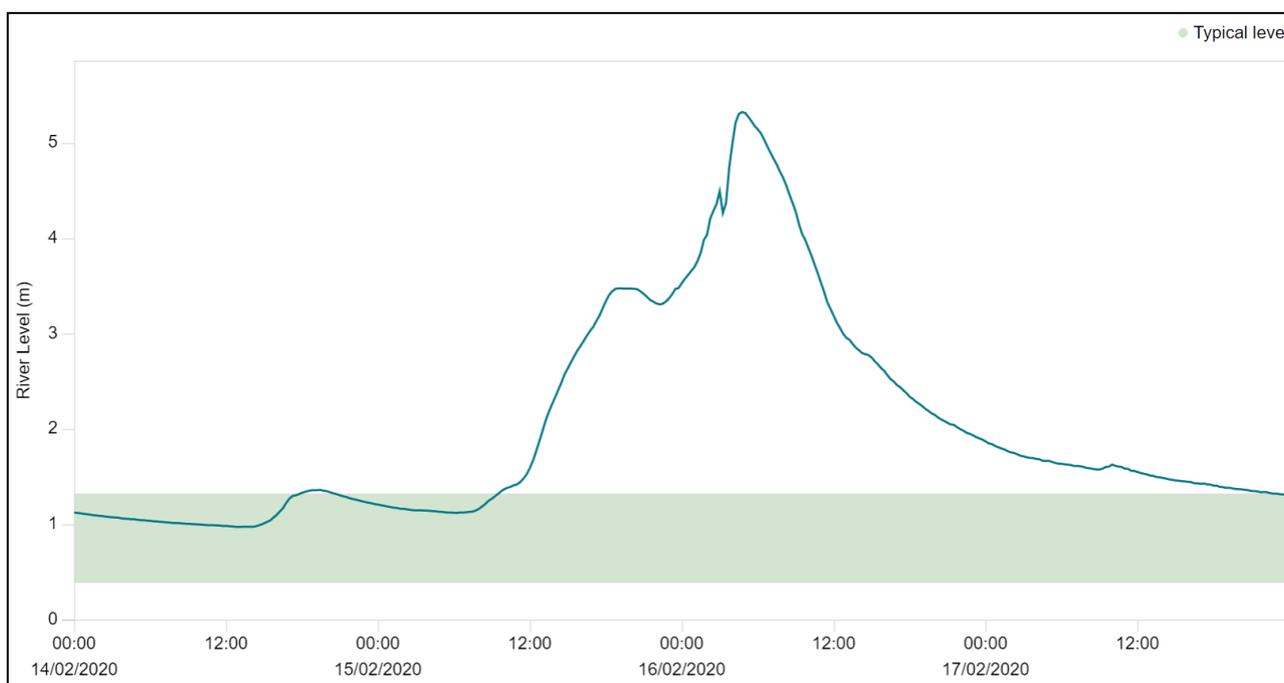
NRW issued a 'Flood Alert' (indicating possible flooding) for the entirety of the River Taf at approximately 13:30 on the 15<sup>th</sup> of February; at which point the main river was over 2 metres in depth and continuing to rise at Pontypridd station. At approximately midnight on the 16<sup>th</sup> February the River Taf began to rise again, reaching a peak river level of 5.32 metres at 04:45 on the 16<sup>th</sup> of February; the highest level recorded for the River Taf at Pontypridd since 1970.

The green bar displayed on the hydrograph shows the typical level of the River Taf at the Pontypridd station, ranging between 0.4 and 1.3 metres. The river level was above this green line for over 48 hours, highlighting the severity of the storm event and its unprecedented nature. At its peak, the River Taf at Pontypridd was almost four meters higher than its average level.

**Figure 10:** The River Taf levels at Pontypridd station between the 14<sup>th</sup> and 17<sup>th</sup> February 2020 (Natural Resources Wales)

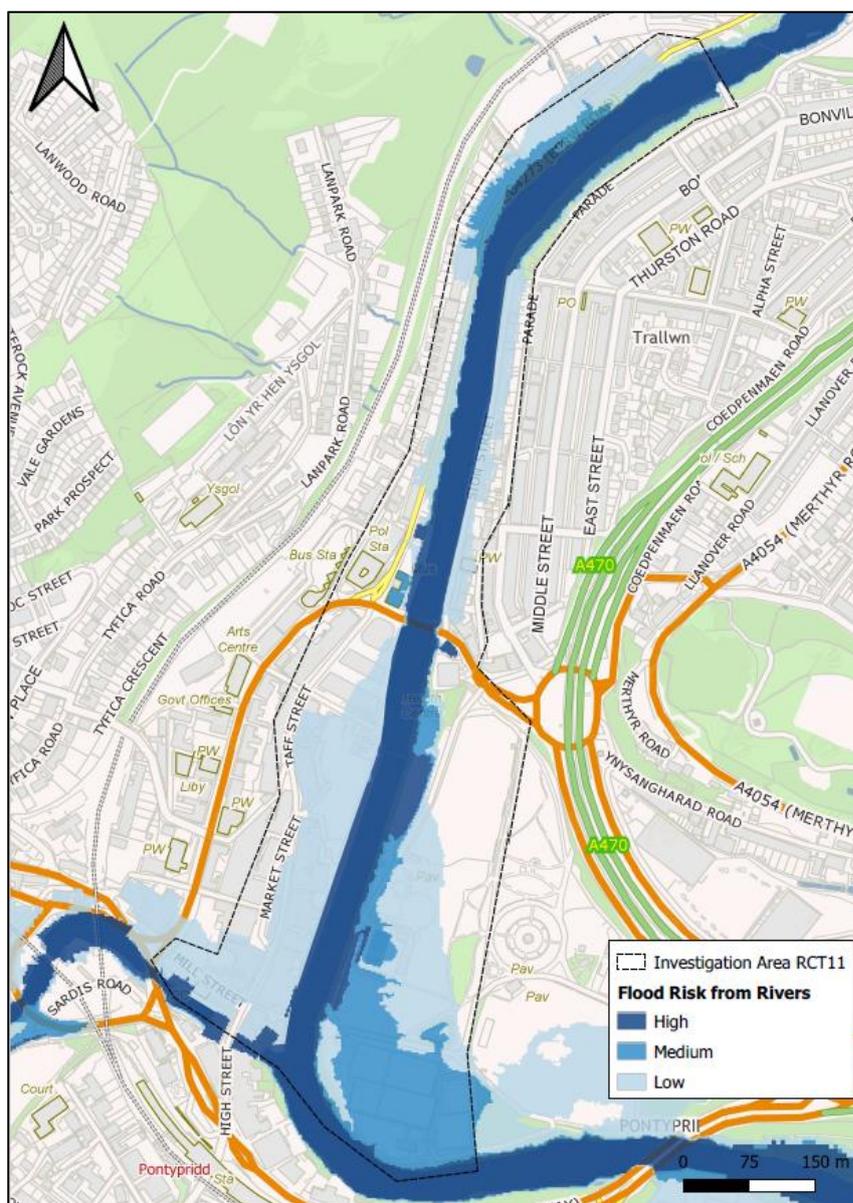
Figure 11 is an excerpt from NRW's Flood Risk Assessment Wales (FRAW) mapping exercise which depicts the main river flood risk extents for the 'Defended' scenario, i.e., with the presence of flood defence assets. The darker shading identifies areas at higher risk of flooding (more frequent/less extreme rainfall events) and lighter shading showing the lower risk areas (less frequent/more extreme rainfall events).

**Figure 11:** NRW's FRAW map for River sources at RCT11. Contains Natural Resources Wales information © Natural Resources Wales and database right. All rights reserved.

The flooding that occurred within RCT11 during Storm Dennis is largely consistent with the modelled outputs of NRW's FRAW map (Figure 11), with the majority of the affected properties falling within an area of low main river flood risk. Notably, a small area of Berw Road, in addition to Ynysangharad Park, are identified at medium risk of main river flooding.

A low risk of flooding means that an area has a chance of flooding of between 1 in 1000 (0.1%) and 1 in 100 (1%) each year; meanwhile, a medium risk of flooding signifies a yearly chance of flooding between 1 in 100 (1%) and 1 in 30 (3.3%). Considering Storm Dennis was estimated as in excess of a 1 in 200 annual probability (Q200) flood event, the area of flooding during Storm Dennis aligns with those depicted by the low flood risk extents (Figure 11).

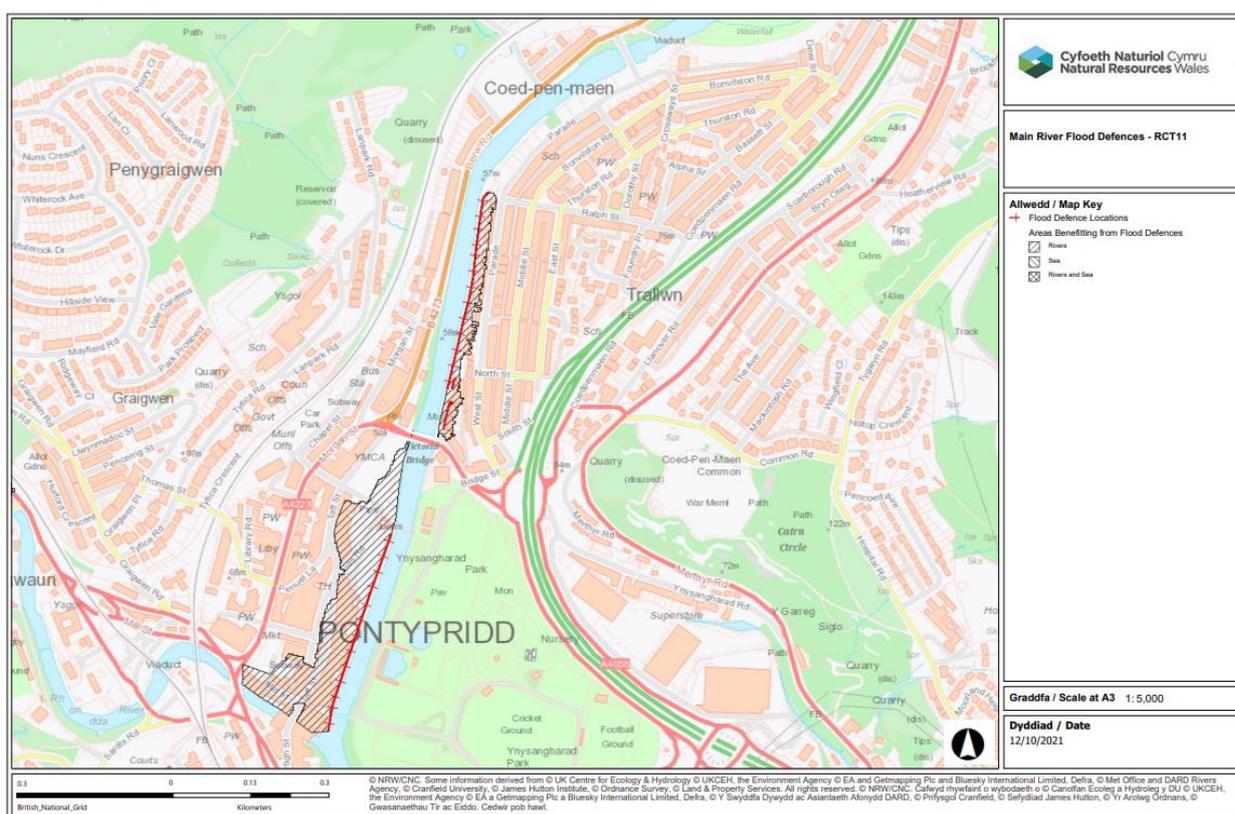
As illustrated in Figure 12 (demarcated by a bold red line), there are approximately 400 metres and 300 metres of formally designated flood defence infrastructure along the eastern and western banks of the River Taf at RCT11, respectively. This infrastructure is operated and maintained by NRW.

According to NRW, flood defence infrastructure throughout Pontypridd town centre and Sion Street provides a standard of protection up to a 1 in 100 annual probability flood event (Q100) to several properties within the investigation area (black hatched area in Figure 12). There are no formal flood defenses under the operation and maintenance of NRW on the western river embankment at Berw Road, any pre-existing highway walls are considered NFD Structures.

**Figure 12:** Natural Resources Wales’ map for Main River Flood Defences and areas benefiting at RCT11. Contains Natural Resources Wales information © Natural Resources Wales and database right. All rights reserved.

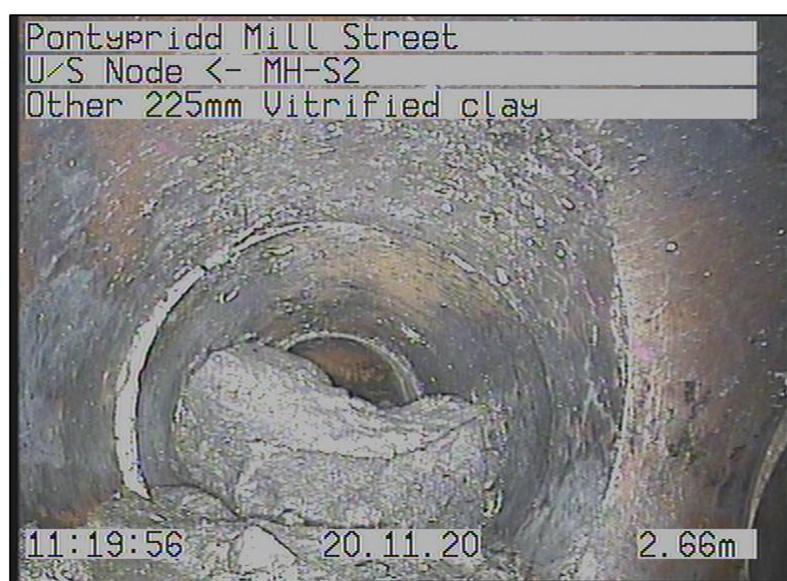
Several streets throughout RCT11 were observed to be flooding as a result of the overtopping of the River Taf during Storm Dennis. These fluvial flows deposited mud, silt and debris across the investigation area which are assumed to have entered the highway drainage system, leading to blockages and a reduction in the hydraulic capacity of the surface water network. Accompanied by intense rainfall and significant surface water conveyance, it is considered that the highway drainage infrastructure in the affected regions of RCT11 became overwhelmed during the storm event.

CCTV inspections undertaken in the months following the storm event confirm this, with surveys completed on Mill Street identifying settled deposits of silt and debris within the highway drainage network. Figure 13 depicts the operational condition of the highway drainage at Mill Street prior to its cleansing. A cross-sectional area loss of 60% was observed due to silt accumulation within the network.

**Figure 13:** Photo of silt accumulation within the Mill Street surface water drainage network prior to cleansing operations

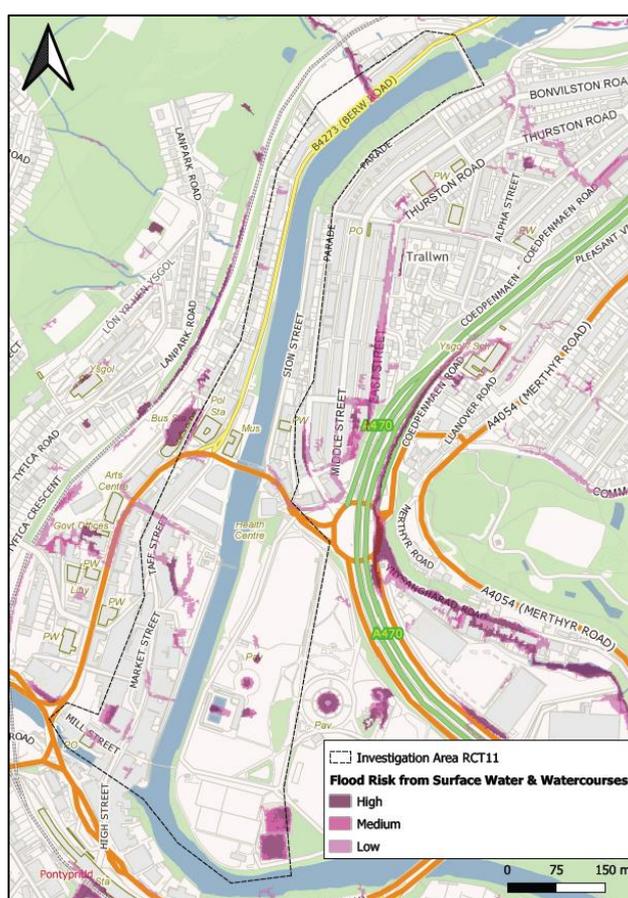
On review of NRW's national surface water and ordinary watercourse flood map (Figure 14), the extent of flooding from pluvial sources is minimal, with only small, localised areas of high to low flood risk observed along parts of Taff Street, Mill Street and Ynysangharad Park within the town centre. Despite the FRAW map indicating little to no surface water and ordinary watercourse flood risk across RCT11, surface water conveyance was observed along several highway networks and pedestrian footways within Pontypridd Town Centre. The conveyance of surface water within RCT11 has been attributed to intense and persistent rainfall resulting in the accumulation of runoff towards localised low points.

**Figure 14:** NRW's FRAW map for Surface Water and Ordinary Watercourse flood sources at RCT11. Contains Natural Resources Wales information © Natural Resources Wales and database right. All rights reserved.
