**RHONDDA CYNON TAF COUNTY BOROUGH COUNCIL
MUNICIPAL YEAR 2014-2015**

**REPORT OF THE GROUP
DIRECTOR, ENVIRONMENTAL
SERVICES**

Land Reclamation Report

Appendix A Typical Section through Albion lower Tip – Horizontal Directional Bore

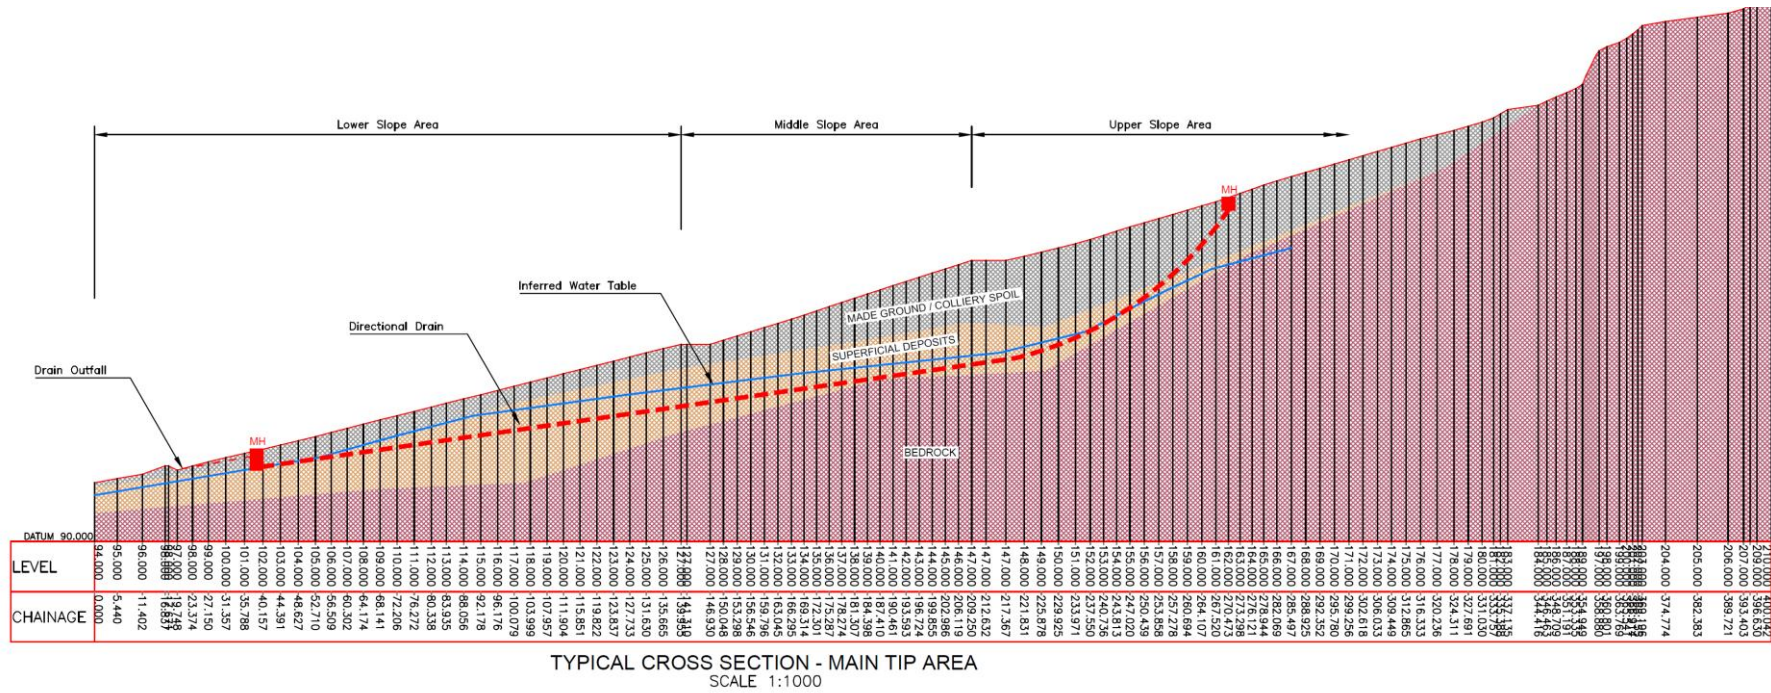
- 4.5 Cabinet approval was gained on 22 February 2010 to progress an alternative scheme based on the already successful “under tip drainage”. The basic elements of the scheme are re-produced below:-

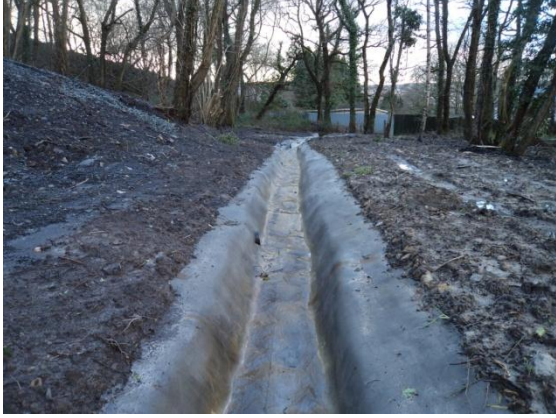
- 6.4 Vertically Drilled holes are nearing completion. They will assist in relieving the water pressure in the lower slopes by allowing it to rise within the vertical pipes rather than press on the bottom of the tip. An example of the drilling equipment is shown in Appendix B photo 3

A close-up view of a large pipe or hose discharging a thick, brown, muddy liquid. The liquid is flowing out of a hole in the ground, creating a small stream on the dark, rocky soil.
<p>Photo 1 – Directional Drilling Equip.</p>	<p>Photo 2 – Water Flow after Drilling</p>
  A vertical drilling rig is operating on a steep, excavated slope. A worker in a high-visibility vest is standing near the base of the rig. A blue tracked vehicle is parked nearby. The background shows a residential area with houses and trees.	
<p>Photo 3 – Vertical Holes</p>	
  A view of a drainage system installed in a wooded area. A long, narrow, dark-colored drainage pipe runs through the ground, surrounded by gravel and soil. The background shows trees and a building.

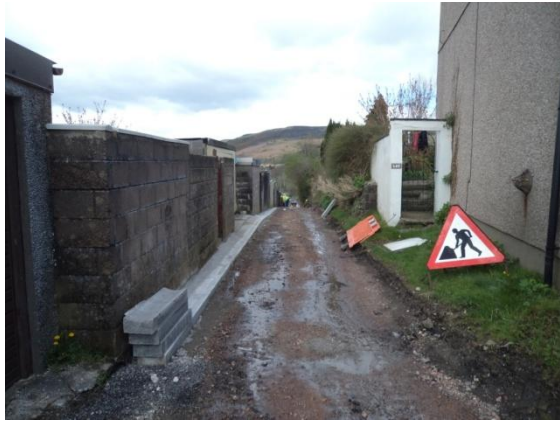
Photo 6 – Lane during Construction.

- 6.6 The rear lane of Mary St has been resurfaced and additional drainage installed to receive residual groundwater flows at the toe of the tip. A photo during (photo 6) and after (photo 7) is shown in appendix B

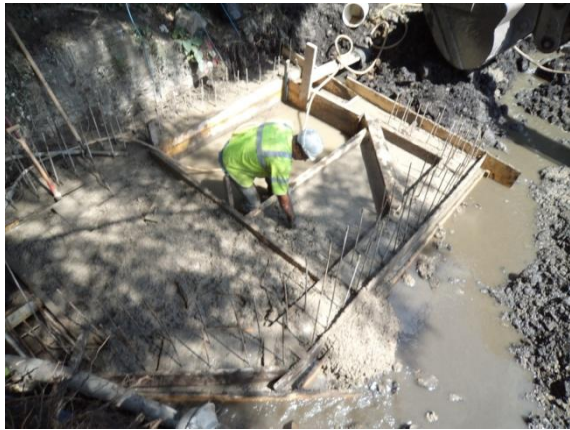
Photo 8 – Headwall Construction

- 6.7 Improvements to the drainage regime are also being constructed such as a new headwall and pollution control pond. The construction of the headwall is shown in photo 8 Appendix B

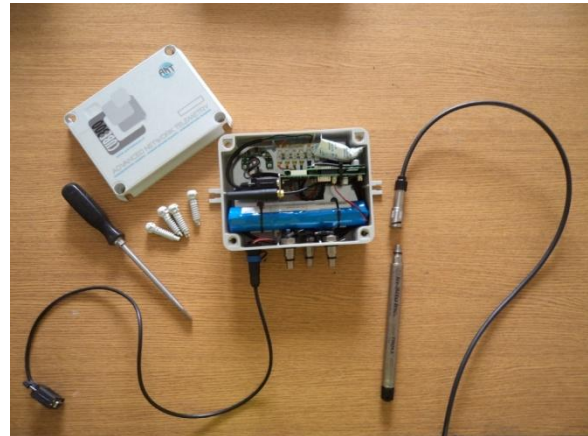
Photo 9 – Data Telemetry

- 6.8 Electronic monitoring equipment will be installed to monitor the post project water levels. The equipment will allow the council's engineers to receive "real time" data. An example of the equipment is shown in Photo 9 in Appendix B
