Tylorstown Landslide

Environmental Impact Assessment
Volume 3 - Appendices

Series 10 Contaminated Land, Geology,
Soils and Waste

Preliminary Sources Study Report

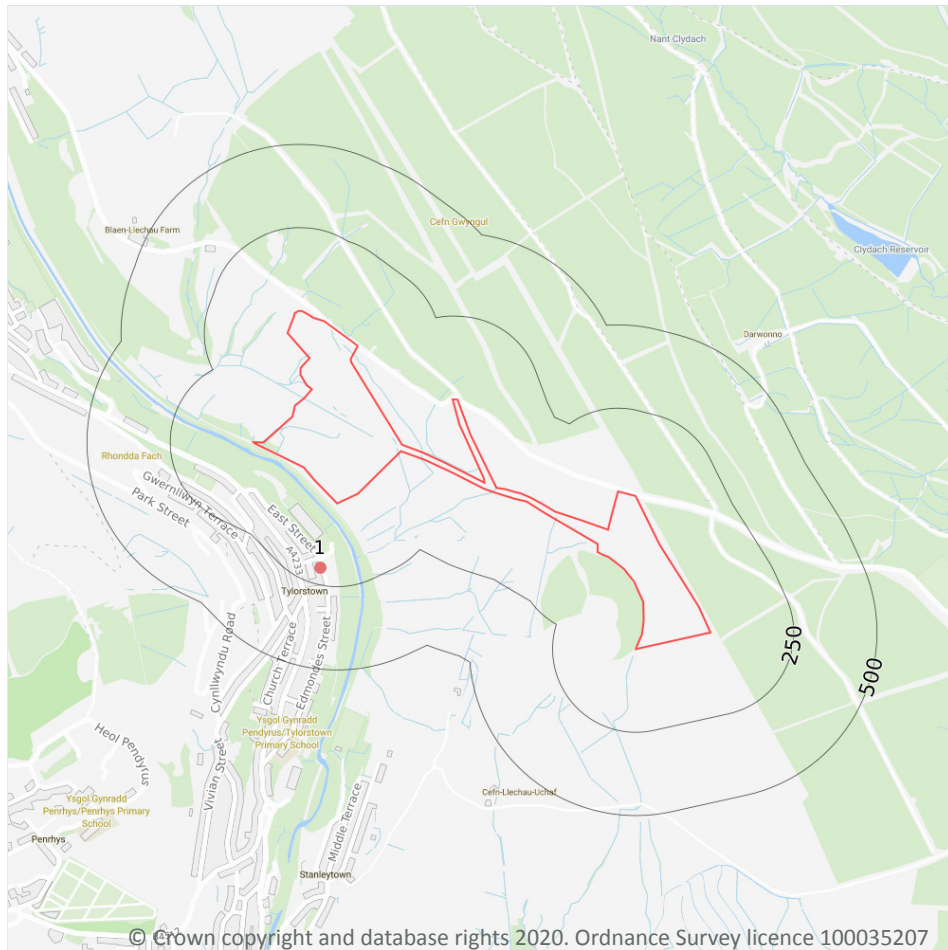
- Site Outline
- Search buffers in metres (m)
- Waste exemptions

Activities involving the storage, treatment, use or disposal of waste that are exempt from needing a permit. Exemptions have specific limits and conditions that must be adhered to.

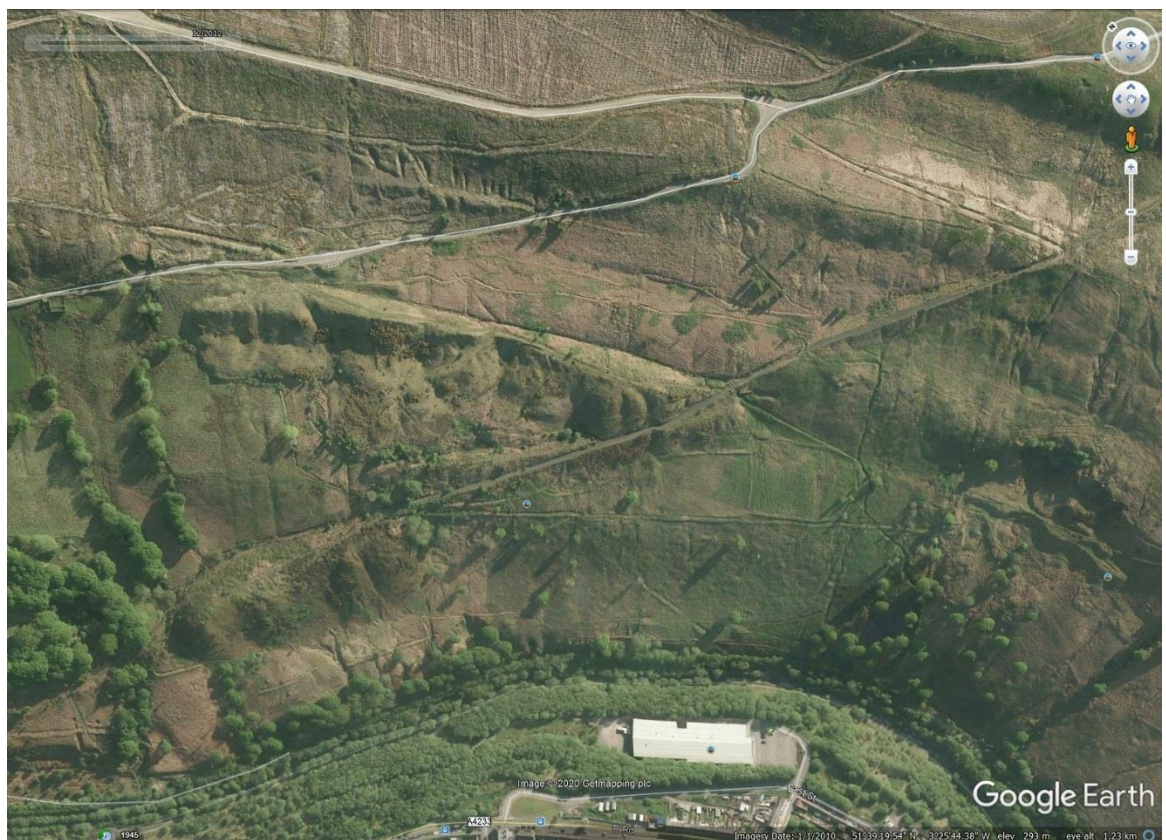
Photograph showing Llanwonno Upper Tip and Lower Tip in central area. The terrain incorporates subdued terracing. Leisure centre at bottom of photo.

It is suggested that an ancient landslide is present within the natural hillside beneath the northern end of Llanwonno Upper Tip, hummocky ground between the Upper and Lower Tips support this landslide concept.

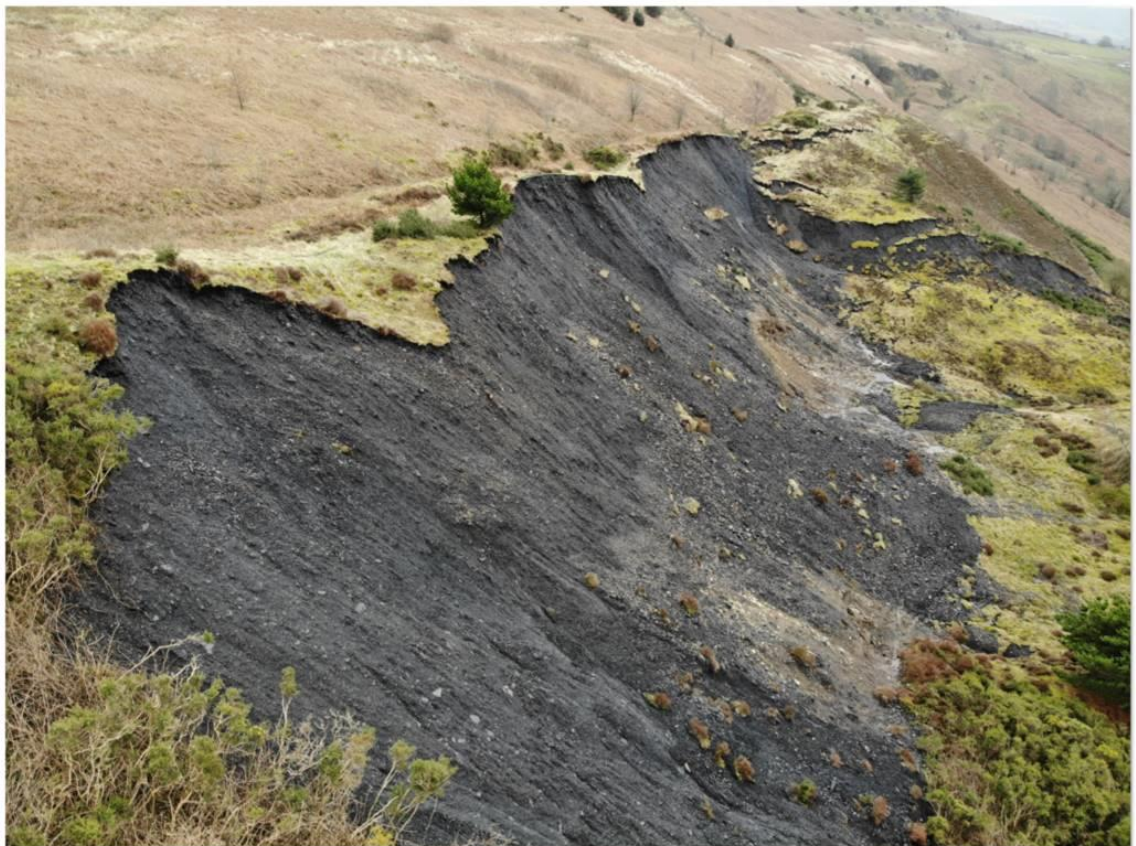
Within the central portion of the tip, the recent landslide has left a bowl-shaped depression with a steep back scar. In the upper half of the back scar, a wedge of colliery spoil remains (the crest of the tip), whereas in the lower half of the back scar, natural ground (a stiff orange till) is visible. In front of the back scar is a back-tilted block, traversed by a multitude of transverse cracks. In front of the landslide block, the surface is scoured to natural ground with ribbons of colliery spoil remaining from the downhill flow slide.

Photograph showing back scar with a high slope of glacial till exposed in lower third of scar face

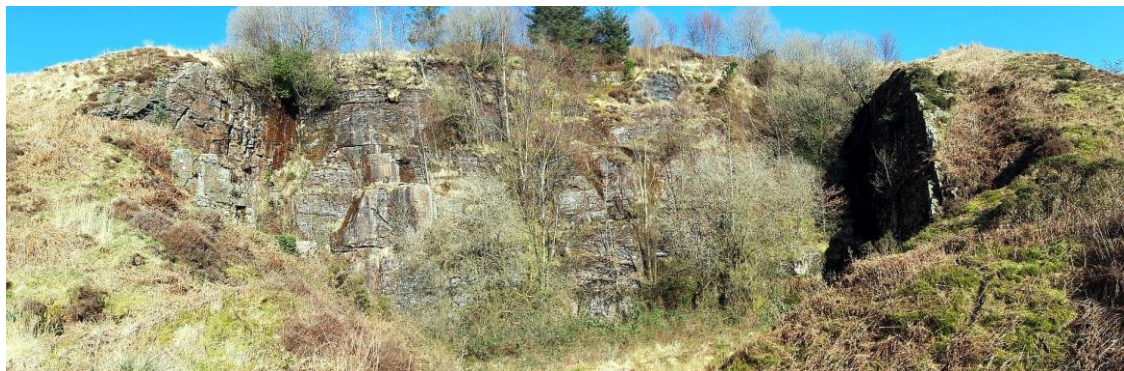
Photograph of quarry located west of the proposed haul road showing Rhondda member of the Pennant Sandstone Formation

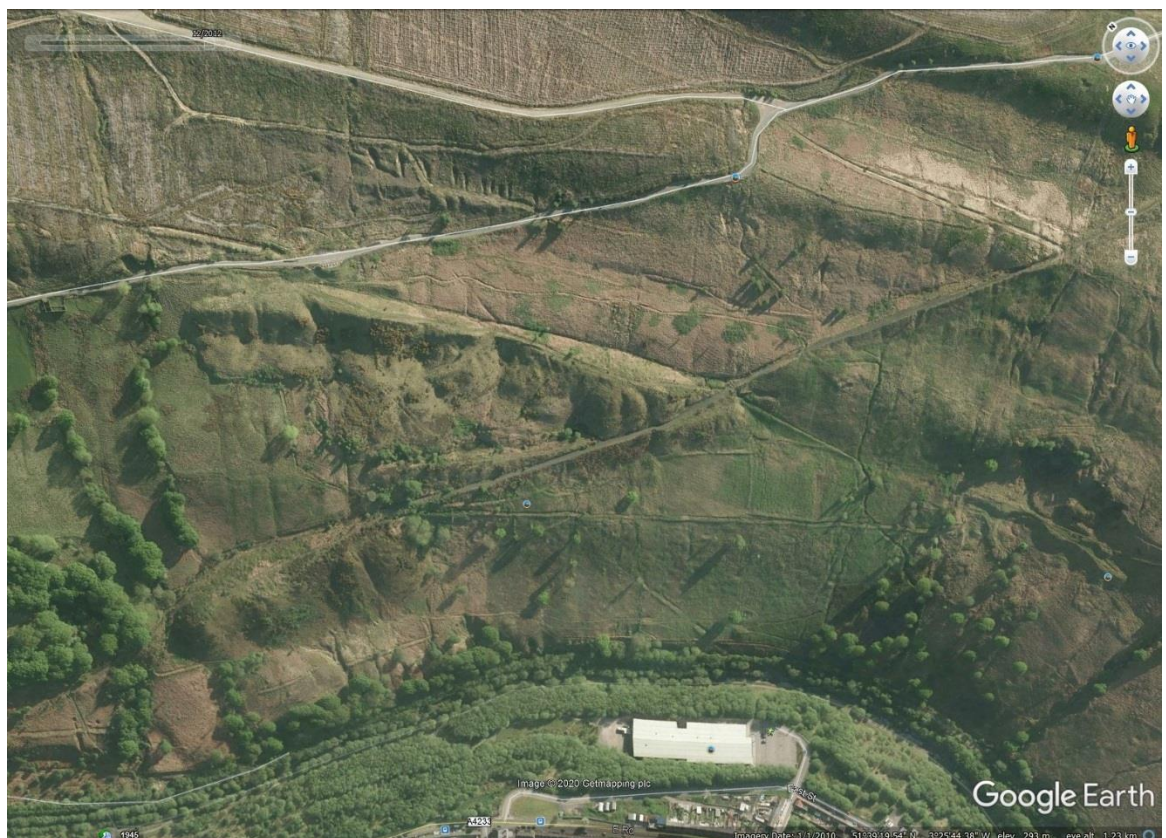
Photograph showing Llanwonno Upper Tip and Lower Tip in central area. The terrain incorporates subdued terracing. Leisure centre at bottom of photo.

It is suggested that an ancient landslide is present within the natural hillside beneath the northern end of Llanwonno Upper Tip, hummocky ground between the Upper and Lower Tips support this landslide concept.

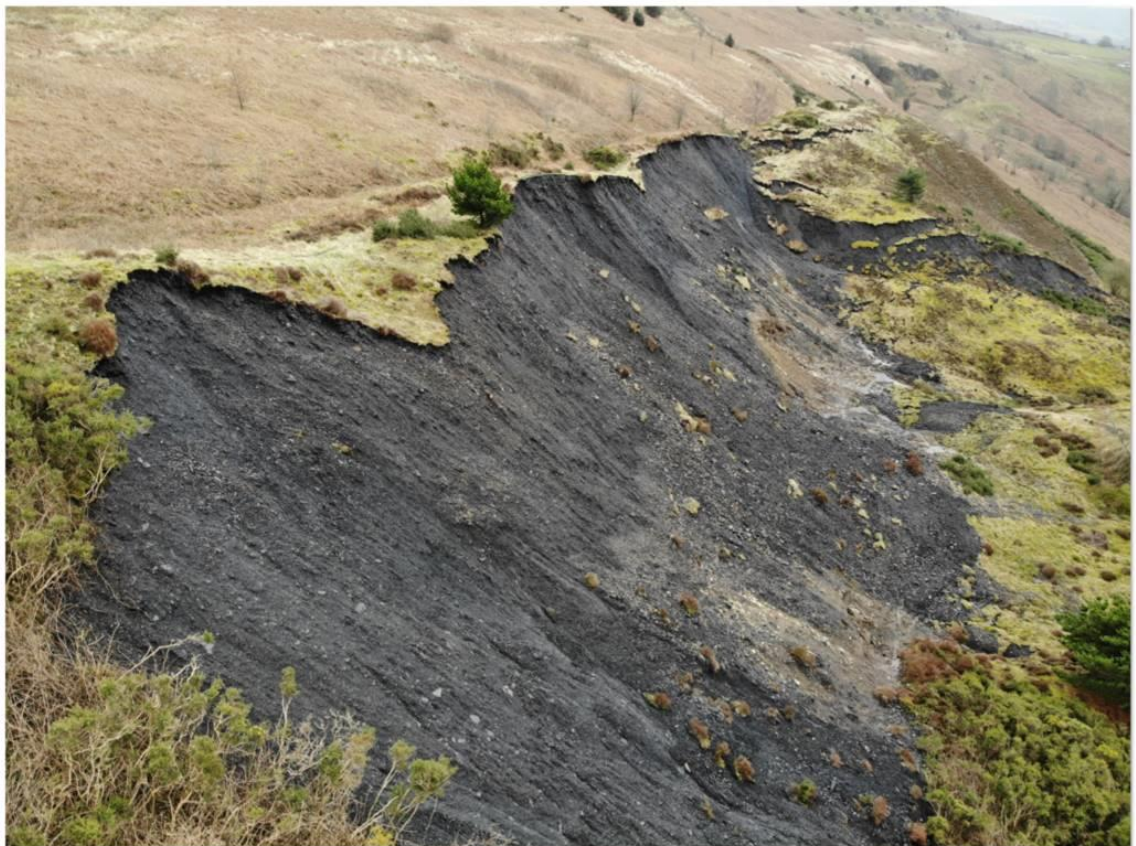
Within the central portion of the tip, the recent landslide has left a bowl-shaped depression with a steep back scar. In the upper half of the back scar, a wedge of colliery spoil remains (the crest of the tip), whereas in the lower half of the back scar, natural ground (a stiff orange till) is visible. In front of the back scar is a back-tilted block, traversed by a multitude of transverse cracks. In front of the landslide block, the surface is scoured to natural ground with ribbons of colliery spoil remaining from the downhill flow slide.

Photograph showing back scar with a high slope of glacial till exposed in lower third of scar face

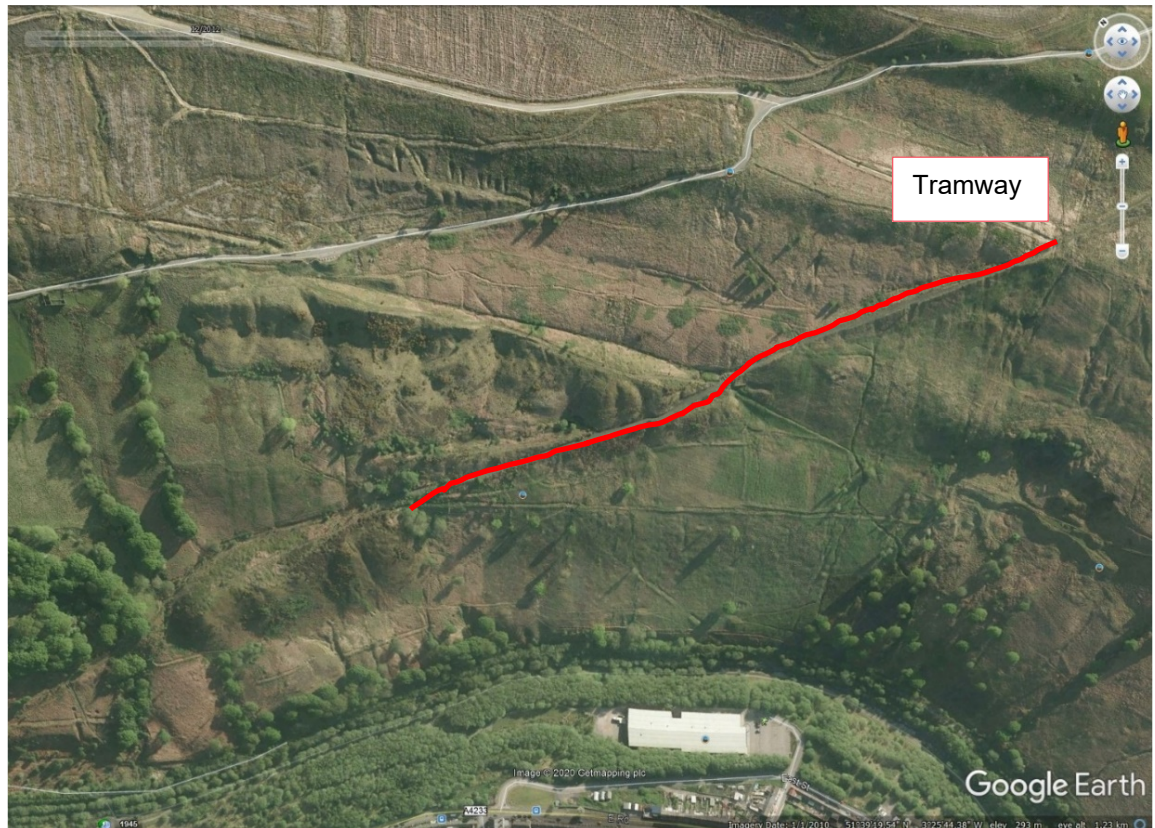
Photograph showing Llanwonno upper tip and lower tip in central area. Terrain subdued terracing can be seen with sports centre to base of photo

It is suggested that an ancient landslide is present within the natural hillside beneath the northern end of Llanwonno Upper Tip, hummocky ground between the Upper and Lower Tips support this landslide concept.

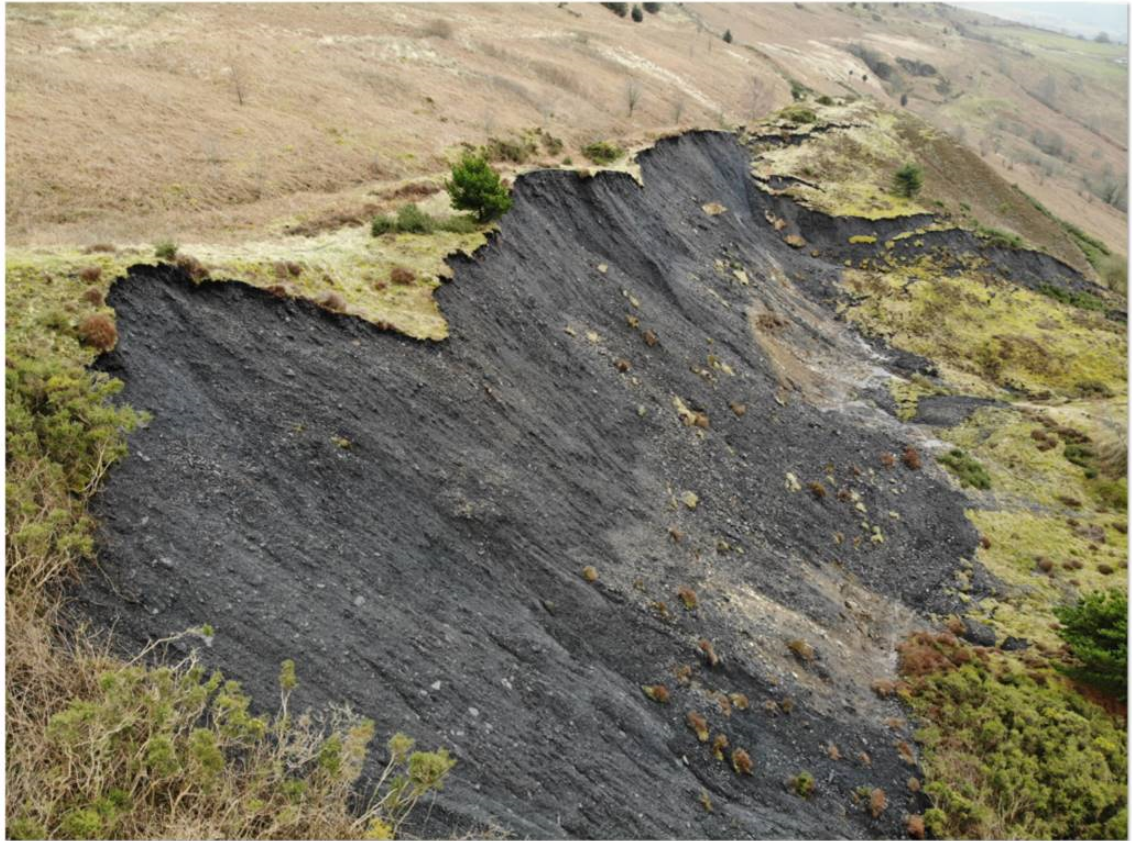
Within the central portion of the tip, the recent landslide has left a bowl-shaped depression with a steep back scar. In the upper half of the back scar, a wedge of colliery spoil remains (the crest of the tip), whereas in the lower half of the back scar, natural ground (a stiff orange till) is visible. In front of the back scar is a back-tilted block, traversed by a multitude of transverse cracks. In front of the landslide block, the surface is scoured to natural ground with ribbons of colliery spoil remaining from the downhill flow slide.

Photograph showing back scar with a high slope of glacial till exposed in lower third of scarp face

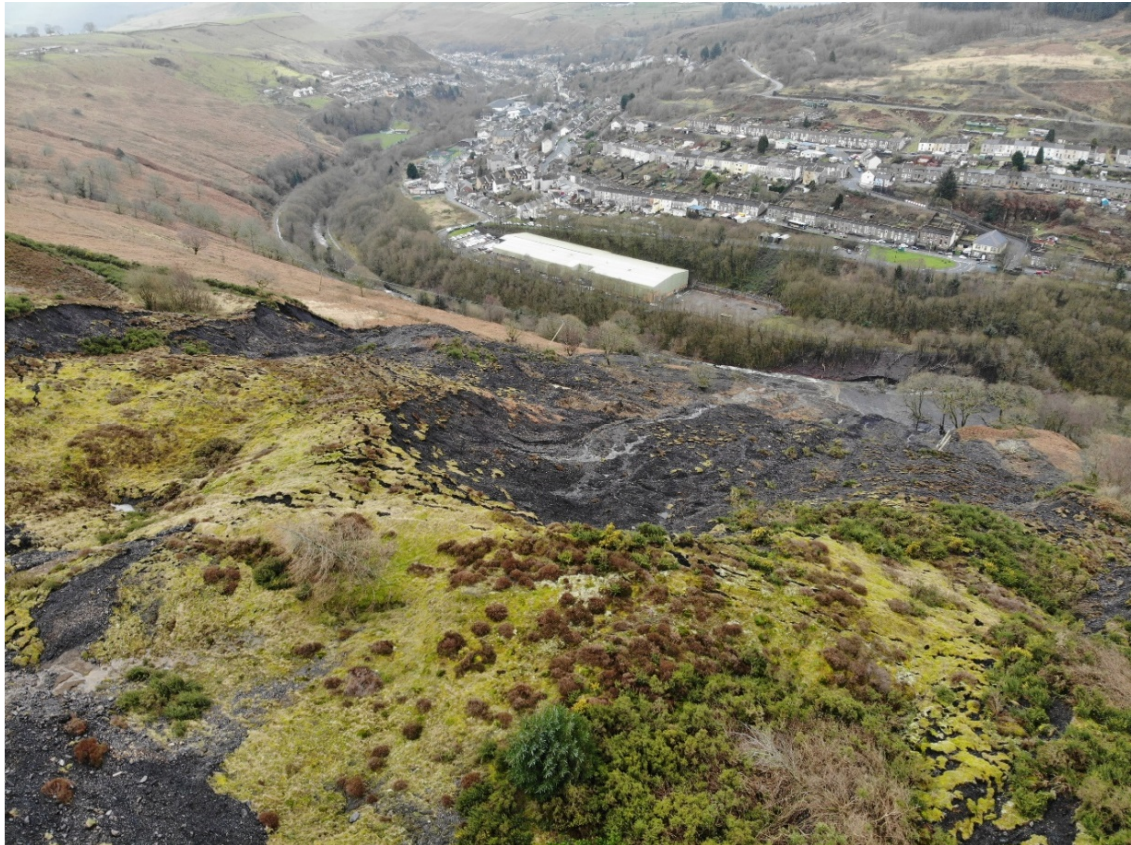
Photograph of central parts of slip looking from the northwest with leisure centre in valley base

The base of the tip lies on a slack, which has water issues along its entire length and inevitably beneath the tip itself. Since the landslide has occurred, water issues have formed deep erosive gullies down to the valley bottom. It is considered that prior to the slip, a longitudinal drain, beneath the tramway, captured these issues and took the water away to the north, and then down to the valley bottom, via a channel that is still partially present, immediately south of Llanwonno Lower Tip.

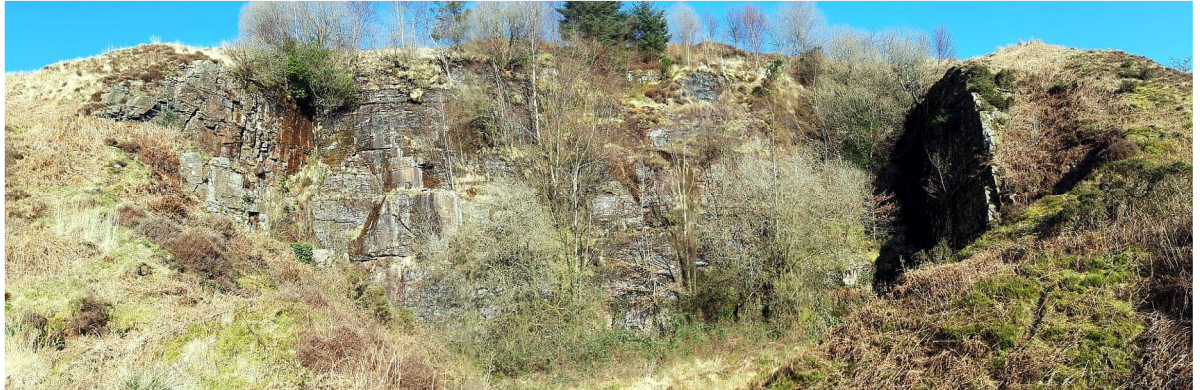
Photograph of quarry located to the west of (below) the proposed haul road showing Pennant Sandstone Formation

These portions of the Phase 4 area are underlain fully by the Brithdir Member of the Pennant Sandstone Formation. This is described by the BGS as having green-grey, lithic arenites with conglomerate lenses at bases of units; thin mudstone/siltstone and seatearth interbeds and mainly thin coals.

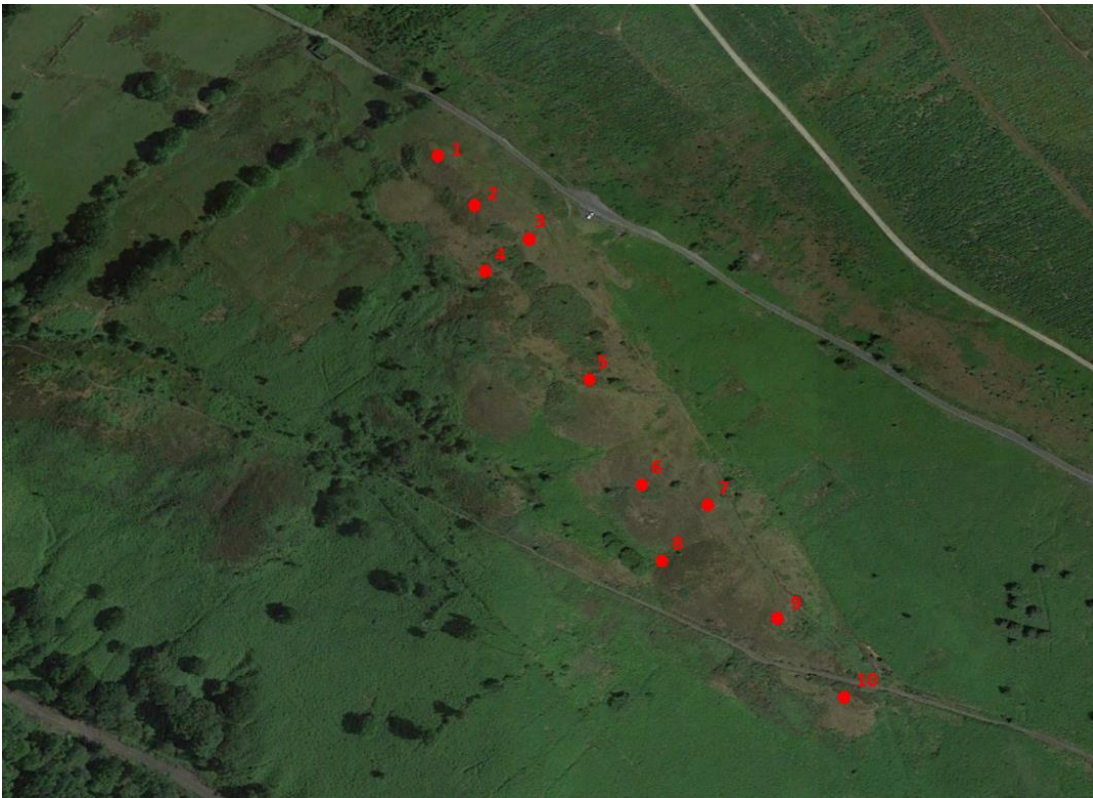
Plan showing fill sampling trial pits taken as a traverse across the slide

The ten trial pits are shown on the sketch below and as mentioned above these were completed in January 2021. Currently a detailed survey plan is not available but one will be included in the ground investigation design note which will feed into planning documentation.

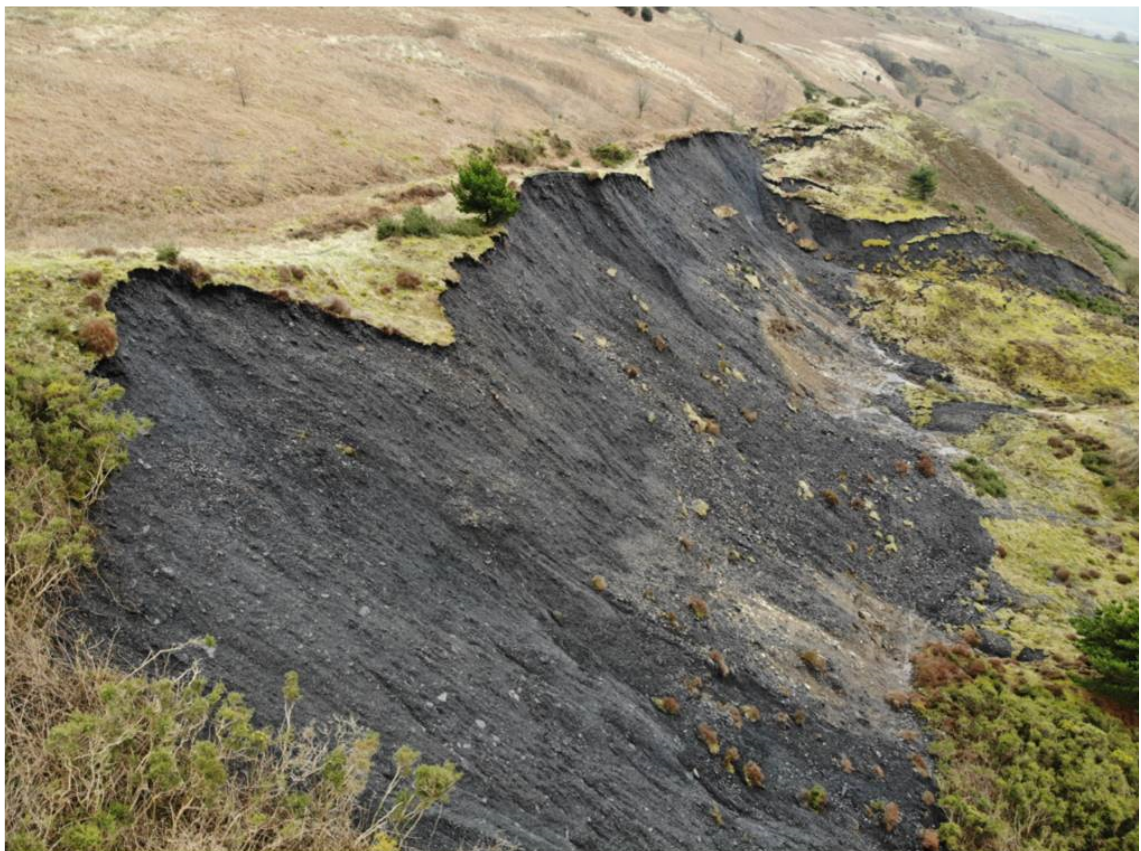
Within the mid-slope area of the northern part of Llanwonno Upper Tip is a tension crack. There are multiple tension cracks in the southern section of the tip, radiating from the landslide back scar as shown in Figure 2.2 below.

Figure 2.2 Photograph showing back scar with a high slope of glacial till exposed in lower third of scar face

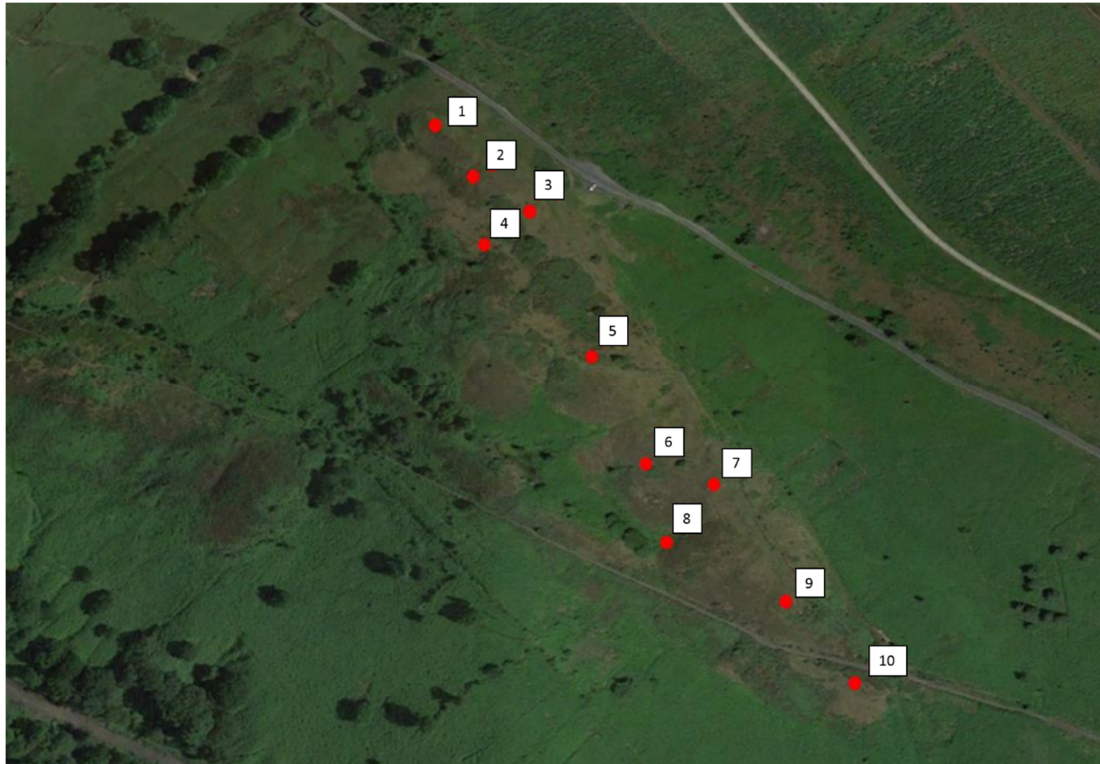
Figure 3.1: Extract from ES showing location of trial pits at Llanwonno Upper Tip excavated in 2021

An intrusive sampling exercise was undertaken at Llanwonno Tip in January 2021 and comprised an initial phase of ten hand pits (0.6m deep), taken as a traverse across the width of the slip at locations where material is to be taken off the slip feature and deposited to Receptor Site C.
