**Flood and Water Management Act 2010**

# **Section 19 Report**

**Storm Bert – Flood Investigation Area 17**

**October 2025**

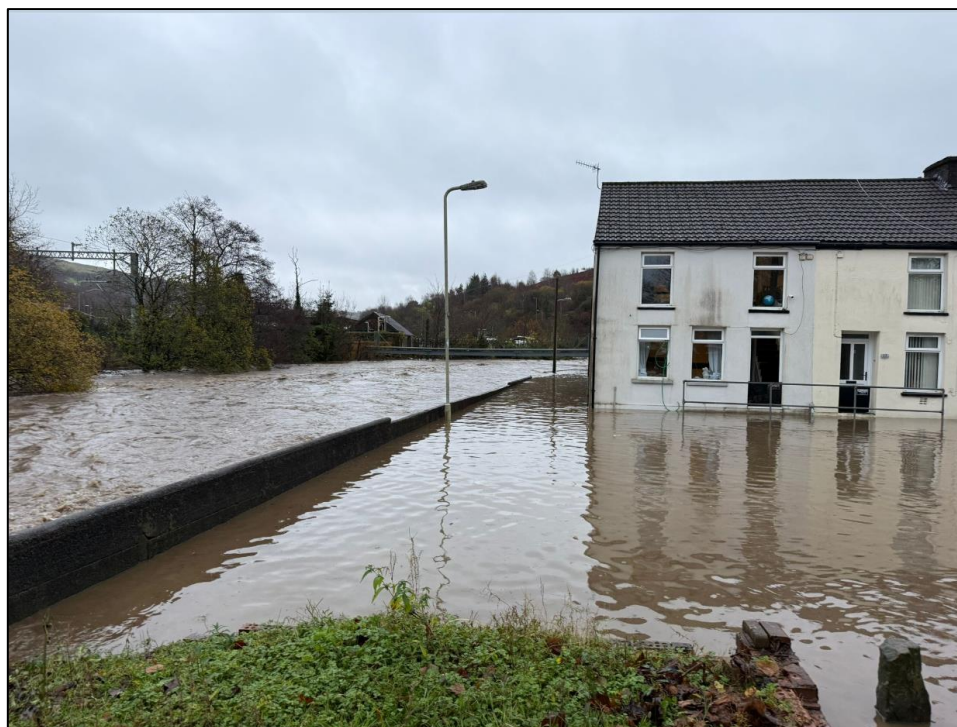
**Figure 4:** The River Rhondda overtopping the highway wall adjacent to Brook Street at 'Area 1' (image captured by a local resident).

During the storm event, a section of retaining highway wall at Brook Street was identified as overtopped. The retaining wall is identified as a NFD structure and is therefore not a designated flood defence structure.

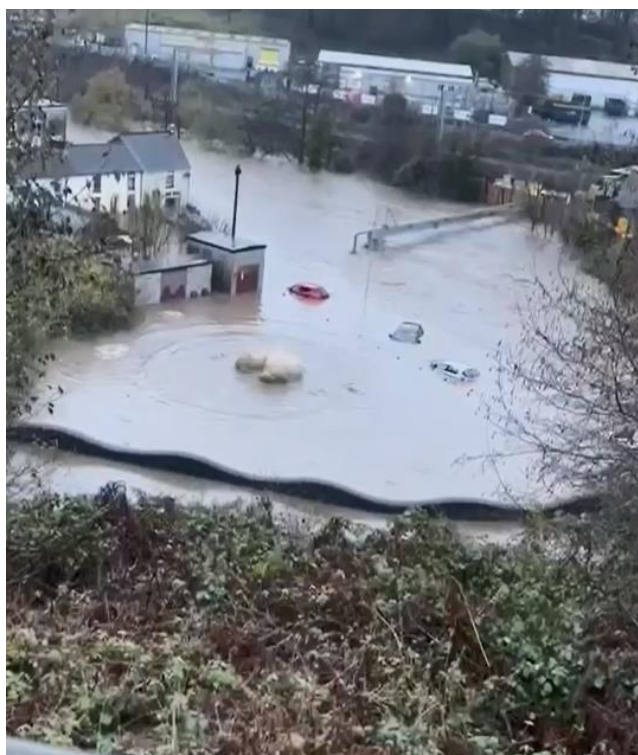
**Figure 5:** A DCWW pumping station impacted by main river flows during Storm Bert (image captured by a local resident).

As discussed in Section 2.2, a DCWW foul water pumping station at Brook Street was observed to be inundated by the River Rhondda, which overtopped the adjacent NFD highway wall. The upwelling of water (Figure 5) was the result of air cyclically releasing from the pumping station as it was operating, however became over capacitated by main river flows entering the system. This is reported to have contributed to the flooding of the DCWW trunk sewer network further downstream. The pumping station at Brook Street is identified as a receptor of the flooding that occurred within FIA 17, not a contributory source.

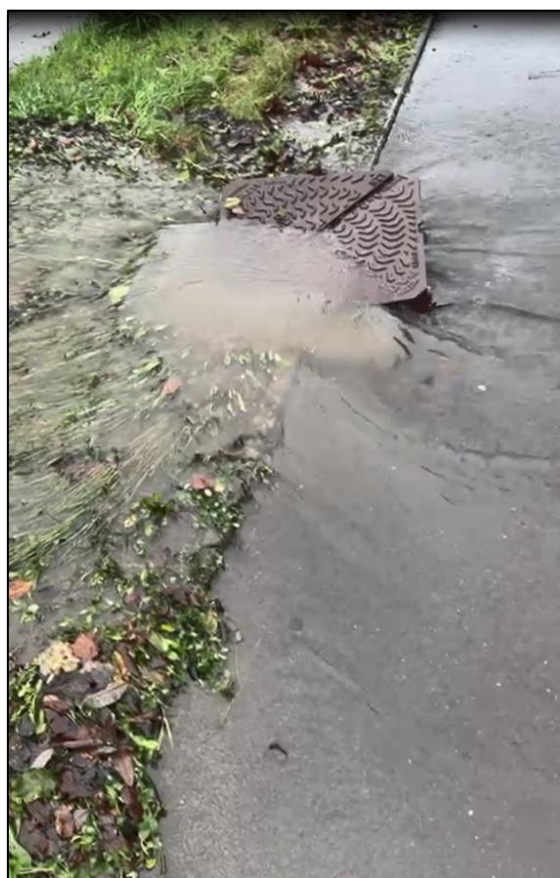
A manhole associated to a culverted ordinary watercourse network and located at the A4058 Coedcae Road, was identified as surcharging during the storm event (labelled 'Manhole 1' in Figure 3 and depicted in Figure 6). Exceedance flows conveyed from the manhole along the kerbside and towards Brook Street, where they accumulated at a topographic low point and contributed to the main river flooding experienced at Brook Street.

**Figure 6:** Surcharging manhole at Coedcae Road ('Manhole 1') (image captured by a local resident).

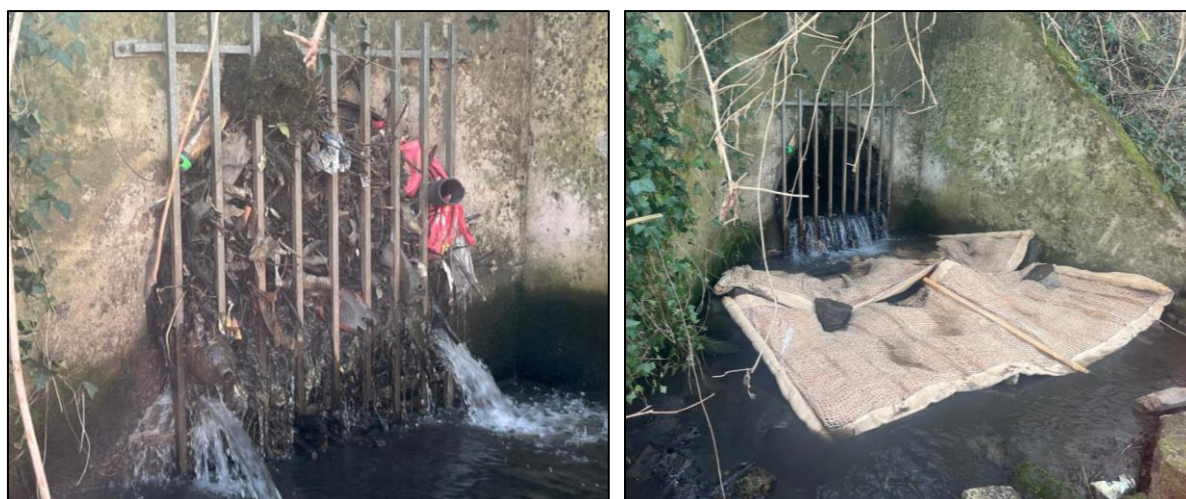
Following the events of Storm Bert, an inspection of the culverted network identified 'Outlet 1' as obstructed by a significant buildup of debris (as shown in Figure 8). This debris consisted primarily of natural scour material (silt, stone, woody debris) and urban litter. The identified obstruction is considered to have reduced the culverted ordinary watercourse's ability to discharge flows into the River Rhondda, resulting in the surcharging of 'Manhole 1'.

**Figure 8:** (Left) Significant debris accumulation at the culvert out post event. (Right) Culvert outlet post cleansing utilising appropriate silt control measures (images captured by RCT's FRM team post event).

In response to the identified obstruction, the material was removed from the network by the Council's appointed contractors during survey and jetting works post event.

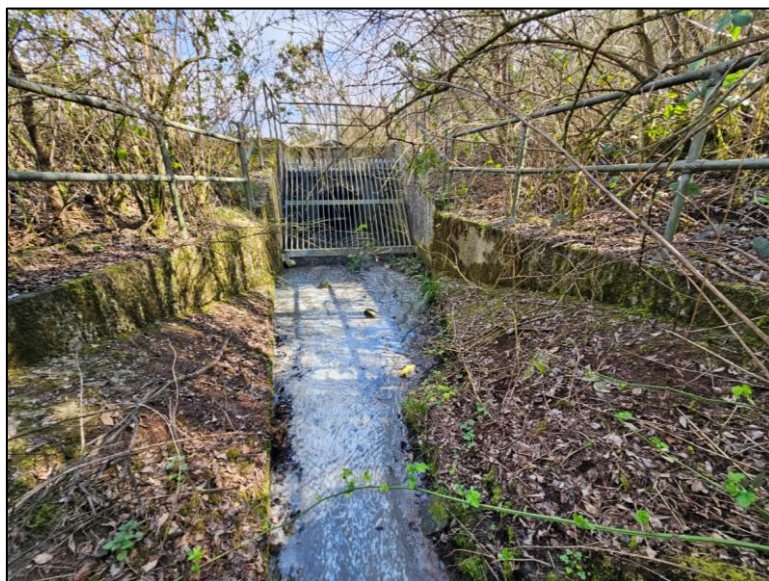
Post event investigations carried out by RCT's Flood Risk Management team inspected 'Inlet 1', '2' and '3' to determine their condition and whether they served as contributing factors to the obstructions present within the culvert network. Figures 9-11 show the condition of the three culvert inlets which were all identified to be in acceptable condition, with minor woody debris and natural scour material observed on the debris screens. This material is similar to the material cleansed from the downstream culvert network.

**Figure 9:** Photo of 'Inlet 1' (image captured by RCT's FRM team post event).

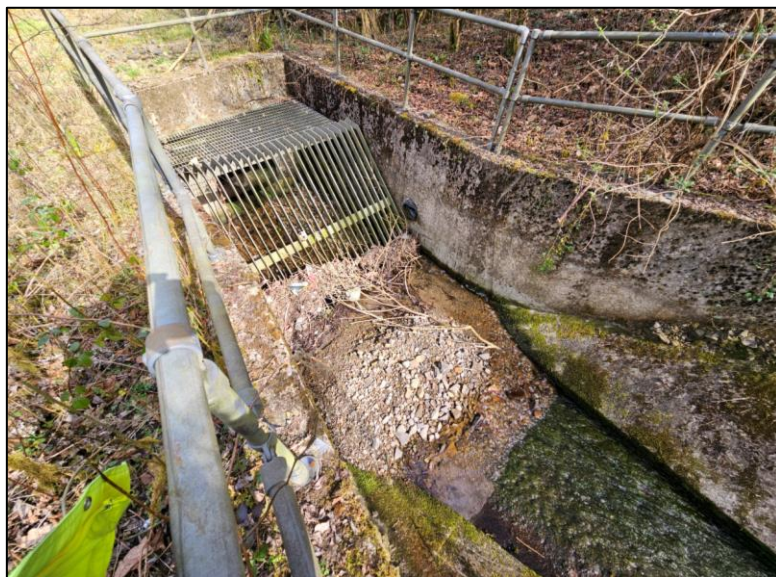
**Figure 10:** Photo of 'Inlet 2' (image captured by RCT's FRM team post event).

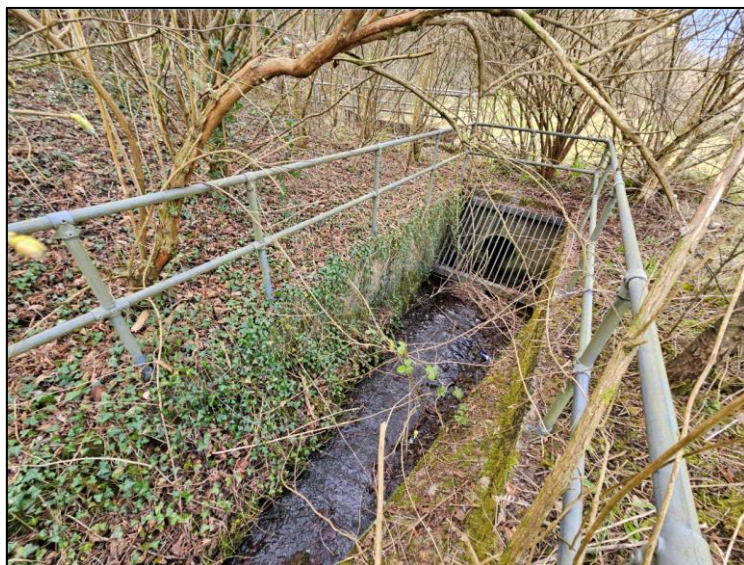
**Figure 11:** Photo of 'Inlet 3' (image captured by RCT's FRM team post event).

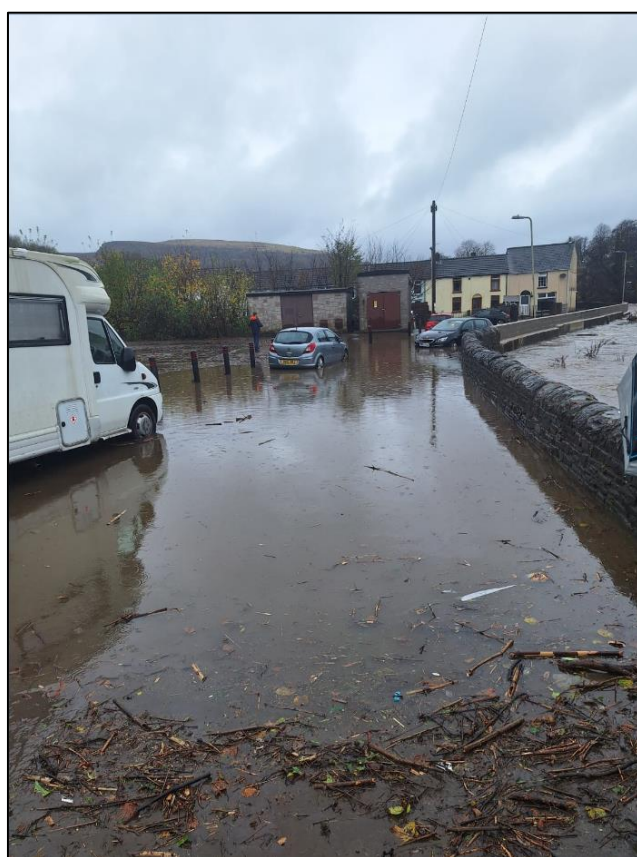
During Storm Bert, Eirw Road, Brook Street and Britannia Street were observed as flooding as a result of the overtopping of the River Rhondda. As illustrated in Figure 14, the resultant fluvial flows deposited mud, silt and debris across the investigation area which are considered to have entered the highway drainage system, leading to blockages and a reduction in the hydraulic capacity of the surface water network.

**Figure 14:** Debris deposited at Brook Street as a result of the overtopping of the River Rhondda during Storm Bert (image captured by a local resident).

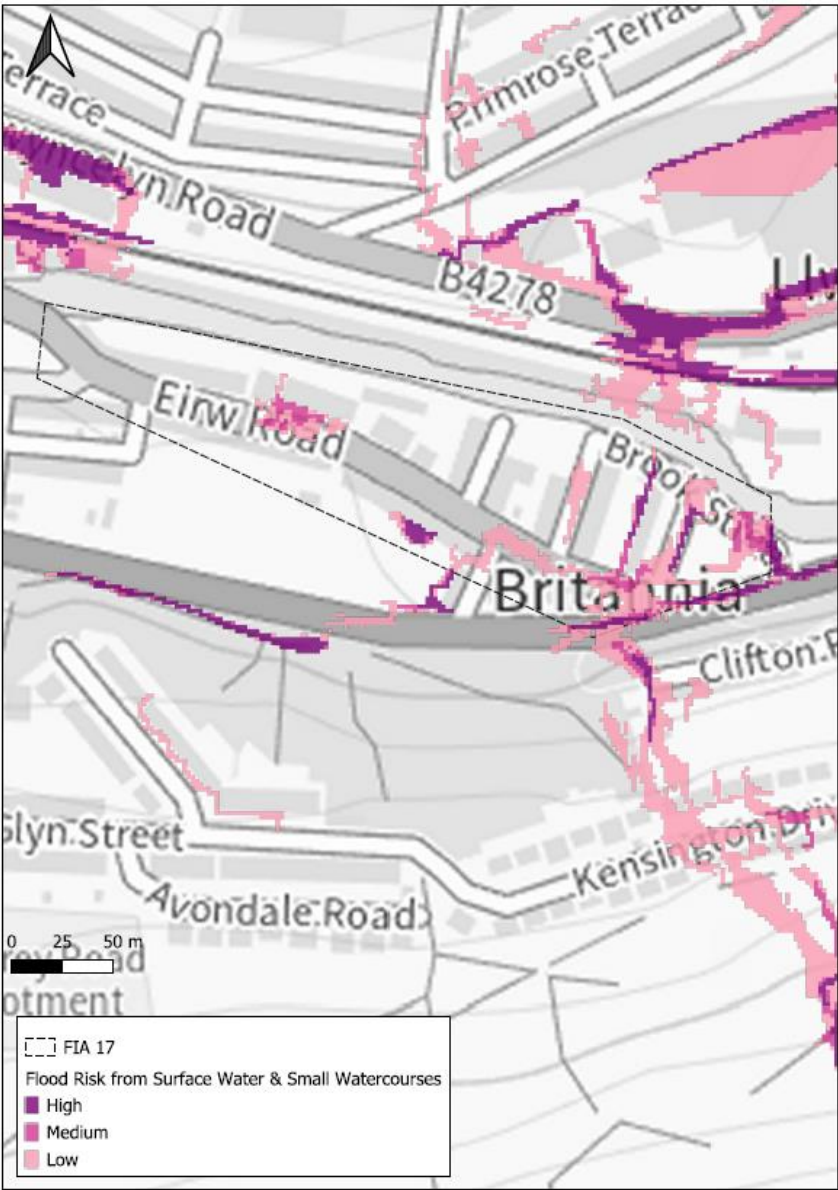
On review of NRW's national surface water and ordinary ("small") watercourse flood map (Figure 15), several streets within the investigation area are noted to be at high to low risk of flooding from these sources. The modelled risk is primarily associated with the network of ordinary watercourses and culverted infrastructure conveying through FIA 17, with high risk noted across Coedcae Road and Brook Street.

**Figure 15:** NRW's FRAW Map for Surface Water and Ordinary Watercourse flood risk at FIA 17.  
Natural Resources Wales data.
