**Flood and Water Management Act 2010**

# **Storm Bert November 2024 - Overview Report**

**February 2025**

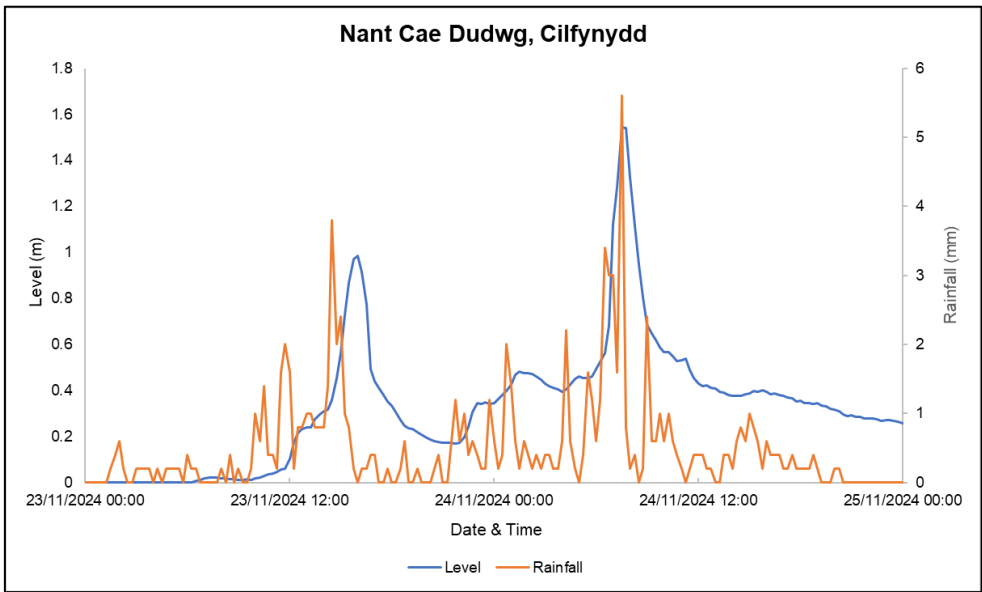
**Figure 8:** Level and rainfall data (hydrograph) and images of the Nant Cae Dudwg inlet captured at RCT's monitoring station on 24<sup>th</sup> November 2024 (06:48 (top left), 07:15 (top right), 07:48 (bottom left), 15:16 (bottom right)).

Examples of the rapid rise and subsequent fall in watercourse levels in response to rainfall is illustrated below within the hydrographs and supported by CCTV footage which show the response of two high-risk ordinary watercourses situated at Cilfynydd (Figure 8) and Rhydyfelin (Figure 9) during the storm event. Both watercourses rose rapidly over a short amount of time, with a lag time of approximately 15 to 30-minutes following peak rainfall. This exceptionally short lag time between peak rainfall and peak discharge was experienced across several of RCT's watercourses, causing them to become overwhelmed during the storm event, causing flooding downstream.

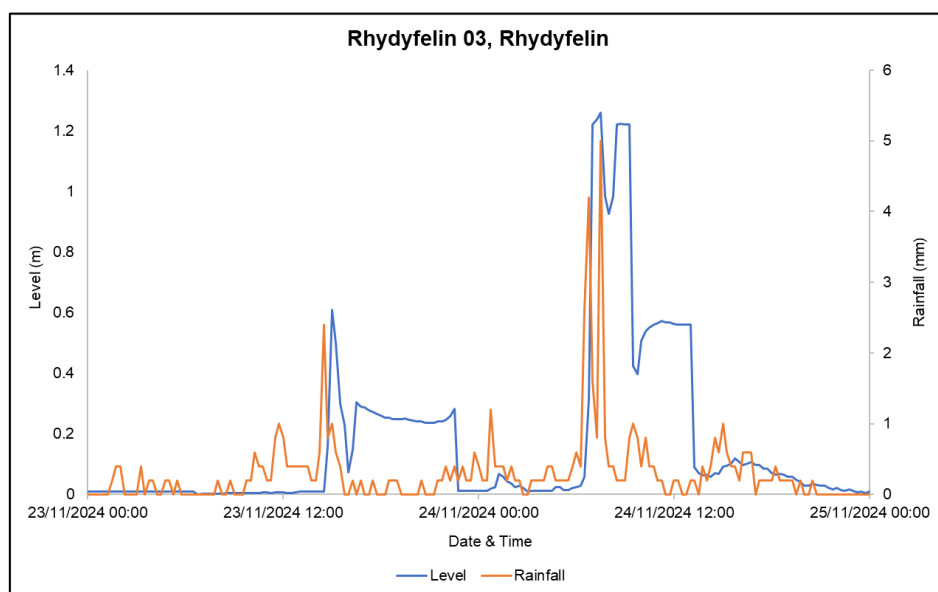
**Figure 9:** Level and rainfall data (hydrograph) and images of the Rhydyfelin 03 inlet captured at RCT's monitoring station on 24<sup>th</sup> November 2024 (06:24 (top left), 07:15 (top right), 07:48 (bottom left), 09:43 (bottom right)).

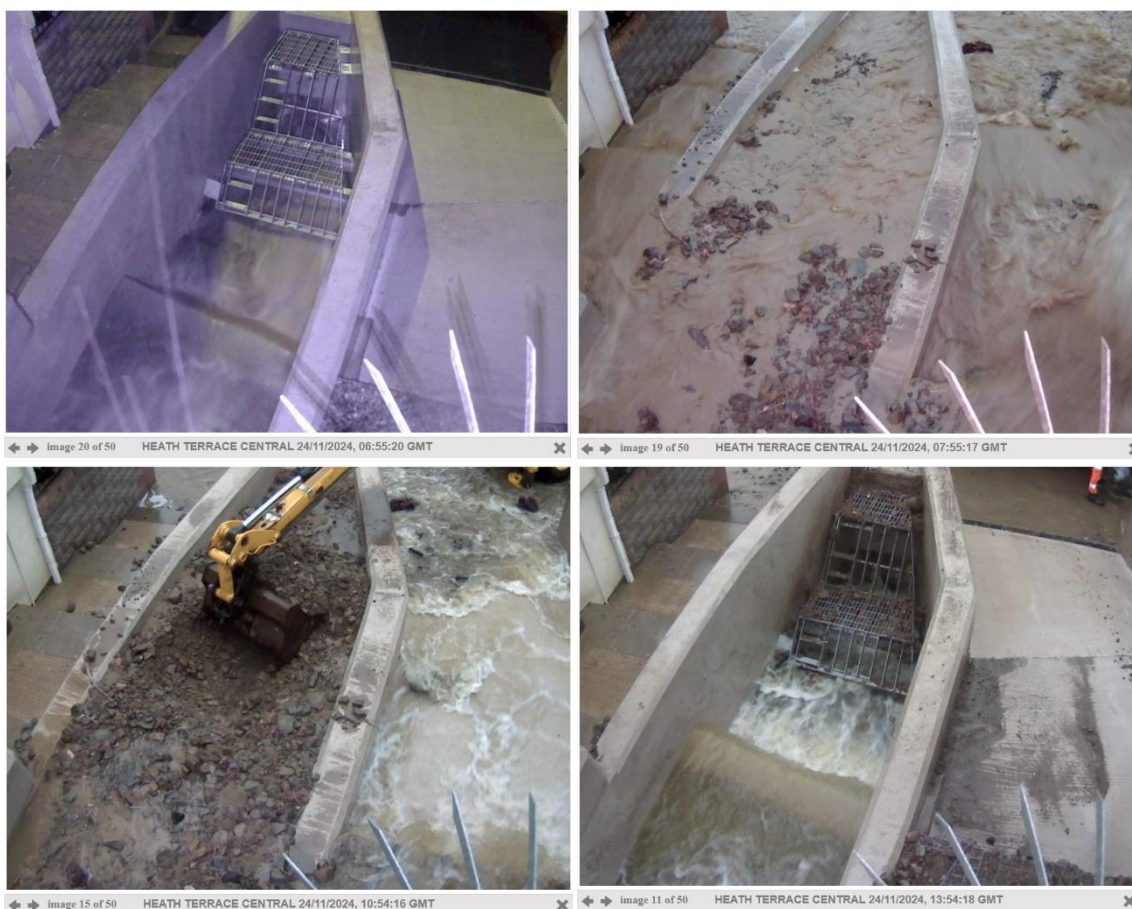
**Figure 10:** Images of the Heath Terrace Central culvert inlet captured at RCT's monitoring station on 24<sup>th</sup> November 2024 (06:55 (top left), 07:55 (top right), 10:54 (bottom left), 13:54 (bottom right)).

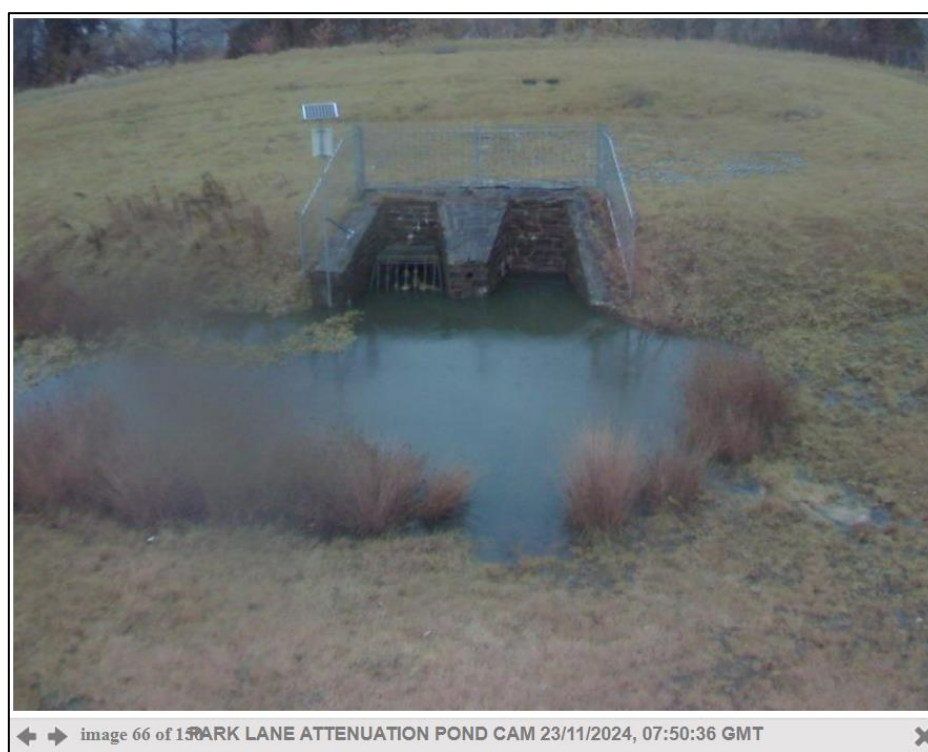
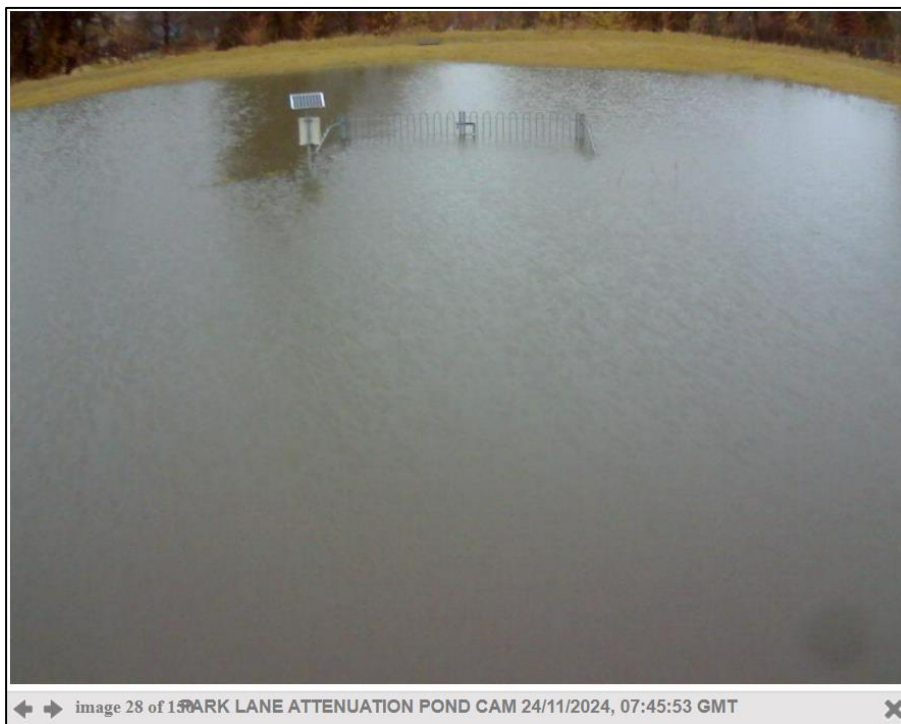
**Figure 11:** RCT's Park Lane attenuation basin captured by CCTV before (top) Storm Bert at 07:50 23<sup>rd</sup> November 2024, and during (bottom) Storm Bert at 07:45 24<sup>th</sup> November 2024 (it's peak level)

Figure 11 displays RCT's Park Lane attenuation basin before and during Storm Bert, demonstrating the peak storage utilised based on CCTV footage. The basins achieved peak storage capacity between 07:00 and 08:00 on Sunday 24<sup>th</sup> November, with a lag time of approximately one hour after peak rainfall which again illustrates the rapid response of RCT's catchments to rainfall.

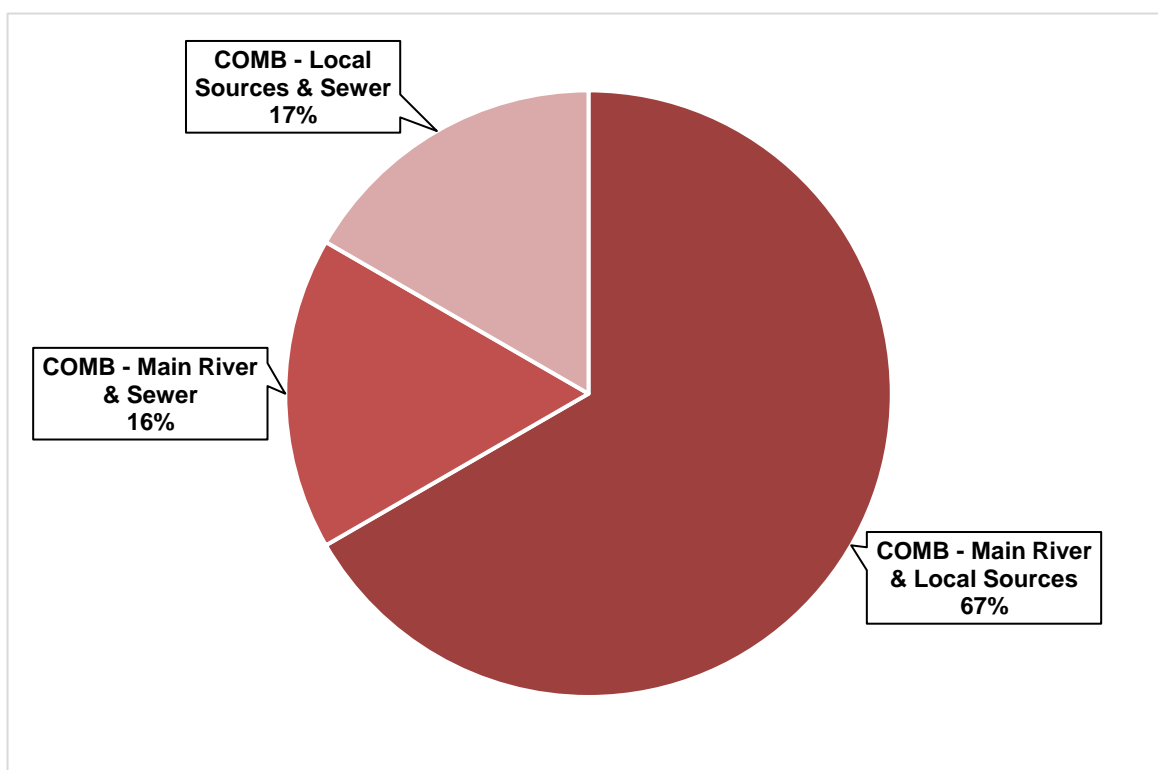
**Figure 19:** Percentage of the flooded receptors during Storm Bert which were impacted by a combination of flood types

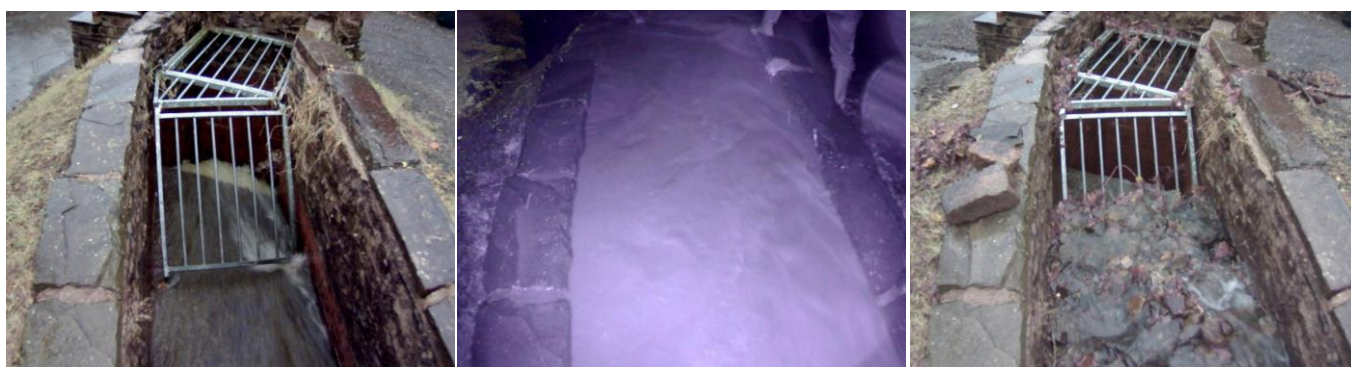
**Figure 20:** Image of a private culvert inlet in Treorchy pre (left), during (middle) and post Storm Bert (right) showing evidence of overtopping during the event and mobilised debris obstructing the trash screen immediately following the event.

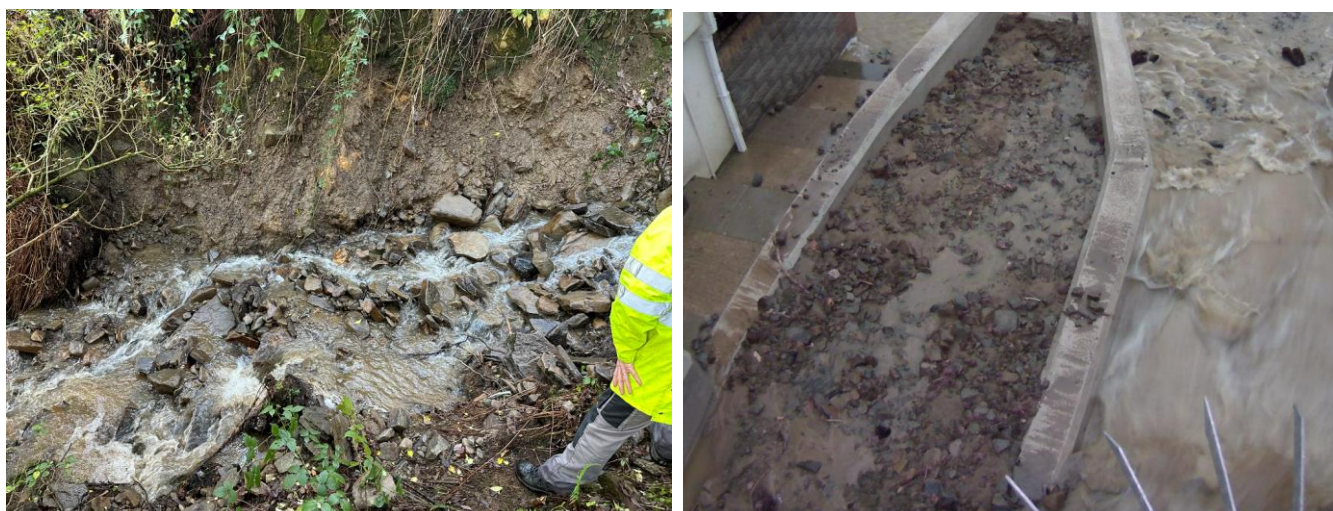
Evidence of scour in the upper catchments of RCT indicate the power of the flows within the watercourses which mobilised and transported large amounts of debris and stonewash downstream towards culvert inlets and carrier lines during the storm event (illustrated in Figures 23). Minor landslips and fallen trees were also identified during post event inspections (Figure 24), increasing the risk of obstruction to infrastructure downstream.

**Figure 23:** Evidence of scour to the banking of the unnamed ordinary watercourse (left) and the subsequent deposition of material downstream at the Heath Terrace Central culvert inlet in Ynyshir (right) during Storm Bert.

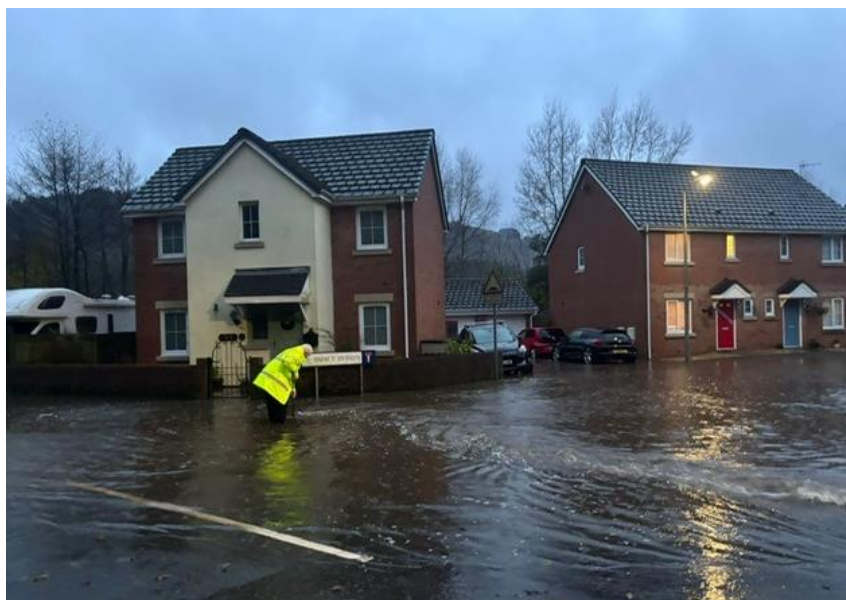
**Figure 25:** Surface water flooding at Trem y Dyffryn, Mountain Ash during Storm Bert

Notable areas of surface water flooding include parts of Aberdare, Cwmbach and Mountain Ash. An example of surface water flooding at Trem y Dyffryn, Mountain Ash is included in Figure 25.

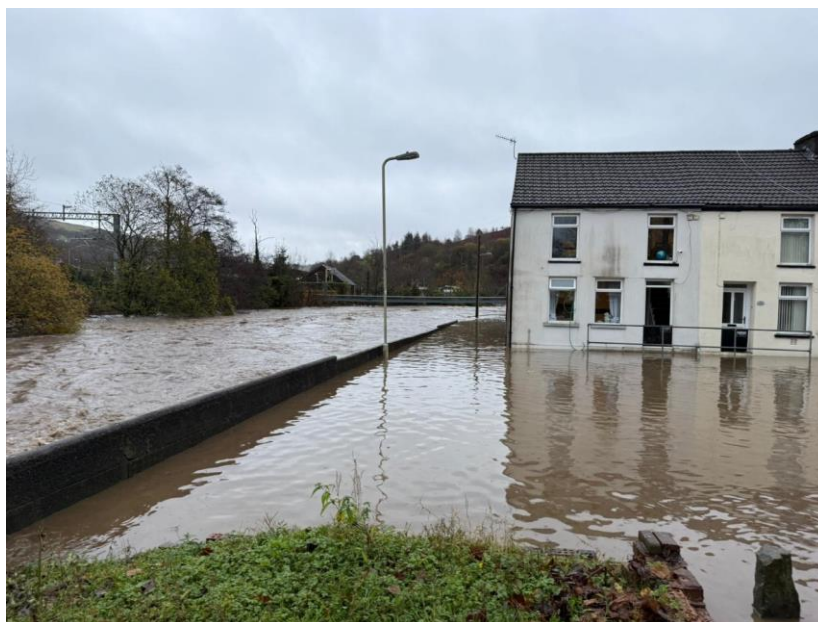
**Figure 26:** Flooding from the River Rhondda at Britannia Street, Porth during Storm Bert

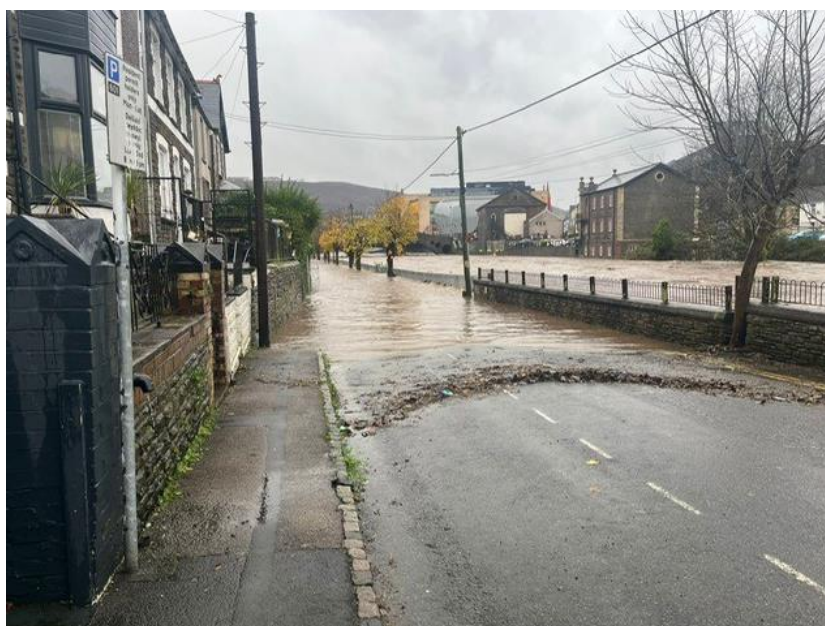
**Figure 27:** Flooding from the River Taf at Berw Rad, Pontypridd during Storm Bert

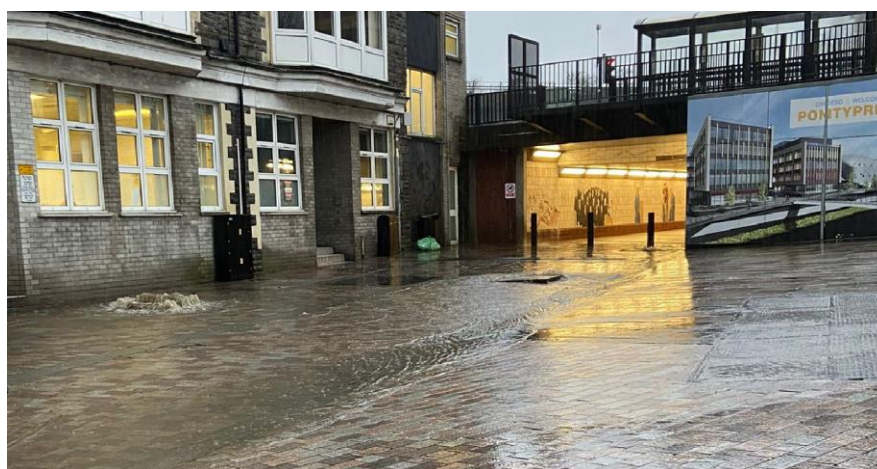
**Figure 28:** Two combined sewer manholes showing evidence of surcharge at Mill Street, Pontypridd during Storm Bert

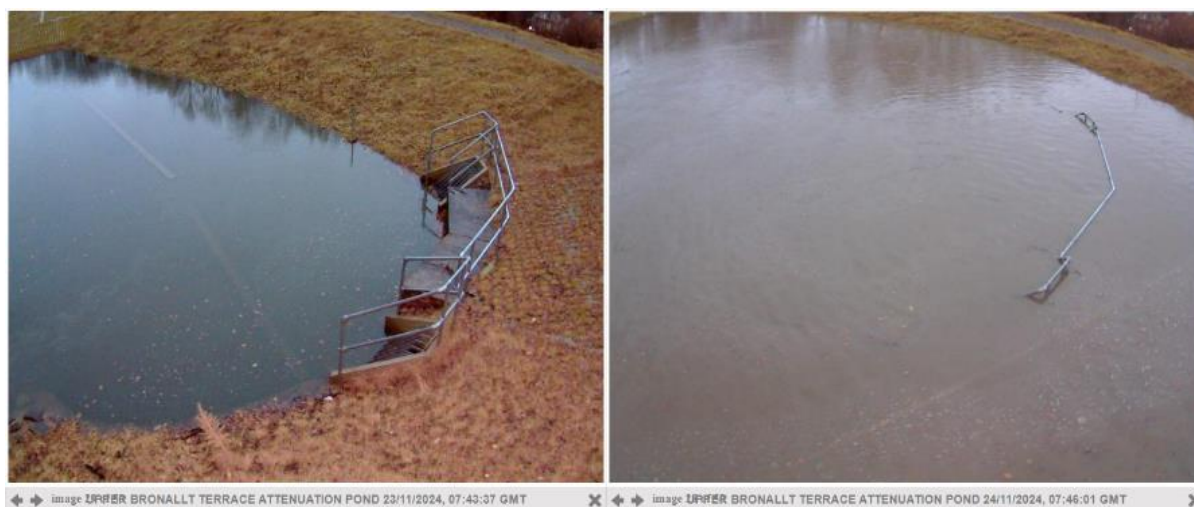
**Figure 29:** The response of the Upper Bronallt Terrace Attenuation Basin Flood Alleviation Scheme in Abercwmboi during the peak of Storm Bert

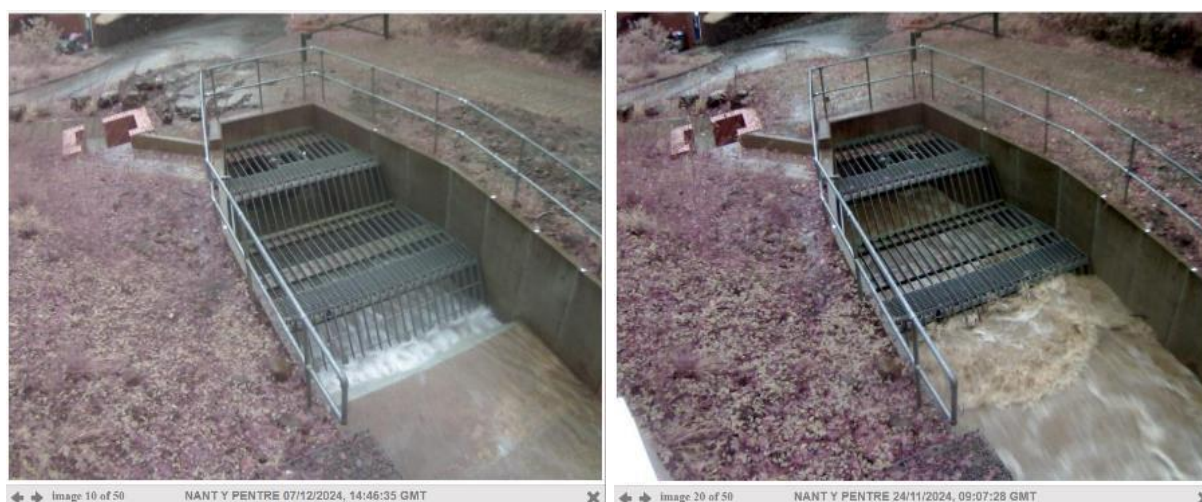
**Figure 30:** The response of the Pentre Road culvert inlet improvements in Pentre during the peak of Storm Bert

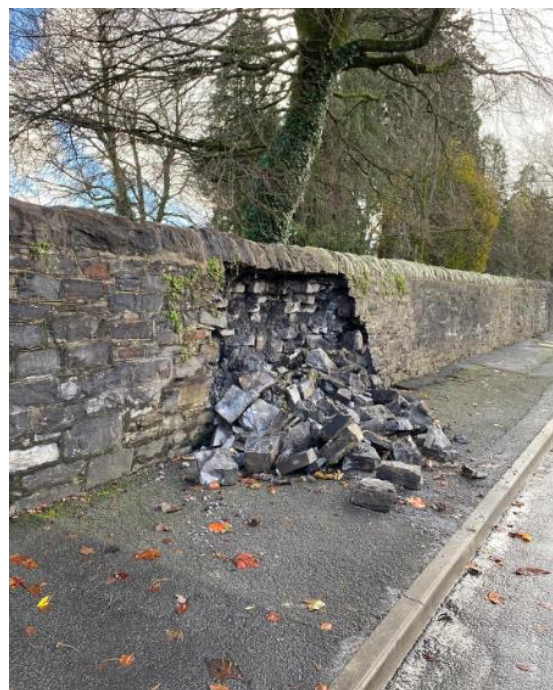
**Figure 31:** Landslip at Tylorstown in the Rhondda Fach (left) and collapsed retaining wall at Aberdare Park (right) captured following Storm Bert

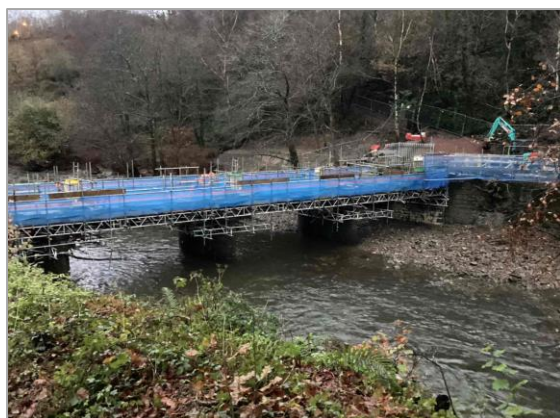
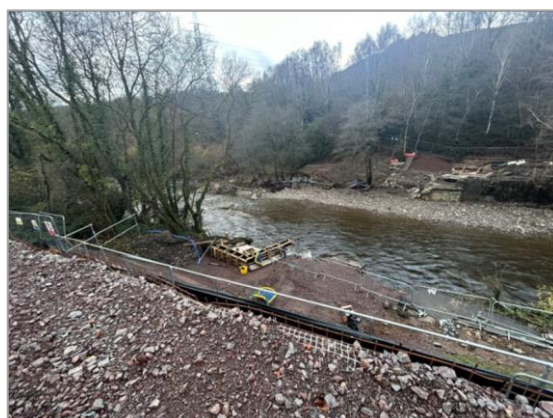
Debris was identified as caught underneath bridges at twelve locations across RCT, in addition to ongoing construction works to replace Feeder Pipe Footbridge in Abercynon which were washed away during Storm Bert. Images showing the construction works at Feeder Pipe Footbridge before and after Storm Bert are shown in Figure 32.

**Figure 32:** Feeder Pipe Footbridge, Abercynon before and after Storm Bert

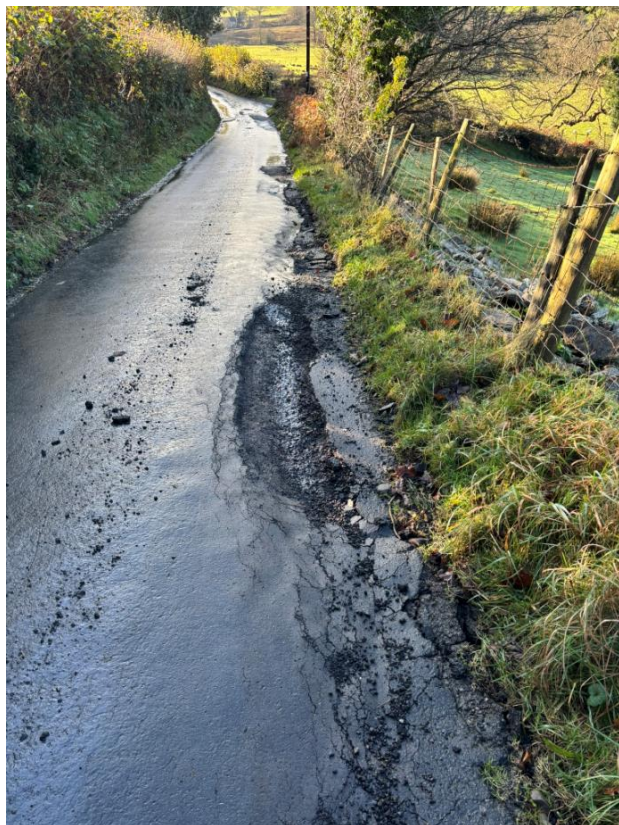
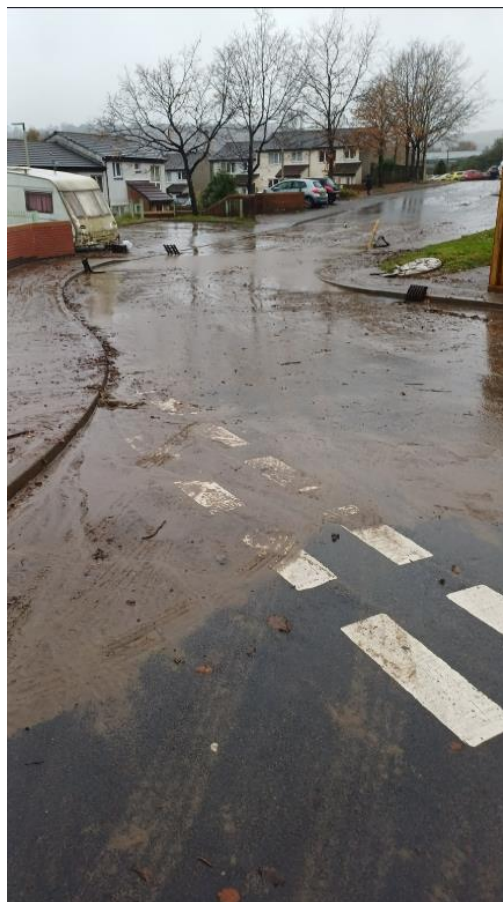
Damages to highway infrastructure, rural lanes and carriageway surfacing was also commonplace during Storm Bert (Figure 33 left). Debris and stonewash mobilised from the upper catchments above residential settlements and carried downstream via watercourses resulted in blockages to the highway drainage network which not only caused significant damages but also exacerbated the flooding to the highway. Figure 33 (right) depicts evidence of silt and stonewash deposited onto the highway at Wordsworth Gardens in Rhydyfelin following the overtopping of watercourses upstream.

**Figure 33:** Scour damage to the highway in Beddau (left) and silt and debris deposited along the highway at Rhydyfelin following Storm Bert
