Rhondda Fach Active Travel Route

Ground Investigation Report (Phases 3, 4 & 5)

Doc Ref: GC3569-RED-74-ATR-RP-D-0005

Rhondda Cynon Taf County Borough Council

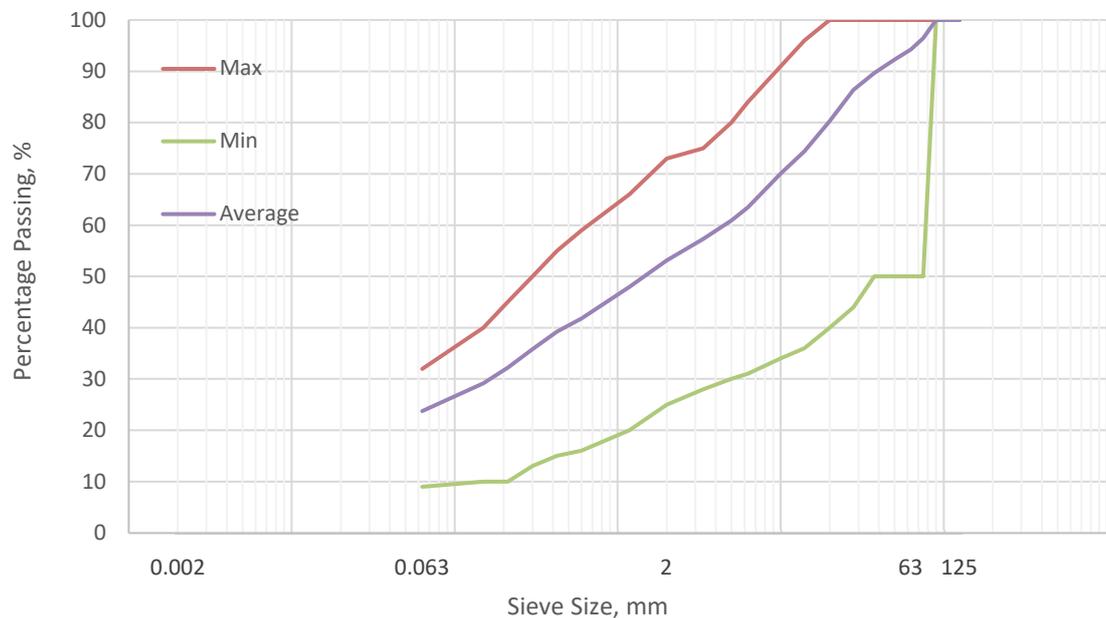
Figure 5.0 – Grading Envelope in Phase 3 Made Ground

The PSD test results provide a typical description for these materials as a very clayey/silty, sandy gravel.

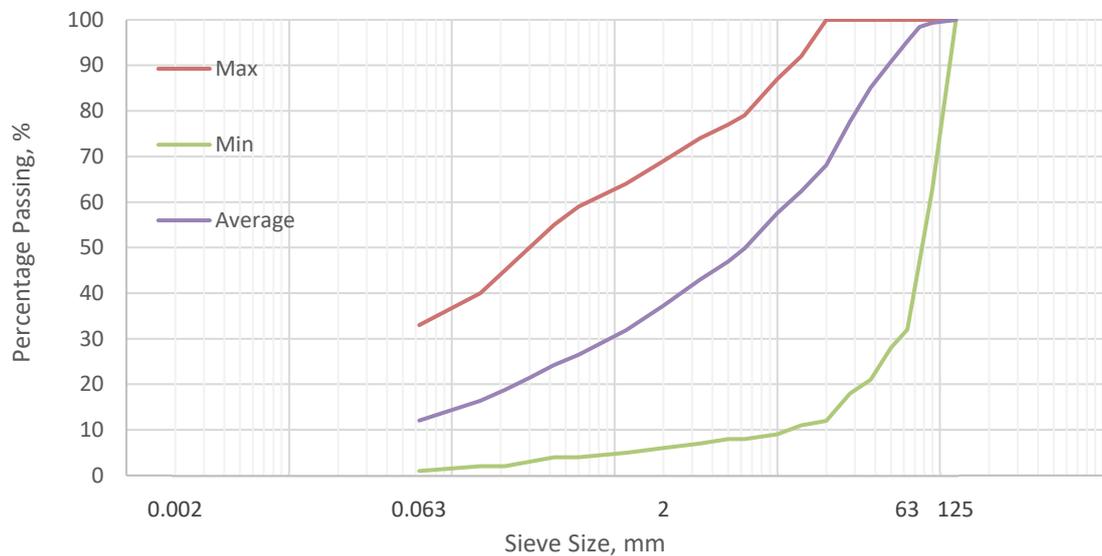
Figure 5.1 – Grading Envelope in Phase 4 Made Ground

The PSD test results give a typical soil description for these materials as a very clayey/silty, sandy gravel.

A total of 66 No. PSD tests were undertaken on material from the Phase 4 area, between the depths of 0.0 and 3.5 mbgl (average 0.85 mbgl). The results are summarised in the Table 5.1 and Figure 5.1.

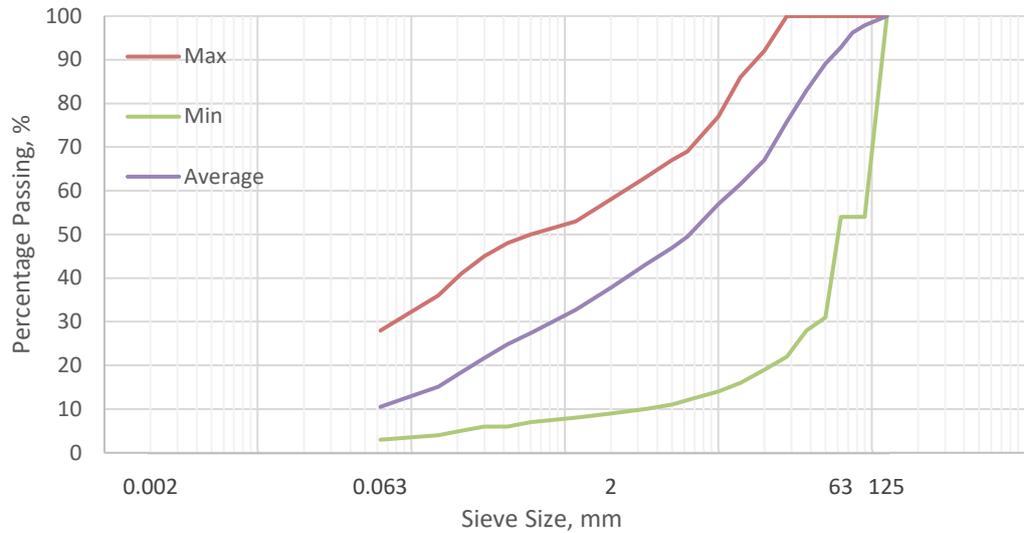
Figure 5.2 – Grading Envelope in Phase 5 Made Ground

The grading for Phase 5 proved to be very similar to that of Phase 4.

22 No. PSD tests were undertaken on material from the Phase 5 area, between the depths of 0.2 and 1.0 mbgl (average 0.45 mbgl). The results are summarised in Table 5.2 and Figure 5.2.

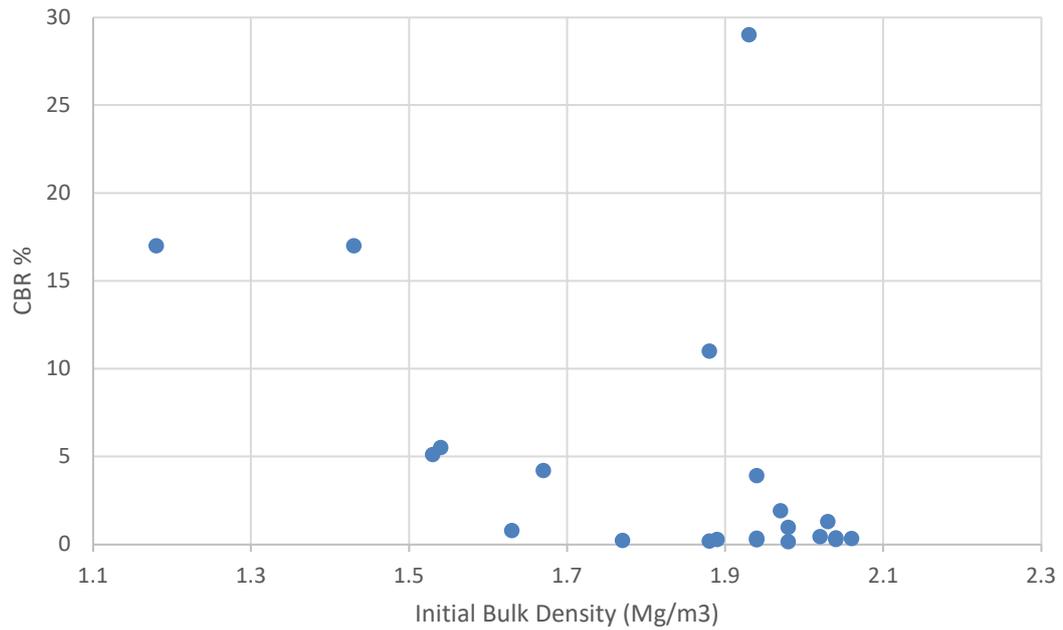
Figure 5.3: Laboratory CBR (%) Vs Initial Bulk Density (Mg/m3)

The laboratory CBR tests provide a wide range of CBR values: 14 No. having a CBR greater than 2 %, 2 No. samples with CBR between 2 and 5 %, and 6 No. with a CBR greater than 5 %, the trend however was those samples with the highest sample density to have the lowest CBR value, see Figure 5.3.

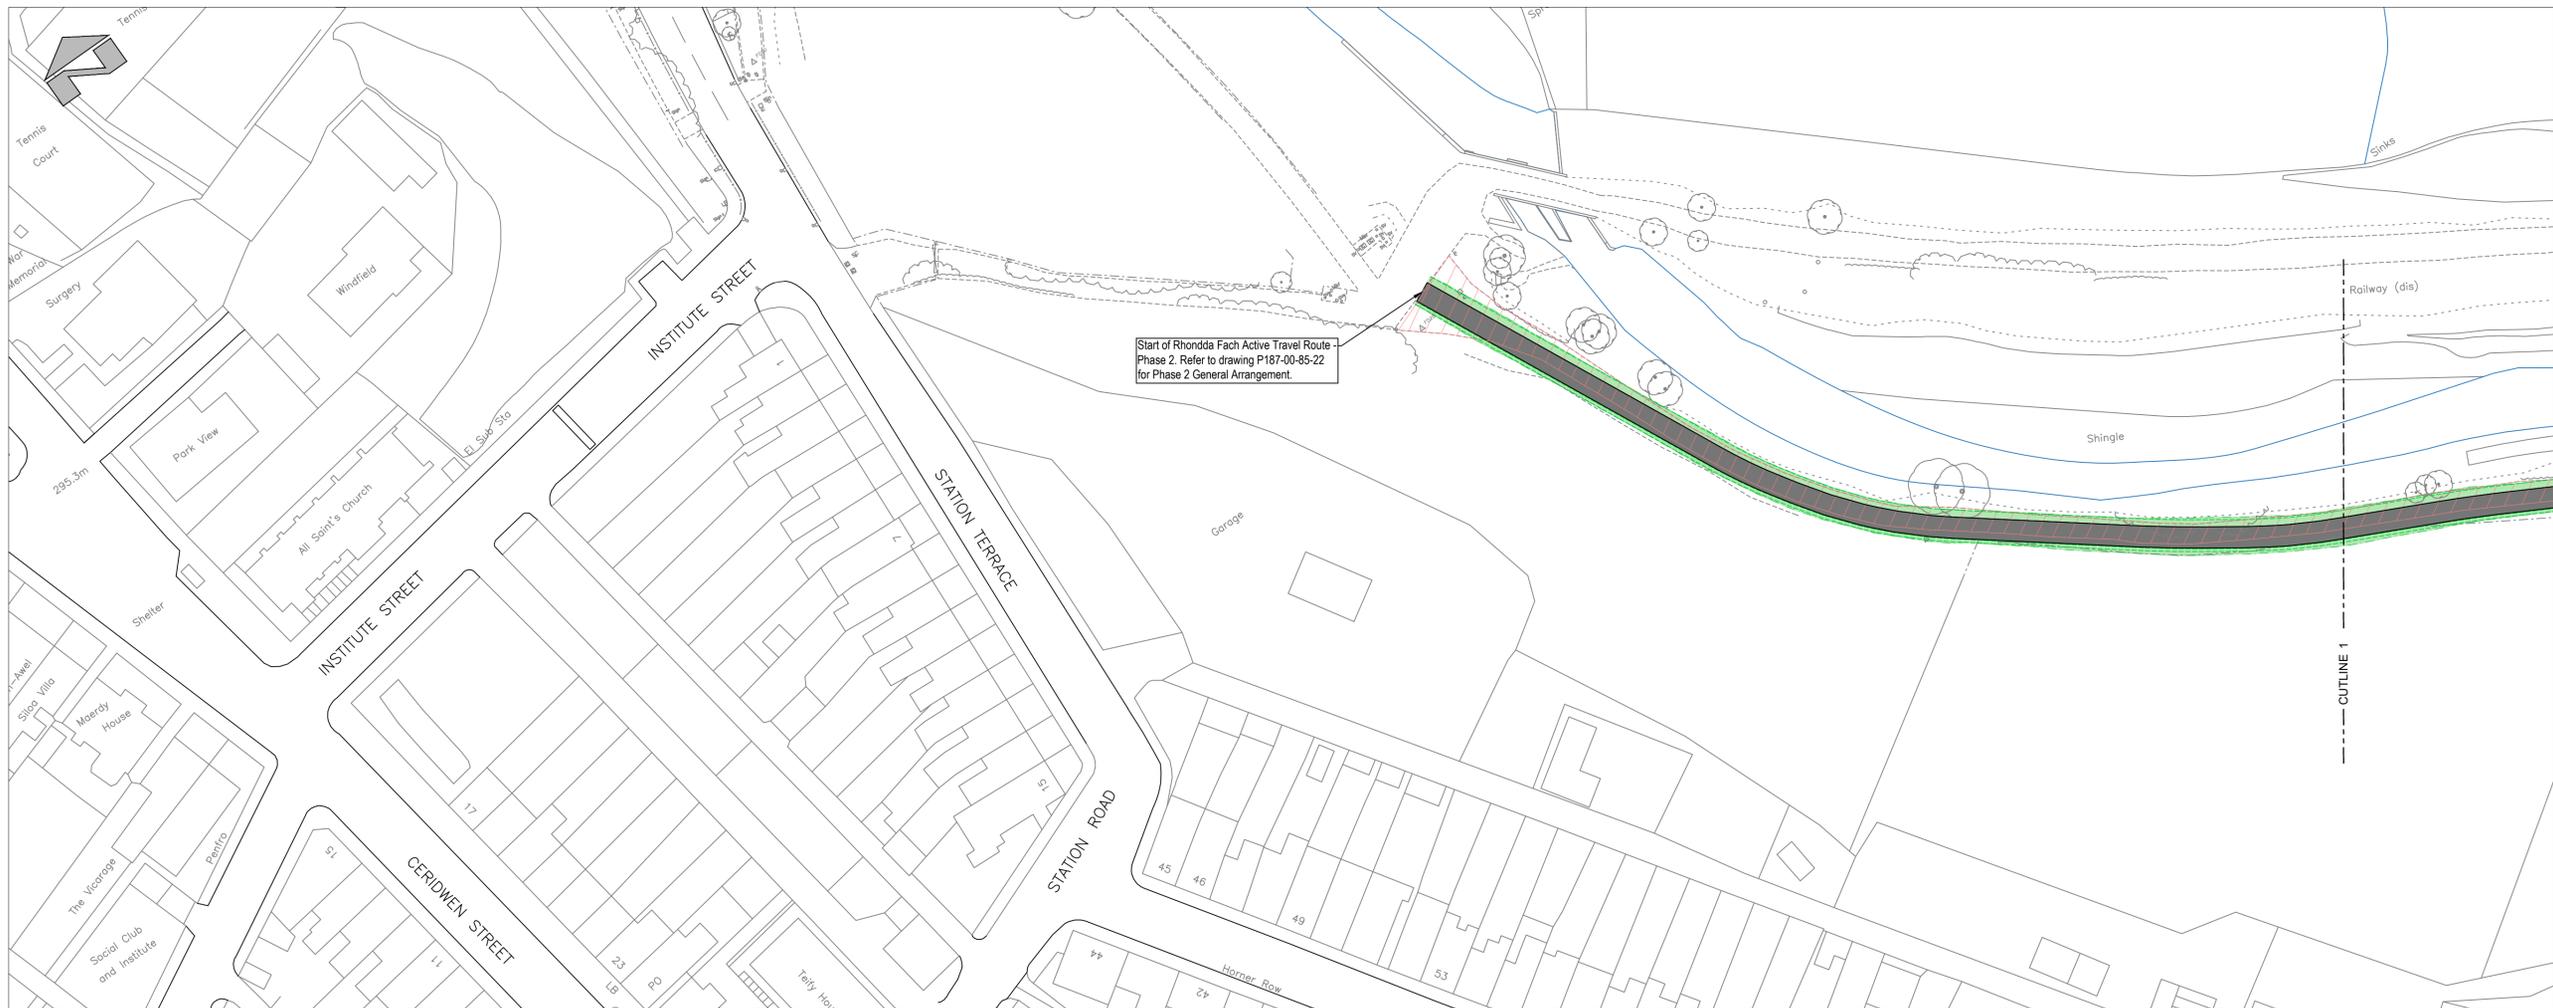
- Key**
- Existing unbound gravel path
 - Existing surfaced path
 - Proposed 3m wide permeable surfaced footpath
 - Proposed verge and embankment
 - Proposed timber post and four rail fence

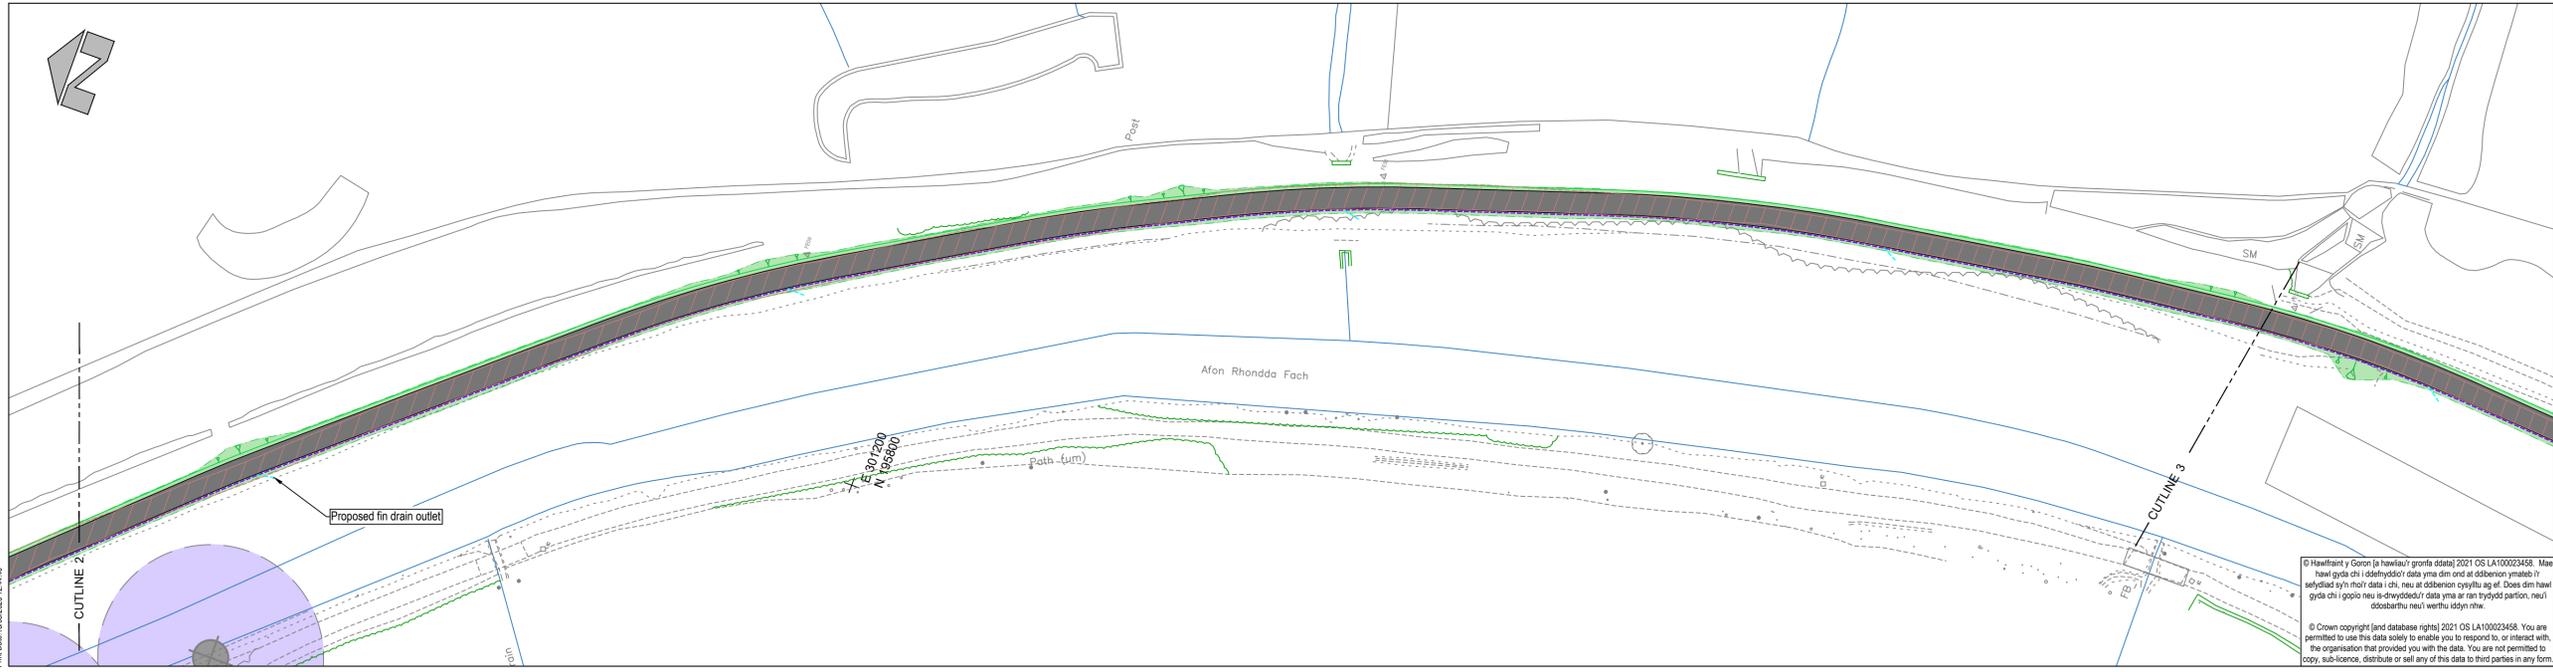
Existing unbound gravel path
	Existing surfaced path
	Proposed 3m wide permeable surfaced footpath
	Proposed verge and embankment
	Proposed fin drain
	Proposed connection pipe
	Mineshaft

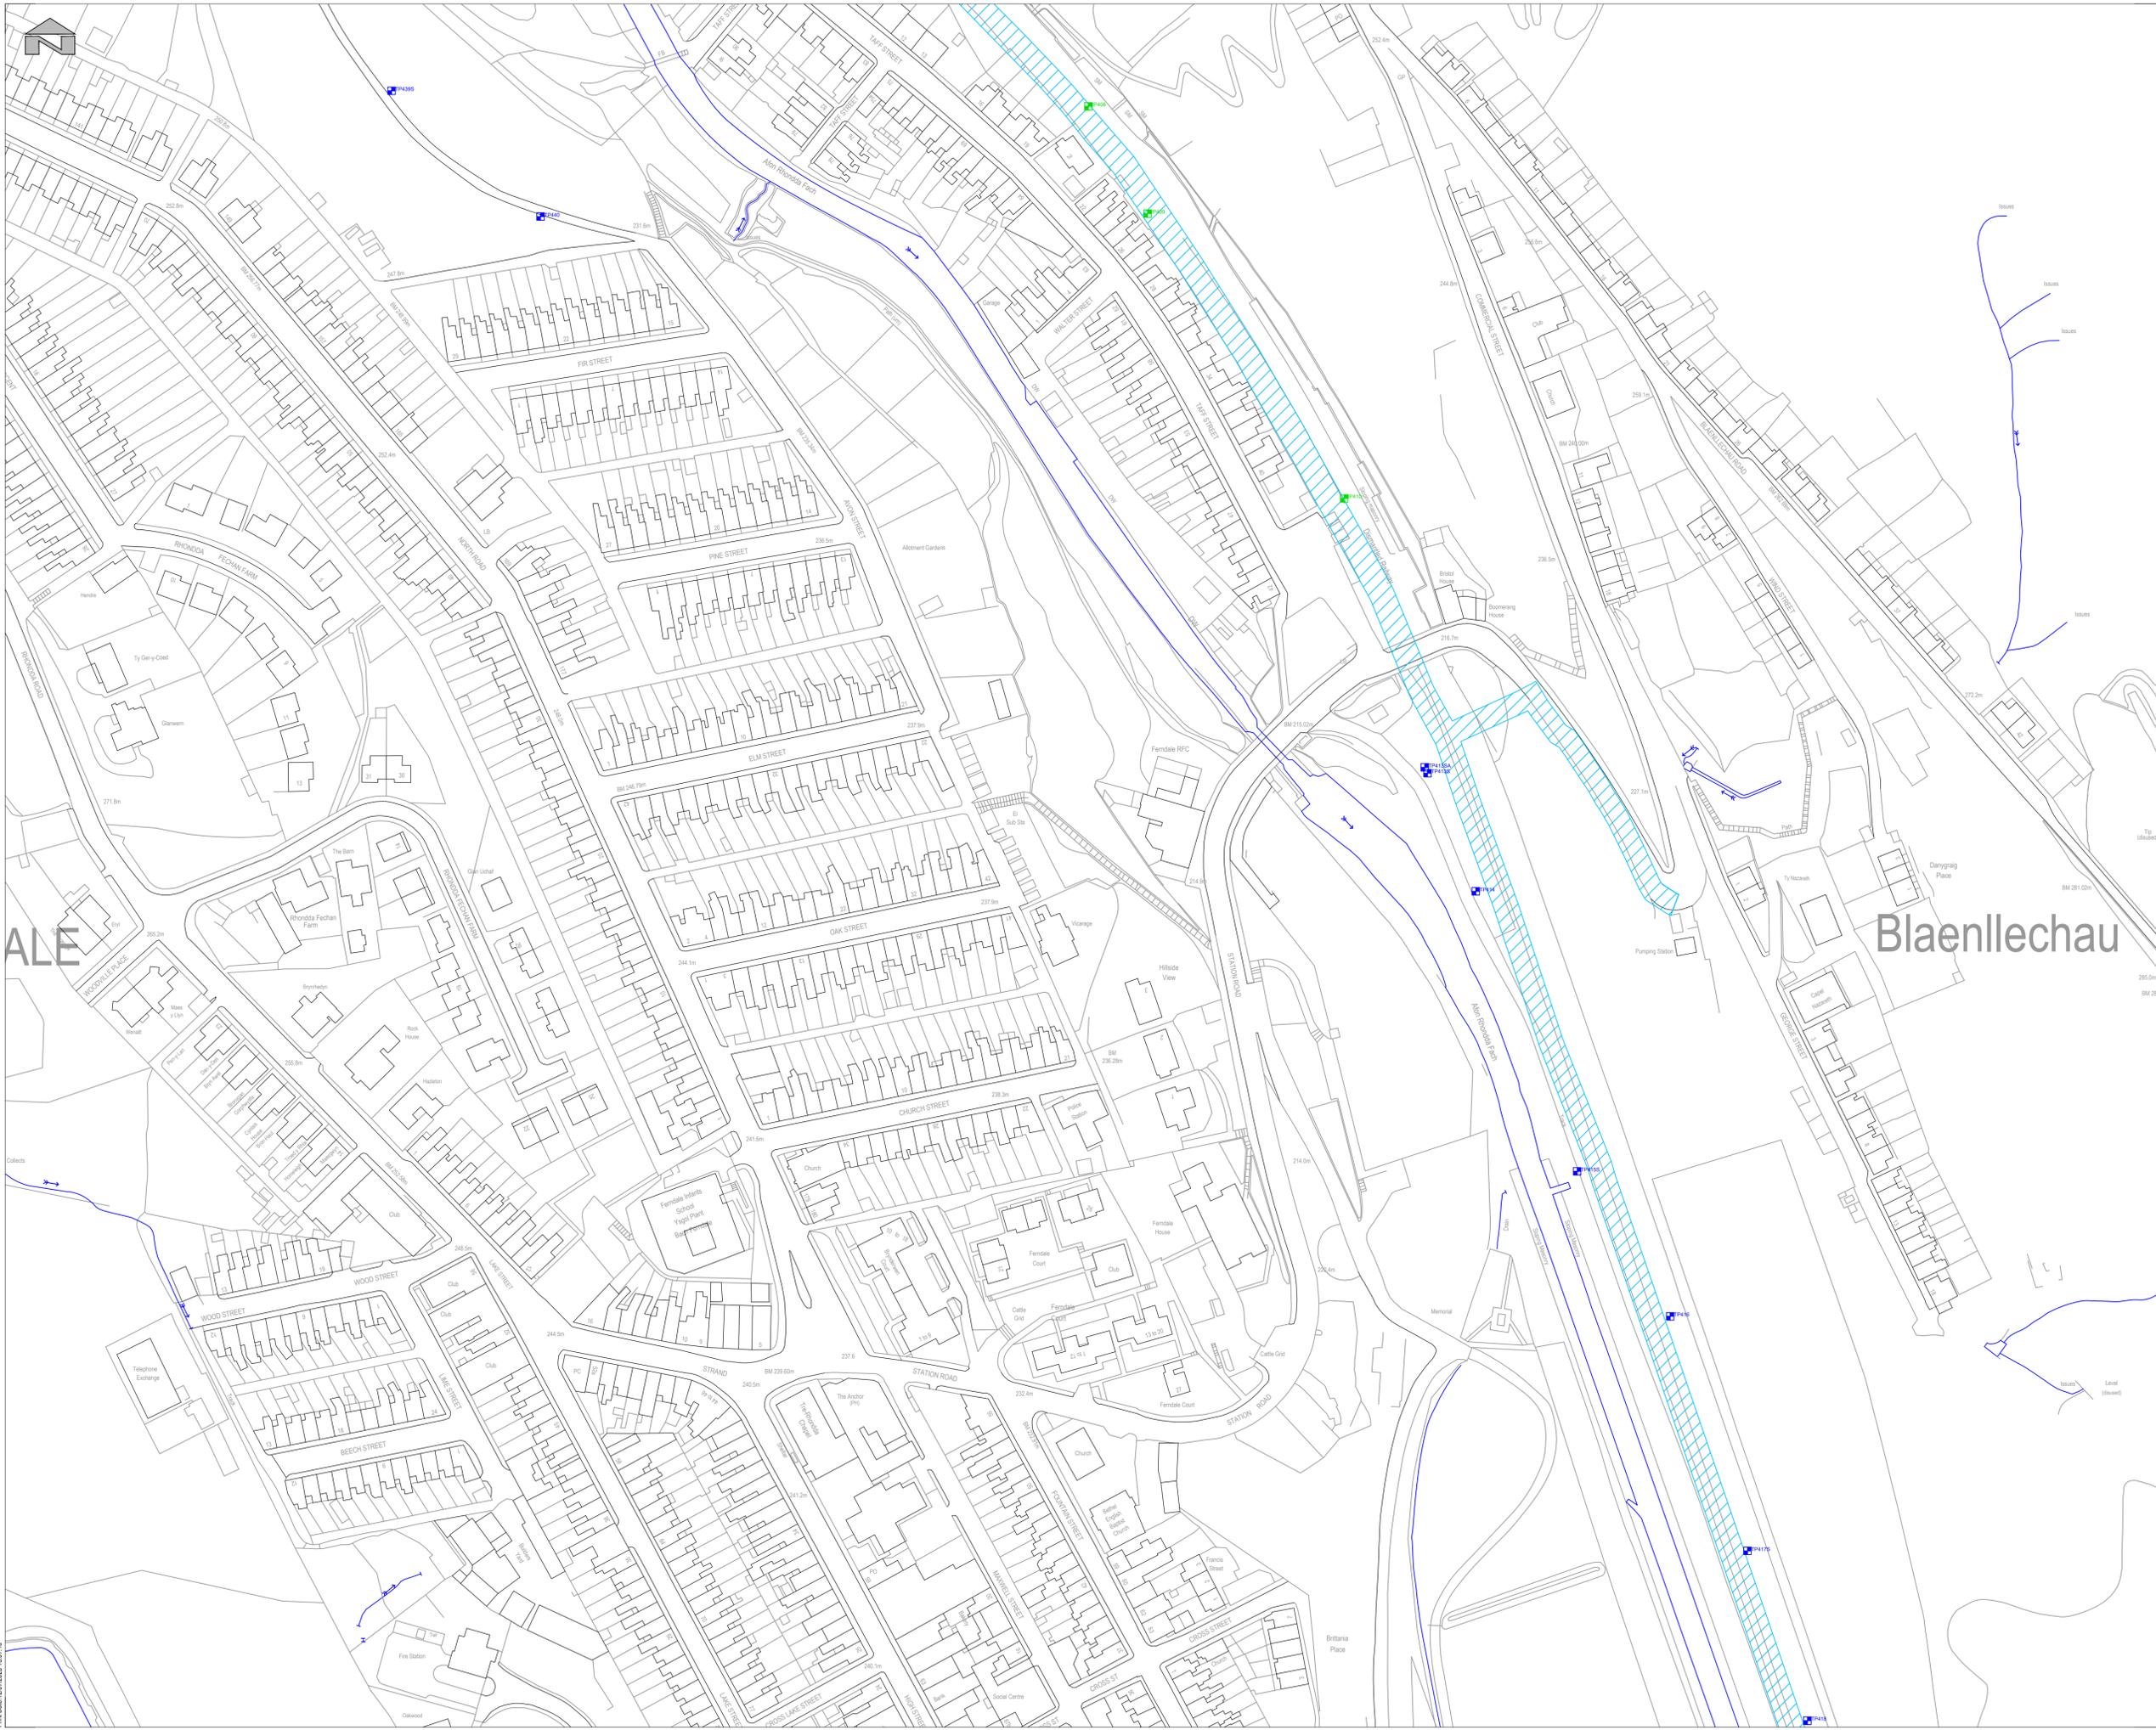
Drawing Identifier	Revision
Project - Originator - Zone - Level - File Type - Title - Number GC3569-RED-75-XX-DR-C-7512	C01

- NOTES**
- DO NOT SCALE FROM THIS DRAWING.
 - THIS DRAWING SHALL BE READ IN CONJUNCTION WITH ALL OTHER CONTRACT DRAWINGS AND DOCUMENTS.
 - A NON-INTRUSIVE PAS 128 TYPE B SURVEY (TO QL-BP3) IS REQUIRED AT EACH EXPLORATORY HOLE LOCATION.
- KEY**
- PROPOSED BOREHOLE
 - PROPOSED TRIAL PIT
 - PROPOSED INSPECTION PIT
 - INDICATIVE DCWW EXCLUSION ZONE (SUPPLIED BY RCT)

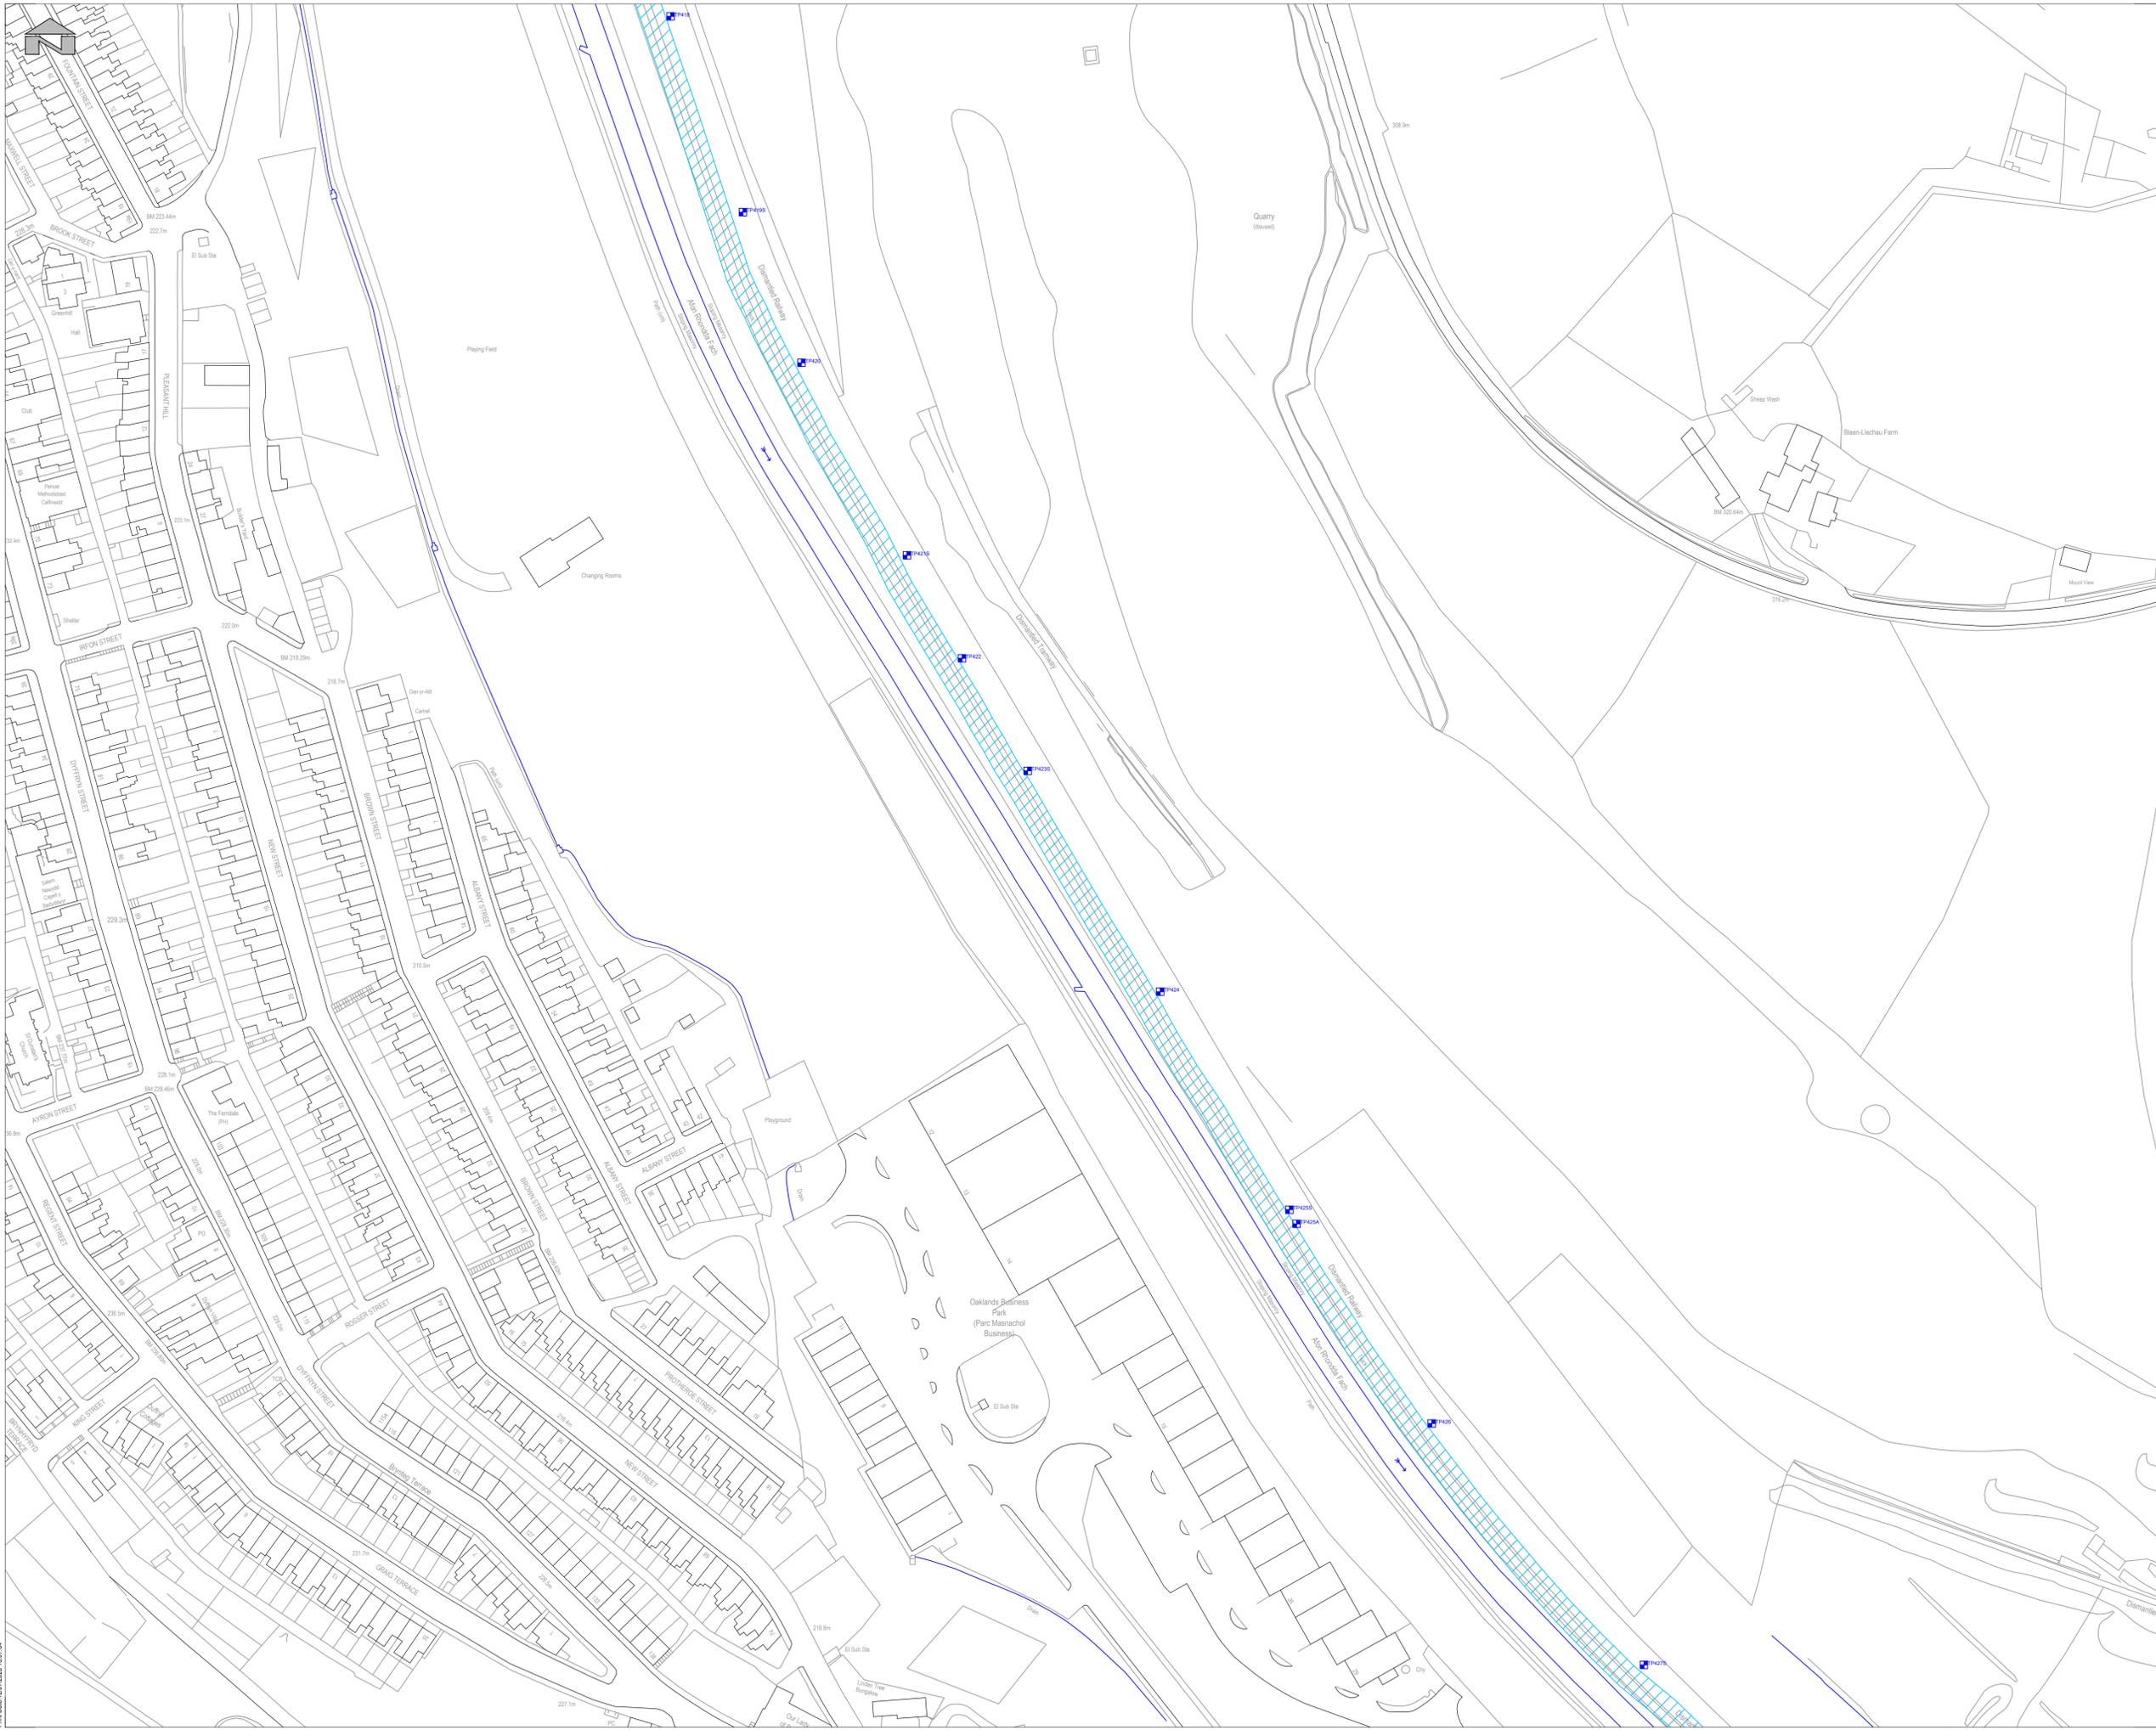
- NOTES**
- DO NOT SCALE FROM THIS DRAWING.
 - THIS DRAWING SHALL BE READ IN CONJUNCTION WITH ALL OTHER CONTRACT DRAWINGS AND DOCUMENTS.
 - A NON-INTRUSIVE PAS 128 TYPE B SURVEY (TO QL-BP3) IS REQUIRED AT EACH EXPLORATORY HOLE LOCATION.
- KEY**
- PROPOSED BOREHOLE
 - PROPOSED TRIAL PIT
 - PROPOSED INSPECTION PIT
 - INDICATIVE DCWW EXCLUSION ZONE (SUPPLIED BY RCT)

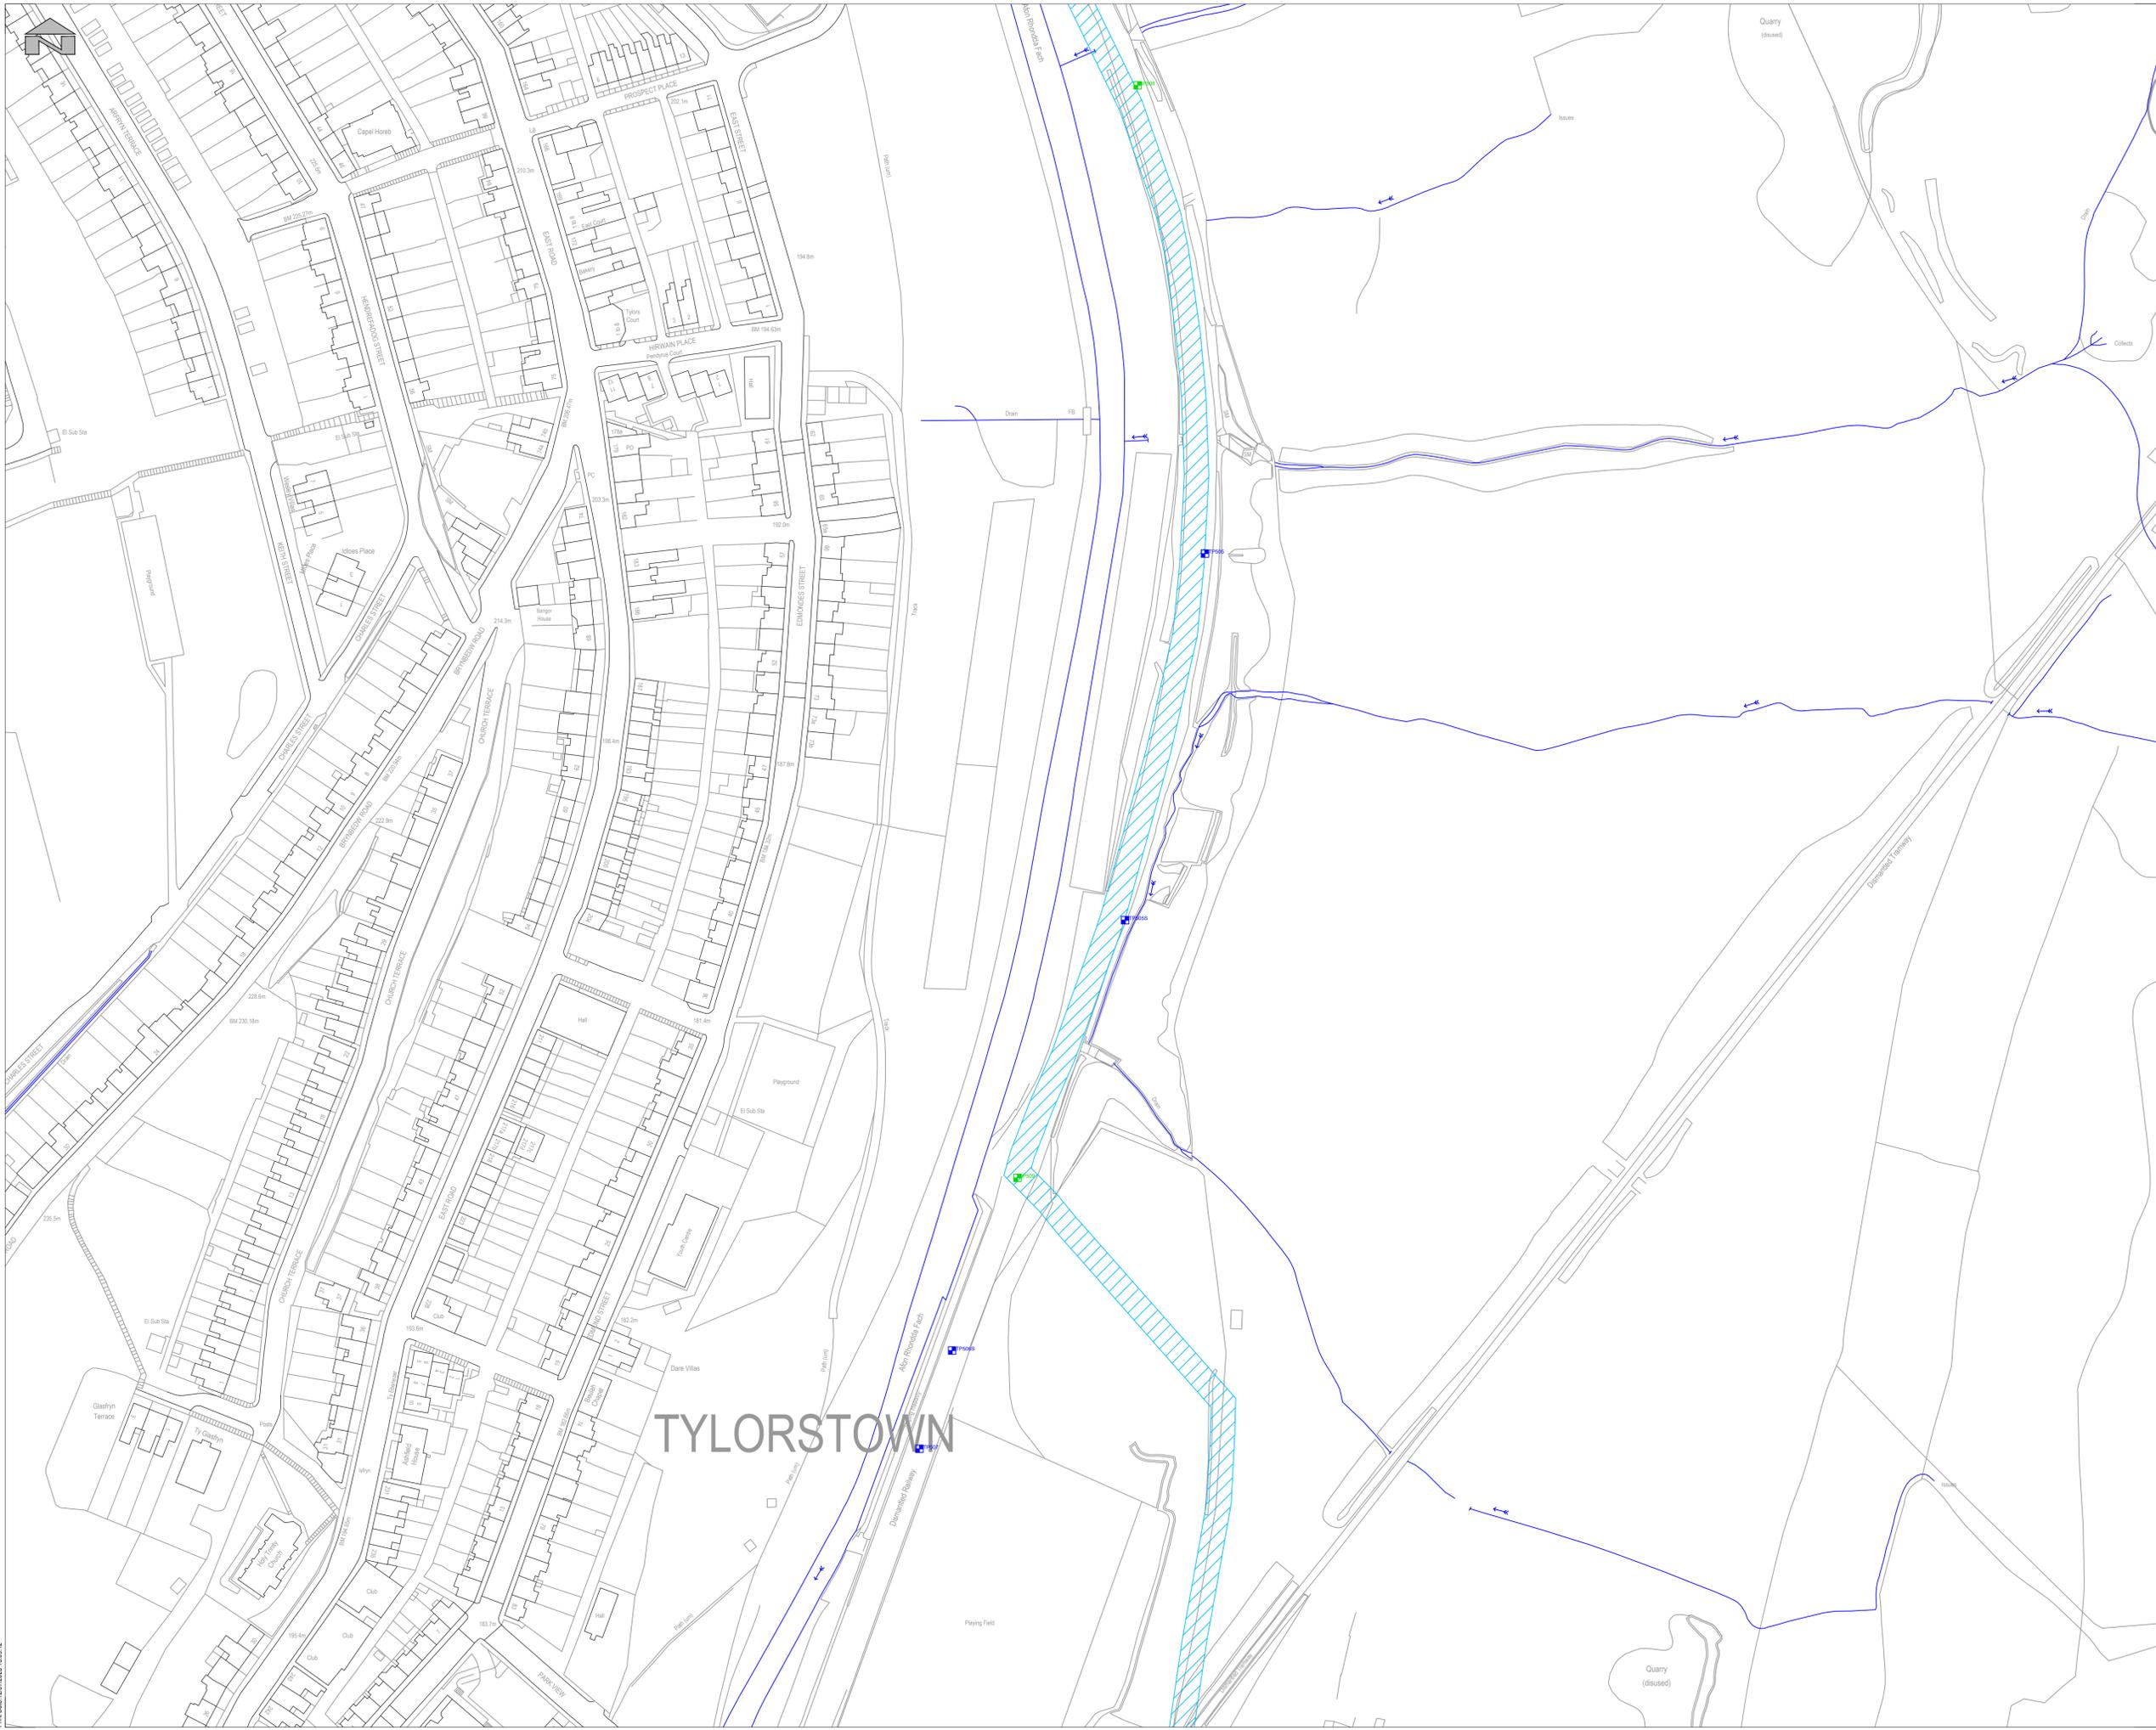
Drawing Identifier	Revision
Project - Originator - Zone - Level - File Type - Title - Number GC3569-RED-75-XX-DR-C-7514	C01

- NOTES**
- DO NOT SCALE FROM THIS DRAWING.
 - THIS DRAWING SHALL BE READ IN CONJUNCTION WITH ALL OTHER CONTRACT DRAWINGS AND DOCUMENTS.
 - A NON-INTRUSIVE PAS 128 TYPE B SURVEY (TO QL-BP3) IS REQUIRED AT EACH EXPLORATORY HOLE LOCATION.
- KEY**
- PROPOSED BOREHOLE
 - PROPOSED TRIAL PIT
 - PROPOSED INSPECTION PIT
 - INDICATIVE DCWW EXCLUSION ZONE (SUPPLIED BY RCT)
