Flood and Water Management Act 2010

Section 19 Report

Storm Bert – Flood Investigation Area 12

October 2025

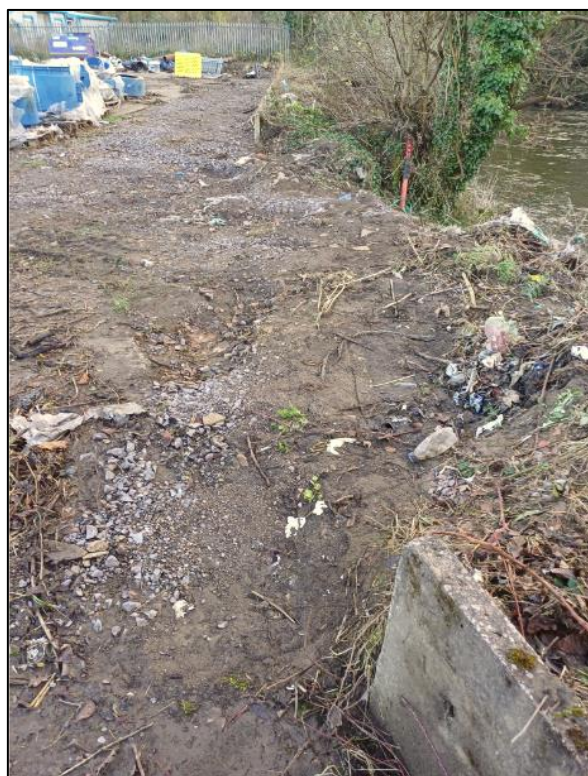
On review of Table 5, the primary source of the recorded flooding within FIA 12 was a result of the River Taf overtopping its river bank and conveying through a gap created by the removal of a service crossing located at Treforest Industrial Estate. The abutment of the service crossing previously tied into the flood defences upstream. According to Natural Resources Wales (NRW), the service crossing had been removed without a Flood Risk Activity Permit from NRW (as the regulatory body for main rivers) prior to the storm event. The location of the removed service crossing is illustrated in Figure 3 which was captured by the Council's Flood Risk Management team during post event investigations.

Figure 3: Image of the location of the removed service crossing at Treforest Industrial Estate (image captured by RCTCBC Flood Risk Management officers on 28/11/2024).

Furthermore, due to the unpermitted removal of a service crossing (refer to Figure 3) the perceived SOP is expected to have been reduced and the area benefitting from flood defences would have been impacted during the flood event.

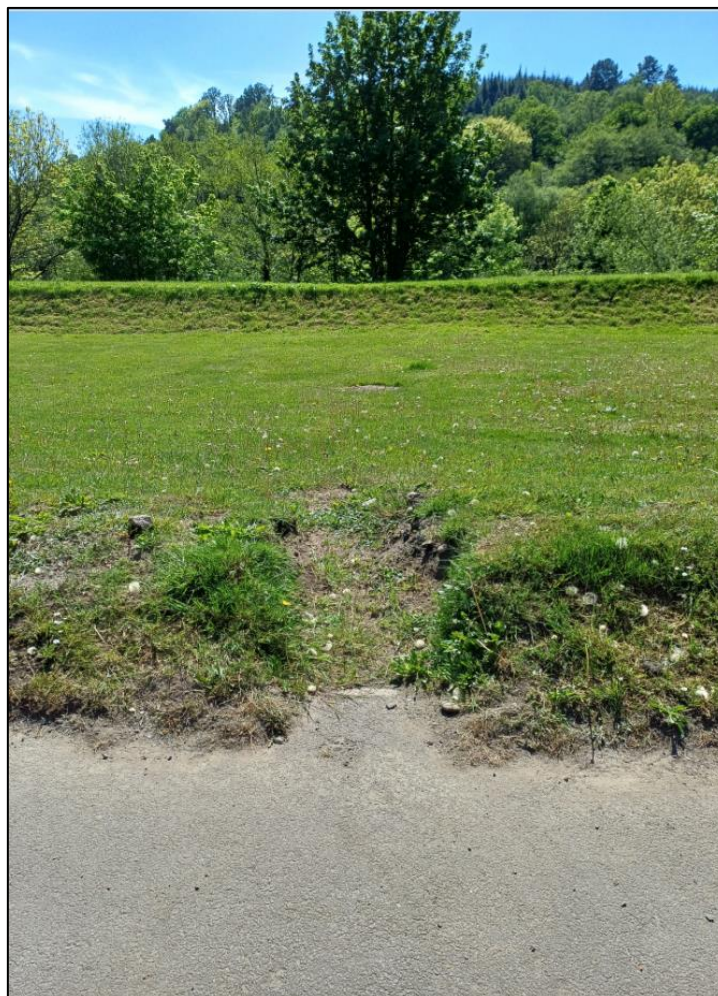
Figure 5: Channels cut in the grass verge to divert floodwater during the event at Oxford Street.

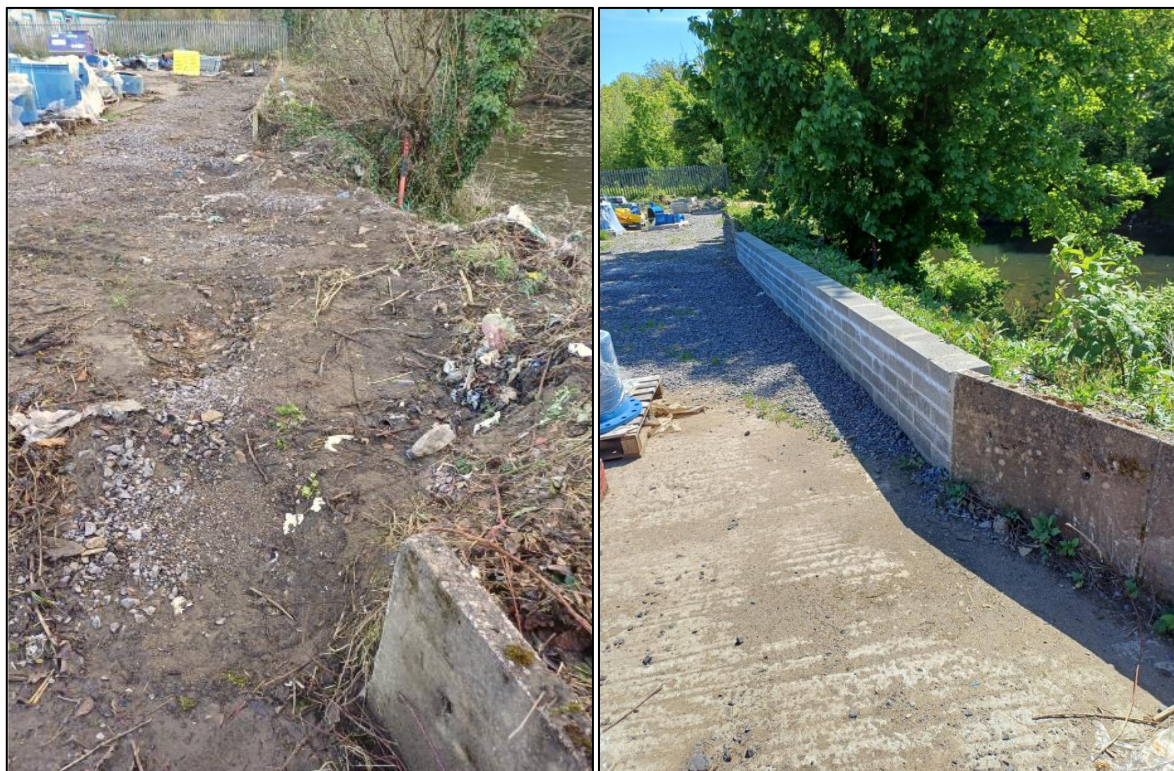
Figure 9: (Left) Gap created downstream of NRW flood defence wall by unpermitted removal of service crossing (image captured on 28/11/2024). (Right) New wall constructed to infill the gap downstream of NRW flood defence wall (image capture on 06/05/2025).
