## Section 19 Flood Investigation Report

### Storm Dennis – Flood Investigation Area RCT17

January 2022

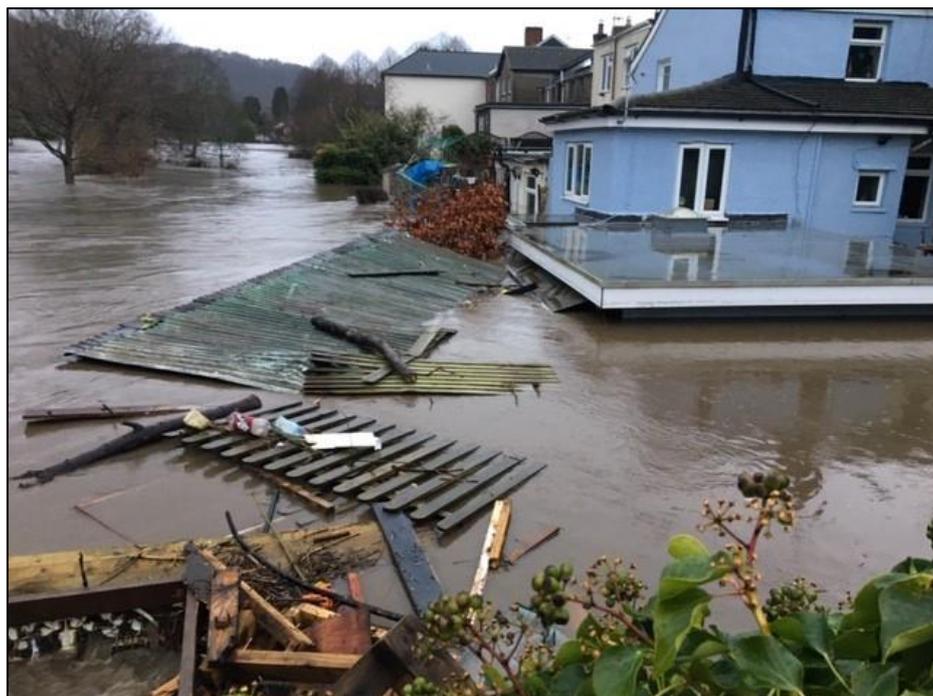
The River Taf was also observed to have overtopped its embankments directly into the rear gardens of adjacent properties along Cardiff Road, exacerbating the flooding that was already ongoing due to the initial flow path depicted in Figure 3. Figure 5 shows the complete submergence of the river embankment to the north of Cardiff Road during the storm event.

Once flood water had entered the rear gardens of properties on Cardiff Road, it was unable to recede due to the difference in height between the gardens and the existing flood defences, as depicted in Figure 6. This resulted in up to 2.5 metres of fluvial flood water becoming trapped in the rear gardens of properties on Cardiff Road for approximately 12 hours during the storm event.

A total of 25 residential and 9 non-residential properties were internally flooded by the River Taf, with several properties on Cardiff Road reporting basement flooding of between 1.5 and 2 metres in depth.

**Figure 5:** Image showing the overtopping of the River Taf to the rear of Cardiff Road which submerged the rear gardens and ground floor of several properties during Storm Dennis (image provided by resident)

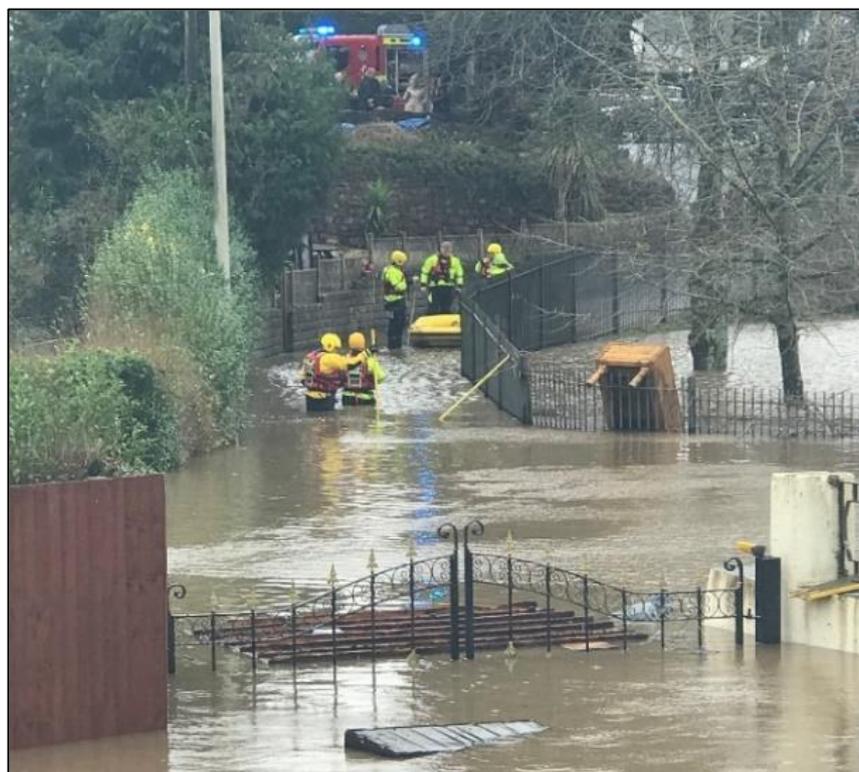
Emergency rescue efforts by the Fire Service were in operation following the overtopping of the River Taf on the 16<sup>th</sup> February 2020 to evacuate residents from their homes (Figure 7).

**Figure 7:** Image capturing the rescue efforts by the Fire Service to evacuate residents at Park Lane on 16<sup>th</sup> February 2020 (image provided by resident)

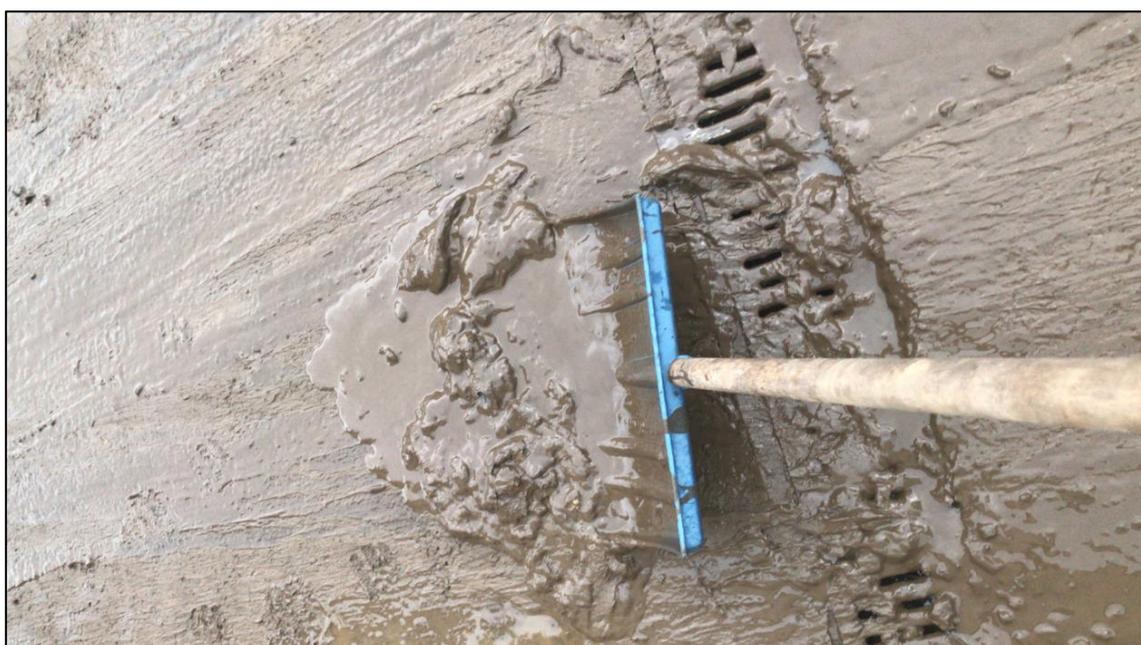
Park Lane was primarily flooded by the overtopping of the River Taf during Storm Dennis. The resultant fluvial flows deposited mud, silt and debris across the impacted area. These sediments are assumed to have entered the highway drainage system, leading to blockages and a reduction in the hydraulic capacity of the surface water network. Figure 12 depicts the deposits of mud left behind following the receding river water.

**Figure 12:** Photo shows deposits of mud blocking the surface water drainage infrastructure at Park Lane following the flooding during Storm Dennis (image provided by resident)

Highway drainage is not designed to manage overland flows from private areas, parks or open space, nor is it designed to accommodate fluvial flows that may arise during storm events. In this instance, the capacity of the highway drainage in RCT17 was exceeded at different locations as a result of main river and surface water flows entering the network. The maintenance condition of the highway drainage infrastructure is not considered to have significantly impacted the flooding experienced.

| 3 | Surface water drainage network across RCT17 | Rhondda Cynon Taf CBC Highway Authority | Surface Water | Highway Authority and Lead Local Flood Authority | R3A | The Highways Authority to jet and cleanse the highway drainage network and action repairs accordingly. |
