# Flood and Water Management Act 2010

## Storm Dennis February 2020 – Overview Report

**July 2021**

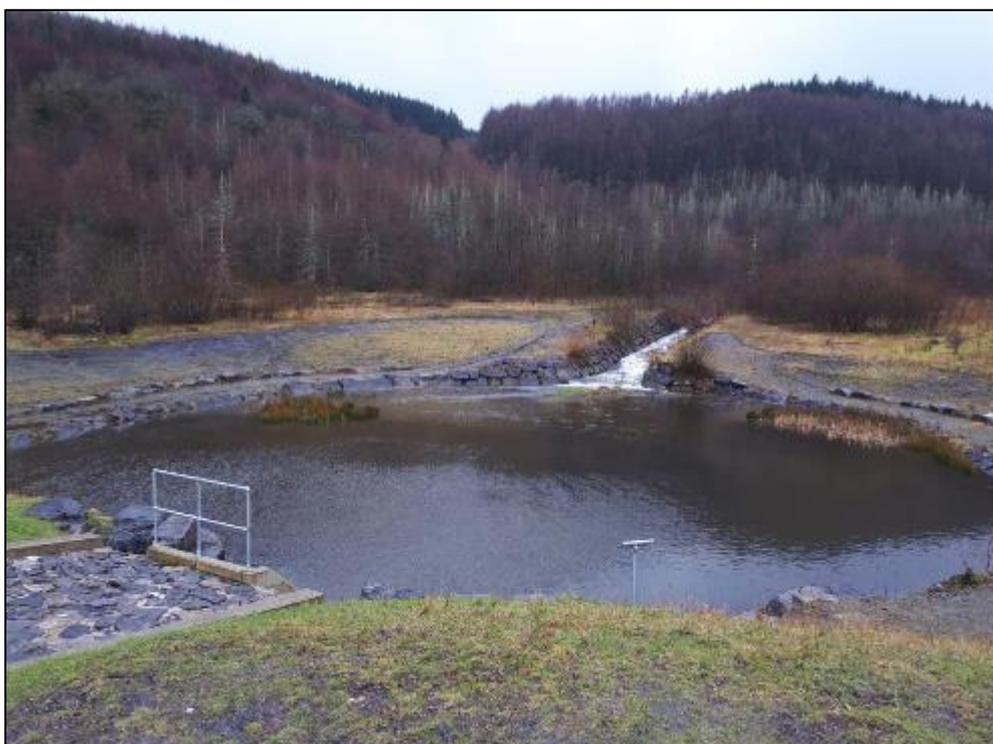
Notably the attenuation basin was active for approximately 12 hours during the storm event. At its peak the basin attenuated 2000m<sup>3</sup> of flood water. The volume of flood water being attenuated during the event shows the volume of water generated by the intense rainfall over a short duration.

**Figure 9:** Cwmaman Attenuation Basin located in the Cynon valley catchment

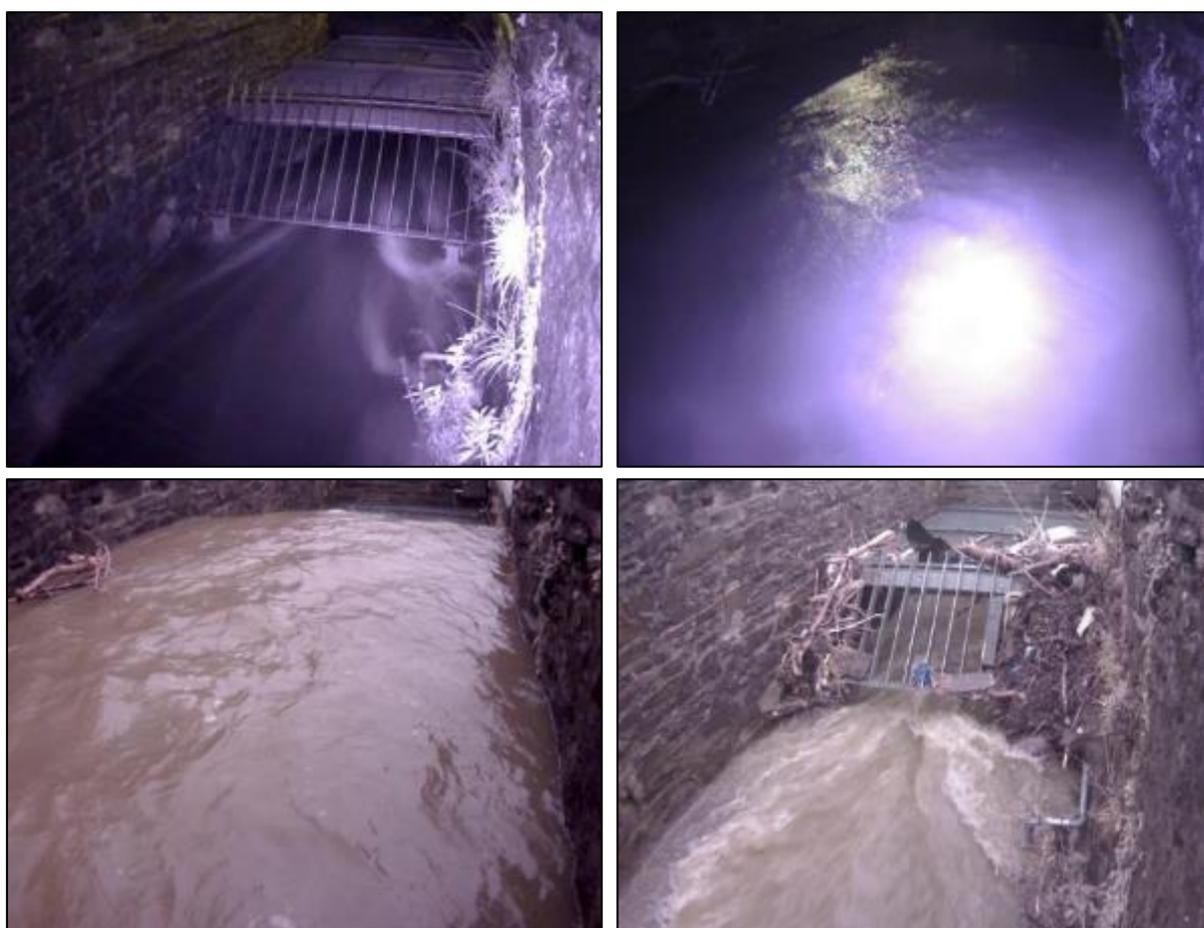
Within a 14-hour period, levels within the Nant Gwawr which flows west to east through the town of Aberaman, rose extremely suddenly during Saturday (15 Feb) night and remained high until suddenly falling by Sunday (16 Feb) morning, leaving behind deposited debris mobilised during the peak flows. The images captured by RCT's monitoring station demonstrate the watercourses' rapid response to rainfall which was replicated across the borough at a number of ordinary watercourses (Figure 11).

**Figure 11:** Images of the Nant Gwawr inlet captured at RCT's monitoring station (15/02/20 20:34 (top left), 16/02/20 03:30 (top right), 16/02/20 08:27 (bottom left), 16/02/20 10:27 (bottom right))

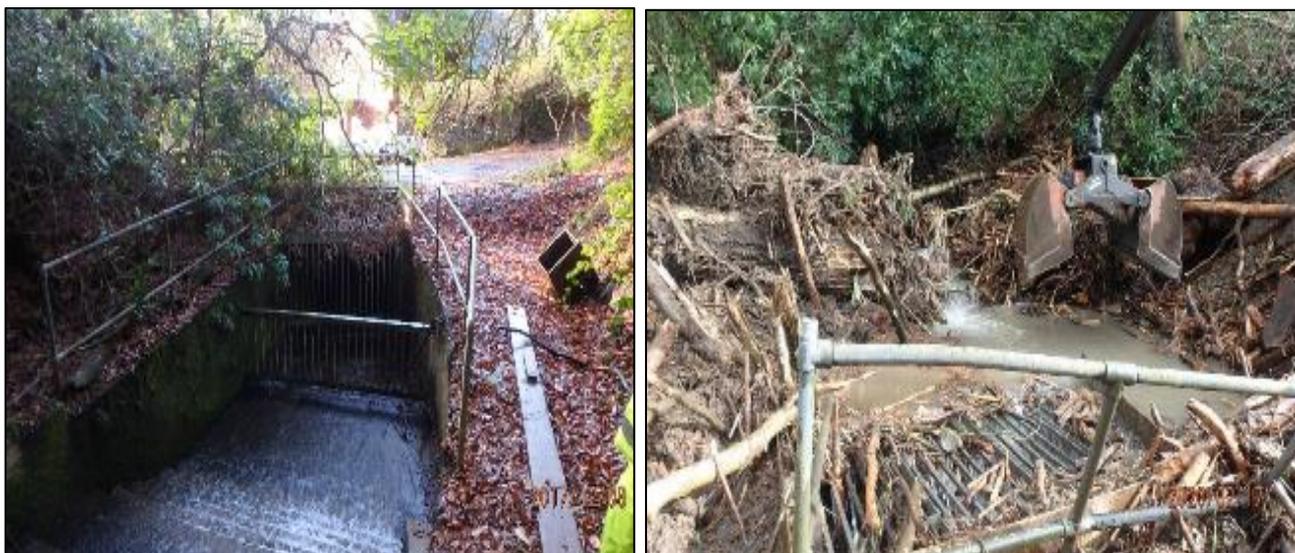
**Figure 15:** Pentre Road culvert inlet pre (left) & post Storm Dennis (right) showing evidence of significant blockage to the inlet

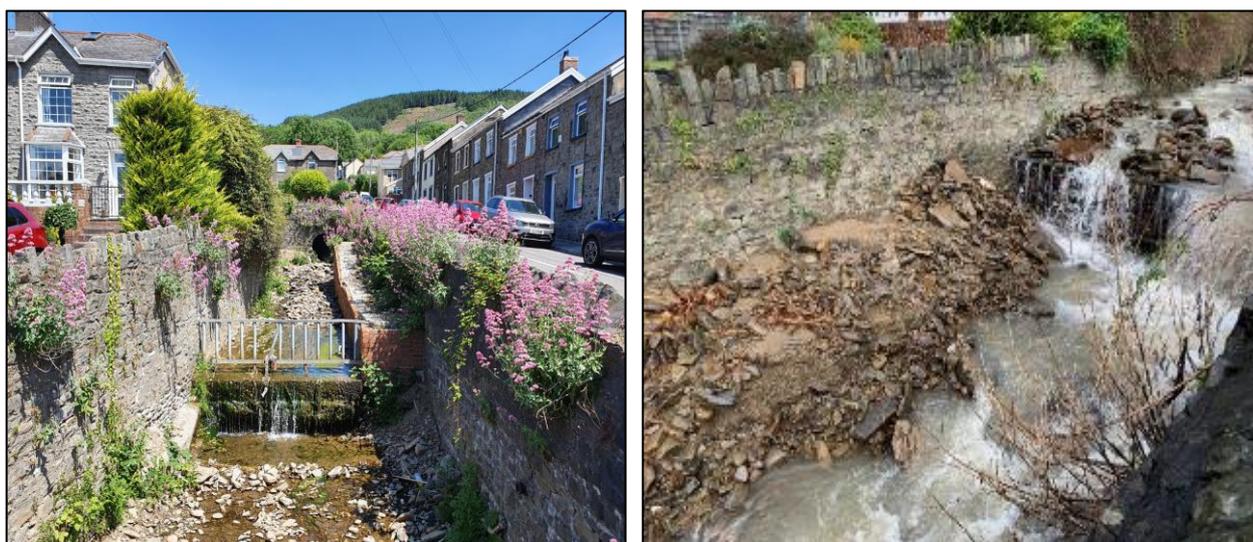
**Figure 16:** Section of open watercourse, upstream of the Nant-y-Ffrwd culvert inlet near Granville Terrace, Mountain Ash immediately after Storm Dennis (right) and three months post storm event (left)

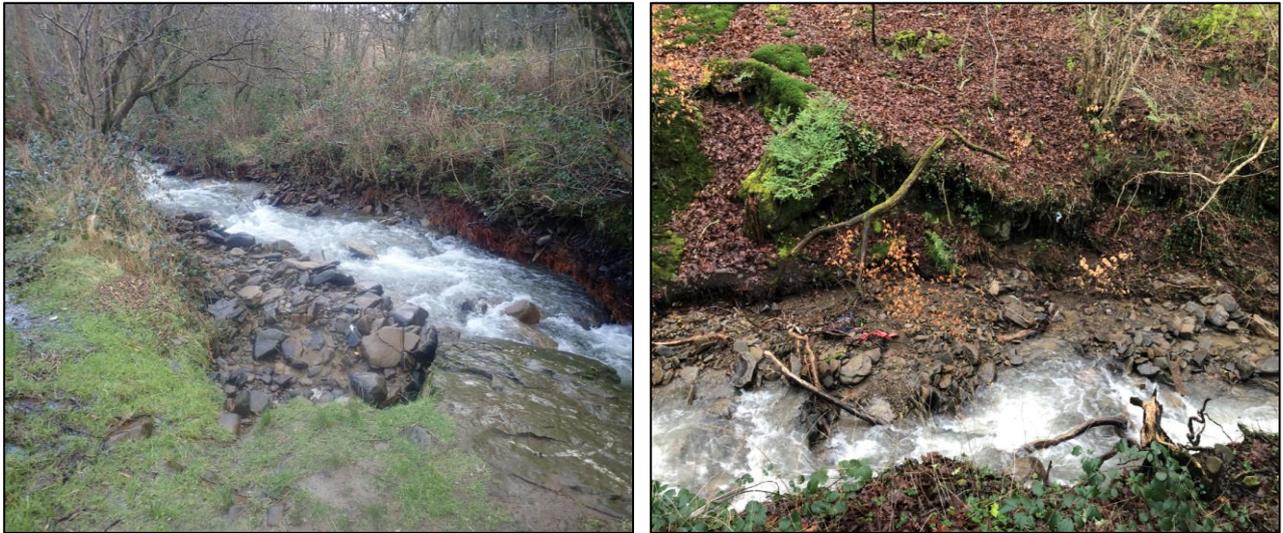
Evidence of scour in the upper catchments of RCT (illustrated in Figure 17) indicate the power of the flows within the watercourses which mobilised and transported large amounts of debris and stonewash downstream towards culvert inlets and carrier lines during the storm event.

**Figure 17:** Upper catchment of the Nant Cae Dudwg watercourse, Cilfynydd (left) and the Nant y Ffrwd watercourse, Mountain Ash (right) showing evidence of bank scour and deposition of debris in and adjacent to the channel

Storm Dennis has highlighted the role of morphological processes as a significant contributor to flood risk in many areas in RCT. The degree of morphological instability and potential sediment supply varies from catchment to catchment, however both historical and present-day anthropogenic landscape changes at the catchment scale have been identified as key influences on ordinary watercourse behaviours and local flood risk.

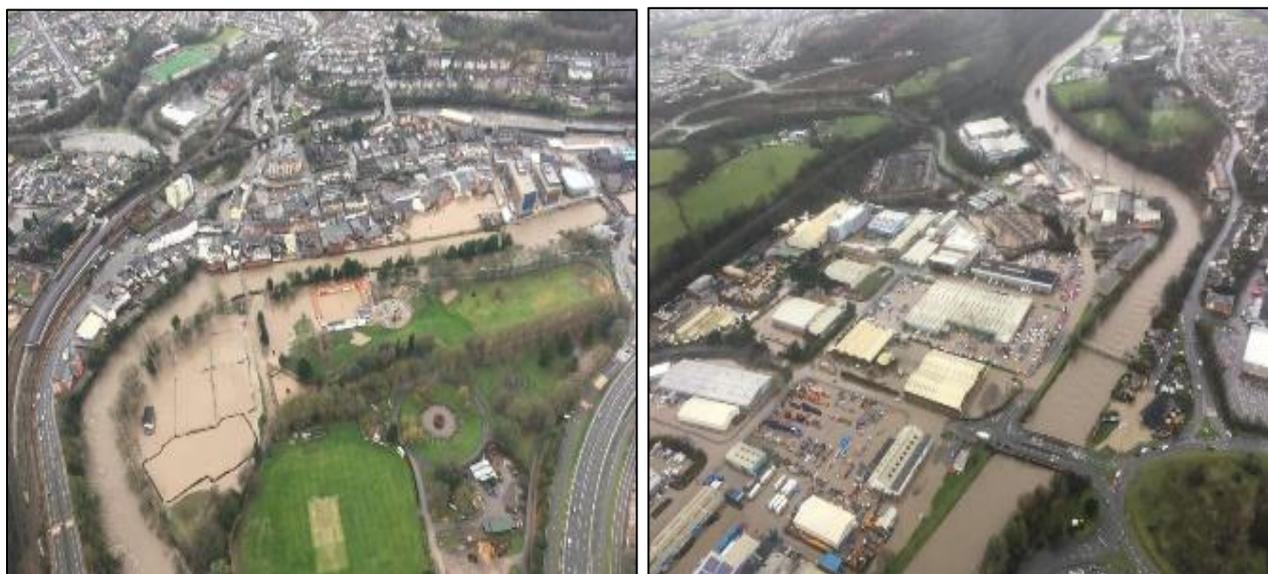
The River Taff, Cynon and Rhondda (Fawr and Fach) are the primary Main Rivers running through Rhondda Cynon Taf. All three primary Main Rivers overtopped their banks at various locations across the borough, with the most notable flooding impacts occurring along the River Taff which is fed by both the Cynon and Rhondda rivers and caused flooding to multiple receptors situated within the urban and industrial floodplains of the Taff. Areas worst affected include Pontypridd, Nantgarw, Treforest Industrial Estate and Taffs Well and the affected receptors primarily being commercial units. The aerial photographs captured below by South Wales National Police Air Service (Figure 18) show the dramatic inundation of Pontypridd Town Centre and Treforest Industrial Estate by the River Taff on Sunday morning (16<sup>th</sup> February 2020).

**Figure 18:** Main River flooding from the Afon Taf at Pontypridd (left) and Treforest Industrial Estate (right). South Wales National Police Air Service.

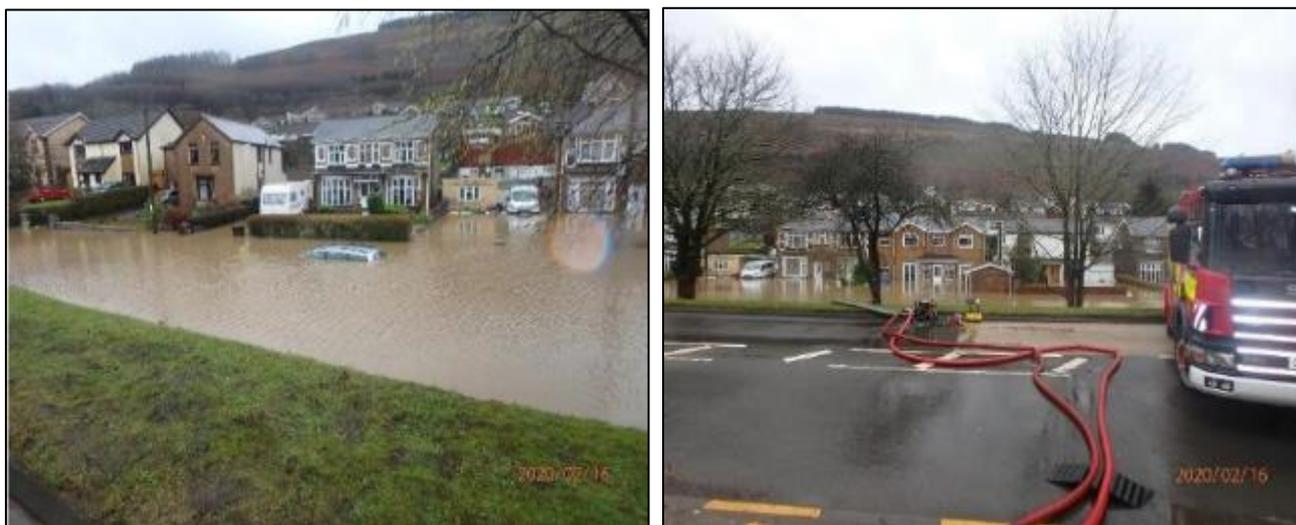
**Figure 19:** Surface water flooding at Glenboi, Abercwmboi captured by RCT's FRM team during Storm Dennis (16th February)

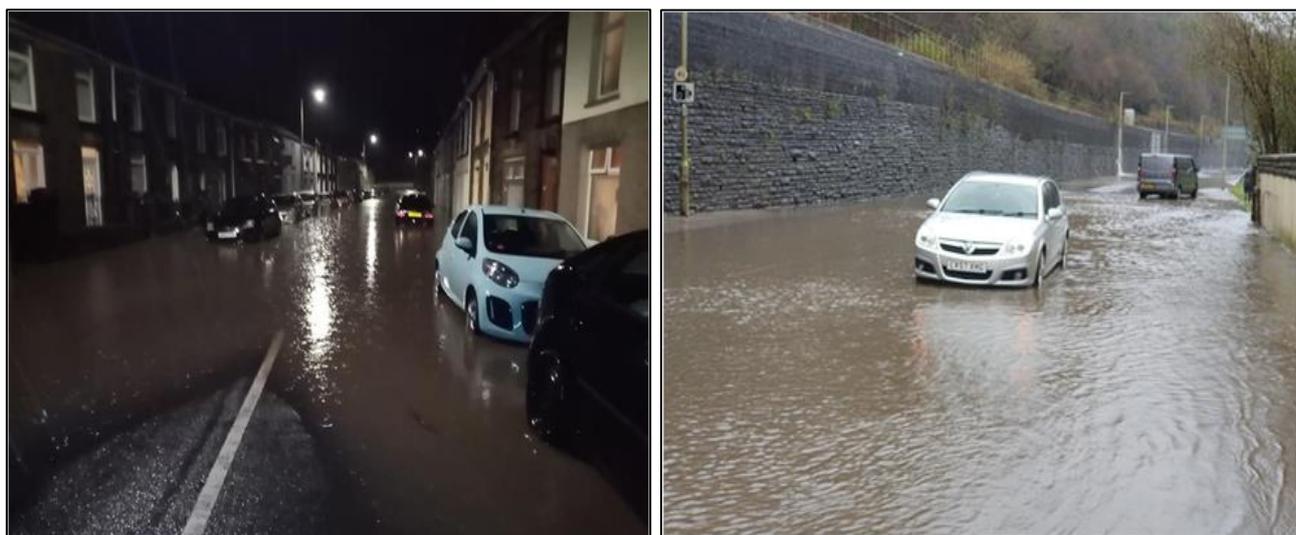
**Figure 20:** Surface water flooding at Trehafod Road (left) and the A4058 above Trehafod captured during Storm Dennis (16th February) (source: Facebook)

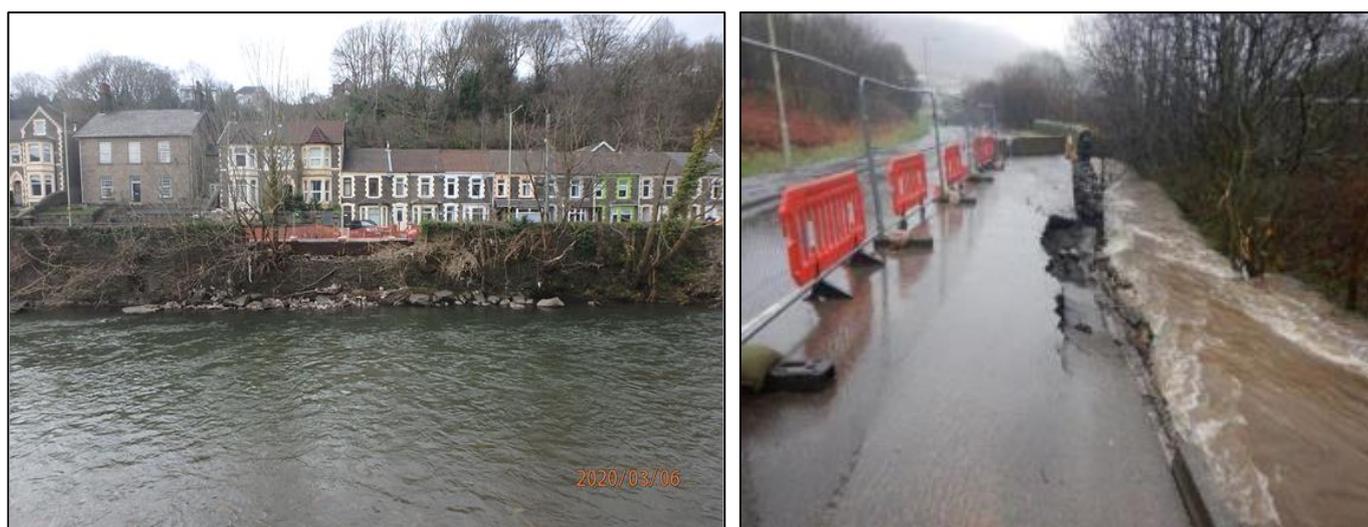
Extensive damages to infrastructure across RCT including bridges, culverts and retaining walls occurred during Storm Dennis. Many of the damages caused by the storm was as a result of Main River flows carrying large debris at high velocity along the watercourses and subsequently breaching its banks at several locations, causing significant damage to several highway and privately owned retaining walls. Figures 21 show sections of damaged river retaining walls at Blaenrhondda and evidence of severe scouring to the riverbanks of the River Taff caused by the storm event.

**Figure 21:** Damages to Berw Road retaining wall at Pontypridd (left) and Blaen y Cwm Road river wall at Blaenrhondda (left)

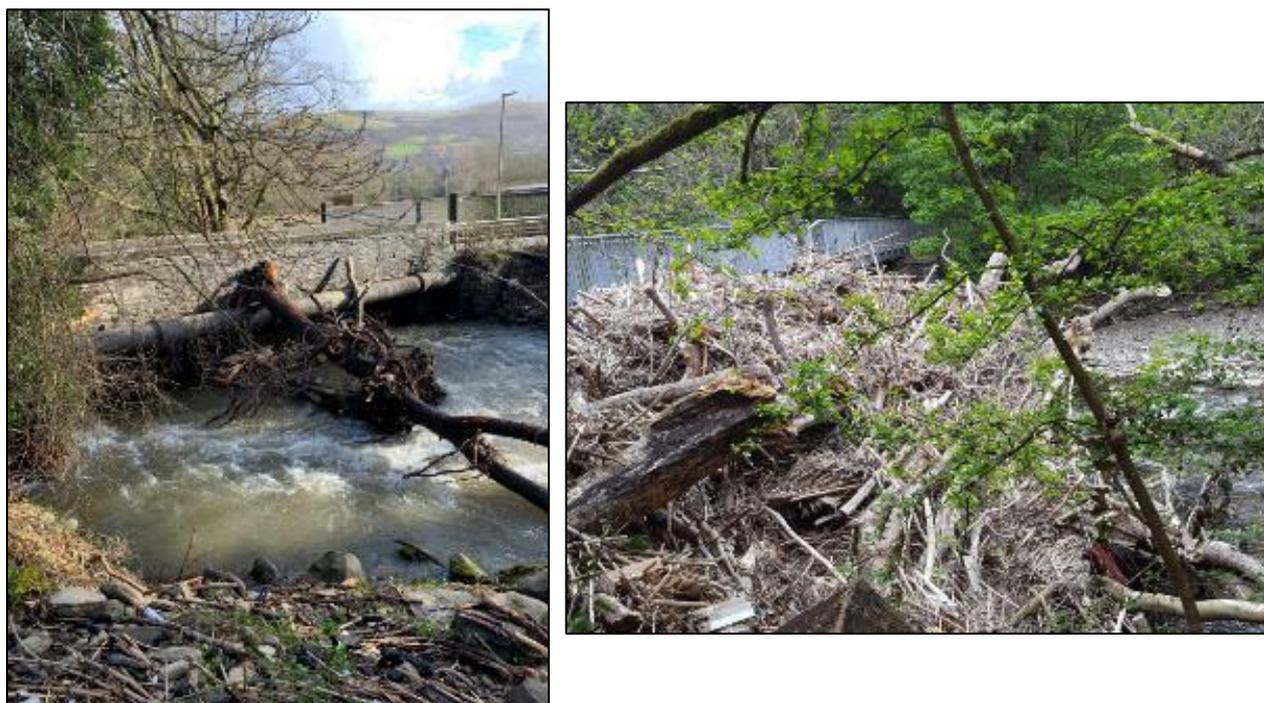
Record breaking river levels and velocities caused whole trees to uproot from the banks and other woody debris to be transported along the watercourses resulting in damages to approximately 72 bridges and footpaths across the county borough. Evidence of accumulated material at the Nant Clydach Bridge at Ynysybwl and Feeder Pipe footbridge at Abercynon are illustrated below (Figure 22).

**Figure 22:** Damages to Nant Clydach Bridge at Ynysybwl (left) and Feeder Pipe footbridge at Abercynon (right)

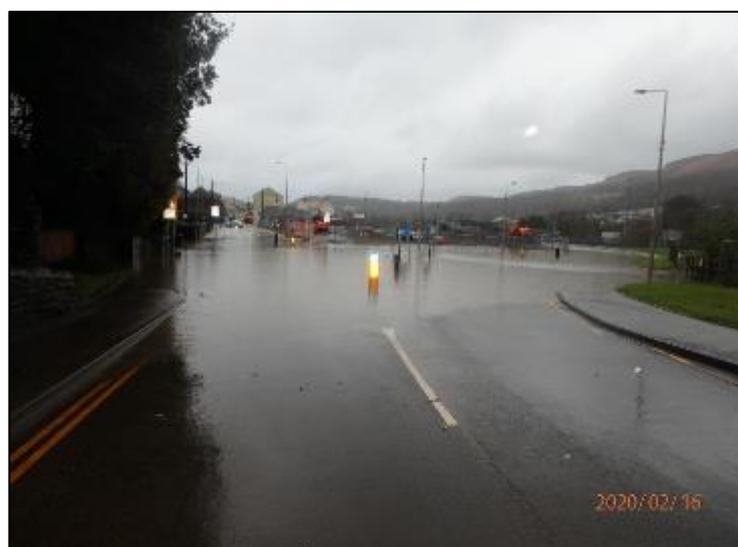
Flooding to the highway network across RCT was widespread. Highway drainage infrastructure in several locations became overwhelmed by the sheer volume of surface water entering the drainage network, resulting in surface water ponding which led to many of the borough's primary transport corridors becoming impassible, including the A465 at Hirwaun and the A4095 at Mountain Ash (Figure 23).

**Figure 23:** Images captured by Local Authority officers of the A465 Underpass at Hirwaun Industrial Estate (left) and the A4059 (New Road) at Mountain Ash on 16th February 2020

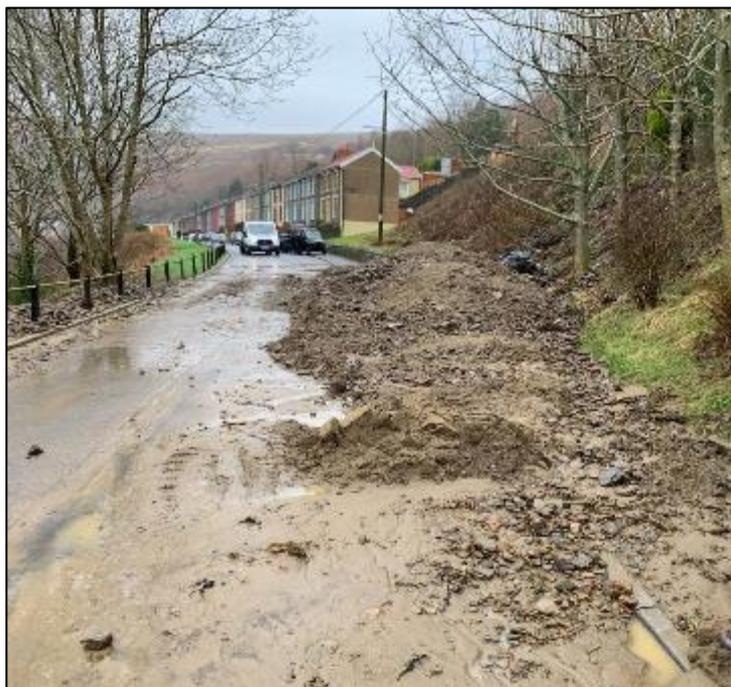
Damages to highway infrastructure was also commonplace. Debris and stonewash mobilised from the upper catchments above residential settlements and carried downstream via watercourses resulted in blockages to the highway drainage network which not only caused significant damages but also exacerbated the flooding to the highway. Figure 24 depicts evidence of silt and stonewash deposited onto the highway below Heath Terrace, Ynyshir following the storm event.

**Figure 24:** Image captured by Council Highways and Streetcare Depot officers at Heath Terrace, Ynyshir on 17th February 2020
