# RCT School Walking Route Assessment

Ferndale to Coleg y Cymoedd (Llwynypia)

March 2025

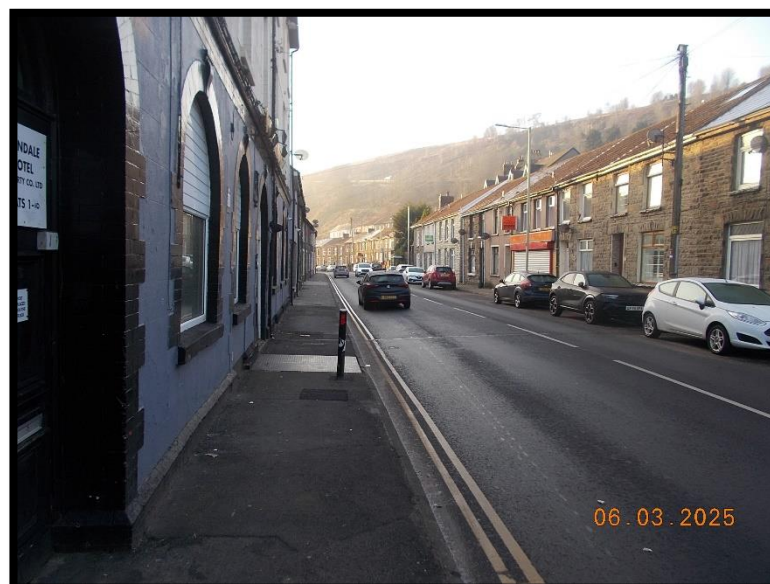
**Photograph 4.1 – Start of the route from Ferndale Hotel (PH) along the A4233 Dyffryn Street**

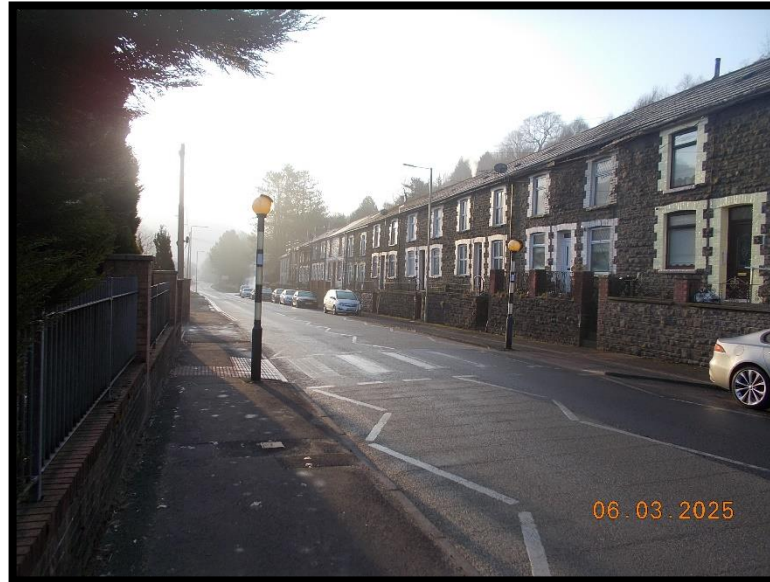
**Photograph 4.2 – Zebra crossing linking the northern and southern footways across the A4233 on Oakland Terrace**

- 8.1.9 There are controlled crossing facilities at the following locations:
- Zebra Crossing – On the A4233 outside no. 15 Oakland Terrace.
  - Signalised crossing – On the A4058 Tyntyla Road outside the Tripple Crown Garage.

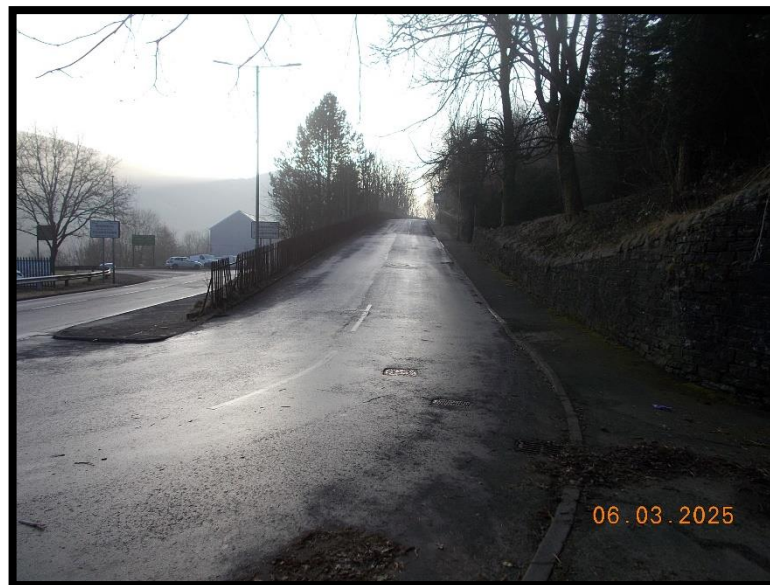
**Photograph 4.3 – Footway along Brynheulog Terrace**

- 8.1.1 The route lies within 20mph and 30mph speed limits.
- 8.1.2 There are footways present in reasonable condition along the route. Some sections of footway along Brynbedw Road, Vivian Street and Brynheulog Terrace were noted to end abruptly. Pedestrians will be required to cross the carriageway at these locations. Visibility is good and there were sufficient gaps in traffic that met the criteria outlined in the Learner Travel Guidance.

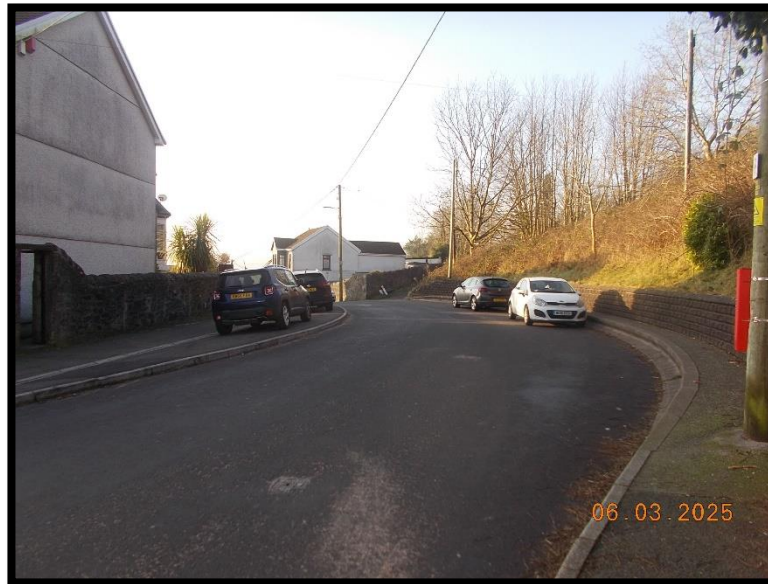
**Photograph 4.4 – Vehicles parked on footways reducing its usable width along Vivian Street**

- 8.1.5 On street parking obstructs visibility along the walking route and vehicles parking on the footways along Vivian Street and Buckland Drive restricts access. Local neighbourhood policing teams are working with residents to help reduce the risks posed to pedestrians by indiscriminately parked vehicles.

- 9.1.1 The route meets the criteria and is considered available to walk in line with the Learner Travel guidelines.
- 9.1.2 Further enhancements to the walked route ***could be considered*** to improve conditions for route users. These include the following:
- Monitor the condition of overhanging trees and foliage. Where trees and/or foliage overhang or encroach into footways, these areas should be cut back to improve the usable width, sight lines and natural surveillance. In addition to this leaf debris should be removed from footways when required.
  - Monitor footway obstructions. Where footways widths continue to be restricted by parked cars, action be taken in conjunction with the appropriate Council Department / local neighbourhood policing teams.

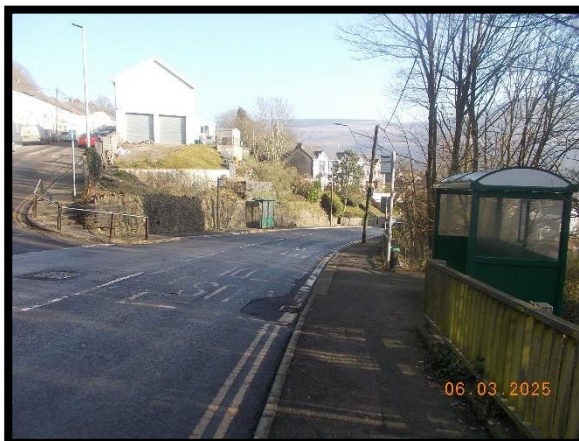
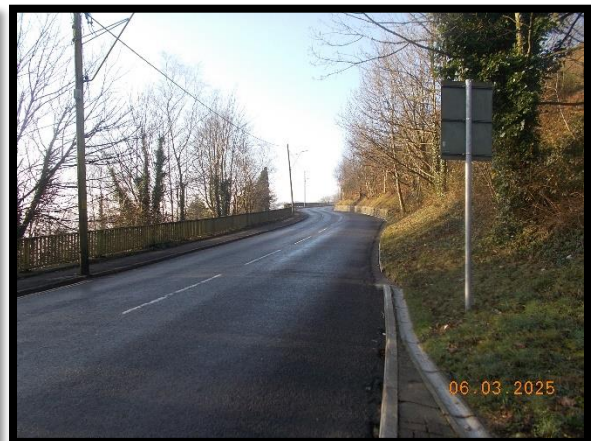
**Photographs 4.5 & 4.6 – Uncontrolled crossing point on Penrhys Road within the 20mph speed limit (showing visibility on the uphill and downhill approaches)**

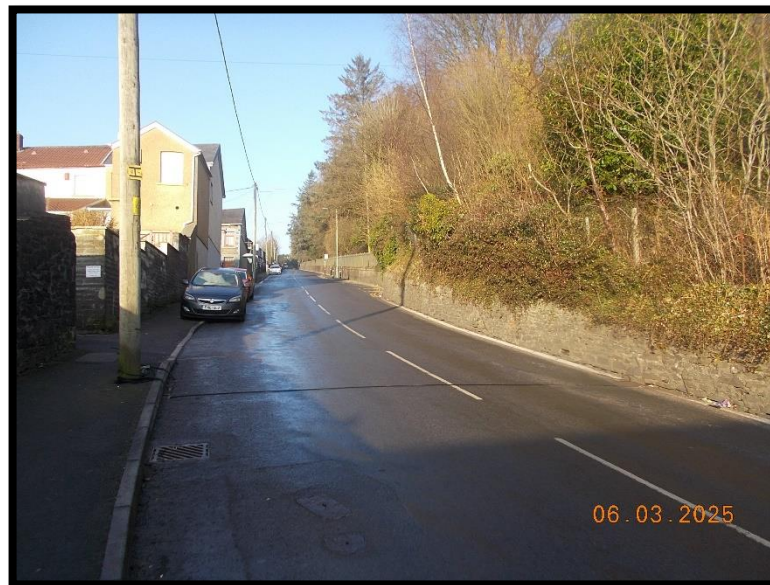
**4.7 – Vehicles parked on the footway reducing its usable width along the B4512 Penrhys Road**

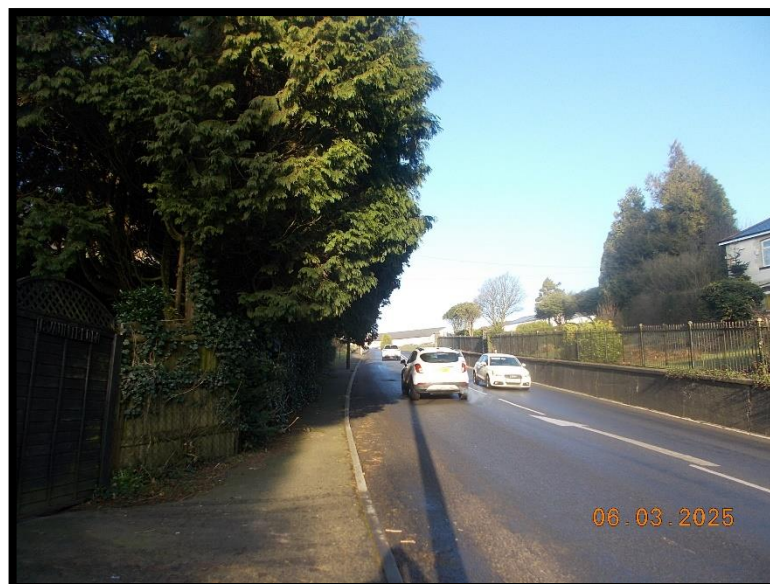
**Photograph 4.8 – Trees overhanging the footway on the B4512 Penrhys Road**

- 8.1.3 Footway widths are reduced due to overhanging trees and overgrown vegetation along sections of the route on the B4512 Penrhys Road. Ongoing maintenance is required to maximise footway width and ensure pedestrians can pass one another safely.

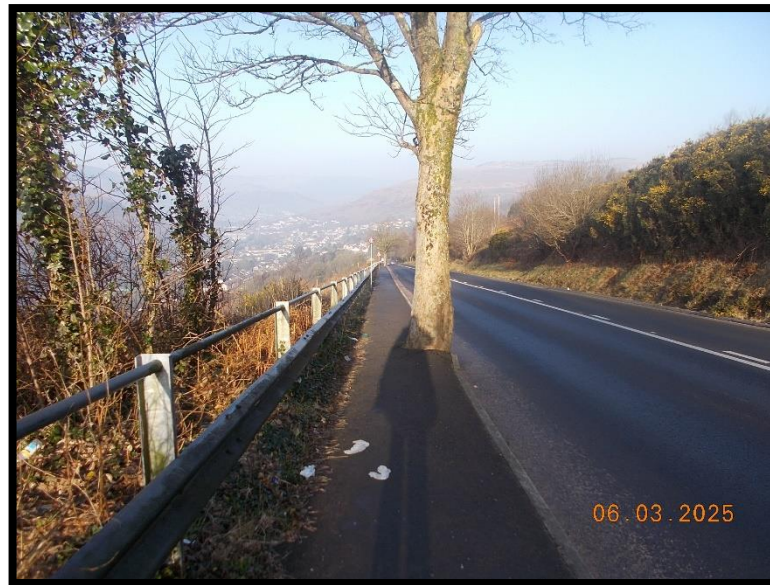
**Photograph 4.9 – Trees locally reducing the available footway width requiring pedestrians to give way to pass one another**

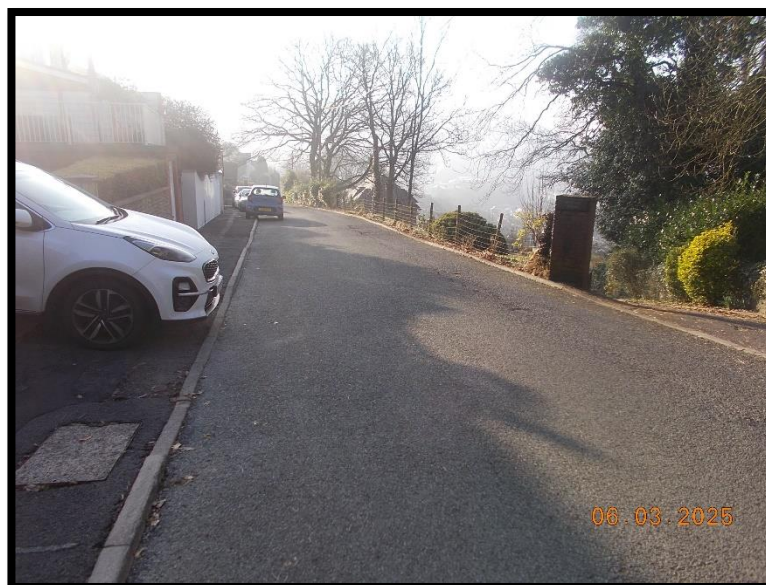
**Photograph 4.10 – Vehicles parked on the footway reducing its usable width on Buckland Drive. This street however is for access only has very low traffic flows and speeds**

- 8.1.4 There are discrete sections of footway along Buckland Drive where the footway width reduces. Pedestrians will be required to step into the carriageway to pass one another at this location. Visibility is good and due to the 'for access only' nature of the road, there were sufficient gaps in traffic that met the criteria outlined in the Learner Travel Guidance.

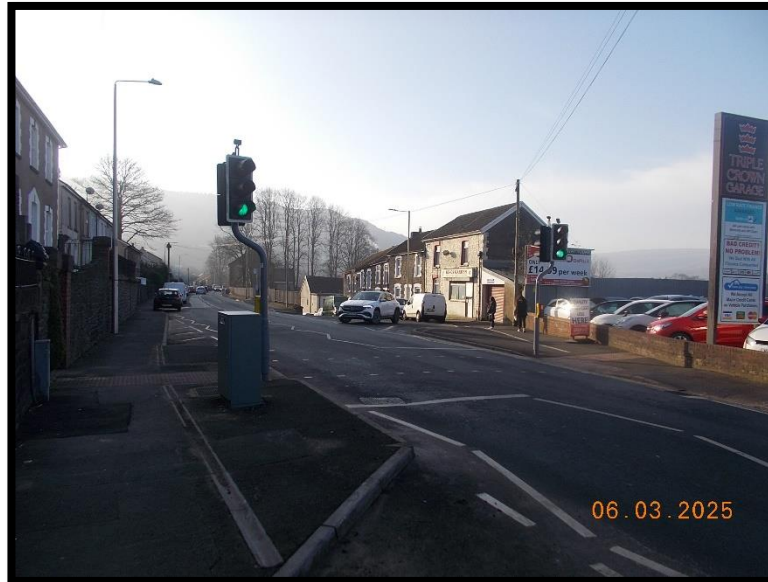
**Photograph 4.11 – Signal controlled crossing on the A4058 Tyntyla Road and link to Sherwood Street**

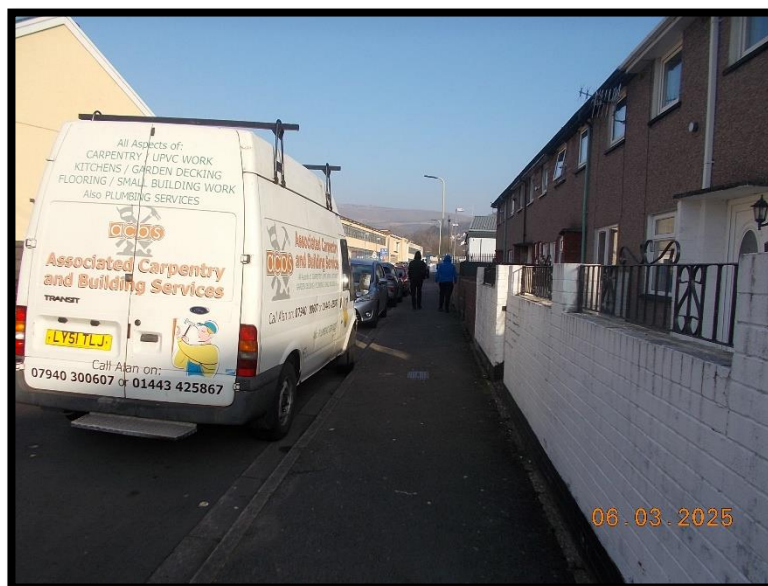
**Photograph 4.12 – Footway access to Coleg y Cymoedd (Llwynypia) along Turberville Street**
