RCT School Walking Route Assessment

Ty Rhiw to Coleg y Cymoedd (Nantgarw)

March 2025

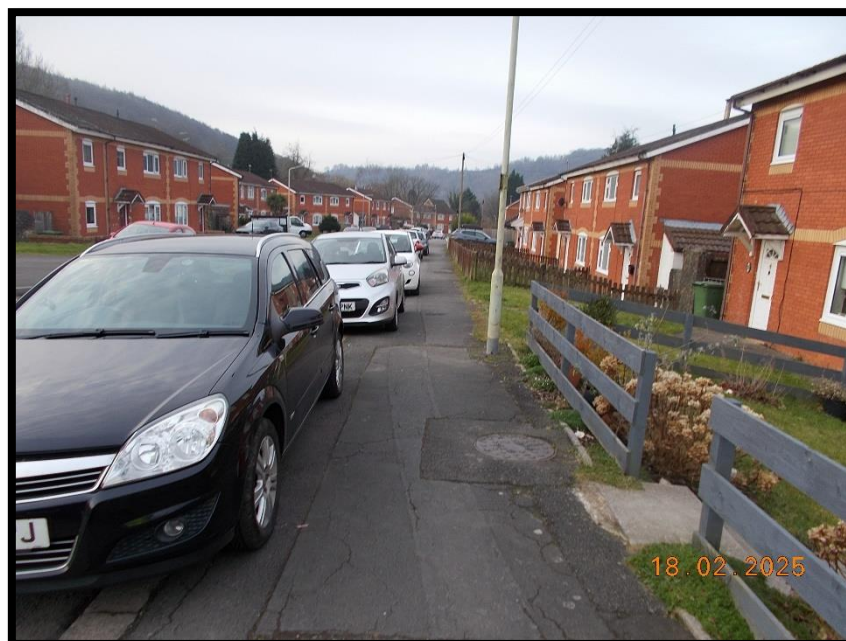
Photograph 4.1 – Start of the route at Ty Rhiw with vehicles parked on footways reducing its usable width

8.1.4 On street parking obstructs visibility along the walking route and vehicles parking on the footways along the A4054 Cardiff Road restricts access. Local neighbourhood policing teams are working with residents to help reduce the risks posed to pedestrians by indiscriminately parked vehicles.

- Monitor footway obstructions. Where footways widths and visibility to crossing points continue to be restricted by parked cars, action to be taken in conjunction with the appropriate Council Department / local neighbourhood policing teams.
- Monitor the condition of overhanging trees and foliage. Where trees and/or foliage overhang or encroach into footways, these areas should be cut back to improve the usable width, sight lines and natural surveillance. In addition to this leaf debris should be removed from footways when required.

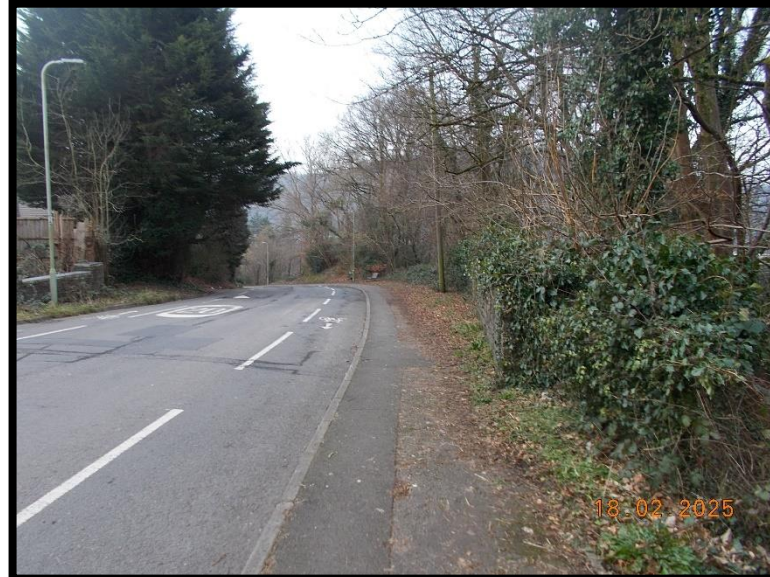
Photograph 4.2 – Leaf debris and vegetation reducing the usable footway width along Cemetery Road

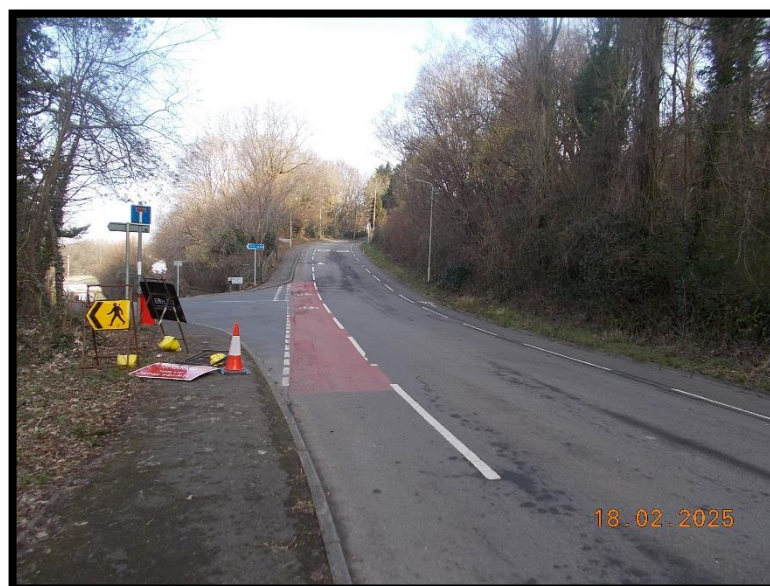
Photograph 4.3 – Wide crossing (with Active Travel priority for cycling) of the junction of Cemetery Road with the lightly used Forest Road

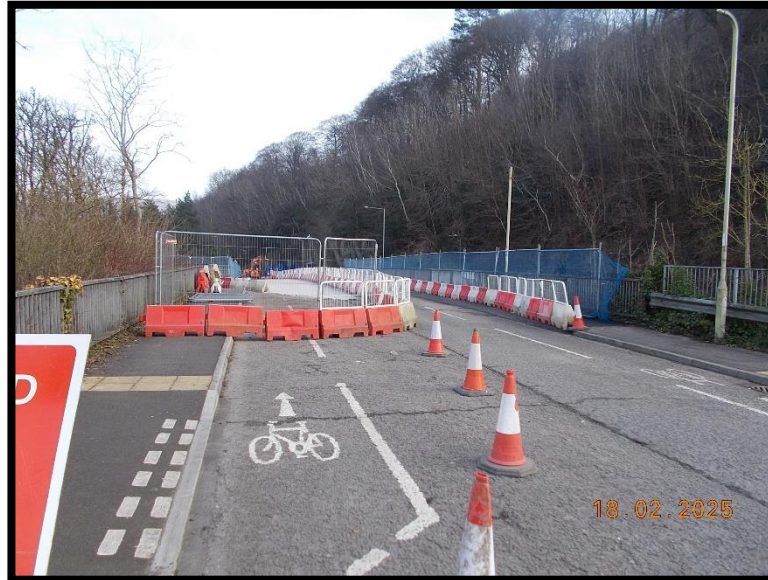
Photograph 4.4 – Temporary footway closure for repair/improvement works (under construction during the time of the assessment) at the A470 overbridge on Cemetery Road

- The footway along Cemetery Road from the A470 overbridge up to the junction with A4054 Cardiff Road is temporarily closed due to bridge repair/improvement works. This loss of footway is key to the proposed route.

In order to mitigate the above issue, it is recommended that while the main footway route along Cemetery Road to the A4054 Cardiff Road junction is closed, a **Temporary Alternative Route** along the existing NCN 8 Active Travel route is used (see **paragraph 4.2** for details). The proposed walking route will then revert back to the main available route on completion of the bridge works.

9.1.2 The section between Cemetery Road and the A470 overbridge / junction with A4054 Cardiff Road is temporarily closed due to bridge repair/improvement works. The overbridge repair/improvements and associated temporary footway closure are prohibiting this section of the main route from being used by pedestrians. It is therefore recommended that the **Temporary Alternative Route** between the junction of Forest Road and Cemetery Road and the junction of Moy Road with the A4054 Cardiff Road, along the NCN8, be used during the closure period until the overbridge works are completed. The walking route will then revert to the **Main Route** in its entirety on completion of these works.

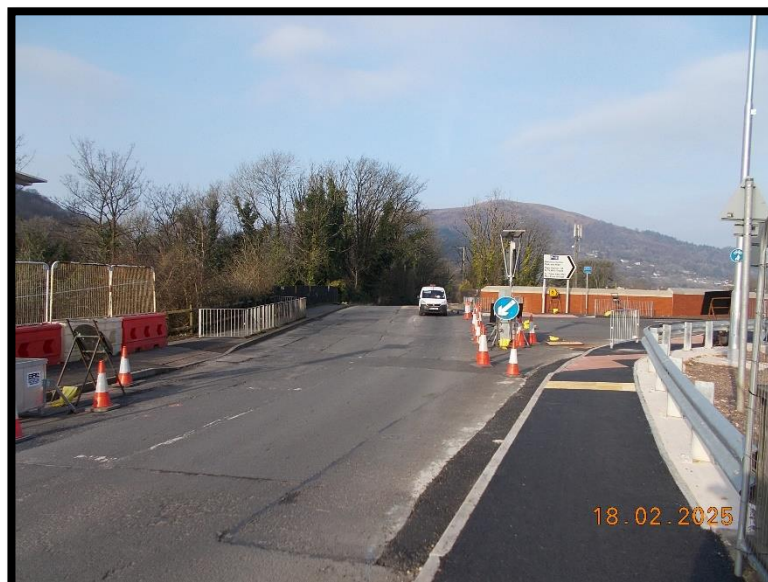
Photograph 4.5 – Signalised crossing (under construction during the time of the assessment) at the junction with Cemetery Road and the A4054 Cardiff Road

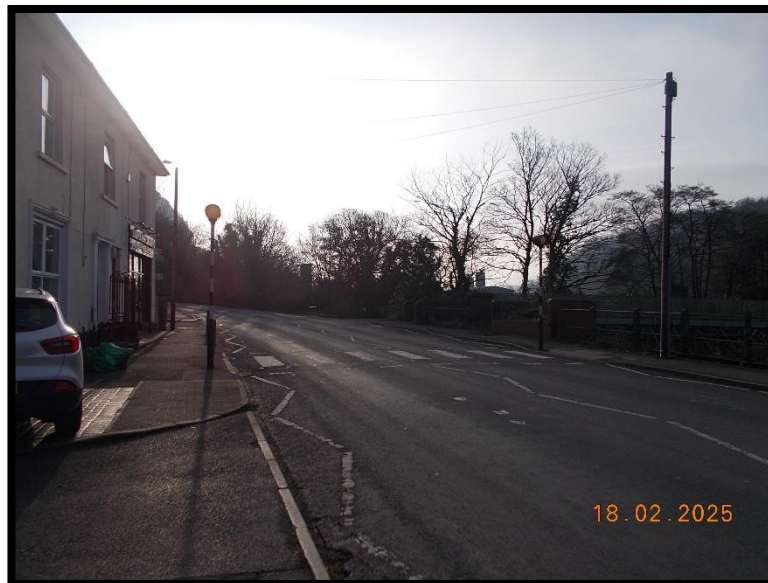
Photographs 4.6 – Zebra crossing outside no.3 on the A4054 Cardiff Road

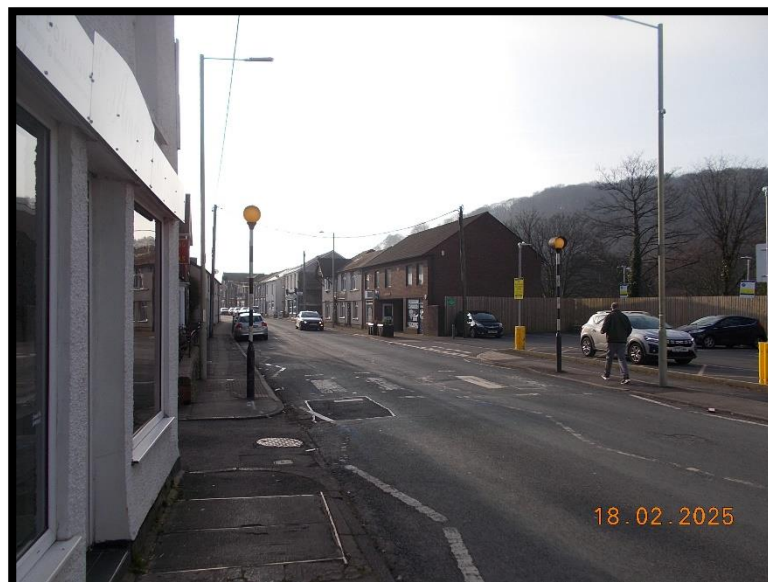
Photograph 4.7 – Zebra crossing outside the Co-op on the A4054 Cardiff Road

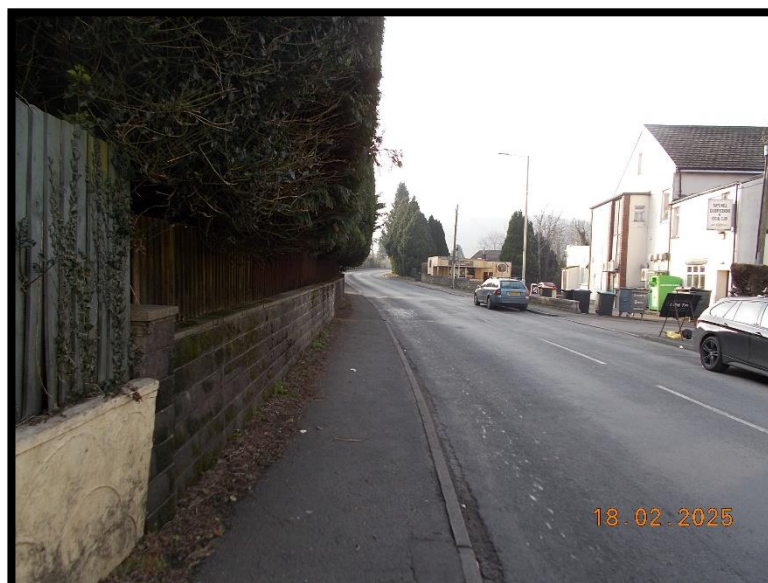
Photograph 4.10 – Overhanging trees reducing the usable footway width on the A4054 Cardiff Road opposite the Ex-servicemen's club

8.1.3 Footway widths are reduced due to overhanging trees, leaf debris and overgrown vegetation along sections of the route on the A4054 Cardiff Road. Ongoing maintenance is required to maximise footway width and ensure pedestrians can pass one another safely.

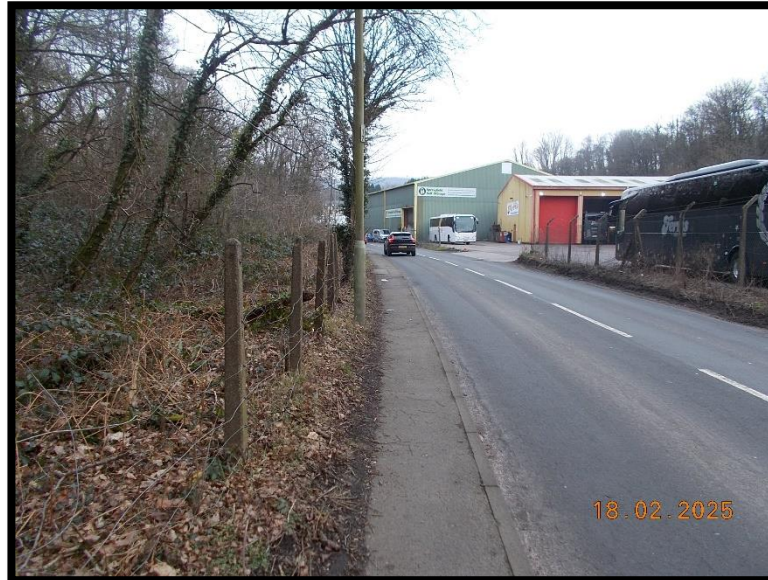
Photograph 4.11 – Leaf debris and vegetation reducing the usable footway width along the A4054 Cardiff Road opposite Ferris Coaches

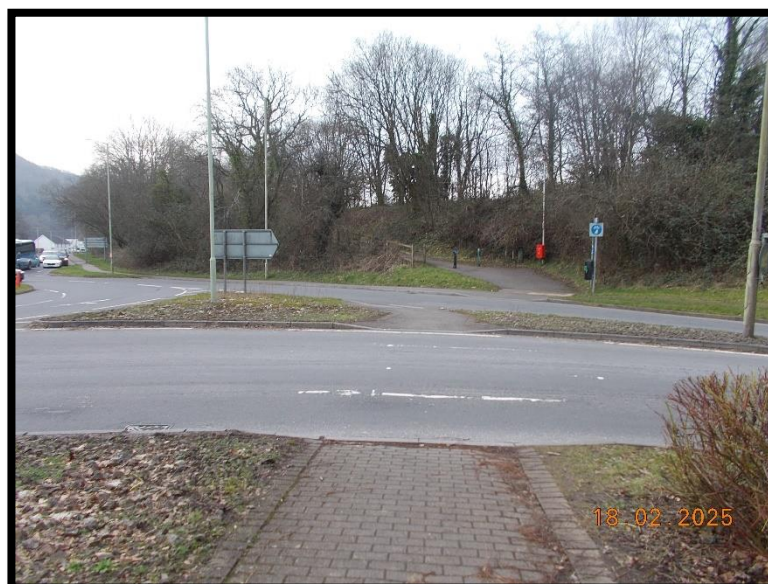
Photograph 4.12 – Uncontrolled crossing with pedestrian refuge island across the Oxford Street arm of the Nantgarw Roundabout

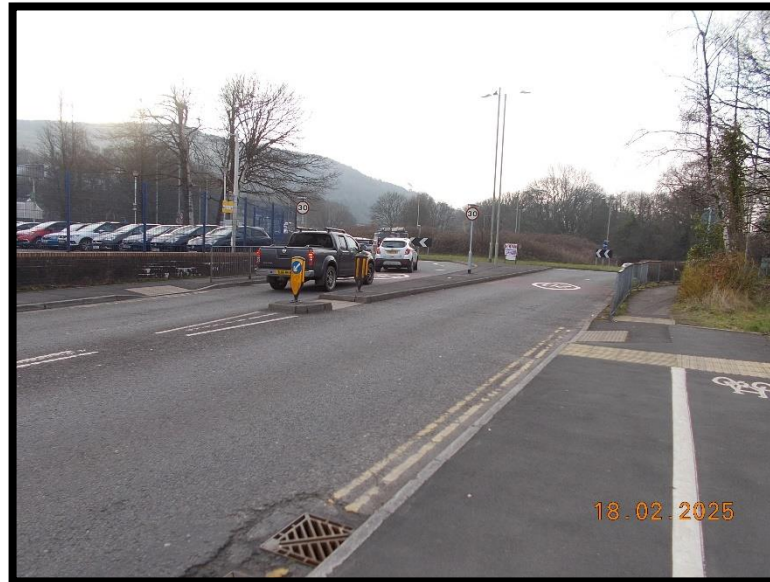
Photograph 4.13 – Uncontrolled crossing with narrow pedestrian refuge island across the Heol Crochendy arm of the Nantgarw Roundabout

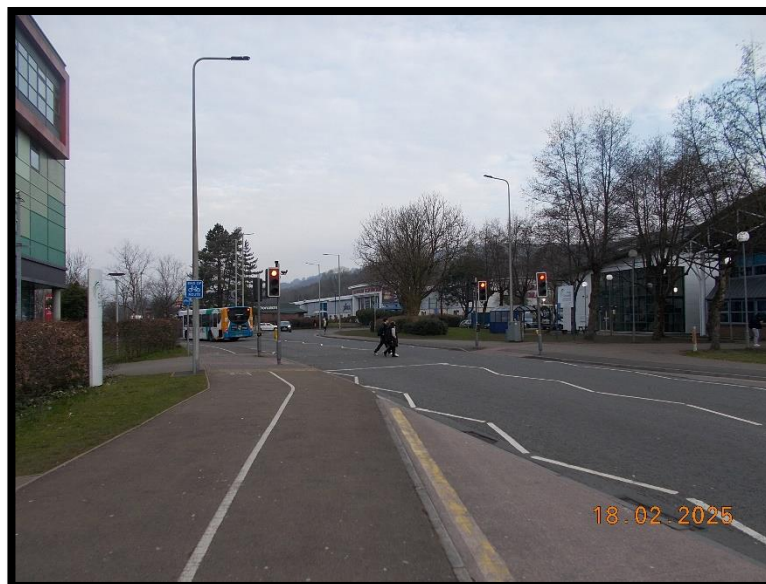
Photograph 4.14 – Signalised crossing across Heol Crochendy to the main college campus building

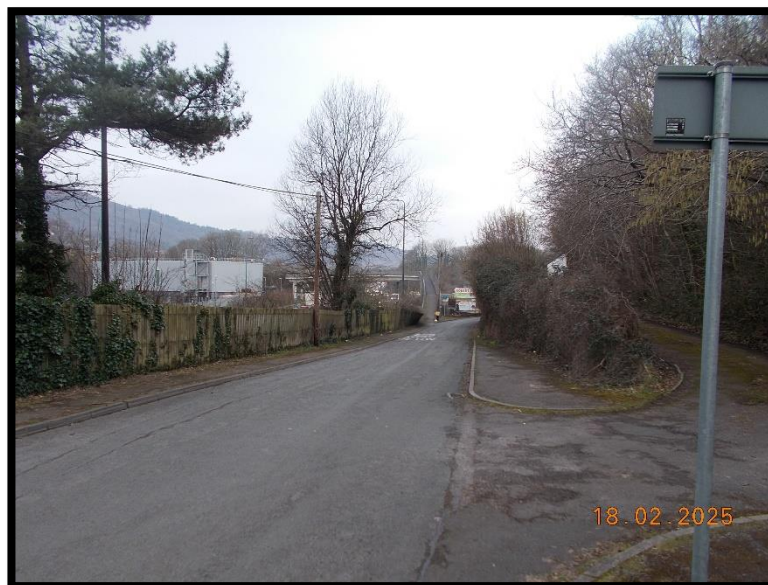
Photograph 4.15 – Footway on NCN8 along Forest Road

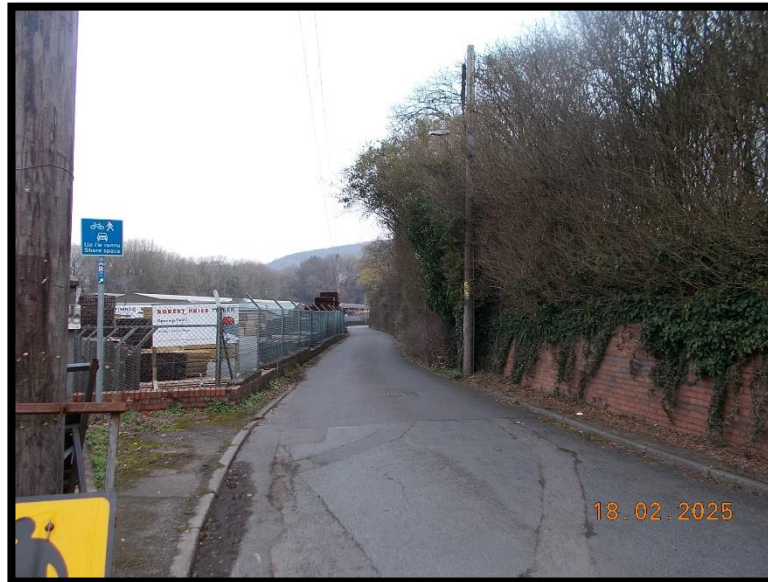
Photograph 4.16 – Shared use space (walking, cycling and motor vehicles) along NCNC8 with footways and step-offs available for pedestrians

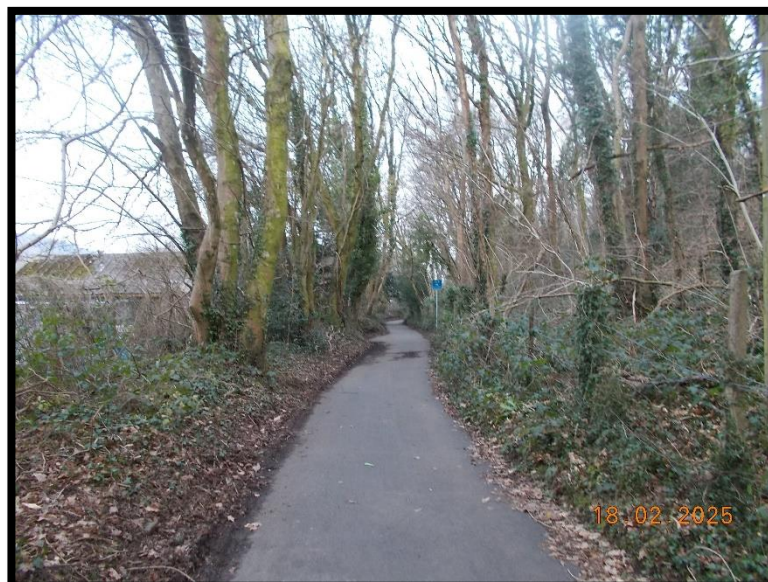
Photograph 4.17 – Virtually traffic free shared use space (walking, cycling and motor vehicles) along NCN8

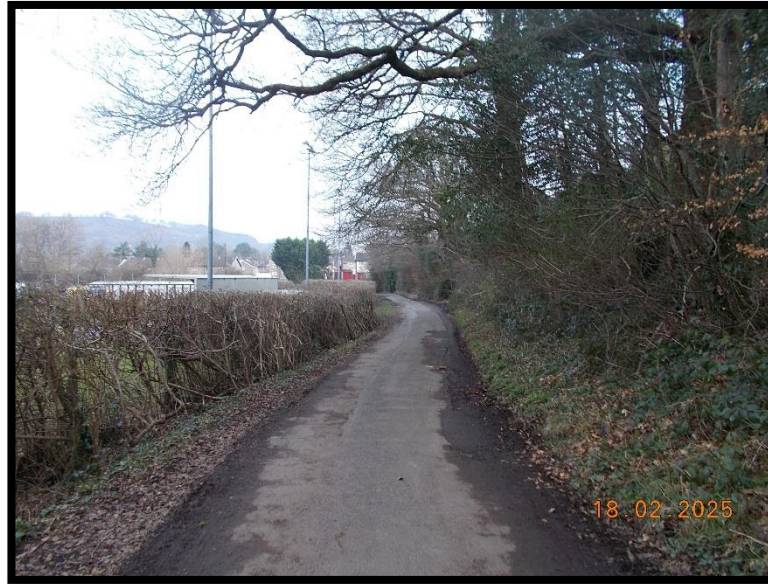
Photograph 4.18 – Virtually traffic free route around the rear of Taffs Well football ground along NCN 8

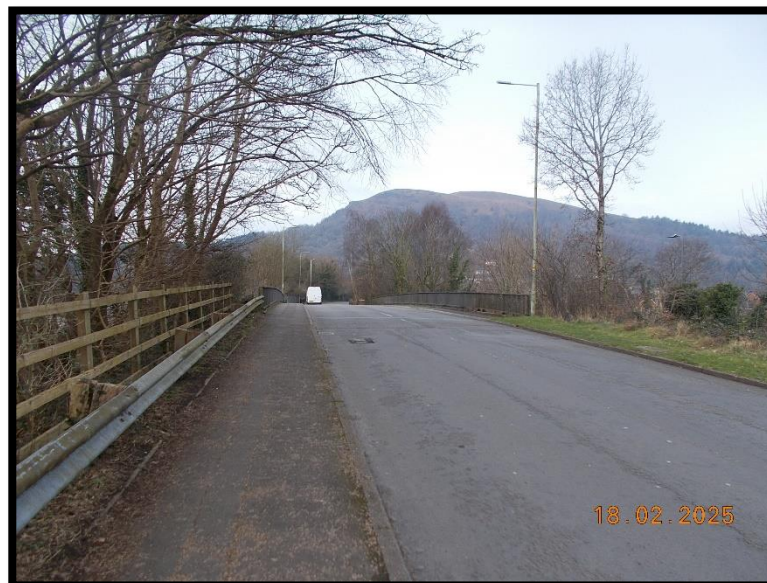
Photograph 4.19 – Footway link on Moy Road to join the Main Route at the A4054 Cardiff Road
