5 Strategic Site Analysis⁵

5.1 Site 1: Former Maerdy Colliery, Rhondda Fach

Project: **Rhondda Cynon Taf County Borough Council Strategic Flood Consequence Assessment**
Title: **Former Fernhill Colliery Site - WAG DAM**

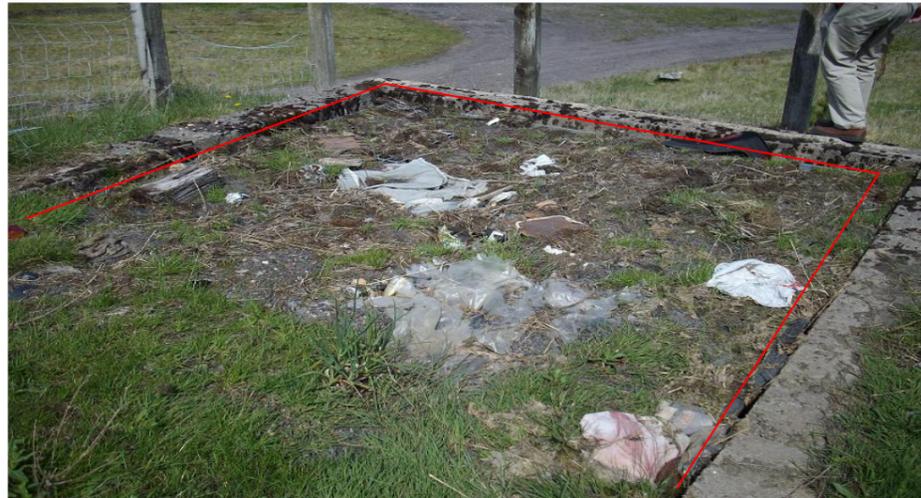
Plate 5-2: Illustration of a blocked entrance (outlined in red) to a surface water culvert at the former Maerdy Colliery.

In addition there is an existing surface water management system on site from previous coaling mining operations, which includes man made concrete channels and earth ditches. During the site visit it was observed that the channels and ditches have fallen into a state of disrepair (Plate 5-2). The current lack of maintenance may increase the potential flood risk.

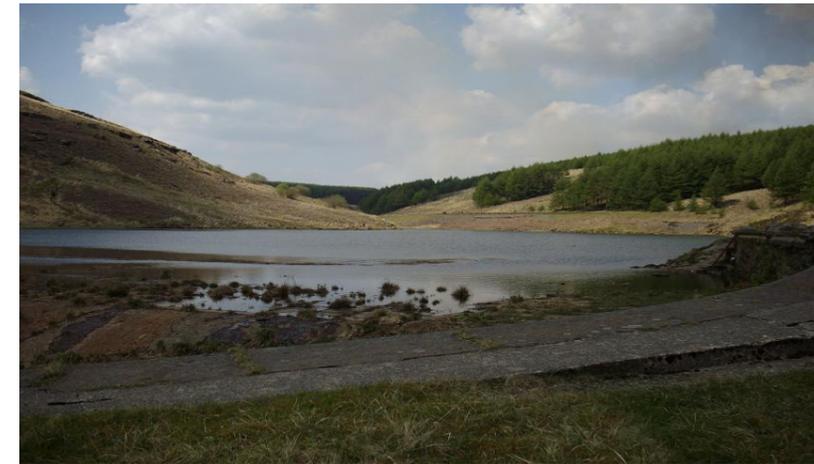
Plate 5-3 : Castell Nos Reservoir

In 1969, flooding disaster was narrowly avoided when the dam wall subsided into a large hole that appeared just above the water line. Local police evacuated residents from Station Terrace and Oxford Street, Maerdy, and throughout the Rhondda Fach valley. The reservoir was drained and the necessary repairs made. In order to protect the dam against mining subsidence, coal was not extracted from beneath the dam post this event. However, coal has been worked under part of the reservoir and the effects of mining subsidence have been seen.

Today the reservoir is owned and operated by Dwr Cymru Welsh Water (DCWW). They have an annual maintenance and inspection regime which the Environment Agency has the duty to regulate. There are no known issues with the reservoir or its inspection or maintenance programme.

Utilising GIS and DTM the flood risk afforded from the failure of the dam has been estimated. The peak water level, derived from the top of the dam wall, has been extrapolated down through the site and the flood risk area highlighted graphically (Figure 5-5). This method of calculating flood risk is in keeping with the precautionary approach of TAN15. However it does not evaluate the flow or depth of water as it flows through the site. It can be estimated that velocities and flood depths would be in excess of the policy requirements.

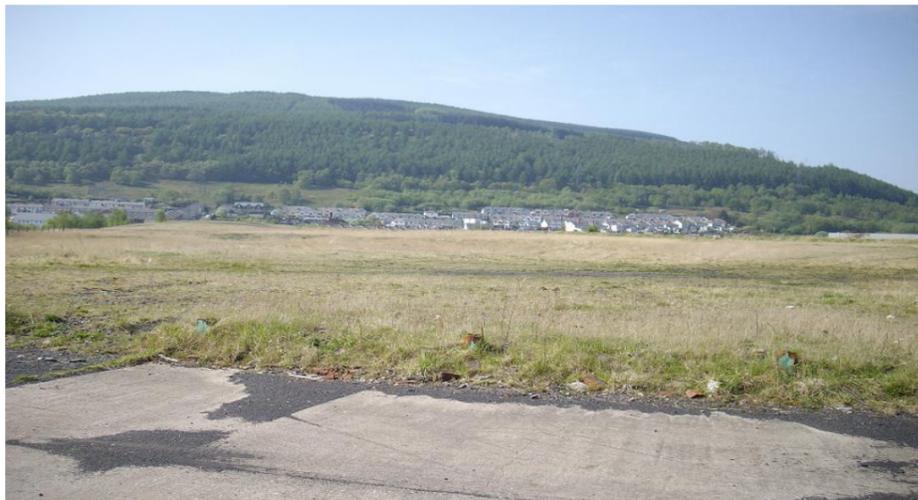
Plate 5-5: Looking west across the former Phurnacite Plant site to the village of Abercwmboi.

The site comprises of rough grassland and large areas of concrete hard standing (Plate 5-5) which remain from when the plant was operational. In addition there are three large lakes which from part of the previous surface water management system (Figure 5-10).

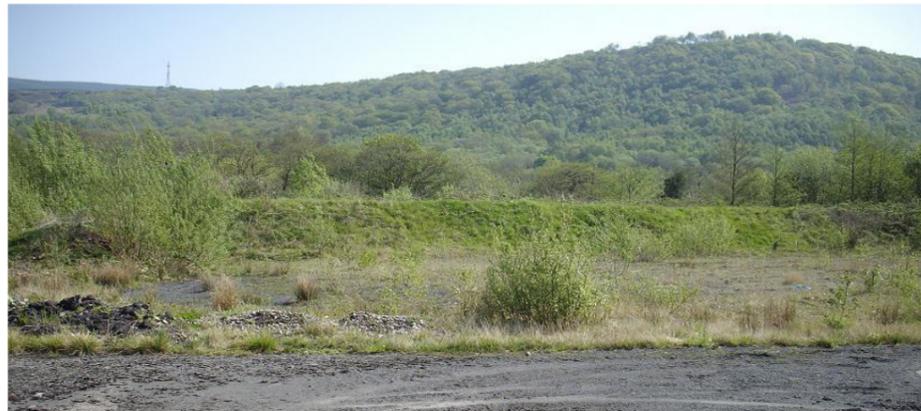
Plate 5-7: A levee or earth bund structure along the right bank of the River Cynon which potentially offers flood protection to part of the former Phurnacite Plant site.

A review of the topographical data within the HEC-RAS model has highlighted that the site slopes away from the channel of the River Cynon towards Abercwmboi. Flood water escaping onto the River Cynon's right bank will therefore flow over much of the site and pool at low points, potentially along the southern boundary and within the lakes. In addition, the modelling has also shown that the north corner of the site, on the River Cynon's right bank, is afforded some protection by an earth embankment / levee structure, as shown in Plate 5-7.

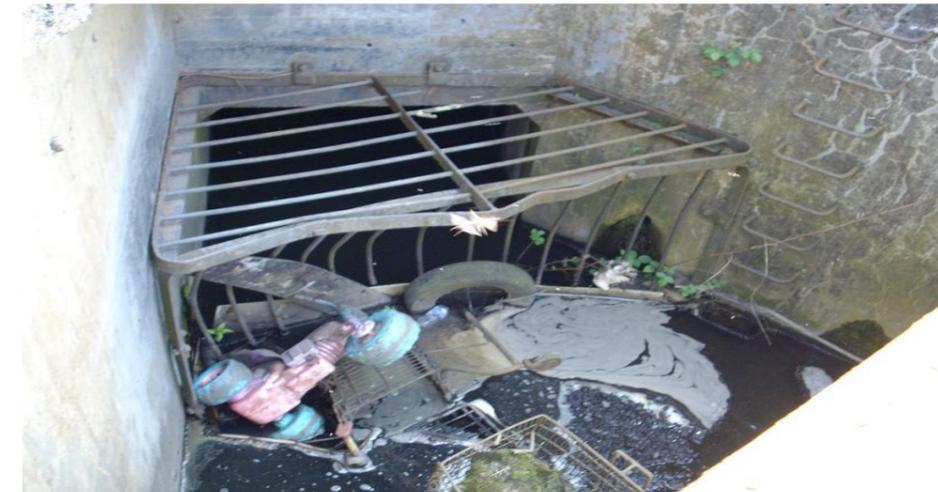
Plate 5-8: Photo of the primary outfall from the surface water lagoons to the River Cynon. While it has fallen into a state of disrepair it is not thought to have a significant impact on existing flood risk.

observed that the overflow channels and trash screens had fallen into a state of disrepair (Plate 5-8). It was also noted that they still had the ability to discharge waters to the River Cynon and as such it is estimated that they do not currently pose a flood risk to the site. However it is recommended that a detailed study of their functionality be undertaken as part of a site specific FCA.

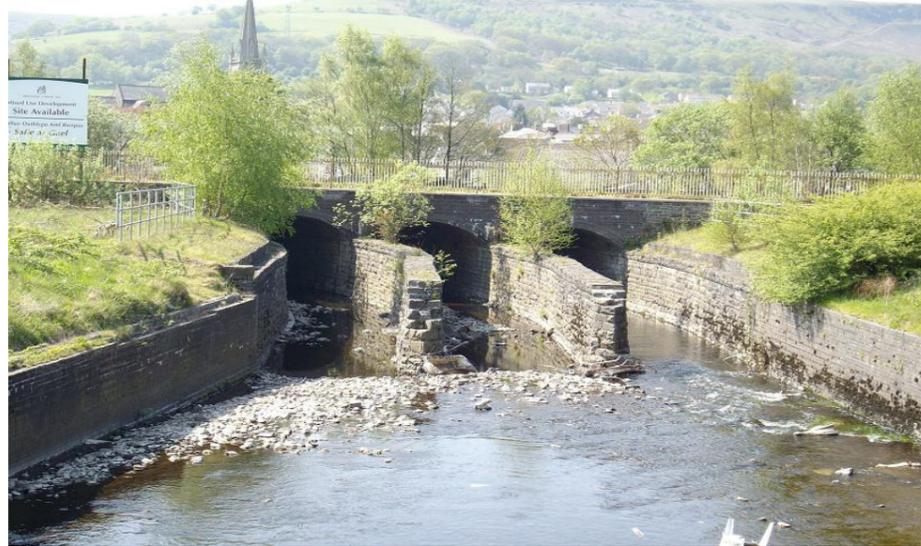
Plate 5-9: Looking downstream at the brick arch culvert channelling the River Cynon beneath the Valley Line railway.

extending upstream of the structure. While this assessment has not undertaken an evaluation of the capacity of the structure, site observations suggest that it is unlikely to be able to convey the 1 in 100 year return period flood event. Its design is susceptible to blockage. As such water could be held back upstream and overtop the channel when capacity is reached. This will impact on the site and its primary access road. Similar observations were recorded with regards to the bridge upstream of the culvert. While having no piers to increase blockage risk, it will impact on the movement of floodwaters downstream.

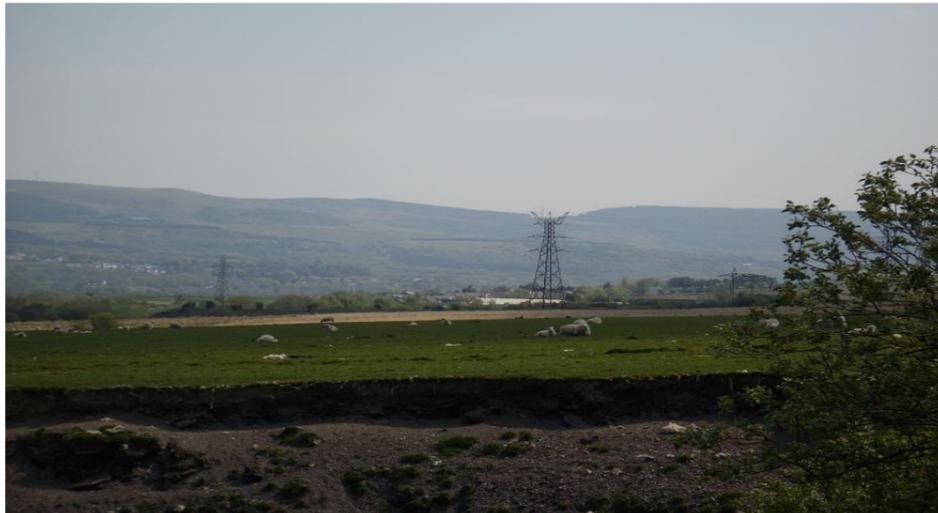
Plate 5-10: Photo looking north-east across the land south of Hirwaun and Penywaun.

The proposed development site lies on land south of the town of Hirwaun and the village of Penywaun just south of the Beacon Beacons National Park in the uppermost reaches of the River Cynon catchment. The site covers an area of approximately 340 ha. It is located on the northern slopes of Mynydd Cefn-y-Gyngon and is predominately elevated above the River Cynon floodplain. There are also numerous tributaries that cross the site. In addition, there are man made surface water channels and lagoons remaining from the open cast coaling surface water management systems.

From observations during a site walkover, the lagoons appeared to be functioning and discharging as designed and any significant flood risk would only result from their structural failure.

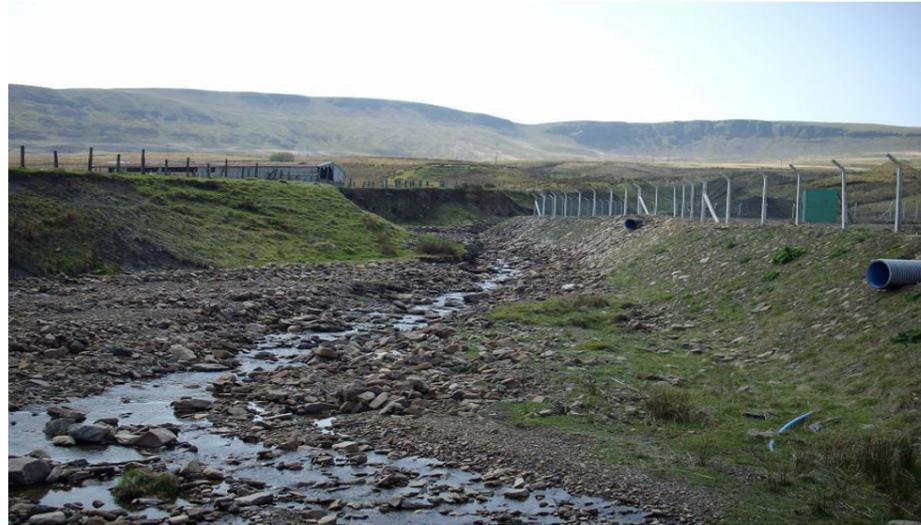
The local geology in this area affects the site topography and surface water flood risk. Upslope and to the south of the site, Cefn-y-Gyngon Mountain directs overland flow towards the development site. Due to its position in the catchment, bedrock is predominantly near to the surface. This combined with the steep topography typically results in a flashy stream response to rainfall events. High flow peaks soon after rainfall events are therefore typical. Rapid overland flow has not been known to cause flooding but surface water management in the form of lagoons and ditches was used during past site operations to prevent water from entering the open cast void. Field observations identified that the existing surface water management system has fallen into a state of disrepair. Evidence of channel collapse and blockage was observed that would impede flows and increase flood risk.

Plate 5-11: Photo viewed south across the site to Cefn-y-Gyngon Mountain in the distance. The high velocity in which water enters the site is evident from the highly eroded channel and the large boulders which it transports. To the right is one of the surface water lagoon systems which remain from the coaling operations at the site.
