Flood and Water Management Act 2010

Section 19 Report

Storm Bert – Flood Investigation Area 02

October 2025

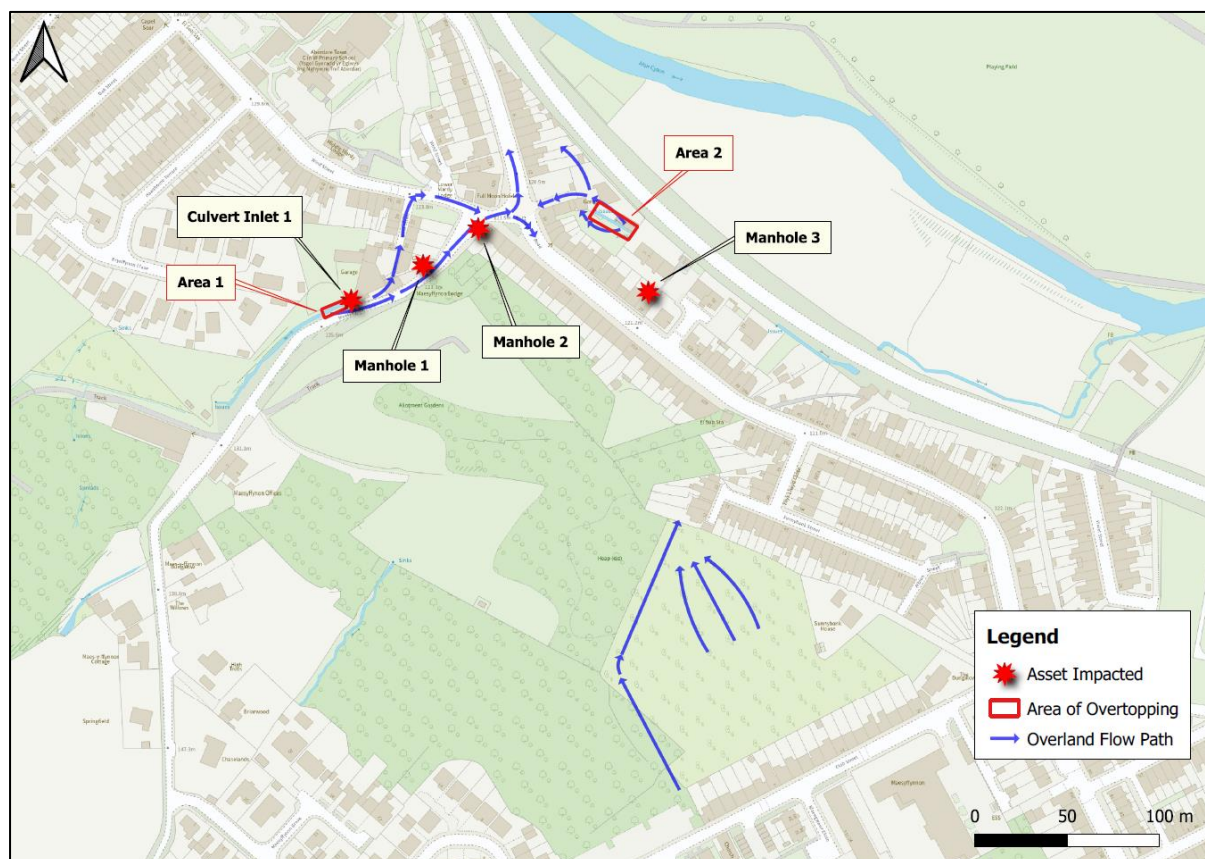
Figure 3: Observed overland flow paths, areas of overtopping and surcharging assets at FIA 02 during Storm Bert (23-24 November 2024)

An unnamed ordinary watercourse adjacent to Maesyffynon Lane was identified as overtopping during the storm event at approximately 06:00 on Sunday 24 November. CCTV footage from RCT's monitoring station shows the culvert inlet (labelled 'Culvert Inlet 1' in Figure 3) surcharging, and the incoming watercourse overtopping at the upper debris screen during the storm event (identified as 'Area 1' in Figure 3). Exceedance flows from the overtopped watercourse travelled down Maesyffynon Lane towards Wind Street and Cardiff Road, where the flows accumulated and entered the front and rear of several homes, contributing to the internal flooding of 16 residential and 1 non-residential properties along Cardiff Road and Wind Street.

Two manholes associated to the culverted watercourse were also identified by residents to have surcharged during the storm event. Both manholes are depicted as 'Manhole 1' and '2' in Figure 3, and both contributed flows towards Cardiff Road.

the section of open ordinary watercourse to the east of impacted properties overtopping during the storm event (labelled 'Area 2' in Figure 3) and conveying towards the lower elevations of the rear gardens. These ordinary watercourse flows also contributed to the internal flooding of at least 1 residential and 1 non-residential property at Cardiff Road, situated in close proximity to the watercourse.

A combined sewer manhole located in the rear garden of a residential property was also noted as surcharging during the storm event (labelled 'Manhole 3' in Figure 3). Flood water from the manhole was mostly contained to the rear garden of one property but was also reported to have conveyed into the basement of the property, resulting in internal flooding.

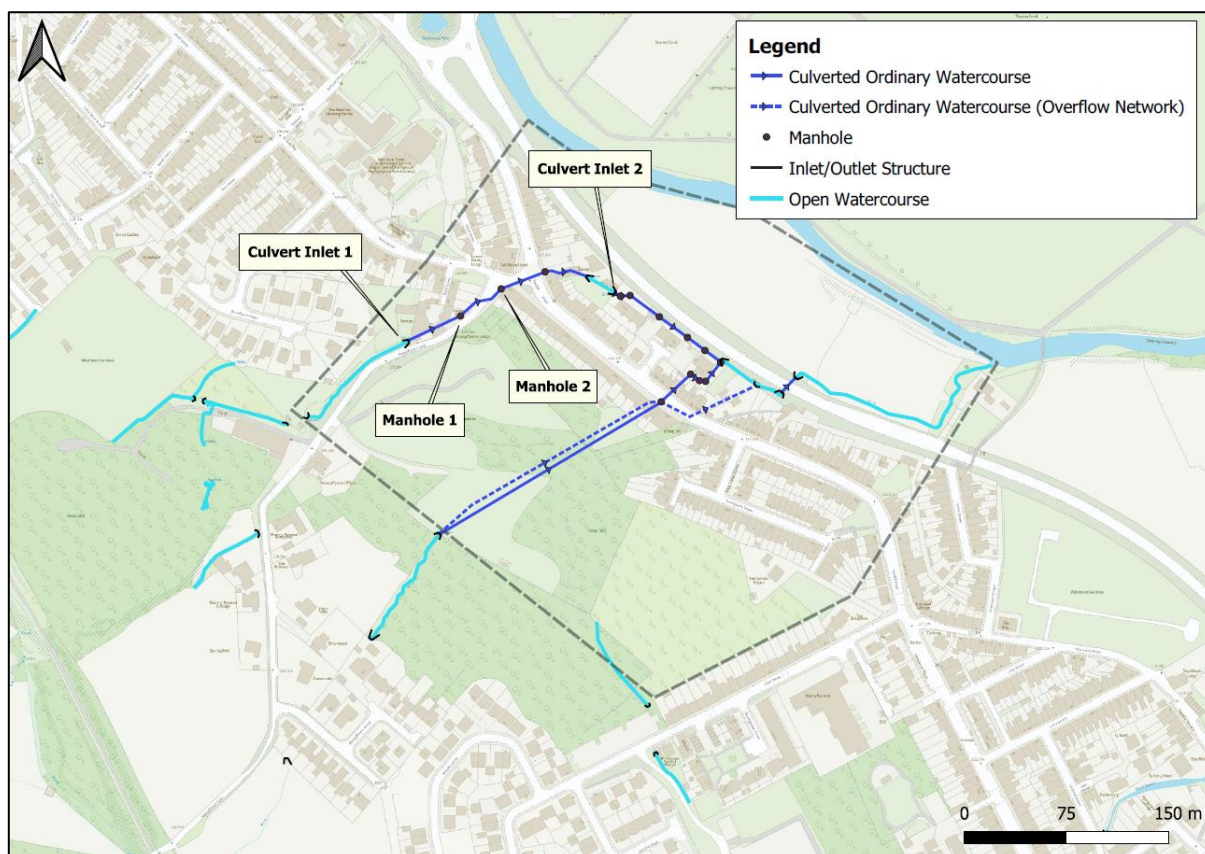
Figure 7: Culverted ordinary watercourse networks within FIA 02

The surcharging of 'Manhole 1' and 'Manhole 2' (associated to the culvert network downstream on 'Culvert Inlet 1') were identified as secondary sources of flooding to properties along Cardiff Road and Wind Street during Storm Bert. The culverted watercourse network downstream of 'Culvert Inlet 1' was assessed as being in poor condition. The results of the survey found various structural and operational defects in the line, indicating that the condition of the culvert network is considered to have contributed to the surcharging of 'Culvert Inlet 1', 'Manhole 1' and 'Manhole 2' during the storm event.

Based on the available evidence presented within this report, it can be concluded that ‘Culvert Inlet 1’, ‘Manhole 1’ and ‘Manhole 2’ became hydraulically overwhelmed during Storm Bert, however, on review of the poor condition of the culvert network downstream of ‘Culvert Inlet 1’ (described in Section 3.1), it is considered that the network’s hydraulic capacity was further reduced, resulting in the surcharging of the inlet and both manholes.

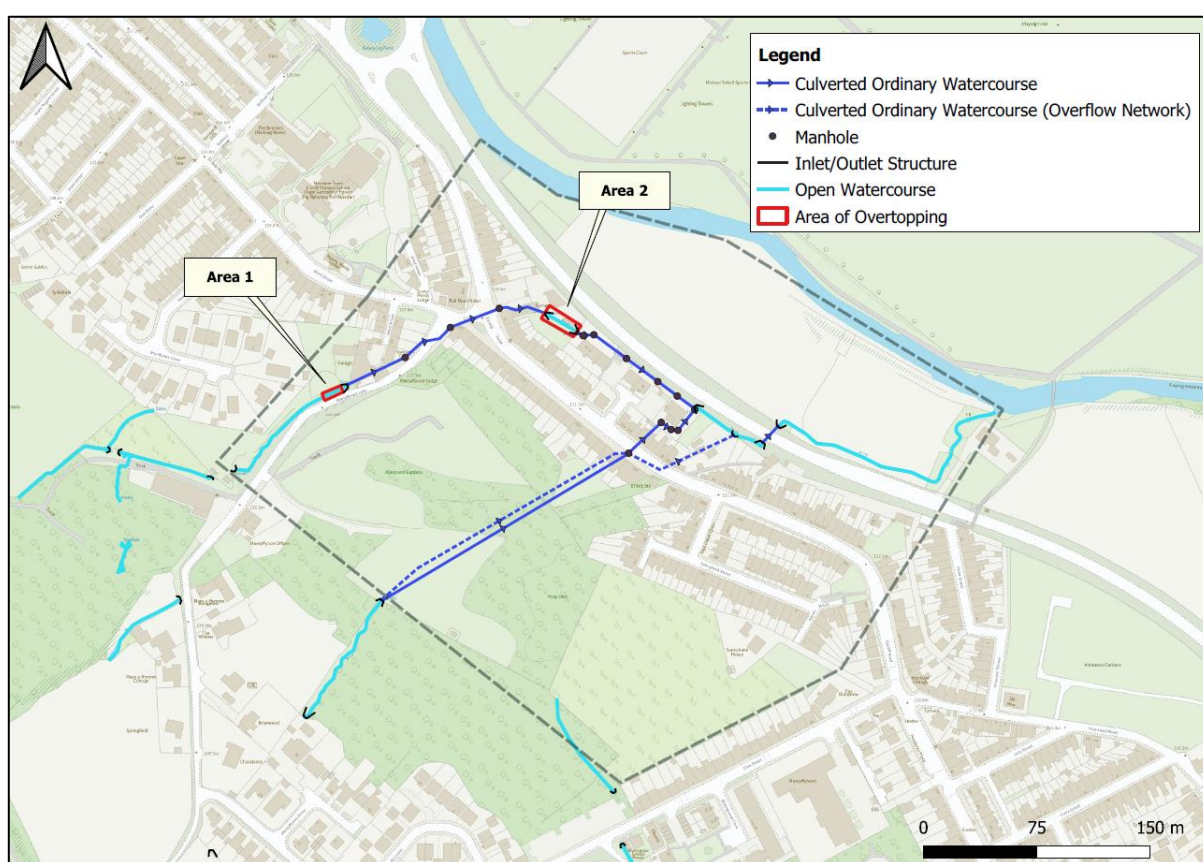
Figure 9: Map of open ordinary watercourses and areas of overtopping within FIA 02

‘Area 1’ in Figure 9 was observed via CCTV footage to have overtopped during the storm event. The open channel upstream of ‘Area 1’ is largely natural while the downstream channel comprises of gabion structures and twin debris screens to minimise the risk of scour and debris mobilisation entering the culvert system. The watercourse was identified to be in acceptable condition albeit with evidence of minor scouring to the eastern embankment and some natural debris deposition in the channel, as shown in Figure 10.

'Area 2' (shown in Figure 9) was also identified as a contributing source of flooding to approximately 5 properties along Cardiff Road during Storm Bert. Upon an inspection of 'Area 2' following Storm Bert, the watercourse was identified to be in poor condition, with dense vegetation obstructing the flow of water through the channel. On-site inspections were also restricted due to the dense vegetation, as shown in Figure 11. This section of open watercourse and its associated drainage infrastructure is identified to be in private ownership.

The poor condition of the open watercourse channel in 'Area 2' is considered to have contributed to its overtopping however, the primary cause of overtopping at 'Area 2' has been attributed to the significant flows entering the system and the poor capacity of the ordinary watercourse and the downstream culvert network resulting in the system becoming hydraulically overloaded and overtopping during the storm event.

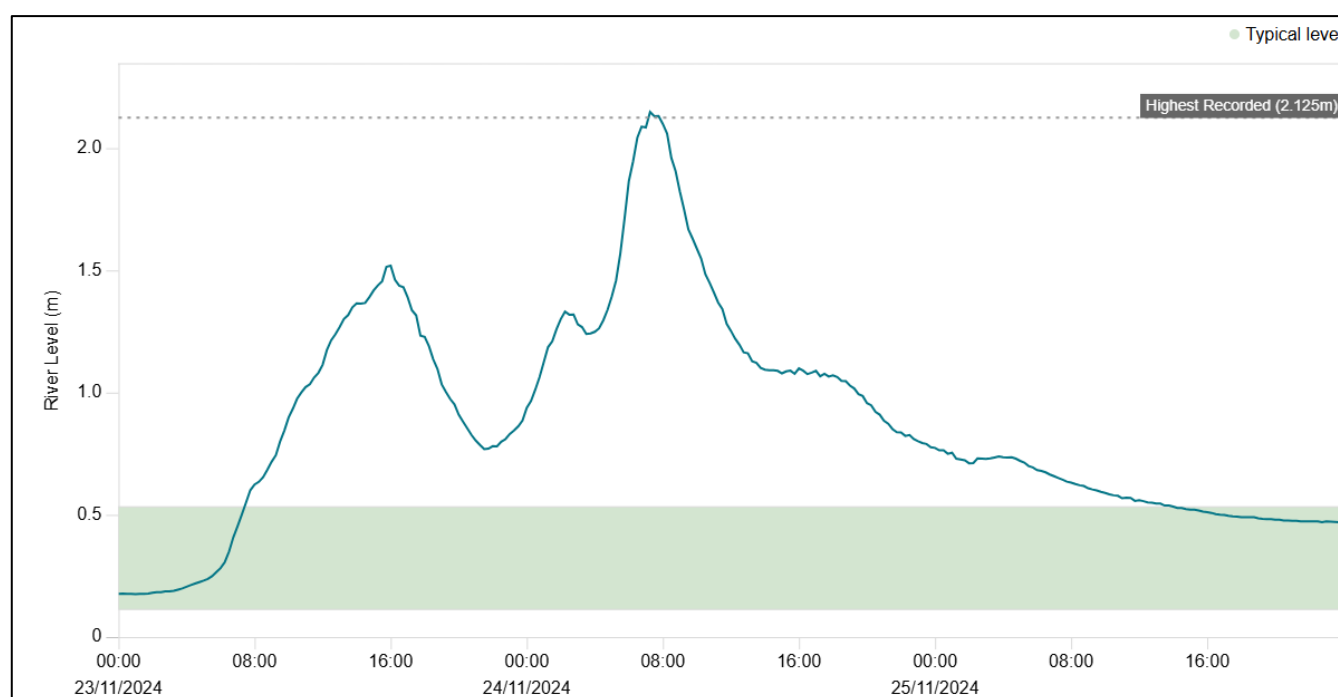
Figure 12: The River Cynon levels at Aberdare station between 23 and 25 November 2024 (Natural Resources Wales).

The hydrograph in Figure 12 illustrates the rapid rise in levels of the River Cynon in response to rainfall between the 23 and 25 November 2024, captured at NRW's Aberdare station. The River Cynon at Aberdare reached its highest peak recorded at approximately 07:15 on 24 November 2024, reaching 2.148 metres.

The green bar displayed on the hydrograph shows the typical level of the River Cynon at Aberdare, ranging between approximately 0.1 and 0.55 metres. At its peak, the River Cynon was over 3 times higher than its average level.

There is no evidence from this investigation to suggest that the River Cynon significantly contributed to the recorded flooding of properties in FIA 02 during Storm Bert, however, based on the relative high levels recorded within the River Cynon during the storm event, it is considered likely that the outfall conditions of the culverted ordinary watercourse, surface water and sewer structures were influenced by the high levels. There is limited evidence to outline this interaction, however.

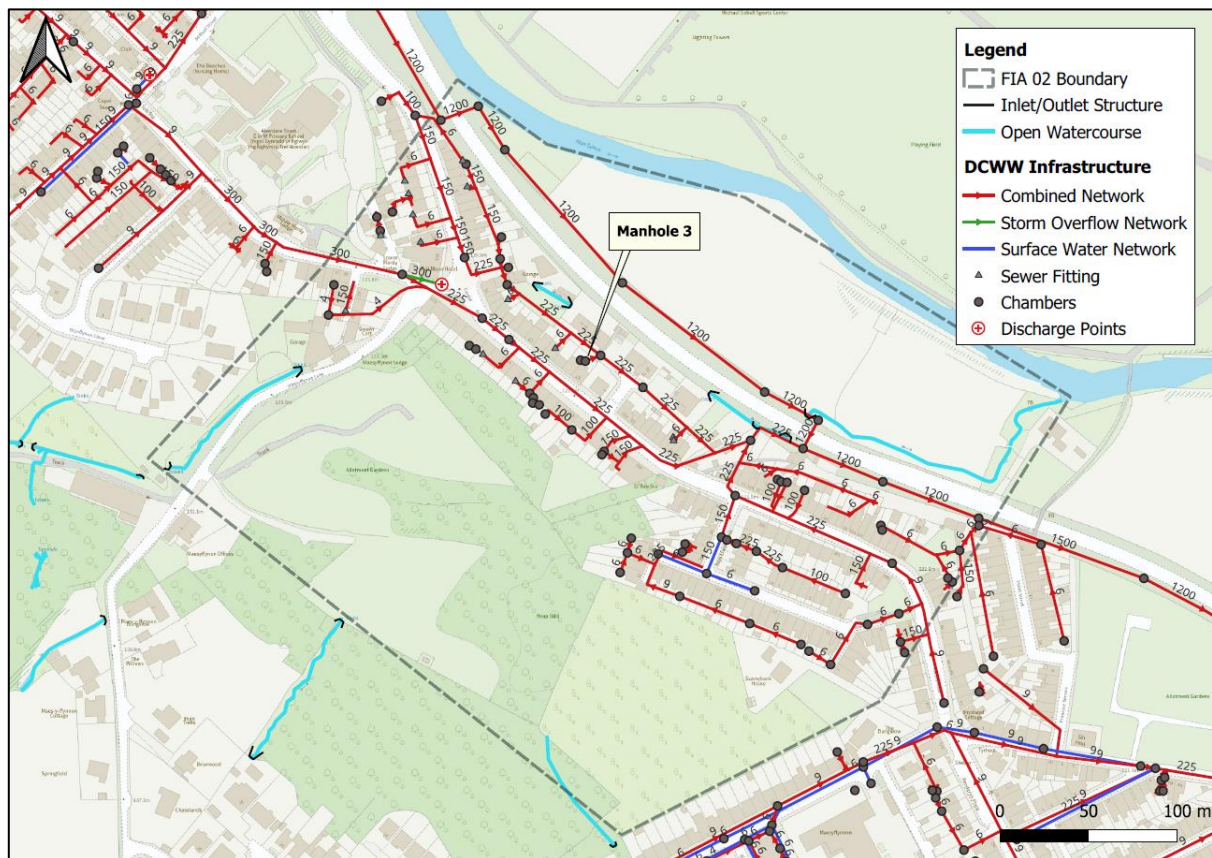
Figure 13: Map of DCWW sewer infrastructure within FIA 02

The DCWW sewer infrastructure within FIA 02 is depicted in Figure 13, along with ‘Manhole 3’ which was identified by residents’ accounts to have surcharged and caused flooding to one residential property during the storm event.

Accounts provided by residents, and supported by post event inspections, identified foul-smelling, dirty water to have entered the homes of 9 residential properties along Cardiff Road. Water was reported to have entered properties via a surcharging

Based on the available evidence, and information provided by DCWW, it is considered that the combined sewer system conveying to the rear of impacted properties at Cardiff Road became hydraulically overloaded during the storm event as a result of intense rainfall and exceedance ordinary watercourse flows within the investigation area, which resulted in foul and surface water ingress into several properties.

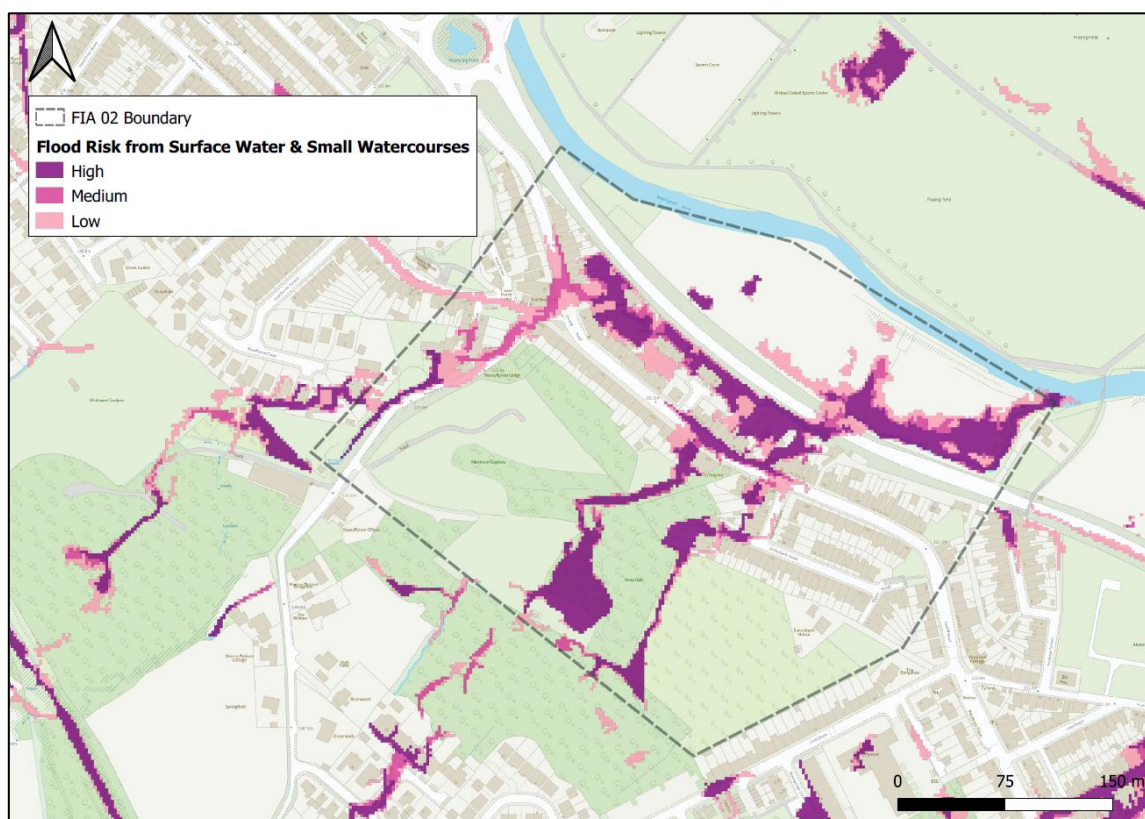
Figure 14: NRW's FRAW map for Surface Water and Ordinary Watercourse flood risk at FIA 02. Natural Resources Wales data.

On review of NRW's national surface water and ordinary ("small") watercourse flood map (Figure 14), the extent of flooding from these sources is significant and correlates with the observed overland flow paths during Storm Bert. Flood risk is primarily associated to the network of ordinary watercourses and culverted infrastructure conveying through FIA 02, with particularly high risk noted across parts of Cardiff Road, Wind Street and the rear of Sunnybank Street.

As discussed in Section 2.2, two residential properties at Sunnybank Street were internally impacted by surface water flooding associated to overland flows conveying down an area of open hillside to the rear of Sunnybank Street, and onwards towards a topographic low point adjacent to properties. The observed overland flow paths towards Sunnybank Street during Storm Bert correlate well with the surface water flood risk extents illustrated in Figure 14.

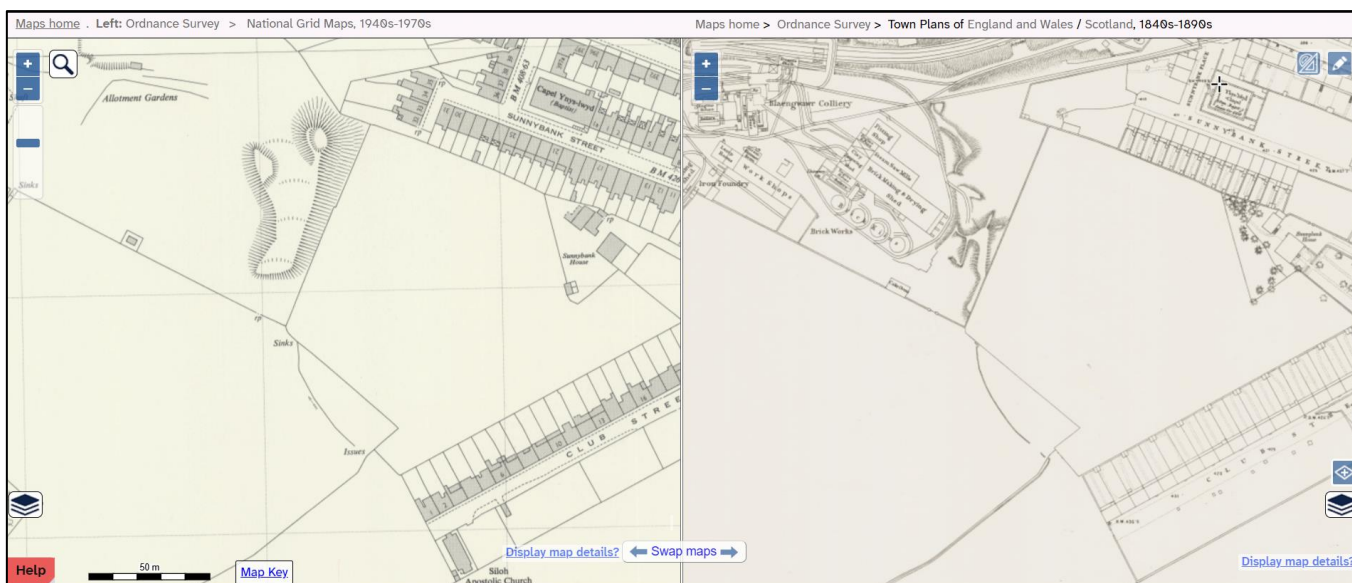
Historical mapping from 1944-74⁸ (shown in Figure 16), indicates the presence of a natural sink located at the base of the open channel ('Area B' in Figure 15). This feature appears to have historically served as a point of infiltration for surface water flows. Observations made during the site visit did not identify any formal drainage infrastructure at the base of the channel, and the land surrounding the sink was saturated and boggy, indicating limited infiltration capacity.

Figure 16: Historic Ordnance Survey maps from the 1840s-1890s (right) and 1940s-1970s (left) (National Library of Scotland) showing the location of a natural sink at the base of an open channel located on the hillside south of Sunnybank Street
