**Flood and Water Management Act 2010**

# **Section 19 Report**

**Storm Bert – Flood Investigation Area 25**

**October 2025**

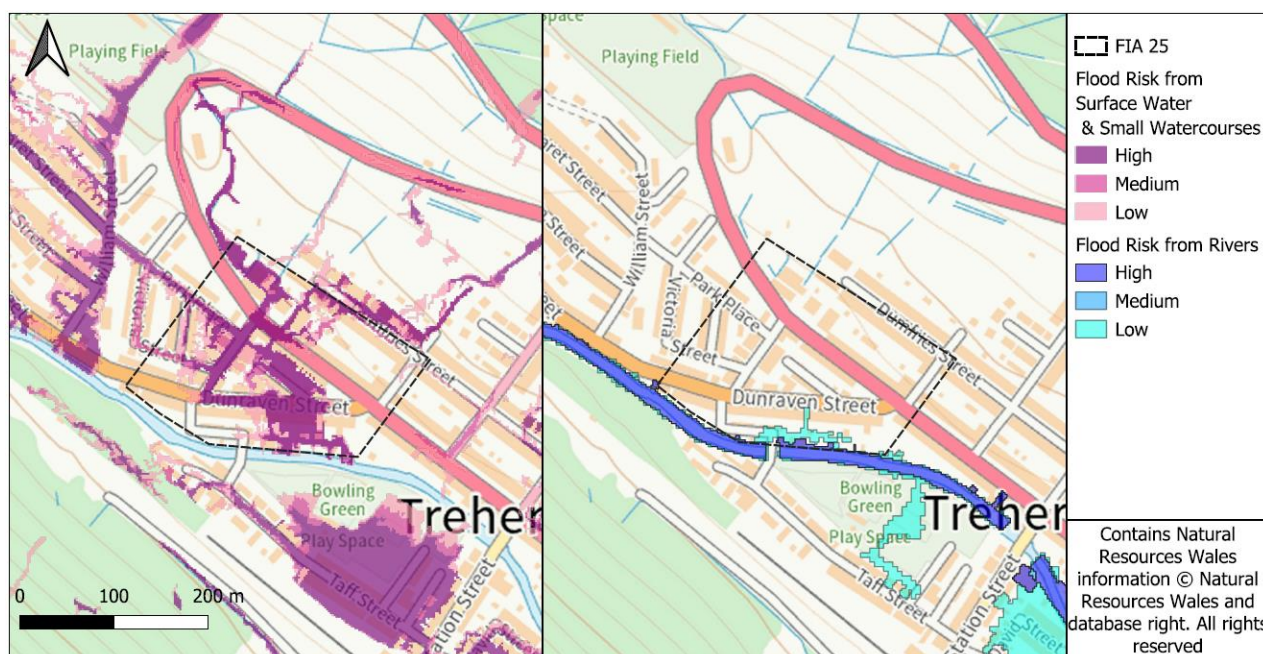
**Figure 2:** Natural Resources Wales's Flood Risk Assessment (FRAW) map for surface water and small watercourse, and main river flood risk at FIA 25.

As illustrated by Natural Resources Wales's (NRW) Flood Risk Assessment Wales (FRAW) maps (Figure 2), the highest risk to people and properties within FIA 25 is broadly associated with culvert inlets, the overtopping of watercourse embankments and overland flows owing to the steep topography of the upper catchment. A low risk of main river flooding is also noted south of Dunraven Street along the flood plain of the River Rhondda.

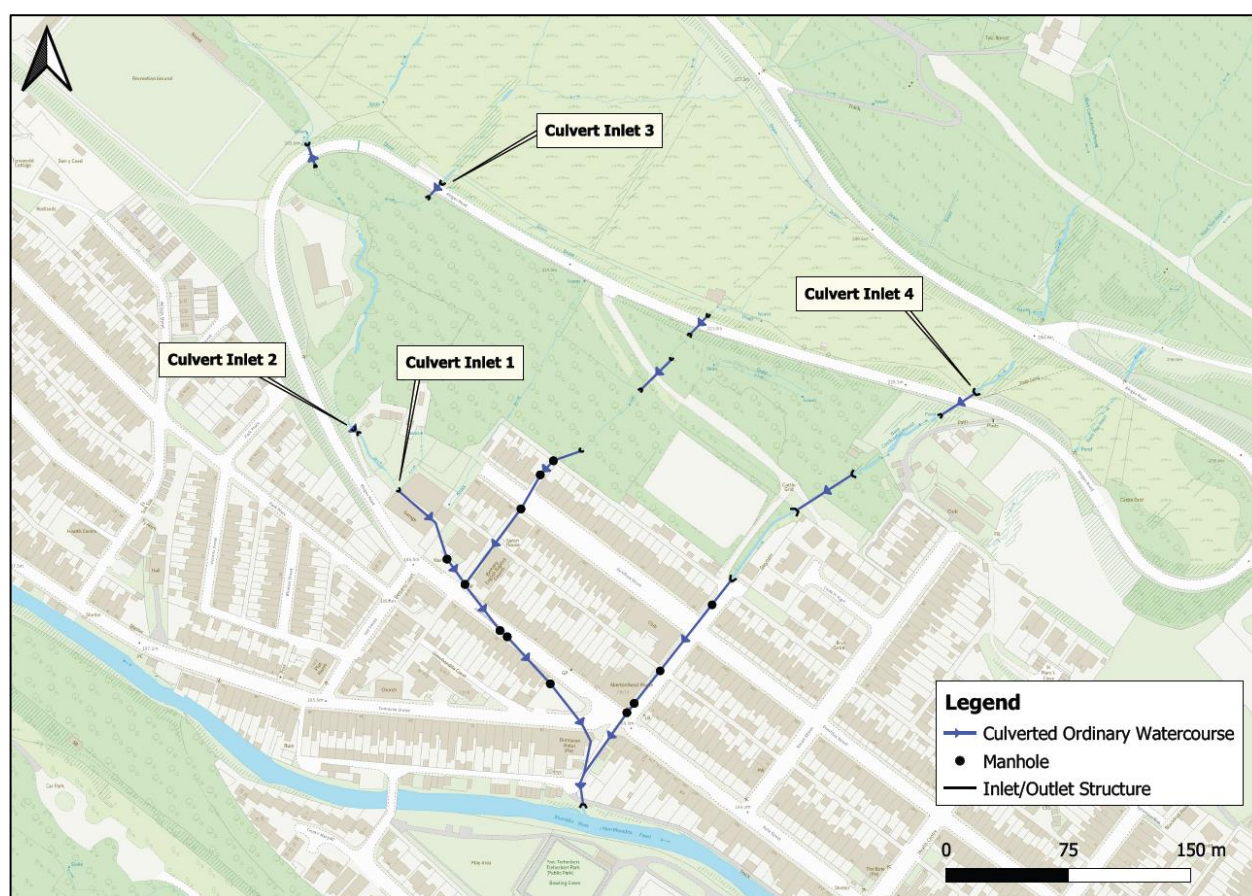
**Figure 12:** Culverted ordinary watercourse networks within FIA 25.

Within FIA 25 there are unnamed ordinary watercourses which drain the hillsides to the north and east of investigation area and discharge into the Rhondda Fawr River. Many of these watercourses are culverted beneath Treherbert's urban settlements. The known culverted watercourse networks present in FIA 25 are shown in Figure 12.

An assessment of the hydraulic capacity of the culverted watercourse networks identified as sources of flooding within FIA 25 during Storm Bert has been undertaken to ascertain its current standard of protection in free-flowing conditions. The results of the inlet capacity assessments are summarised in Table 6 below (refer to Figure 12 for culvert labels).

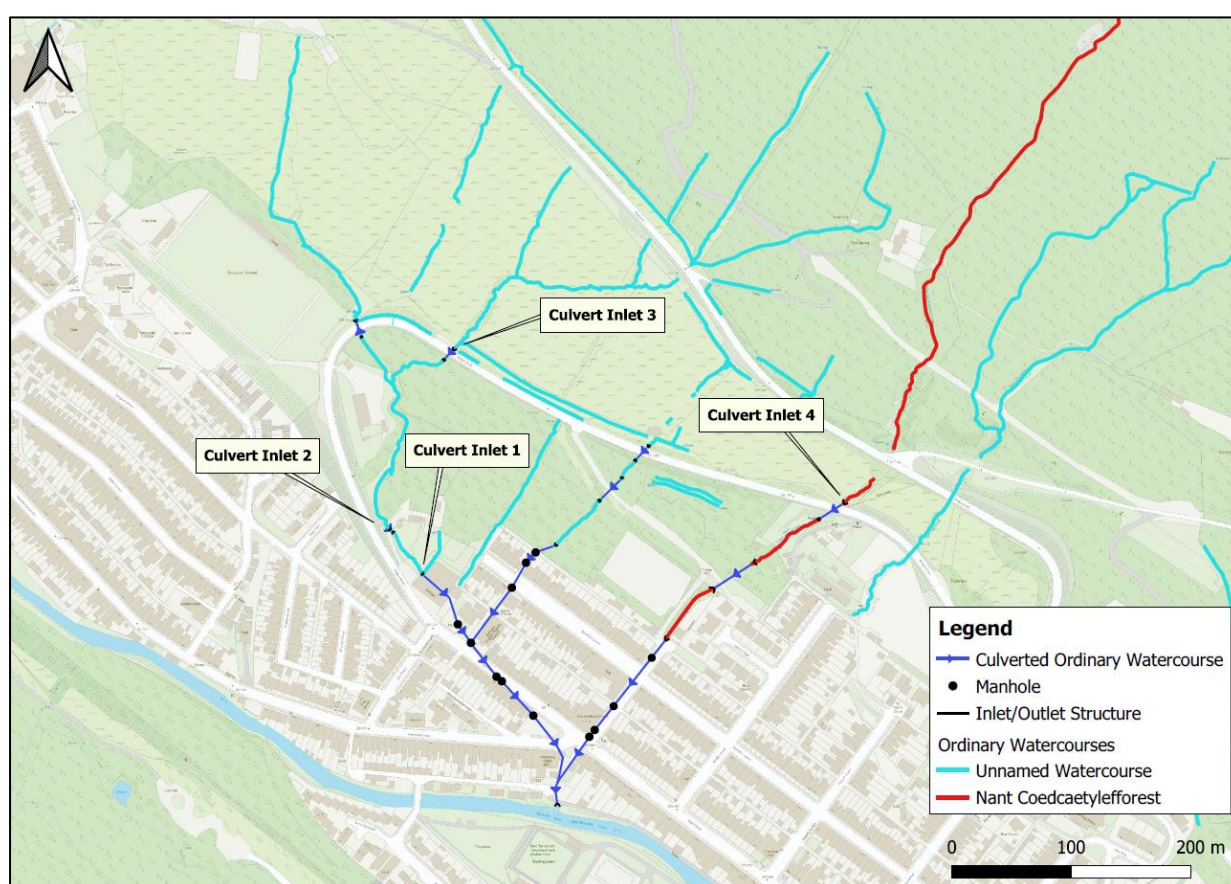
**Figure 15:** Map of open ordinary watercourses within FIA 25.

Several sections of open watercourses which drain the steep hillsides to the north and east of FIA 25 are identified to flow through the investigation area and discharge into the River Rhondda Fawr, as illustrated in Figure 15. The named watercourse entering the investigation area is the Nantcoedcaetylleforest (highlighted red in Figure 15).

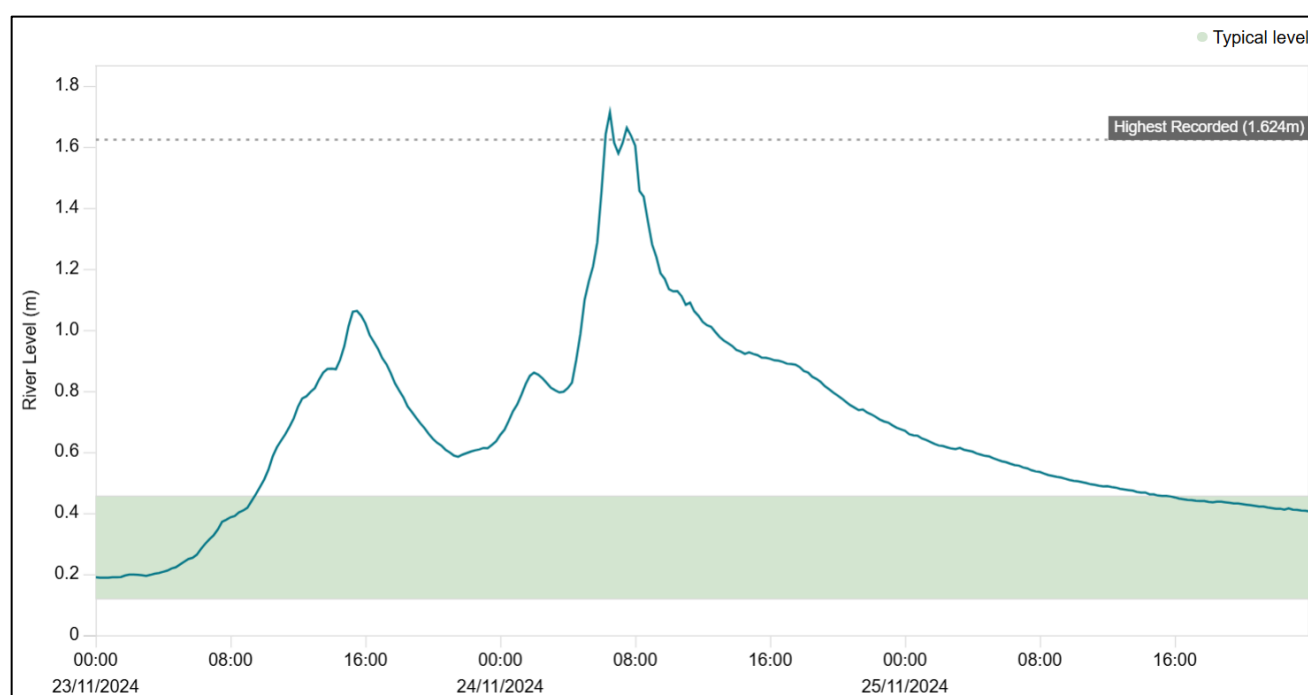
**Figure 20:** The River Rhondda Fawr levels at Tynewydd station between 23 and 25 November 2024 (Natural Resources Wales).

The hydrograph in Figure 20 illustrates the rapid rise in levels of the River Rhondda Fawr in response to rainfall between the 23 and 25 November 2024, captured at NRW's Tynewydd station. The River Rhondda Fawr at Tynewydd reached its highest peak recorded at approximately 06:30 on 24 November 2024, reaching 1.714 metres.

The green bar displayed on the hydrograph shows the typical level of the River Rhondda at Tynewydd, ranging between approximately 0.1 and 0.45 metres. At its peak, the River Rhondda Fawr was almost 4 times higher than its average level.

There is no evidence from this investigation to suggest that the River Rhondda Fawr significantly contributed to the recorded flooding of properties in FIA 25 during Storm

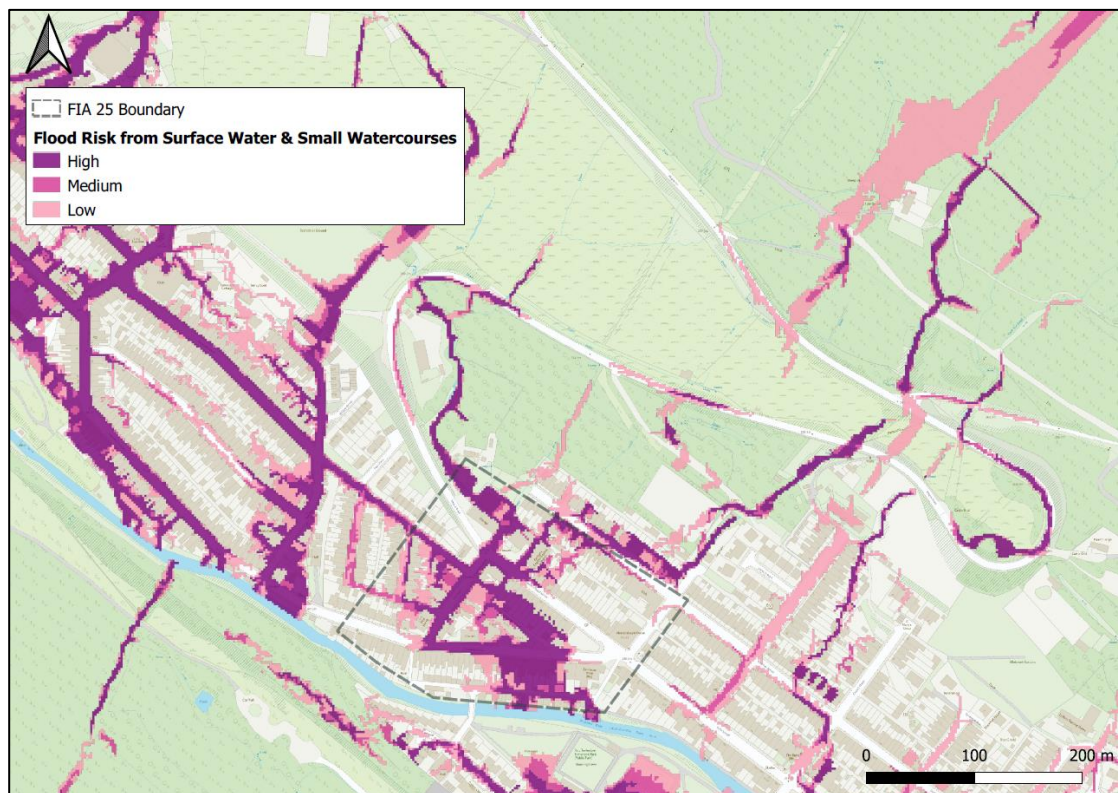
**Figure 23:** NRW's FRAW map for Surface Water and Ordinary Watercourse flood risk at FIA 25. Natural Resources Wales data.

Due to the steepness of the hillsides above Treherbert, the delivery of overland and ordinary watercourse flows towards the investigation area are accelerated, meaning the catchment will respond rapidly to rainfall. As a result, surface water flooding generated by intense rainfall and ordinary watercourse flows that overwhelmed culvert inlets has been determined as a contributing source of flooding to properties within the lower reaches of the investigation area where water naturally accumulates.

On review of NRW's national surface water and ordinary ("small") watercourse flood map (Figure 23), the extent of flooding from these sources is significant and correlates with the observed overland flow paths and areas of surface water accumulation during Storm Bert (particularly along Dunraven Street and Hill Street).
