Section 19 Flood Investigation Report

Storm Dennis – Flood Investigation Area RCT10

September 2021

| Document Ref | FRM – S19 - 010 |

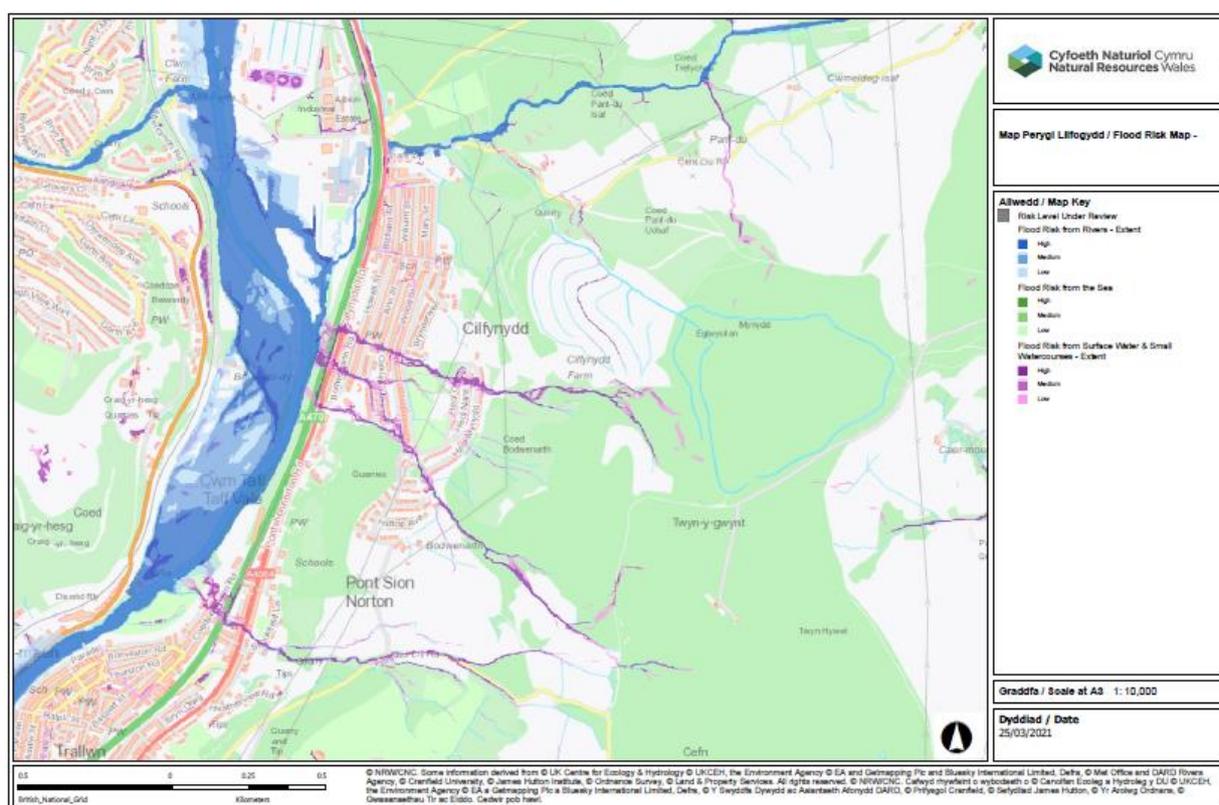
The highest risk posed to people and properties according to RCT's Flood Risk Management Plan (FRMP)³ is broadly associated with the culvert inlet of the Nant Cae Dudwg where it crosses under Cilfynydd Road. The FRMP also notes a low to high risk of flooding sourced from the unnamed watercourses culverted beneath Cilfynydd. The risk of flooding from these watercourses is illustrated within Natural Resources Wales' Flood Risk Assessment Wales (FRAW) map presented in Figure 2. Flooding from the Main River is noted within the floodplains adjacent to the River Taff, however these areas fall outside of investigation area RCT10.

Figure 2: Natural Resources Wales' Flood Risk Assessment Wales (FRAW) map for rivers and ordinary watercourse and surface water flood risk at investigation area RCT10. Contains Natural Resources Wales information © Natural Resources Wales and database right. All rights reserved.

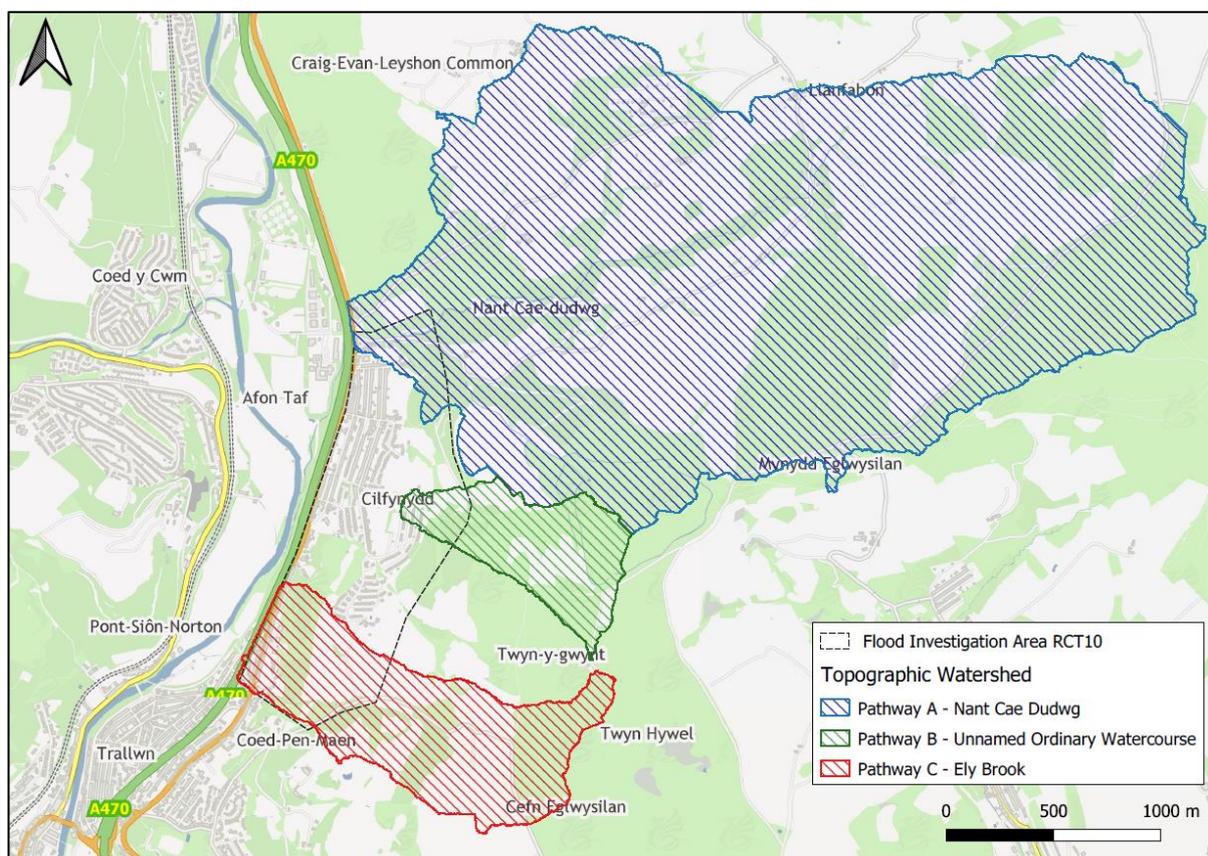
The principal sources of flooding, as depicted within Table 2, have been spatially represented within Figure 3, which depicts the topographic watershed of the three primary watercourses that drain towards the Cilfynydd urban area. The area of land that would expect to drain towards the three watercourses under investigation is shown in the hatched areas within Figure 3.

Residents of the affected properties in Cilfynydd reported the overtopping of the three watercourses flowing through the village, which resulted in flood water flowing overland towards the lower reaches of Cilfynydd and affecting several properties on its course. The primary flow paths that occurred during Storm Dennis have been identified as 'A' to the northeast (blue hatched area), 'B' on the eastern edge (green hatched area), and 'C' to the south (red hatched area) of investigation area RCT10 (Figure 3). These flow paths have been further described within their individual sections below.

Figure 3: Rainfall Topographic Watersheds of the three primary watercourses flowing through investigation area RCT10

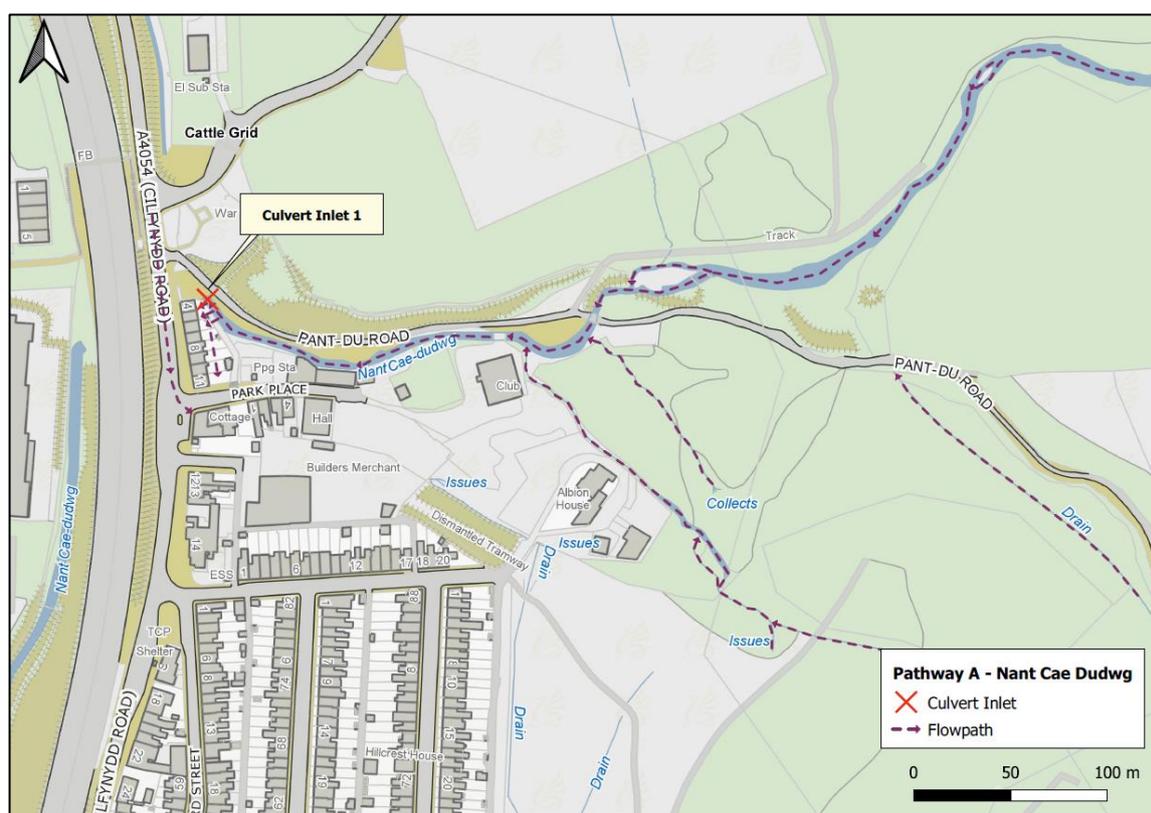
Several calls were received from residents at Cilfynydd Road on the 16th February 2020, to report that water from the Nant Cae Dudwg watercourse had overtopped the flood wall at the inlet (labelled 'Culvert Inlet 1' in Figure 4) and was threatening to enter the rear gardens of properties situated directly downstream of the culvert inlet. The inlet location is provided in Figure 4.

Figure 4: Map illustrating flow path A and the Nant Cae Dudwg culvert inlet, 'Culvert Inlet 1'

During the early hours of Sunday 16th February, the Nant Cae Dudwg ordinary watercourse overtopped the flood wall at the inlet, causing water to accumulate within the lane behind properties at Cilfynydd Road. The result of which saw riverine debris including silt and mud being deposited in the lane area. This resulted in blockages to the surface water drainage gullies in the lane, reducing the capacity of the drainage network to manage the excess water (Figure 5).

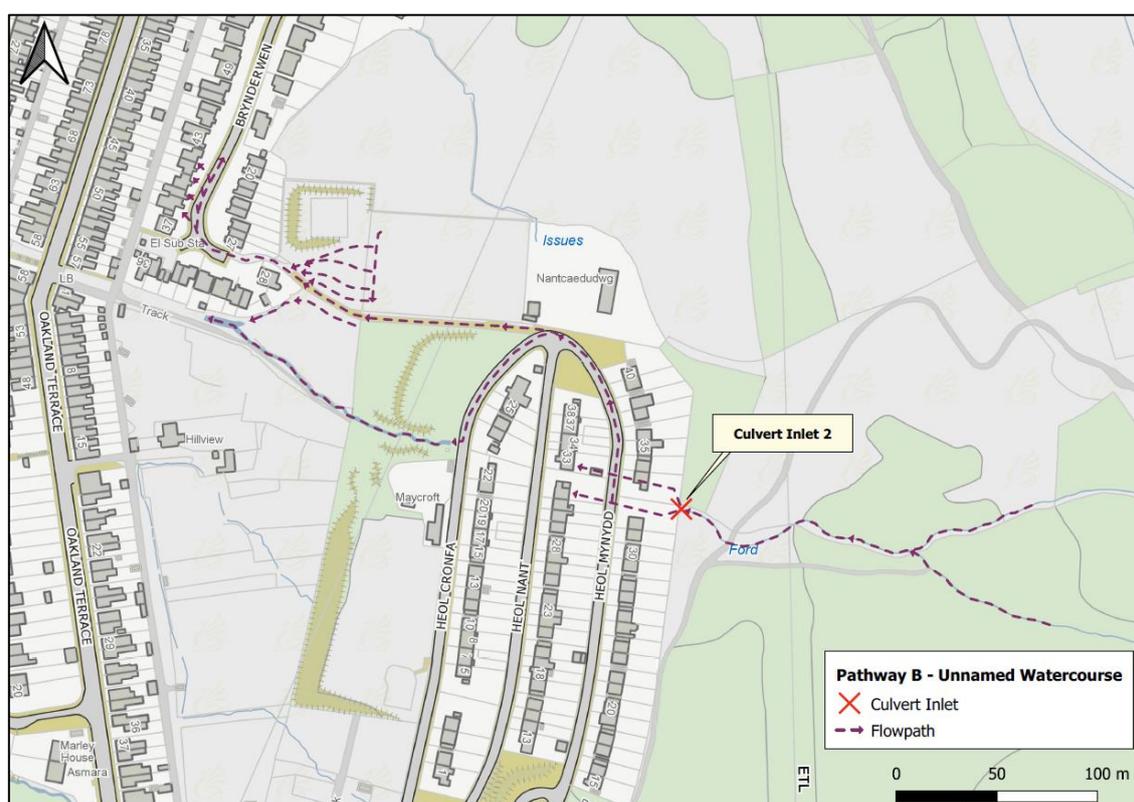
Pathway B, shown in Figure 3, shows where surface water flows from the east of Cilfynydd enter the town through an unnamed ordinary watercourse. The watercourse crosses the town via several culverts before discharging into the River Taff. Calls were received from residents at Heol Mynydd and Heol Nant to report that water from the unnamed watercourse to the rear of Heol Mynydd was overtopping near the inlet and beginning to flood properties. The inlet's location, labelled 'Culvert Inlet 2', is provided in Figure 8.

Figure 8: Map illustrating flow path B the culvert inlet of the unnamed watercourse, 'Culvert Inlet 2'

Post event inspections identified the inlet's debris screen as blocked with woody debris mobilised during the event, reducing the inlet's capacity to manage the flow and causing the inlet to surcharge and flood. According to residents, water was observed to have overtopped the garden walls to the rear of Heol Mynydd, flowing through the properties and out onto the street (Figure 9). Water then continued to flow downhill, flooding two properties on Heol Nant from the rear. As the water cascaded over the

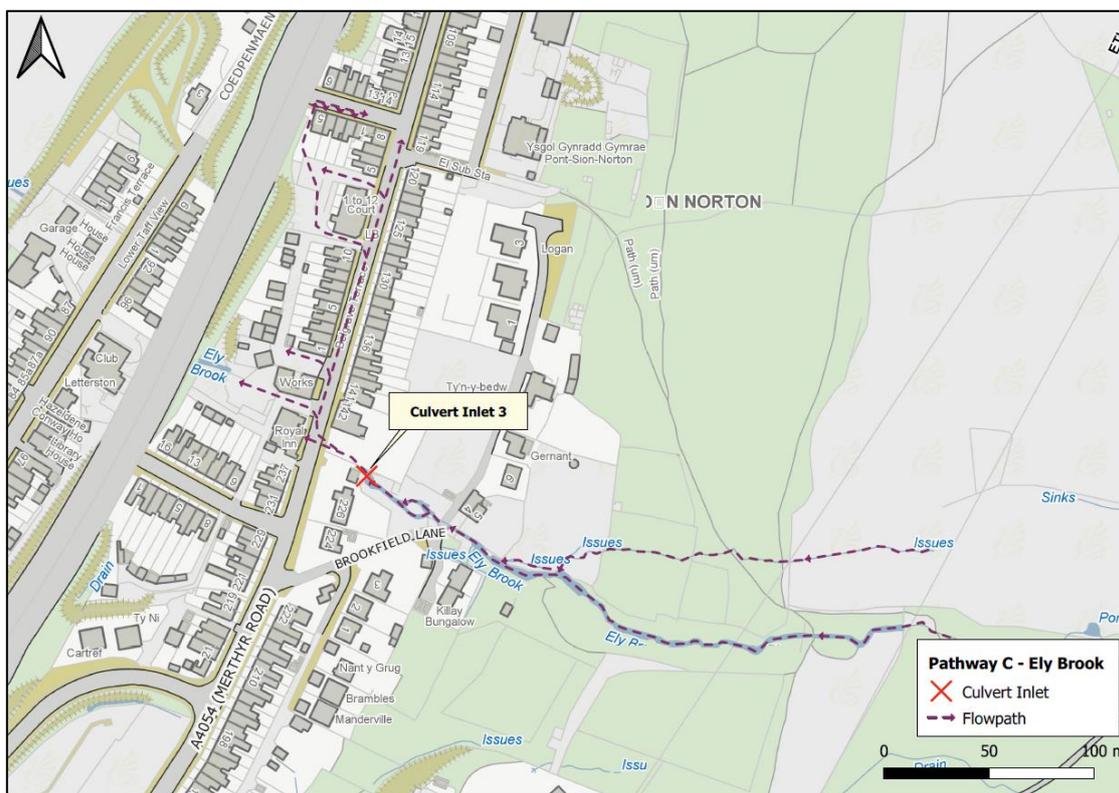
Pathway C, shown in Figure 3, shows where surface water flows enter the investigation area from the southeast corner of the catchment. The surface water flows through the Ely Brook ordinary watercourse, passes through the southern catchment via several culverts, and ultimately discharges into the River Taff. On its course of flow, the Ely Brook culvert ('Culvert Inlet 3', Figure 13) surcharged at the inlet opposite the Royal Oak Inn and resulted in flooding to properties and the highway during the storm event. The inlet location is shown in Figure 13.

The evidence suggests the inlet became blocked with debris during the storm event which caused water to overflow from the culvert inlet and flow down the driveway of a residential property opposite the Royal Oak Inn, and onto Pontshonnorton Road. Post event inspections also identified a section of the tarmac driveway to have suffered from subterranean hydraulic pressure, i.e., the driveway appears to indicate that water from the culvert network erupted, through the tarmac and contributed to the flooding along Pontshonnorton Road (Figure 14).

Figure 13: Map illustrating flow path C and the Ely Brook culvert inlet, 'Culvert Inlet 3'

of 'Culvert Inlet 3' (noted in Figure 13), alongside evidence of culvert failure (Figure 14), it is likely that the networks' hydraulic capacity was further reduced.

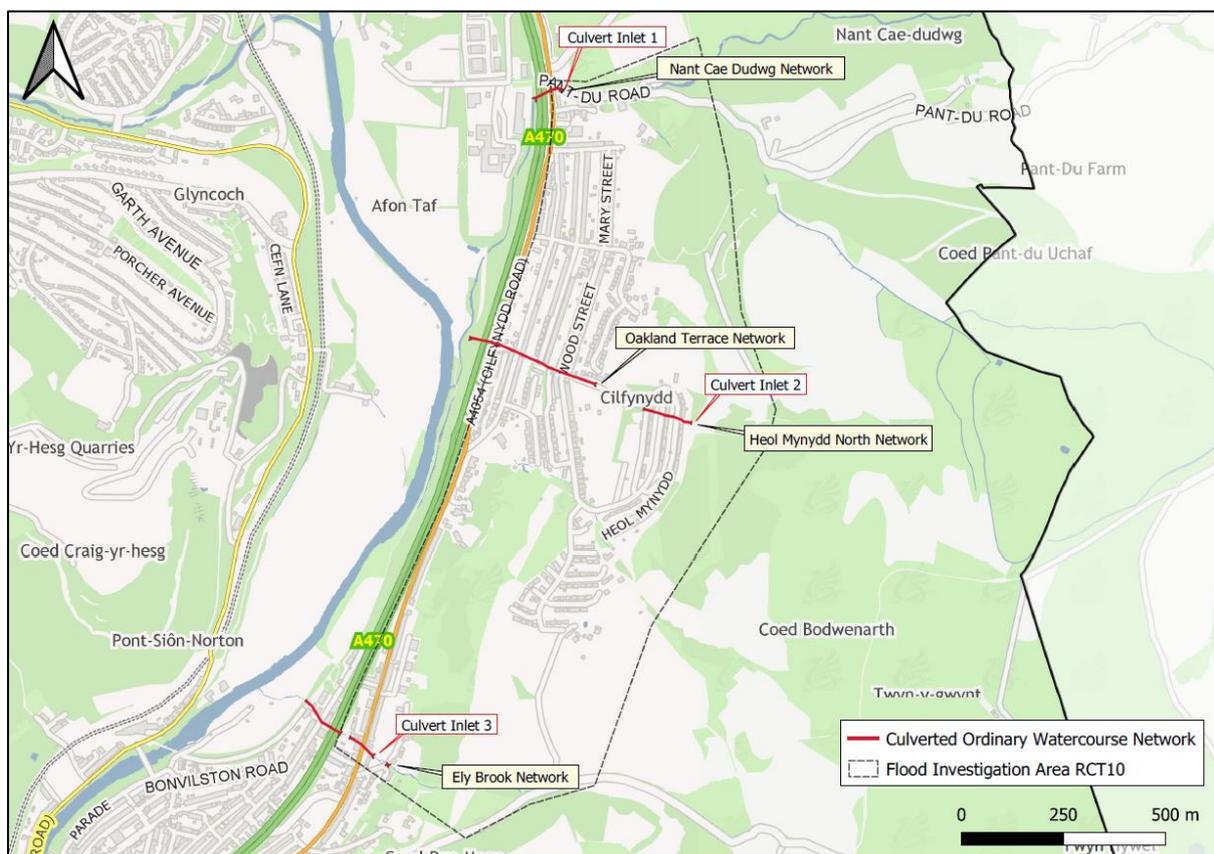
Several culvert inlets were inspected by RCT's Flood Risk Management team after the flood event to assess their condition and to determine whether they served as a contributing factor to the flooding in Cilfynydd. CCTV survey inspections of the culvert networks were also undertaken to ascertain both the operational condition of the network, and its structural integrity along sections of the network. Figure 15 outlines the four networks surveyed and highlights the culvert inlets known to have surcharged.

Figure 15: Surveyed culverted watercourse networks within flood investigation area RCT10

Culvert networks within the flood investigation area (Figure 15) were surveyed post event to ascertain the internal condition of the network, the results of which fed into a review of the hydraulic performance of the network to ascertain its current standard of protection using Causeway Flow modelling. The results of the culvert inlet capacity assessments are summarised in the Table below, along with a determination of whether flooding was observed during Storm Dennis.

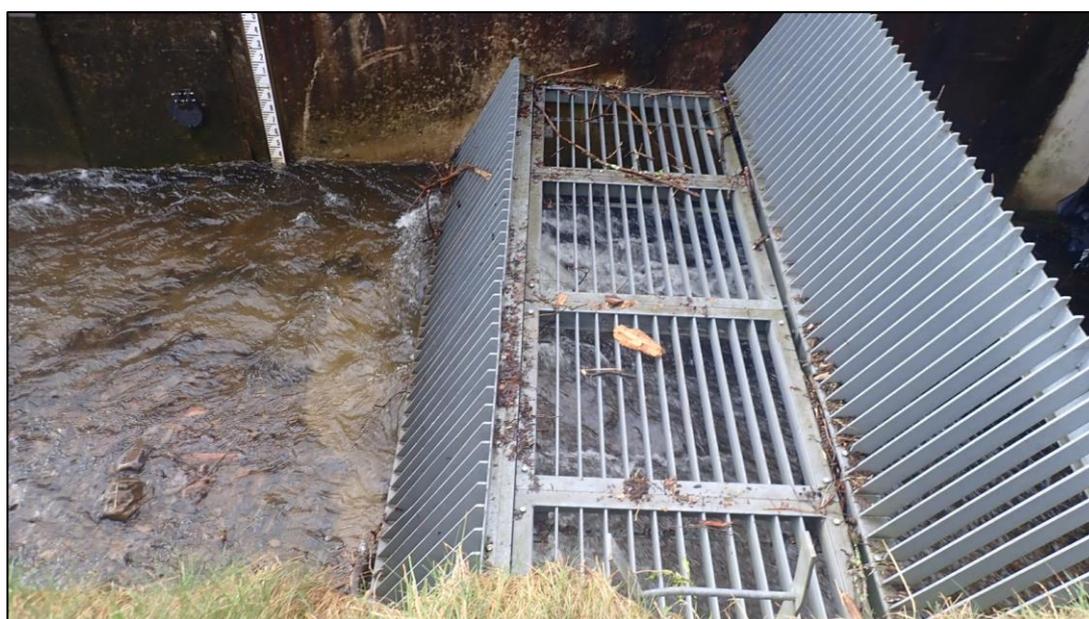
The culvert inlet was inspected by RCT's Highway Authority prior to the storm event on the 13th February 2020 and was found to be in good condition with no significant blockages or debris present (Figure 16).

Figure 16: Photo of 'Culvert Inlet 1' (Nant Cae Dudwg culvert inlet) captured by RCT's Flood Risk Management team prior to Storm Dennis on 13th February 2020

Following reports that 'Culvert Inlet 1' which conveys the Nant Cae Dudwg ordinary watercourse beneath Cilfynydd Road was the source of flooding to eight residential properties at Cilfynydd Road, post event inspections were carried out. According to emergency responders, the culvert inlet debris screen was partially blocked with woody debris, suggesting some debris was likely deposited during Storm Dennis however, there was little evidence to suggest that the inlet surcharged due to blockage during the event.

The culvert inlet was cleared of debris on 17th February 2020 by the Council's Depot once the watercourse level had subsided and safe working conditions were available. Notably, the debris screen shows no evidence of damage caused by the flood event (Figure 17). Trash screens further upstream of the inlet had significant stonewash and debris trapped behind which would suggest that the largest debris did not reach the

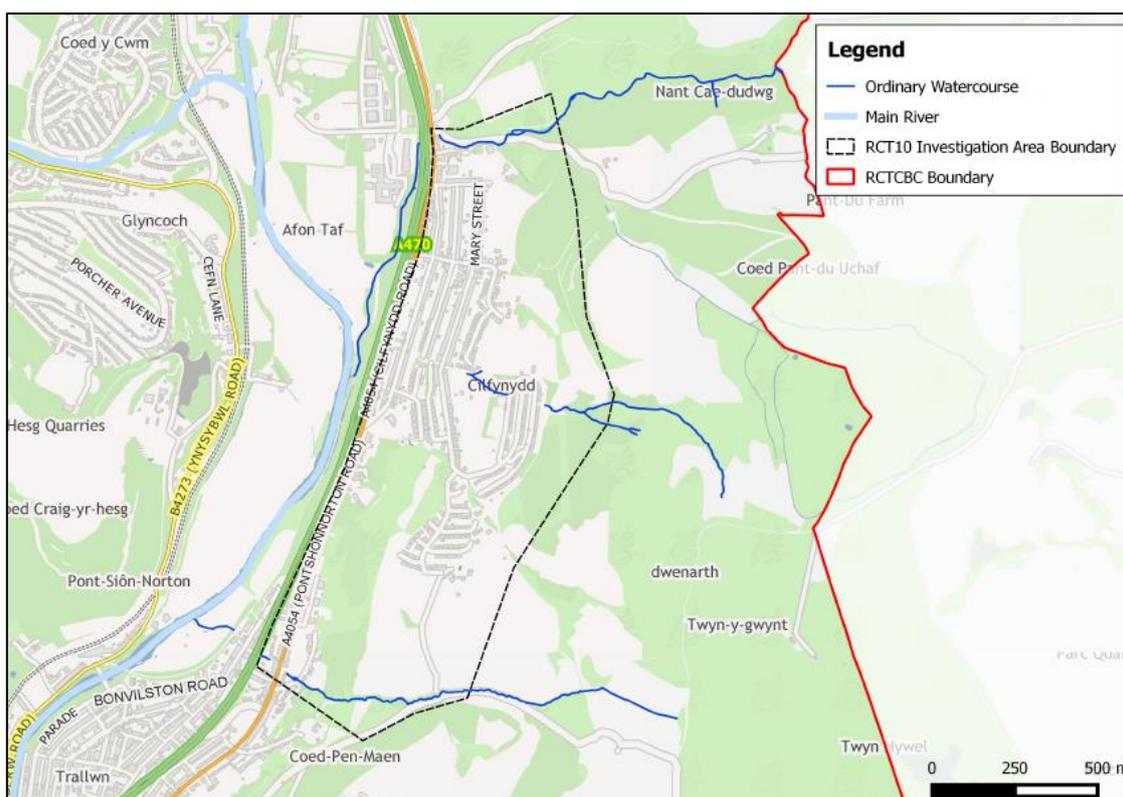
Several unnamed open watercourses and ditches which drain the steep catchment to the east and northeast of Cilfynydd are identified to flow through investigation area RCT10. The ordinary watercourses associated to the flooding at Cilfynydd are illustrated in Figure 21.

Figure 21: Map of Ordinary Watercourses which feed into investigation area RCT10

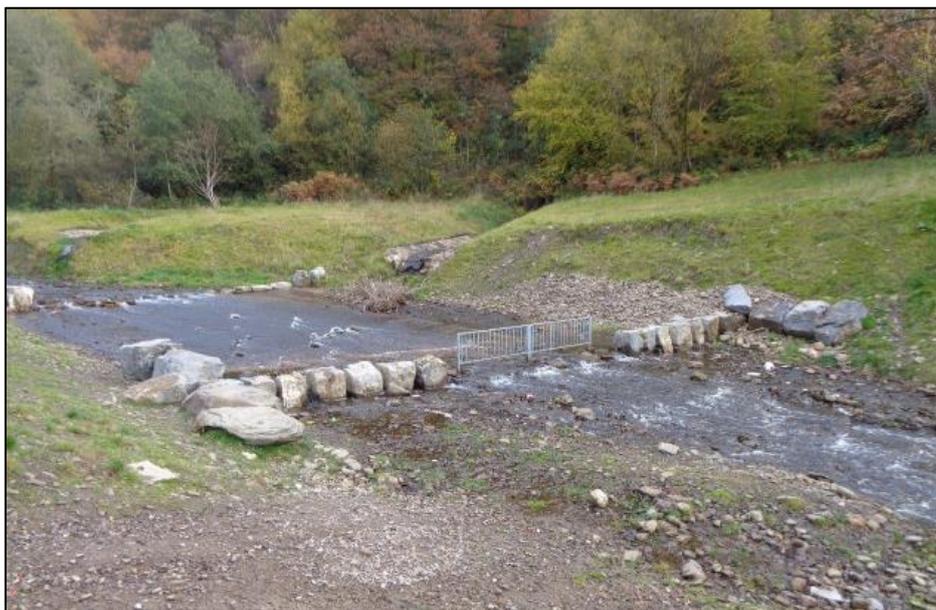
Figures 24 and 25 have been provided to illustrate the condition of the upper catchment debris screens operating debris free prior to Storm Dennis.

Figure 24: Initial upstream debris screen in the Nant Cae Dudwg watercourse captured prior to Storm Dennis

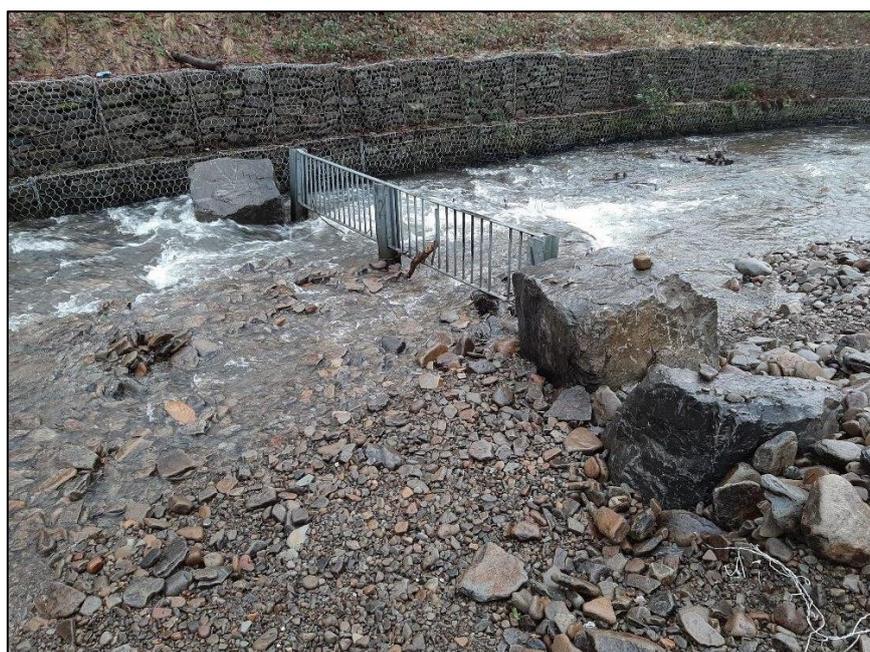
Figure 25: Second upstream debris screen in the Nant Cae Dudwg watercourse captured prior to Storm Dennis

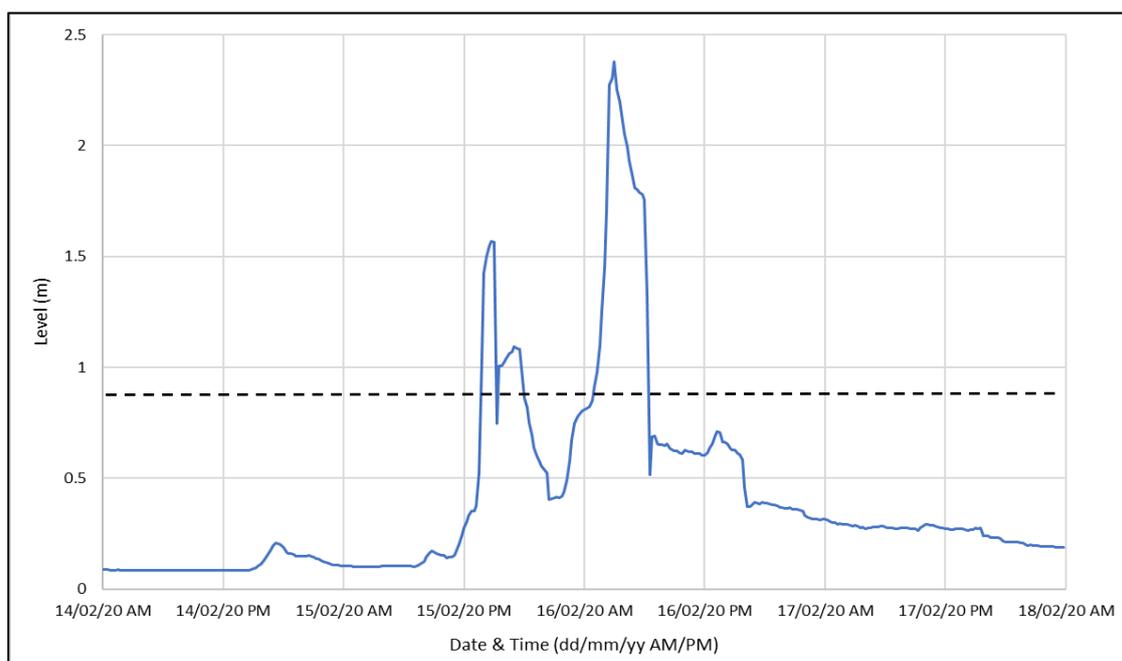
Based on data captured by RCT's Nant Cae Dudwg monitoring station, the storm resulted in two significant peaks in the level of flow within the Nant Cae Dudwg watercourse. Both peaks are illustrated in Figure 28. The initial peak triggered the alarm system at 13:45 on 15th February 2020 which resulted in a peak watercourse level of 1.567 meters at 14:45. During this hour the Nant Cae Dudwg rose suddenly by 528mm. The second and most prominent peak activated the alarm system at 01:00 on 16th February 2020 and caused a peak level of 2.37m at 03:00.

Figure 28: Water level in the Nant Cae Dudwg ordinary watercourse during the 14 – 18th February 2020 captured by RCT's monitoring station. Dashed line represents the alarm trigger threshold (0.9m)

Based on data captured by the monitoring station, and accounts provided by residents, it is considered that the volume of water in the Nant Cae Dudwg watercourse exceeded the capacity of the inlet and headwall structures during the early hours of Sunday 16th February 2020. This resulted in the watercourse backing up the channel where the flood water overtopped the flood wall before ultimately entering the affected properties from the rear.

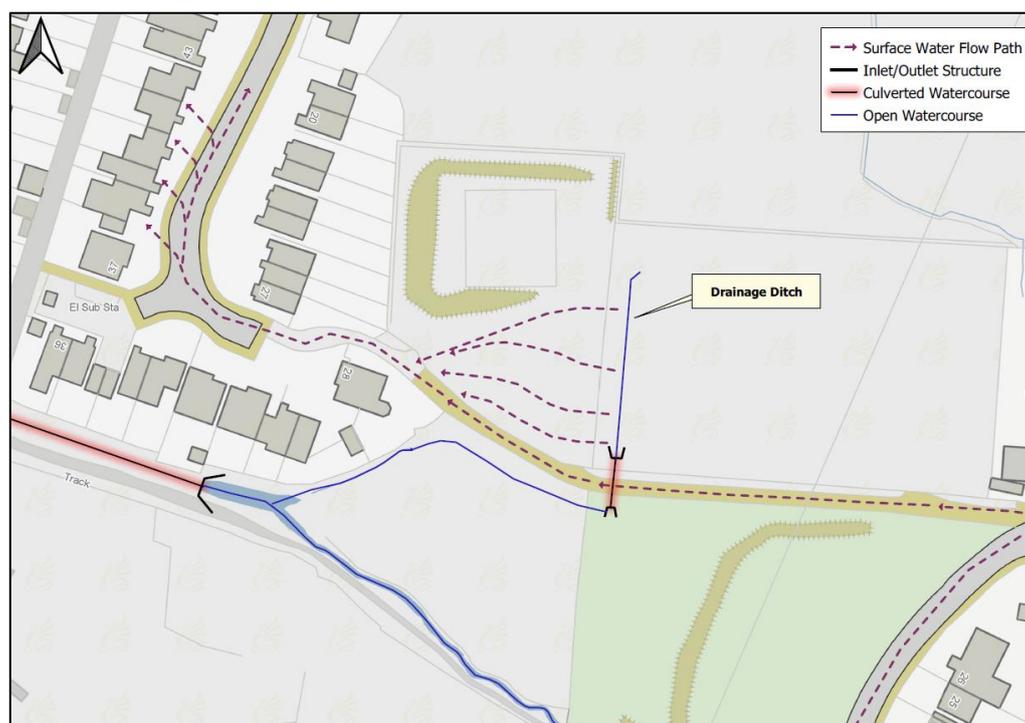
The inspection noted that the land drainage channel is culverted beneath the lane before outfalling into the adjacent stream that flows towards Oakland Terrace culvert network. Residents report that the inlet became blocked during the event, resulting in water overtopping the channel (Figure 32) and flowing towards the downstream field and onwards to impact properties at Brynderwen. The land drainage channel and observed flow paths have been illustrated in Figure 33.

Figure 33: Location of the identified land drainage ditch and observed surface water flow paths during Storm Dennis

Despite the land drainage channel being identified as a secondary source of flooding, the primary source of flooding to properties in this area originated from the surcharged culvert inlet to the rear of Heol Mynydd.
