Flood and Water Management Act 2010

Section 19 Report

Storm Bert – Flood Investigation Area 08

October 2025

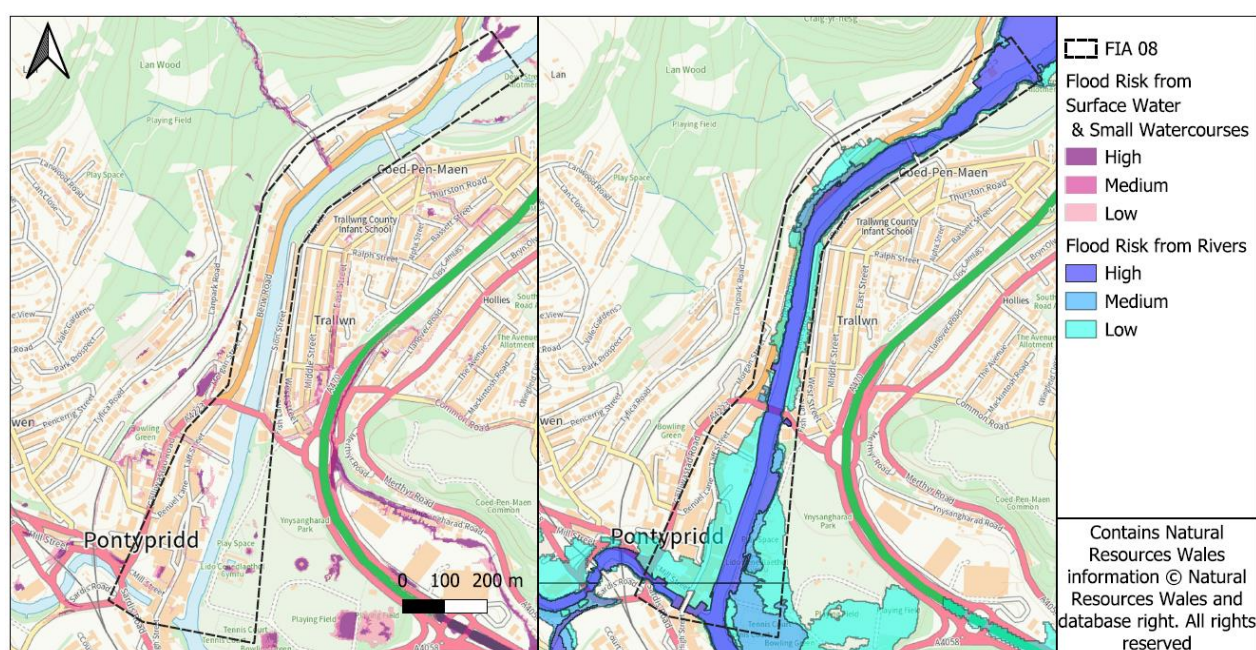
Figure 2: Natural Resources Wales's Flood Risk Assessment Wales (FRAW) map for surface water and small watercourses, and main river flood risk at FIA 08.

According to Natural Resources Wales's (NRW) Flood Risk Assessment Wales (FRAW) maps, the most apparent source of flood risk within the investigation area is associated with main river flooding (Figure 2). The highest risk to people and properties within FIA 08 is broadly associated with the River Taf. Low to high main river flood risk is observed along the eastern and western embankments of the river, particularly at the confluence of the River Taf and Rhondda, which flows into the investigation area from the southwest. Flood risk from surface water and ordinary ('small') watercourses is also noted across parts of FIA 08, although not as widespread or severe. Areas adjacent to the main river may be at risk of both surface water and main river flooding, as illustrated within RCT's Flood Risk Management Plan 2015⁵.

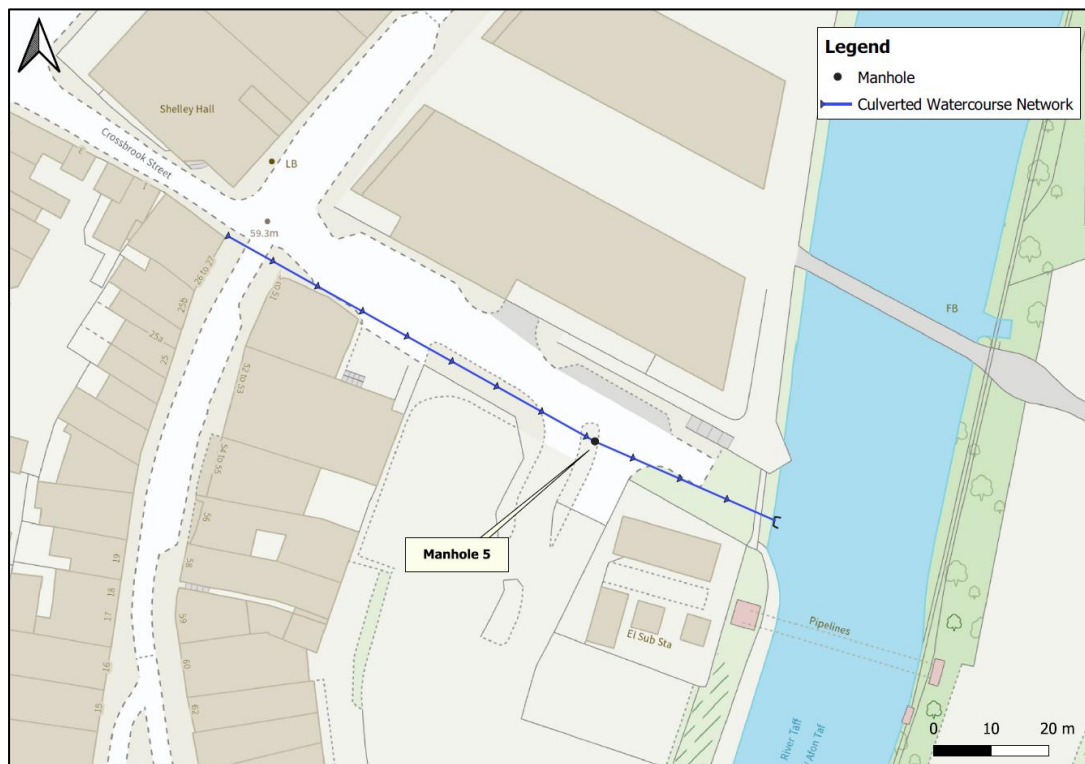
Figure 18: Surveyed culverted ordinary watercourse network conveying beneath Gas Road in FIA 08.

Following the surcharging of 'Manhole 5' which resulted in flooding to Gas Road Car Park during the storm event, the Council and DCWW, respectively, undertook CCTV survey operations to establish the assets connectivity. It was identified that 'Manhole 5' is associated to a culverted ordinary watercourse which conveys beneath Gas Road and discharges into the River Taf. The section of surveyed culverted watercourse network at Gas Road is shown in Figure 18.

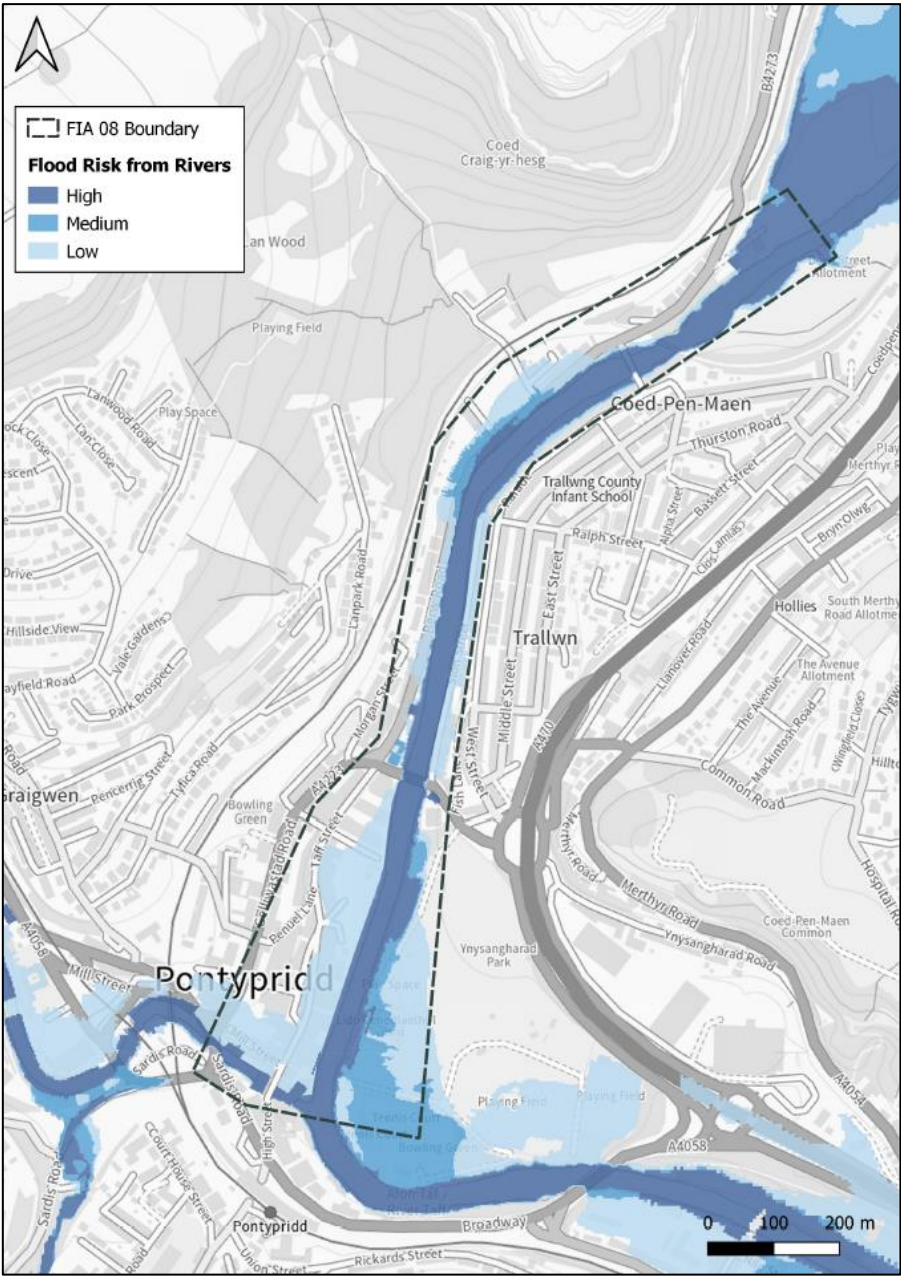
Figure 22: NRW's FRAW map for River sources at FIA 08. Natural Resources Wales.

Figure 22 is an excerpt from NRW's Flood Risk Assessment Wales (FRAW) mapping exercise which depicts the main river flood risk extents for the 'Managed' scenario, i.e., with the presence of flood defence infrastructure. The darker shading identifies areas at higher risk of flooding (more frequent/less extreme rainfall events) and lighter shading showing the lower risk areas (less frequent/more extreme rainfall events). The flooding that occurred within FIA 08 during Storm Bert is largely consistent with the modelled outputs of NRW's FRAW map (Figure 21), with the majority of the impacted properties falling within an area of low main river flood risk. Notably, areas of Berw Road, Mill Street and Ynysangharad Park are identified at medium and high risk of main river flooding according to NRW's mapping.

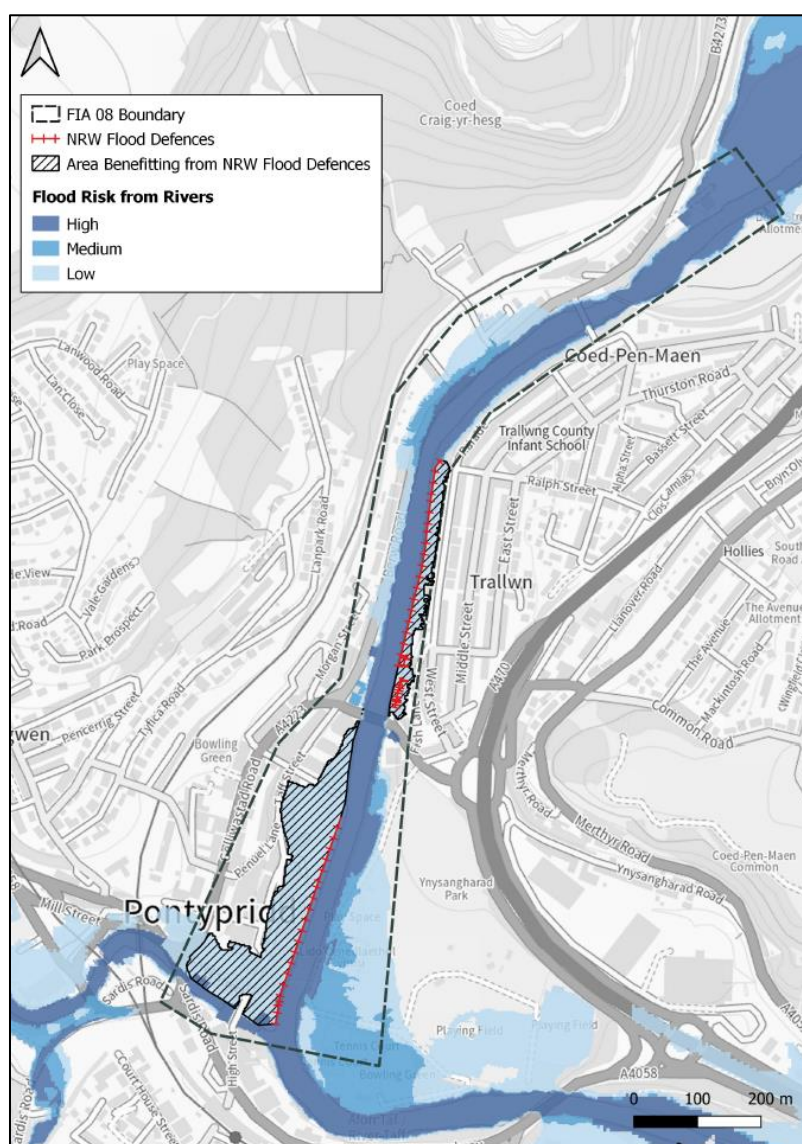
Figure 23: NRW map for Main River Flood Defences and areas benefitting at FIA 08. Natural Resources Wales.

As illustrated in Figure 23 (demarcated by the bold red line), there are approximately 2.3 kilometres of recorded flood defence infrastructure along the eastern and western banks of the River Taf at FIA 08. This infrastructure comprises of flood walls, embankments, flood gates and demountable defences which are operated and maintained by NRW.

According to NRW's FRAW maps, the flood defence infrastructure shown in Figures 23 and 24 provide a standard of protection (SOP) up to a 1 in 100 annual probability (Q100) flood event to several properties within the investigation area (demarcated by the black hatched area in Figure 23). The existing flood defence infrastructure at FIA 08 is therefore shown to be in accordance with current indicative standards. The areas noted as defended by flood defence infrastructure include properties at Sion Street, Taff Street and Mill Street.

Based on the available evidence collated from residents, Council officers and NRW, the formal main river flood defences at Taff Street and Sion Street did not overtop during Storm Bert. The River Taf exceeded its channel capacity, resulting in the overtopping of the highway wall at the southern end of Sion Street. This section of wall is not identified as a formal flood defence by NRW and should be referred to as a Non-Flood Defence (NFD) Structure. The formal flood gates (maintained and operated by NRW) at the entrances to residential properties along the southern end of Sion Street were not reported to have overtopped however, 10 properties benefiting from flood gates suffered internal flooding primarily as a result of water emerging from the ground and through external garden walls. This water was reported as being dirty and brown in colour which is not indicative of a groundwater source

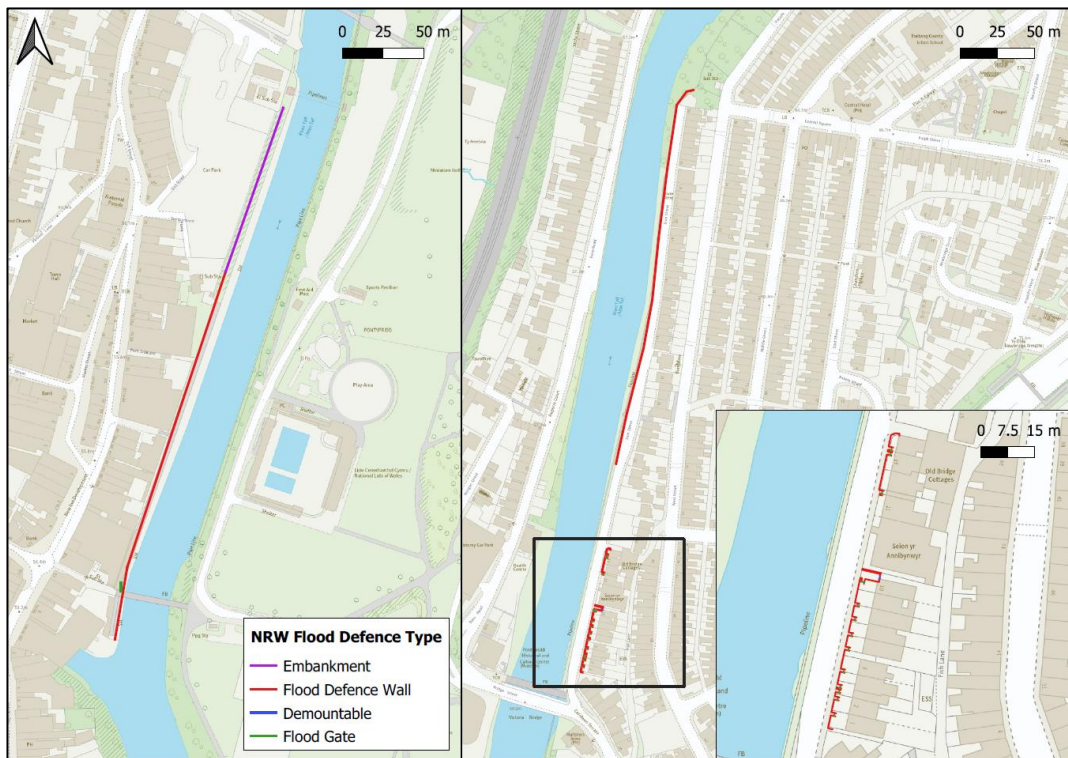
Figure 24: Map showing NRW's Main River Flood Defence Sub-Types at Taff Street and Sion Street. Natural Resources Wales.

NRW's flood defence sub-types along Taff Street and Sion Street have been enlarged in Figure 24. The flood defence type along Taff Street consists of an embankment and flood defence wall to the rear of commercial properties and a flood gate at the entrance to Ynysangharad Park bridge. The flood defence type at Sion Street consists of a flood defence wall adjacent to the highway and a combination of flood gates and flood defence walls outside the fronts of several residential properties.

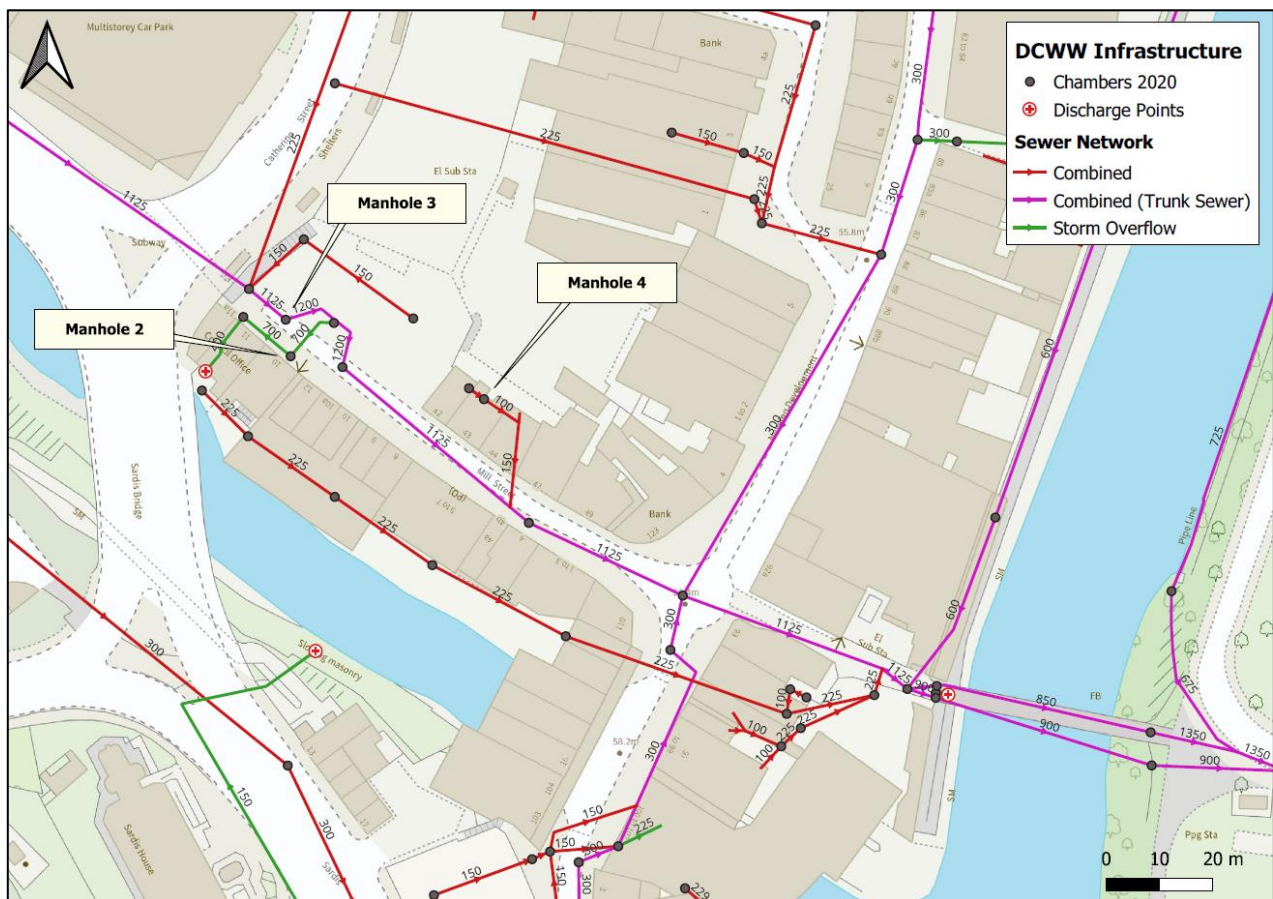
At Mill Street, 3 DCWW owned and operated manholes which are connected to the combined sewer network were observed as surcharging and causing flooding to properties during the storm event. The DCWW sewer infrastructure within the Mill Street area is depicted within Figure 27, along with the assets known to have surcharged and caused flooding during Storm Bert.

Figure 27: Map of DCWW sewer infrastructure in and around Mill Street

As depicted in Figure 27, there is a 1200-1125mm dia. Trunk Sewer running through Mill Street highway. A Trunk Sewer is a large diameter pipe that receives wastewater from smaller diameter sewer pipes and conveys this wastewater either to an intercepting sewer or treatment plant. The Trunk Sewer at Mill Street receives wastewater from several smaller diameter sewers and conveys wastewater towards Ynysangharad Park.

There is also a 700-450mm dia. Storm Overflow network which conveys from the Trunk Sewer to a Combined Sewer Overflow (CSO) which discharges into the Rhondda River. Storm Overflows are an outlet from the public sewer that is designed to allow excess rainwater and sewage to escape when the sewerage system is at risk of being overwhelmed, such as during heavy rainfall.

Based on the available evidence, and information provided by DCWW, it is considered that the combined sewer network surcharged during Storm Bert after becoming hydraulically overloaded as a result of intense rainfall, resulting in the surcharging of 'Manhole 2', '3' (see Figure 10) and '4', which contributed to the internal flooding of 17 commercial premises at Mill Street.

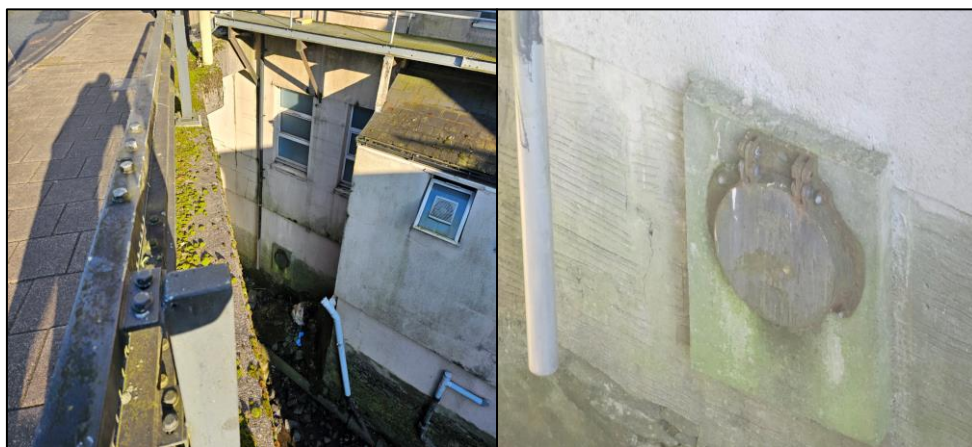
On review of the asset information, 'Manhole 2' is situated within a 700mm dia. Storm Overflow network which conveys combined sewer overflows from the Trunk Sewer, beneath commercial properties, before discharging into the River Rhondda. The discharge point is fitted with a non-return flap valve on the outfall structure, visible from the A4058 Sardis Bridge and depicted within Figure 28, which was operating according to DCWW. The high levels in the River Rhondda are not considered to have entered the Storm Overflow network..

Figure 28: Image of the outfall structure associated to the DCWW Storm Overflow outfall.

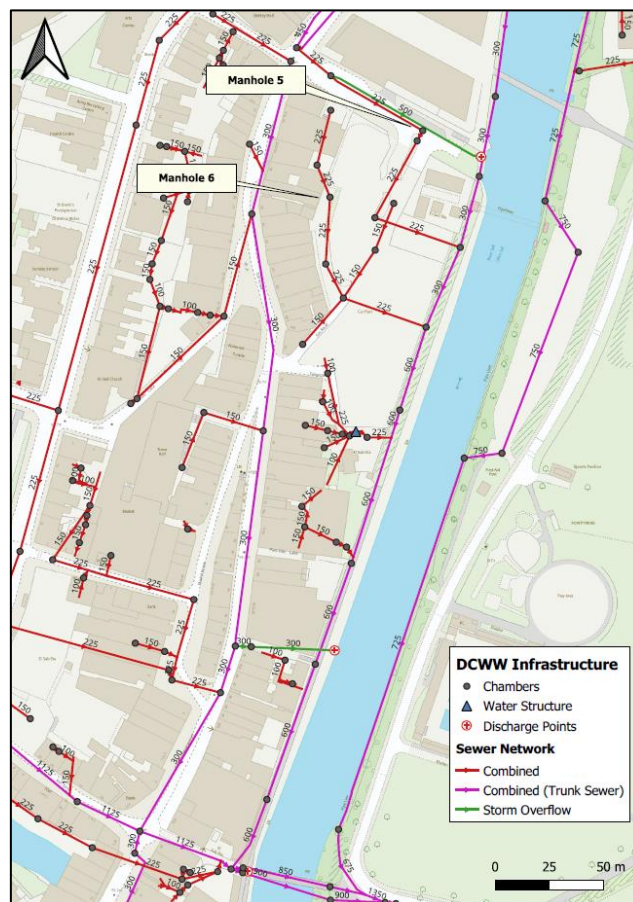
The combined sewer network elsewhere in FIA 08 also became hydraulically overwhelmed during the storm event as a result of intense rainfall. This resulted in the surcharging of 'Manhole 6' located to the rear of commercial properties at Taff Street, causing internal flooding to 2 commercial premises from the rear. The location of 'Manhole 6' is shown in Figure 30. The asset is connected to the Trunk Sewer which conveys sewer water from Taff Street towards Ynysangharad Park.

Figure 30: Map of DCWW sewer infrastructure in and around Taff Street.

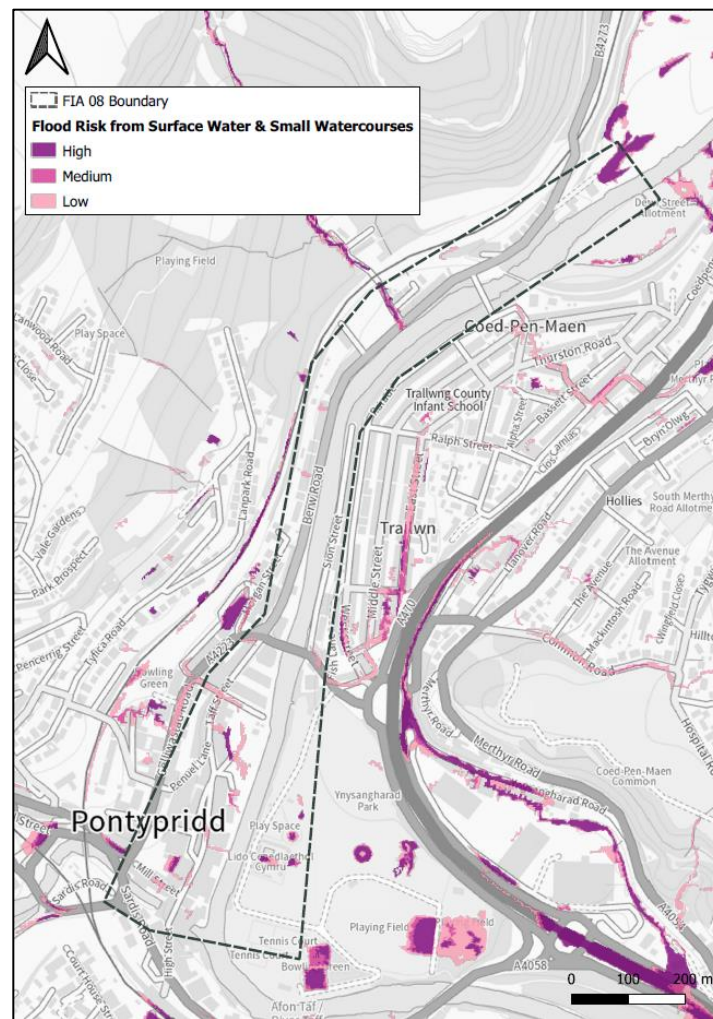
On review of NRW's national surface water and ordinary ("small") watercourse flood map (Figure 31), the extent of flooding from these sources is minimal, with only small, localised areas of high to low flood risk observed along parts of Taff Street, Mill Street, northern end of Berw Road and Ynysangharad Park.

Figure 31: NRW's FRAW map for Surface Water and Ordinary Watercourse flood risk at FIA 08. Natural Resources Wales data.
