# Flood and Water Management Act 2010

## Section 19 Flood Investigation Report

Storm Dennis –

Flood Investigation Area RCT02  
(Aberdare & Aberaman)

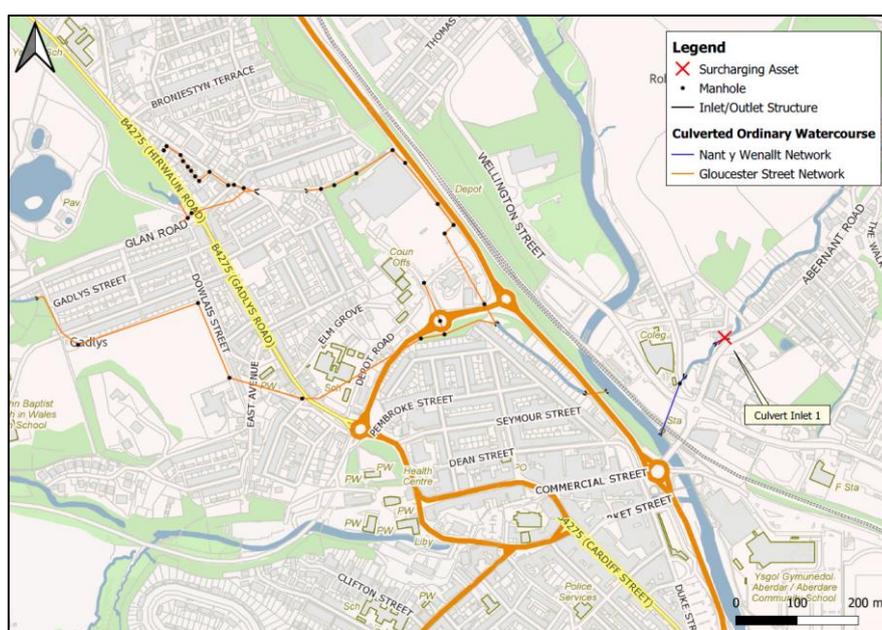
**Figure 12:** Surveyed culverted ordinary watercourses and surcharged culverted infrastructure within the northern half of RCT02 (Abernant & Aberdare sub-catchments)

Based on the available evidence presented within this investigation, 'Culvert Inlet 1' associated to the 'Nant y Wenallt' culvert network (Figure 12) is considered to have surcharged during the storm event, contributing to the internal flooding of two properties at Abernant Road. 'Culvert Inlet 1' conveys the Nant y Wenallt beneath the highway leading from Abernant Road and is identified as a privately owned asset. Post event surveying of the 'Nant y Wenallt culvert network' identified large debris reducing the culvert networks cross-sectional area by 90% as illustrated in Figure 14. The identified debris is considered to have been mobilised from upstream, causing an obstruction and reduction in the culvert network's hydraulic capacity to manage the flow of water, leading to the Nant y Wenallt surcharging at 'Culvert Inlet 1'.

The CCTV survey also identified significant defects and blockages present in the culvert network downstream of 'Culvert Inlet 1', further indicative of the mobilisation of debris from the upper catchment.

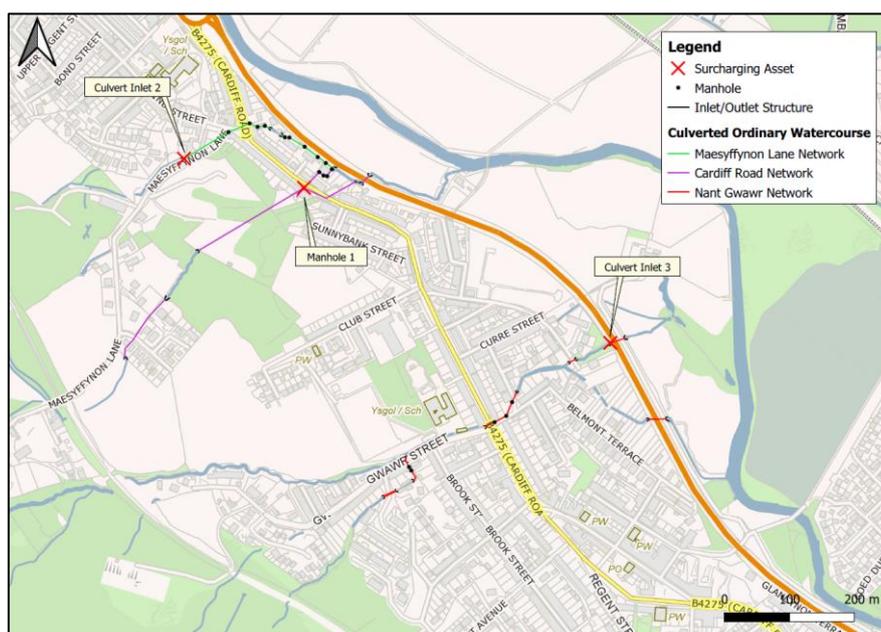
**Figure 13:** Surveyed culverted ordinary watercourses and surcharged culverted infrastructure within the southern half of RCT02 (Aberdare & Aberaman sub-catchments)

'Culvert Inlet 2' associated to the 'Maesyffynon Lane' culvert network (Figure 13) was observed to have surcharged during the storm event, resulting in flooding to properties at Wind Street and Cardiff Road within the Aberdare West sub-catchment. The inlet is identified as the responsibility of the Council and was inspected by RCT's Highway and Streetcare Depot post event and identified as blocked with debris mobilised from the upstream channel.

The culvert network downstream of 'Culvert Inlet 2' was assessed as being in acceptable condition with limited structural defects and settled debris observed. The outfall was also observed to have little debris, inferring that the debris screens upstream of 'Culvert Inlet 2' succeeded in reducing the volume of debris conveying into the culvert network but in doing so caused an obstruction to the debris screen at 'Culvert Inlet 2' which led to the watercourse overtopping.

Following the observed surcharging of 'Manhole 1', the associated 'Cardiff Road' culverted watercourse network and overflow system (Figure 13) were surveyed on several occasions post Storm Dennis. The culvert network was assessed as being in poor structural and operational condition with debris identified within the network, both downstream and upstream of 'Manhole 1', restricting CCTV operations. Figure 15 illustrates the poor condition of the 'Cardiff Road' culvert network during CCTV survey operations.

The main line culvert network downstream of 'Manhole 1' was assessed as being in poor condition. The culvert network was identified as deformed with several fractures present which is considered to have impacted the hydraulic efficiency of the network to manage the flows entering the system. The main line culvert network also has a 90-degree bend downstream of 'Manhole 1' which is considered to have hydraulically locked the culvert system, contributing to the surcharge at 'Manhole 1' during Storm Dennis.

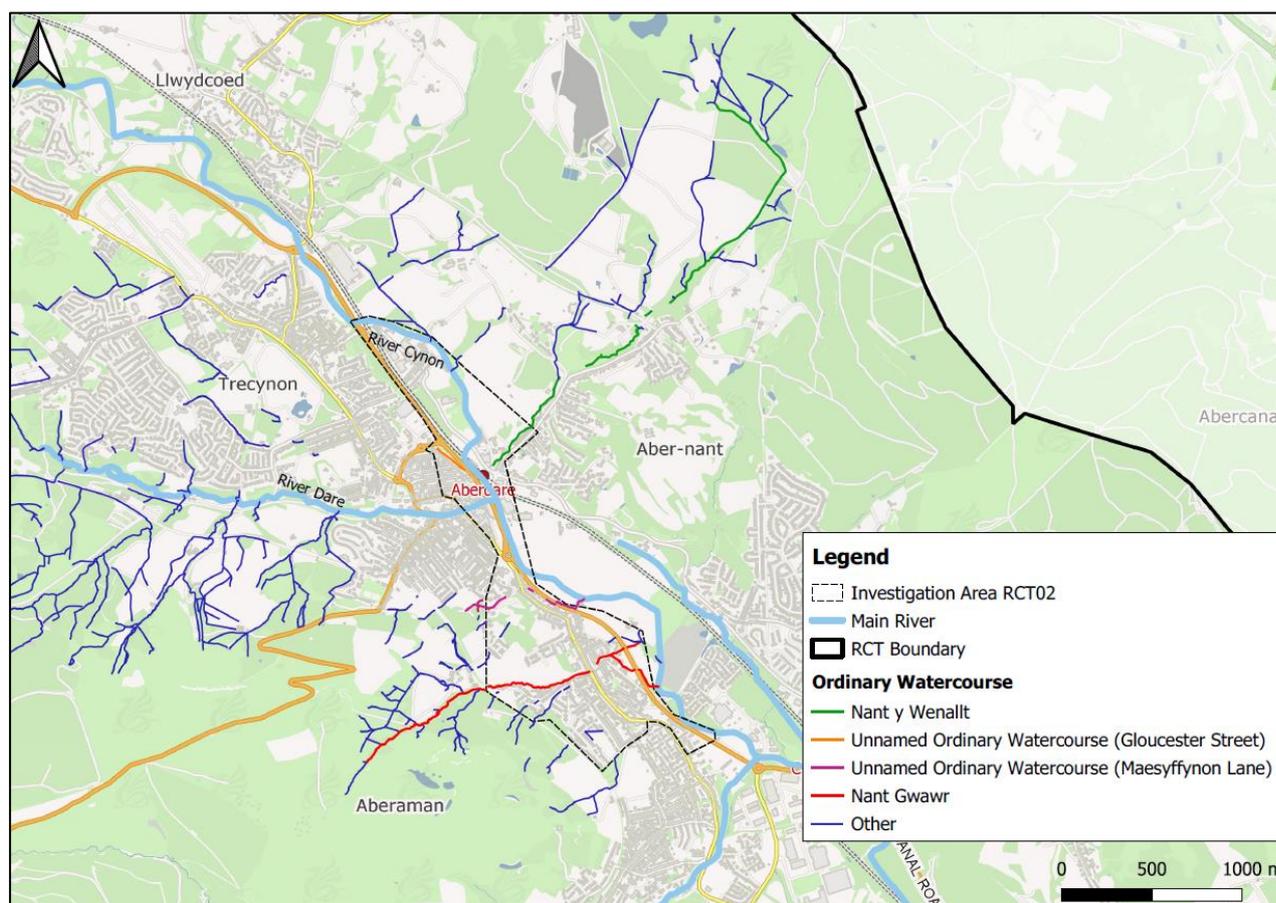
**Figure 19:** Map of Ordinary Watercourses flowing through RCT02

Several sections of natural ditches and open watercourses which drain the steep hillsides above RCT02 are identified to flow through the investigation area and discharge into the River Cynon (Figure 19). The most notable watercourses include the Nant y Wenallt watercourse to the east of Aberdare and the Nant Gwawr watercourse which flows through the Aberaman.

The Nant y Wenallt ordinary watercourse conveys from the upper Abernant catchment to the northeast of investigation area RCT02 towards the River Cynon at Aberdare (highlighted green in Figure 19). The Nant y Wenallt largely flows as an open channel along the hillside before becoming more heavily culverted towards the lower reach of Abernant Road where ‘Culvert Inlet 1’ was identified as surcharging during Storm Dennis.

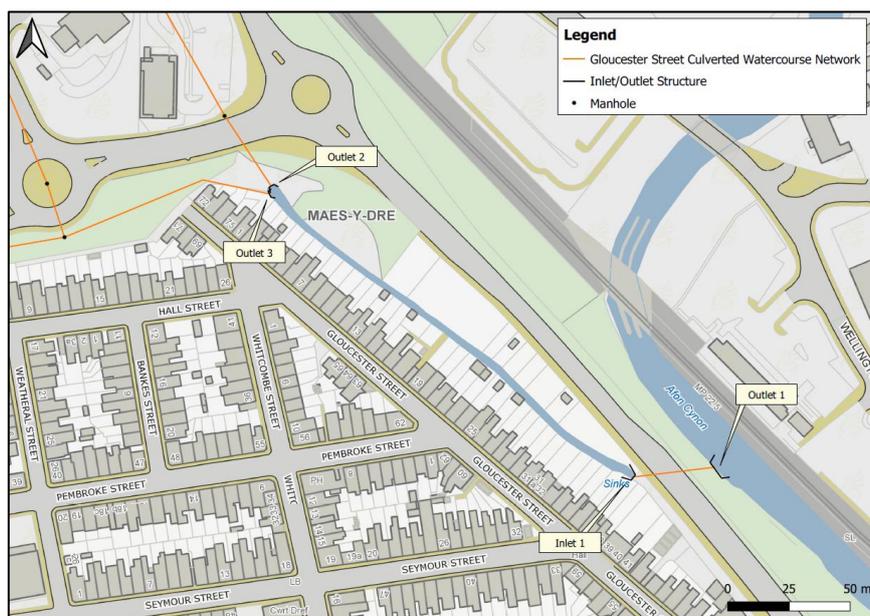
**Figure 21:** Map of unnamed ordinary watercourse to the rear of Gloucester Street and labelled culverted infrastructure

The unnamed ordinary watercourse to the rear of Gloucester Street (highlighted orange in Figure 19) was identified as overtopping and causing internal flooding to 9 residential properties. The watercourse and associated culverted infrastructure are depicted in Figure 21.

Responses provided by residents during the public engagement exercise reported that the unnamed ordinary watercourse near 'Inlet 1' (Figure 21) was observed as ponding with little flow identified within the channel during the storm event. The unnamed ordinary watercourse discharges into the River Cynon beneath the A4059 at 'Outlet 1'. It is considered that the high river levels on the River Cynon during Storm Dennis restricted the discharge of flow from the unnamed ordinary watercourse contributing to the overtopping of the watercourse into the rear gardens of several properties.

Asset information relating to the culverted infrastructure depicted in Figure 21 was assessed to determine the cross-sectional area of the outlet and inlet structures to manage the flows. 'Outlet 2' and 'Outlet 3' (Figure 21) comprise of 1200mm dia and 750mm dia concrete pipes, providing a combined cross-sectional area of 1.57m<sup>2</sup>. Both outlet structures are depicted in Figure 23.

According to residents affected by the overtopping of the unnamed watercourse to the rear of Gloucester Street, the watercourse was observed to be unmoving and ponding. It is considered that the elevated levels on the River Cynon contributed to the overtopping of the unnamed ordinary watercourse by influencing the discharge of water from 'Outlet 1' (Figure 21) and into the River Cynon.

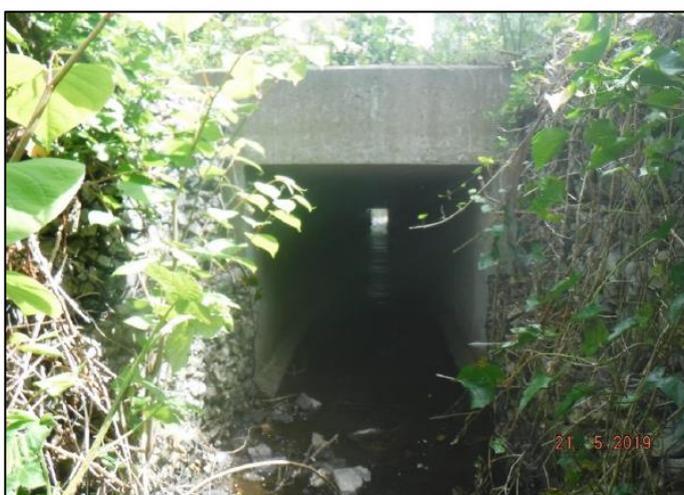
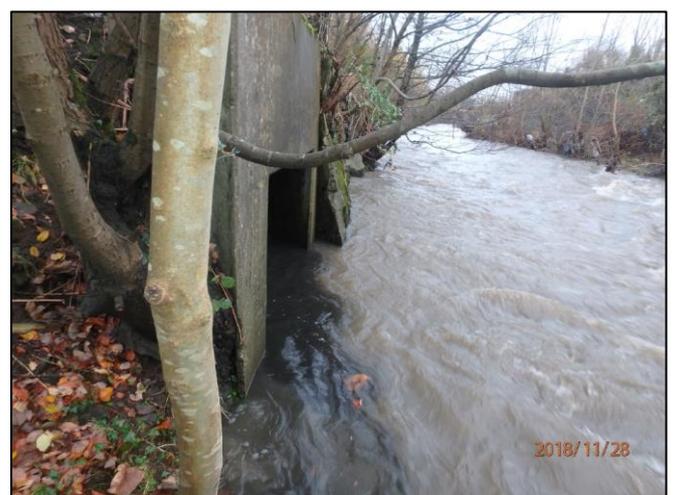
**Figure 24:** Downstream view of 'Inlet 1' (left) and image of 'Outlet 1' looking upstream of the River Cynon (right) (captured by RCT officers prior to Storm Dennis)

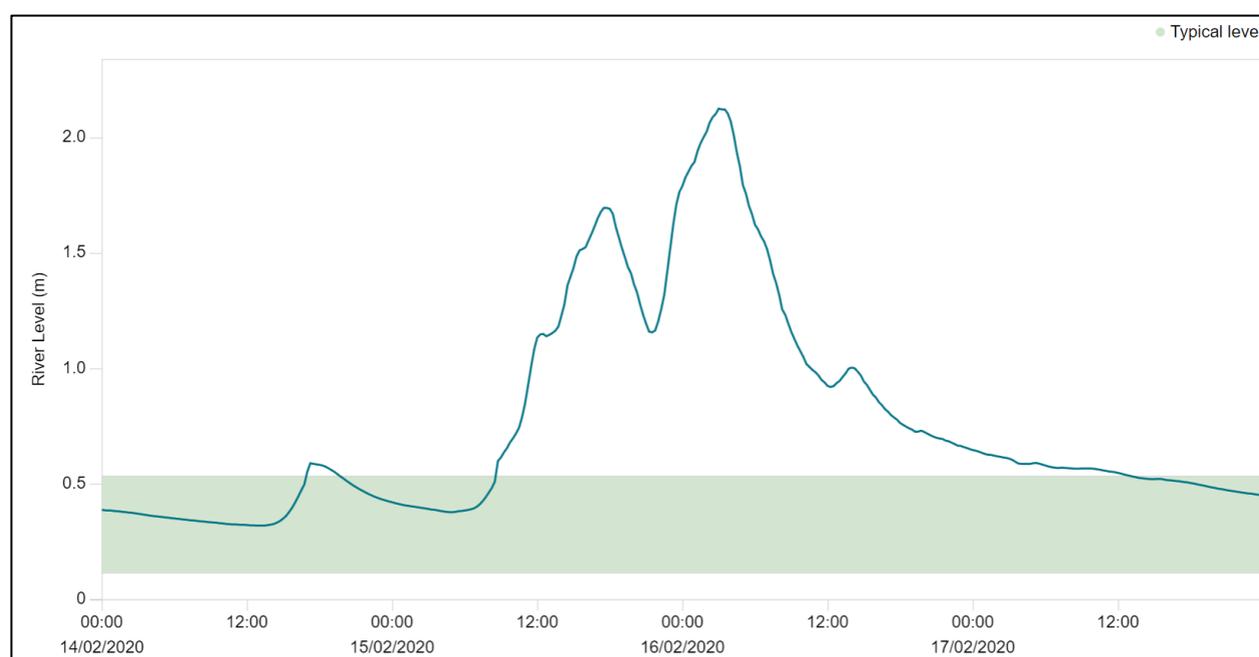
The hydrograph in Figure 29 illustrates the rapid rise in levels of the River Cynon in response to rainfall between the 14 – 17<sup>th</sup> February 2020. River level data was captured at NRW’s Aberdare monitoring station which is situated within Aberdare town centre.

NRW issued a ‘Flood Alert’ (indicating possible flooding) for the River Cynon at 12:51 on the 15<sup>th</sup> of February, during that time the River Cynon at Aberdare had reached over a metre in depth. The River Cynon continued to rise during the early hours of Sunday 16<sup>th</sup> February morning before reaching a peak level of 2.125 meters at 03:00 on 16<sup>th</sup> February 2020; the highest level recorded for the River Cynon at Aberdare.

**Figure 29:** The River Cynon levels at Aberdare station between the 14<sup>th</sup> and 17<sup>th</sup> February 2020 (Natural Resources Wales)

The green bar displayed on the hydrograph shows the typical level of the River Cynon at Aberdare station, ranging between 0.1 and 0.55 metres. At its peak, the River Cynon

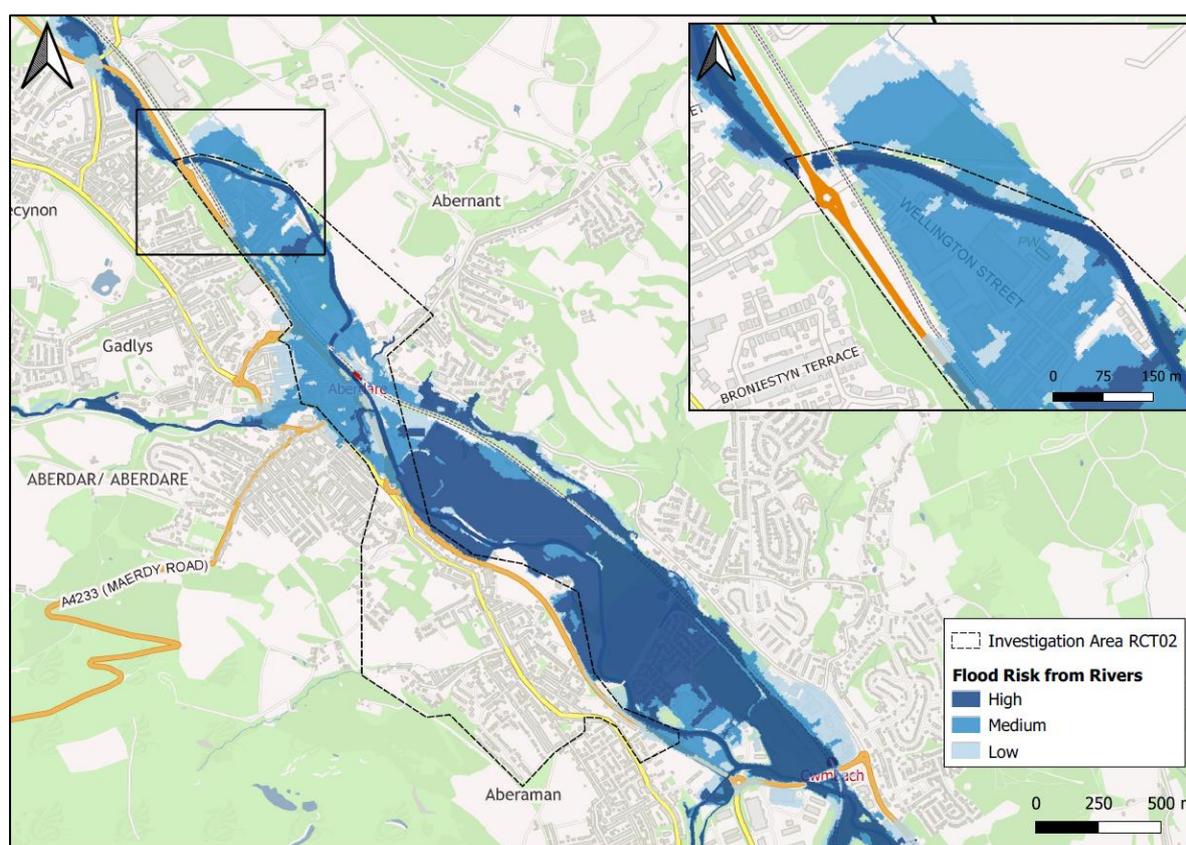
**Figure 30:** NRW's FRAW map for River sources at RCT02. Contains Natural Resources Wales information © Natural Resources Wales and database right. All rights reserved.

The flooding that occurred within RCT02 during Storm Dennis is largely consistent with the modelled outputs of NRW's FRAW map (Figure 30), with the impacted properties falling within an area of high and medium risk of fluvial flooding. A high risk of flooding means that an area has a chance of flooding of greater than 1 in 30 (3.3%) each year; a medium risk of flooding signifies a yearly chance of flooding between 1

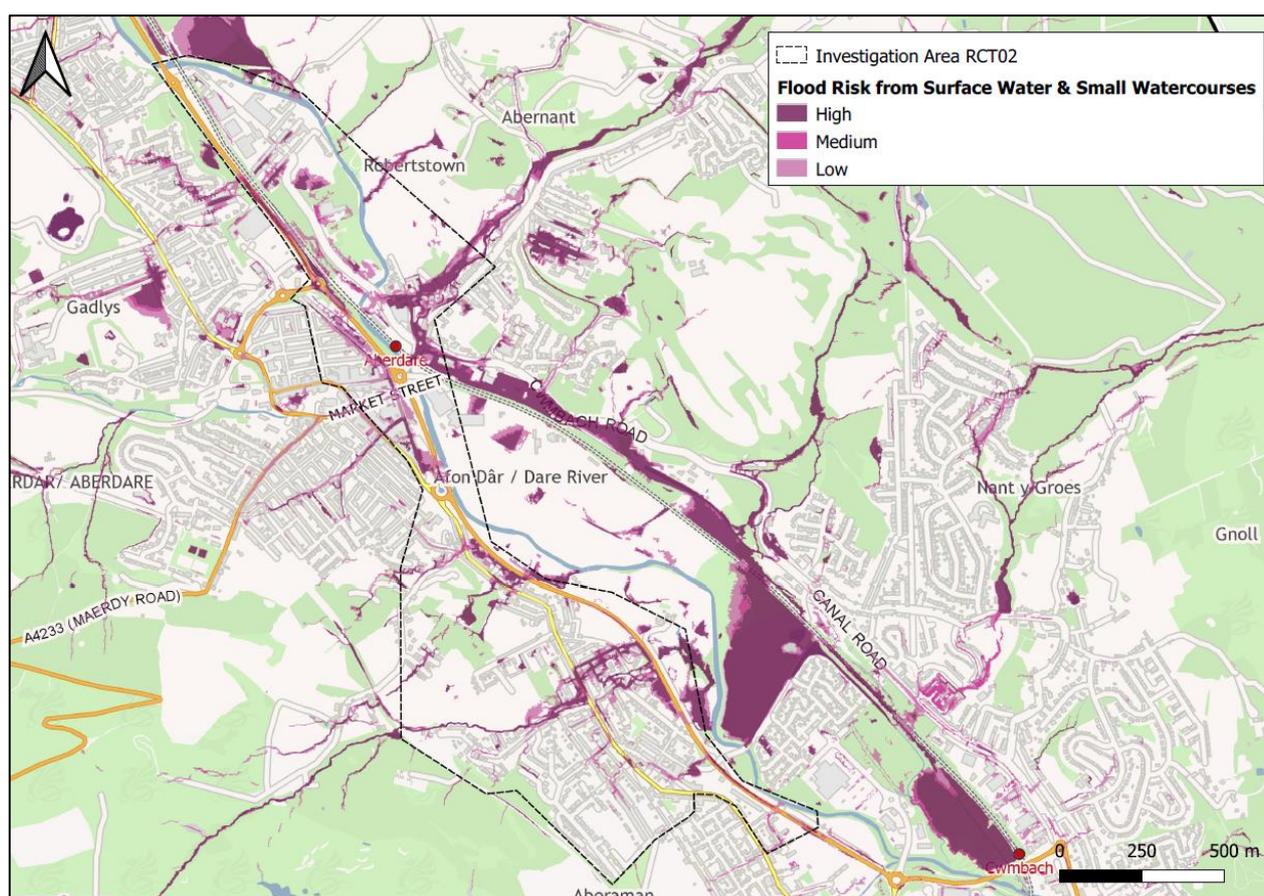
**Figure 32:** NRW's FRAW map for surface water and ordinary watercourse sources in RCT02. Contains Natural Resources Wales information © Natural Resources Wales and database right. All rights reserved.

On review of NRW's national surface water and ordinary watercourse flood map (Figure 32), the extent of flooding from pluvial sources within RCT02 is significant and correlates well with the observed flooding during Storm Dennis. A high to low flood risk is observed along several streets within the investigation area, mainly associated to the network of ordinary watercourses and culverted infrastructure.
